Hydraulic Laboratory Technical Memorandum PAP-1043

## Scanning Sonar Survey Report- Buffalo Bill Power Plant Tailrace

Pick-Sloan Missouri Basin Program

November 2011

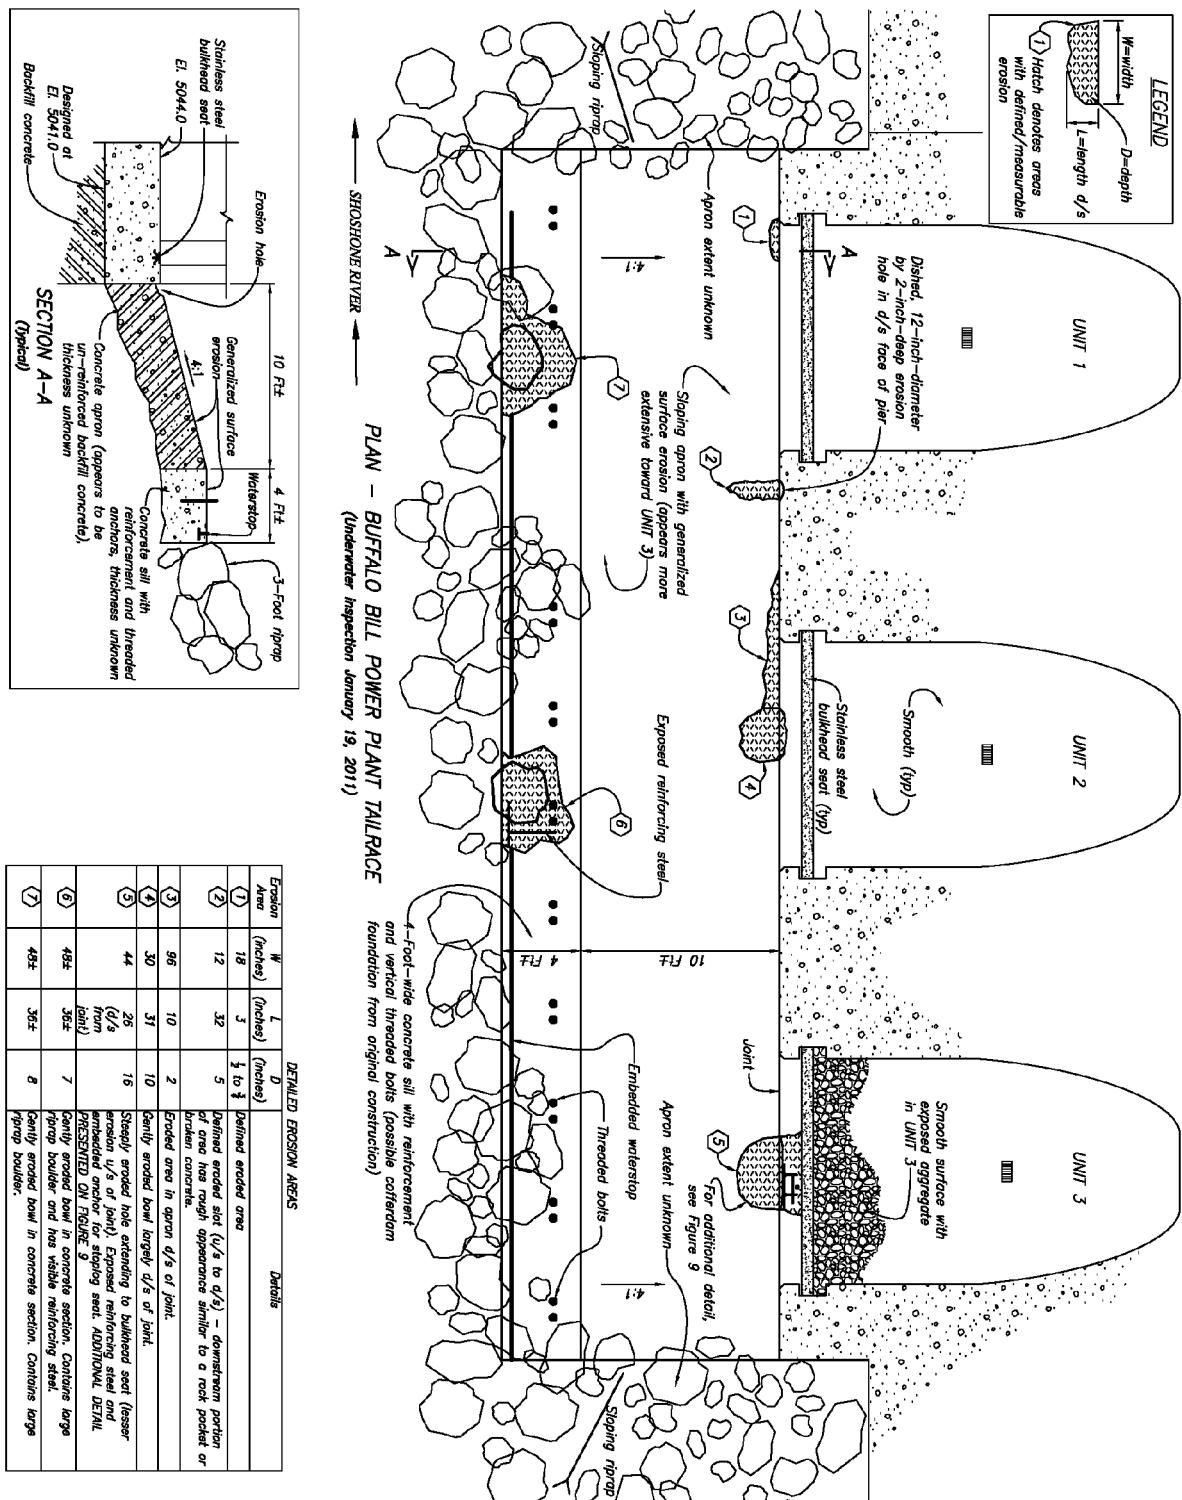
**Unit 1-** The January 2011 dive report stated: “There was only minimal damage observed at the end of the unit 1 draft tube. Other than the general surface erosion on the apron concrete, one defined erosion area was located just downstream of the right corner of the draft tube and one area just to the left of the draft tube (see areas 1 and 2 on Figure 4). The first area extended about 18 inches from the right wall toward the center, had a depth of  $\frac{1}{2}$  to  $\frac{3}{4}$  inches and extended 3 inches downstream. There was a small amount (10 to 15 stones) of 1- to 3-inch-diameter rounded material in this area.”

Figure 4. Drawings of tailrace and draft tube damage observed by Reclamation divers during their January 2011 underwater inspection.

**Unit 2** -The January 2011 dive report stated: “There was measurable damage across about half of the end of the draft tube (see areas 3 and 4 on Figure 4) and was comprised of two distinct areas which were connected. The first area of erosion was a band along the joint between the apron and the power plant. This extended from about 48 inches to the right of the right draft tube wall to a point about 48 inches to the left of the right draft tube wall. This strip was about 2 inches deep and extended a maximum of about 10 inches downstream from the joint. At the time of the inspection, the eroded area contained about 2 gallons of 1- to 3-inch-diameter rounded rock and one sub-rounded boulder with a 28 inch maximum dimension. The boulder and most of the smaller rock were located in this erosion hole just to the right of the right draft tube wall and were likely held captive in eddy currents at this location during power releases.”

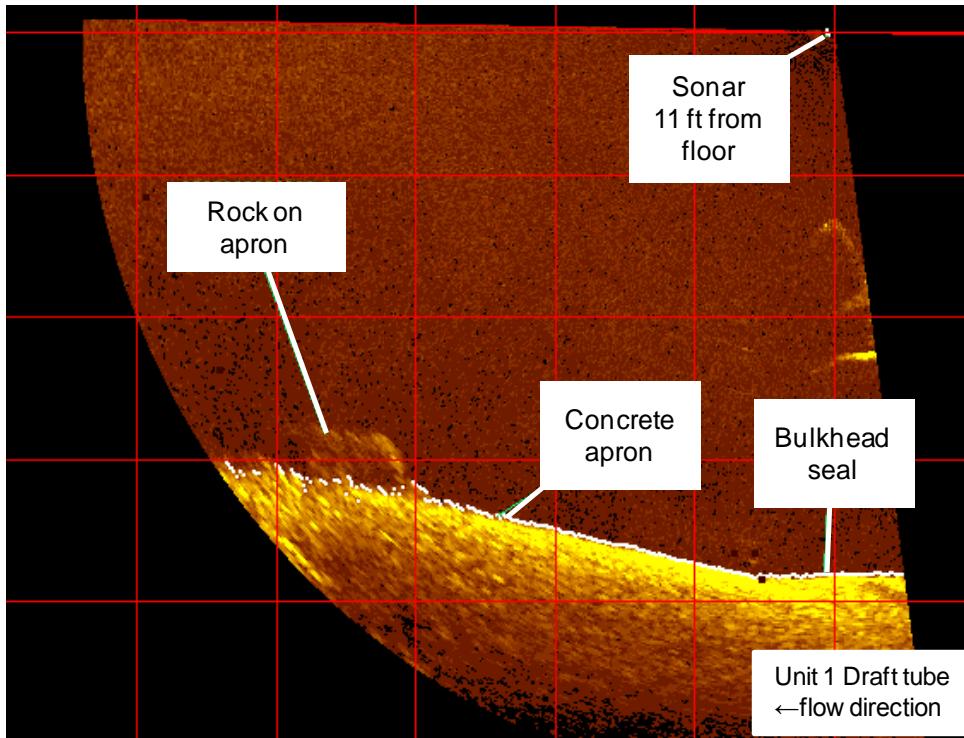
Sonar profiles were collected at 5 stations along the bulkhead gate slot. Figure 5 shows an east wall profile that did not reveal the minor erosion on the right corner of the draft tube that was observed by the divers. Furthermore, the profile did not detect the  $\frac{1}{2}$  to  $\frac{3}{4}$  inch depression in the apron concrete, but it is possible that the depression was filled with gravel. Figure 6 is a close-up sonar image collected along the unit 1 draft tube centerline (6 ft from the east wall). This image did not reveal any significant erosion around the bulkhead seal plate. Damaged area 2 in Figure 4 could not be profiled with the sonar deployed through the bulkhead slot.

Figure 5. Sonar profile collected 2 ft from the right (east) side of the unit 1 draft tube. No significant erosion damage was detected for erosion area 1 on figure 4. It is possible the erosion area is filled with sediment. A large piece of riprap was located about 8 ft from the draft tube-apron construction joint. The grid spacing is 3.0 ft/division and the scanning range was 15 ft.

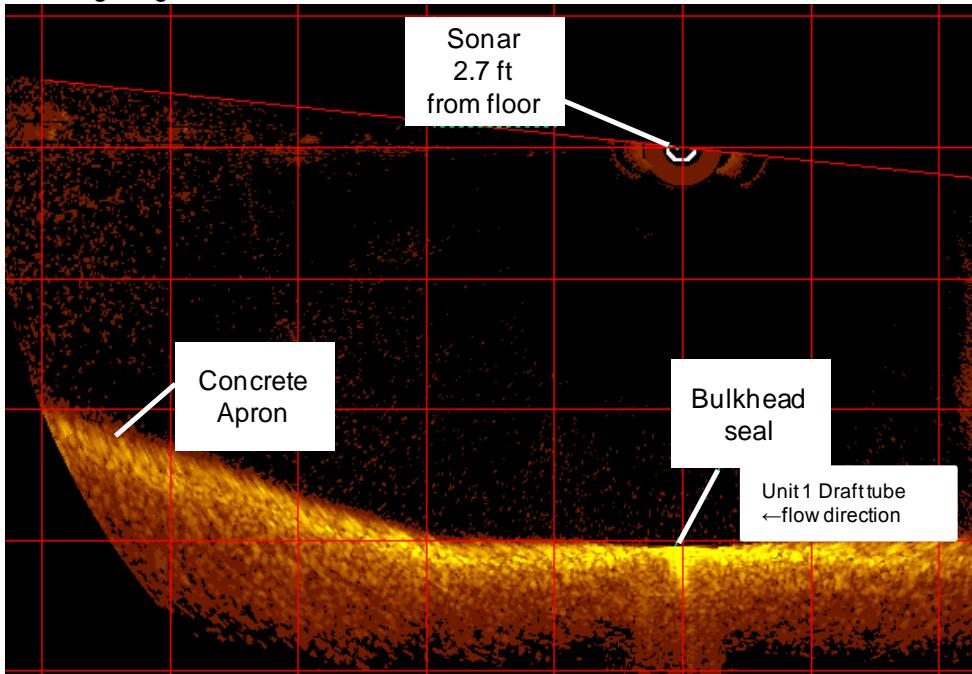
Figure 6. Close-up sonar profile collected 6 ft from the right (east) wall of the unit 1 draft tube. No significant erosion damage was detected in the vicinity of the bulkhead seat. The grid spacing is 0.9 ft/division and the scanning range was 4.5 ft.

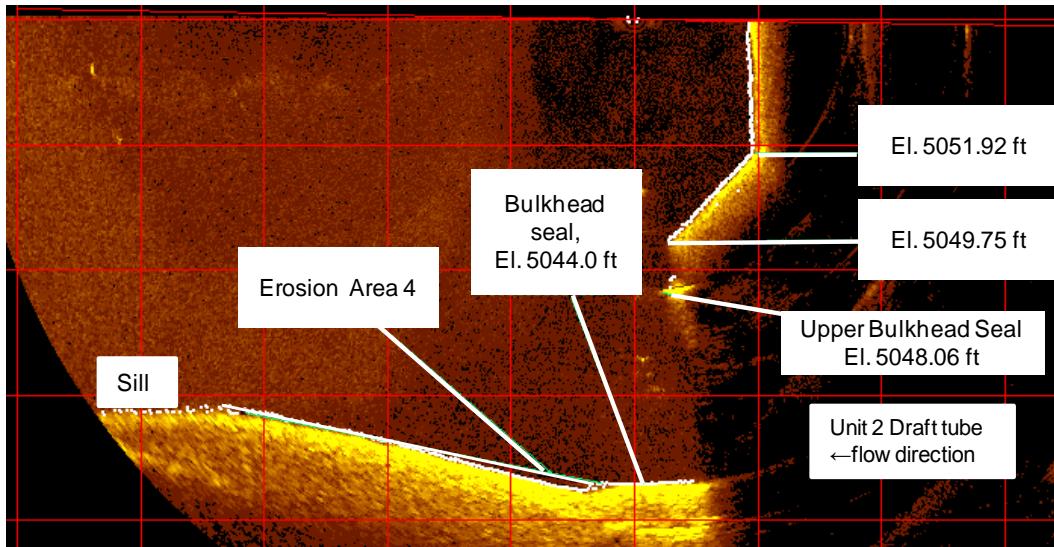
Sonar profiles were collected at 5 stations along the bulkhead gate slot. Figure 7 shows a typical profile that shows erosion damage areas near the centerline of the unit 2 draft tube. The length (L) of the erosion hole is about 45 inches which is larger than the length divers reported for erosion area 4 in Figure 4. However, the profile doesn't indicate a 10 in. depth for erosion area 4. It is likely that the hole is partially filled with rocks. Furthermore, the profile also shows the apron sill which has an uneven surface which is consistent with erosion area 6 in Figure 4.

Figure 7. Sonar profile collected 6 ft from the right (west) wall of the unit 2 draft tube. The vertical feature is the bulkhead guide wall and the upper bulkhead seal. Erosion area 4 is shown with a depth of about 3 in. and a length of 45 in. The hole appears to be partially filled with sediment. The grid spacing is 3.0 ft/division and the scanning range was 15 ft.

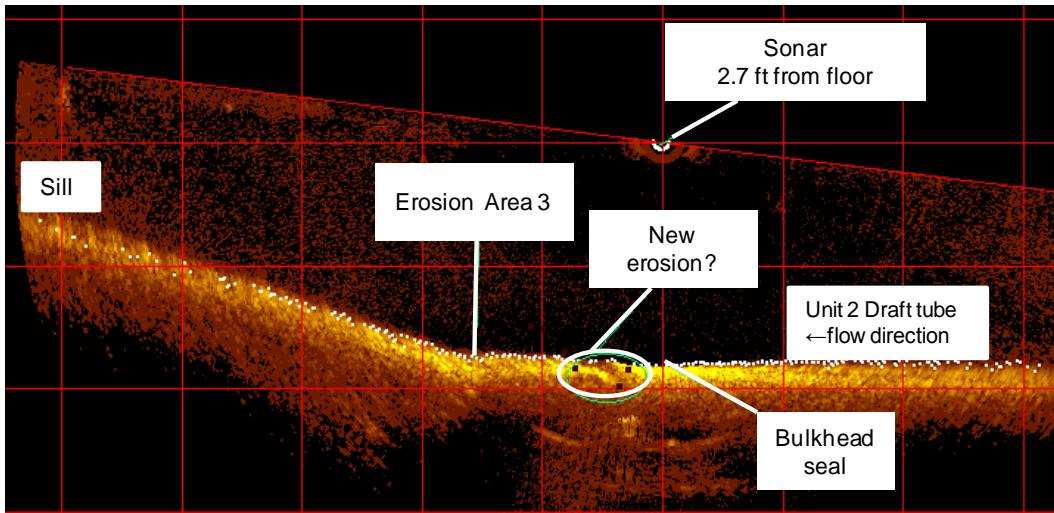
Figure 8 is a sonar profile collected 2 ft from the right (east) wall of the unit 2 draft tube. A slight depression was detected that is consistent with damage area 3. New erosion damage may be present in the vicinity of the bulkhead seal plate as indicated by a lack of profile points (white dots) and by a strong reflection located below the seat plate.

Figure 8. Sonar profile collected 2 ft from the right (east) wall of the unit 2 draft tube. A slight depression was detected that is consistent with damage area 3. New erosion damage may be present in the vicinity of the bulkhead seal plate. The grid spacing is 1.5 ft/division and the scanning range was 7.5 ft.

Sonar images were used to estimate size of erosion damage areas and there appears to be a small increase in the horizontal extents of erosion damage since the January 2011 underwater inspection. In addition, there appears to be new erosion damage which could be undermining the unit 2 seal plate. It is recommended that this damage be confirmed by divers.

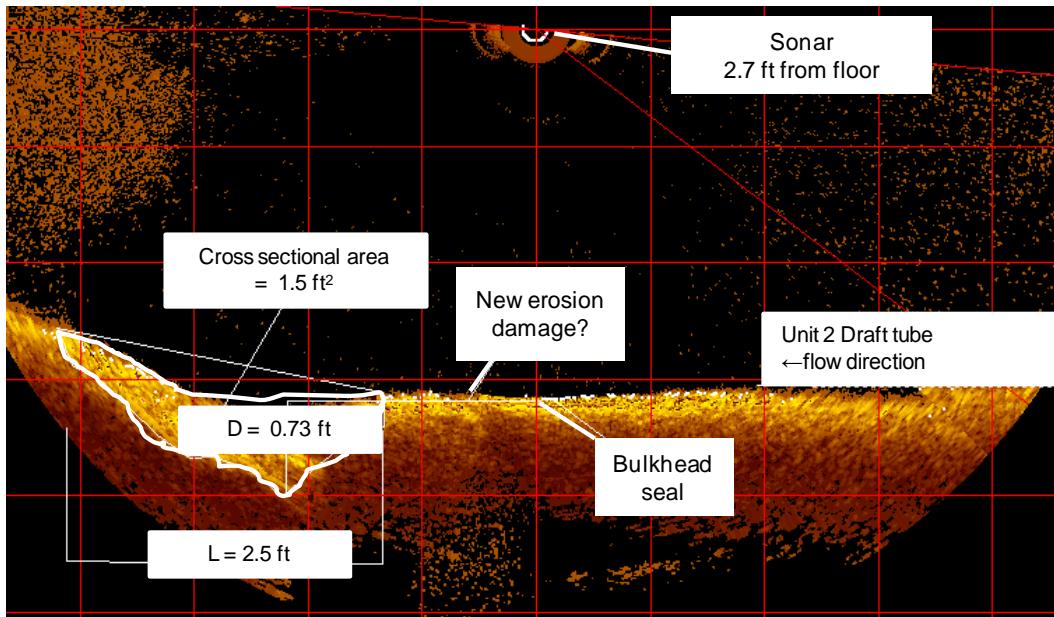
Figure 9 is a close-up sonar profile collected 6 ft from the right (east) wall of the unit 2 draft tube. An eroded area was detected at the toe of the apron slope which is consistent in dimension with damage area 4 in Figure 4. There also appears to be some new concrete erosion just downstream from the bulkhead seat.

Figure 9. Close-up sonar profile collected 6 ft from the right (east) wall of the unit 2 draft tube. A damaged area was imaged which is consistent in dimension with erosion area 4. There also appears to be new erosion damage just downstream from the seat. The grid spacing is 0.9 ft/division and the scanning range was 4.5 ft.

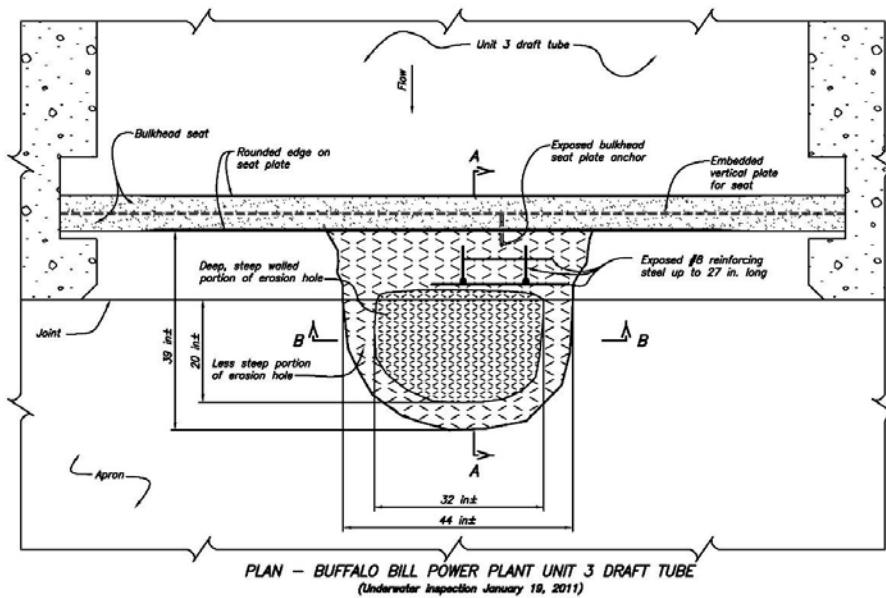
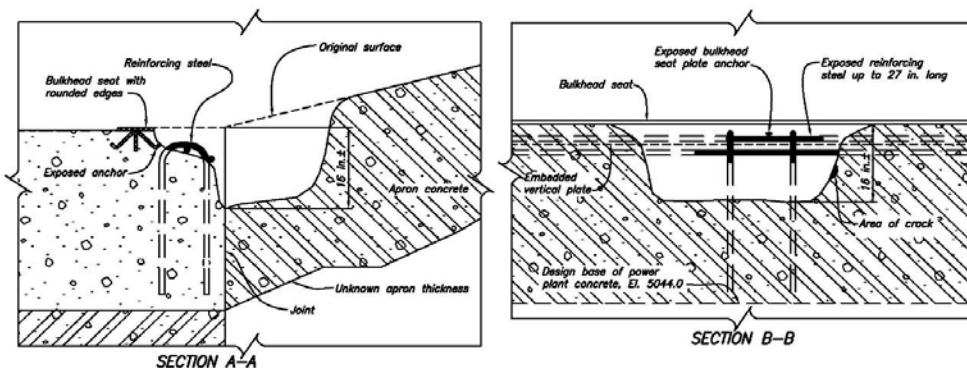
**Unit 3** -The January 2011 dive report stated: “There was a large erosion hole at the end of the unit 3 draft tube near the tube centerline (see Figure 10). The hole had a maximum depth of about 16 inches measured from the level of the stainless steel bulkhead seat. The top of the hole was about 44 inches wide with gently sloping side walls for the top several inches. Upstream to downstream the top of the hole measured about 39 inches and extended upstream to the edge of the bulkhead seat. The hole extended about 26 inches downstream from the joint. Below the top 4 inches of the hole, the hole became very steep with nearly vertical side walls. This steep portion of the hole was bounded roughly by the joint on the upstream side and extended about 18 to 20 inches downstream and had a width of about 32 inches.”

Other damage noted by the divers was to the unit 3 draft tube invert upstream of the bulkhead seat. The bulkhead seat was scratched, dented, with rounded edges both upstream and downstream. The surface of the seat was constructed flush with the concrete invert; therefore, this exposure of the upstream seat edge and rounding are indications of concrete material loss in the unit 3 draft tube invert.

Figure 10. Drawings of unit 3 tailrace and draft tube erosion damage observed by Reclamation divers during their January 2011 underwater inspection.

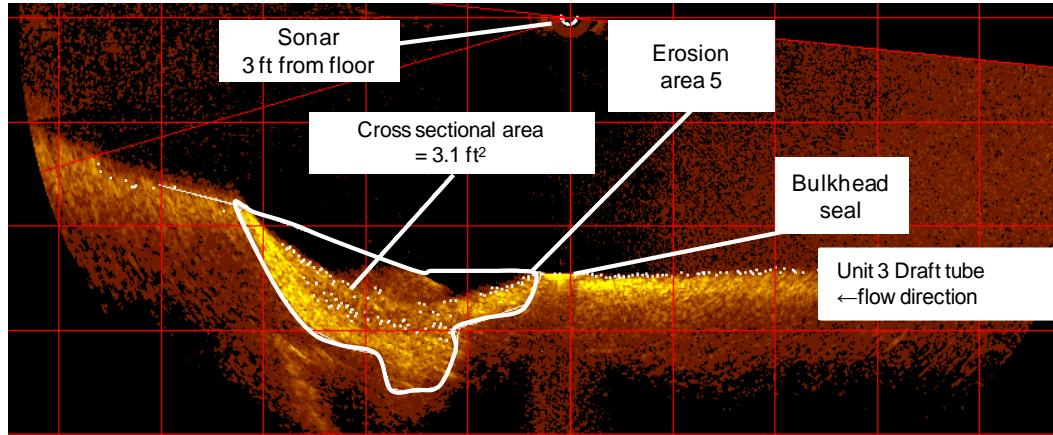
Figure 12. Close-up sonar profile collected 4 ft from the right (west) wall of the unit 3 draft tube. At this location a profile through erosion area 5 is shown with an apparent depth of at least 12 inches and a length of about 42 inches. An estimate of the cross sectional area of the eroded hole is  $3.1 \text{ ft}^2$ . The erosion hole appears to be partially filled with gravel and rocks. The grid spacing is 1.2 ft/division and the scanning range was 6.0 ft.

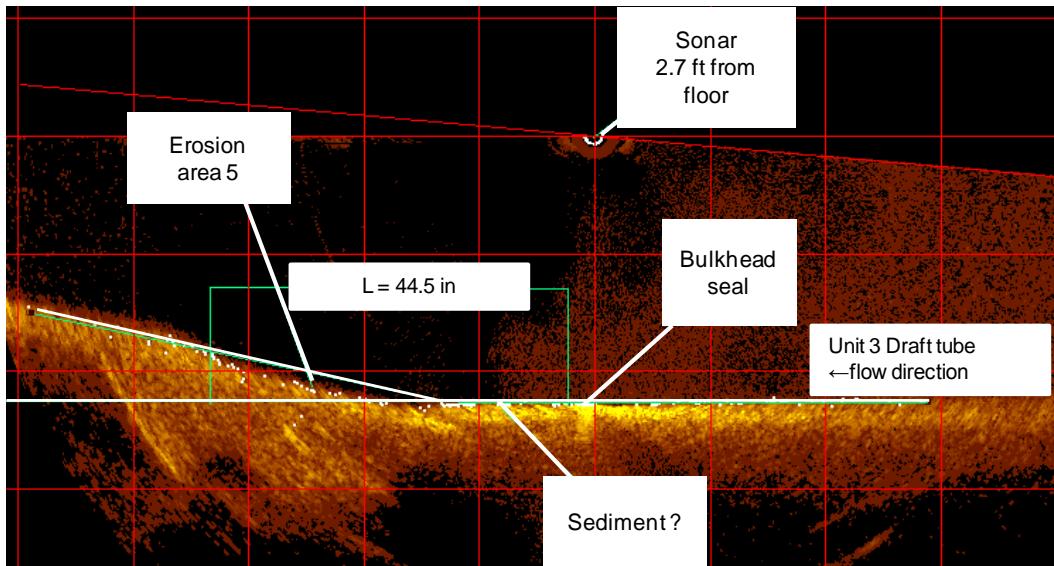
Figure 13. Close-up sonar profile collected 6 ft from the right (east) wall of the unit 3 draft tube. A depression was detected that is consistent with erosion area 5, and the length (L) of the damage appears to have expanded from 39 to 44.5 inches. There appears to be a slight depression on the upstream side of the bulkhead seat that might be filled with sediment. The grid spacing is 1.2 ft/division and the scanning range was 6 ft.

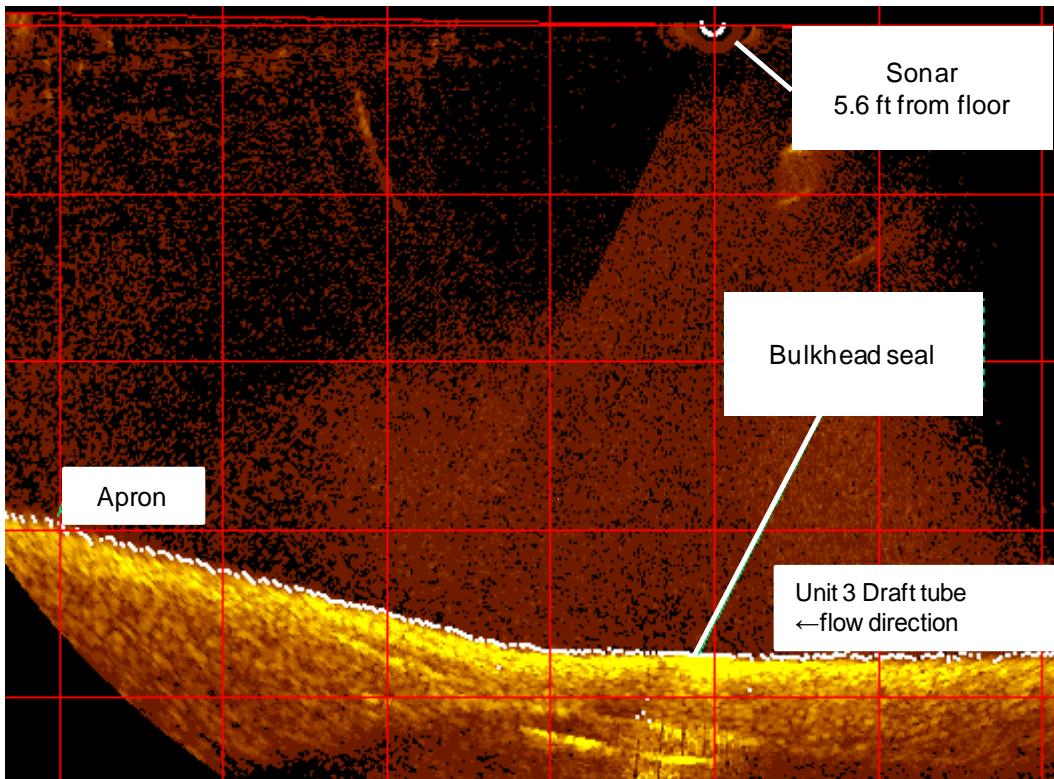
Figure 14. Sonar profile collected 8 ft from the right (west) wall of the unit 3 draft tube. Other than some surface roughness or loose rocks, no erosion holes were imaged at this station. The grid spacing is 1.5 ft/division and the scanning range is 7.5 ft.

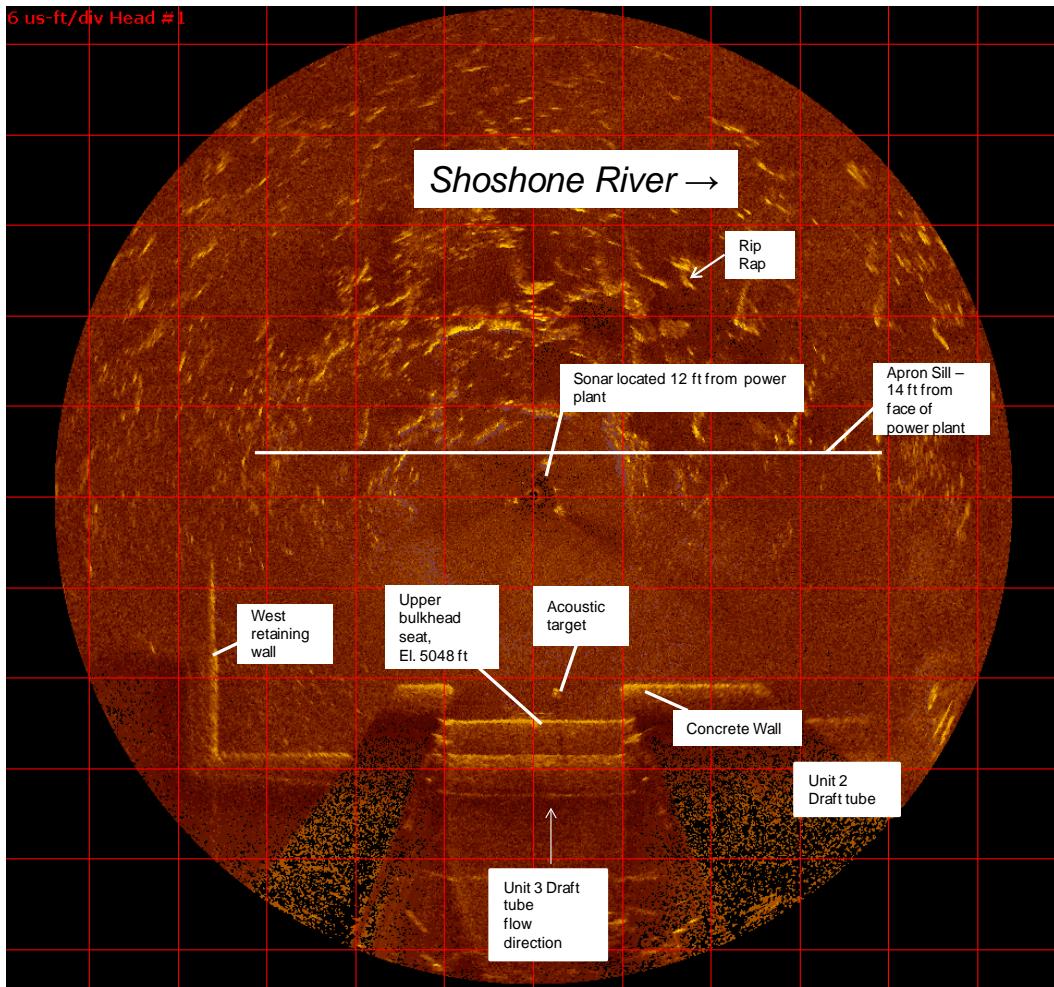
Figure 15 shows a typical image of the unit 3 draft tube collected with the sonar located 12 ft from the power plant. The sonar image (a plan view) clearly shows the east and west bulkhead guides and the upper bulkhead gate seat (El. 5048.06 ft) and surrounding concrete. The acoustic target was also clearly visible from this location. The scan range was 30 ft which allowed imaging of rocks on the apron sill and along the Shoshone River bed.

Figure 15. Sonar image of the draft tube face collected along the unit 3 centerline. The sonar was located 12 ft from the power plant face and the scan range was 30 ft. The grid spacing is 6.0 ft/division.

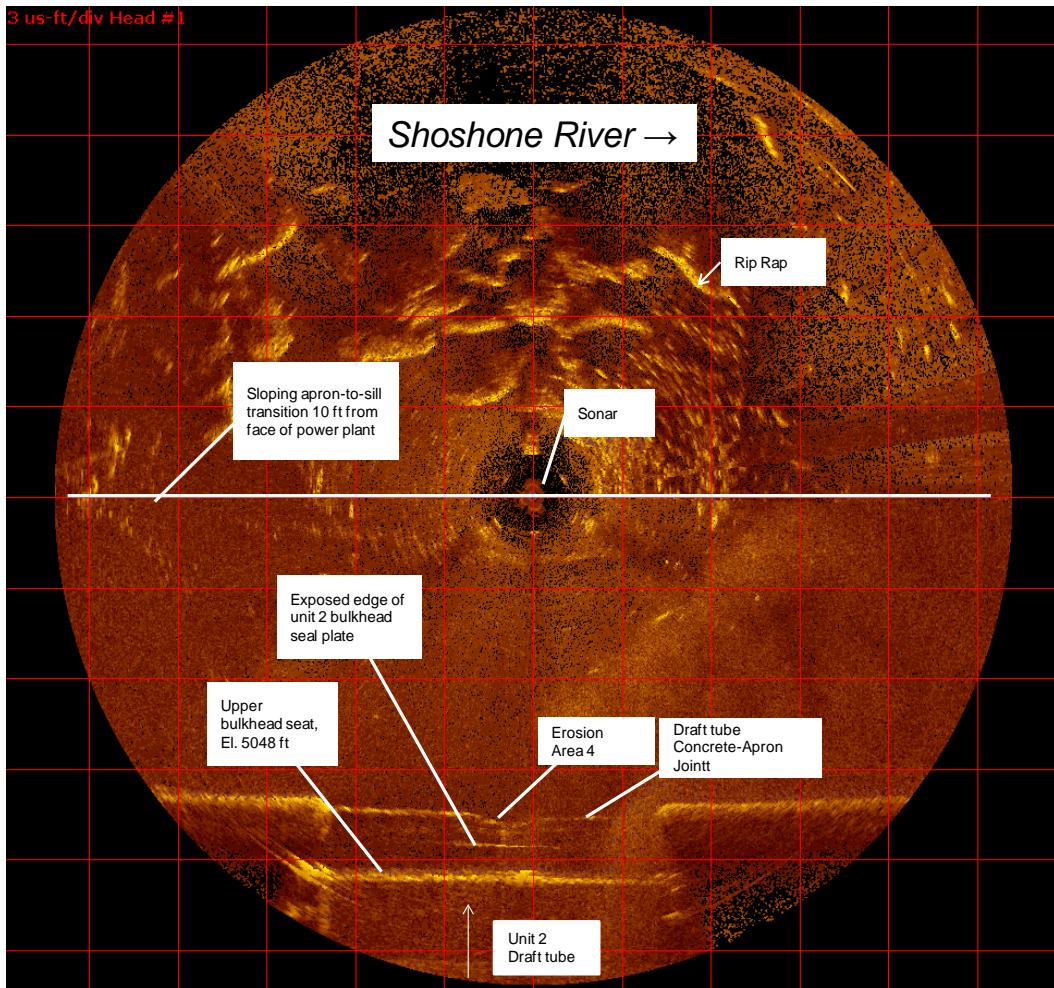
Figure 16 is an image collected with sonar lowered to just above the apron floor at a distance of 10.6 ft from the unit 2 draft tube exit. The primary linear feature is the upper bulkhead seat, but a weaker linear feature appears to be the eroded face of the concrete joint between the draft tube and apron at unit 2. This damaged area was measured to be about 34.8 inches long which is consistent with the width of erosion area 4 in Figure 4. The scan also shows what appears to be the exposed edge of the bottom bulkhead seat located about 12 inches from the damaged construction joint.

Figure 16. Image collected with sonar lowered to the apron floor in front of unit 2. This sonar scan detected the eroded face of the concrete joint between the draft tube and sloping apron. The thin line about 18 inches behind the joint is the exposed edge of the bulkhead seat. This damaged area was measured to be about 2.89 ft (34.7 in.) wide which is larger than the width of erosion area 4 in Figure 4 ( $W=31$  in.). The grid spacing is 3.0 ft/division

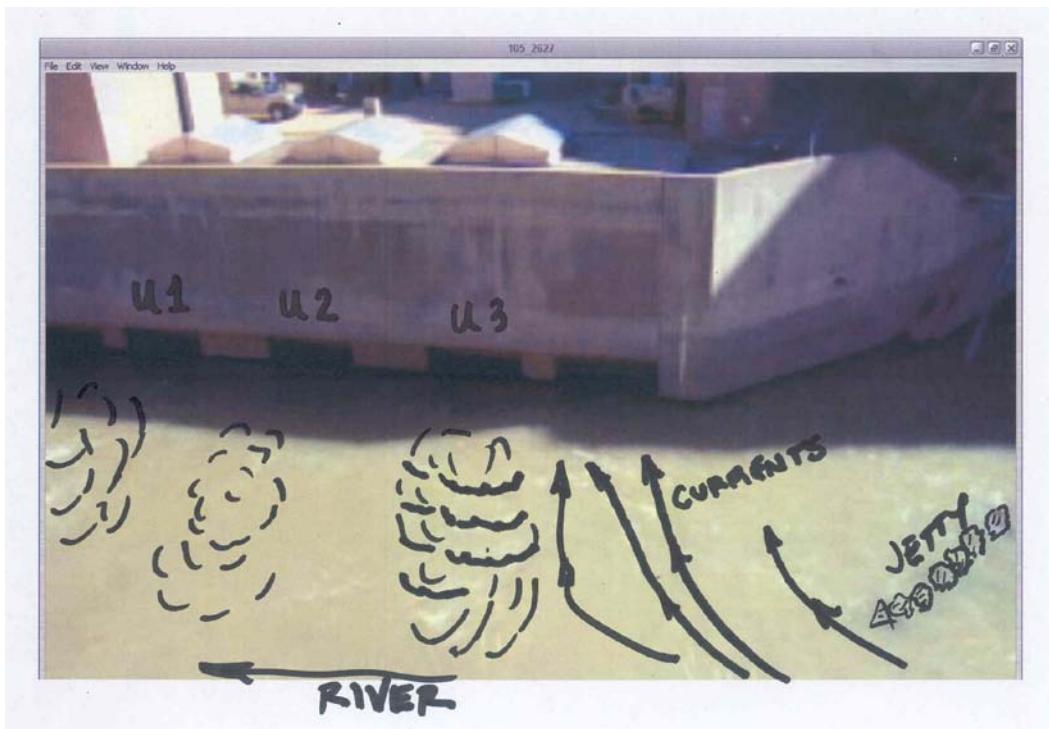
Observations of river and power plant flow interactions during this field visit helped to formulate a hypothesis on how sediment is transported into the tailrace and draft tubes. For high flowrates through the power plant, water flows upslope and causes large surface boils which extend across the river channel. This increased water level deflects the Shoshone River flow toward the bay upstream

from unit 3 (Figure 17). When outlet works releases from Buffalo Bill Dam are sufficient to mobilize river bed material, this flow condition appears to be capable of moving sediment into the tailrace where it is available to cause concrete erosion damage. Another source for rocks may be the tailrace protection dike located immediately upstream from the power plant (Figure 18). Once the material reaches the concrete apron the 4:1 slope facilitates the sediment movement toward the powerplant structure.

Figure 17. Photograph of tailrace looking from the access road opposite the power plant. All 3 units were operating which resulted in upwelling that deflected Shoshone River flow toward the power plant. High flows released from Buffalo Bill Dam and power plant combine to create a flow pattern that is likely responsible for moving sediment into the tailrace and draft tubes.

Releases from Buffalo Bill Power Plant and the sloping tailrace apron create strong upwelling that re-directs Shoshone River flows toward the upstream end of the power plant. This hydraulic condition is likely responsible for moving sediment into the tailrace only when river flows are high enough to mobilize bed material (i.e. during large bypass flows from Buffalo Bill Dam). The rock jetty (dike) upstream from the power plant may have eroded during previous flood events; thereby reducing its effectiveness. It is recommended that the existing rock dike be extended to train the Shoshone River flows toward the north canyon wall. The length of the dike should be extended further downstream to prevent the river from flowing toward the power plant.

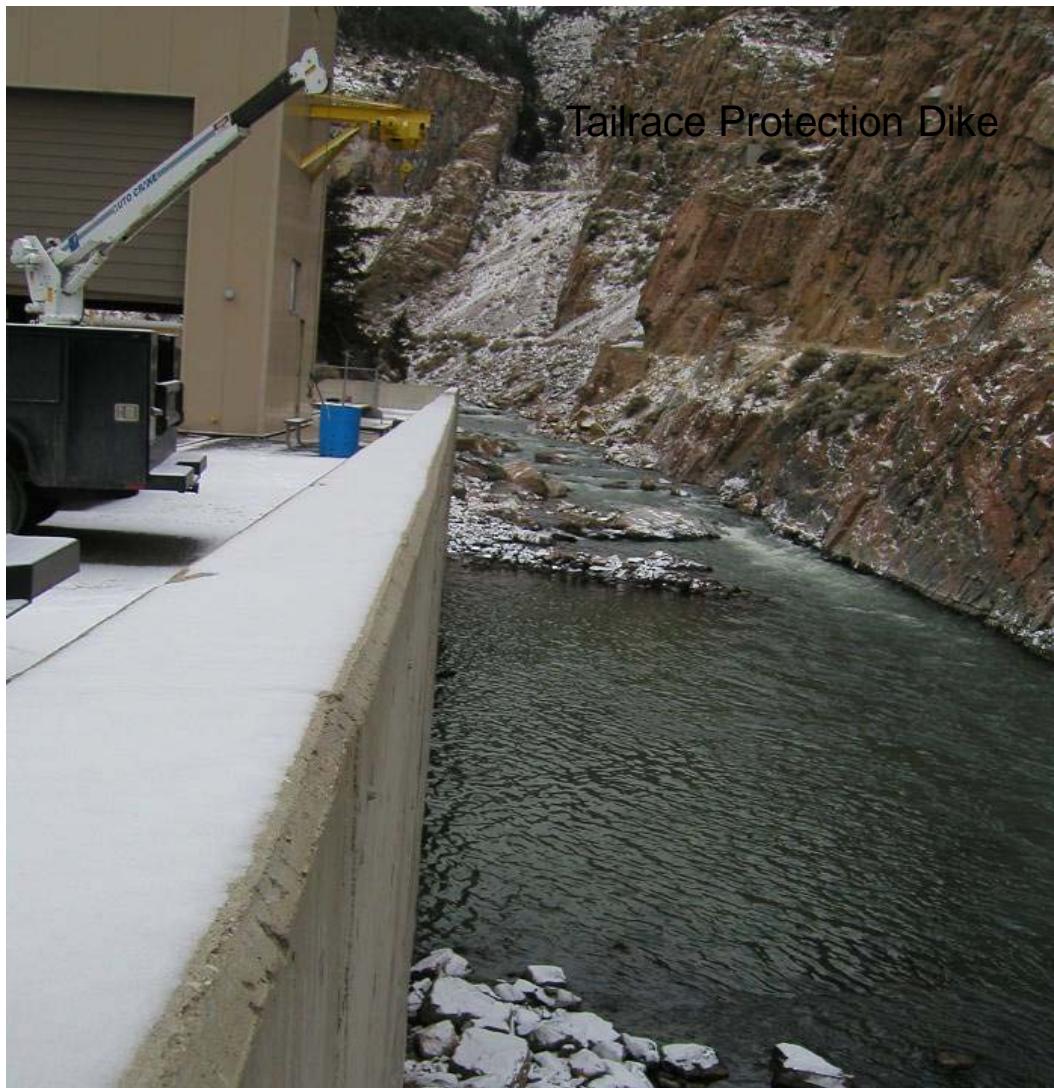
Figure 18 shows the tailrace protection dike at low flows. This dike could be a source of rock material entering the tailrace. It is difficult to tell if the length or elevation of the dike has changed since construction. Therefore, a survey of the dike should be conducted to document any loss or movement of rip rap.

Figure 18. View of the Buffalo Bill Power Plant tailrace area, looking upstream along the Shoshone River. Photograph was taken from the January 19, 2011 dive inspection report.

A survey of the tailrace protection dike should be conducted to document any loss of rip rap in the years since it was built.
