Hydraulic Laboratory Technical Memorandum PAP-1102

Canal Lining Drawdown Tests for the Brock Reservoir Inlet Canal

May 2014

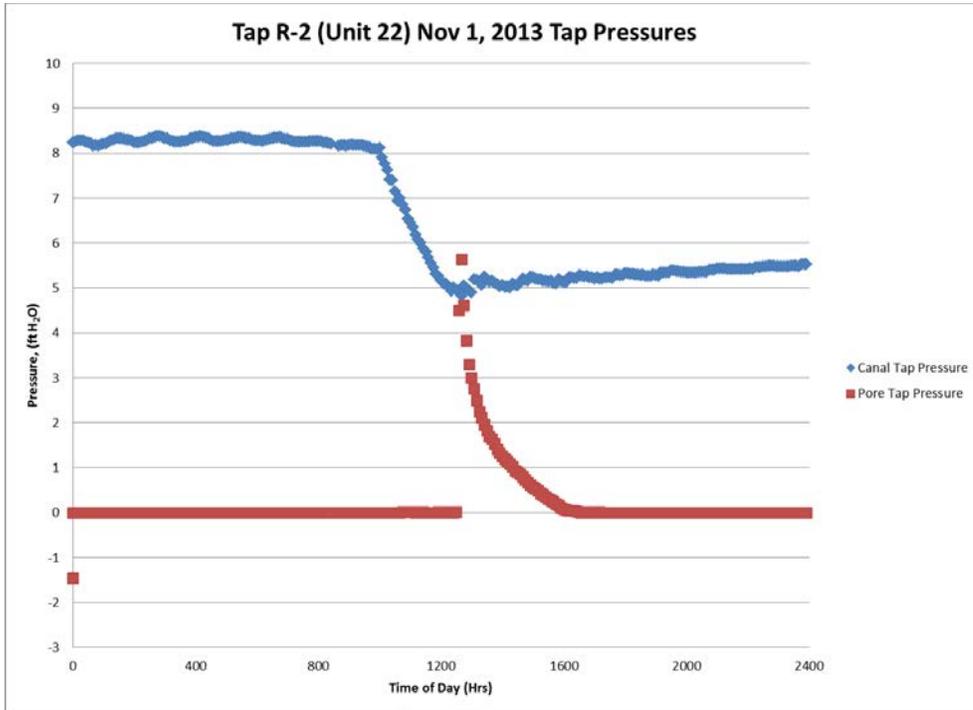
and L-2 sight tubes at about noon on 11/01/2013. For the L-1 site, the sight tube apparently drained completely within the 5 minute logging interval as there was no recorded deviation in pore pressure from the atmospheric level. For the L-2 site a spike in measured sight tube pressure was measured beginning at 12:35 PM. This data spike that coincided with the pouring of dyed water into the sight tube (initially in excess of 5.5 ft. H₂O pressure) dissipated back to an atmospheric pressure level over a period of approximately 4 hours. This data spike may be seen in Figure 6.

Figure 6. Plot of Nov. 1 data at the R-2 Tap

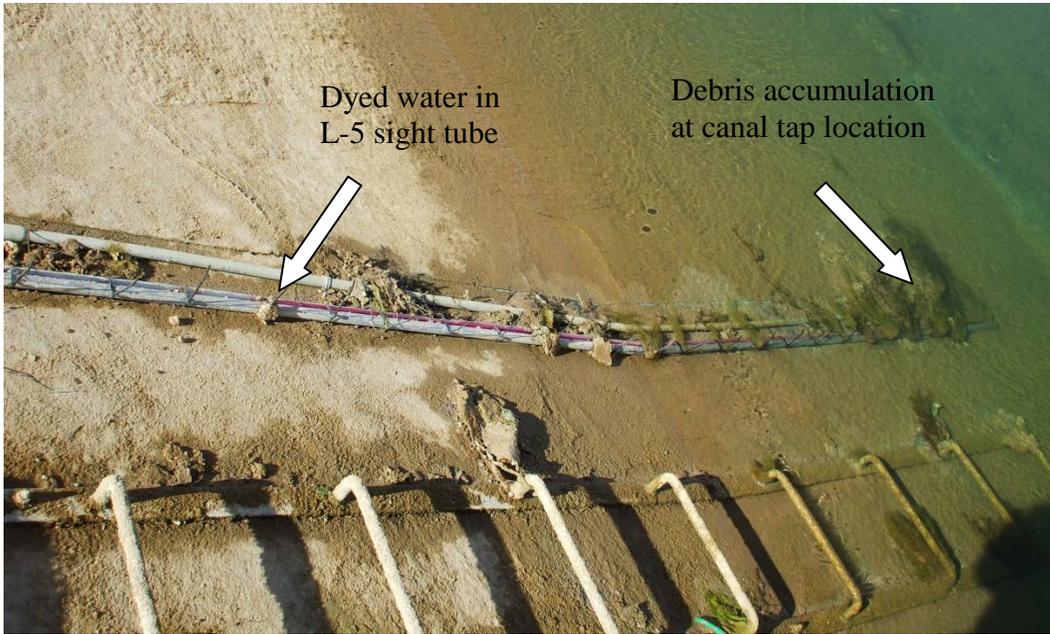
Figure 7. Red dyed water in the L-5 sight tube

Another item visible in Figure 7 is the debris accumulation at the location of the canal bubbler tap. The nature by which a bubbler sensor operates tends to provide a self-cleaning capability. In the event a tap becomes clogged, the bubbler will – within its operational range – continue to build pressure until the clog becomes dislodged. This would potentially result in an occasional excessively high apparent pressure measurement. Figure 8 shows the logged data at the L-5 station for 11/04/2013.

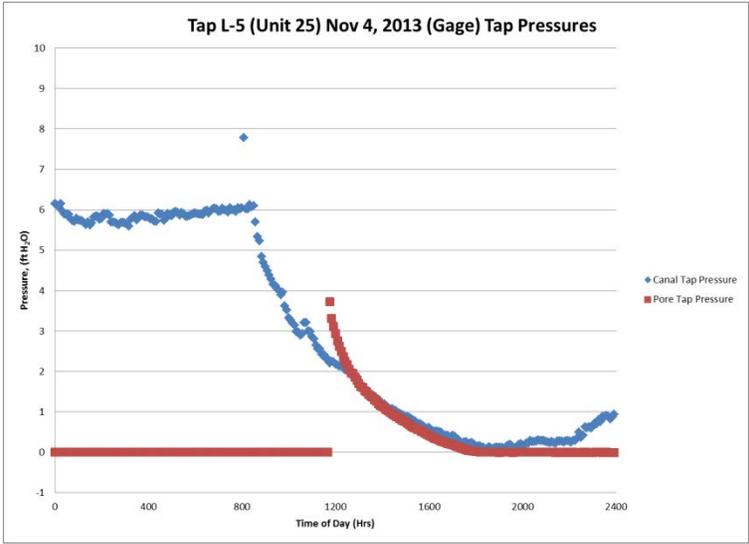
Figure 8. 24 hour plot of measured pressures at the L-5 site

From Figure 8 it is clear that prior to pouring dyed water into the sight tube at the L-5 site the measured pore pressure is at atmospheric pressure (zero gage pressure) at the site tube bubbler tap. This implies that any phreatic surface in the soil behind the canal lining is lower than the elevation of the tap. An outlier data point is seen for the canal tap pressure in Figure 8 at approximately 8:00 AM. This high value may be the result of debris having temporarily clogged the canal tap port.

It is apparent from Figure 8 that the spike in measured sight tube pressure seen beginning at approximately noon is a function of pouring the dyed water into the sight tube as opposed to something related to the changing water level in the canal. The information presented in Figures 7 & 8 serves to provide verification that the electronic pore pressure monitoring equipment was functioning properly. During periods of time when the dyed water was visible above the sight tube bubbler tap, readings exceeding atmospheric pressure were measured and recorded.

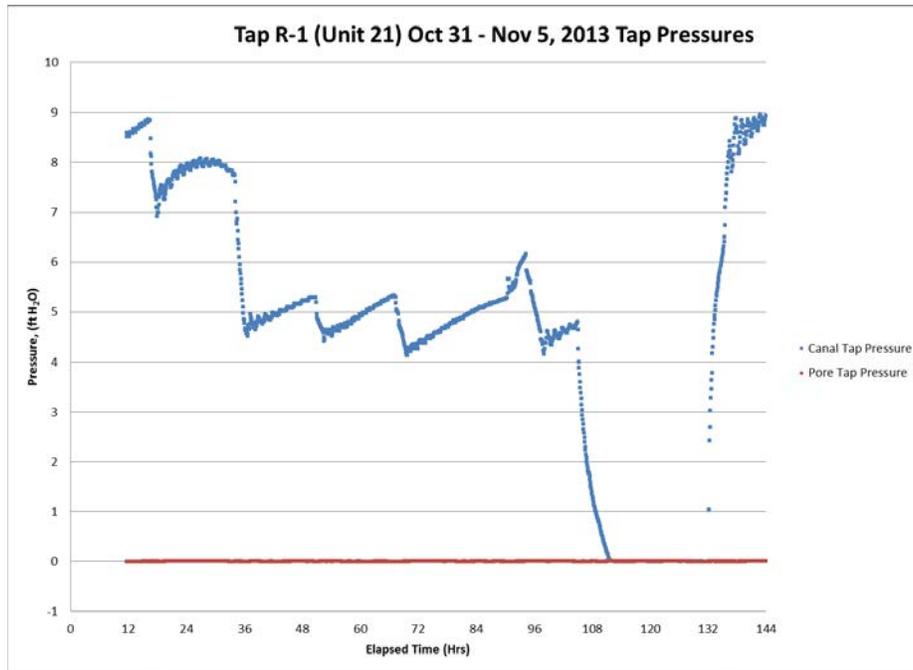
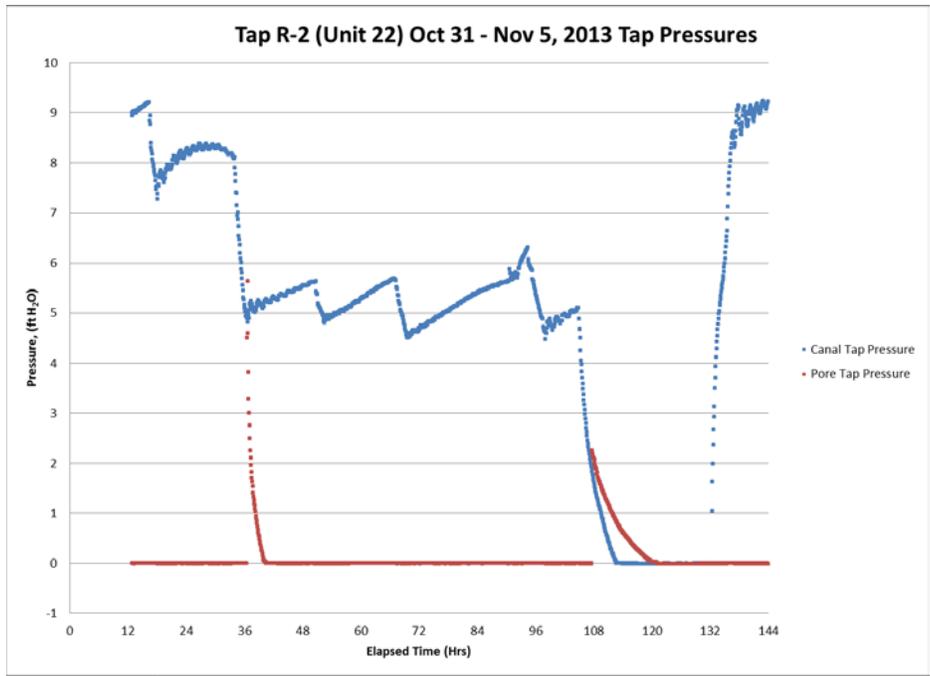
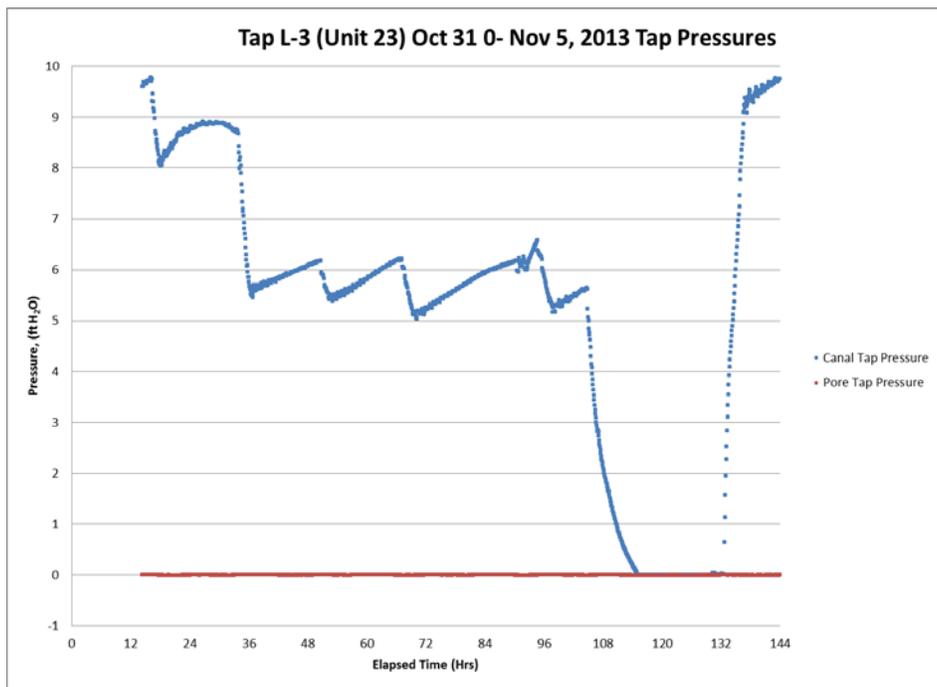
Figures 9, 10 & 11 presenting data from the R-1, R-2 and L-3 sites respectively, show that during the minimum canal level period when the canal bubbler taps at these locations were above the water level, the canal tap pressure readings were the same as the pore tap pressure. Figures 12 & 13 presenting data from the L-4 and L-5 sites show that during the minimum canal level the canal tap pressures are higher than the pore tap pressures (presumed to be atmospheric pressure). This is consistent with the observed position of the canal tap levels at the respective sites which remained slightly submerged during the minimum water level period.

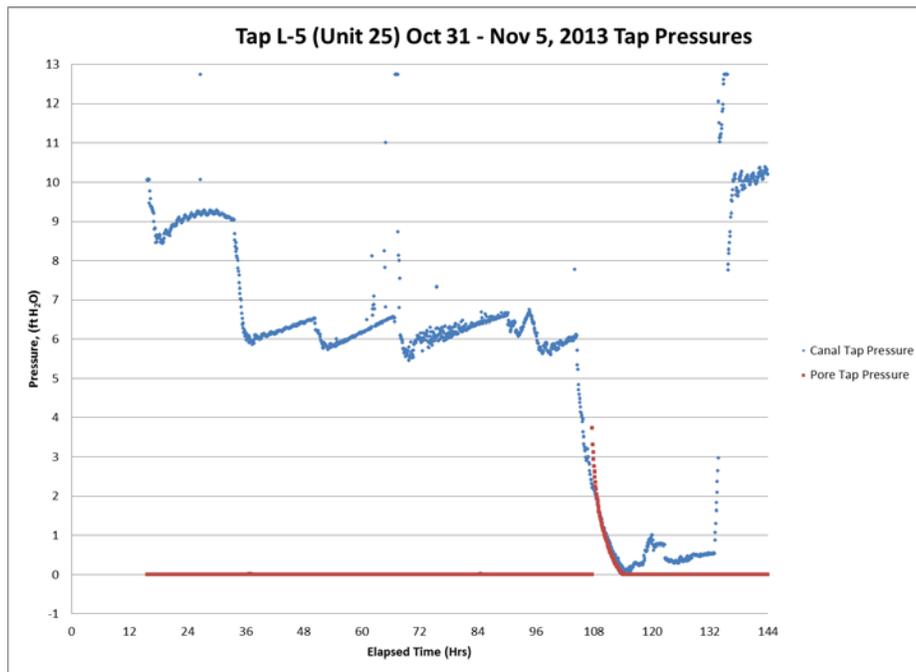
Figure 13. Tap L-5 Measured Pressures

In Figure 13 a significant number of apparent “outlier” values were recorded for canal level pressures which are all higher than adjacent data points. During testing it was observed that a mat of aquatic debris had accumulated around the bubbler canal tap location at the L-5 site. Debris can cause erroneous measurements because air pressure in the bubbler tube must continue to increase until an air bubble is eventually forced out.
