## St. Mary Diversion Dam – Case Study of a 100 year Old Diversion

### ABSTRACT

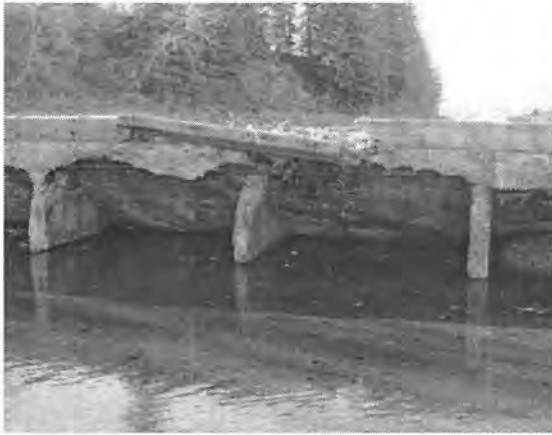
Recent examinations of the 100-year-old diversion dam, headworks, and canal revealed substantial freeze-thaw damage to exposed concrete surfaces. Concrete core samples taken from the piers on the dam and sluiceway indicated that the condition of the concrete is very poor where exposure to ice and frequent freeze-thaw cycles have degraded the strength (Mefford 2003). Based on available inspection data and visits to the structure, the weir (Figure 6), abutments (Figure 7), piers (Figure 8), sluiceways (Figure 9), and diversion headworks will

Figure 6. St. Mary Diversion weir concrete failure and exposed rebar.

likely all require demolition and replacement in the near future. Recently, some modifications and repairs to the facility have been made that will prevent catastrophic failure of the structures.

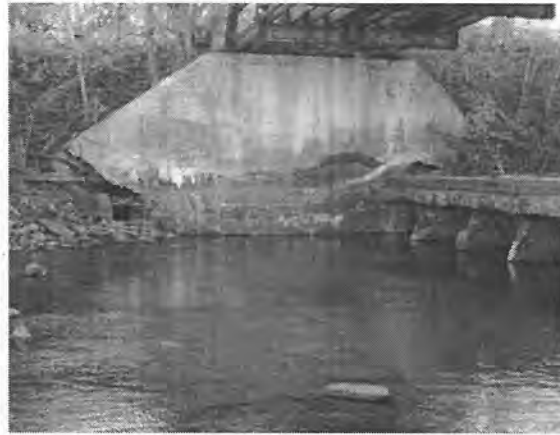
Figure 7. St. Mary Diversion right abutment damage and exposed rebar.

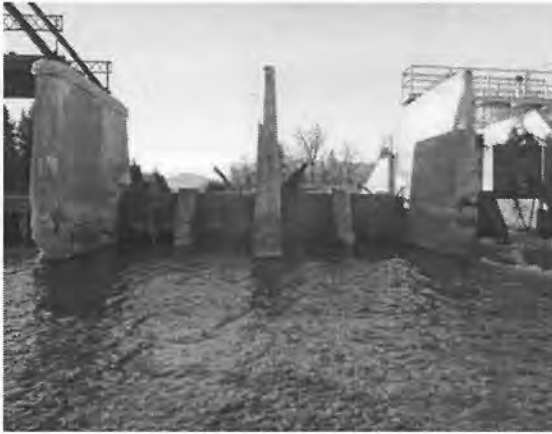
Figure 8. Concrete degradation on the downstream end of piers surrounding sluice bays.

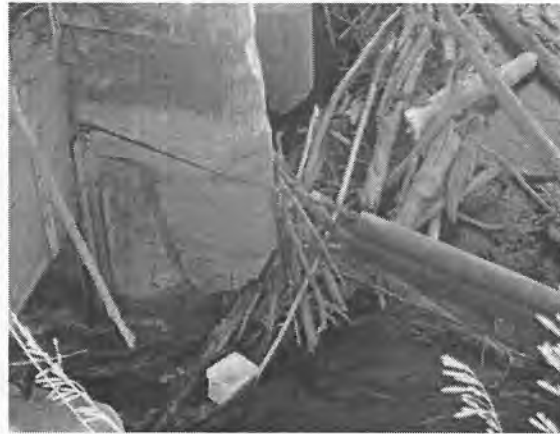
Figure 9. Concrete degradation upstream end of piers surrounding sluice bays.
