# Visual and Photogrammetric Observations of an Internal Erosion Failure

T. L. Wahl

*Bureau of Reclamation, twahl@usbr.gov*

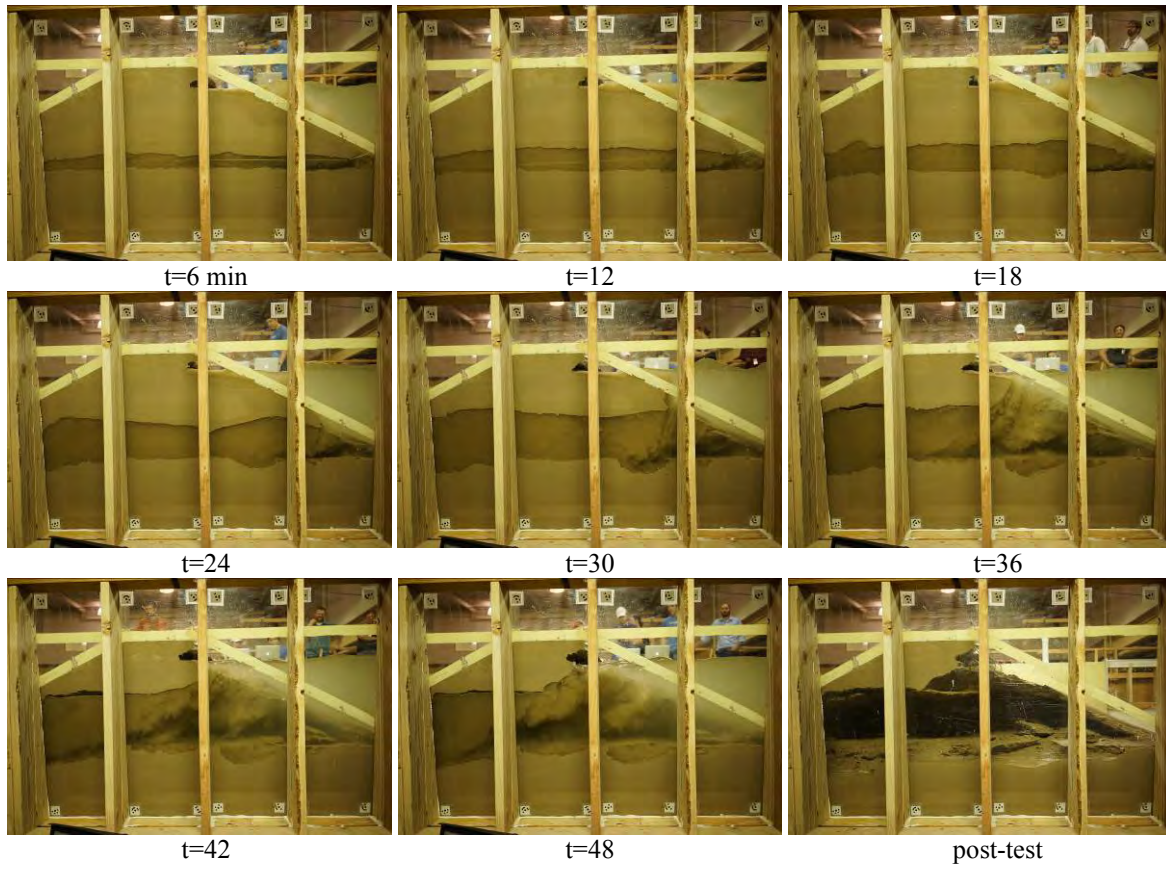
Erosion of the internal channel (pipe) created by removal of the rebar started immediately, indicated by muddy water exiting onto the downstream slope of the embankment. However, the erosion channel was not visible against the clear acrylic abutment wall until about 3-4 minutes after removal of the rebar. For about 15 minutes the erosion channel appeared to enlarge uniformly along its length. As the height of the eroded channel approach one half of the upstream head above the invert of the channel, accelerated scour of the floor of the channel began just downstream from the entrance (Figure 5). The mechanism driving this appeared to be a strong counter-rotating eddy in the channel entrance created by streamlined flow entering the floor of the channel and a strong contraction from the roof of the entrance, where water from the upper part of the reservoir needed to turn a greater than  $90^\circ$  corner to enter the channel (Figure 6). The flow structure was very similar to that of a submerged hydraulic jump that might be observed downstream from a partially open sluice gate. Coincident with formation of this scour in the floor of the entrance, accelerated scour of the roof of the channel began about 4-5 diameters further downstream, seemingly due to a deflection of flow out of the scour hole and up toward the roof. For several minutes a system of stationary, alternating vortices persisted in the enlarging eroded channel. As the channel enlarged further, this flow structure broke down and seemed less dominant.

Figure 5. Time lapse photos at 6 minute intervals. The photos show progressive development of the internally eroded flow passage. Note the structure of the flow that leads to development of an enlarged chamber at the upstream end of the conduit. The final photo was taken after the headbox had drained.

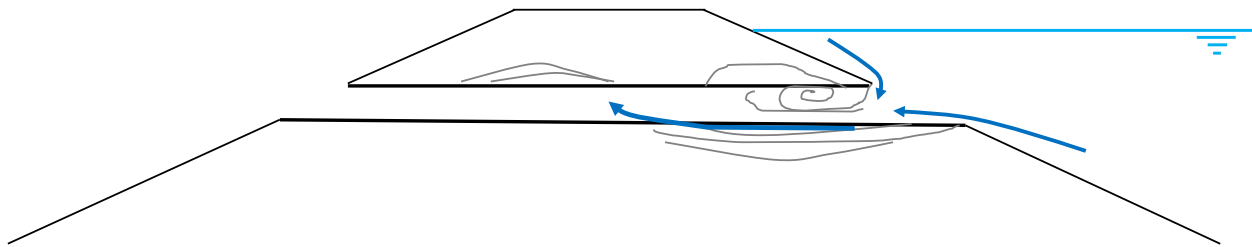
Figure 6. Sketch showing flow structure and related erosion patterns observed during internal erosion test.

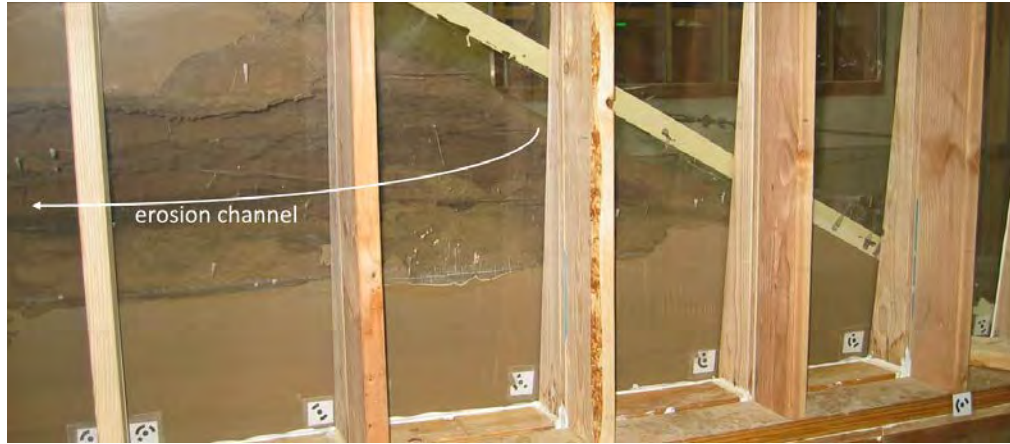
The test was stopped after about 48 minutes due to the tailbox filling to its capacity. After flow was shut off and the reservoir had drained, it became evident that horizontal enlargement of the channel had also been very significant, especially around the entrance to the channel (Figure 7). The width of the eroded channel was much greater just inside the entrance than it was at the opening visible from the upstream side of the embankment (Figure 8). Distinct lift lines were visible in the eroded channel walls and erosion had either accelerated along weak layers or was just generally more rapid in a horizontal direction, perhaps due to non-isotropic compaction structure of the soil. The three-dimensional nature of the flow approaching the channel entrance may have also contributed to a difference in horizontal and vertical erosion rates. There was a large overhang at the entrance to the eroded channel with the widest eroded section being near the invert of the channel. It appeared that lateral flow along the embankment face had created a vortex in the entrance of the channel that accelerated lateral erosion of the channel (Figure 9). This flow structure seems similar to that observed by other investigators during the later stages of breach widening (e.g., in fuse plug embankment erosion tests by Pugh [1985]). Here, there seems to be evidence that such a structure may be important even before the breach has fully formed and moved into the dominantly widening phase.

Figure 7. Post-test photo illustrating significant widening of the erosion channel, especially near its base.

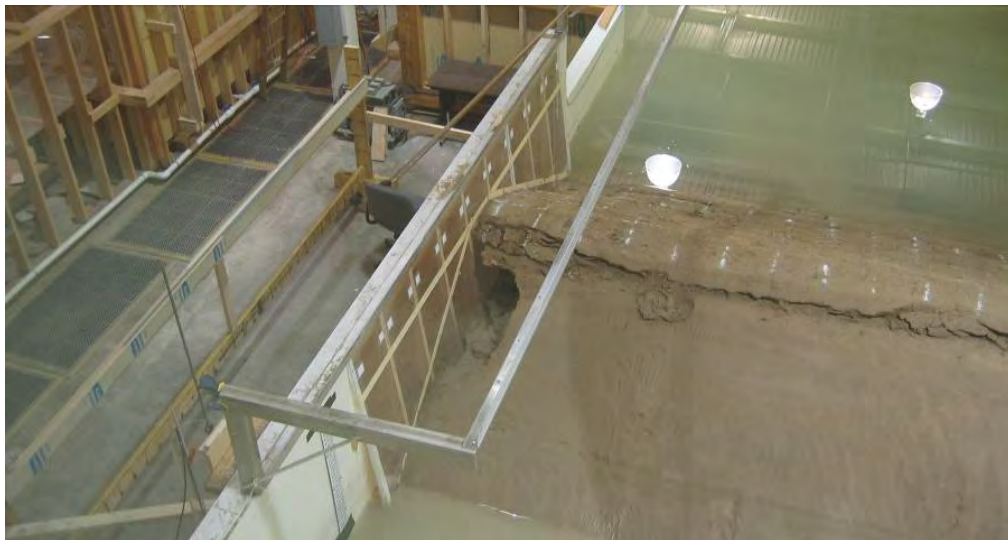
Figure 8. Post-test overhead view of the entrance to the internal erosion flow channel.

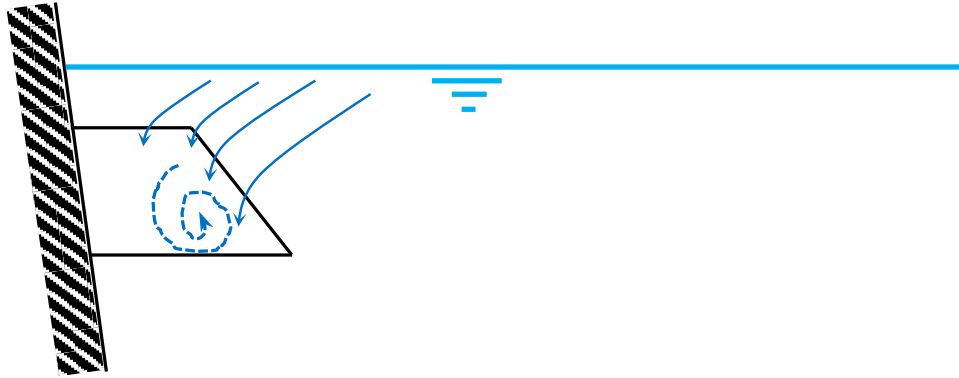
Figure 9. Sketch showing an idealized view of the flow, looking downstream during enlargement of the internal erosion flow channel. This type of vortex formation may lead to accelerated widening of the base of the channel.

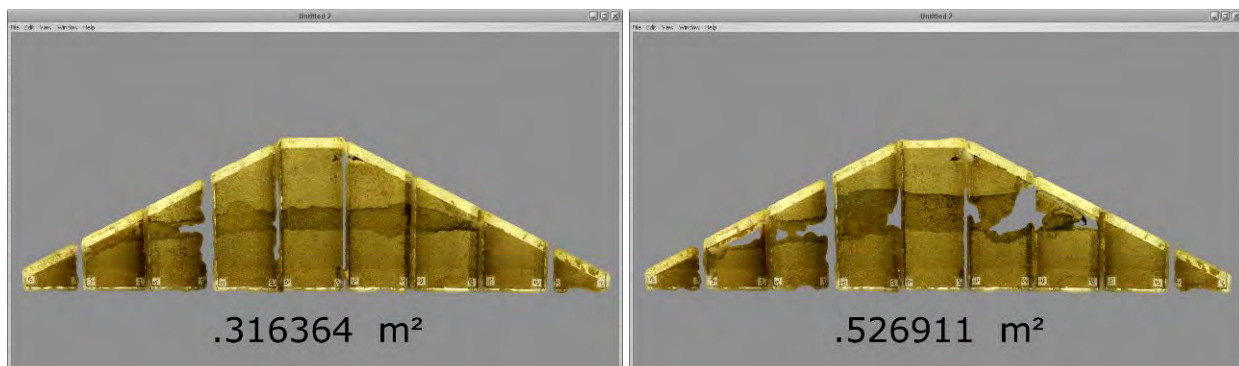
Following completion of the test, approximately 120 GB of fixed camera imagery was processed to create 4D photogrammetry models of the erosion visible through the clear abutment wall and on the downstream slope (4D=3 spatial dimensions plus time). Two images from the abutment model are shown in Figure 10. At each time step, flow cross-sectional areas of the eroded channel were calculated. These data will be valuable for making later comparisons to numerical model simulations of the test.

Figure 10. Two images from the 4D photogrammetry model of the internal erosion flow channel. In blanked-out (gray) areas the model was not able to resolve the far side of the channel due to turbidity or other image quality problems.
