Hydraulic Laboratory Technical Memorandum PAP-1167

Senator Wash Penstock Stress and Vibration Testing

Prepared for Lower Colorado Region and Yuma Area Office

March 2018

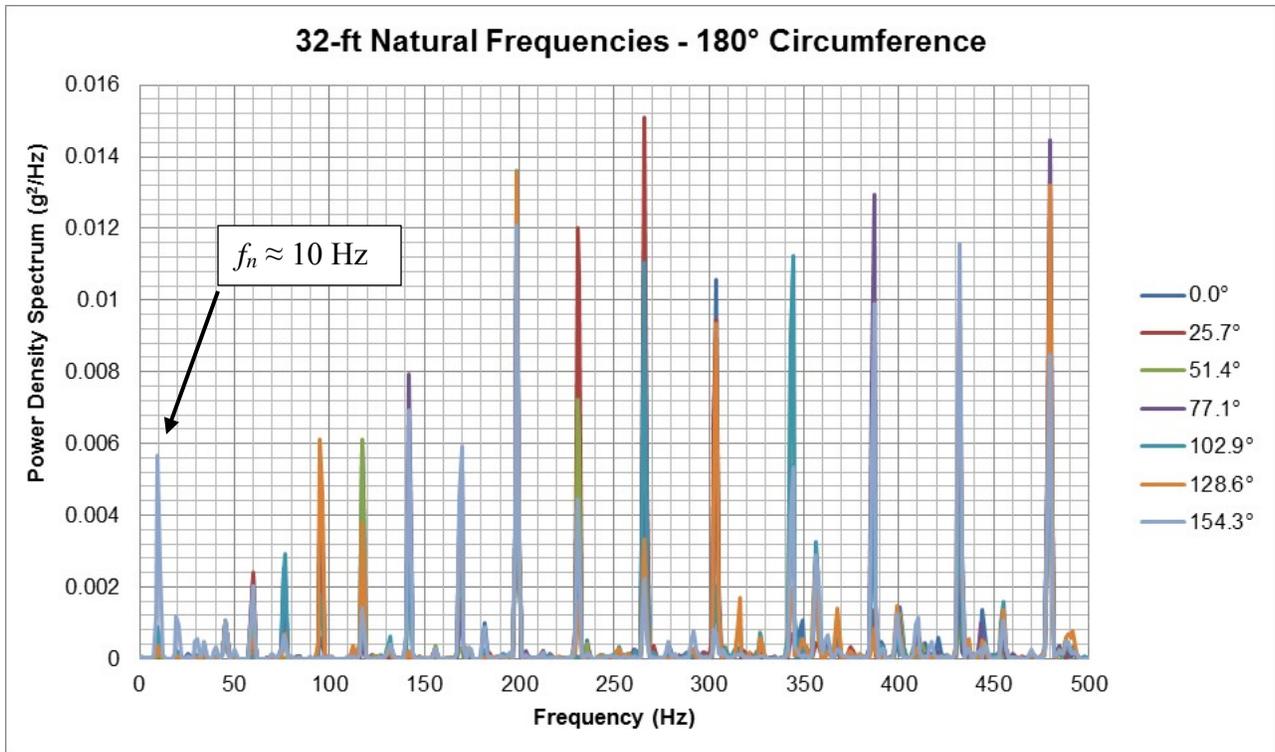
Figure 8. Power Density Spectrum vs. frequency from impulse hammer on the 32-ft section.

Results indicate that the dominant frequencies are much higher than those expected during operation i.e., greater than the blade passing frequency of 42 Hz. While not as strong, the first natural frequency of approximately 10 Hz, approximately half of the estimated natural frequency without the added mass of the water, does appear in the frequency spectrum. This is of interest as it is near the running frequency of the plant (6 Hz) and within the range of operational frequencies.

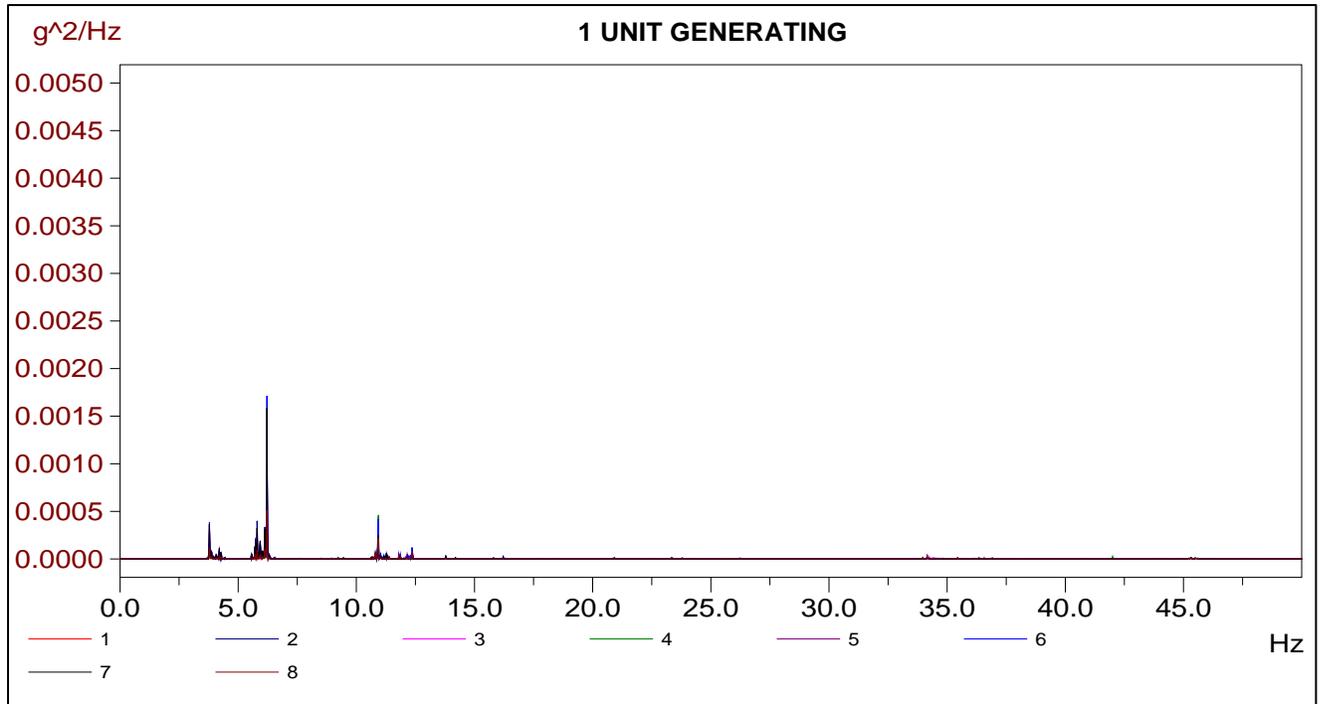
Figure 10. Power Density Spectrum for 1 unit generating (G1).

From operational vibration tests dominant frequencies were identified near or within the range of running and blade passing frequencies (6 – 42 Hz). Circumferential frequencies are shown in Figures 10 through 12 and all operational frequency data are summarized in Tables 4 and 5 of Appendix B. Vibration at the running frequency dominated in most test conditions and the frequency increased as more units were brought online as shown in Figure 11. Operation in pumping mode produced vibrations dominant at the running and blade passing frequency but amplitudes were significantly less compared to generating mode.

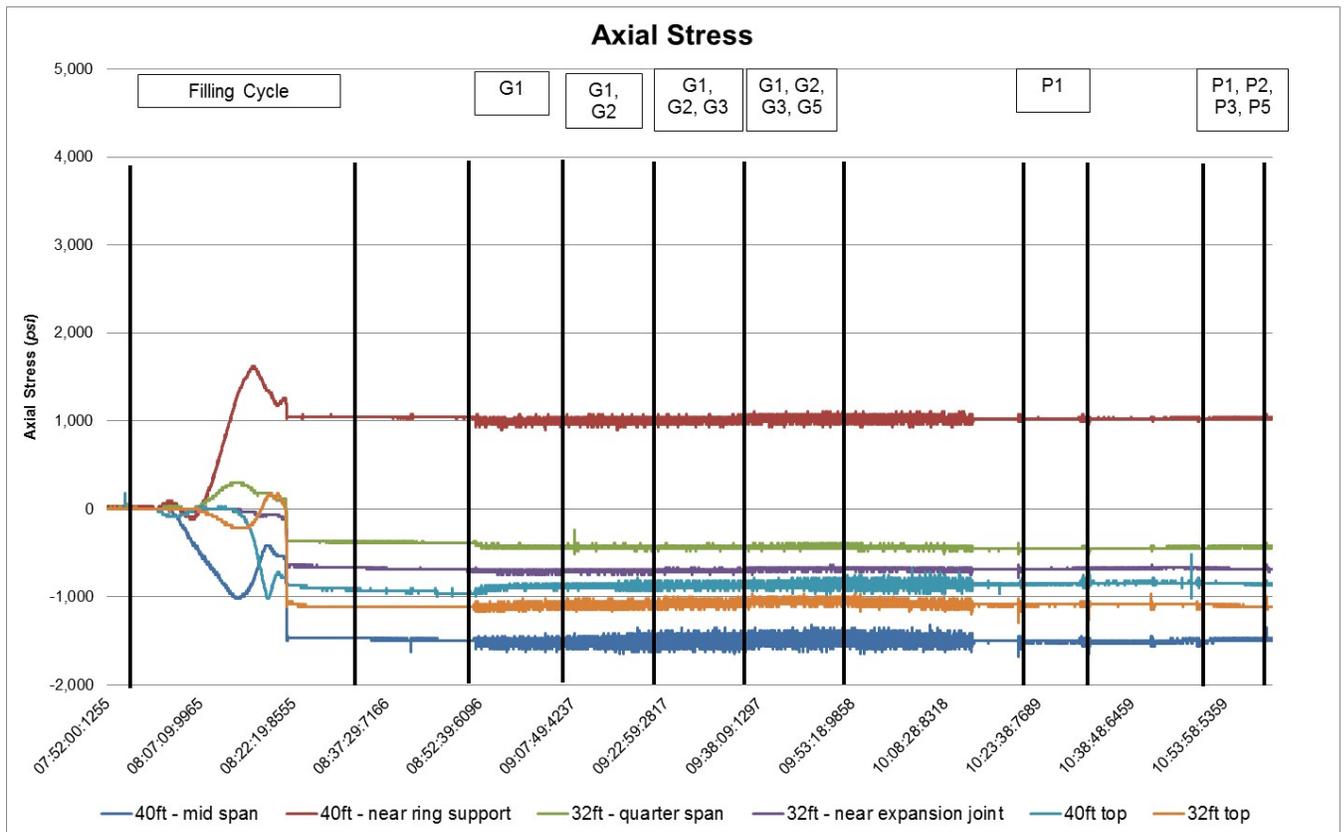
Figure 13. Plot of axial stress measurements for both generating and pumping modes.

Maximum axial stresses occurred at mid-span in the 40-ft section. Negative values indicate that the steel was in compression which was due to the weight of the water causing the penstock to sag. The absolute maximum was 1,620 psi with a peak-to-peak fluctuation of 300 psi. These values are within the normal range and well below the endurance limit.

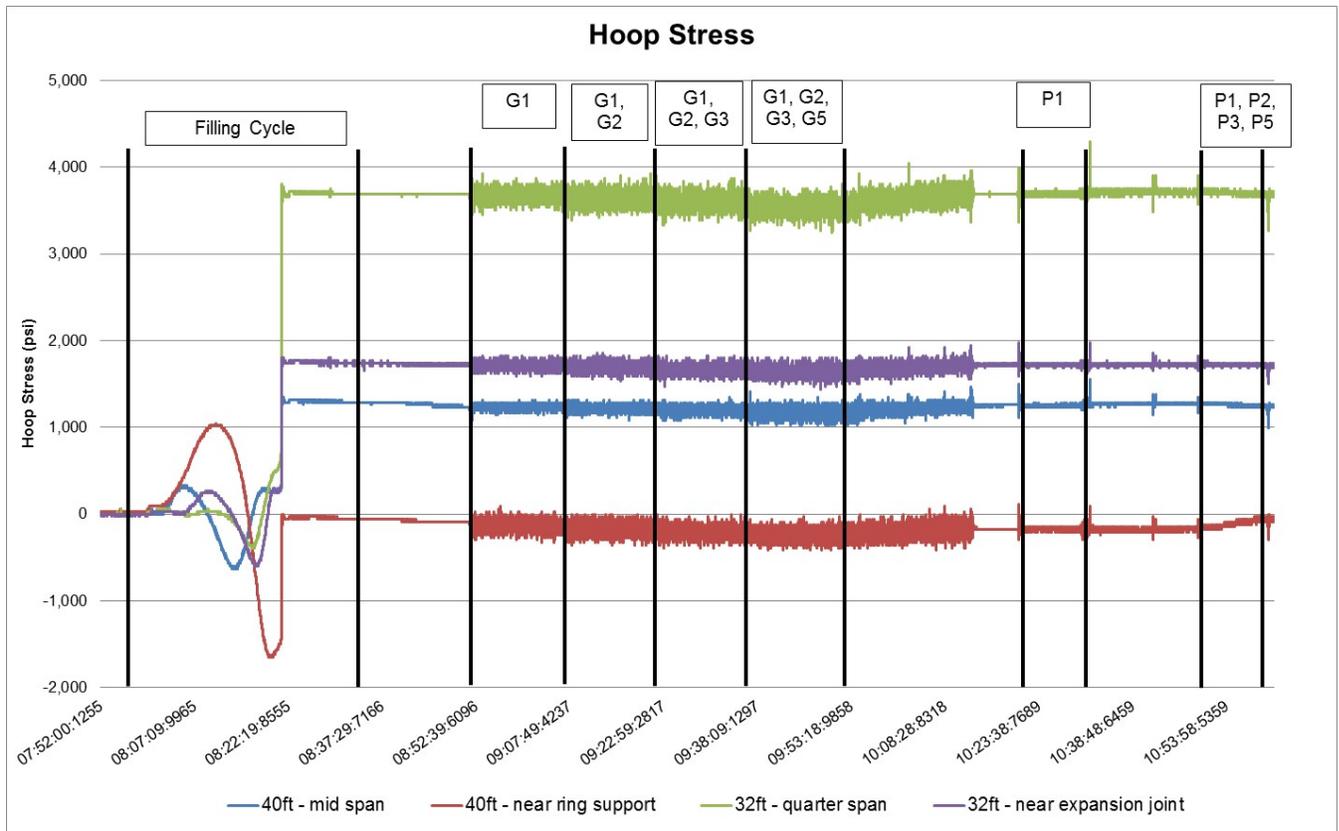
Figure 14. Plot of hoop stresses measured for both generation and pumping modes.

Hoop stresses are shown for the test period in Figure 14. The largest stresses were measured at quarter-span of the 32-ft section with a maximum of 3,900 psi and peak-to-peak fluctuating stress of 510 psi. Again, this is well below the endurance limit, producing a safety factor of approximately 7. The theoretical hoop stress is approximately 2,900 psi based on Eq. (3) [5], which compares reasonably to measured hoop stresses given the uncertainty of the actual grade of steel and true penstock thickness and diameter.

For generating mode there was not much difference in stress fluctuation with various units operating, especially with two or more units. Conversely, there were almost no fluctuations during pump mode operation regardless of the number of units in operation. Peaks shown in pumping mode coincide with bringing another pump online which causes a transient in the pipe. However, these are still well within the acceptable range.
