Hydraulic Laboratory Technical Memorandum PAP-1175

Hydraulic Model Study of Abrasion Damage to Mason Dam Outlet Works Stilling Basin

**HYDRAULIC MODEL STUDY
ABRASION DAMAGE - MASON DAM
OUTLET WORKS STILLING BASIN**

A laboratory investigation was conducted to study hydraulic characteristics related to abrasion damage for outlet works stilling basins where flow enters from high-head slide gates and to test remedial measures to prevent abrasion damage caused by material entering the basin.

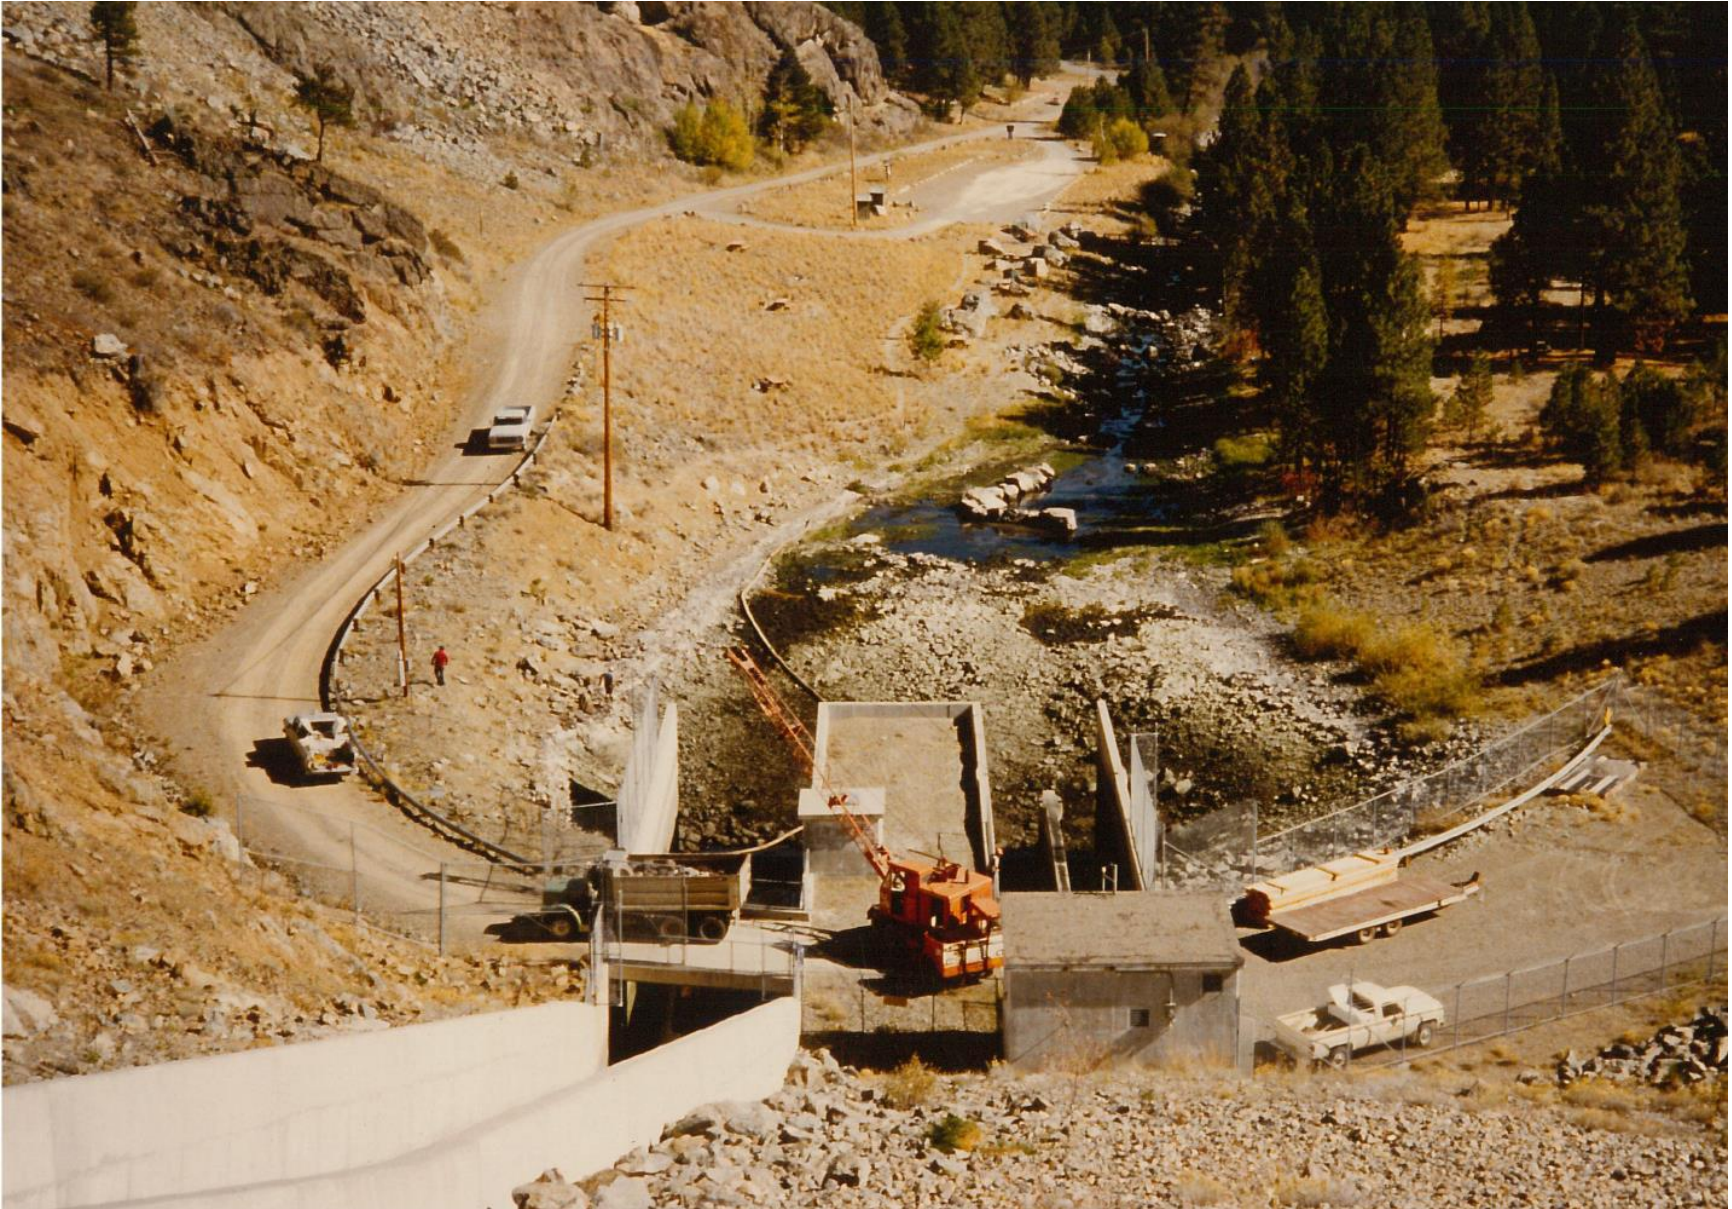
The dam has two stilling basins as shown on figure 1. The outlet works stilling basin is on the right, and the spillway stilling basin is on the left. Dimensions of the outlet works stilling basin are shown on figure 2. The basin is divided into two bays by a center wall, and flow enters the basin from two 2-foot 9-inch (838-mm) square high-pressure slide gates.

Figure 1. — Stilling basins at Mason Dam, Oregon. The spillway stilling basin is on the left, and the outlet works stilling basin is on the right.

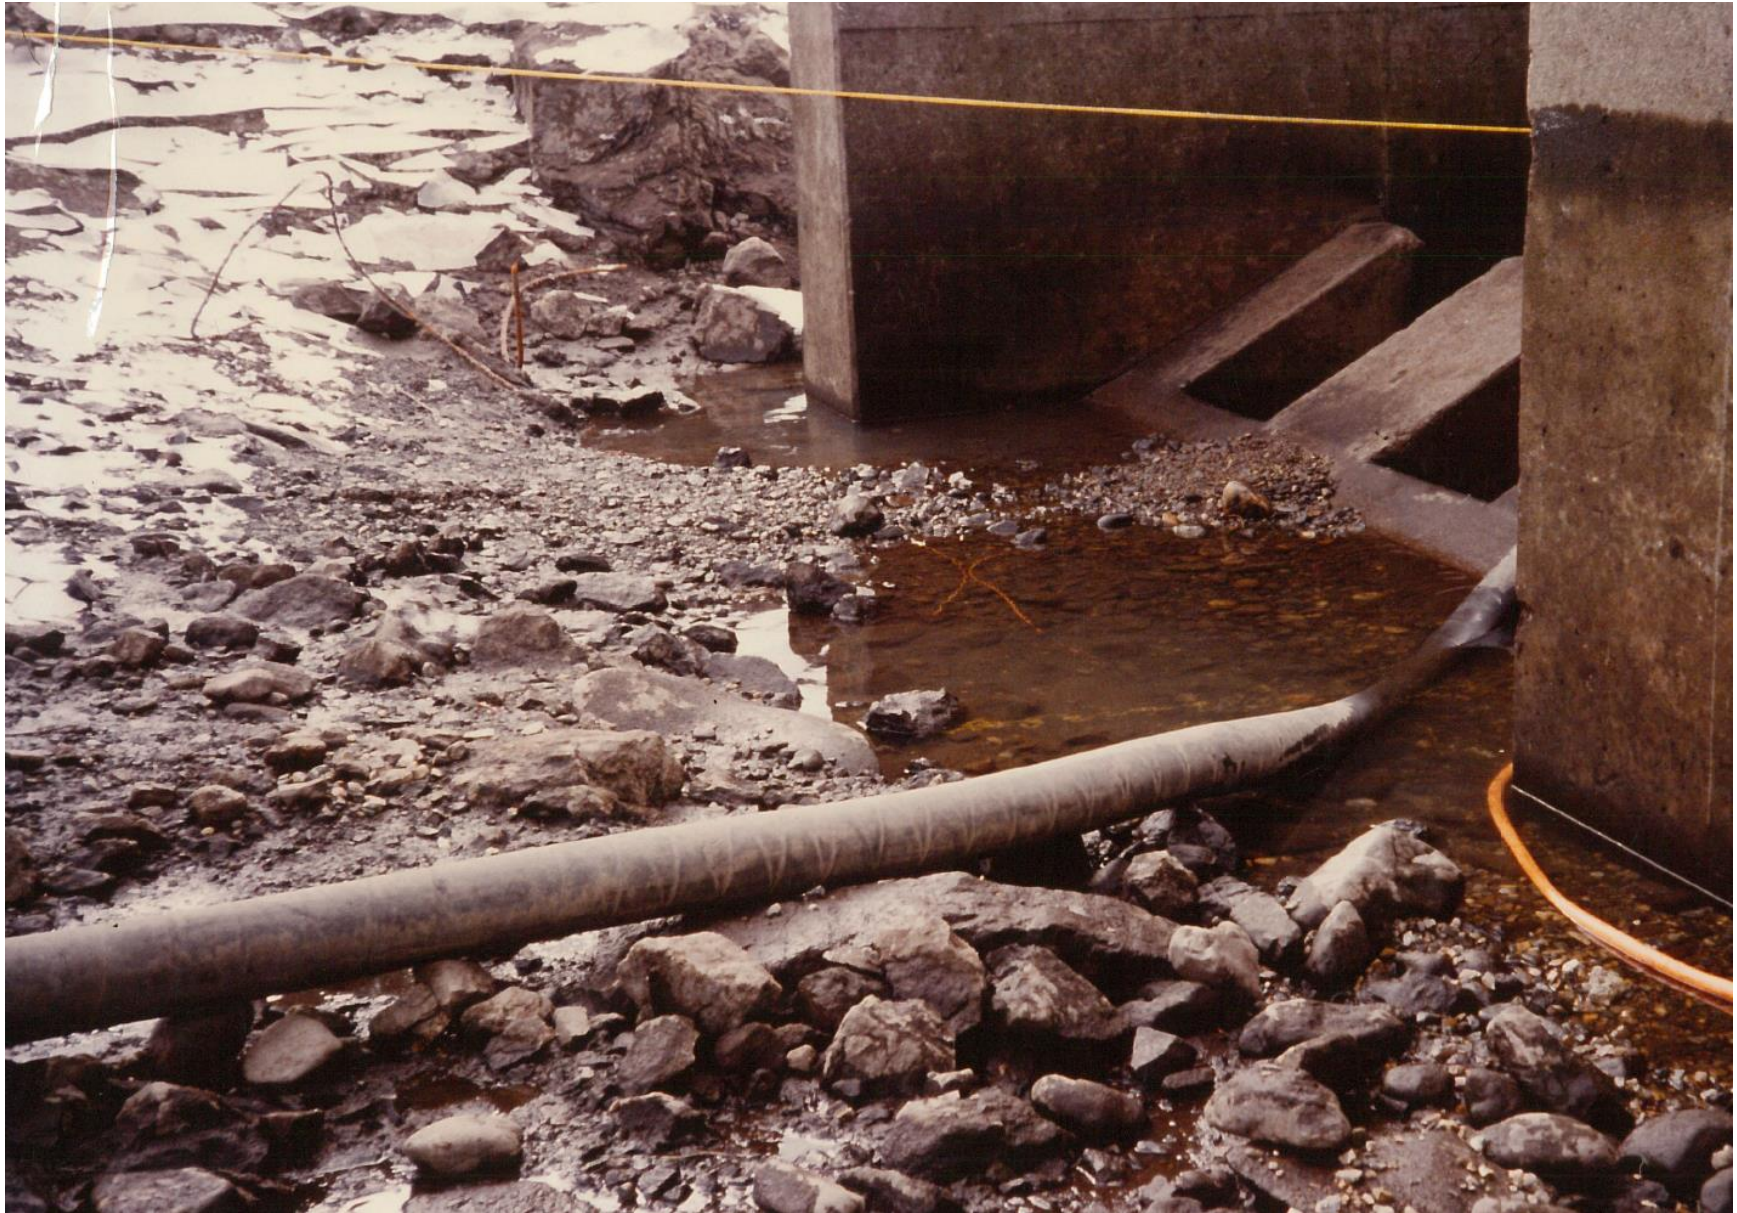
Conditions of the downstream channel at the end of the basin are shown on figure 3. Some gravel was deposited on the sloping face of the end sill. (Note: the gravel deposit is highest just downstream of the dentate near the centerline of the basin and has the appearance of being drawn upstream toward the basin.) Topography of the downstream channel is shown on figure 4; (need fig. 4) a longitudinal cross section view along the basin centerline is shown on figure 5. (need fig. 5) The basin invert is at elevation 3889 feet (1185.4 m), and the downstream channel bottom is at 3904 feet (1189.9 m). A tailwater depth of 15 feet (4.5 m) is present in the stilling basin without discharge. Most basin operation (fig. 6) (need fig. 6) is with considerably less discharge than the maximum design discharge of 900 ft³/s (25.5 m³/s); consequently, the hydraulic jump is submerged.

Figure 3. — Gravel deposit on the end sill of the outlet works stilling basin.

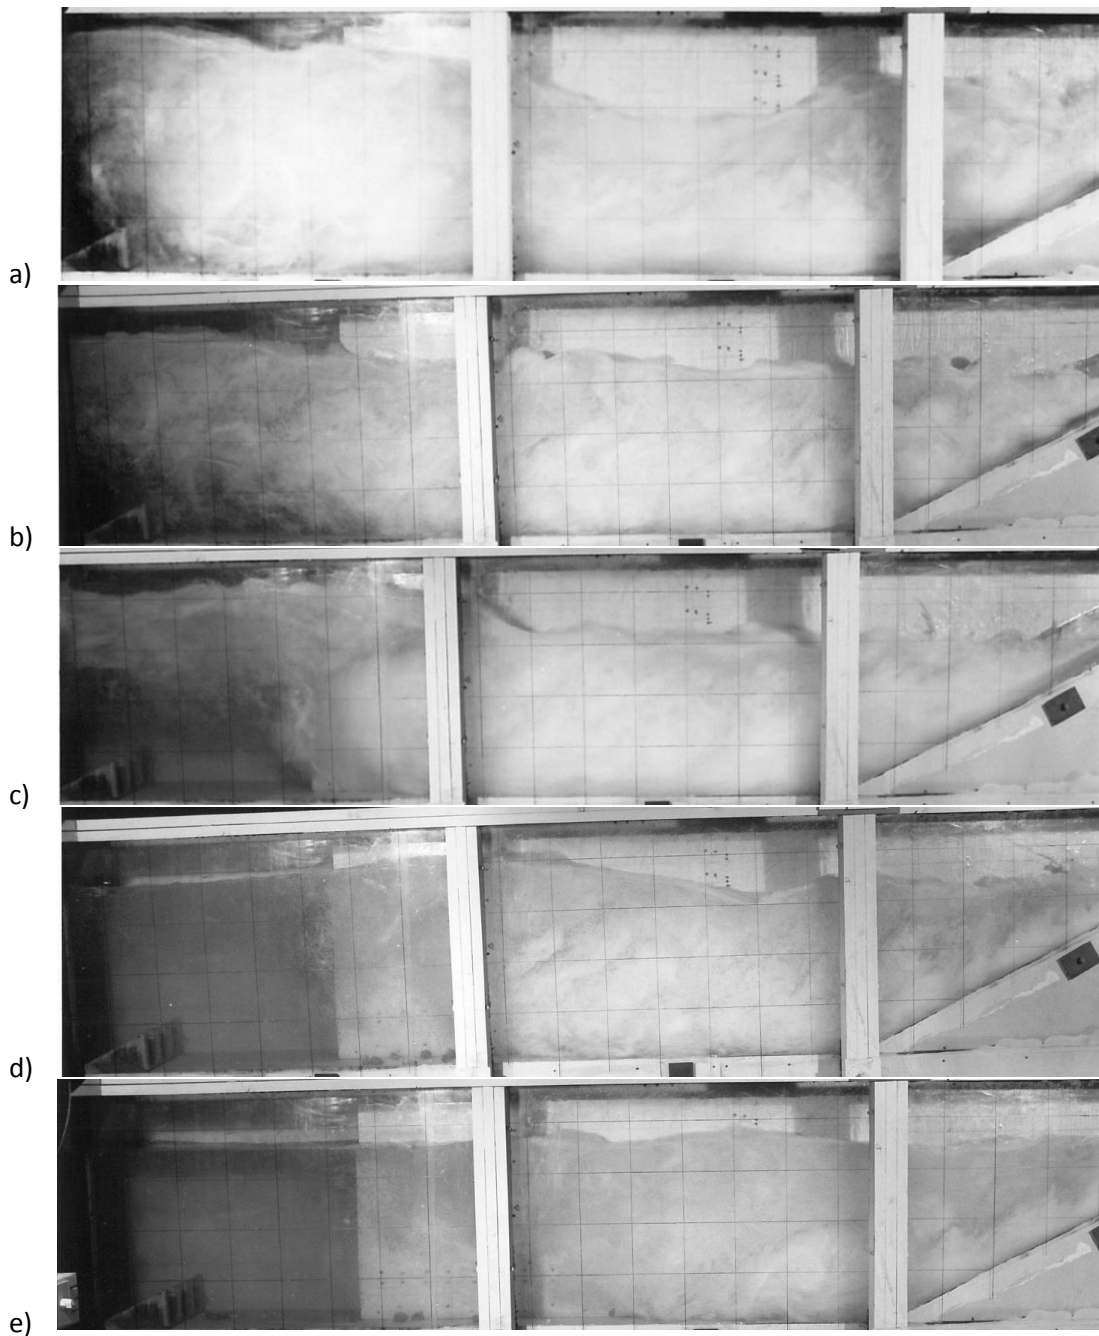
Rock movement in the model stilling basin was affected by hydraulic flow characteristics in the basin similar to a hydraulic jump (fig. 10). A high-velocity jet exits from the gate, travels down the chute, and along the basin floor. Some distance downstream the high-velocity flow leaves the basin floor and moves upward causing a turbulent boil at the water surface. The distance the high-velocity flow travels along the floor varies with discharge (fig. 11). For low discharges, smaller gate openings, the jet leaves the basin floor further upstream (fig. 11e). Flow conditions of a hydraulic jump are very turbulent with considerable surging. Thus for a given discharge, the point where the jet leaves the basin floor also varies (figs. 11b and 11c).

Figure 11. — Stilling basin flow conditions.

- a) 100% gate opening, $30.6 \text{ m}^3/\text{s}$ ($1080 \text{ ft}^3/\text{s}$). Photo H-1920-148
- b) 60% gate opening, $19.0 \text{ m}^3/\text{s}$ ($670 \text{ ft}^3/\text{s}$). Photo H-1920-9
- c) 60% gate opening, $19.0 \text{ m}^3/\text{s}$ ($670 \text{ ft}^3/\text{s}$). Photo H-1920-14
- d) 30% gate opening, $9.8 \text{ m}^3/\text{s}$ ($345 \text{ ft}^3/\text{s}$). Photo H-1920-91
- e) 20% gate opening, $6.9 \text{ m}^3/\text{s}$ ($245 \text{ ft}^3/\text{s}$). Photo H-1920-100

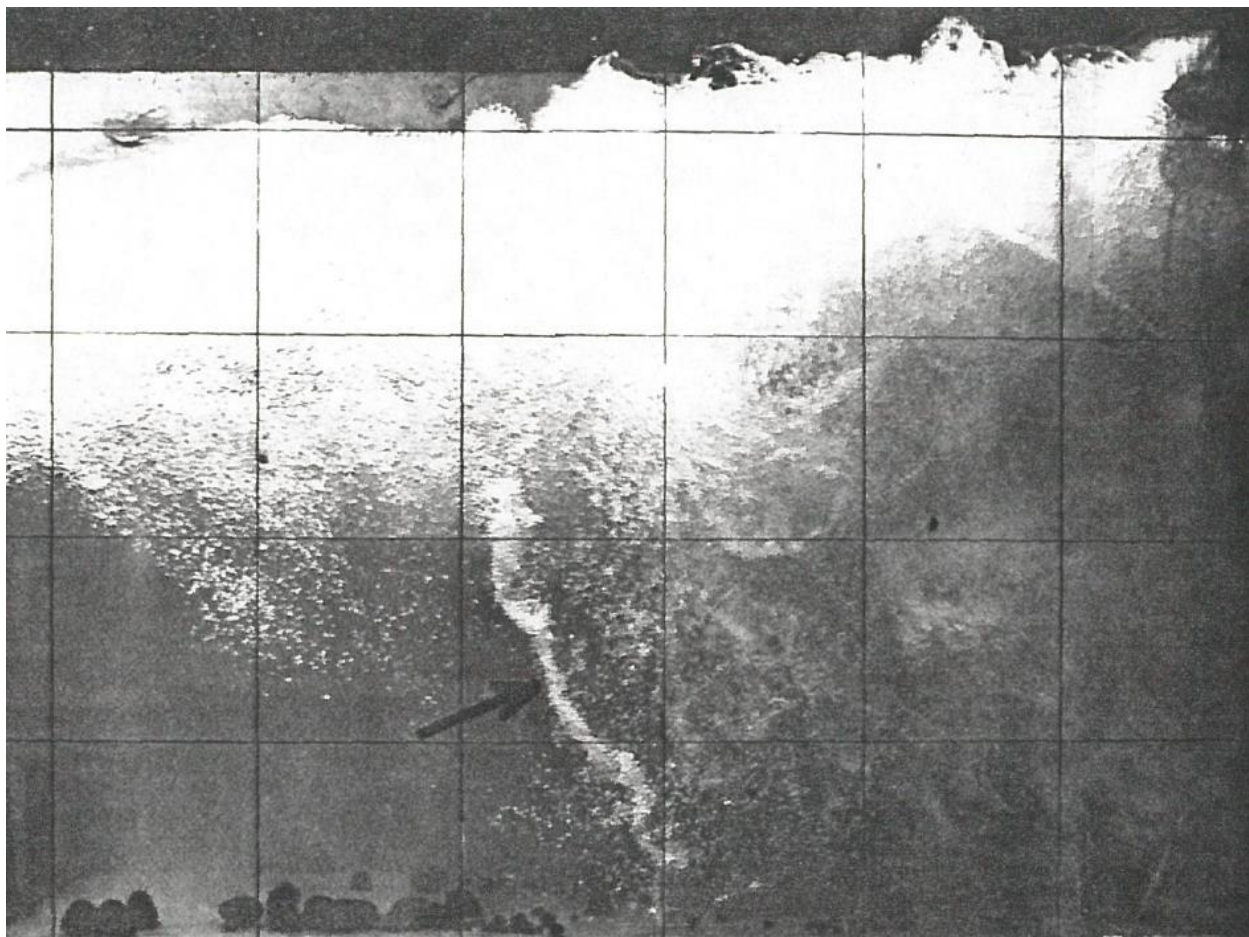
Figure 12. — Eddy with air bubble core. 50% gate opening, discharge = $16.0 \text{ m}^3/\text{s}$ ($565 \text{ ft}^3/\text{s}$).

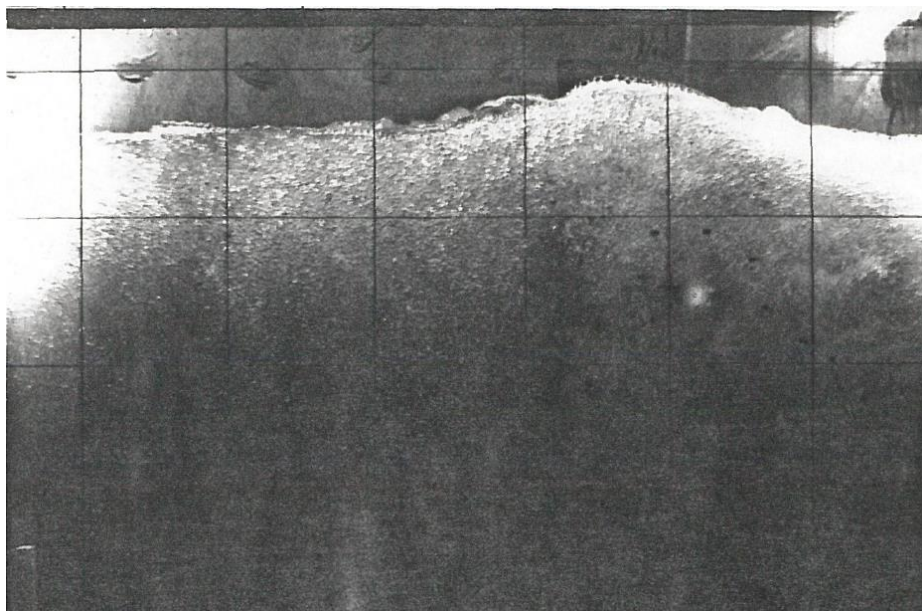
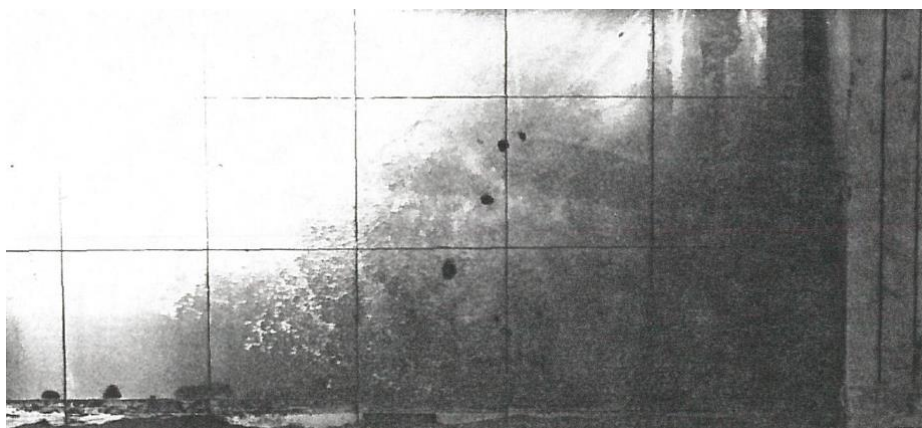
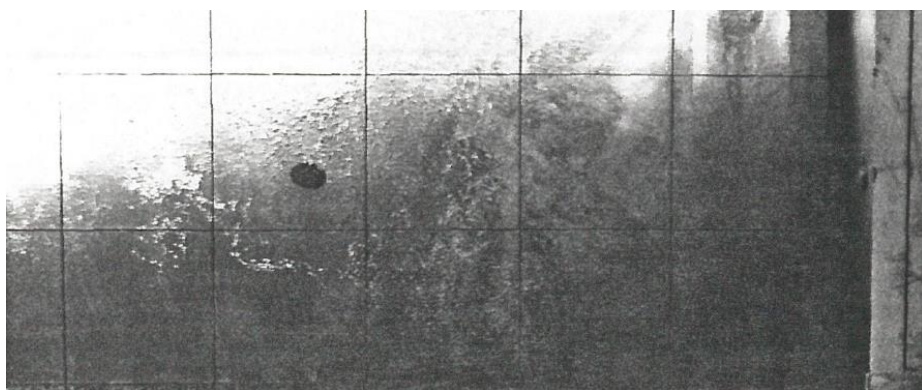
a) 50-mm (2-in.) rocks, 40% gate opening, $13.0 \text{ m}^3/\text{s}$ ($460 \text{ ft}^3/\text{s}$)

b) 100-mm (4-in.) and 200-mm (8-in.) rocks, 50% gate opening, $16.0 \text{ m}^3/\text{s}$ ($565 \text{ ft}^3/\text{s}$)

c) 300-mm (12-in.) rock, 50% gate opening, $16.0 \text{ m}^3/\text{s}$ ($565 \text{ ft}^3/\text{s}$)

Figure 14. — Rocks lifted above the basin floor.

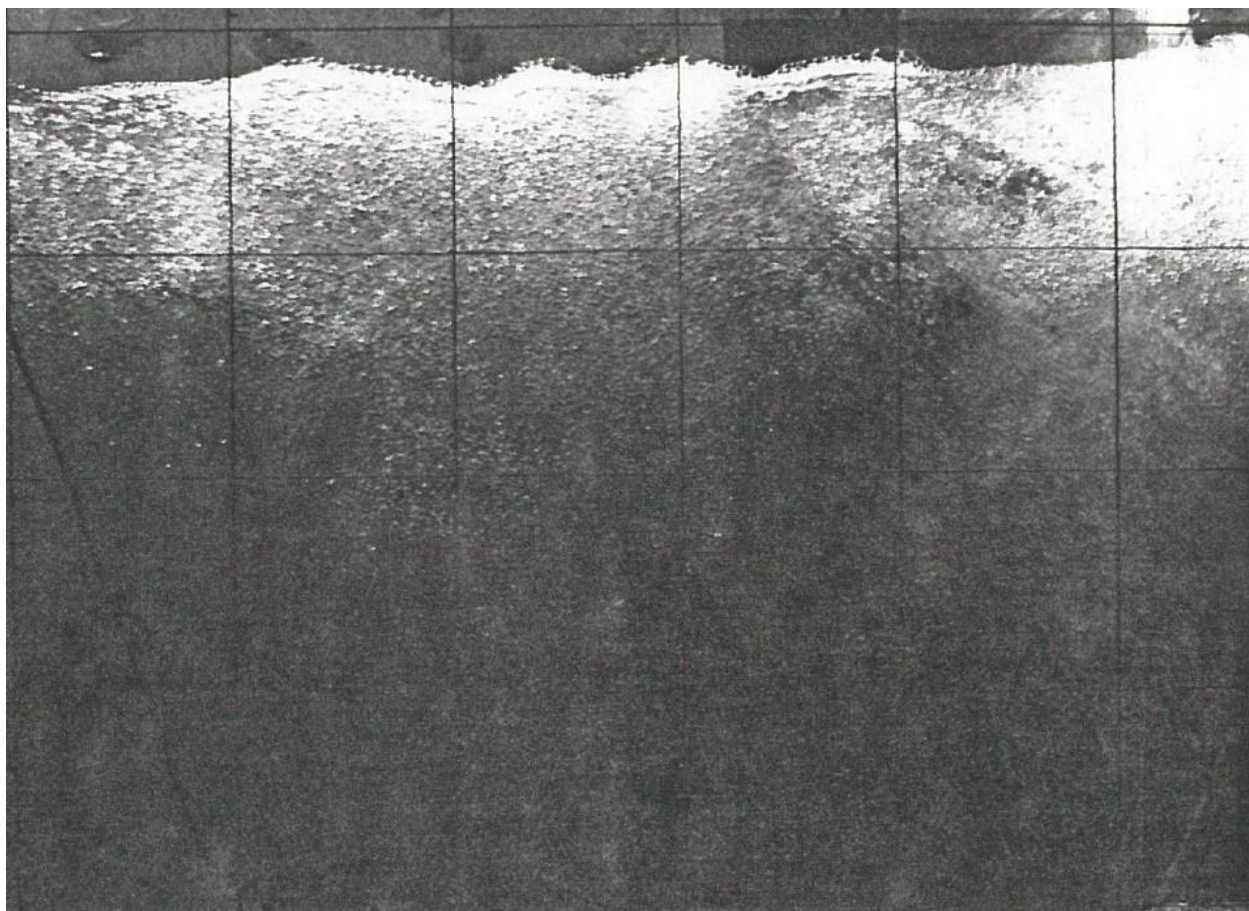
Figure 16. — Dye injected near the end of the stilling basin, 40% gate opening, discharge = $13.0 \text{ m}^3/\text{s}$ ($460 \text{ ft}^3/\text{s}$).

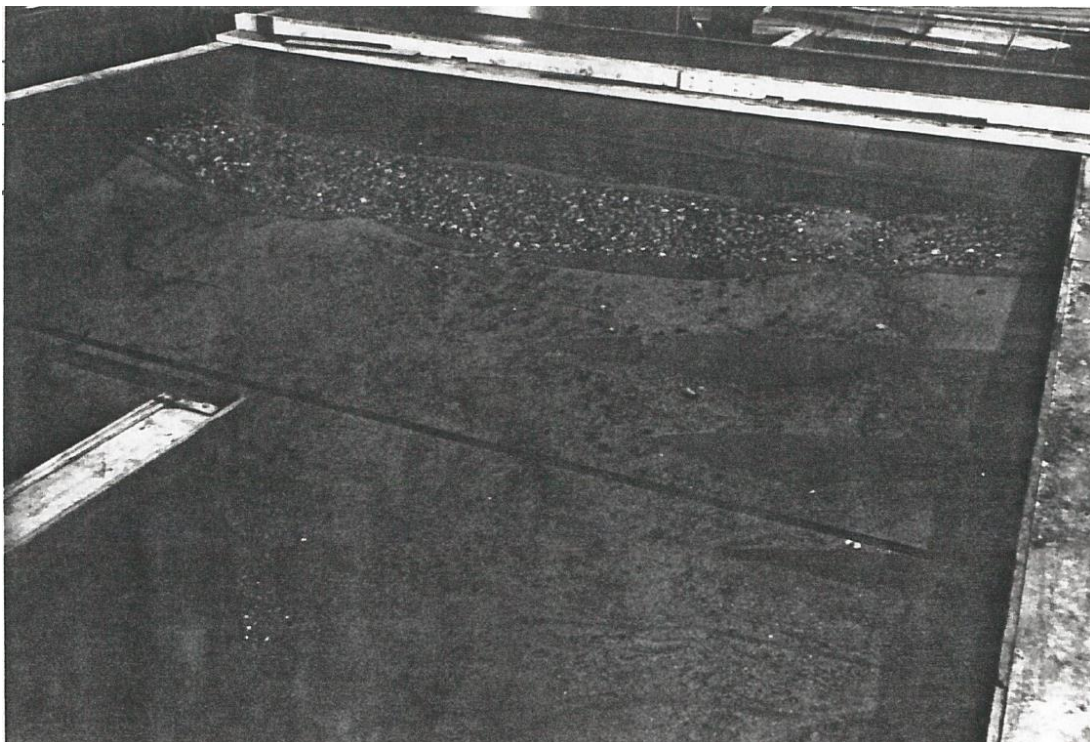
Figure 17. — Unacceptable erosion of model topography.

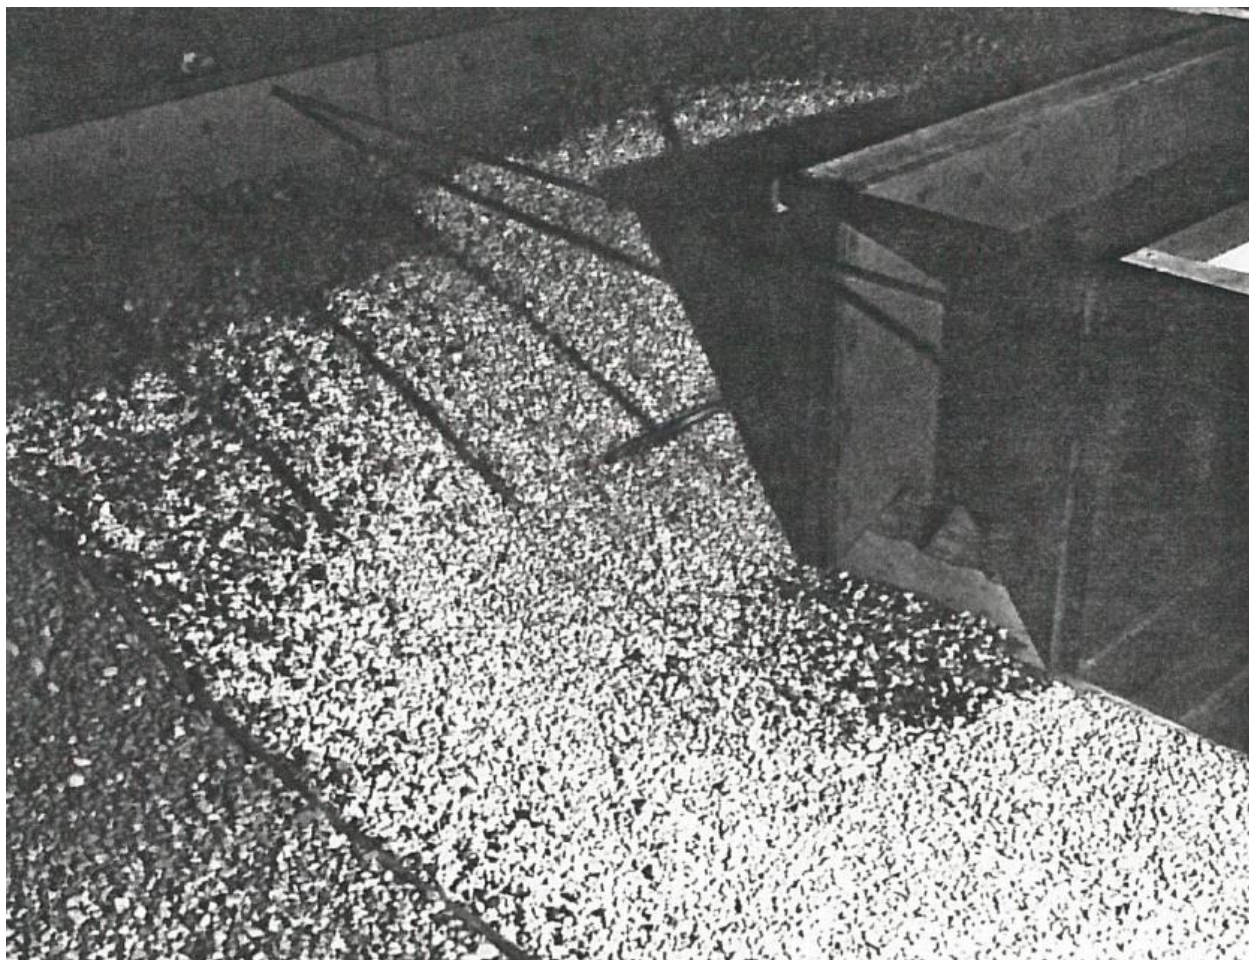
Three-fourth-inch gravel was placed in the model, and the gravel bed was painted white to help detect rock movement. Displacement of the stones would expose a darker color. No movement of the gravel bed was detected until the 70-percent gate opening. Figure 20 exhibits the condition of the gravel bed after 100 percent gate opening. Most erosion was located near the left portion of the basin and extended 15 feet (4.6 m) downstream from the basin. Stones, which had been moved, were noted 25 feet (7.6 m) from the basin. Also, some stones were moved on the right bank, 20 to 45 feet (6.1 to 13.7 m) downstream from the basin (fig. 20, left side).

Figure 20. — Gravel bed after 100% gate opening, prototype gravel size 3.5 to 6 inches.

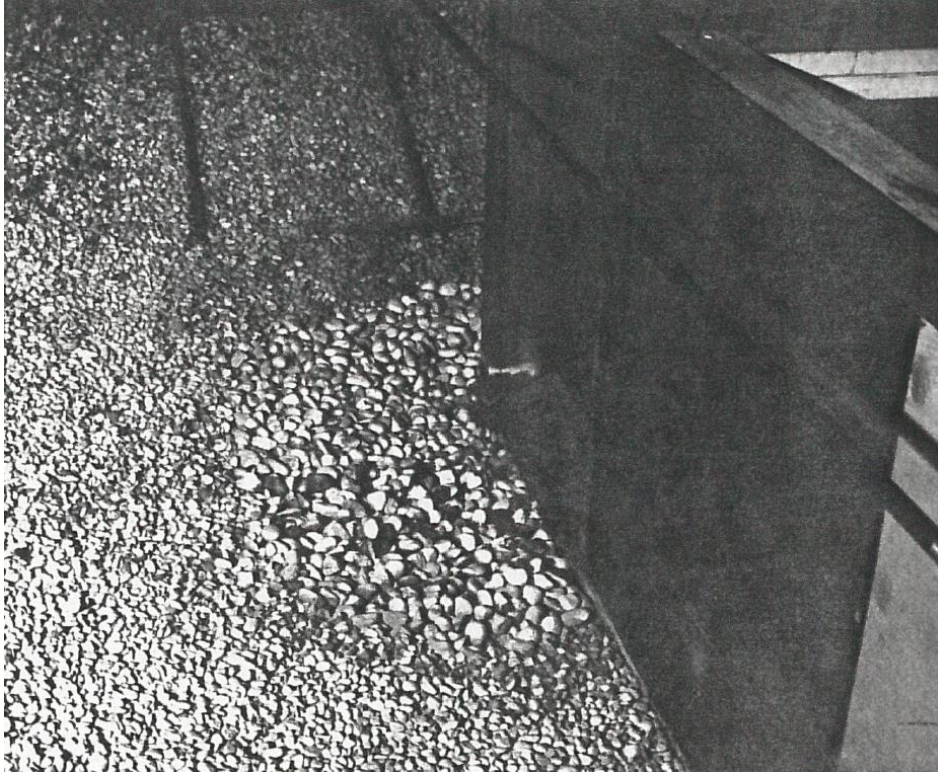
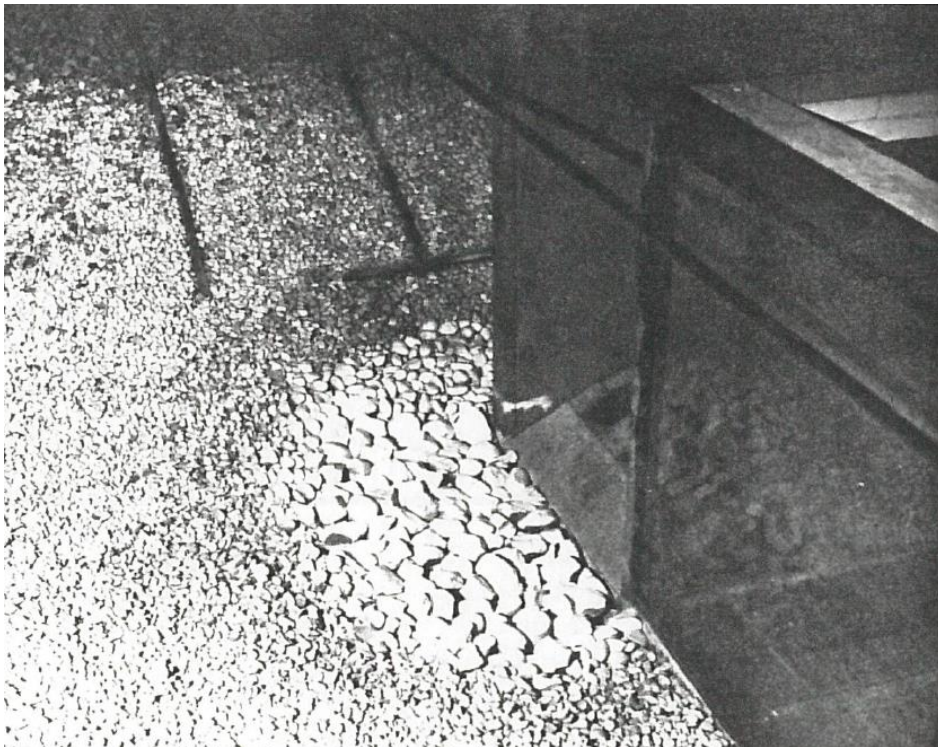
a) Prototype gravel size 8 to 12 inches

b) Prototype gravel size 16 to 21 inches

Figure 21. — Gravel bed after 100% gate opening.

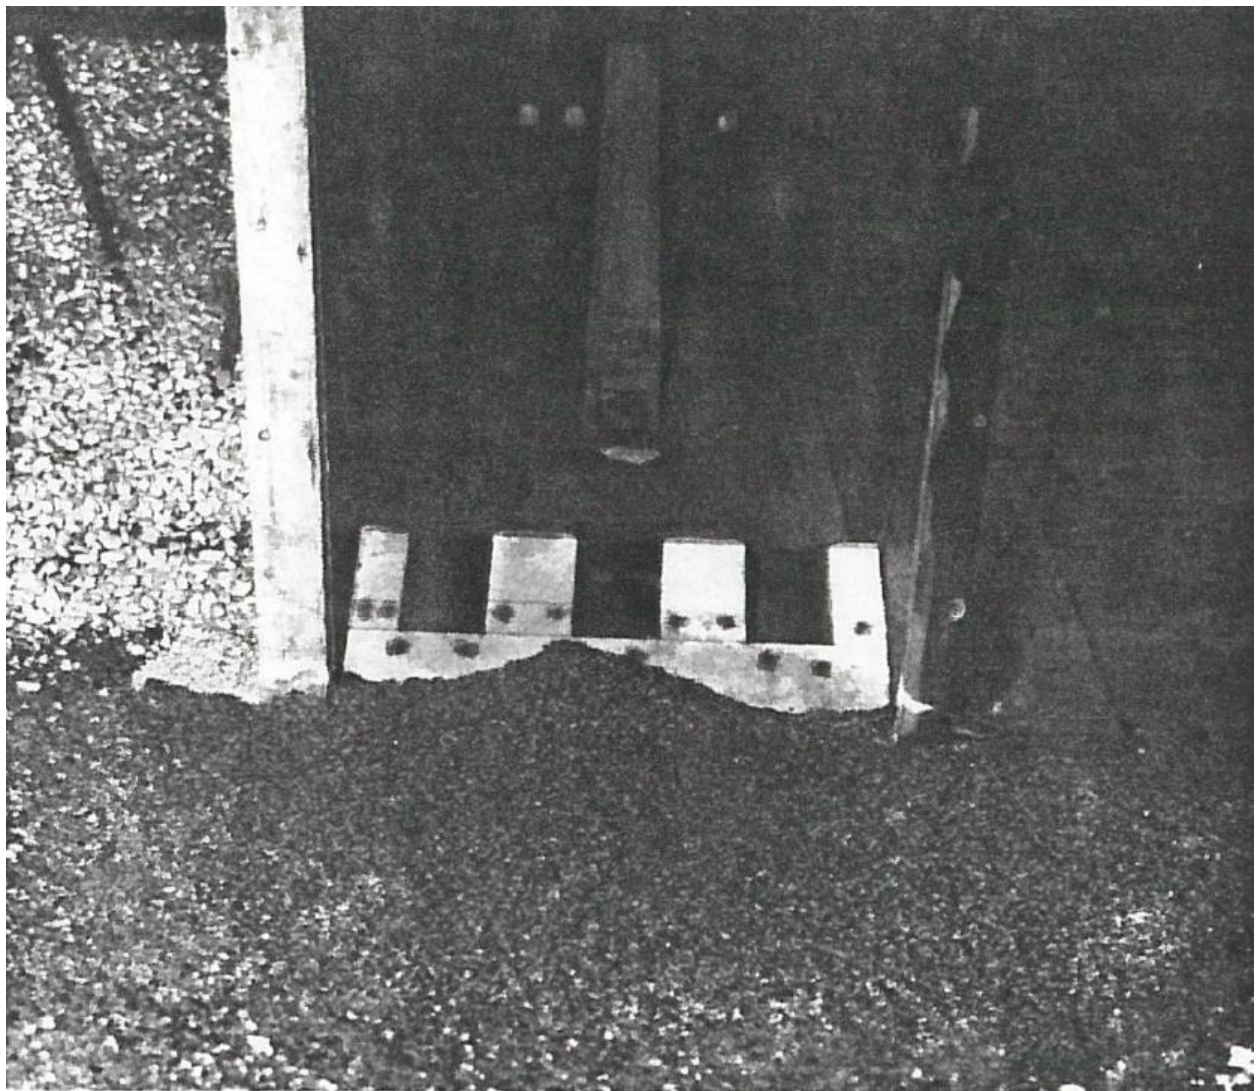
Figure 22. — Sand deposit on end sill, #8 to #16 sand, 15 hours operation at 20% gate opening.

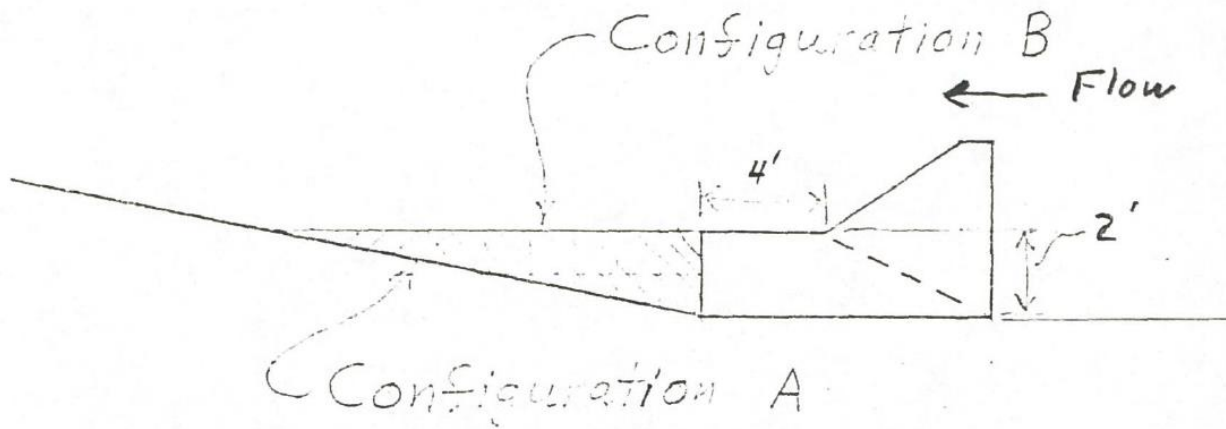
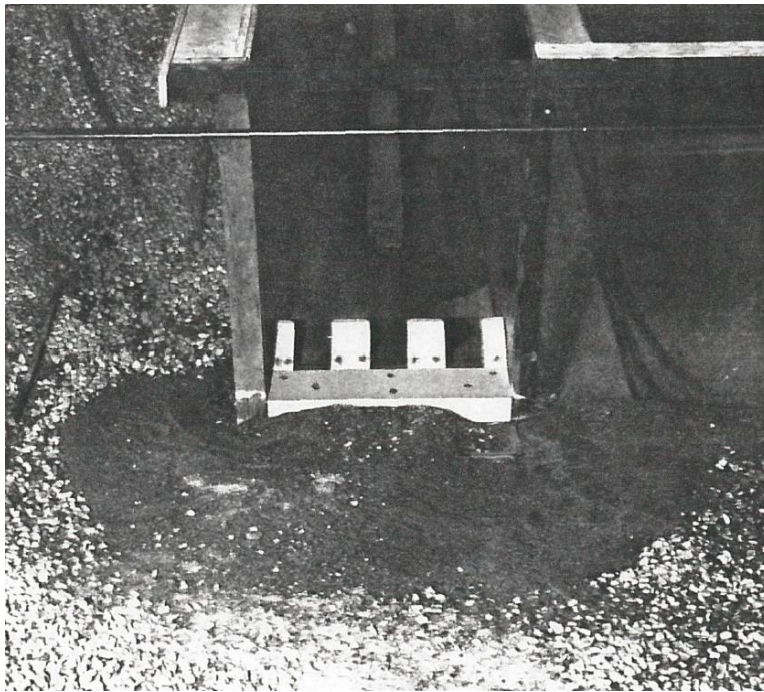
a) Two configurations of end sill topography that were tested.

b) Erosion after 1 hour model operation, 100% gate opening, configuration B.

Figure 23. — Modified end sill.

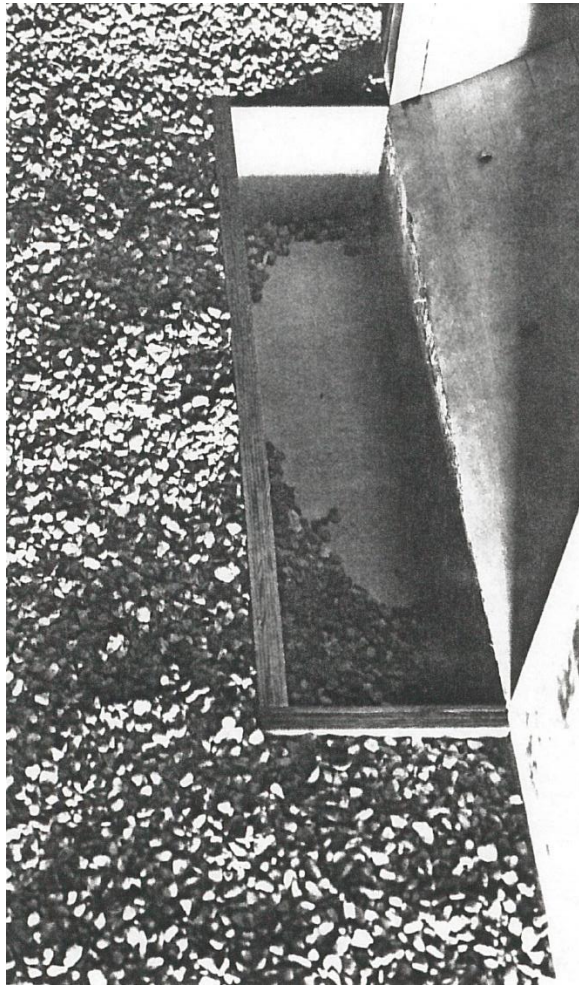
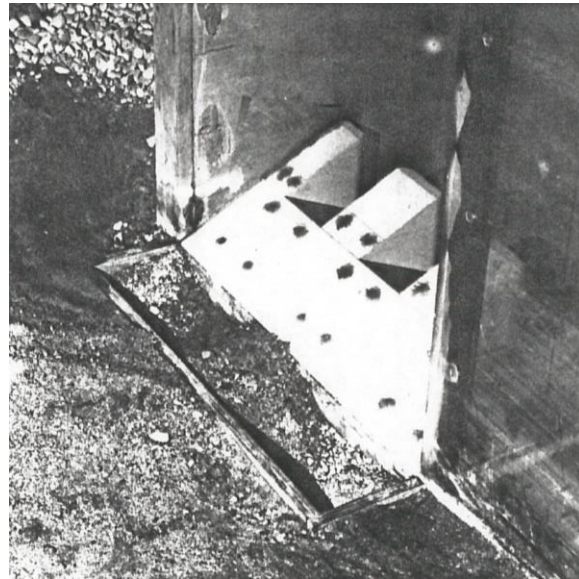
Various size materials were tested in the model. With pit run sand, a slight amount of sand entered the rock trap at the 40-percent gate opening. More sand entered the rock trap as the gate openings increased. At the 80-percent gate opening, fines evidently were not trapped because fines were observed on the downstream sloping portion of the end sill. With pea gravel, the first rock moved into the trap at a 50-percent gate opening. Pea gravel drawn into the rock trap after the 100-percent gate opening is exhibited on figure 25a. With 3/4-in rock, the gates were 70 percent open before the first rock moved into the trap. A couple of 1-inch rocks moved slightly; none of the rocks were dislodged.

Figure 25. — Rock trap in model after operating at a 100% gate opening. a) Rocks were captured by rock trap and were not drawing into the stilling basin. b) Erosion from the rock trap. (Before the test, the model rock trap was filled with pit run sand.) The rock trap will require cleaning before material accumulates to within 0.3 m (1 ft) of the top.

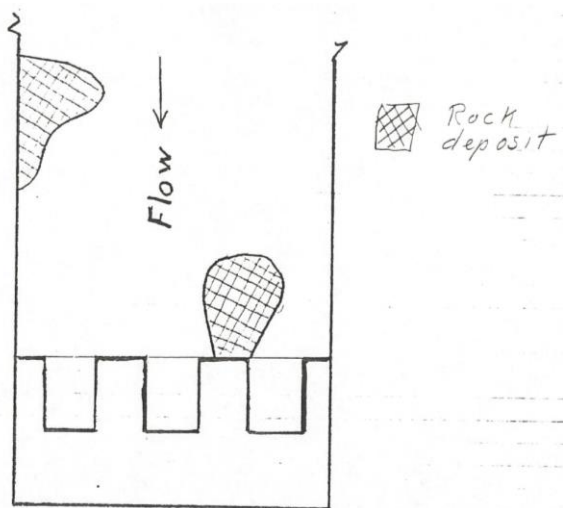
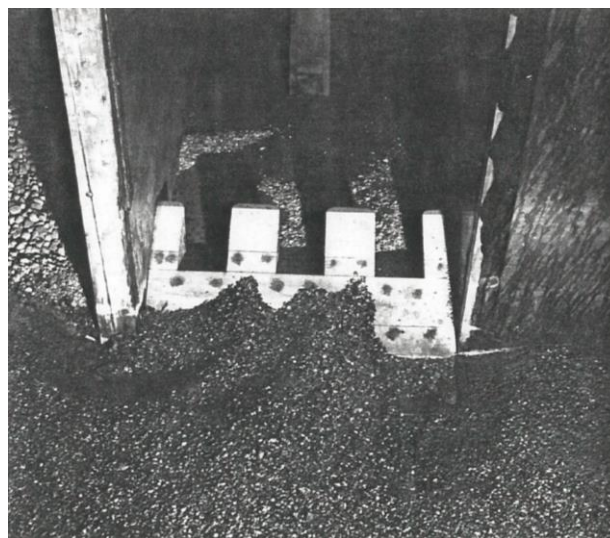
- During August 1980, field tests were made to test single bay (gate?) operation. Single bay operation provided more discharge to the hydraulic jump, and theoretically the jump should operate with less submergence. (Does single bay and single gate imply the same thing?) Single bay operation field tests were conducted for only a short time. Following a 1-hour test and immediate inspection, divers found that rocks had been brought into the basin. Single bay operation was not the answer to the abrasion problem. The test results substantiated the Reclamation's operating criteria prohibiting single bay operation.

Figure 26. — Operations test results for single (left) bay. A) Results of field test. B) Results of model test.
