## ANALYSIS OF SPILLWAY FAILURES BY UPLIFT PRESSURE

By Thomas E. Hepler<sup>1</sup>, Associate Member, ASCE, and  
Perry L. Johnson<sup>2</sup>, Member, ASCE

Results of a model study to evaluate the development of uplift pressures beneath concrete chutes are presented. Two spillway failures are described to support the study results. Common design features to control or prevent uplift pressure development are provided.

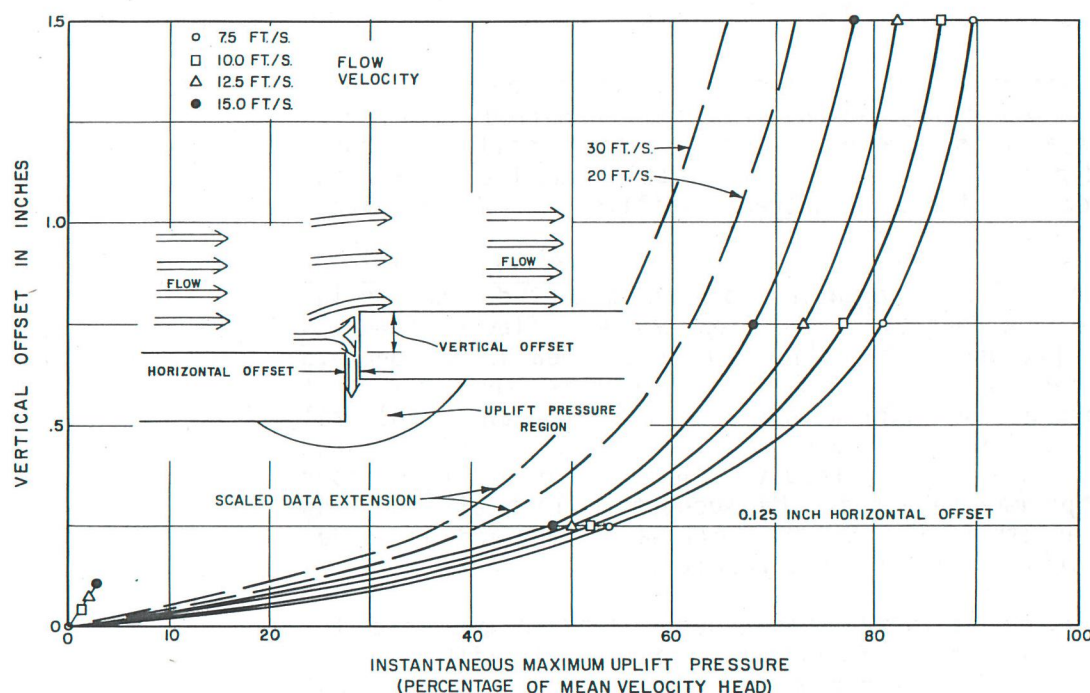
FIGURE 1 - TYPICAL MODEL STUDY FINDINGS

Typical study results are shown in Figure 1, with uplift pressures presented as a percentage of the mean velocity head for the flow over the offset. The hydrostatic component was subtracted from the measured pressures to obtain the dynamic uplift pressures shown. Thus, to define total hydraulic loading on a floor lining, hydrostatic loads should be added to both top and bottom surfaces. The dynamic uplift pressures presented in Figure 1 are maximum instantaneous values which yield short term maximum loadings and thus are critical with respect to lining stability.

Several conclusions can be made. Dynamic uplift pressures increase with increase in vertical offset. This is due to boundary layer influences which reduce flow velocities near the boundary and thus reduce the velocities intercepted by smaller offsets. Boundary velocity magnitude and boundary layer thickness are dependent on mean flow velocity, the extent of boundary layer development, flow surface configuration (the presence of vertical curves, contractions, expansions, etc.), and flow surface roughness. Since boundary layer thickness and velocity distribution may vary with location on the flow surface, what constitutes an acceptable offset may also vary with location. The findings indicate that with a 0.125-inch (3.2 mm) horizontal offset, 80 to 90 percent of the mean velocity head will be converted to instantaneous uplift pressure. Average uplift pressure will be less. The size of the horizontal offset also influences the resulting uplift pressure. The 0.125-inch (3.2 mm) horizontal offset (the smallest studied) yielded the largest uplift pressures. Increasing the horizontal offset to 0.25 inches (6.4 mm), 0.5 inches (13 mm), and 1.5 inches (38 mm) reduced the resulting uplift pressures by approximately 10, 20, and 40 percent, respectively. Reduced uplift pressure development appears to result because larger horizontal offsets allow more flow circulation which dissipates energy.

Finally, flow velocity over the offset affects the development of uplift pressure. In general, it appears that higher velocities convert a slightly smaller percentage of the mean velocity head into dynamic uplift pressure. However, because velocity heads increase as the

square of the velocity, the resulting dynamic uplift pressures increase substantially with velocity.
