Hydraulic Laboratory Technical Memorandum, PAP-1198

# Field Test of Green Springs Turbine Bypass Operation

**Rogue River Basin Project, Oregon**  
**Interior Region 9: Columbia Pacific Northwest (CPN)**

April 2021

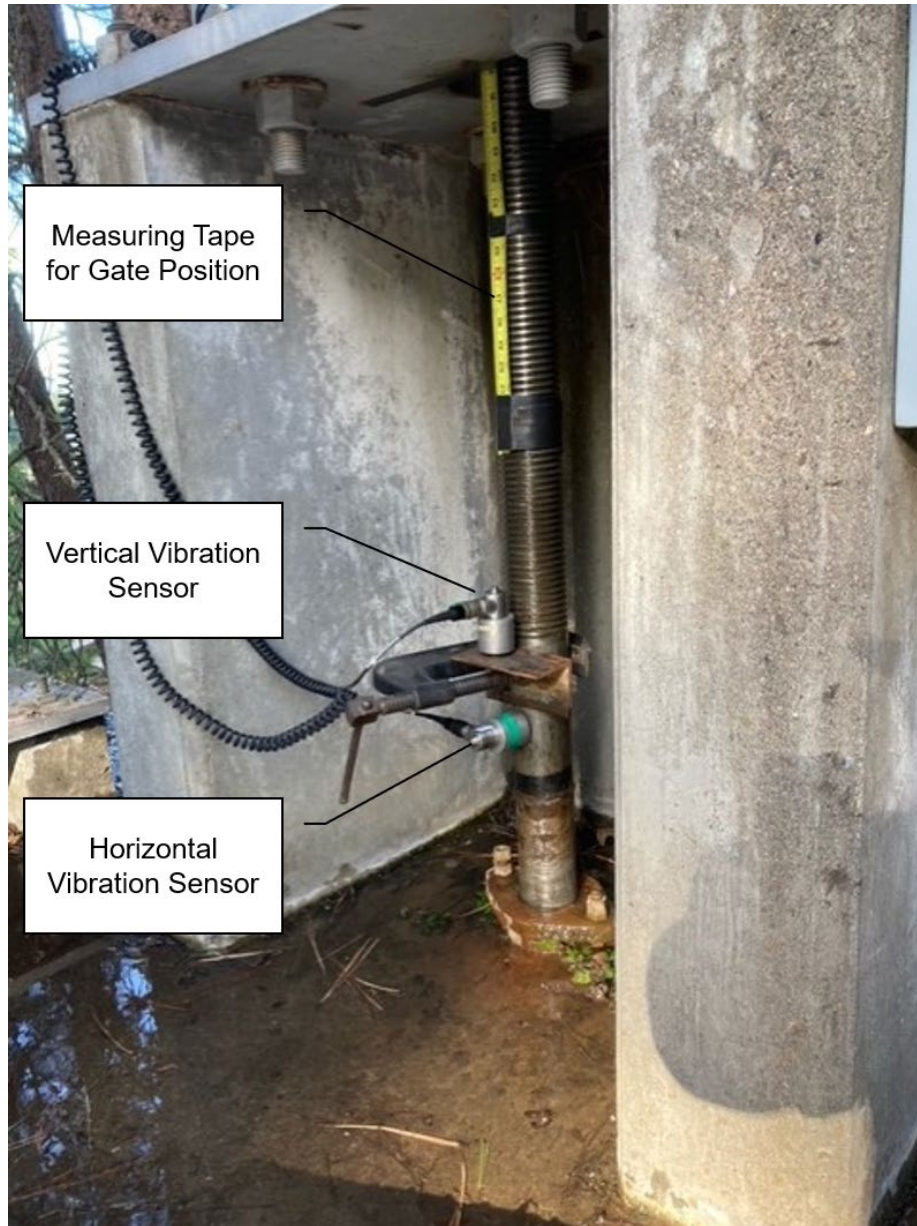
Figure 1 Measuring tape used for gate position and accelerometers mounted on the 60-inch slide gate shaft to measure horizontal (in direction of flow) and vertical vibrations.

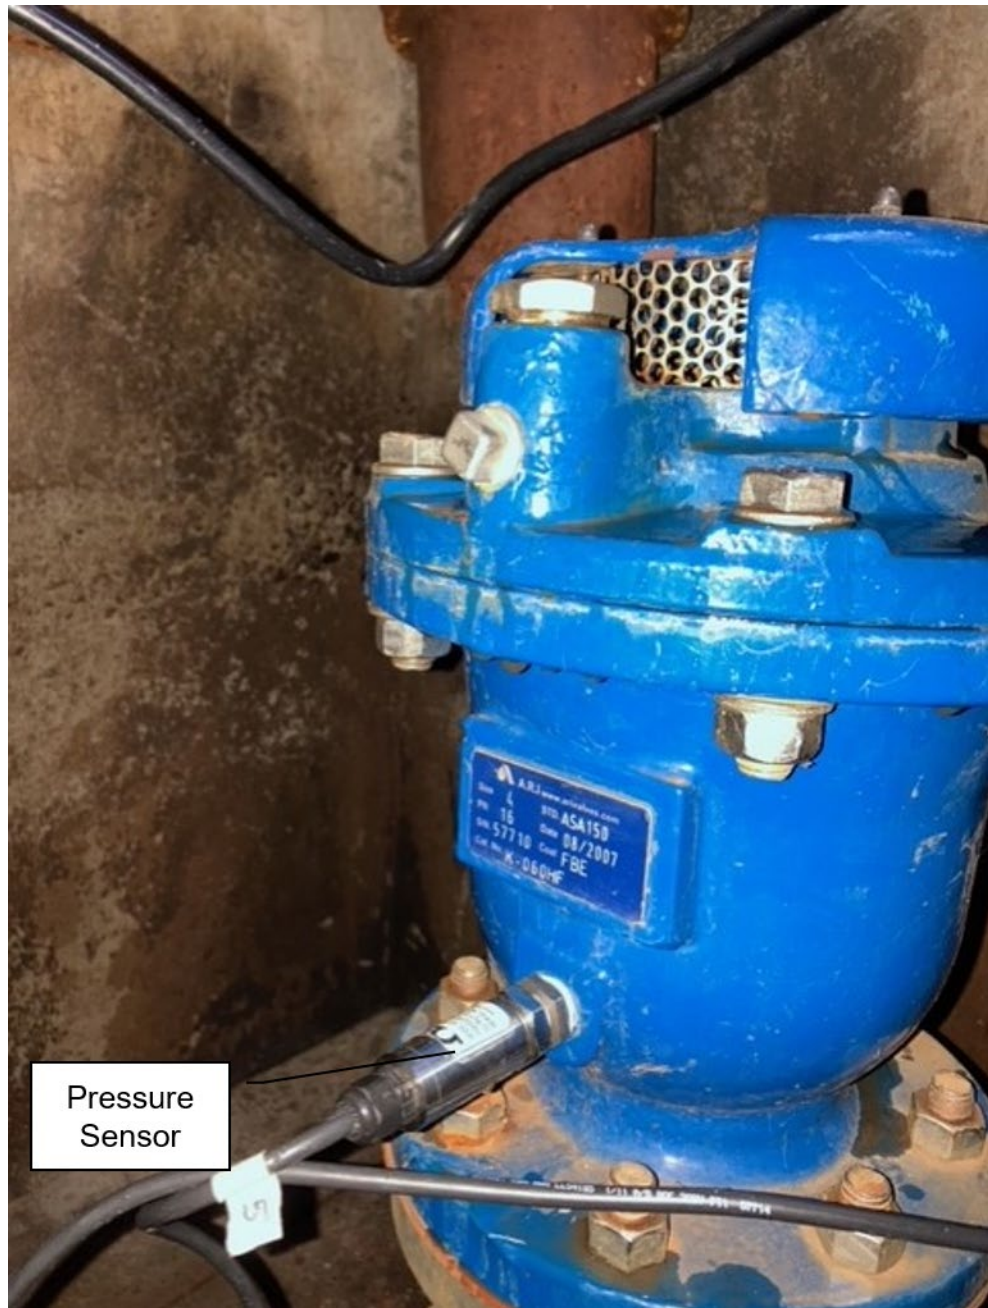
Figure 2 Pressure sensor mounted on the downstream side of the 4-inch air valve to measure pipe pressures directly downstream of the slide gate.

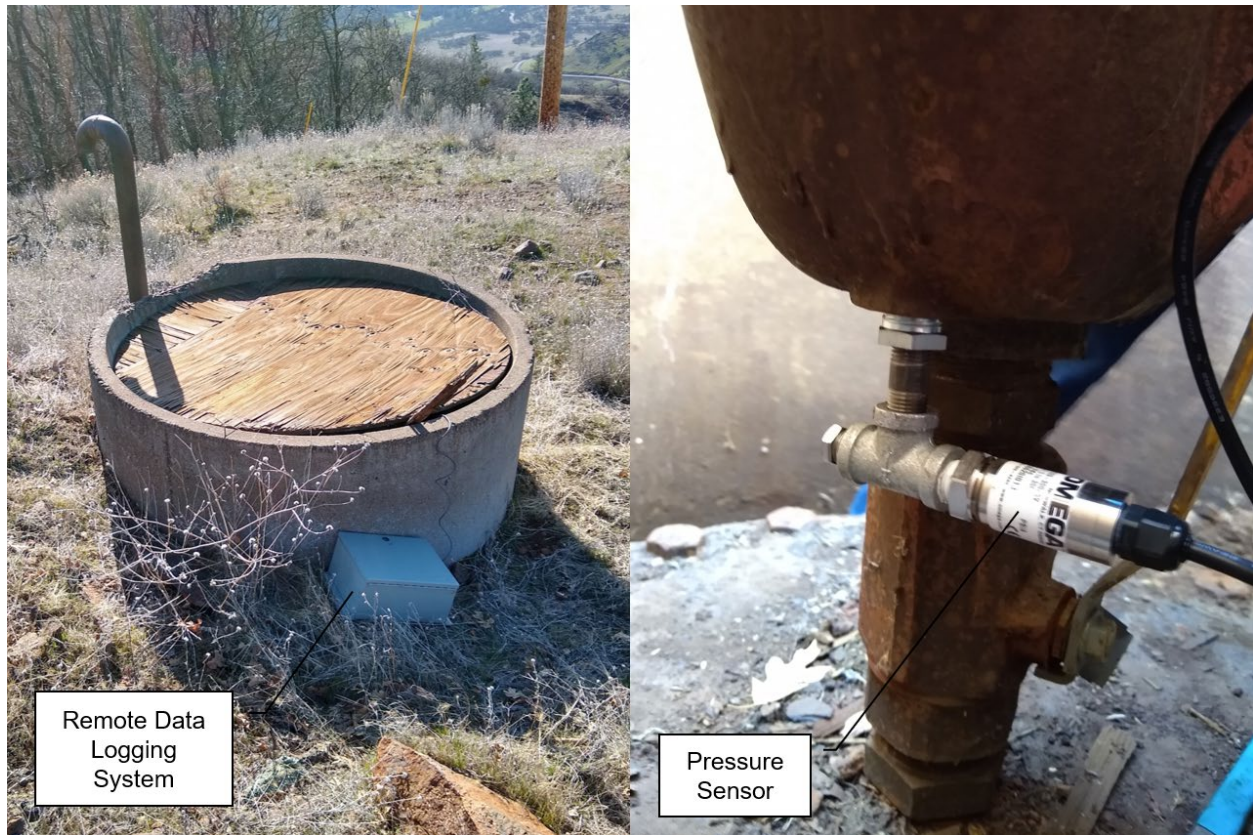
Figure 3 Manhole access for the 2-inch air valve and remote data logger (left) and pressure sensor mounted on the downstream side of the 2-inch air valve to measure penstock pressures at a high point downstream of the last saddle in the piping system.

2. Performance of the 2-inch air valve was satisfactory at all flow conditions tested and did not produce excessively low internal pressures or adverse transient conditions within the penstock that would limit bypass operation. The wire mess screen on the 2-inch air valve inlet should be repaired immediately.

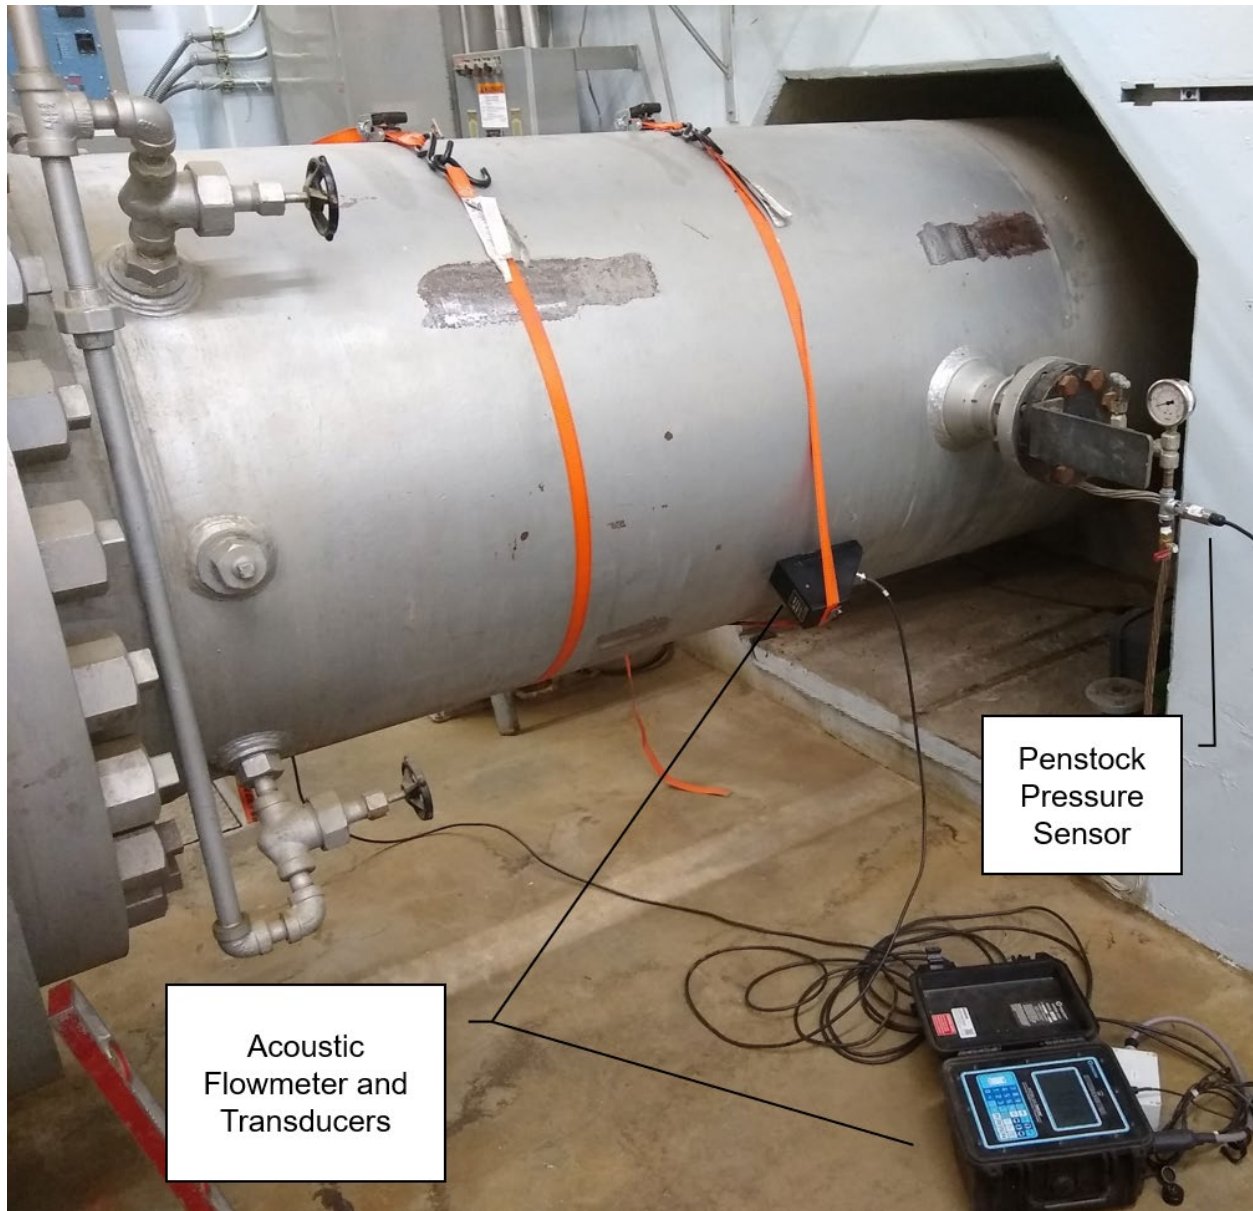
Figure 4 Acoustic flow meter and pressure sensor mounted on the exposed penstock in the powerplant immediately upstream of the turbine guard valve and scroll case. Flow is from right to left in photo.

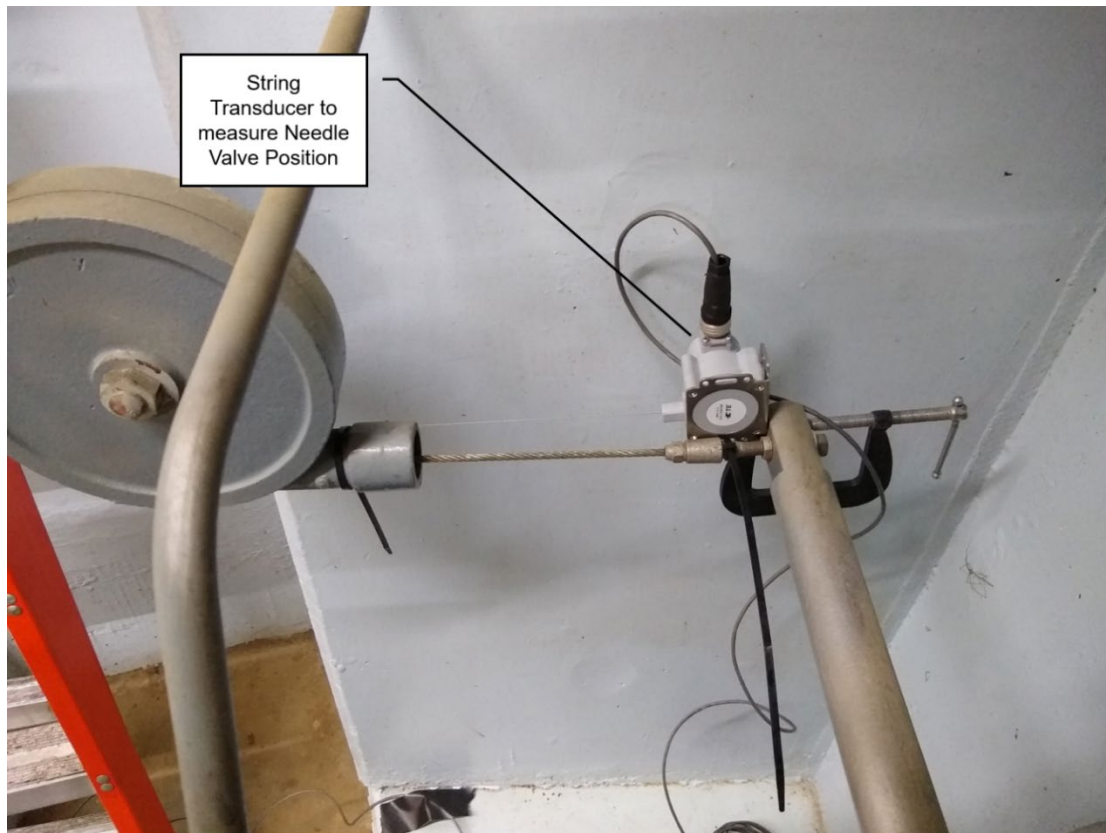
Figure 5 String transducer used to measure the position of the Turbine Needle Valve 4.

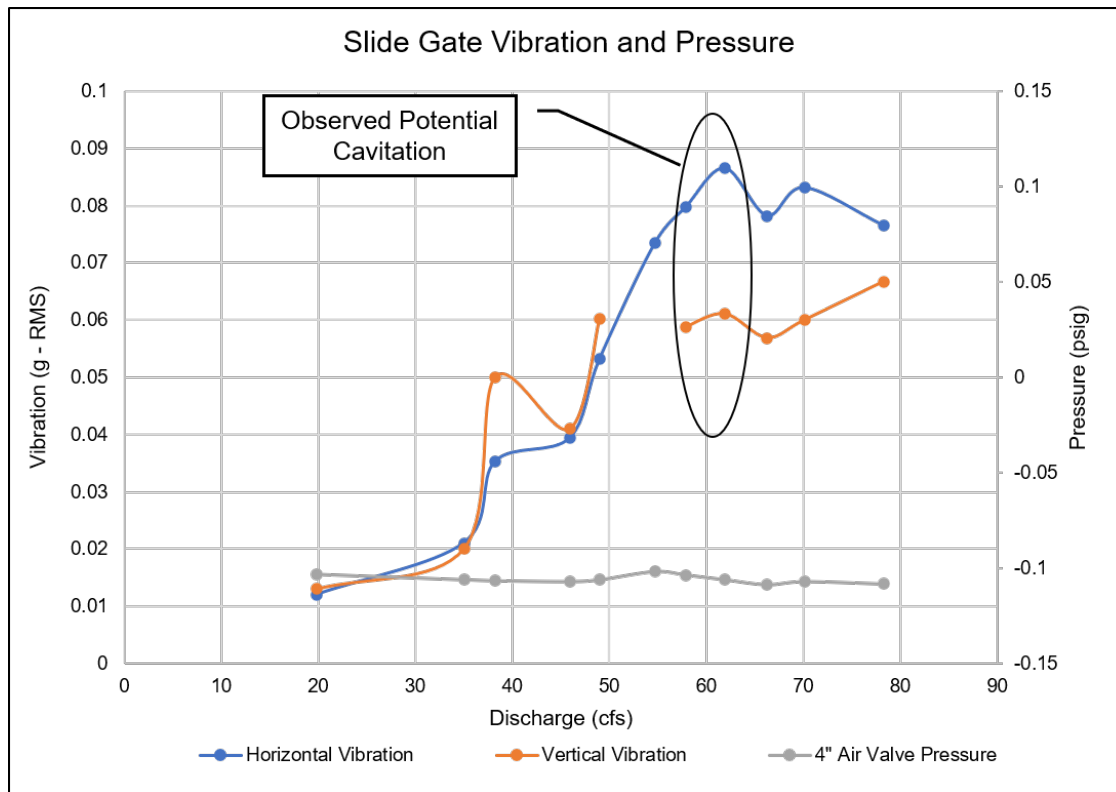
For bypass operations, the slide gate was partially opened to control the flow into the pipeline. Observations and vibration measurements suggested that, for most gate positions, the gate performed well with no observed erratic operation (i.e. gate chatter, flutter, etc.) or damage to the gate or structure. For gate positions of 6.5- to 7-inches open (58 – 62 cfs in this case) pinging and crackling noises were heard coming from the gate structure which may be indicative of cavitation. These observations are not alarming and agree with higher vibration levels measured for the same conditions (Figure 6). The magnitude of vibration recorded is less than 0.1g and is not an area of concern for excessive wear or fatigue of the slide gate over the lifespan of the gate given the limited occurrence of bypass operations.

Pressure measurements (Figure 6) as well as observations showed that air flow through the 4-inch air valve immediately downstream of the slide gate was almost imperceptible. The lack of air flow through the valve suggests that the piping between the slide gate and surge tank was only partially filled which maintained atmospheric pressure within this reach of pipe. While the slide gate opening should be limited to 6-inches if possible to avoid cavitation potential, an unrestricted air supply from both the 4-inch air valve and surge tank will help alleviate operational issues at the gate if openings greater than 6-inches were required for larger discharges.

Figure 6 Slide Gate vibration (root-mean-square) and 4-inch air valve pressure (average) measured for each discharge test condition.

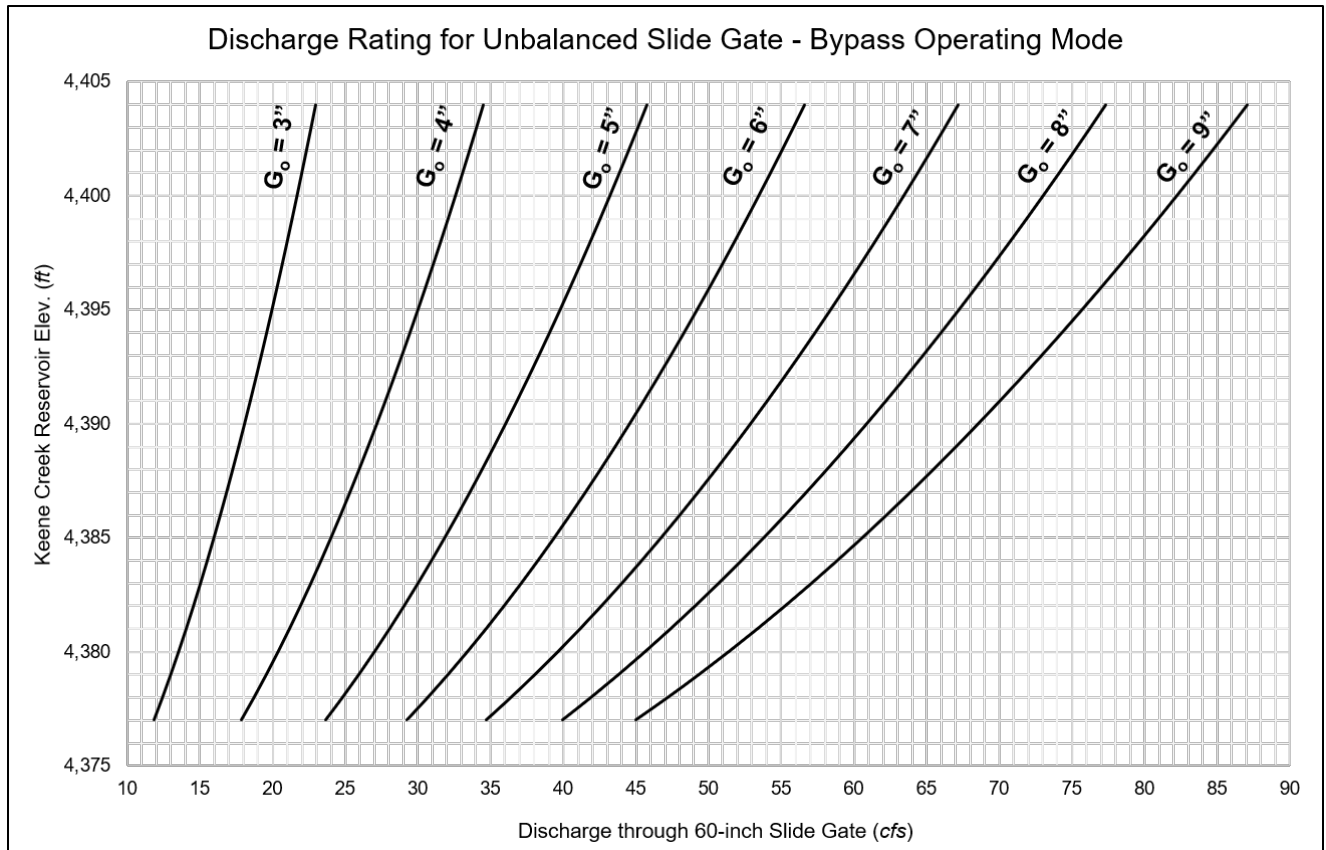
Test results were helpful in developing a discharge rating for the 60-inch slide gate. Discharge controlled by the slide gate depends on both slide gate position and the reservoir elevation at Keene Creek. These data were recorded along with discharge during the field test to produce Table 2 and Figure 7 for use in estimating the flow rate and slide gate opening for bypass operation.

Figure 7 Discharge rating curve for the 60-inch slide gate when used for flow control during emergency bypass operations. Rating curve was developed from data in Table 2.

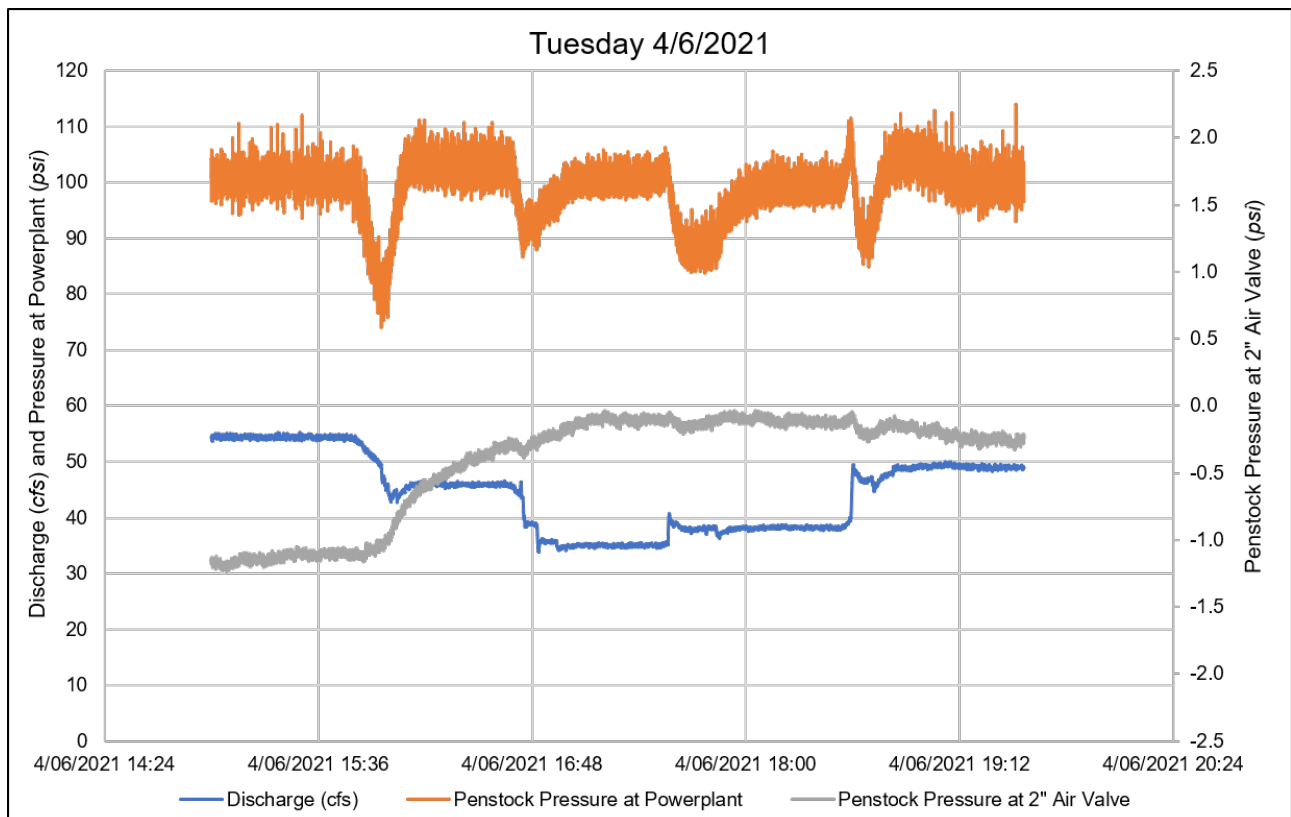
Pressure measurements at the 2-inch air valve and within the powerplant showed that airflow and internal pipe pressures were well within the design limitations of both the air valve and penstock for all discharge conditions tested (Figures 8 through 10). For discharges up to approximately 80 cfs, the minimum penstock pressure at the 2-inch air valve was negative 2 psi gage (Figure 9). The noise observed at the valve at this condition, although quite loud, was constant suggesting a constant air flow. The greatest penstock pressure fluctuation was 25 psi at the powerplant and less than 1 psi at the 2-inch air valve.

Figure 8 Time series for turbine needle discharge and penstock pressure at the powerplant and 2-inch air valve measured on Tuesday 4/6/2021.

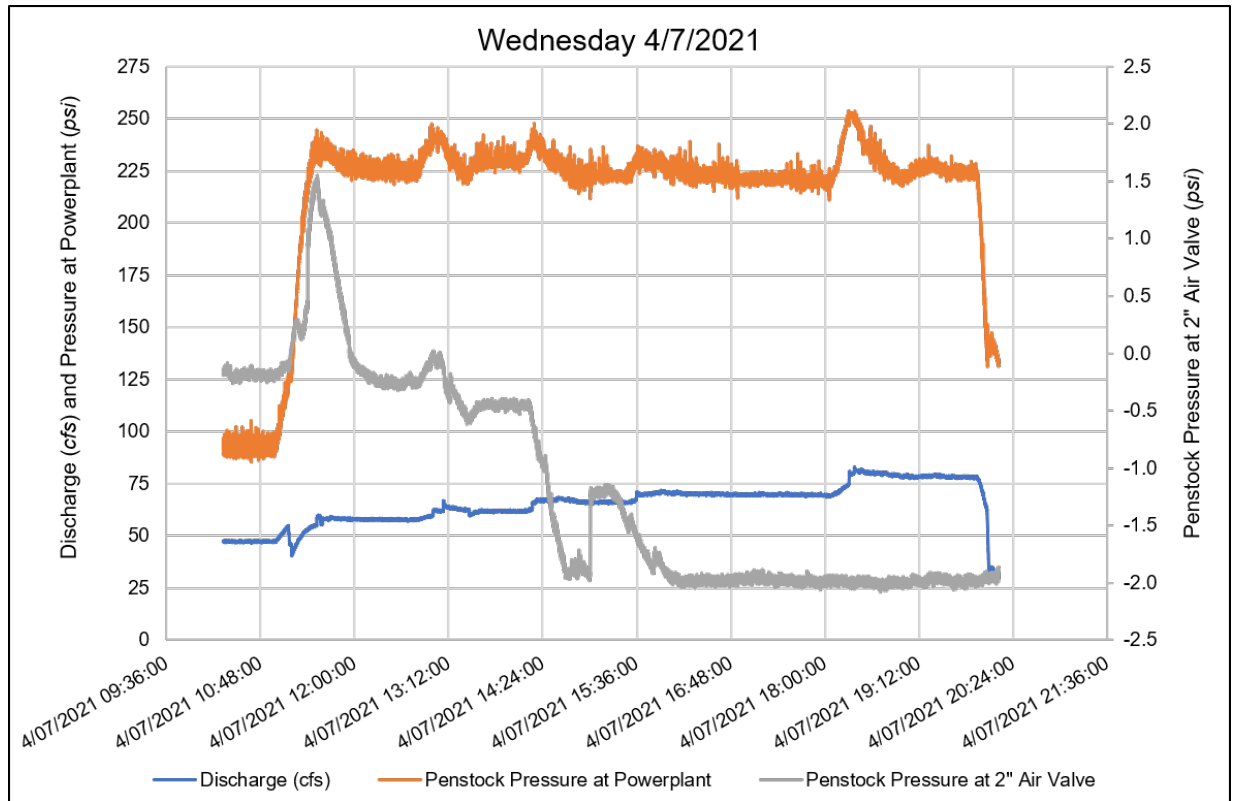
Figure 9 Time series for turbine needle discharge and penstock pressure at the powerplant and 2-inch air valve measured on Wednesday 4/7/2021.

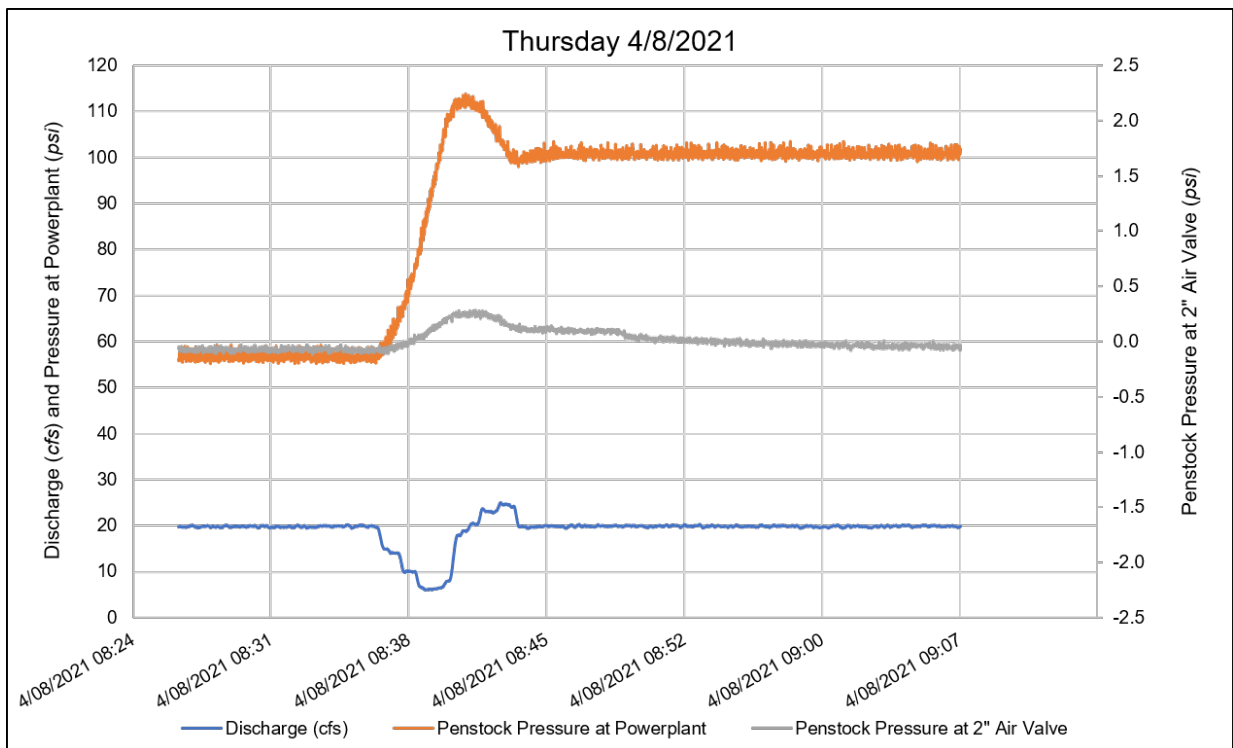
Figure 10 Time series for turbine needle discharge and penstock pressure at the powerplant and 2-inch air valve measured on Thursday 4/8/2021.

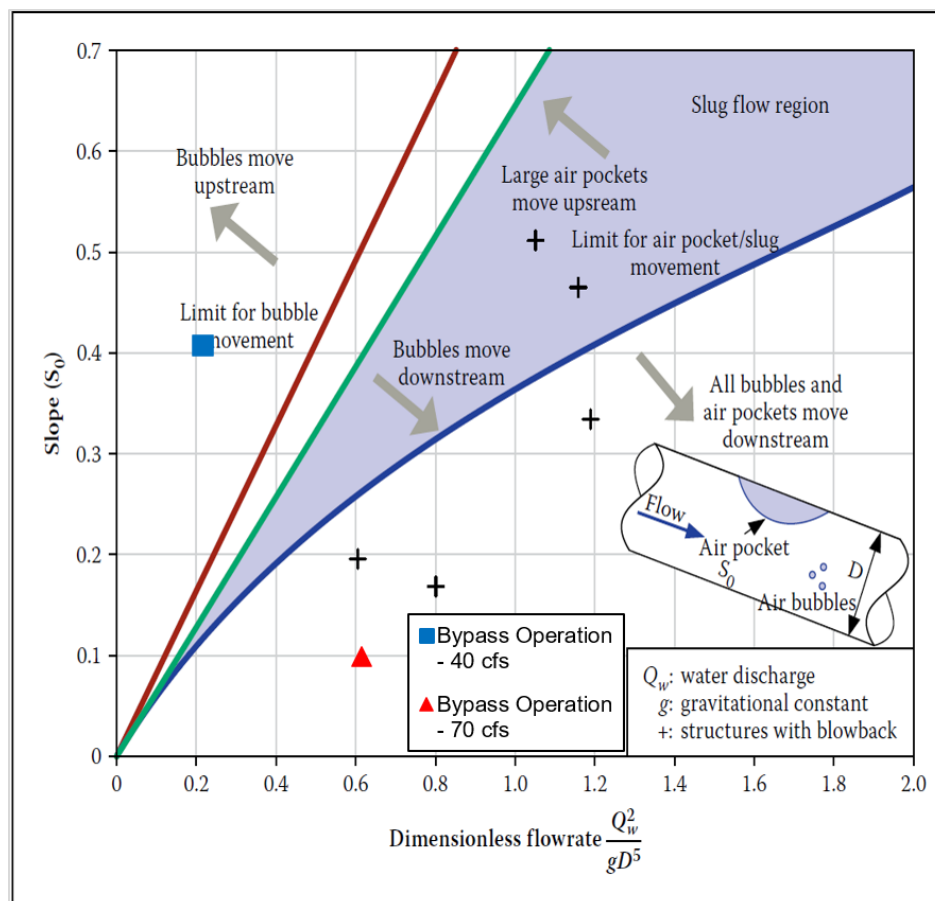
Test measurements and observations suggest that there is low potential for extreme pressure surging or “blow-back” to occur with sufficient force to damage the penstock for the range of conditions tested. Figure 11 shows operating points for 40 cfs (at 100 psi – results in hydraulic jump at a location with a pipe slope of 0.410) and 70 cfs (at 225 psi – results in hydraulic jump at a location with a pipe slope of 0.097). These points are outside the area of concern (shown in purple), where air bubbles may accumulate downstream and then surge back upstream with sufficient force to cause damage.

Several factors help provide confidence that pressure surging will not be a concern for bypass operations. Pressure measurements and observations at the 2-inch air valve indicate that air flow was minimal but fluctuated to some degree at discharges of 40 cfs and lower which support the finding on Figure 11 where air does not flow downstream. For 70 cfs, the air flow was constant and much greater according to both observations and measurements at the 2-inch air valve suggesting that all air entrained into the pipe was passed downstream with the water flow in agreement with Figure 11. This test condition was held steady for approximately 4 hours with no observed adverse conditions. Finally, the reach of penstock with turbulent air mixing and surging in question is also the most robust of the system with thick pipe walls designed for pressures above 300 psi at the weakest section (near the 2-inch air valve), well above pressures and surges measured during the bypass test.

Figure 11 Plot used to indicate air bubble movement within pipes with mixed air/water flows as a function of pipe slope and dimensionless discharge [2]. Points are shown for Green Springs bypass operations at 40 and 70 cfs.

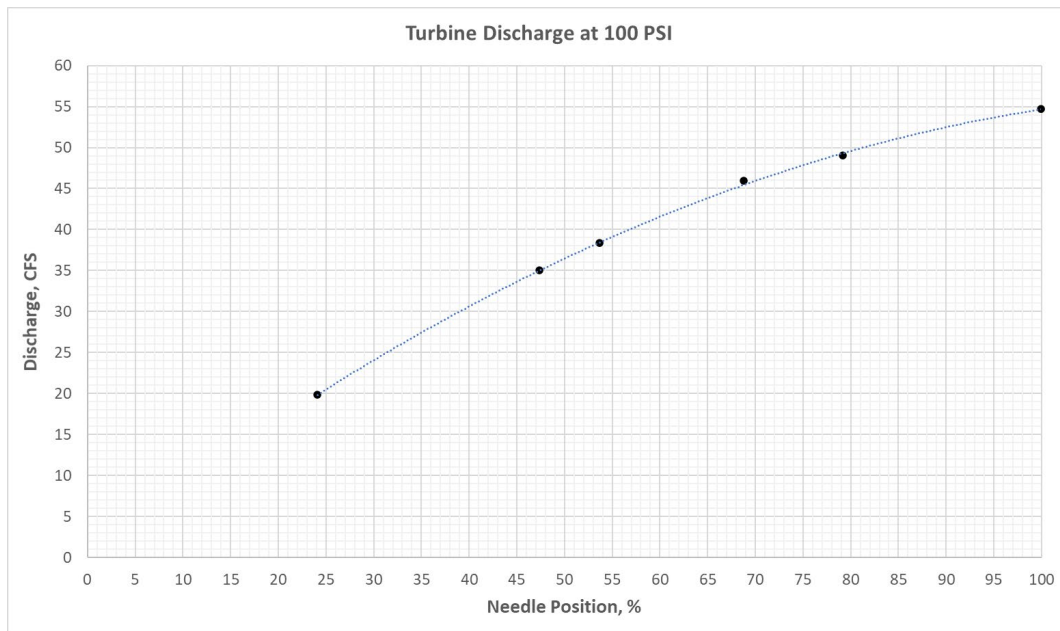
Test results were also used to develop discharge rating curves for the turbine needle valves. Within the powerplant discharge controlled by the needle valves depends on both needle position and the penstock pressure immediately upstream. Discharge ratings curves were developed for penstock pressures at both 100 psi (Figure 12) and 225 psi (Figure 13). A pressure of 225 psi was necessary to pass higher discharges for needle valve positions where reasonable flow control could be maintained.

Figure 12 Turbine needle discharge at 100 psi.

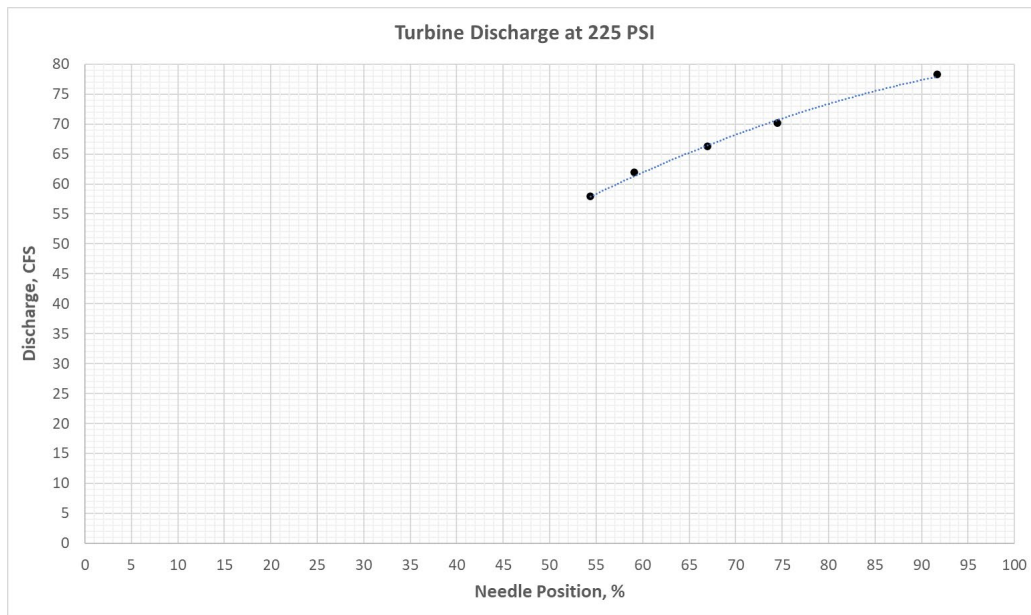
Figure 13 Turbine needle discharge at 225 psi.

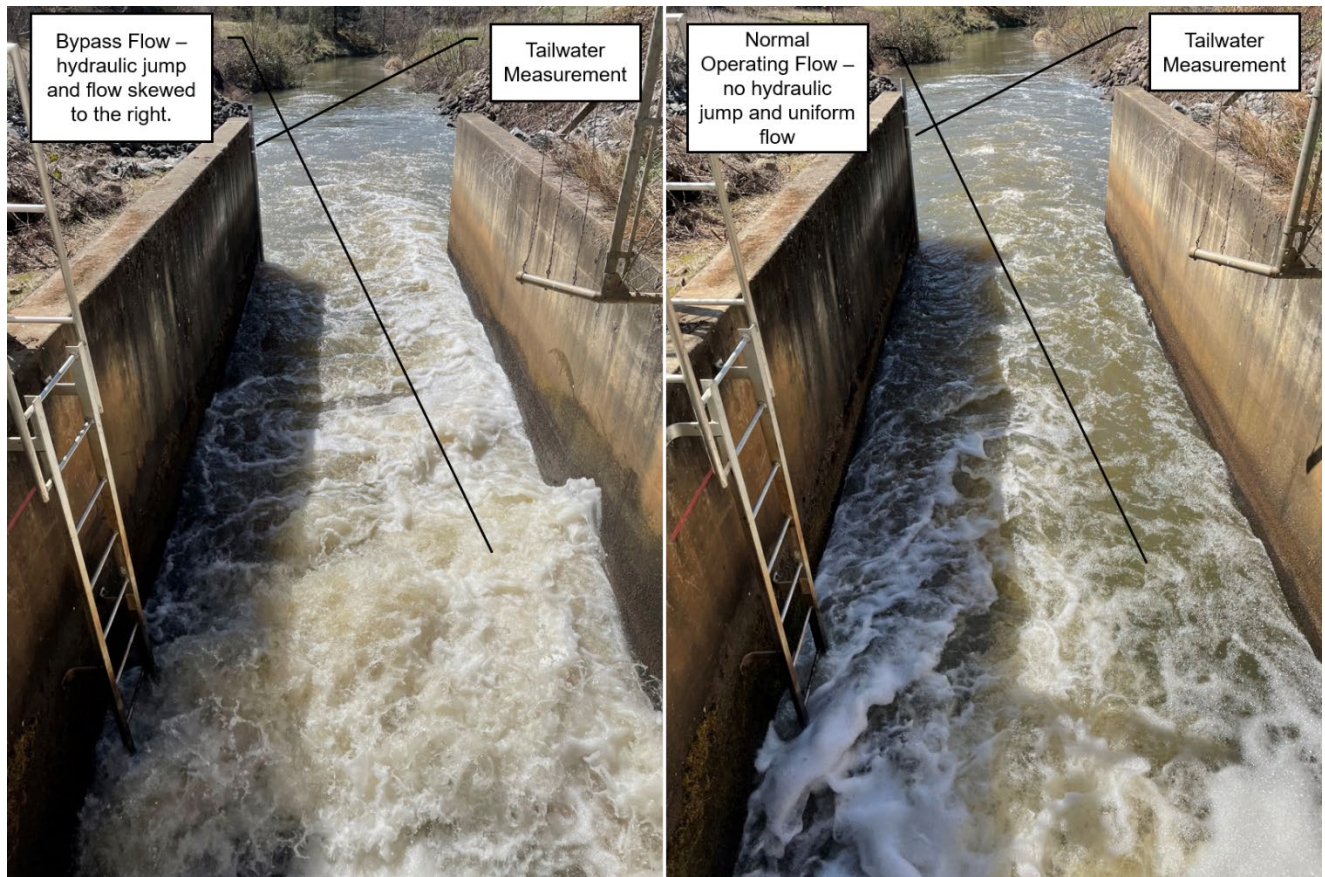
Water levels in the tailrace were measured and observed for all test conditions with the original intent to correlate discharge with tail water levels that could be estimated with a staff gage during normal operation. Test results and observations showed this is not possible because of the different exit conditions of the flow for bypass and normal operations in the tailrace chute (Figure 14) as well as the potential for different back-water conditions from the irrigation weir and diversion downstream which may result in incorrect discharge estimates. The location of the open channel hydraulic jump and energy dissipation remained within the concrete chute for all bypass conditions tested, eliminating any concern for scour and erosion of the downstream channel.

Figure 14 Flow conditions in the powerplant tailrace (looking downstream) for approximately 70 cfs in both bypass mode (left) and normal power generation mode, post-test (right).

4. Tailrace water levels should not be used to estimate discharge due to the potential to provide incorrect discharge readings caused by different exit flow and back-water conditions from the irrigation diversion downstream.
