Hydraulic Laboratory Technical Memorandum, PAP-1218

Canyon Ferry Stilling Basin Sonar Inspection

Canyon Ferry Unit, Pick-Sloan Missouri River Basin Project,
Montana, Missouri Basin and Arkansas-Rio Grande-Texas Gulf
Regions

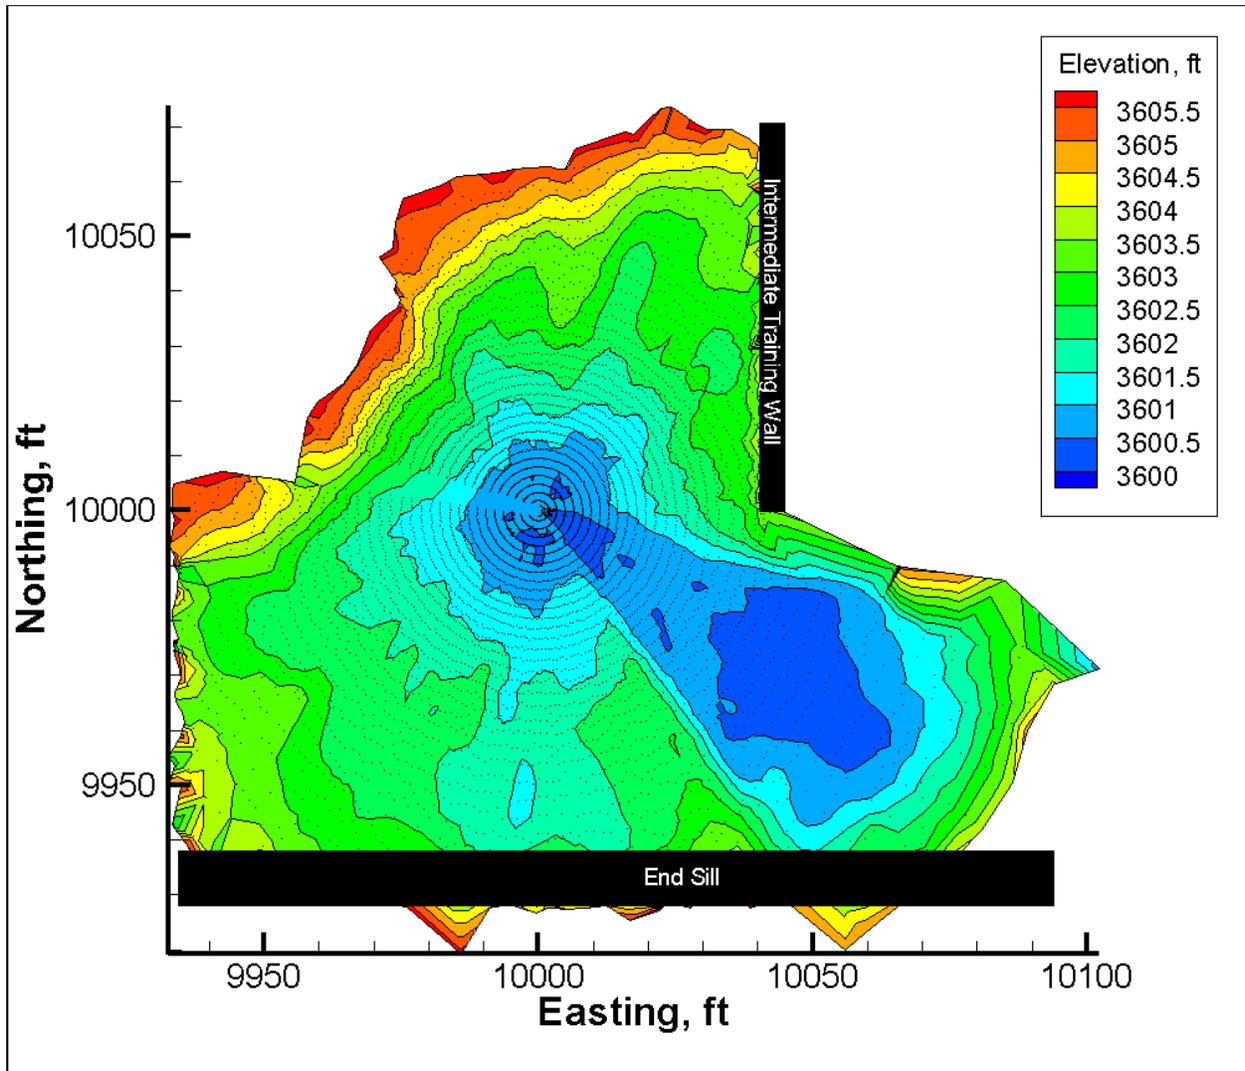
Figure 3. Color contour map of point cloud data collected for pre-test conditions in the right bay of the Canyon Ferry Dam stilling basin.

For future point cloud surveys, it is recommended that a saddle mount be designed to mount the scanning sonar and rotator on the intermediate training wall. This mounting system would remove boat movement errors so that the point cloud data would be precise enough to compare the stilling basin volume before and after a high flow test. Additionally, mounting the sonar on a saddle mount in the center of the stilling basin would allow for repeatable point cloud surveys. Lastly, having more overlap between the scans would allow for cloud-to-cloud registration to produce a complete point cloud for the entire stilling basin rather than each individual bay.

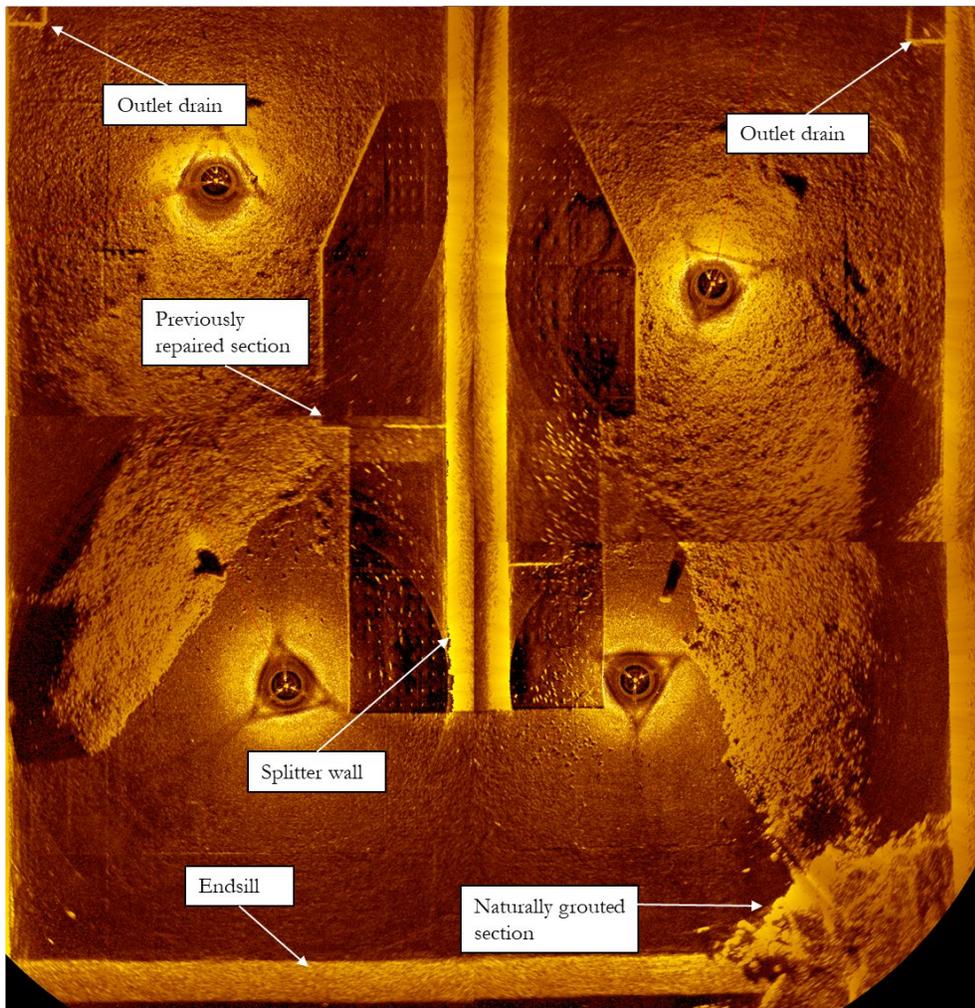
Figure 5 shows the four sonar records overlaid to create a composite image of the entire stilling basin. Prior to the test, the basin has a significant debris pile in each bay that is concentrated in the downstream half of the bay. In the areas around the large debris piles the stilling basin floor is clear enough that construction joints in the concrete floor are visible.

Figure 5. This composite image is made from four sonar scans taken at a range of 120 ft. Notable features include the endsill, previously repaired floor section, and outlet drains near the top of the image. Areas with uneven color contrast indicate locations with sediment deposition.

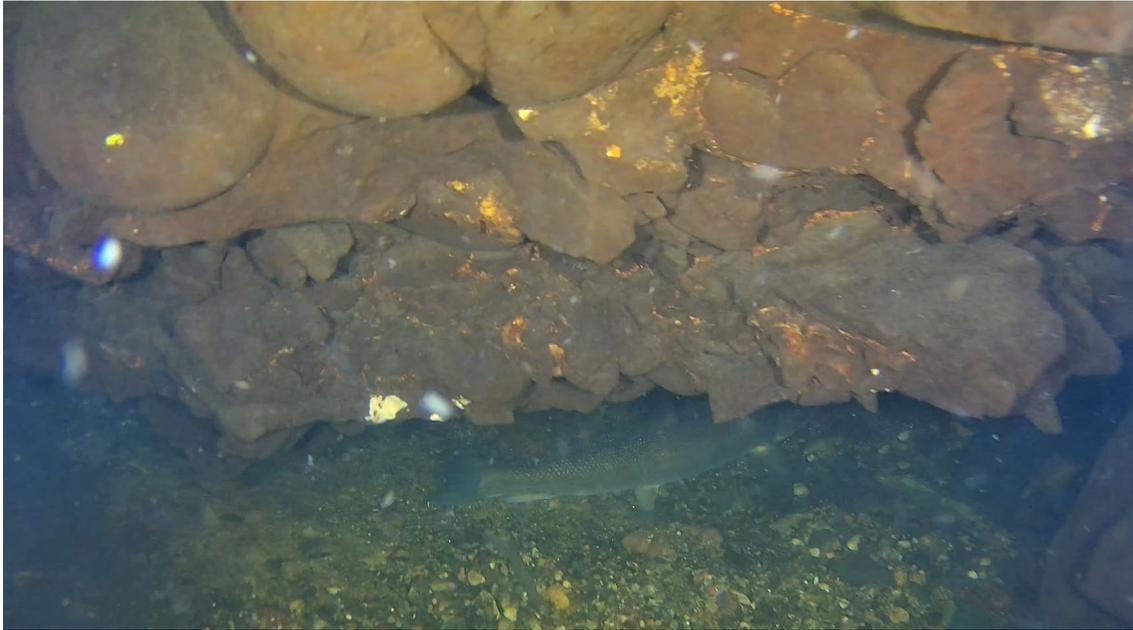
Figure 6. Naturally grouted section at the end of the stilling basin. The rock section has a small overhang and overlaps the end sill on the left side. This image was taken using the Montana Area Office's Frontier Precision M2 Submersible ROV.

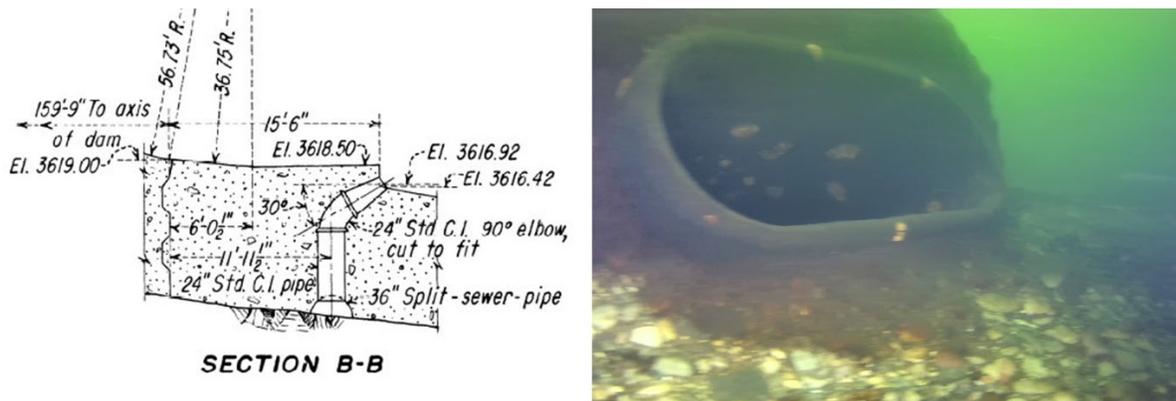
Figure 7. Outlet drains seen at the top of the of the composite sonar record. This image was taken using the Montana Area Office's Frontier Precision M2 Submersible ROV. The drawing to the left is Section B-B from Drawing 296-D-378.

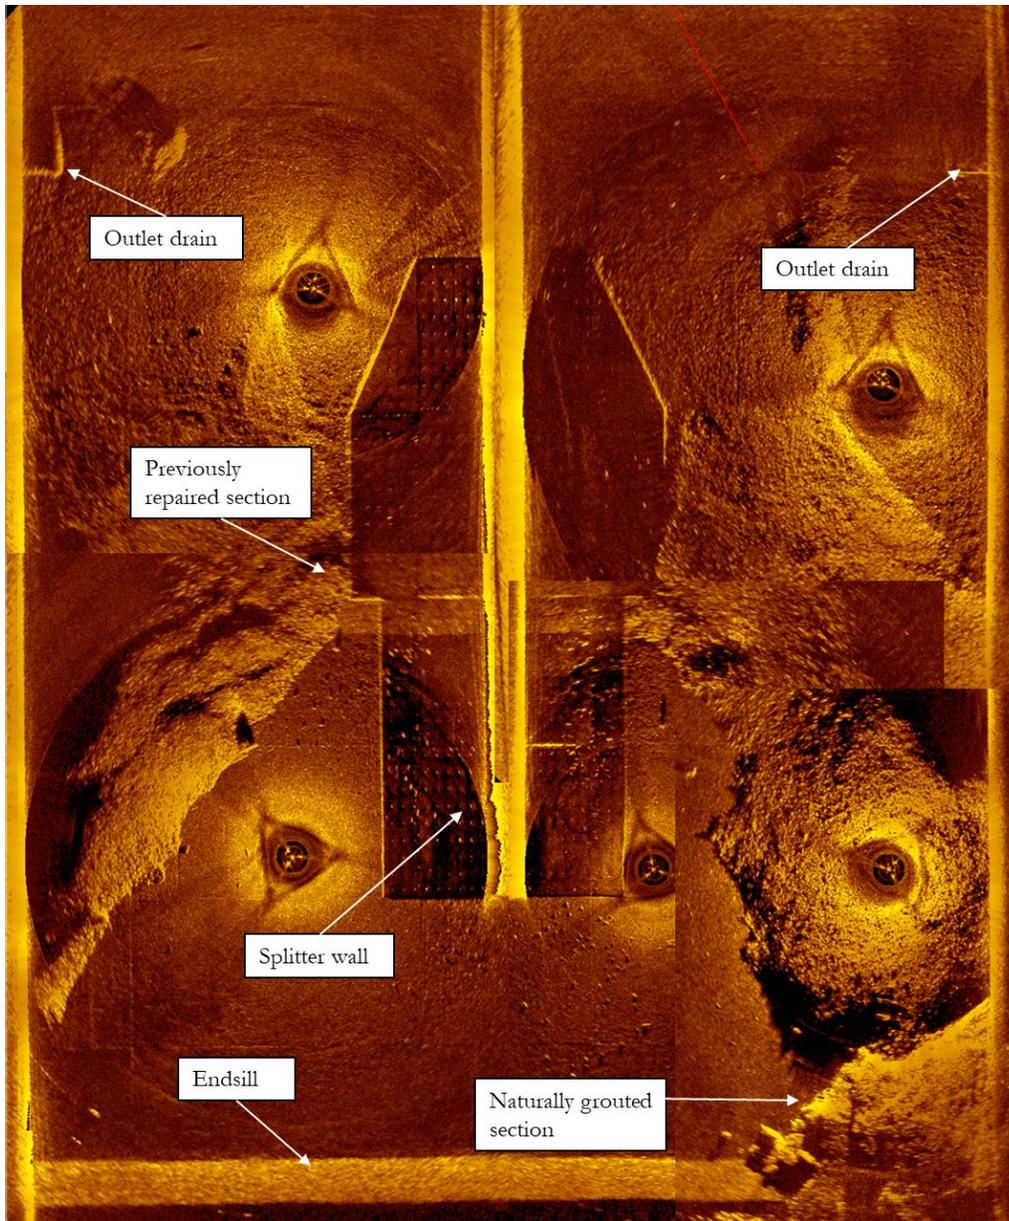
After the test, the sonar imagery was taken in the same four sonar locations using the same ranges. During the downstream left bay scan, the area behind one of the debris piles was obscured so an additional scan on top of the mound was taken to confirm the extents. As shown in Figure 8, the endsill is still completely clear except for the naturally grouted section on the left bank, just as in the images from before testing.

Figure 8. This after test composite sonar image is made up of five images taken at 120-ft range. The four primary images were taken in the same locations as the before test scans with a fifth taken on the left debris pile. Similar to the before test scans, the outlet drains, previously repaired patch and end sill are all clearly visible.

During the test period, the material appeared to move but was not being flushed out or pulled into the basin. For further analysis, the most well-defined and deepest section of debris near the narrow section of the patch will be used for the direct comparison.

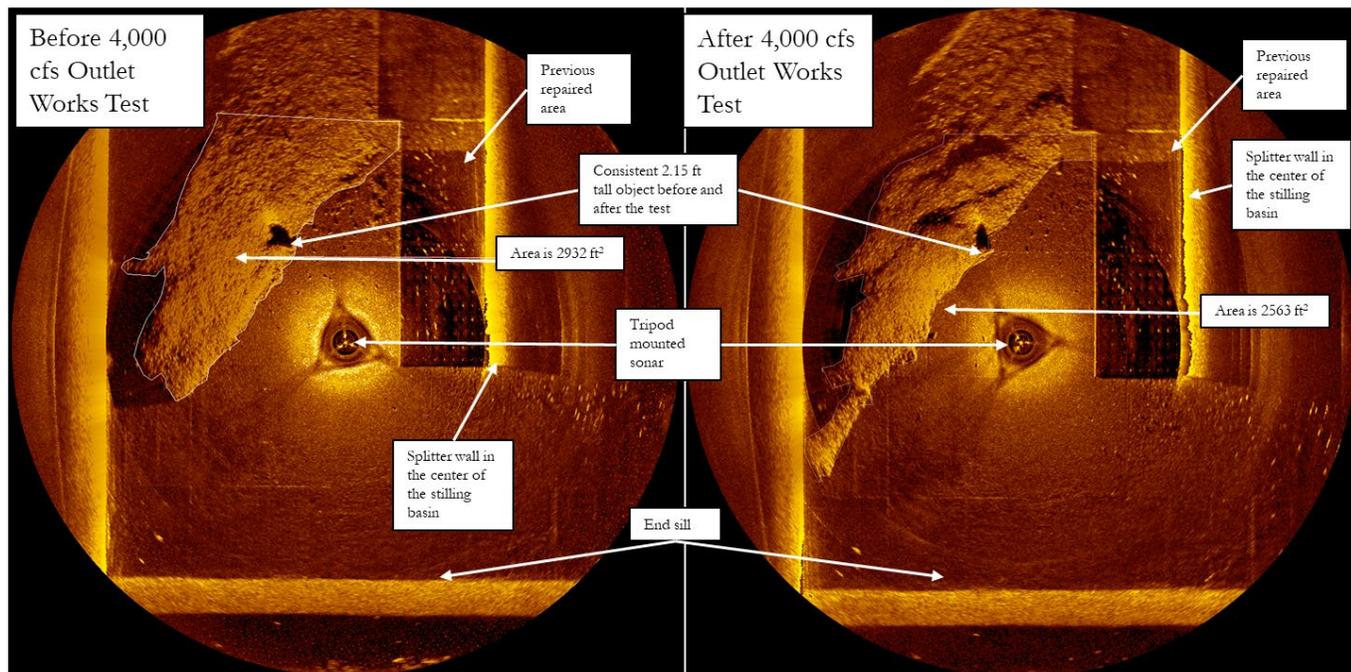
Before the test, the area of material along the narrower section of the repair patch was measured to be 2,932 ft². This area was defined by the section below where the patched section widens to 32 ft from the training wall. The area not covered in debris is assumed to be clear due to the faint construction joints visible in both images. Additionally, a 2.15-ft-tall object and its acoustic shadow were observed in an identical location in both the pre- and post-test images.

Figure 9. Right bay of the stilling basin before and after the 4,000-cfs river outlet gates test. There are several consistent objects between the imagery before and after the test including the end sill, splitter wall, a 2.15-ft tall object and the previously repaired area.

After the test, the area of material in the same section of the basin was 2,563 ft², indicating an area reduction of 369 ft². This difference is likely explained by the dark striations that run through the area of material in the after test image. These darker areas are consistent with taller ridgelines casting a shadow behind them. It can be reasonably assumed that there is minimal material being brought into the basin due to the clear end sill before and after the test. The similarity in the shape of the debris pile indicates that the shear forces from the river outlet gate releases are enough to move material within the basin, but not high enough to flush it out. However, without an accurate

volumetric comparison it is not possible to know for certain if any new material was transported into the basin. It is also important to note that upon starting the high flow test, an unknown volume of fine material was entrained into the flow as indicated by turbid water exiting the basin.

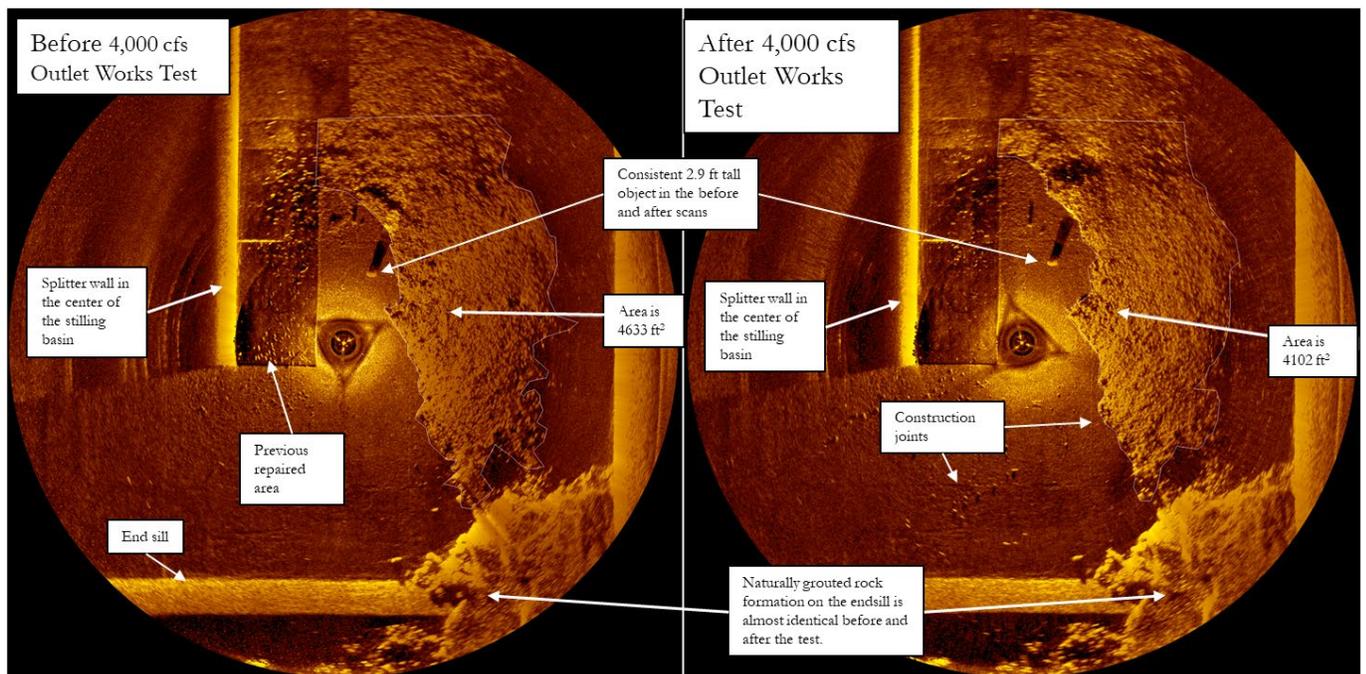
Before the test, the area of material along the narrower section of the repair patch was measured to be 4,633 ft². The patch is clearly visible before and after the test, indicating that the debris depth is less than four inches (the height of the repaired concrete). Additionally, the left bay has a 2.9-ft-tall object that is consistent between the two images, indicating that the shear forces were not high enough to move it.

Figure 10. Left bay of the stilling basin before and after the 4,000 cfs river outlet gates test. The location of the 2.9-ft-tall object is consistent before and after the test and the shape of the debris pile is similar. This indicates that the debris did not move much during the test.

After the test, the area of material next to the narrow section of the patch was 4,102 ft², creating a reduction of 531 ft². The material post-test shows a stronger return on the leading edge closest to the sonar. This is typically associated with a taller steeper edge, indicating the height of the material increased after the test was run. The naturally grouted rock formation on the end sill of this bay is unchanged in the before and after images.

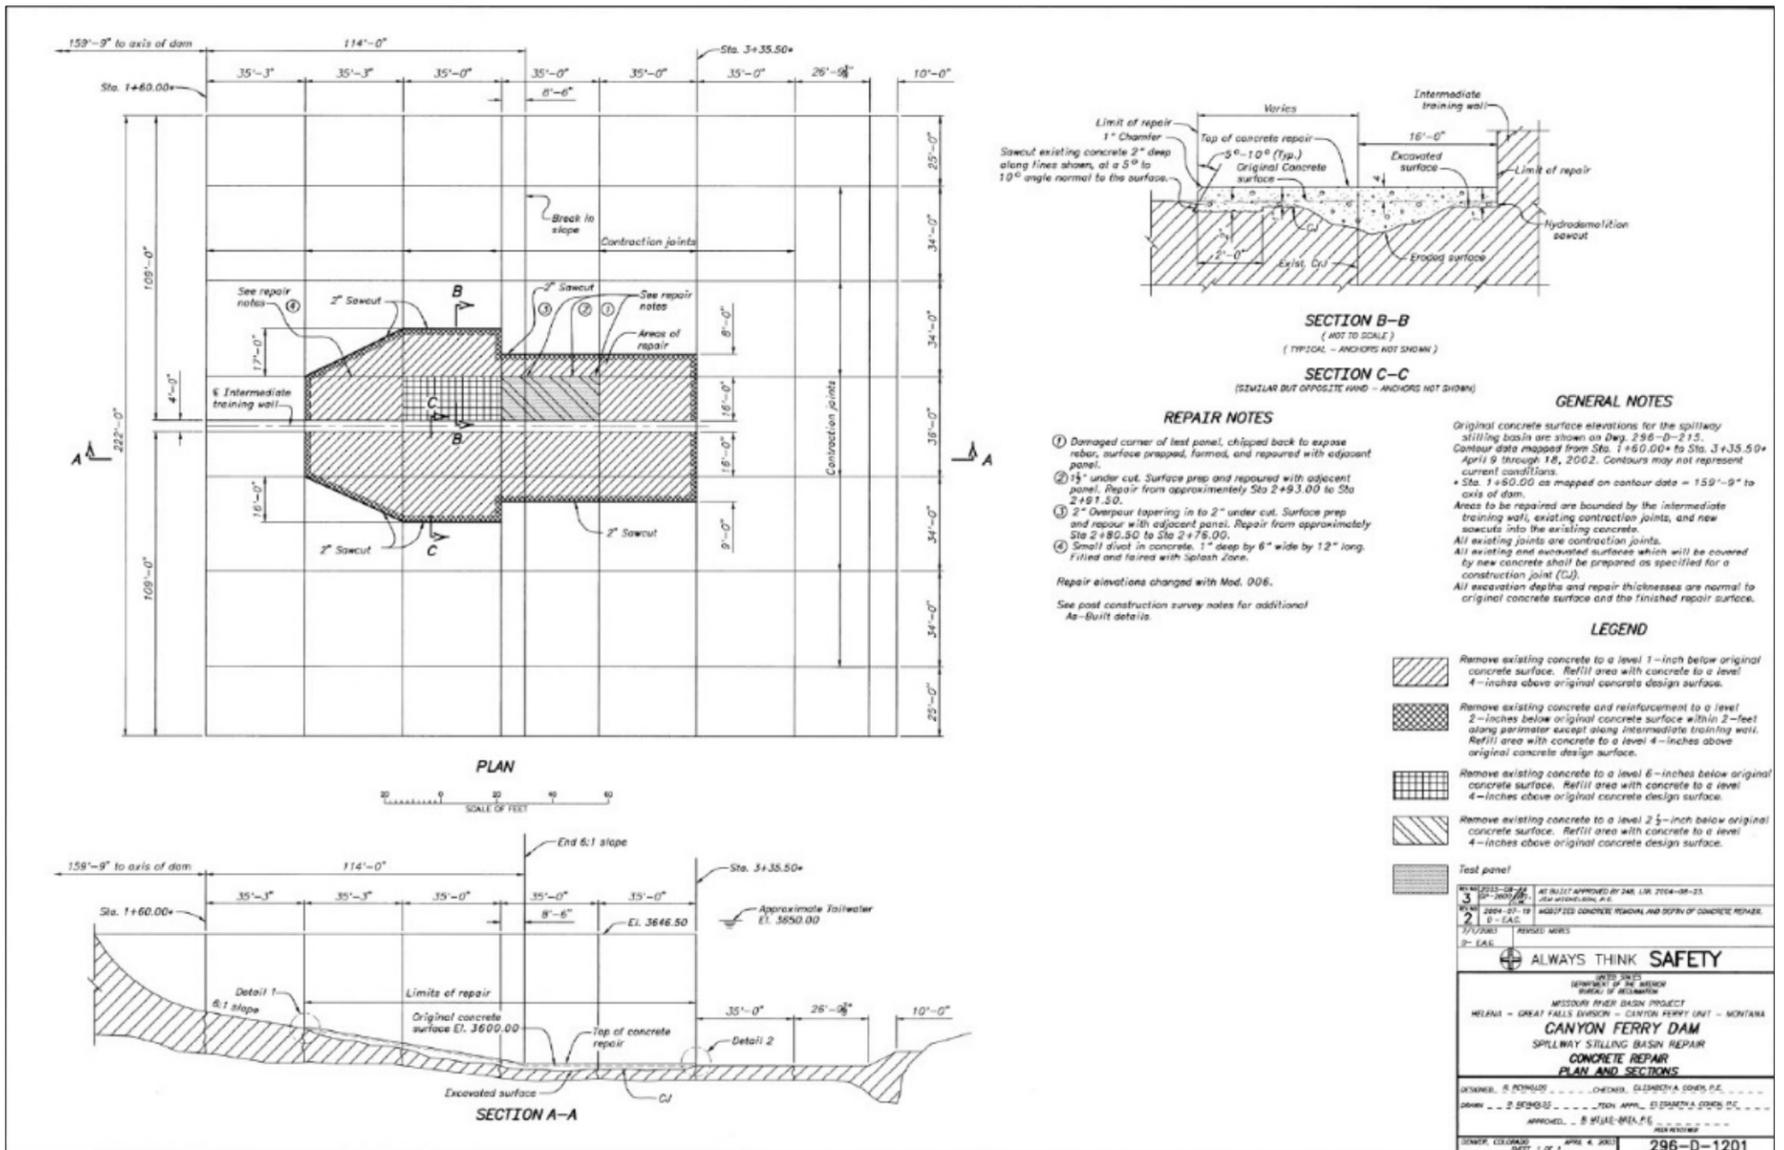
The previously repaired floor patch on either side of the splitter wall has well defined bright edges, indicating that the debris in the stilling basin is less than four inches tall (Figure 19). After the outflow test, the Montana Area Office conducted a quick inspection of the stilling basin using a Frontier Precision M2 Submersible ROV. Figure 6 and Figure 7 show images taken with the ROV of the naturally grouted section on the end sill and the outlet drains, respectively.

Figure 19. 296-D-1201 “Concrete Repair Plan and Sections”.
