Hydraulic Laboratory Technical Memorandum, PAP-1222

# Evaluation of Canal Flow Measurement System for the Indian Unit

## Yuma Project, Reservation Division Lower Colorado Region

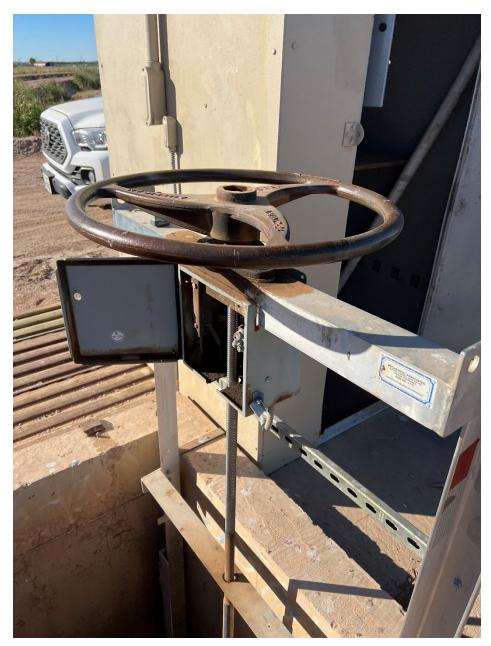
Figure 2. Manually operated 36-inch slide gate at the Waco Diversion Structure.

At the time of the site visit, the Waco site was observed to be completely non-operational. Although the RTU appeared to have power, it was unresponsive to user commands for displaying or conducting measurements. The 12V battery was no longer holding a charge and all power was completely supplied through the solar panels. The worm gear attached to the potentiometer was disconnected from the gate's lead screw (Figure 3). Further investigation revealed that the RTUs firmware had become corrupted, and the bubbler compressor no longer functioned.

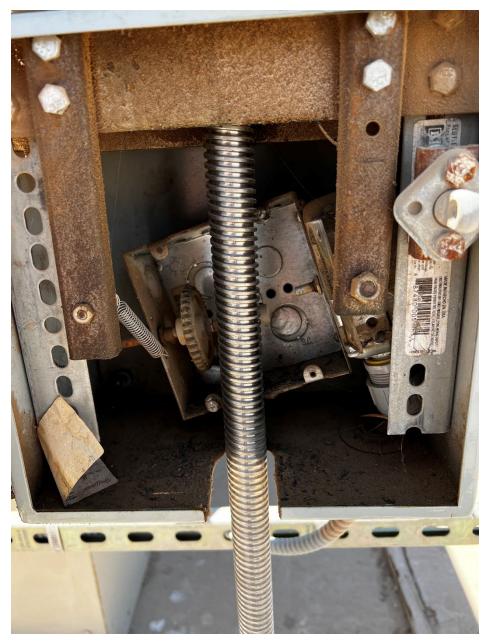
Figure 3. Worm gear assembly for the Waco Diversion structure. The assembly does not function because the worm gear is detached from the lead screw of the gate stem.

The Waco diversion structure depends on measurements of both canal depth and gate position. This is currently achieved using a worm gear connected to the lead screw of the gate stem (Figure 3). TSC recommends replacing the 36-inch gate valve stem with a prefabricated actuator stem with a built-in sensor for measuring gate position. Repairing the existing sensor requires additional labor and will likely exceed the cost of purchasing a prefabricated replacement actuator stem.

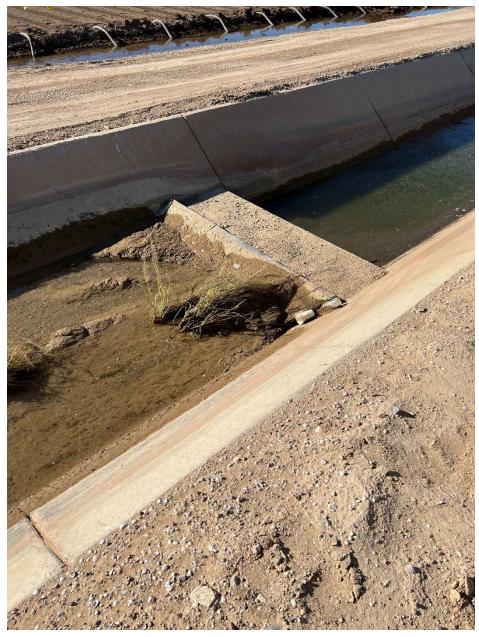
A ramp flume on the Supai Canal translates a single canal depth into flow. It is a prefabricated flume structure that was existing prior to the initial TSC equipment installation in 2019(Figure 4). During the 2022 site visit, the ramp flume was filled with sediment, preventing flow measurement through the flume (Figure 5). Although the battery was no longer holding a charge, both the bubbler and RTU seemed to function. Depth measurements from the RTU, however, were incorrect.

Figure 5. Supai canal ramp flume pictured during a 2022 site visit showing excessive sediment with vegetation against the ramp of the flume.

Regardless of the state of the electronics, flow cannot be accurately measured in a flume with excessive sediment. Sediment deposition may block a portion of the regulating control section or change the velocity at the head measurement device, which affects the accuracy of the relationship between head and discharge. Although minor errors of this type are common (and expected) with most flumes, excessive sediment can result in errors too large for a reasonable flow measurement. The sediment needs to be periodically removed from the canal in and near the flume structures.

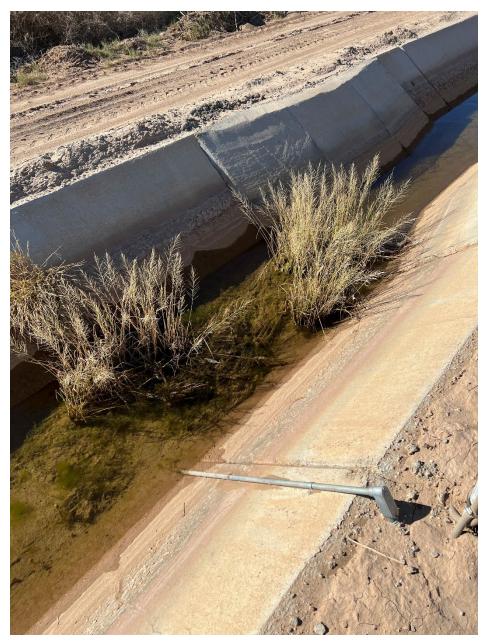
TSC fabricated a long-throated flume for the Pueblo Site in 2019 (Figure 6). During the 2022 site visit, excessive sediment with plant growth was found both upstream and downstream of the flume (Figure 7), leaving the flume incapable of reliably measuring flow. The battery was no longer holding a charge and the RTU was completely non-responsive, regardless of the solar power. Further investigation revealed corrupted firmware.

Figure 7. Pueblo canal long-throated flume pictured during a site visit in 2022 showing excessive sediment and vegetation upstream of the flume.

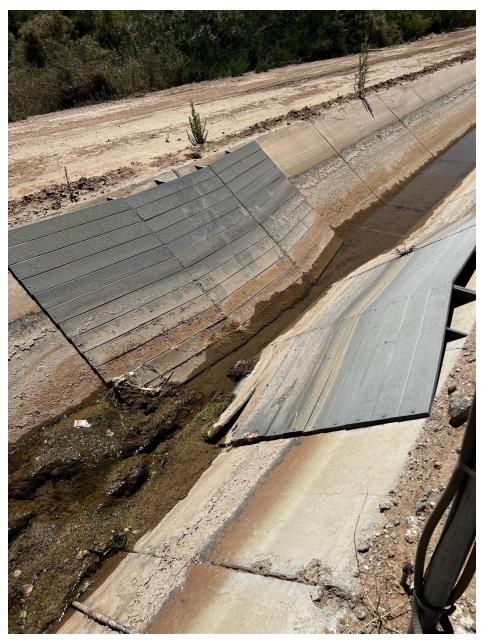
The Pima canal flume is a long-throated flume constructed from 6-inch engineered wood boards (Figure 8). Although the flume was relatively free from excessive sediment, the wood planks are beginning to deteriorate from submergence. This deterioration warps the boards which causes significant energy loss from turbulence and affects the flow measurements. The battery was no longer holding a charge and the RTU was completely non-responsive, regardless of the solar power. Further investigation revealed that the RTUs firmware had become corrupted, and the bubbler compressor no longer functioned.

Figure 8. Pima canal flume pictured during a site visit in 2022.
