HYDRAULIC MODEL STUDIES OF AERATION DEVICES FOR YELLOWTAIL DAM SPILLWAY TUNNEL, PICK-SLOAN MISSOURI BASIN PROGRAM, MONTANA

**D. M. Colgate
Engineering and Research Center
Bureau of Reclamation**

December 1971

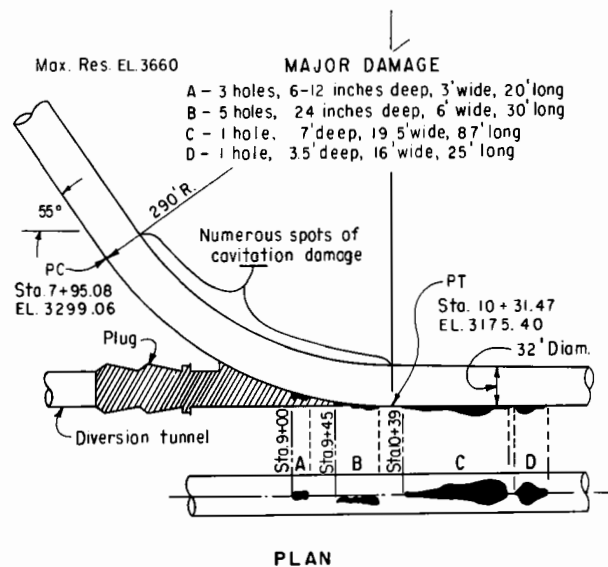
After flood danger had passed, the tunnel was dewatered and the concrete tunnel lining was subjected to a thorough examination (Figure 3). The largest damaged area was centered on the tunnel invert beginning 8 feet downstream from the P.T. of the tunnel bend and extending downstream for 125 feet (Figure 4). A surface discontinuity was responsible for the cavitation that initiated the damage, and a combination of cavitation and jet action continued to erode the concrete and foundation rock downstream. The surface discontinuity resulted from the partial failure of an epoxy patch which had been placed to fill in an eroded area in the tunnel invert before spillway releases were made. The spalled area was 1/4 inch deep, 6 inches wide, and 10 inches long. Remains of epoxy mortar could be seen around the perimeter of the patch. Cavitation damage started immediately downstream from the depression, and damage in the first 25 feet was sufficiently deep to expose reinforcement bars. In the next 100 feet (approximately), the tunnel invert concrete and large quantities of the limestone foundation rock had been

Figure 3. Yellowtail Dam—Section through tunnel spillway bend—Location of major damaged areas, 1967 flood releases.

removed. The crater reached a maximum depth of 7 feet and a width of 19.5 feet. Portions of the concrete lining along the sides of the damaged area had been undercut as much as 6 feet.

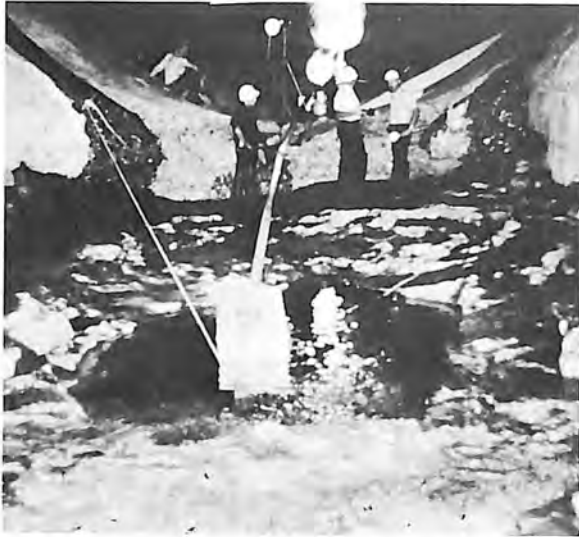
The 1,070 feet of tunnel lining downstream from the large hole was undamaged except for minor gouges probably caused by the movement of large blocks of concrete and rock from the heavily damaged area upstream. (Note: The flow velocity in the spillway tunnel for a discharge of 15,000 cfs is approximately 90 fps at Station 6+50, 140 fps through the bend, and 85 fps at the tunnel exit².)

Figure 4. View looking downstream at the large eroded area below the P.T. of the bend. Cavity is about 100 feet long, 7 feet deep, and 19-1/2 feet wide. Photo P459-D-70515

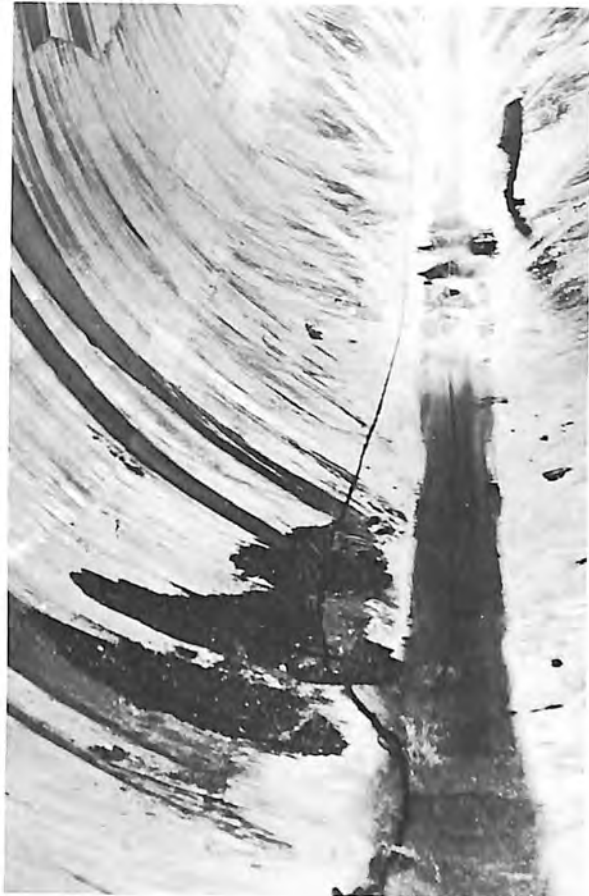
Two areas of major damage occurred in the tunnel elbow (Figure 5). In each instance, the cavitation which resulted in the damage was induced by failure of an epoxy mortar patch within a dry pack mortar patch. One damaged area began at Station 9+00 and extended along the tunnel centerline for 20 feet. The damage consisted of three holes each about 3 feet in diameter, 6 to 12 inches deep, and interconnected by shallow damaged areas. Another area of major cavitation damage in the bend continued for 30 feet downstream from Station 9+45 and was 3 feet to the right of the tunnel centerline. The damage consisted of five distinct teardrop-shaped holes, in line, with a maximum width and depth of 6 and 2 feet, respectively.

Figure 5. View looking upstream showing the two major damaged areas in the vertical bend. One area is in the left foreground, the other in the invert at the center of the photograph. Note man near the upper damage area. Photo P459-640-4088

Specifications were issued for the necessary filling and patching to rehabilitate the tunnel to the original alignment using concrete and epoxy mortar. These specifications were extremely rigid and required very smooth surface finishes and complete elimination of surface discontinuities. As an additional precaution

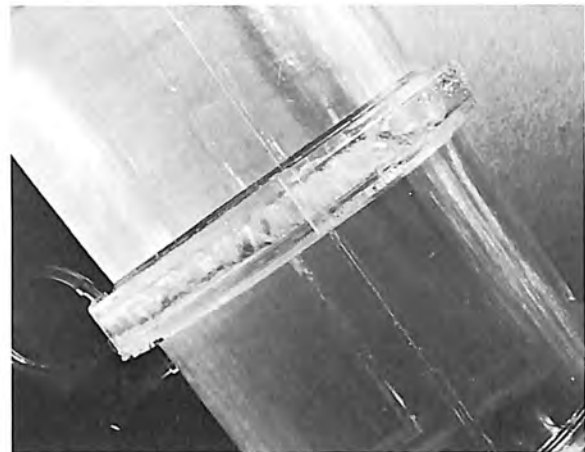
The preliminary aeration slot at Station 7+79 was uniform in cross section for the entire circumference of the tunnel (Figure 7B). Although air was entrained in the flowing water for low flows, the edges of the jet near the water surface impinged on the downstream edge of the slot for discharges greater than about 5,000 cfs. As the discharge increased, more of the jet impinged on the downstream edge of the slot and greater amounts of water entered the slot. As more water entered the slot, the amount of air entrained in the flowing water decreased. Air entrainment in the flowing water stopped entirely at a spillway discharge of about 50,000 cfs.

Figure 8 shows the preliminary slot with 92,000 cfs flowing in the tunnel. Note the absence of entrained air downstream from the slot.

Figure 8. Preliminary aeration slot, Station 7+79. Discharge is 92,000 cfs. The slot has filled with water thus preventing air from entering the jet. Photo P459-D-668807

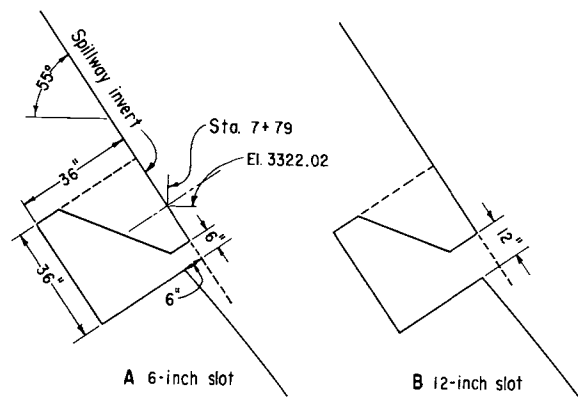
Figure 9. Narrow aeration slots.

In an attempt to prevent water from entering and filling the slot, the slot was narrowed to 6 inches, with a 6-inch away-from-the-flow offset downstream (Figure 9A). Although some air was entrained in the jet at low discharges, water entered the slot near the water surface for all spillway discharges. For discharges less than 20,000 cfs, water drained down the slot and flowed out into the jet at the tunnel invert, reducing the amount of entrained air as the spillway discharge increased. At a spillway discharge of 20,000 cfs, the water surface in the slot was at the same elevation as the spillway water surface, and no air entered the jet. For spillway discharges greater than 20,000 cfs, the water was forced into the slot at a sufficiently high head to cause it to boil up the slot above the spillway water surface and spill out onto the surface of the jet.

The slot width was increased to 12 inches (Figure 9B). The flow with this configuration was similar to that with the 6-inch slot. The discharge, at which the water surface in the slot was equal to that of the spillway water surface, was 30,000 cfs.

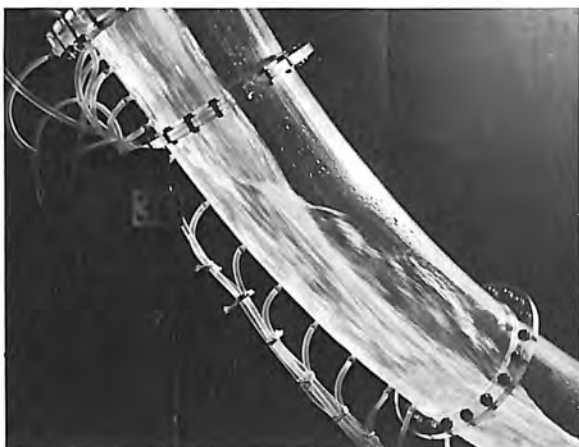
Figure 13. Recommended aeration slot, Station 7+79. Discharge is 30,000 cfs. These maximum side fins, one each side of the jet, do not reach the crown of the tunnel. Photo P459-D-68809

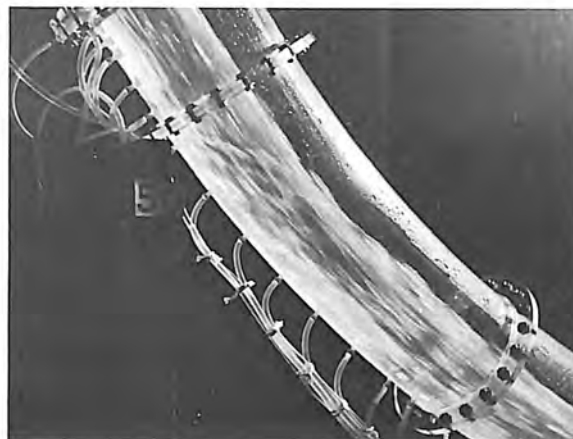
The impingement of the jet on the tunnel invert downstream from the aeration slot caused side fins to form. For discharges less than 50,000 cfs these side fins swept uninterrupted up the walls of the tunnel past the contracted jet. The maximum side fins, which occurred at a discharge of 30,000 cfs, were not objectionable and did not reach the top of the tunnel (Figure 13). Since the lift diminished as it neared the tunnel springline, the upper portion of the jet was subjected to less contraction than the lower portion. Consequently, the upper elements of the jet impinged on the walls of the tunnel farther upstream and at a much smaller angle, as the discharge and flow depth increased. For discharges greater than 30,000 cfs, the upper portion of the jet interfered with and reduced the side fins, and for discharges greater than 50,000 cfs, the side fins were entirely contained by the upper portion of the jet (Figure 14).

Figure 14. Recommended aeration slot, Station 7+79. Discharge is 50,000 cfs. The upper portion of the jet has spread to the tunnel walls and suppressed the side fins. Photo P459-D-68810

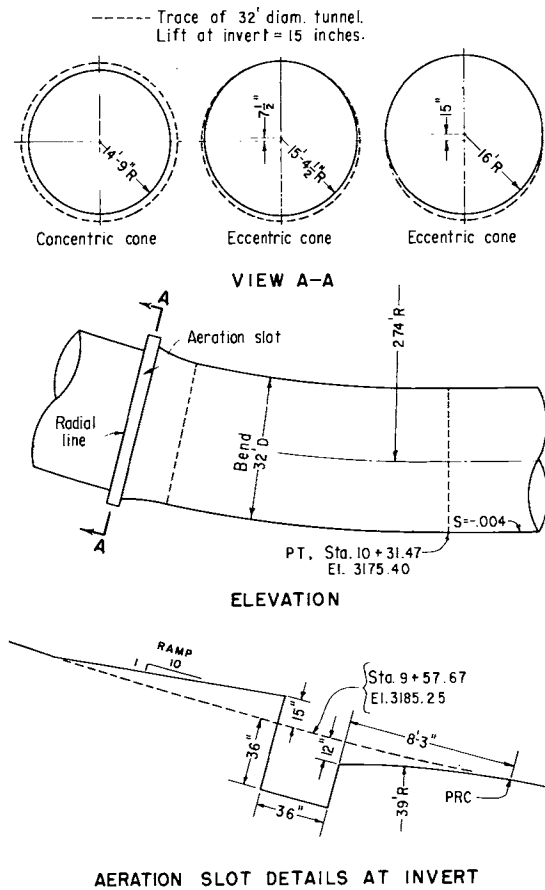
Model studies were continued to evaluate an aeration slot in the downstream portion of the vertical bend at Station 9+57.67 (Figure 16). The centrifugal force of the water in the bend made this location quite different hydraulically from the location in the conical

portion of the tunnel. The initial study was made with no lift upstream from the slot, and a 12-inch away-from-the-flow offset downstream. The slot partially or completely filled with water for all discharges. A small amount of air entered the jet for discharges less than 15,000 cfs, but for discharges

Figure 16. Aeration slot in the bend, Station 9+57.67 (not recommended).

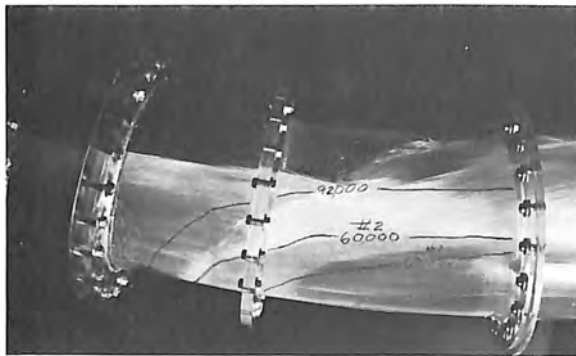
Various ramps and lifts were installed in the tunnel upstream from the slot. Each design tested produced satisfactory air entrainment and hydraulic operation for a limited range of discharges; however, none would operate satisfactorily over the full range of discharges. Figure 17 shows the fin produced by one configuration with a discharge of 60,000 cfs. This fin choked the tunnel downstream.

Figure 17. Aeration slot in the bend at Station 9+57.67. Discharge is 60,000 cfs. The side fins choke the tunnel downstream. Photo P459-D-68811

These limited tests indicated that the necessary modifications for a satisfactory aeration device to be installed in the vertical bend of an existing structure would be too extensive to be practical. However, an aeration device could undoubtedly be developed for installation in a bend during initial construction of a spillway tunnel.
