BUREAU OF RECLAMATION
Technical Service Center
Denver, Colorado

TRAVEL REPORT

Subject: Travel to Idaho Falls, Idaho and vicinity

2. Places or offices visited: Fish screening and passage projects in the Bear River and Snake River basins

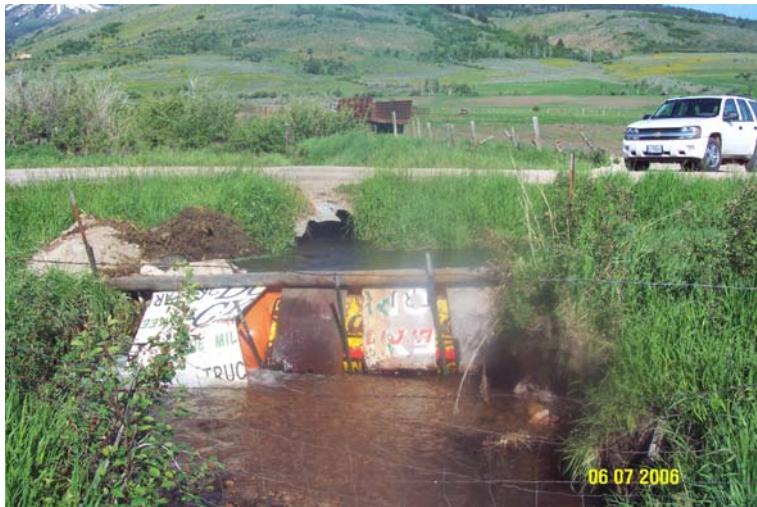
along the height of a well-vegetated alluvial fan connecting the headwater basin to the valley floor below. Figure 1 shows the existing diversion works on Skinner Creek at the bottom of this slope, located immediately downstream from a culvert that carries the creek beneath a county road. This diversion dam is established each year in the early summer by the landowner. Flow is diverted to the left side of the channel (right side of photo). A second temporary diversion (Fig. 2) to the right side of the stream is established later in the season at about the location from which the photo in Fig. 1 was taken. The check dam is actually located in the highway right-of-way. The amount of flow diverted varies; late in the summer the entire creek may be diverted. Downstream from this location the stream channel is incised for about 100 yards (Fig. 2). The riparian area immediately upstream from the road has already been improved through the relocation of a cattle feeding operation to get it away from the stream.

Figure 1. Temporary diversion dam on Skinner Creek.

suggested that overflow Coanda-effect screens could be effective here and would have minimal maintenance requirements. Another alternative would be to use a single diversion and fish screen and pipe the screened flow across the stream to supply the second irrigation channel. Jim has already made arrangements for the upstream culvert to be replaced with a larger, bottomless half-pipe culvert that will better accommodate fish passage.

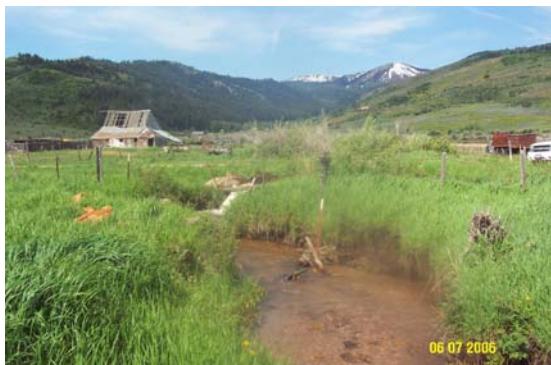
Figure 2. Location of 2nd temporary diversion dam (T-posts in stream). The diversion in Fig. 1 is visible just upstream. Note the channel incision that has taken place in this reach.

Jim's intention for this location is to use a series of rock weir grade stabilization structures to bring the channel back up to grade in the incised section. This should eliminate the need for the temporary check dam. Flow could then be diverted out both sides of the stream from a single diversion pool that would be located downstream on the landowner's property. A fish screen structure could then be installed in the head of each diversion, with bypasses that returned fish to Skinner Creek, a short distance downstream. I

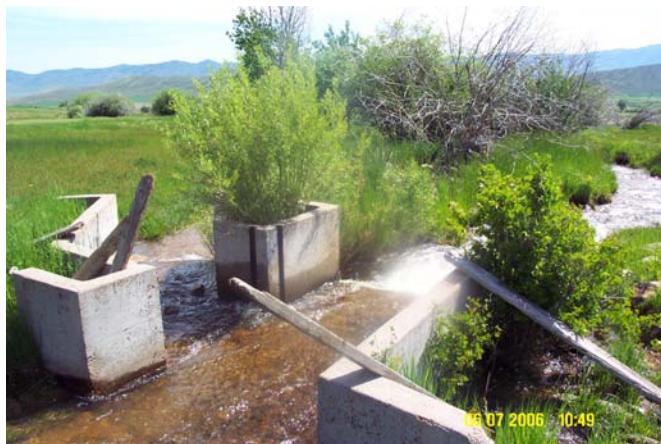
The middle diversion from Skinner Creek is located about a half-mile upstream (Fig. 3) on private property. Flow is diverted to the left side of the creek through a concrete division structure in which stoplogs can be used to adjust the flow split, although none were installed during our visit. The diverted flow is used to irrigate local hay meadows. The drop exiting at this structure into Skinner Creek presents a

Figure 3. Middle diversion from Skinner Creek.

barrier to upstream fish migration. This could be corrected with the addition of one or more rock weirs below the structure to raise the stream grade. A Coanda-effect screen could be added to screen the diverted flow and return fish and debris back to Skinner Creek.

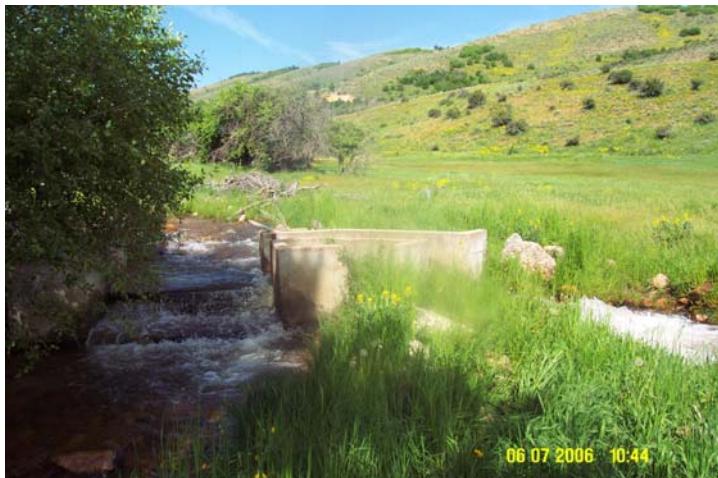
(looking downstream), and the diverted flow passes straight through the structure. Stoplogs were installed at the time of our visit to limit the diverted flow. The geometry of the structure probably causes significant numbers of downstream-migrating fish to enter the diversion, since they must turn a 90° corner to stay in the main channel of Skinner Creek. The flow that is diverted here enters remnant stream channels that may have once contained the main flow of Skinner Creek as it wandered back and forth through the years across this alluvial fan. Flow is further diverted from these channels at numerous temporary diversions established each summer to irrigate different sections of the meadows. Drainage flows eventually recombine and flow into the adjacent Stauffer Creek to the south of Skinner Creek.

Figure 4. Upper diversion from Skinner Creek. The main flow of Skinner Creek is on the right side of the photo, and the diverted flow is coming toward the camera. Check boards in the diversion side of the structure and a drop below the Skinner Creek side are barriers to upstream fish passage.

The upstream diversion from Skinner Creek is located about 150 yards further upstream, again on private property (Fig. 4 and 5). Flow is diverted to the right side of the creek through a similar concrete division structure as the middle diversion.

The main flow of the creek actually passes through the left side of the division box

There are unresolved intermittent fish passage barriers in Stauffer Creek upstream from the point at which the diverted Skinner Creek flows reach lower Stauffer Creek. This makes the upper Skinner Creek diversion to Stauffer Creek potentially valuable as an alternative upstream migration route for fish stymied in their attempts to spawn in Stauffer Creek (although there is presently an undersized road culvert near the bottom of the slope that is an impediment to upstream migration along this route). It would thus be desirable to leave this diversion unscreened, to allow for upstream passage from Stauffer Creek into Skinner Creek. However, the numerous temporary diversions along the way into the hay meadows

probably cause significant mortality of downstream-migrating juvenile fish. Thus, it would be desirable to modify the upper diversion works to reduce diversion of down-migrants into the remnant channels of Skinner Creek.

5. Conclusions: Small Coanda-effect screen structures could be used to screen the diversions on Skinner Creek. The uppermost structure should probably remain unscreened to allow for upstream fish passage from the lower reach of Stauffer Creek, but the diversion structure could be replaced with a new structure that would reduce loss of downstream-migrating juvenile fish. The middle diversion can be retrofitted with a Coanda-effect screen. The lower diversion (which presently utilizes temporary farmer-constructed check dams) can be improved with stream grade stabilization and permanent diversion structures utilizing Coanda-effect screens.

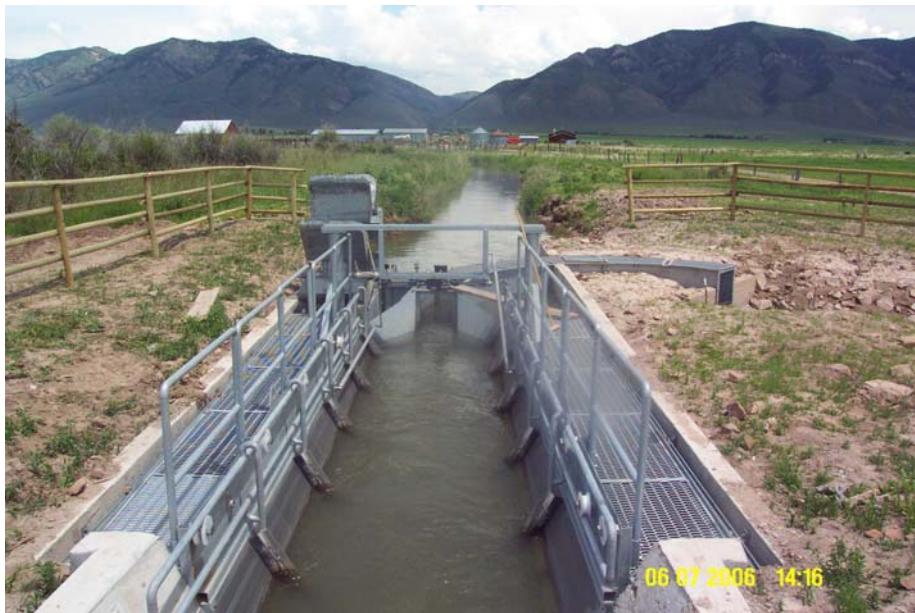
The other two structures we visited on the Thomas Fork were inclined flat-plate screens with a V-shaped layout. Each is equipped with a water-wheel driven brush system to clean the screens. The first structure (Fig. 6) is operating for the first time this spring and is working well. The second structure (Fig. 7) is in its second season of operation. This structure appears to have been installed somewhat high compared to the local water levels, causing the depth of flow against the screens to be relatively low and thereby producing higher screen approach velocities than would be experienced at a deeper setting. However, the structure has been working well thus far. On each of these structures, the center bypass channel also serves as the upstream fish pass. Stoplogs are installed in the bypass channel to produce a stepped-pool fish ladder.

Figure 6. Fish screen structure on Thomas Fork, installed in early 2006.

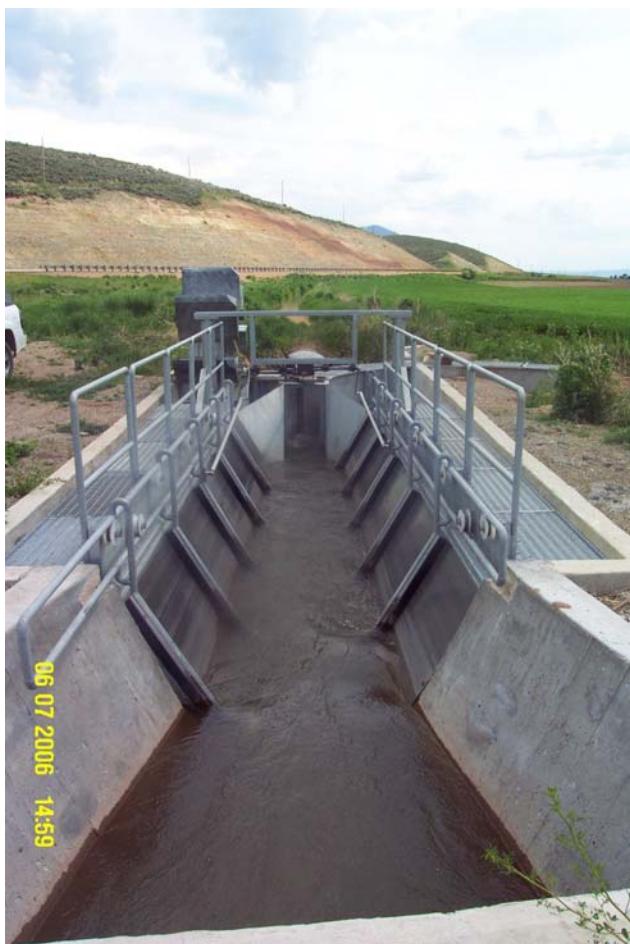
Figure 7. Upstream fish screen structure on Thomas Fork. This structure is set relatively high, limiting the utilized screen area and increasing approach velocities to the screens.
