TRAVEL REPORT

Date: June 28, 2006

Subject: Controlotron Flowmeter, Big Thompson Powerplant, near Loveland, Colorado.

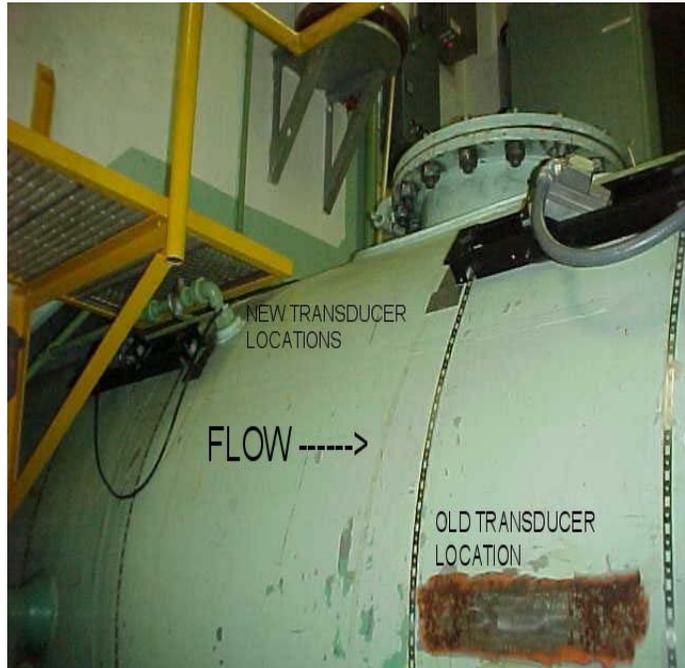
I removed the transducers from their tracks and inspected the condition of the acoustic couplant. The downstream transducer was in good condition and the upstream transducer was in poor condition, i.e. the couplant was dried out. I cleaned the transducers and the pipe and re-applied a thin-layer of a long-lasting acoustic

Figure 1. Photograph (taken in 2000) of the Controlotron flowmeter installation. The old transducer location is also shown. The pipe has since been re-painted to cover the old transducer locations.
