TRAVEL REPORT

Subject: Travel to Tom Green County Water Control and Improvement District #1 near San Angelo,
Texas

Review of Water Measurement and Water Distribution Infrastructure and Operations

**Tom Green County Water Control and Improvement District #1
San Angelo, Texas**

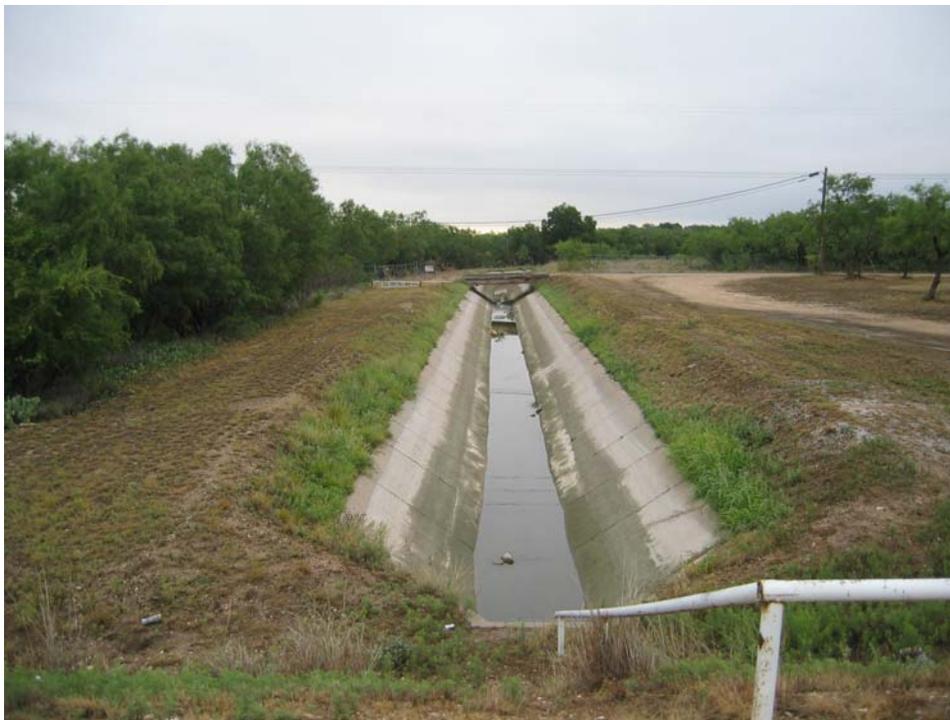
Figure 1. — Head of the main canal, looking downstream from the top of the dam at Lake Nasworthy.

This is a substantial and perplexing difference. We discussed possible sources of error in the use of the gate rating table and the flume. These included blockage of the fish screens around the dam outlet gate, errors in knowledge of the reservoir water surface, errors in gate position, additional tailwater caused by weed growth in the downstream canal, and leakage of flow out of the canal between the head gate and Parshall flume. Nothing we uncovered is able to explain such a large difference in flow. There were significant questions on the part of the district regarding how the reservoir water level is determined, but after our discussions on Thursday with the city representative, we were convinced that reservoir levels are known with sufficient accuracy to prevent this size of error.

- Head of main canal – explore discrepancy between Lake Nasworthy releases and Parshall flume measurements of flow rate.
- Head of main canal – explore options for adding a flow measurement structure or instrument near the head of the main canal.

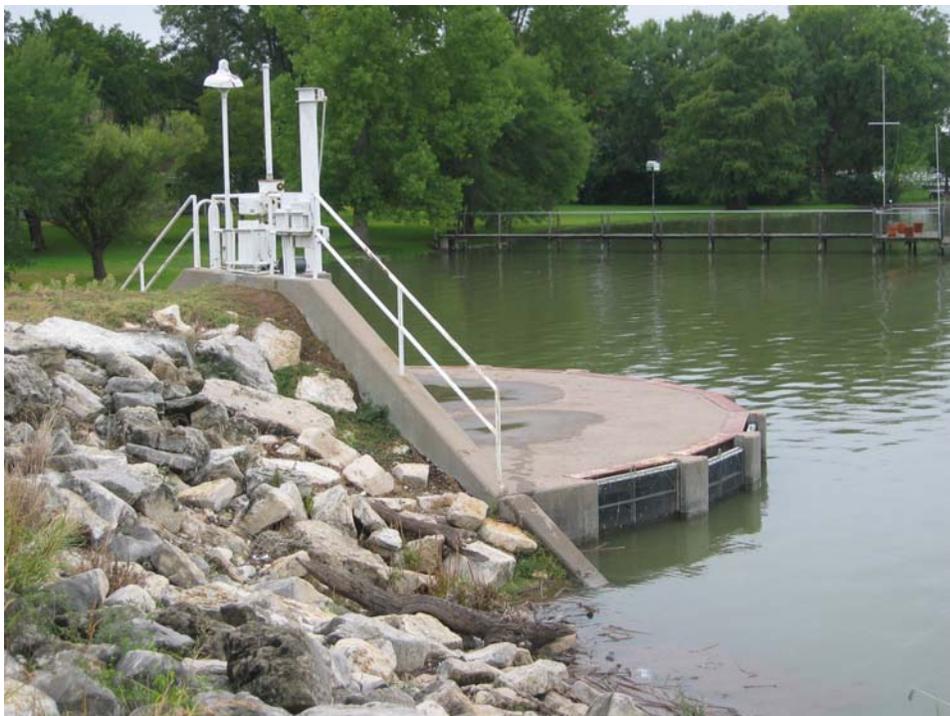
Some minor improvements could be made to the flow measurement systems at the head of the main canal. At the dam, there is presently no staff gage inside of the trash rack and fish screen structure that surrounds the intake. When trash accumulates on the screens, it will reduce the effective head on the gate, which will reduce the flow rate. A gage on the interior of the screened area would allow for measurement of the net reservoir head acting on the gate. Unfortunately, there are few suitable locations where a staff gage could be added inside of the intake structure and still be visible. Another option would be to add a water level sensor that could be integrated into the district's SCADA system.

Figure 2. — Intake structure at Lake Nasworthy.

- Lake Nasworthy outlet into main canal – explore possibility of installing and using a reservoir water level sensor downstream from the intake structure fish screen panels.

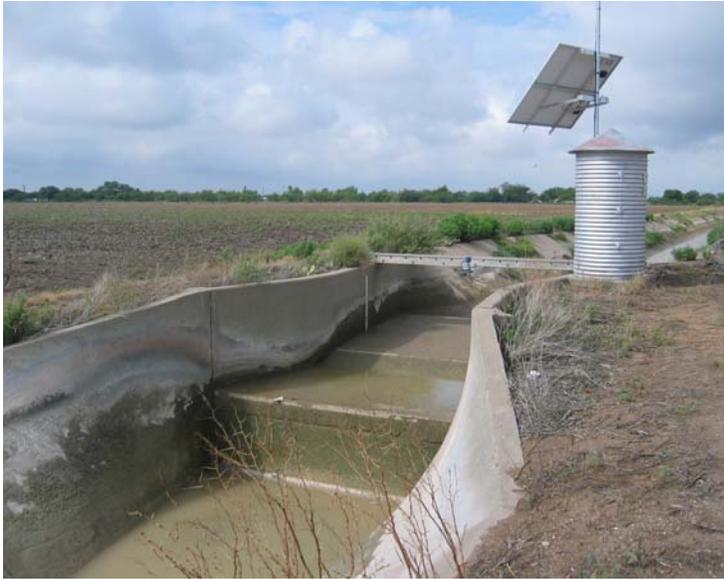
The Parshall flume located 6 miles downstream from the head of the canal provides the first flow measurement in the canal. This is a 10-ft Parshall flume in good condition with a drop on the downstream side. A quick check of dimensions and the placement of stilling well inlet and staff gage showed the flume to have standard dimensions. There is every reason to believe that accurate measurements are being obtained with this flume. The district has equipped this site with an ultrasonic level sensor that will eventually be integrated into the SCADA system so that flows can be monitored from the district office. The sensor is positioned about 6 inches further upstream than the staff gage and stilling well inlet, but this is a minor issue. For best accuracy, the sensor should be located at the same cross section as the stilling well inlet. In a Parshall flume the water level is sensed in the converging section, so locating the level sensor upstream or downstream of the standard position produces a slight bias in the water level reading due to changing drawdown as the flow accelerates in the converging transition. In this case the error would be such that the automated measurement would be higher than the true flow, but the discrepancy is probably no more than 1% to 2% of the total flow.

Figure 3. — Parshall flume at mile 6 of the main canal.

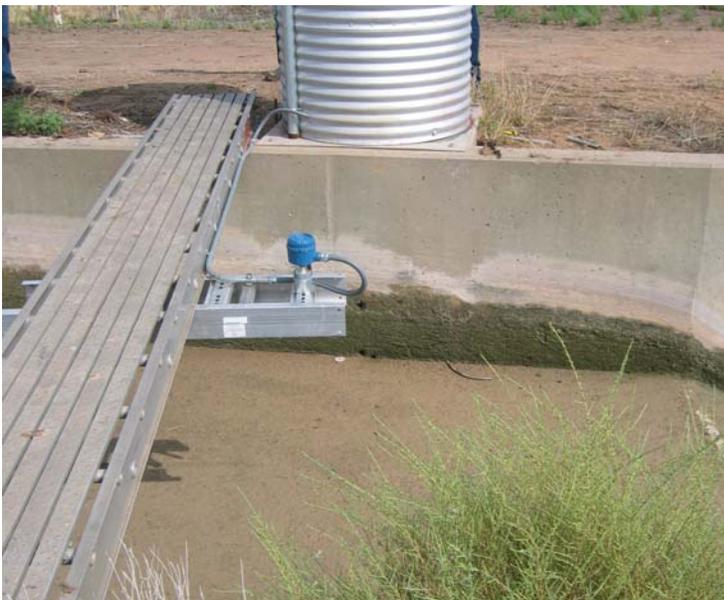
Figure 4. — Ultrasonic level sensor in Parshall flume entrance. The sensor should be aligned with the stilling well inlet holes. In the current position, it appears to be about 6 inches upstream from the inlet holes.

- The acoustic water level sensor at the Parshall flume should be located at the same cross section as the stilling well inlet.
- Consider utilizing a third-party provider for maintenance and recalibration of Sparling flow meters. Two possibilities are:

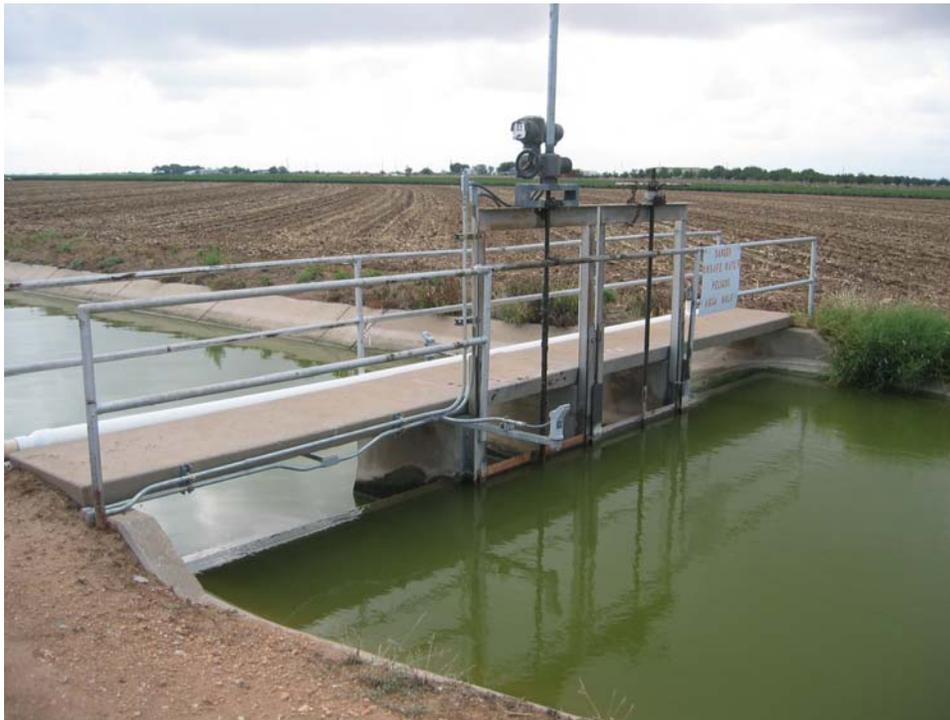
After leaving the flume site, we visited several of the check structures that have been automated in recent years. Most are reported to be working well. They are equipped with upstream and downstream water level sensors and gate position sensors. Flow through the gates is estimated using an orifice equation. Flow over the side weirs could be estimated with a weir equation, but it is uncertain whether this computation is being made at the present time. Figure 5 shows a typical automated check. One common issue with these installations is turbulence downstream from the gate, which affects the ability to make an accurate downstream water level measurement. This is compounded by the fact that ultrasonic level sensors are used, which are

sensitive to disturbance of the water surface. A water level measurement well downstream from the gate would be preferable, but this arrangement has been satisfactory for most of the sites. The district is able to use the instrumentation at the automated checks to estimate flow rates and monitor flow changes as they occur.

Figure 5. — Typical automated check structure.

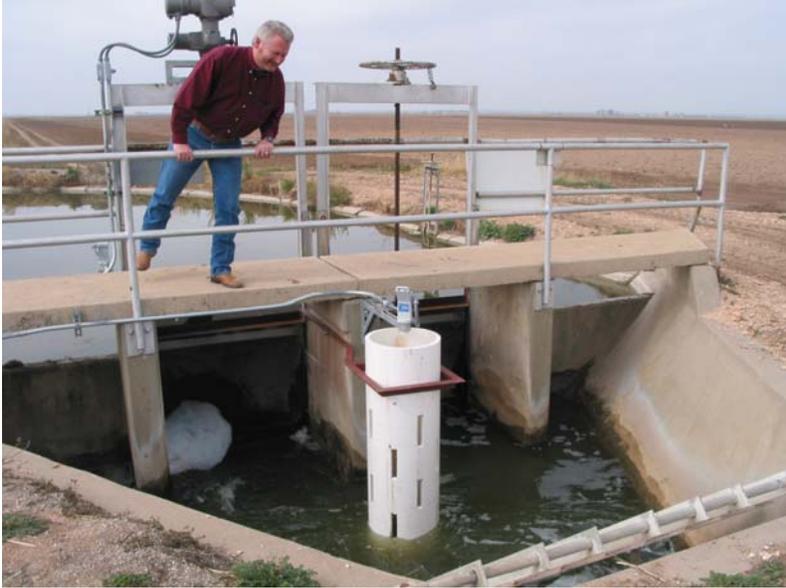
One site that has been especially problematic is check #16, which we were unable to visit on this trip due to the muddy roads. Figure 6 shows a photo from a previous site visit by Brenton Johnson. The downstream side of the check is immediately upstream from a siphon entrance. The short distance and low tailwater produced by the siphon entrance leads to especially high turbulence and makes it difficult to obtain a good downstream water level reading. This site could probably be improved by moving the water level sensor to the downstream end of the siphon, and being sure to locate it far enough from the siphon exit to avoid any highly turbulent flow issuing from the siphon. Some adjustment of the flow rate estimation equations would be needed to account for the losses incurred through the siphon, but the end result would probably be a more stable and reliable output from the instrumentation. This approach will not work if the flow entering the siphon passes through critical depth, but this is not believed to be the case.

Figure 6. — Downstream side of check #16.

- Mid America Meter, Inc., <http://www.midamericameter.com/>
 - Colorado Engineering Experiment Station Incorporated, <http://www.ceesi.com/>
- Check 16 – relocate water level sensor downstream from siphon exit.

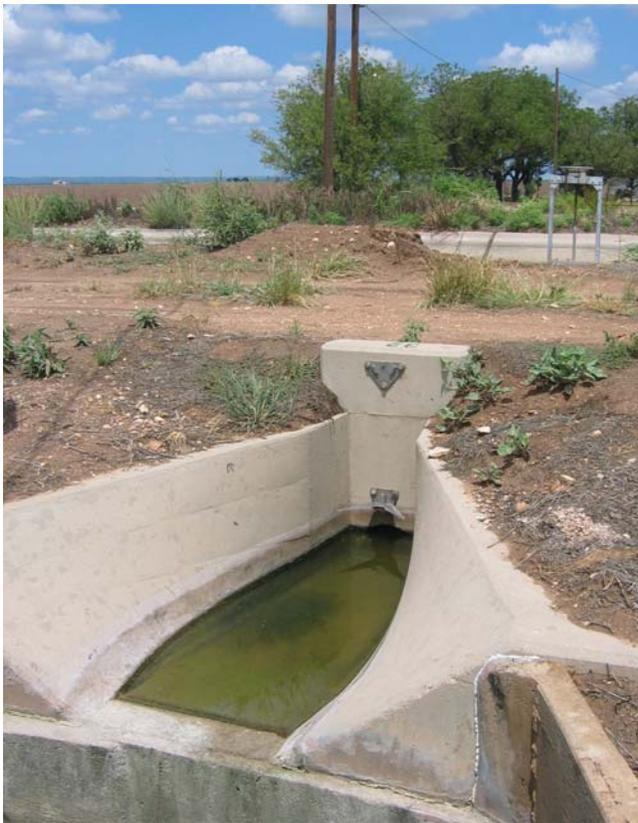
Figure 7. — Mounting bracket for a Sparling meter at a typical turnout.

The district seems comfortable operating either type of turnout. Originally, the project was equipped with a dedicated Sparling meter at each turnout, but the expense of maintaining so many meters was excessive. Today the district's two ditchriders each use one meter with a backup kept available. Newly reconditioned meters with stiffer bearings are reportedly unable to

measure flows less than 1 ft³/s. Yantis Green reported many customer service difficulties dealing with the Sparling Instruments company, including meters that were delayed excessively and then shipped back to the district still in non-working condition. The district should consider utilizing a third-party provider for maintenance and recalibration of meters. Two of many possibilities are:
