**BUREAU OF RECLAMATION
TECHNICAL SERVICE CENTER
DENVER, COLORADO**

TRAVEL REPORT

Subject: Travel to North Dakota to view Missouri River pump intake sites

DKAO Pump Intake Project
Discussion Notes from 10/16-20/06 Site Visit
And from Post-Visit 10/31/06 Staff Meeting:
Attachment A to Travel Report for October 16-20, 2006 Site Visit

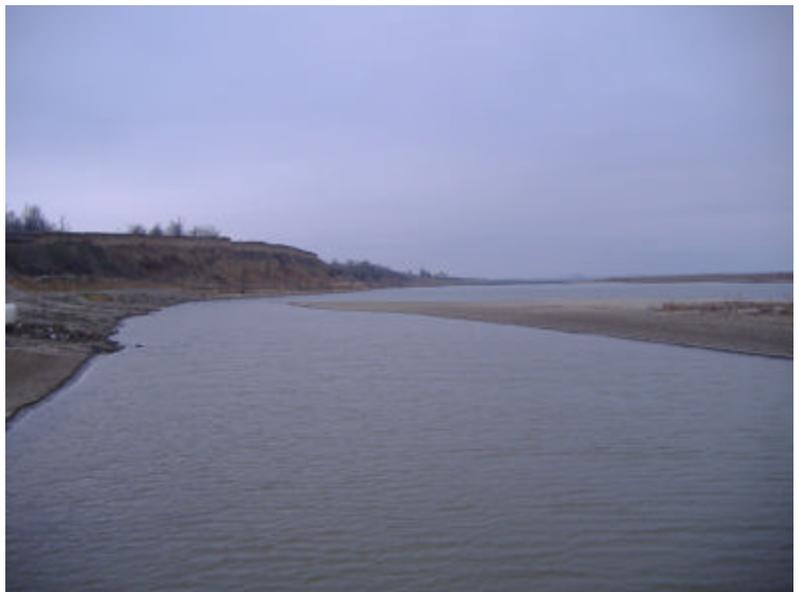
At the lower discharge – as viewed on our site visit – water adjacent this site becomes a back-fed channel. (This channel is shown at right in a view looking downstream.) During irrigation season, a portable pump is positioned in the channel. Water is conveyed via surface pipe up to a point at the bench lands where it is connected to the irrigation distribution pipe system.

At the time of our visit, the USACE had excavation equipment on-site in an effort to maintain sufficient depth in this back-fed channel to provide boat access to the main river

channel. This appears to be one of the most favorable pump sites along Horsehead Project under the current river conditions. As long as the USACE continues to maintain

boating access at this point, pumping should remain viable. The back-fed conditions should be a limiting factor in sediment transport near pumping operations, and hence should tend to limit sediment intake by the pump.

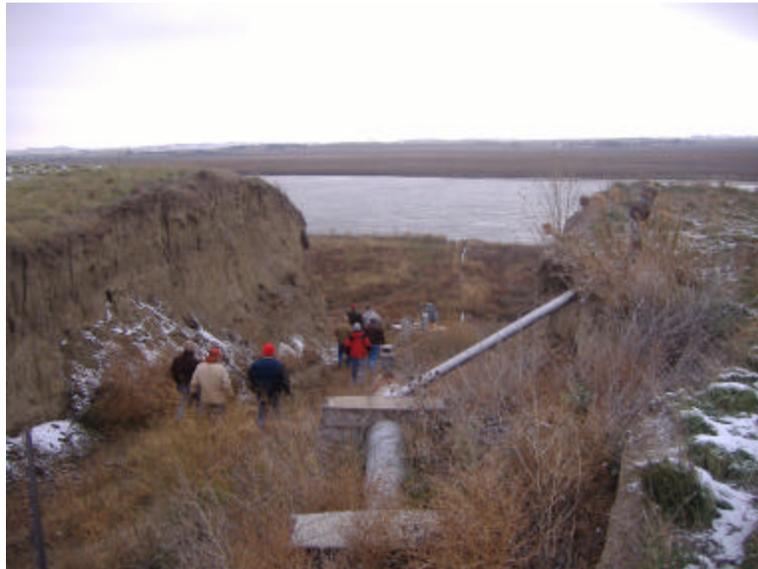
The second pump site visited in Horsehead Part 1 is approximately a mile downstream of the Hazelton boat ramp. At this site, the river is accessed via a cut through the approximately 20 ft vertical wall at the edge of the river bottomland. At this site, (seen in the photo at right), the pump site where water was previously drawn from Lake Oahe is 1500 ft to 2000 ft back from the edge of the river channel as it currently flows.

As an adjustment to river operating conditions, the land owner at this site installed a wet well (just out of view to the right of the cut in the photo) connected to the river channel by a horizontal pipe. Apparently during construction of the wet well, a “blue” sand layer was encountered from which a considerable amount of water flowed into the wet well. North Dakota State Water Commission staff that accompanied us on the site visit stated that this “blue” sand zone in that vicinity is typically suitable as a domestic water source, but insufficient for irrigation.

Functioning of the wet well/horizontal pipe system has apparently been impacted by excessive sediment diversion which resulted in failure of a water-cooled vertical turbine pump installed in the wet well after only a partial season of operation. After this pump failed, the irrigator utilized a portable pump system with a capacity suitable for only a fraction of his acreage to finish the 2006 season.

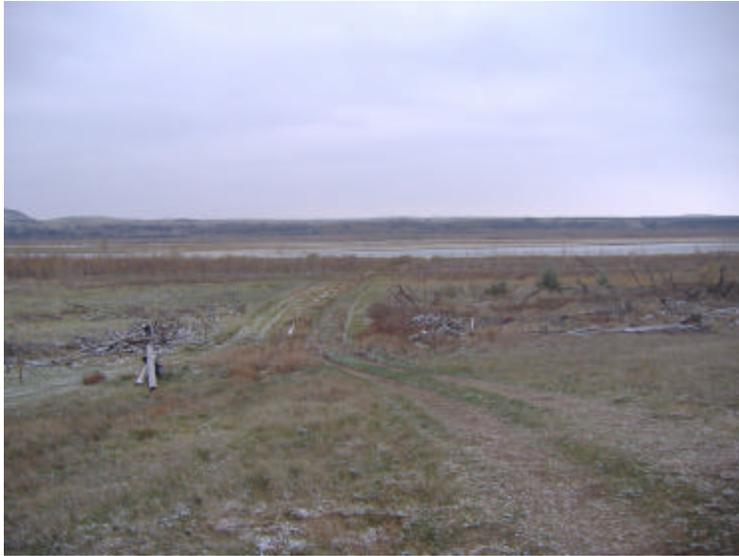
At higher river discharges, land near the portable pump location becomes damp and provides limited support. This site is not close to electric power access. It is being operated by a diesel engine. The soft ground necessitates piping fuel several hundred feet to a small on-site fuel tank that must be refilled twice daily. The irrigator cited high cost of operations as reason for current pumping operations at a capacity that serves about half his irrigated acreage.

Access to water at this site (seen in the photo at right) has been maintained, but under conditions that are clearly marginal at best. While these conditions are superior to some seen at other Horsehead sites discussed below, current operating conditions may not be viable over any significant period of time.

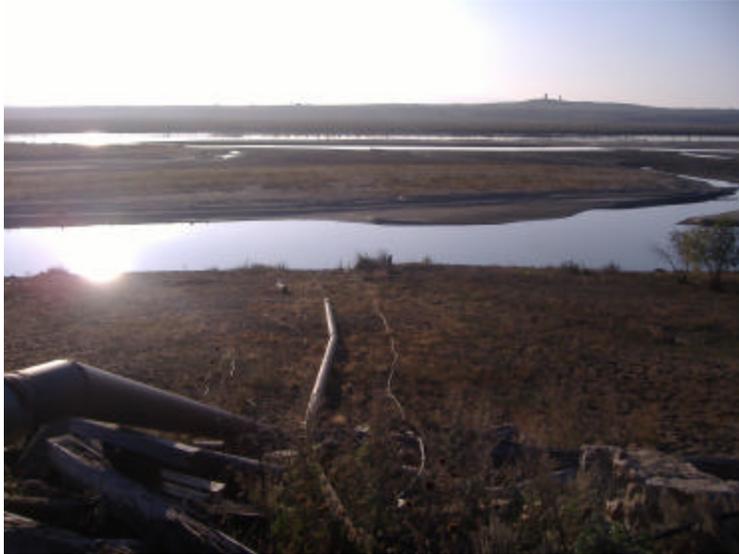
Part 2: Horsehead Part 2 features a single pump site. Since reverting to river conditions, the main channel at this site has been located approximately 1000 ft out from the “reservoir conditions” pump site. Up to 2006, a smaller channel had continued to flow at the toe of the slope about 200 ft from the reservoir pump. (This side channel is seen in the photo at right as viewed from the reservoir pump site.)

During 2006 the upper connection to this side channel apparently silted in. The side channel is currently backwatered from the lower connection to the main channel which is some 3000 ft downstream from the pump site. During the site visit, possible means of re-establishing the upper connection were discussed, including use of a floating dredge that jets dredged material out a good distance (~ 100 ft) from the channel being dredged. Access to the side channel from the upper bench lands at this site has been enhanced by a pavement of concrete slabs the land owner has placed to form a ramp that extends about 200 ft down to the channel.

- The closure of the upper connection to this side channel may actually be beneficial in that sediment transport past the pumps would be significantly diminished.
- As long as the backwater connection remains viable, pumping conditions at this site may be as favorable as can be developed. Identifying potential means of maintaining/improving this backwater connection (i.e. a “thumb” dike at the lower bar point at the backwater connection may serve to keep sediments moving past the connection and keep it from getting choked off.)

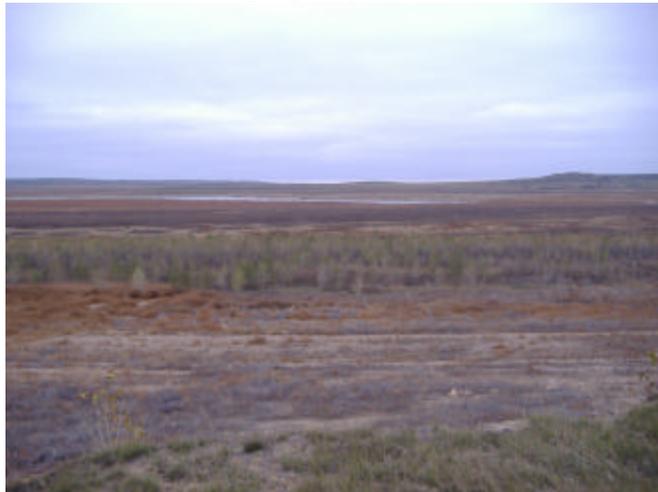
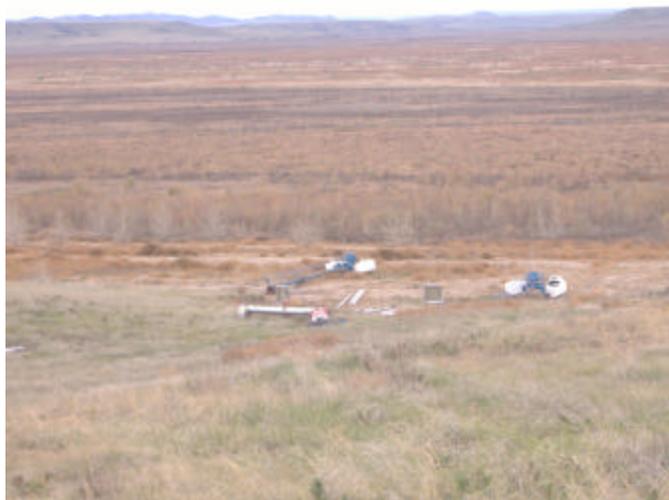
Part 3: Horsehead Part 3 irrigators face highly unfavorable conditions in that the main channel of the river is currently in excess of mile away from their “reservoir conditions” pump sites. As Lake Oahe receded, most were able to extend operations for at least part of an additional season by pumping out of shallow basins on the near side of the bottomlands. Over the past few seasons, a limited amount ongoing irrigation in Horsehead Part 3 has been fed by groundwater supplies. A potential course of action

The lower photo at right shows two floating pumps at a now-idle Part 3 pumping plant. Irrigators that participated in the site visit suggested that a channel along the left side of the bottomlands may be an old path of the river. They expressed interest in investigating the viability of dredging a connection at the upper end of this channel to the existing flow to see if water could be induced to follow this path which is much nearer their pump stations than the current main channel. This channel apparently runs near the tree line that can be seen near the middle (top to bottom) across both the above photos.

- The idea of inducing flow to come down the channel on the left side of the bottomlands – even if initially feasible with a limited amount of excavation – would likely be subject to re-filling with sediment within a limited time frame.
- If it could be shown that zones of streambed alluvium exist that are capable of delivering water in the amounts needed for irrigation pumping, then excavation of

- pits in the proximity of existing “reservoir conditions” pumping plants may be a promising alternative for Part 3 lands .
- If pumping from excavated pits is not viable, the single-upriver pumping site may be the most technically feasible alternative. The significant acreage that would need to be served dictates that this alternative would include significant and costly infrastructure including pump facilities and distribution system, possibly including storage facilities.

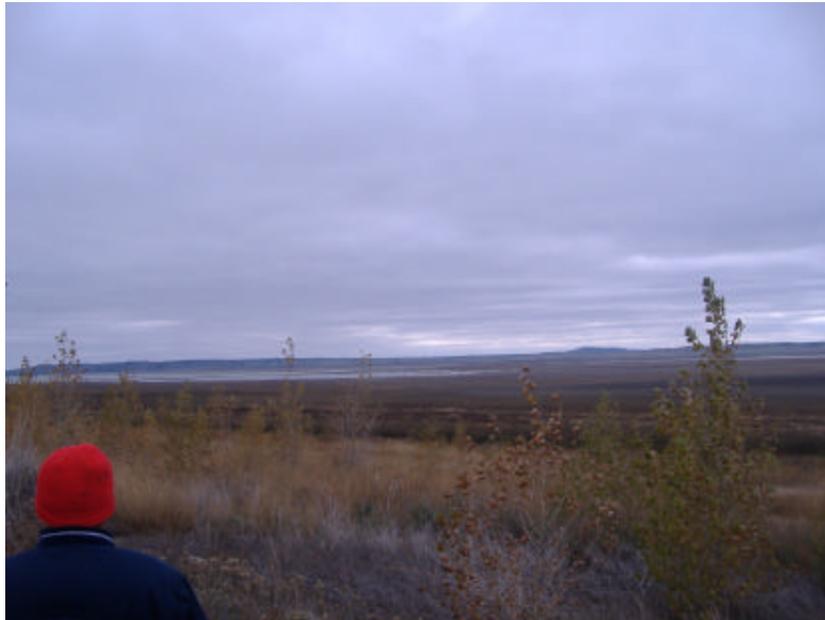
Part 5 lands lie along a reach where during part of the year backwater effects of Lake Oahe may result in the filling of shallow basins. Some early-season shallow pumping was possible during 2006 before the lake dropped to levels that dried the basins up. The dark area at mid right of the photo at right is a now-dry basin which contained 8” – 12” of

water in early summer 2006. This source was utilized for limited acreage in Horsehead Part 5 during the past season.

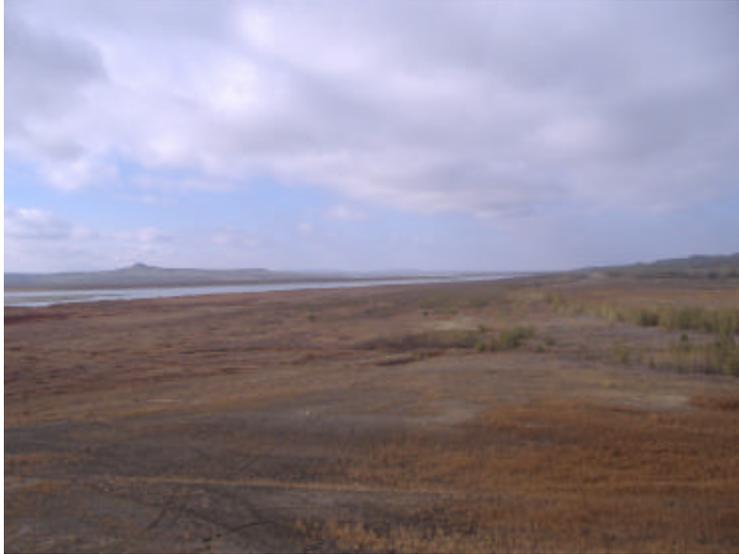
The photo at right is a view looking north across the mouth of Langeliers Bay. An excavated route from the Langeliers Bay boat dock (located to the right of the photo) to the current river channel location (seen in the background moving off to the left of the photo) would be a channel on the order of one mile in length.

- Again, excavated pits fed by alluvium with suitable high transmissivity may be the most viable option – provided such pits are feasible.
- The excavated channel into Langeliers Bay under discussion may be subject to filling in under delta depositional conditions as Lake Oahe fills to higher-than-recent storage levels. If costs of establishing and maintaining such a channel can be shared with recreational interests, this would enhance the cost-effectiveness of what may otherwise represent significant economic risk for agricultural benefits only

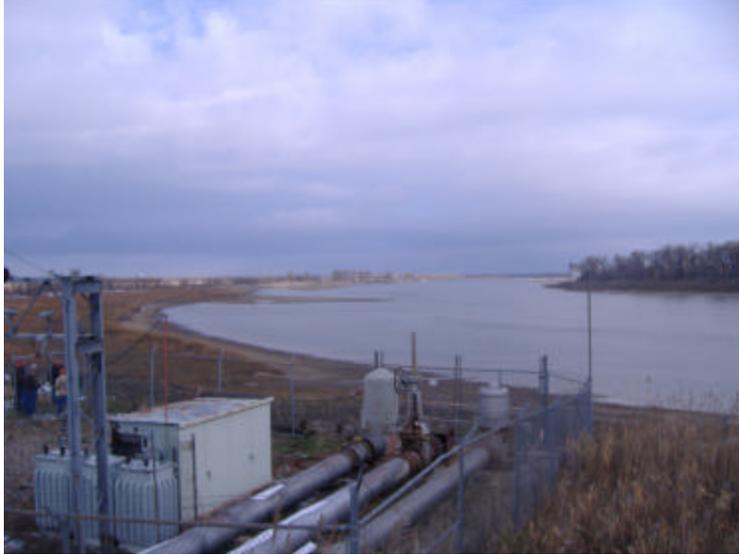
Intake: The Fort Clark Irrigation intake is located in what would seemingly be desirable location along the outside of a channel bend. The photo at right is a view of the pump site looking upstream. A factor which complicates river geomorphology at this location is that the Knife River feeds into the Missouri River upstream from this point, on the outside of the same river bend.

The Knife River sediment load is carried along the outside of the bend. Impacts on pumping operations include a high rate of sediment intake at the pumping plant, and formation of a point bar (visible near the left-center of the photo) which is pushing the river thalweg away from the pump location. Apparently, recently collected river bathymetric data suggests a significant back-fed component of the water entering the pump intake.

- Submerged or “Towa” vanes have been used to effectively limit bed-load sediment diversion at river intakes through creation of secondary currents that direct the bed-load carrying lower segment of the stream profile away from the diversion while the upper segment of the stream profile with lower sediment concentration is directed toward the pump intake. Uncertainties with submerged vanes at this location would include impacts of ice and ice jams, and impacts and/or hazards that may impact river navigation.

- Limiting sediment diversion might be achieved by constructing an elongated entrance structure to the existing diversion that is controlled by an overshot gate. This gate could be automated to adjust to river stage and/or pumping demand to divert water from the upper part of the flow profile containing the least sediment concentrations.

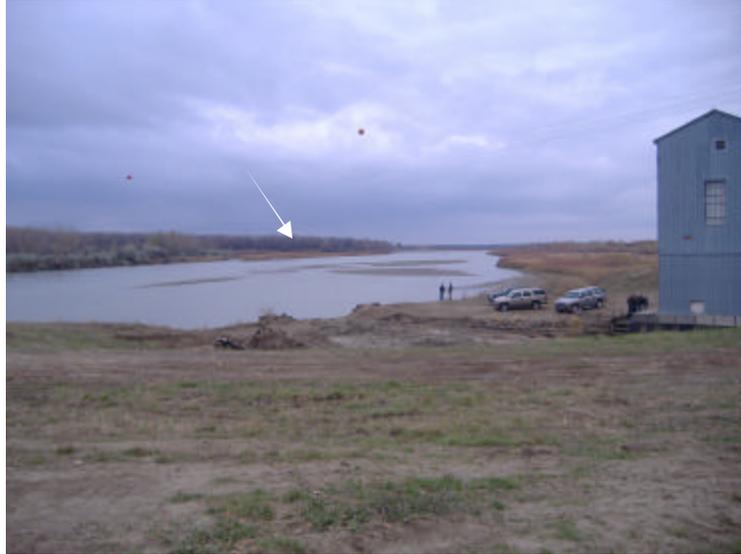
Buford-Trenton Irrigation District Pump Intake: The Buford-Trenton Irrigation District pump intake site on the Missouri River is seen in the view at right looking upstream. Issues with excessive sediment diversion led to a project undertaken by the USACE in recent years to direct the main current toward the pump intake by installing three spur dikes upstream on the opposite side of the river.

Irrigation district personnel report that for the first two to three years after the spur dikes were installed, they appeared to create the desired effect. In recent seasons however a point bar has formed atop the spur dikes (at the location of the arrow in the above photo). Subsequent to the formation of the point bar over the spur dikes, the bar that is seen on the near side of the channel upstream from the pump intake began to form. As a result, the main channel has now been moved out from the intake location. The District has seen a significant increase in diverted bed-load sediments that coincided bar formation over the spur dikes and appearance of the bar on the near side of the channel.

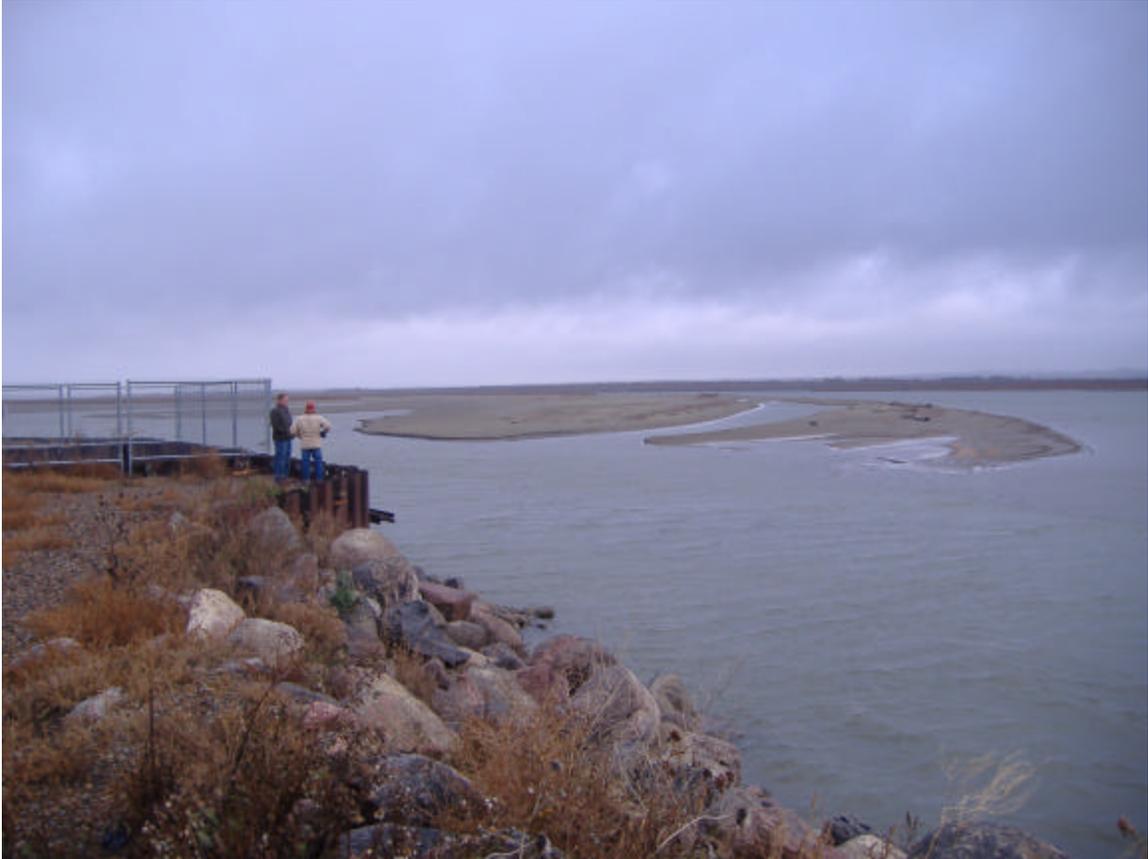
At the Fort Yates municipal intake (Figure 2), historical aerial photos indicate the downstream migration of river bends in the area. As the river meanders progress downstream, the large point bar along the right bank is moving in front of the existing intake, threatening to cut off river flow into the sump. Currently, the leading edge of the point bar is downstream of the sump, resulting in a backwater area along the face of the intake at low flows. Figure 2 shows the existing sump and point bar.

Figure 2. Fort Yates MR&I intake sump, October 17, 2006 (photo courtesy Tom Gill).

Approximately 1,200 to 1,400 gpm year-round is required for municipal use at this site. Sediment deposits in front of the existing intake could eventually prevent adequate water supply from flowing into the sump.

Rising reservoir levels would bring the pool close to the sump, but may cause further sediment deposit until the reservoir delta is a significant distance upstream. Even if the reservoir fills over the next several years, the same low flow problems would likely occur at this site during the next drought period.

- At the municipal water intake, an infiltration gallery should be considered. Historical drill logs indicate that there may be an existing sand/gravel layer sufficient to provide groundwater flow. Several options are available for infiltration galleries to improve their production. If placing gallery pipe in sand and gravel layers is not feasible, then gallery pipe can be placed in open cut trenches, then backfilled with appropriately sized gravel and sand to allow groundwater flow and provide a base level of filtration. Multiple gallery pipes could be extended underneath the river from a central collection well, providing backup sources and increasing gallery production. Whether a directionally drilled or cut and fill placement method is used, fine sediments (silts and clays) can deposit in the sand/gravel surrounding the gallery pipe over time, choking the water inflow. To maintain sufficient inflow, an infiltration gallery can be designed with back-flushing capability to periodically remove fine sediment from the filter layer surrounding the pipe. The water demand for Fort Yates is relatively low (1,200 to 1,400 gpm; 2.7 to 3.2 cfs), increasing the potential of an infiltration gallery as a reliable and consistent water supply.

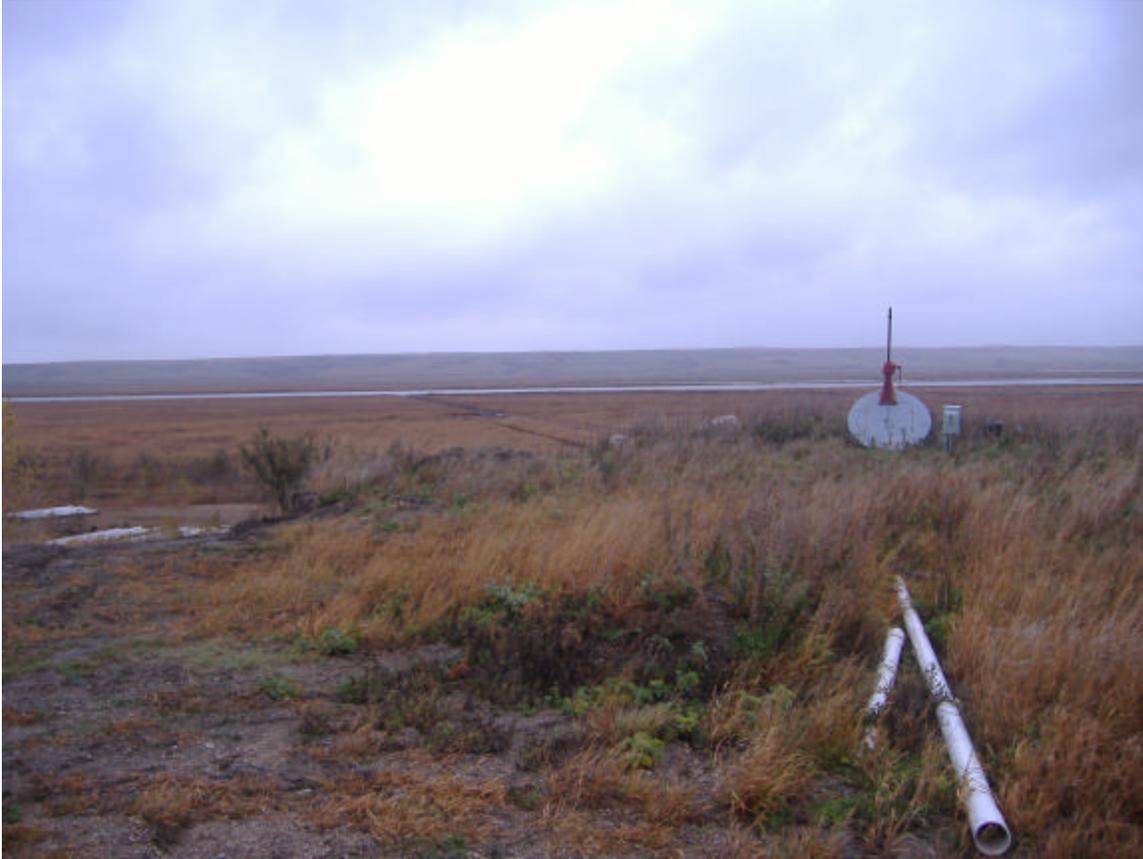
The Fort Yates Unit currently consists of a 3,500 gpm pump drawing water from the river through 2600 feet of 12-inch aluminum pipe to a wet well. Water from the wet well is sufficient to irrigate about one half of the Tribe's irrigated land at this site. During irrigation season, the current system is pumping large amounts of sediment from the river. The Tribe is considering the installation of floating intakes to eliminate most of the sediment being pumped. Figure 3 was taken from the right bank, near the wet well and shows the distance from to the river.

Figure 3. Fort Yates Unit irrigation intake site, October 17, 2006 (photo courtesy Tom Gill).

River migration during low flows and sediment deposit at the intakes are the primary issues at this site as well.

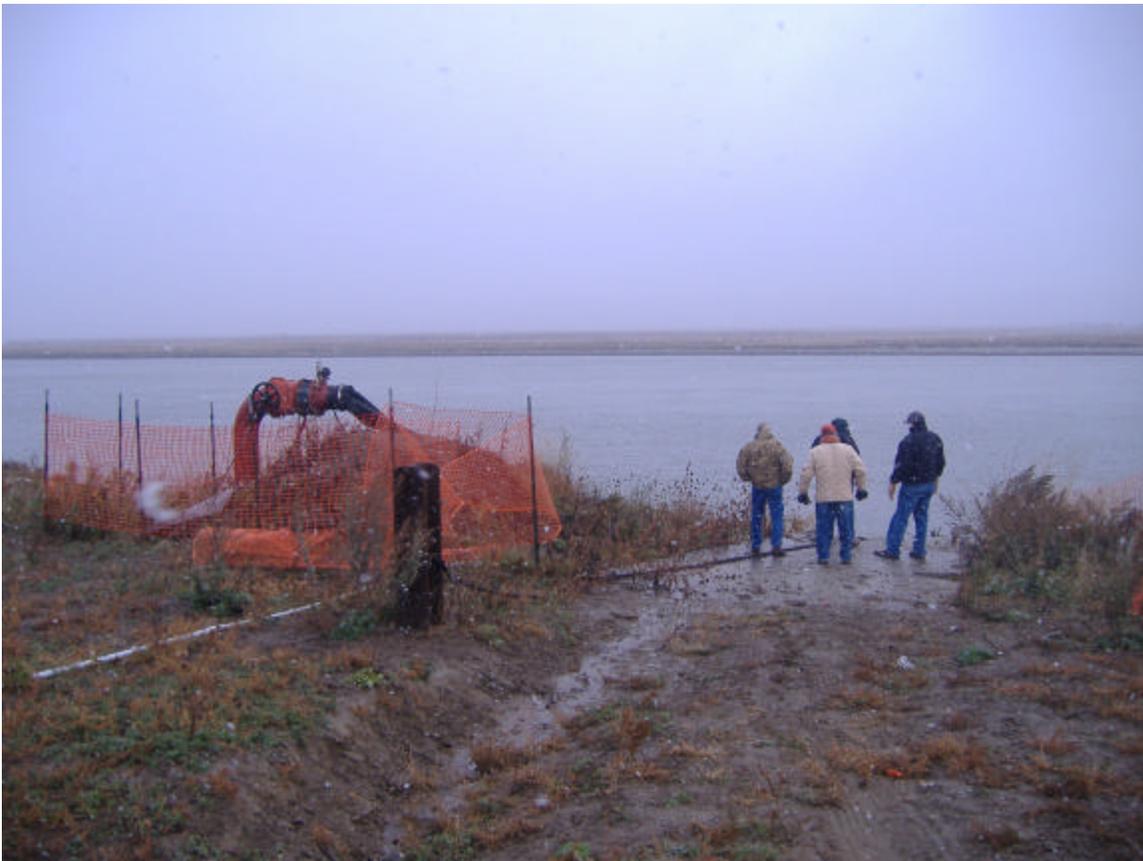
Unlike the Fort Yates sites discussed above, the Cannonball intake site is close to a relatively stable portion of the Missouri River. The river channel here is relatively straight, deep, and close to the right bank. Even under the current low flow conditions, water access is against the right bank, near the Cannonball Irrigation Unit intake (Figure 5).

Figure 5. Cannonball Irrigation Unit intake, October 17, 2006 (photo courtesy Tom Gill).

Problem: The fixed intake failed when the river channel shifted due to declining reservoir levels which moved sediment downstream. The Tribe is currently using a portable pump as the main river channel is close to the pumping plant. The Tribe would like to construct one intake which will operate in both high and low water conditions. Their consultant has proposed constructing an expensive H structure in the channel which will allow the intake to be moved vertically but not horizontally.

- If the river remains in its current low flow channel along the right bank, portable intakes appear to be the best option here. The river at this site is relatively stable and close to the irrigation pumps. While the vertically adjustable intake proposed by Morrison and Maierle may solve most of the problems at this site, the estimated \$1,000,000 price tag seems excessive. Perhaps a less expensive solution could be found that would be just as effective. During discussions of potential alternatives, the possibility of installing an inclined intake on the existing concrete ramp at the Cannonball site (Figure 5) was presented. Inclined rails or a track system could be installed on the concrete slope. A portable intake could travel up and down the rails, following the water surface as it rises and falls. Flexible pipe would be connected to the intake to maintain a connection to the pumps while the intakes were adjusted.

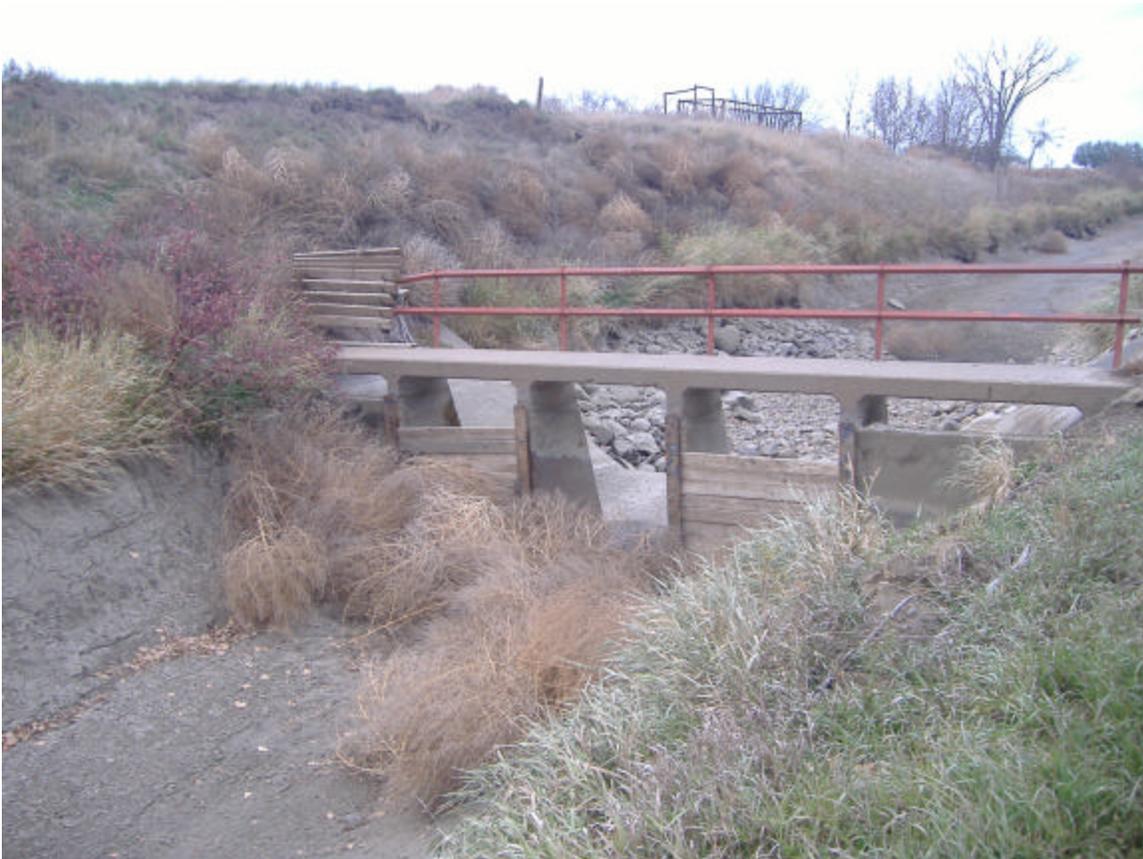
Figure 1: BTID 3.8 check structure

As seen in the Figure 1 above, the 3.8 check is a three bay structure that currently features stop-log control in each bay. Automation at this site would require installation

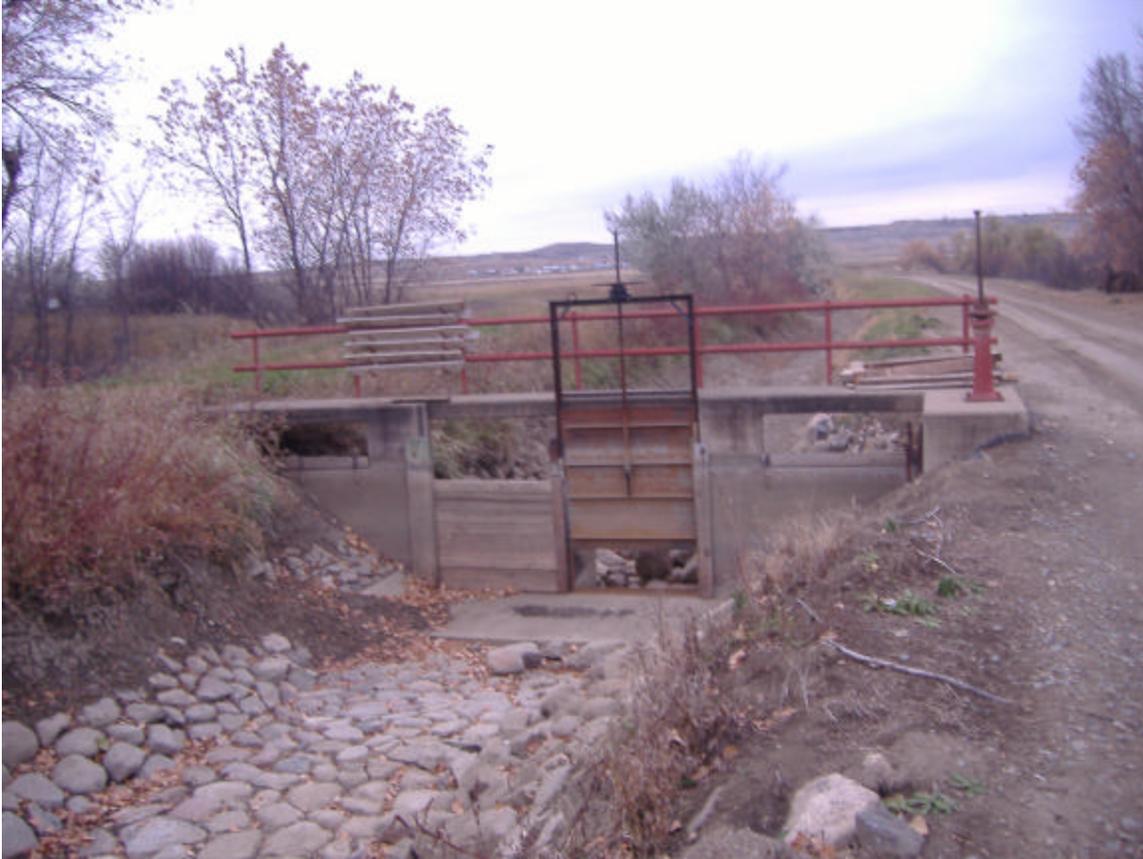
Figure 2: BTID end-of-project spill

The second site suggested by Monte during the site visit is the end-of-project spill. Monte was particularly interested in the possibility of automating the spill control. This site is seen in Figure 2 below. As noted above, a vertical slide gate constructed by the BTID staff has recently been stalled in one bay of the two-bay check structure. The spill off-take may be seen at the right of the structure. There is a vertical slide gate that has long been in place to control flow into the spill. (The stem and upper hardware for this gate can be seen atop the concrete wall at right in the photo.) In recent years, BTID has installed angle irons on the walls of the approach to the spill control gate that form stop-log slots. By passing spill over the stop logs, it has prevented the canal from draining when operational problems are encountered with upstream pumps – a problem apparently experienced on repeated occasions when the vertical slide gate was used to control flow into the spill.

Alternatives discussed for automating the spill control included motorization and control of the existing gate or construction of an adjustable weir which could be placed in the stop-log slots. Automation of the existing gate should address the issue of preventing draining of the canal when pump problems occur. This site would also be a candidate for additional functions similar to items discussed in association with the 3.8 check with regard to making flow measurements passing the gates.
