BUREAU OF RECLAMATION
Technical Service Center
Denver, Colorado

TRAVEL REPORT

Subject: Amarillo Canal Flow Capacity Test Site Visit

1. Travel dates: April 22, 2008, through April 24, 2008
2. Places visited: Amarillo Canal, Farmington, New Mexico
3. Purpose of trip: Chou Cha and Tony Wahl from the Reclamation Technical Service Center (TSC) visited the Amarillo Canal on the Navajo Indian Irrigation Project to gain an understanding of project operations and issues related to canal deficiencies and to identify potential flow measurement sites to be used during an upcoming flow capacity test of the Amarillo Canal.

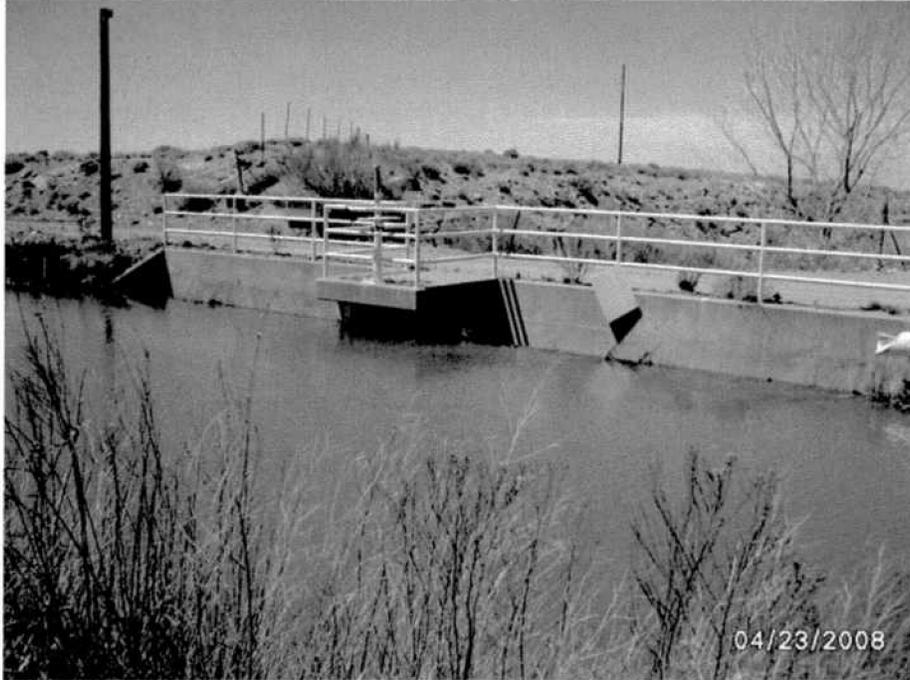
Figure 1. — Gravity wasteway at Sta. 604+00 on left side of canal.

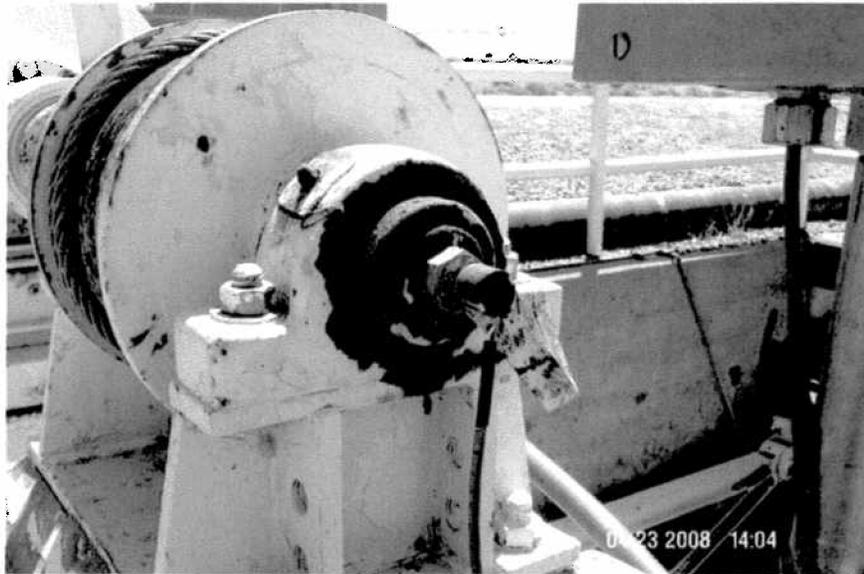
Figure 3. — Radial check gate position sensor.

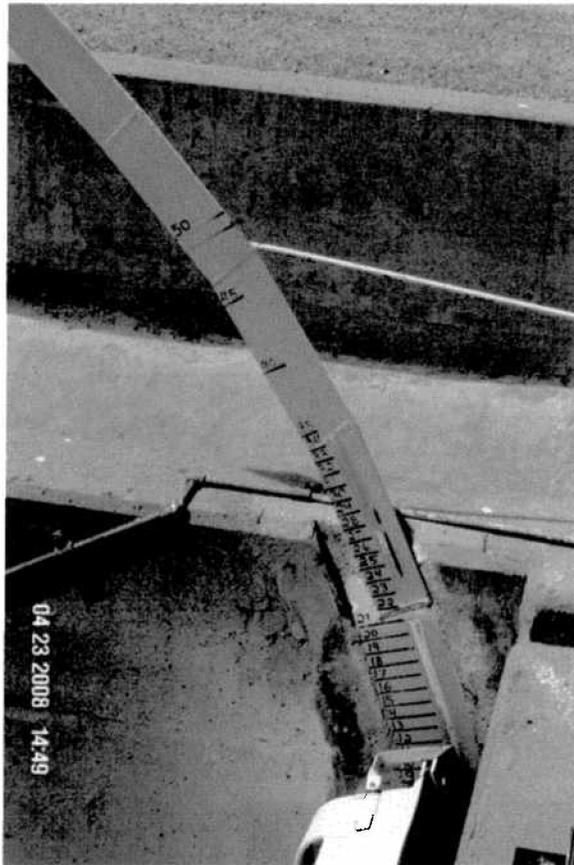
Figure 4. — Radial gate position indicator.
