TR-2009-05

Site Visit to Horseshoe Dam Outlet Works and Spillways, AZ

BUREAU OF RECLAMATION
TECHNICAL SERVICE CENTER
TRAVEL REPORT

Subject: Site Visit to Horseshoe Dam Outlet Works and Spillways, AZ

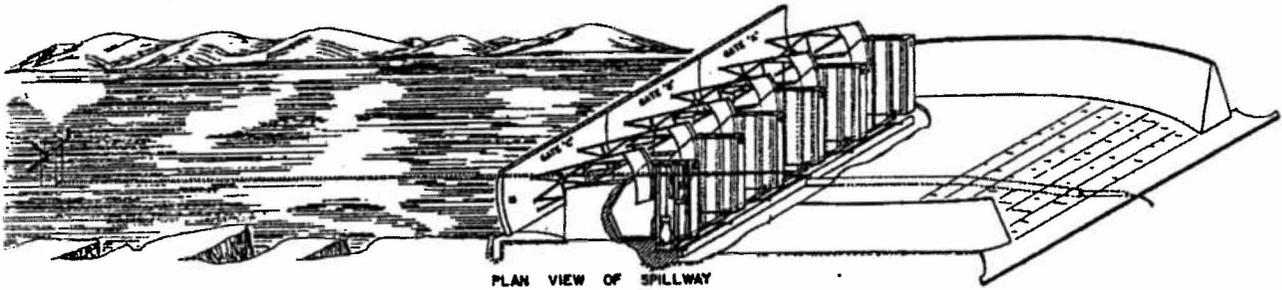
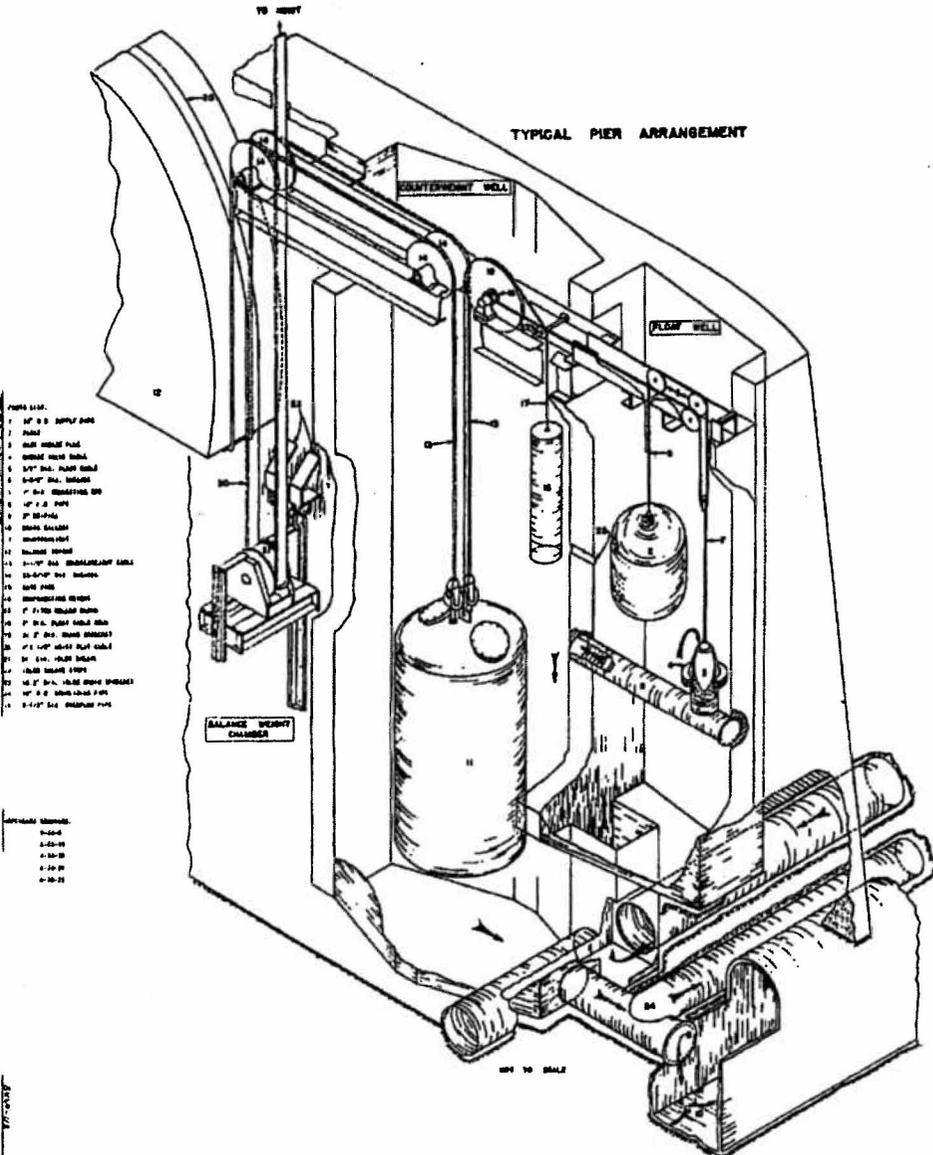
Figure 4. – Horseshoe Dam Service Spillway – Isometric View of Spillway Gate Control System.

As an explanation about why gate No. 3 does not bind under balanced conditions, the following is offered: The steel tank counterweight (noted as part #11 in Figure 4) is neutrally buoyant during automatic operation, and partly buoyant when operated by hoist with water loading against the gates (and counterweight chamber partially filled). When operated in dry conditions, the counterweight experiences no buoyant force and thus exerts maximum force to close the gate. This helps to explain why binding is not observed when the gate is operated under balanced conditions (even large binding forces can potentially be overcome by the full force of the counterweight).

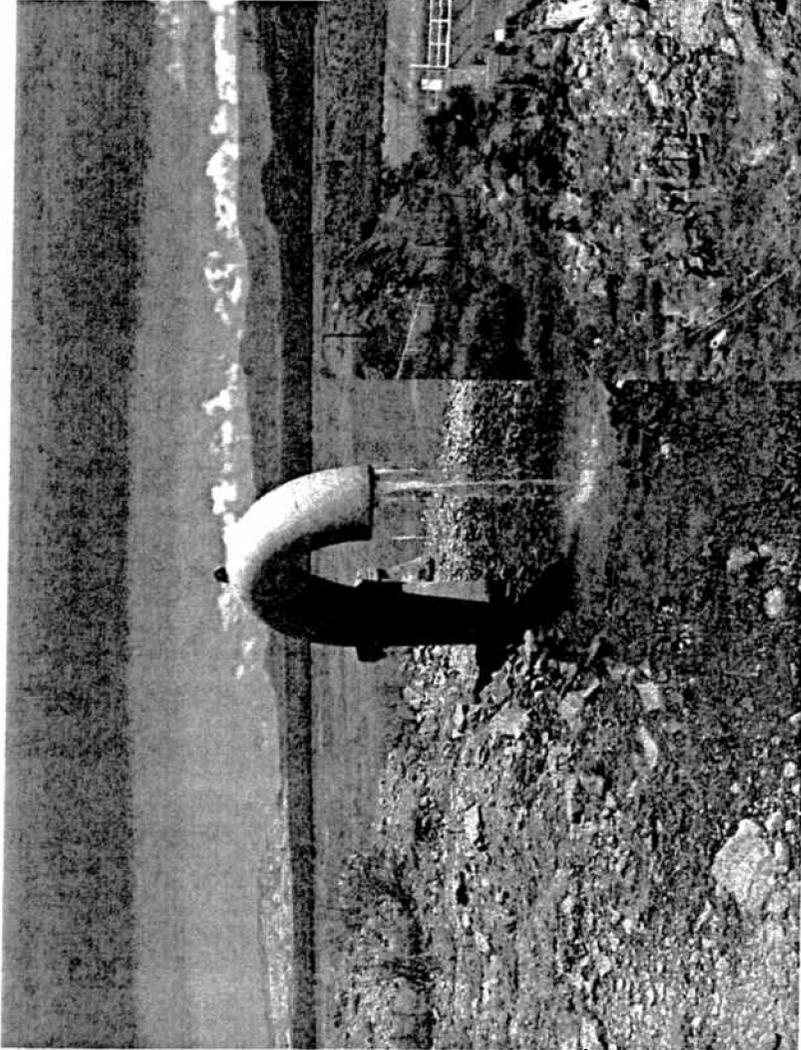
Figure 7. – Horseshoe Dam Outlet Works Air Vent.

- **Air Vent.** – As has been well documented in past inspections, there is significant release of air (and associated water) from the air vent (see Figure 7) located just downstream from the horizontal elbow in the tunnel. Air and water releases are greatest at intermediate gate openings (200 to 625 ft³/s referenced in past reports). Baffles were added to the vent pipe in 2004 and 2005 and have helped to reduce the volume of water being discharged. The observed air releases are consistent with the known performance of cylinder gates at partial openings, where they typically entrain air, which is drawn down through the center of the hollow cylinder. As a result, cylinder gates are not typically used as control (regulating) gates. At most Reclamation dams with cylinder gates, they are used as guard gates set either fully closed or fully open. The greatest problem with the current situation at the air vent is the intermittent water discharge, which has the potential to cause erosion and unsafe walking conditions along the path leading to the outlet works control tower. One modification that might further reduce the volume of water released would be to add an enlarged section of pipe at the top of the riser, between the riser and the gooseneck pipe section.

- Reduce air vent surging. - The discharge of water at the air vent pipe might be further reduced by adding an enlarged section of pipe at the top of the riser, between the riser and the gooseneck pipe. Slugs of water would expand in the larger pipe, allowing the air to bypass them, and the water could then fall back into the riser.

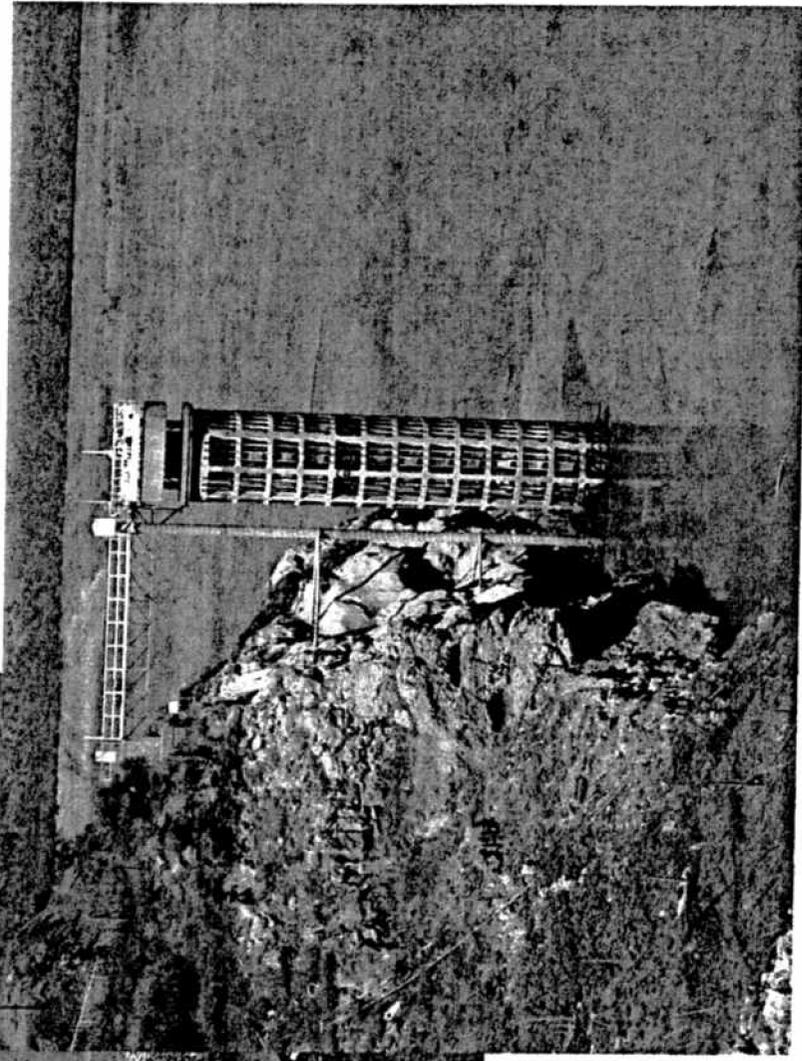
Figure 8. – Horseshoe Dam Outlet Works Intake Tower – View from embankment dam crest.

- **Intake Tower.** – Areas of focus for the inspection of the intake tower (see Figure 8) included:
 - The interior of the cylinder gate was inspected via a bosons' chair. Gary Rood, Rodney Tang and Roger Baker participated in this effort. Overall condition of the cylinder gate was satisfactory, but there was some evidence of corrosion. Specifically, three corrosion conditions were noted along the interior of the gate. Area No. 1: Between approximately elevation 1910 and elevation 1955, some rusting was noted, but overall condition is good (see Figure 11); Area No. 2: Between approximately elevation 1955 and elevation 2000, some rust under coating and some swelling from rusting was noted (see Figure 12); and Area No. 3: Between approximately elevation 2000 to top of gate, there were minor and isolated loss of coating with little rusting underneath.(see Figure 13). All the connection bolts and nuts that were observed were still in very good condition. None of the rusting condition would prevent the gate from being used, but corrosion protection and re-coating would not be out of the question if use of the gate is planned for the long-term (next 50 years).

- There are currently 13 of the 19 levels of the intake tower open from the top to the water/silt line (i.e., the bottom 6 levels are below the water/silt level).

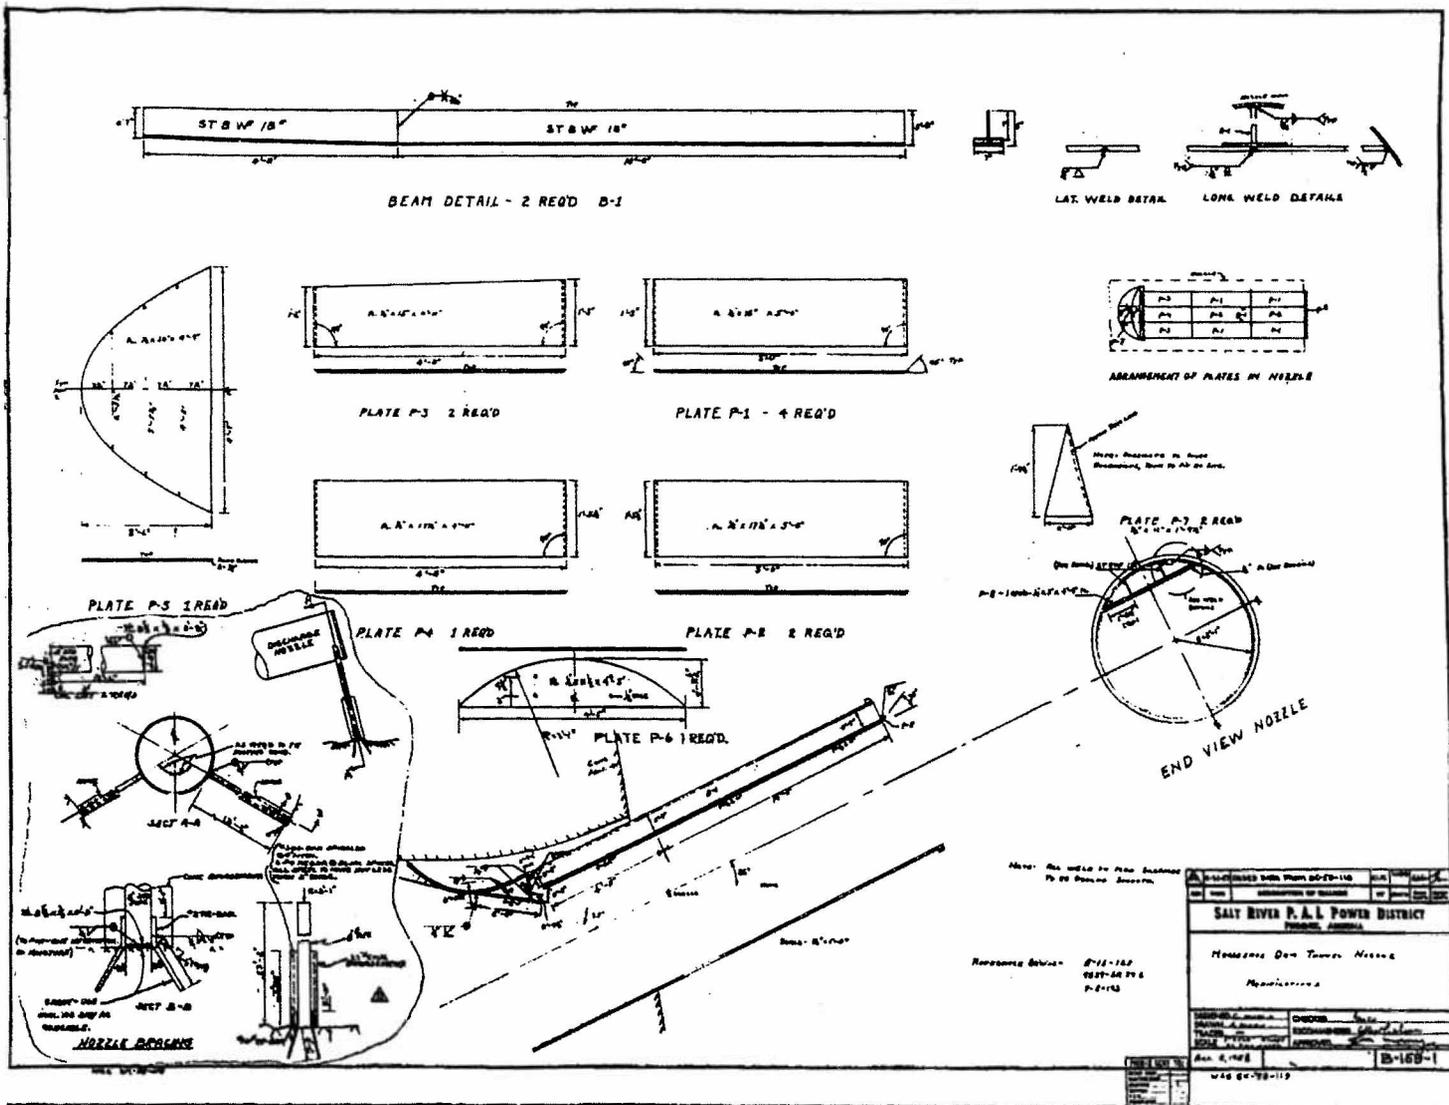
- Based on drawing B-159-1, see (Figure 10), an air vent or inlet channel constructed from steel plate was added in 1958. The plates form a channel in the crown of the steel nozzle, which appears to provide either air admission or release. At low flows, such as those that were observed, the channel seems to allow a controlled escape of air that has accumulated at the tunnel crown just upstream from the nozzle (the crown of the conduit drops at the upstream end of the nozzle as a result of the 1947 modification, thus blocking downstream air movement along the crown of the pipe). Without this modification, it seems likely that air would be released in a more irregular manner and may significantly disrupt the jet issuing from the nozzle. A deflector plate at the upstream end of this channel suggests a second possible purpose, which is the admission of air near the throat (upstream end) of the nozzle to produce a free surface in the flow through the nozzle extension. The deflector plate appears to have been configured to create a local low-pressure zone that would draw air into the conduit. This may improve the flow out of the nozzle at higher flow rates than those observed. It remains unresolved which of these two purposes the air channel serves; it may even serve both purposes.

Figure 10. – Horseshoe Outlet Works Tunnel Portal Nozzle (Drawing B-159-1) – Channel formed in crown of steel nozzle, installed in 1958.

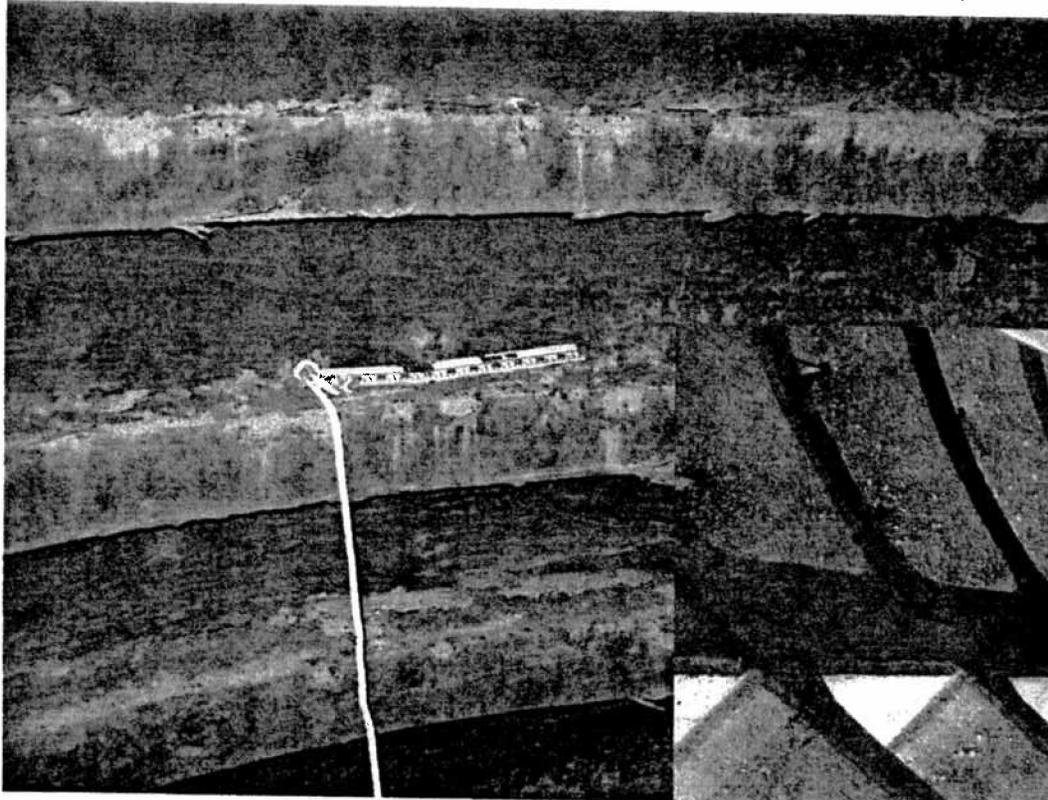
Figure 13. – Horseshoe Dam Outlet Works Intake Tower Cylinder Gate Interior– Area 3: Approximately Elevation 2000 to Top of Cylinder Gate.

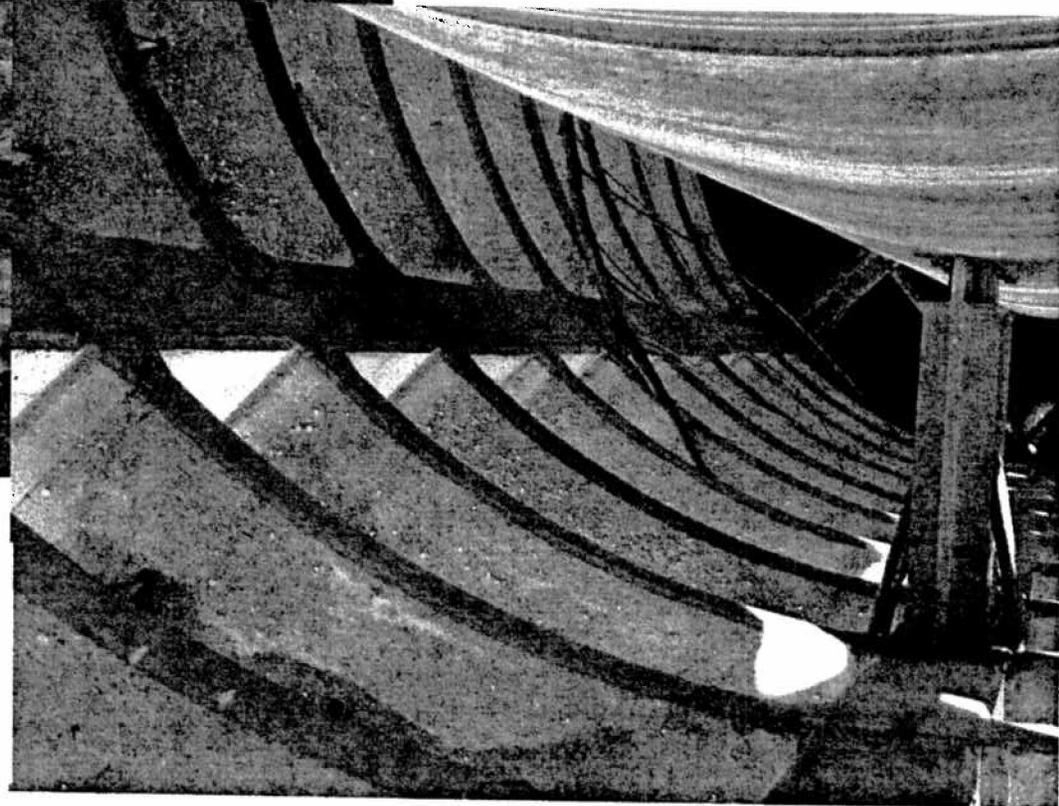
Figure 14. – Horseshoe Dam Outlet Works Intake Tower Cylinder Gate Guides– Visible gate guides in foreground below elevation 2009 and in background above 1951. Not shown are roller guides below 2028 and gate guides below RWS and sediment below elevation 1931.

- Inspect/repair cylinder gate guides and seat. - Once the previous step is accomplished, an inspection of the lowest gate guides (below elevation 1931) and the cylinder gate seat (about elevation 1909) should be undertaken. Depending on the findings of the inspection, repair/replacement may be warranted. After the cylinder gate base and seat is unwatered/dewatered, lift the cylinder gate to a position that the base and seat ring can be removed from the gate body. Remove the base assembly and seat ring from the gate body and if the base ring is still useable, remove the seat ring from the base assembly and machine and fabricate a new seat. Perform any repairs that may be necessary to the cylinder gate, base ring, seat ring, seat, and outlet tube. Fabricate any new parts, including fasteners, which need replacing. Assemble the seat ring to the base ring and reinstall the finished assembly to the body. Open and close the gate at least three times and check that the seat ring is in complete contact with the gate seat.

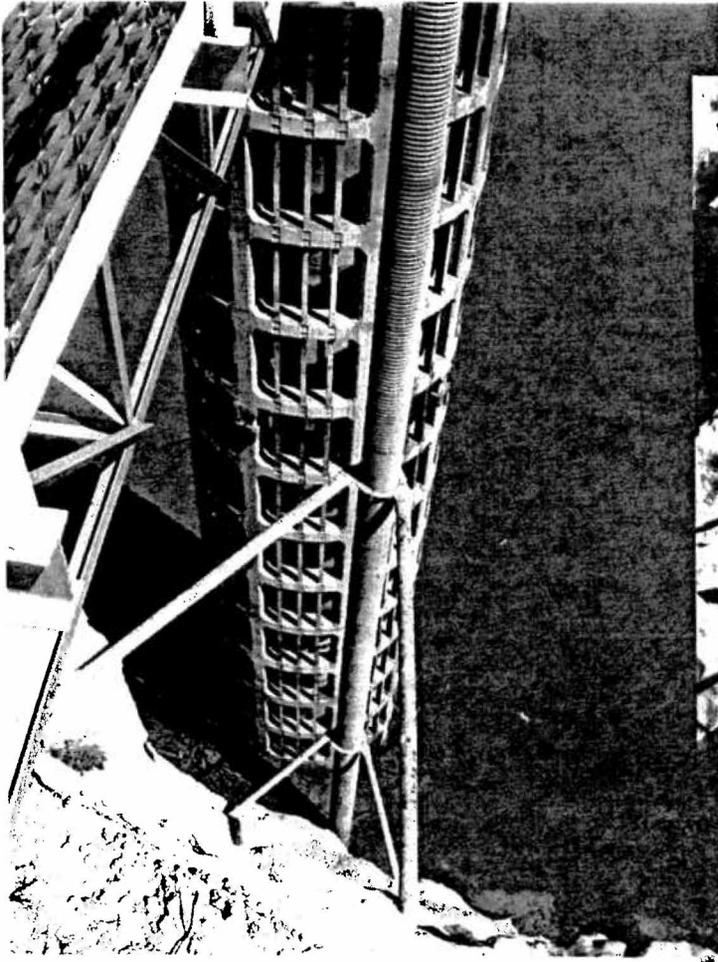
Figure 16a. – Horseshoe Dam Outlet Works Intake Tower Inflow of water appears to be limited to Northeast side of intake tower...

reservoir bottom) of a radius of 50 to 100 feet, then continuing the dredging to create a mild slope (< 5 degrees or flatter than 1V:12H) for an additional until the top of the present sediment/debris is reached. This should prevent the existing sediment from entering the intake tower, but future sedimentation will still be a problem. For a more permanent solution, a reservoir sedimentation study would have to be conducted to develop alternatives for reducing future problems. Generic examples include upstream check dams, discharge of density currents, reservoir drawdown and flushing, and dredging. As examples of using check dams or barriers, Reclamation's Yellowtail and Altus Dams have highway structures that have trapped sediment in the upper reservoirs and can be easily dredged during low reservoir levels. The mobilization cost for dredging may be significant, so the additional cost of dredging larger volumes and restoring more capacity may not be so great. One key consideration will be where to deposit the dredged sediment. As noted in the following section (Other Topics), any sediment/debris deposal must be limited to upland areas.
