TR-2010-03

Travel to Devil's Lake, ND to Observe Planned Levee Breach

TRAVEL REPORT

Code : 86-68460 Date: September 21, 2010
To : Manager, Hydraulic Investigations and Laboratory Services Group
From : Tony Wahl and Dale Lentz
Subject: Travel to Devils Lake, ND to observe planned levee breach

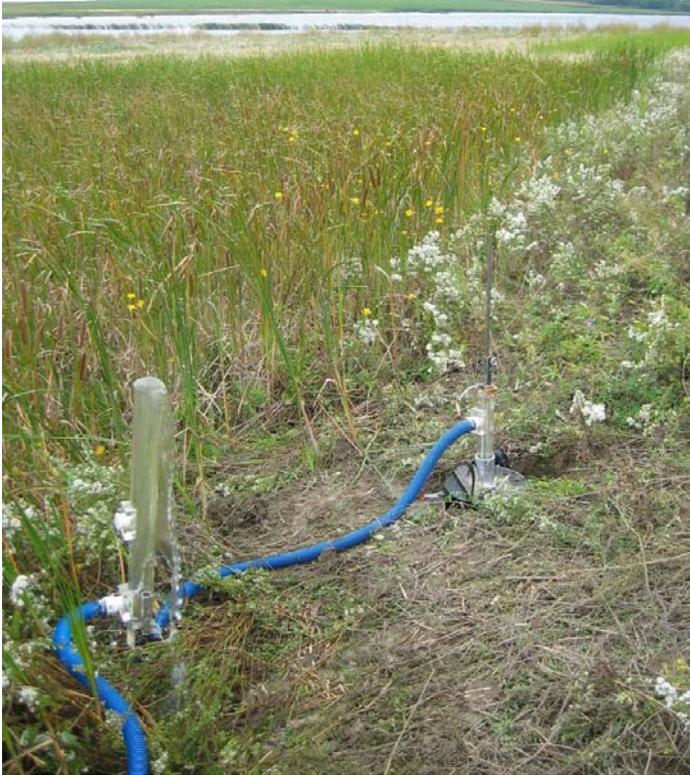
Figure 1. — Jet test underway near downstream toe of embankment. The water surface in the distance is approximately 12 ft lower than the water level on the upstream side of the embankment.

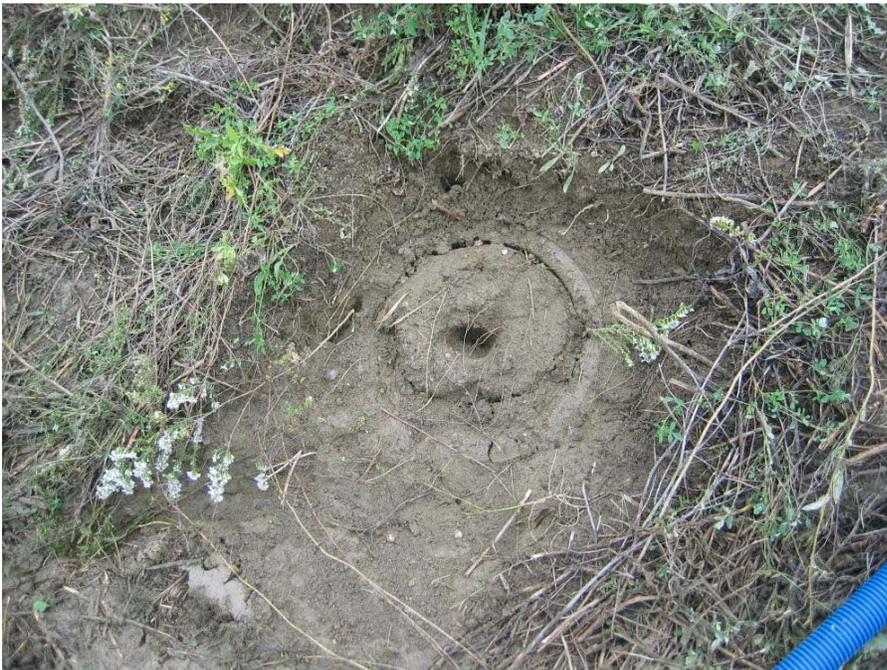
Figure 2. — Scour hole eroded into embankment following completion of the jet test performed on the embankment slope. Approximately 3 inches of surface material was removed prior to performing the test.

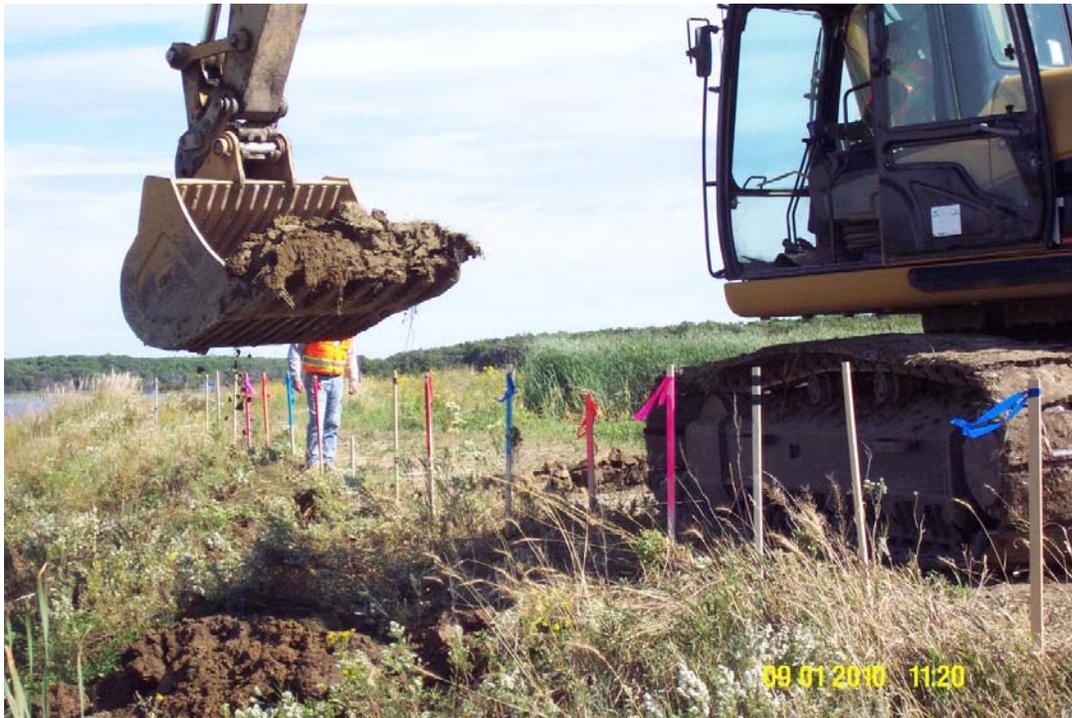
Figure 3. — Excavating the pilot channel to start the breaching process. The pilot channel was excavated into the reservoir at approximately 11:25 a.m.

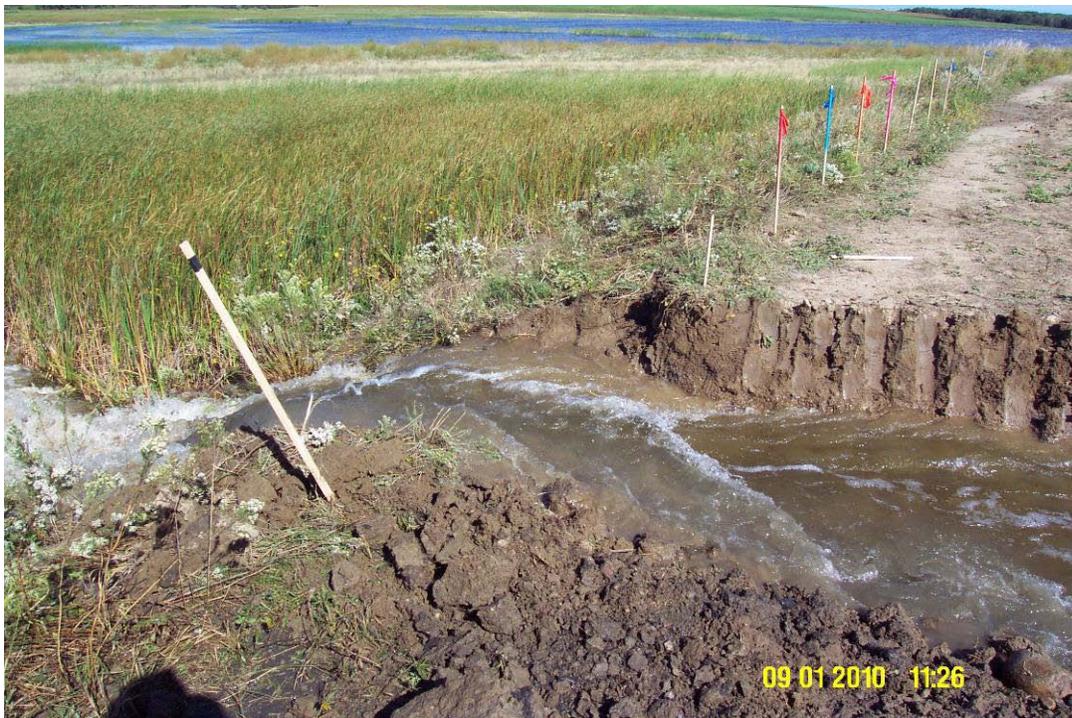
Figure 4. — Initial channel on downstream slope of embankment following pilot channel excavation, $t=1$ min.

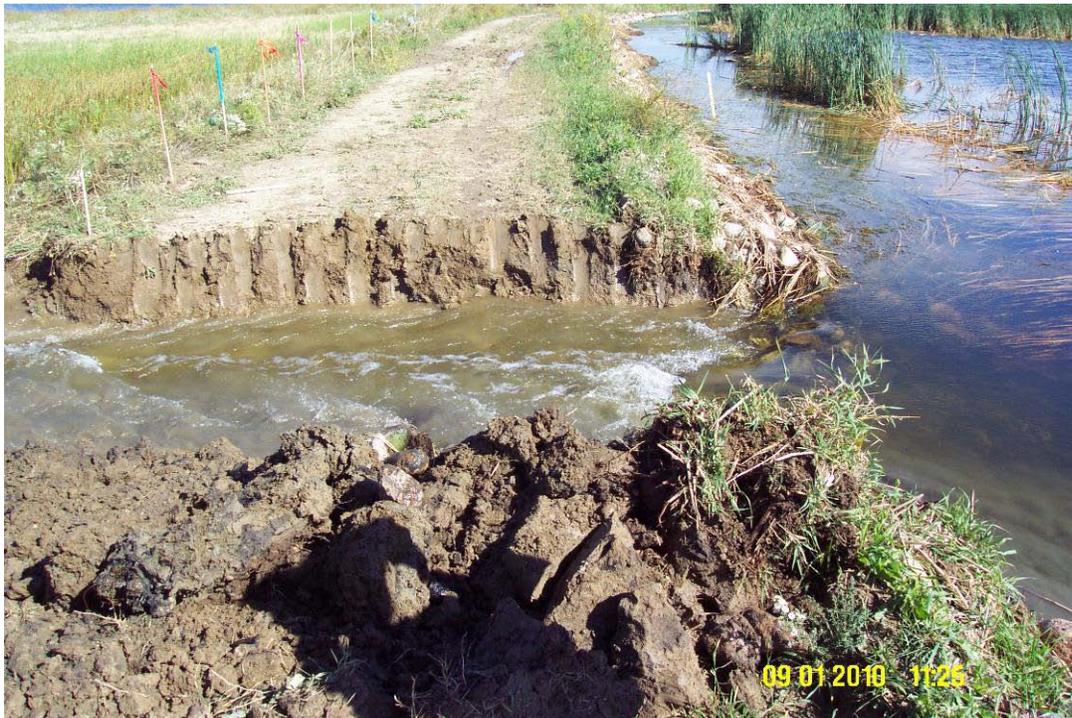
Figure 5. — Flow through the pilot channel immediately after it was excavated.

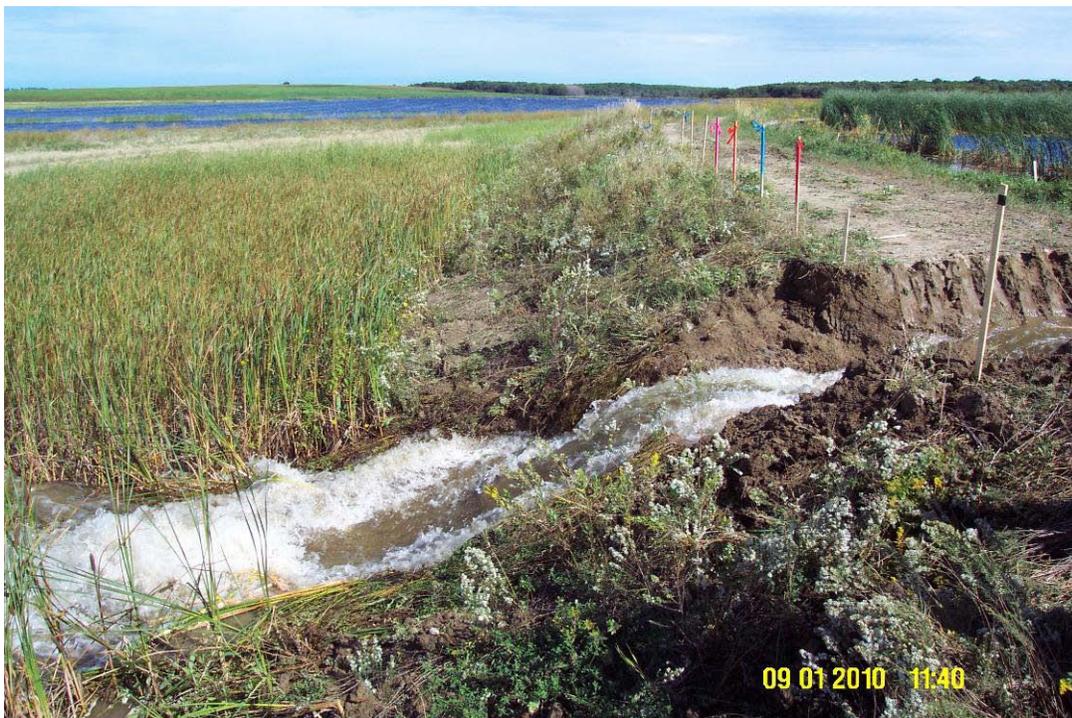
Figure 6. — Step in the downstream channel is visible just below the line of stakes. The visible stakes in this photo are spaced 5 ft apart.

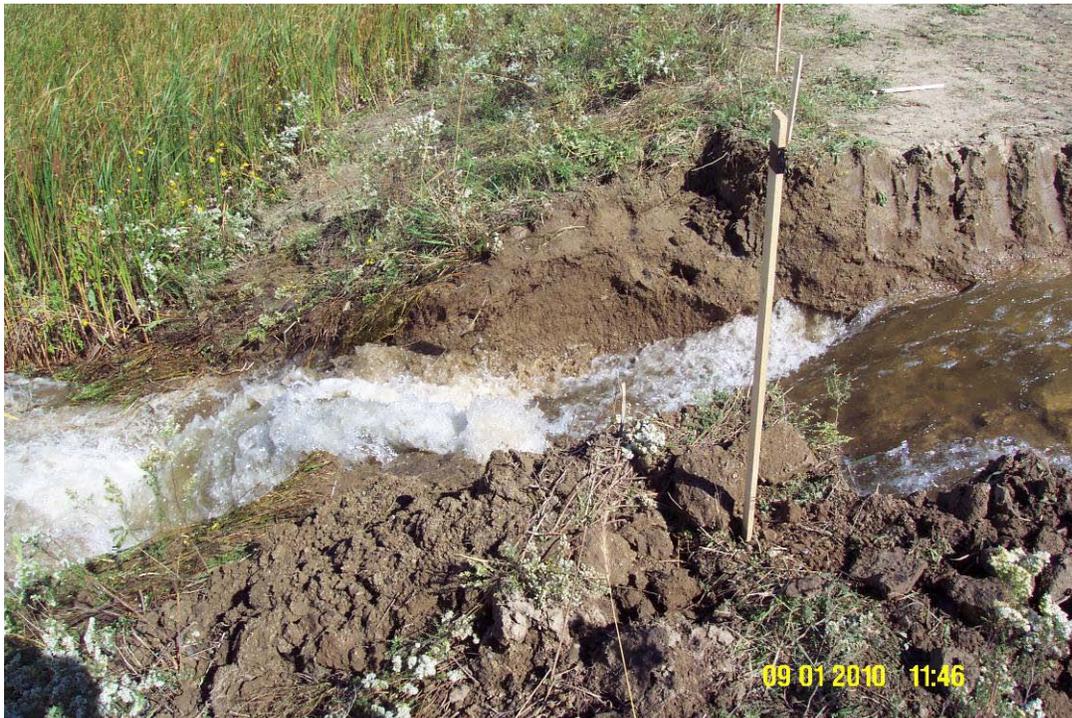
Figure 7. — Step in the downstream channel at $t=21$ min.

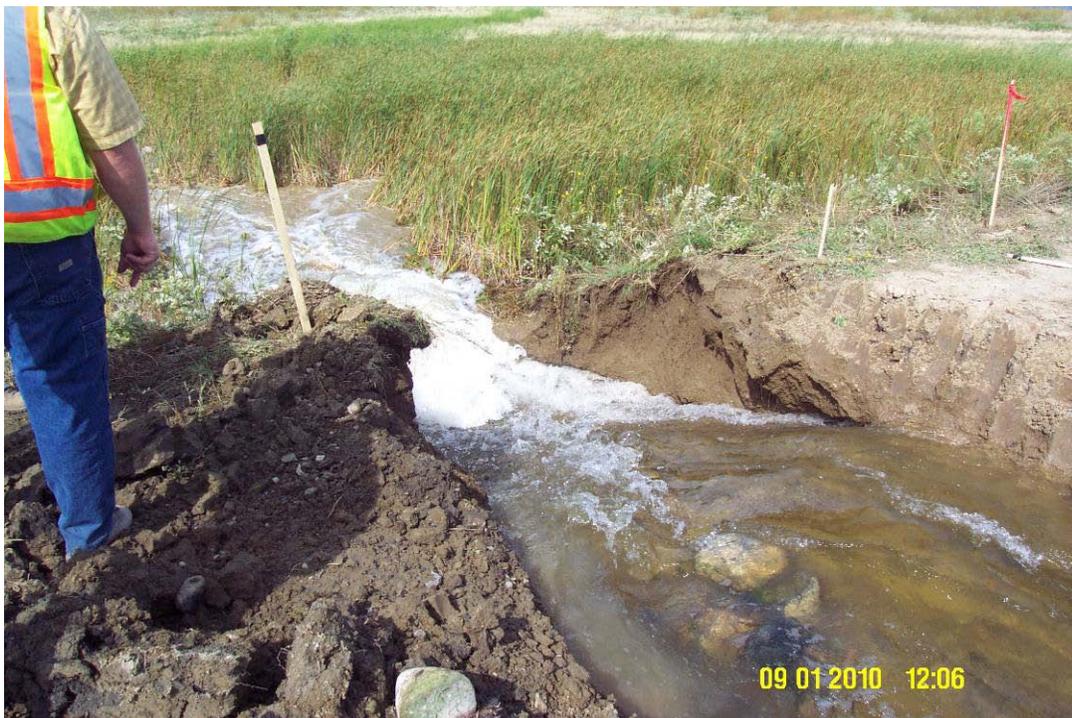
For the first 20-30 minutes the breach developed as expected and at a rate that appeared reasonable based on our modeling. A gully and stair-stepped headcuts quickly formed on the downstream face. The headcut at the downstream toe advanced most rapidly and began to overtake the upstream headcuts, causing the overall slope of the developing channel to steepen. However, in the next 15 minutes the erosion behavior changed. The toe stabilized and the slope began to flatten again, eventually exposing a core of much more resistant material that was apparently an original embankment section that had subsequently been covered by more erodible materials. This section of the embankment proved to be extremely erosion resistant. This material in this section appeared through the flowing water to be different in color and makeup, as it contained a small fraction of large gravel and cobble pieces which had not been present in the outside layers. The increased erosion resistance was probably due to an increased clay content in this material. It is also possible that these internal materials had been originally placed and compacted under conditions that produced optimum erosion resistance.

Figure 8. — The step in the downstream channel has been washed out down to the toe leaving a smoothly sloped chute, the bottom of which is more resistant soil, apparently the original embankment, $t=41$ min.

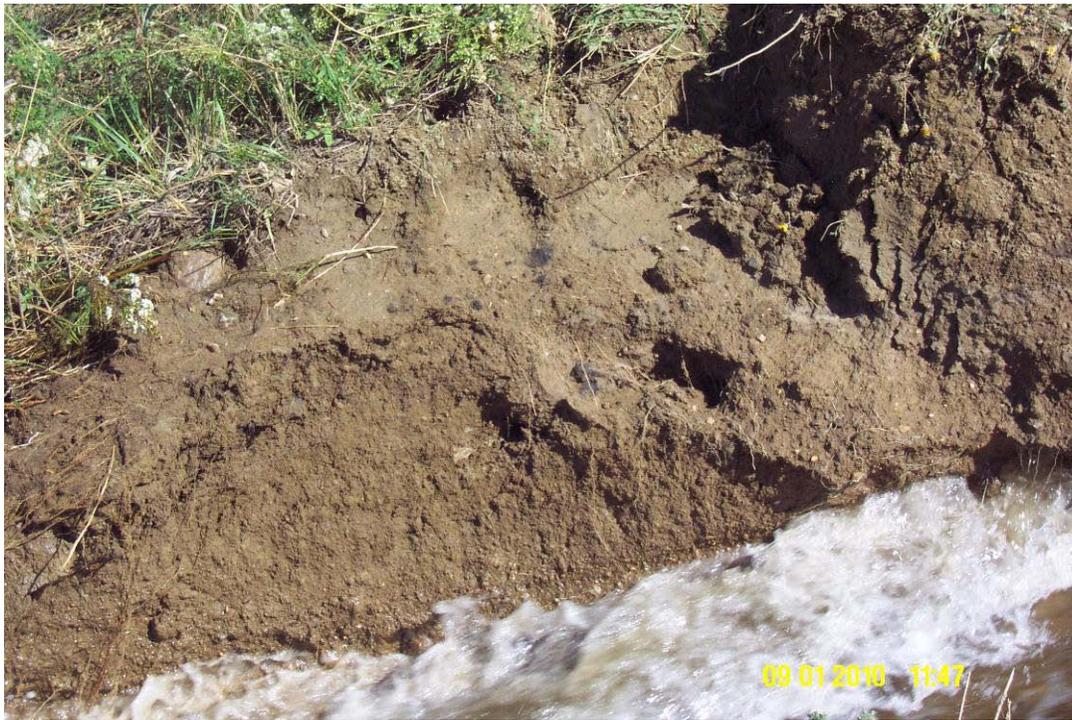
Figure 9. — Side walls of the channel standing nearly vertical. Note the presences of pockets of darker soil (probably high in organic content) in the upper layer.

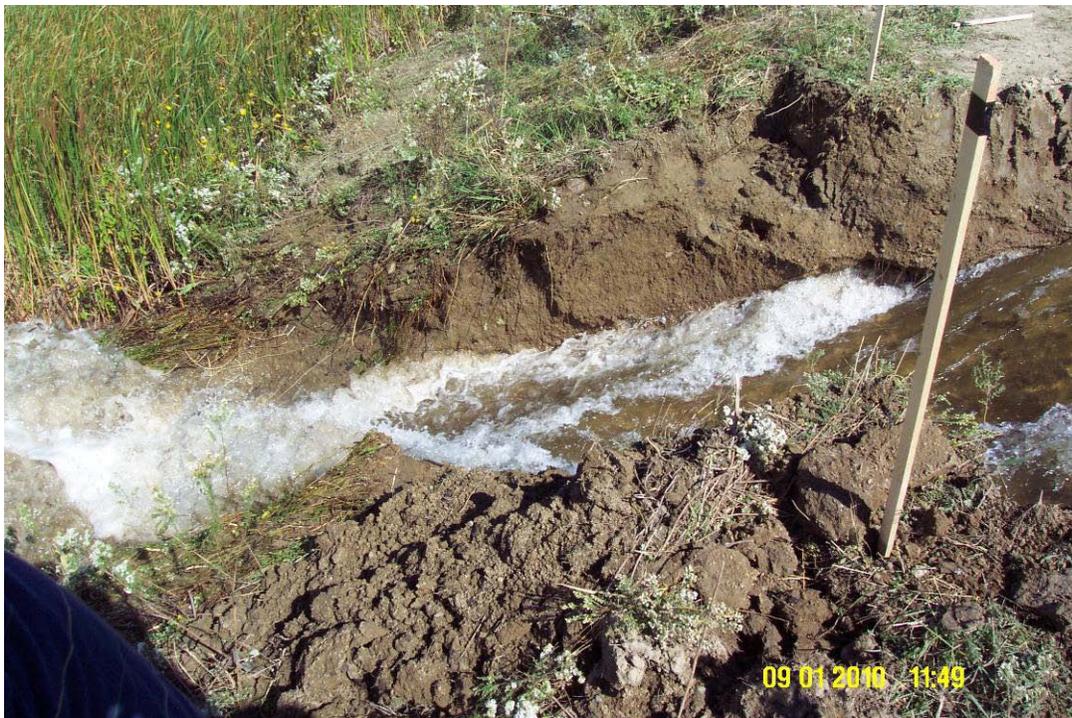
Figure 10. — Smooth chute excavated through weaker material down to more erosion resistant original embankment.

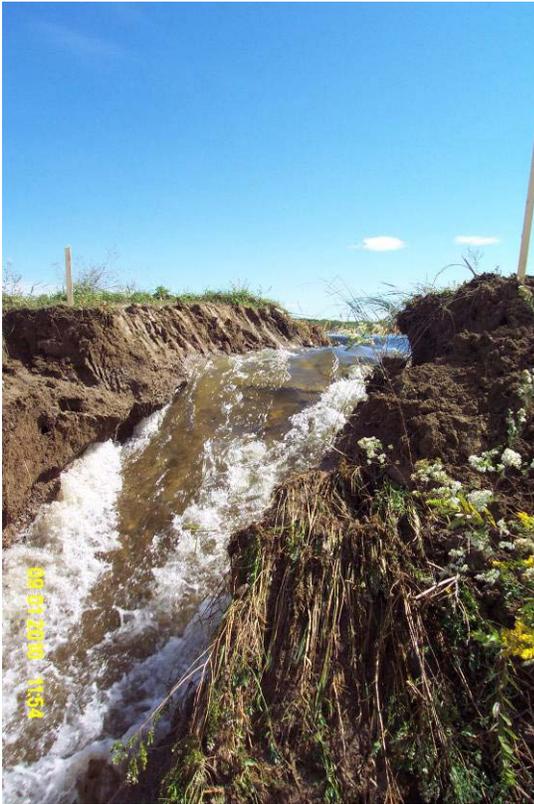
Figure 11. — View of excavated chute looking back upstream through the pilot channel.

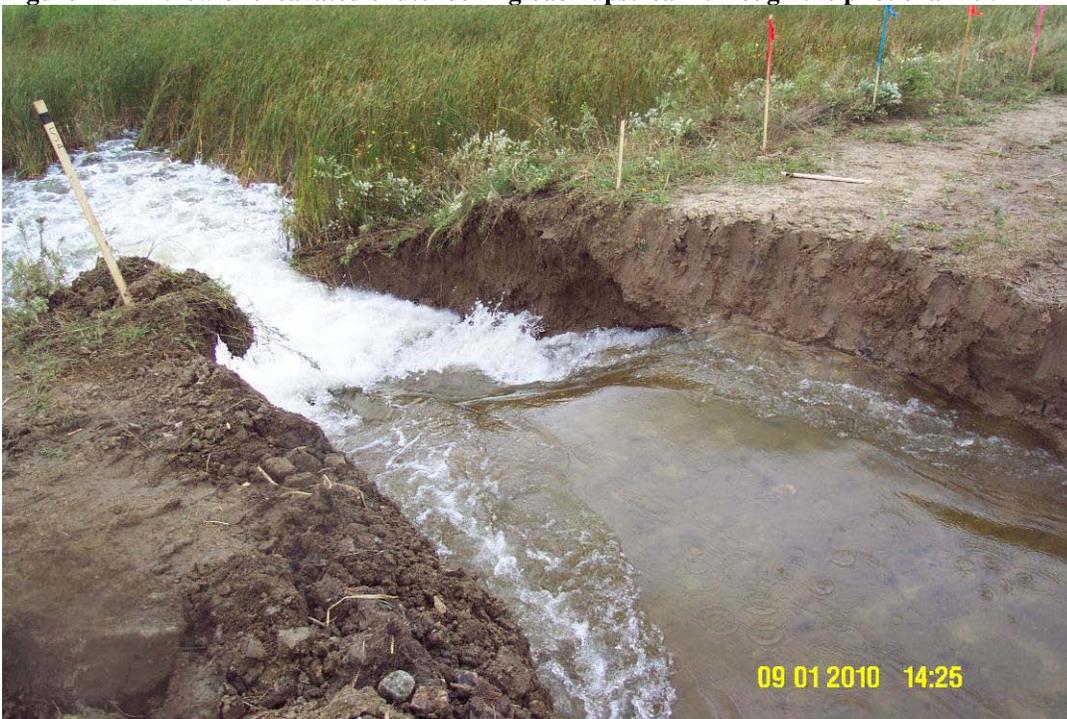
We continued to monitor the embankment until about 3:30 p.m. During this time the downstream slope began to redevelop headcuts and gradually steepen, but the process was very slow, and by the time we left the site the headcut had advanced upstream only 1-2 ft. We returned to Denver on an evening flight from Fargo.

Figure 12. — Final view of the eroded channel before we left the site, t=3 hours.
