TR-2011-07

## **Travel to Durango Pumping Plant, Durango, CO to measure opening torque on pump discharge and guard butterfly valves**

**November 2011**

TRAVEL REPORT

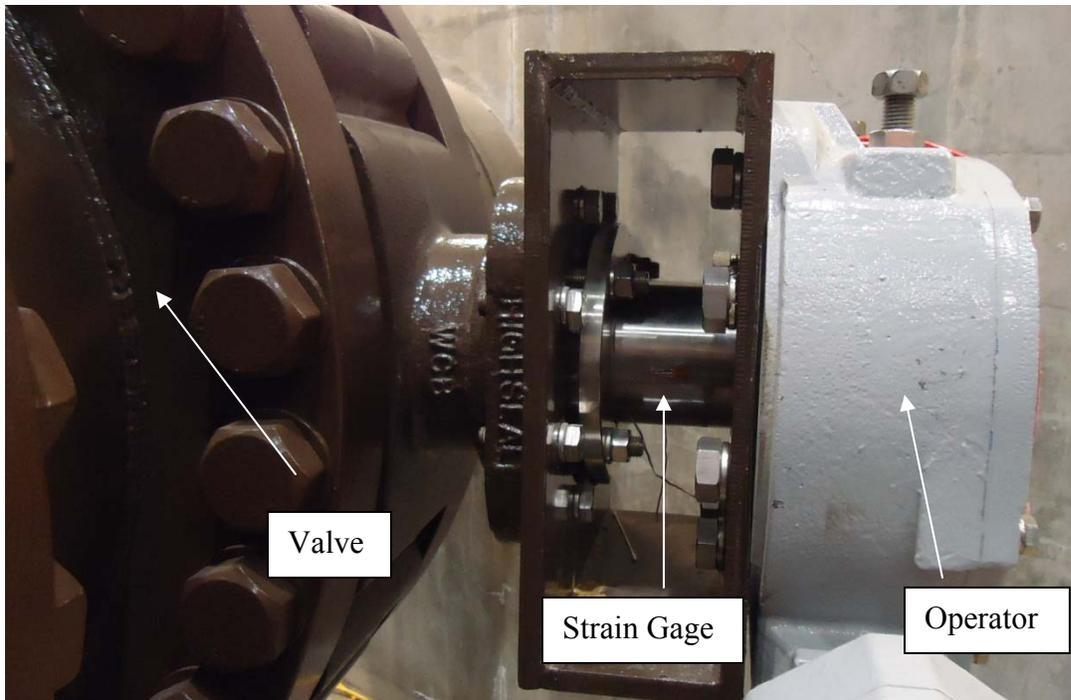
Figure 1 Location of strain gage installation on exposed shaft between valve and operator on Unit 6.

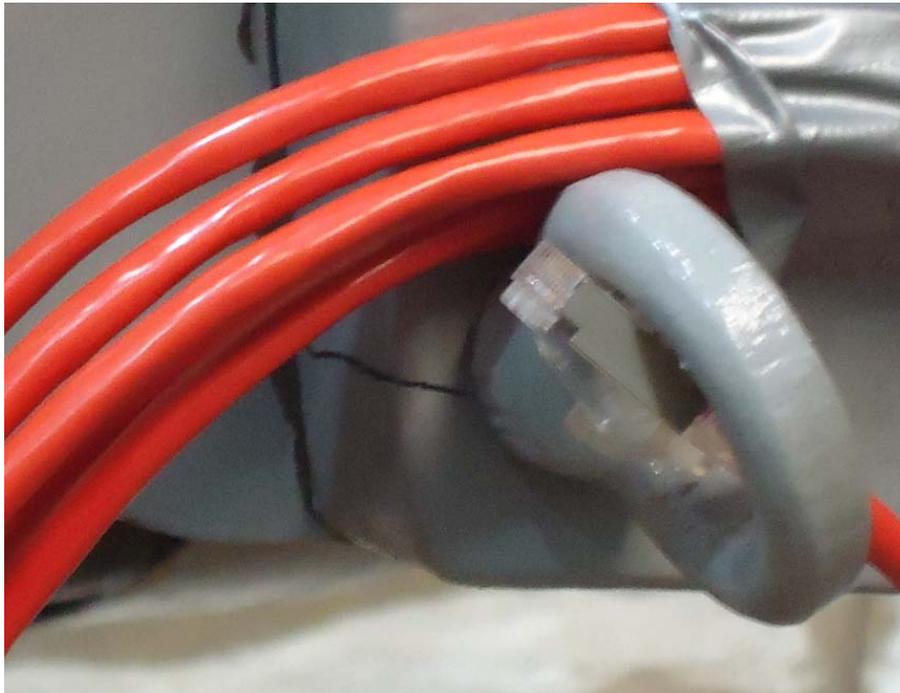
Figure 4: Note crack in operator cover, 36-inch guard valve, manually operated, Unit no. 6.
