TR-2012-02

Site Visit to Mirage Flats Irrigation District

TRAVEL REPORT

Subject: Site Visit to Mirage Flats Irrigation District

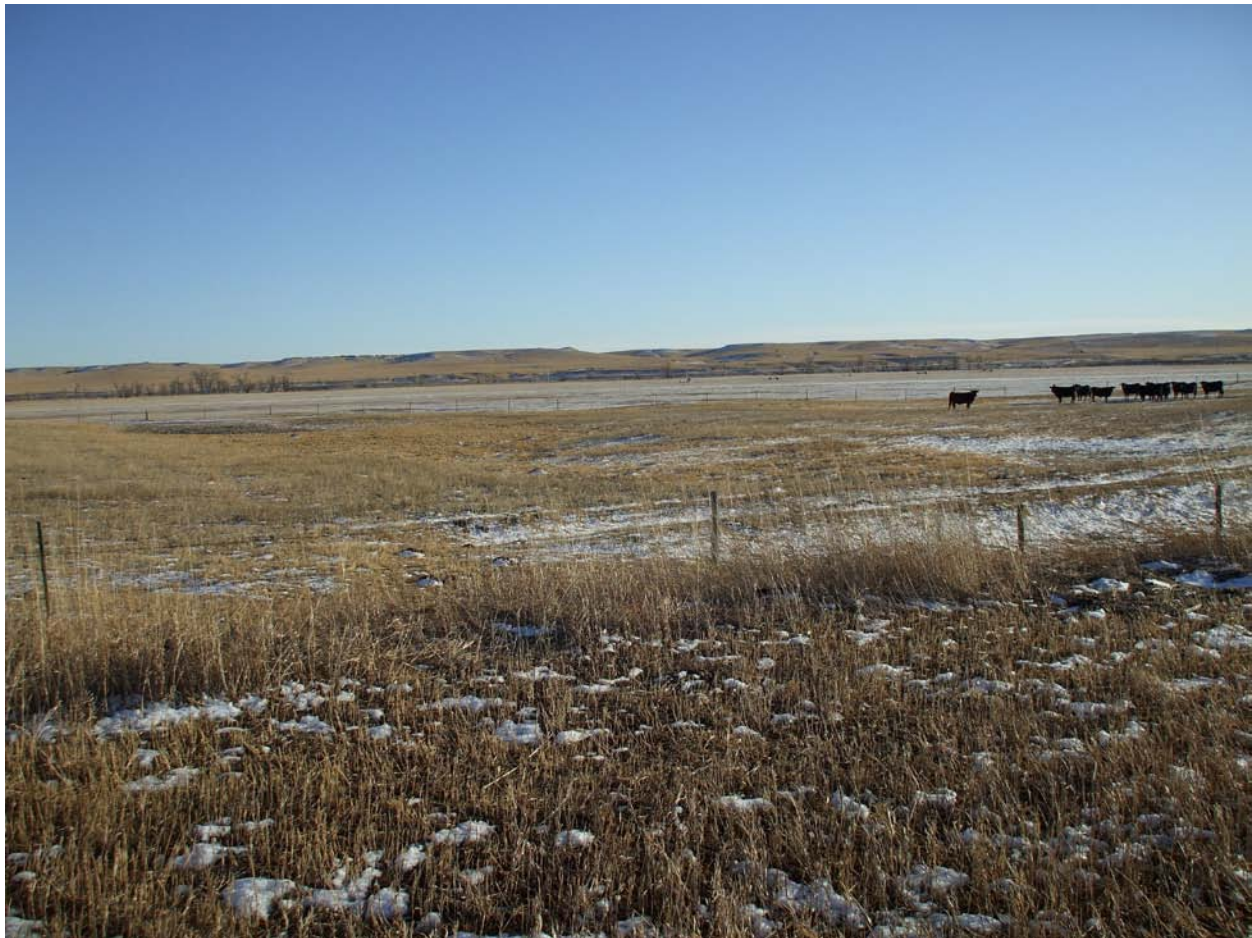
Figure 1. Center-pivot field (in background) where high ground water below the MFID canal resulted in crop damage in 2011

Figures 1 and 2 were taken from approximately the same location, one looking away from the MFID canal to the southwest and the other looking across the canal roughly due north. Presence of water in the MFID canal at this location when no flow has been diverted from the Niobrara River since early August, along with the seepage inflow seen in Figure 2 are evidence of the high water table in this vicinity.

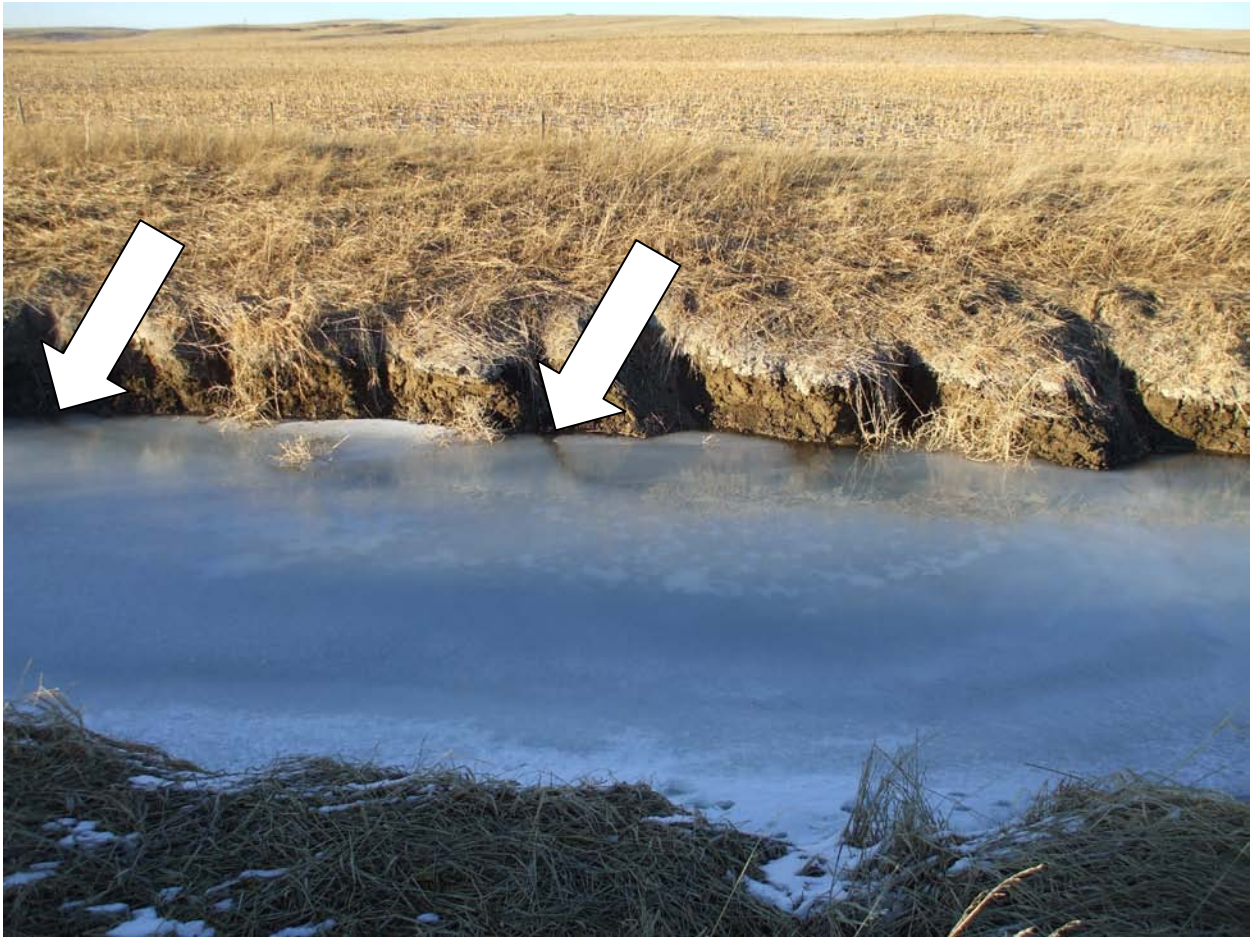
Figure 2. This photo of the MFID canal taken on 01/23/2012 shows patterns in the ice (arrows) that indicate the canal is functioning as a ground water interceptor at the time of the visit.

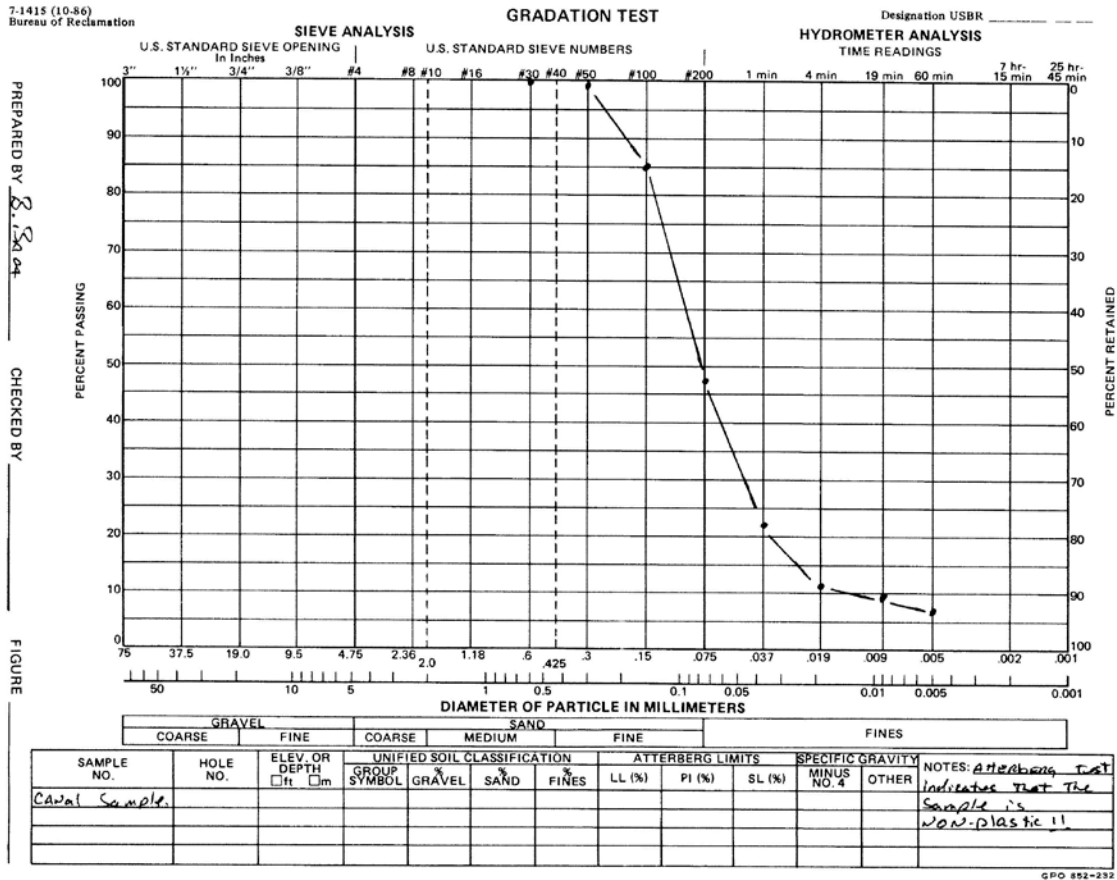
A soil sample taken from the canal bank in the vicinity of the seepage showed the material to be a non plastic very fine silty sand (see figure 3).

Figure 3. Gradation of a canal embankment soil sample near the worst seepage area in the upper reach of the system.

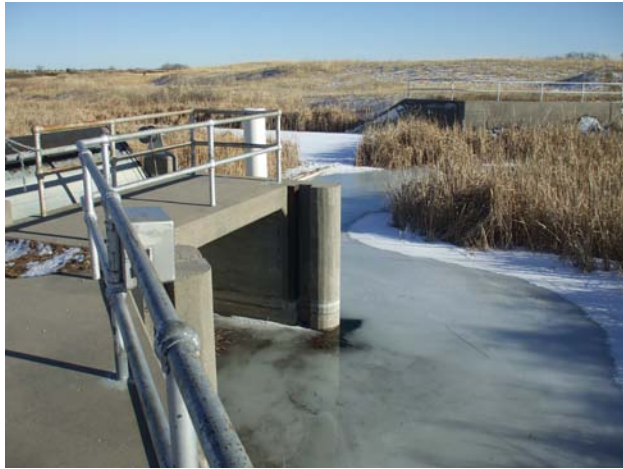
Figure 4. Dunlap Dam & bypass gate bay.

An area land owner has constructed a dam that creates a pond on the Niobrara River that impounds water extending to the downstream side of Dunlap Diversion dam. In recent years of operation, ponded flow conditions downstream of the diversion dam have limited transport of sediments away from the structure on down the Niobrara River. Hence not only is MFID faced with dredging accumulated sediments from the canal, the district has also recently had to dredge sediments from the Niobrara River channel below the diversion dam. Figures 4 and 5 show the Dunlap Diversion Dam span across the Niobrara.

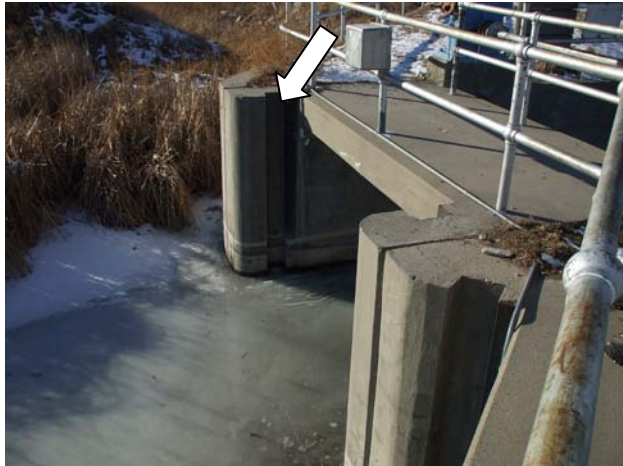
Figure 6. MFID canal heading gate bay

White arrows in Figure 7 show berms of dredged sediments piled on the left bank of the canal. The blue arrow in Figure 7 shows the toe of a large pile of dredged sediments. Mel stated that he has considered installing a plank in the stop log slot in the canal heading gate bay (arrow in Figure 6). This might block diversion of the more sediment-laden flow near the bottom of the channel. NKAO and MFID have also discussed replacing the radial gate at the canal heading with an overshoot to achieve the same objective. The limited available freeboard at the overflow wall crest observed at the time of the visit would suggest raising the dam crest may be necessary in order to create the additional upstream head that would be required for installing a stop-log sill or operating an overshoot gate in the canal heading gate bay. The ability to increase the upstream

level may also enhance transport of sediments being passed downstream in the Niobrara away from Dunlap Dam.

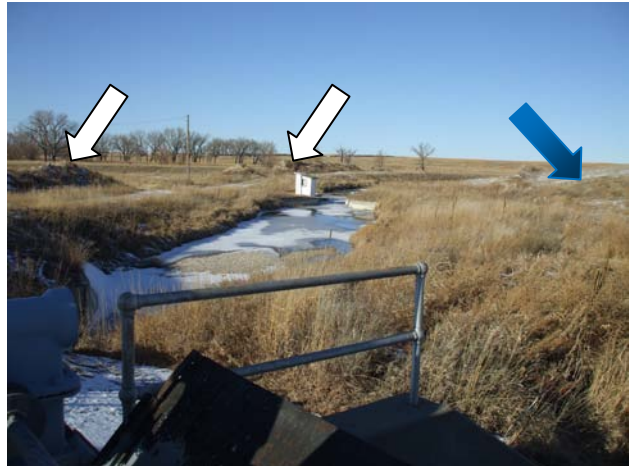
Figure 7. Parshall Flume below Dunlap Dam

Sediments arriving at Dunlap Diversion Dam have apparently become an operational problem whether diverted into the canal or passed on downstream in the Niobrara. Diverted sediments must be dredged from the upper reaches of the canal. Mel informed the Reclamation visitors that within a few days of operation at the beginning of the 2011 delivery season, the upper canal reach that had been dredged prior to beginning deliveries in 2011 had filled in with accumulated sediments to the extent that the Parshall flume near the head of the canal was operating with excessive submergence.
