TR-2012-08

Travel to Price-Stubb Diversion Dam on the Colorado River near Palisade, Colorado

TRAVEL REPORT

Subject: Travel to Price-Stubb Diversion Dam on the Colorado River near Palisade,
Colorado

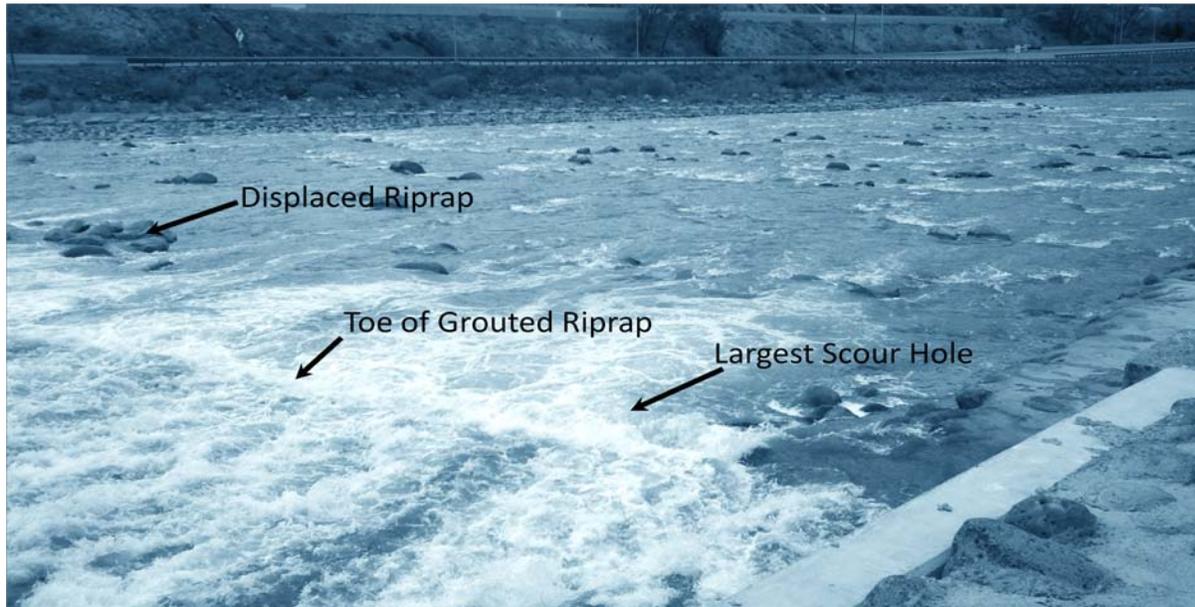
Since completion, the facility has passed several high flows. Sustained high flows of about 20,000 ft³/s, peaking at 30,000 ft³/s in the spring of 2011, resulted in some scouring/displacement of ungrouted oversize riprap.

On the day of visit, the flow on the ramp was reported to be about 1,000 ft³/s. The ramp was constructed using locally quarried riprap that is typically rounded volcanic river rock of generally good quality although some material was observed to contain considerable gas pockets. We observed several areas on the ramp where significant loss of riprap appears to have occurred immediately downstream of the grouted riprap (see photograph). The largest scour hole

measuring about 10 feet deep appears to be close to the right (looking downstream) dam abutment. Scour holes appeared to decrease in depth and frequency from right to left side of dam, likely due to the left-hand bend in the river upstream. A number of 3- to 4-ft boulders were visible above water that probably were displaced from the scour holes. Very few larger boulders were visible downstream of the scour holes.

View looking downstream from dam crest.

We discussed two repair options. An extensive repair with additional grouting would require removing the ungrouted oversize riprap, cleaning it, replacing and replenishing it, and extending the grout 50 to 100 ft downstream. This would be expensive, could result in the formation of

undesirable thin surface grout layers, and could result in increased scour potential downstream of the toe of the new grouted material. We believe the preferred repair method is to rework the areas of oversize material to some depth between the scour holes and replace as needed with large (5- to 6-foot) angular boulders in the scour holes and in the removal areas, raising the ramp surface back to roughly the surface of the existing grouted material. Pit-run rock material (~3-inch to 12-inch angular material if available) and the existing smaller 18- to 36-inch riprap material should be used to choke the voids between the large riprap and achieve good contact with surrounding material. We also suggest stockpiling some additional large riprap near the site for future use should the material be required.
