TR-2012-09

## **Travel to Davis Dam for Modifications to Turbulence Research Test System and Lake Mead for Repairs and Documentation of the Quagga Research Boat**

**Dates of Travel: May 28-June 1, 2012**

TRAVEL REPORT

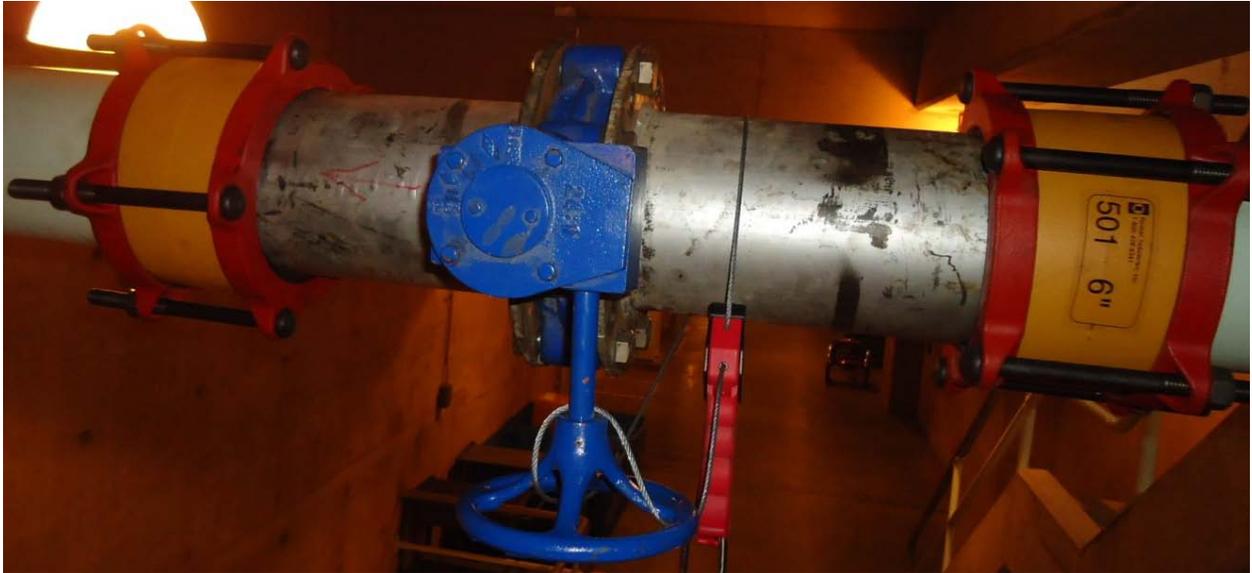
On Monday May 28<sup>th</sup> Josh and Jimmy travelled to Laughlin, NV to modify the turbulence pipe research test system, located on Davis Dam's unit 4 cooling line. Josh transported necessary tools and equipment in a government vehicle and picked up Jimmy at the Las Vegas airport. Work began Tuesday morning (29<sup>th</sup>) on unit 4's cooling system air insertion vent which draws airflow necessary for proper cooling system operation. An attempt was made to reduce the amount of airflow to the research test pipes at the downstream end of the cooling system by throttling the incoming airflow with a 6-inch butterfly valve (Fig. 1). Air velocity measurements in the vent before and after installation showed that the volumetric air flowrate was reduced by only 4 percent when safely throttling with the valve. The valve was left in place at 45 percent open (opening necessary to prevent water column separation for a sudden shutdown of cooling system) and then locked with a cable to prevent accidental closure by vibration (Fig. 1).

Figure 1. Butterfly valve (blue components) installed on 6-inch air vent to the cooling system

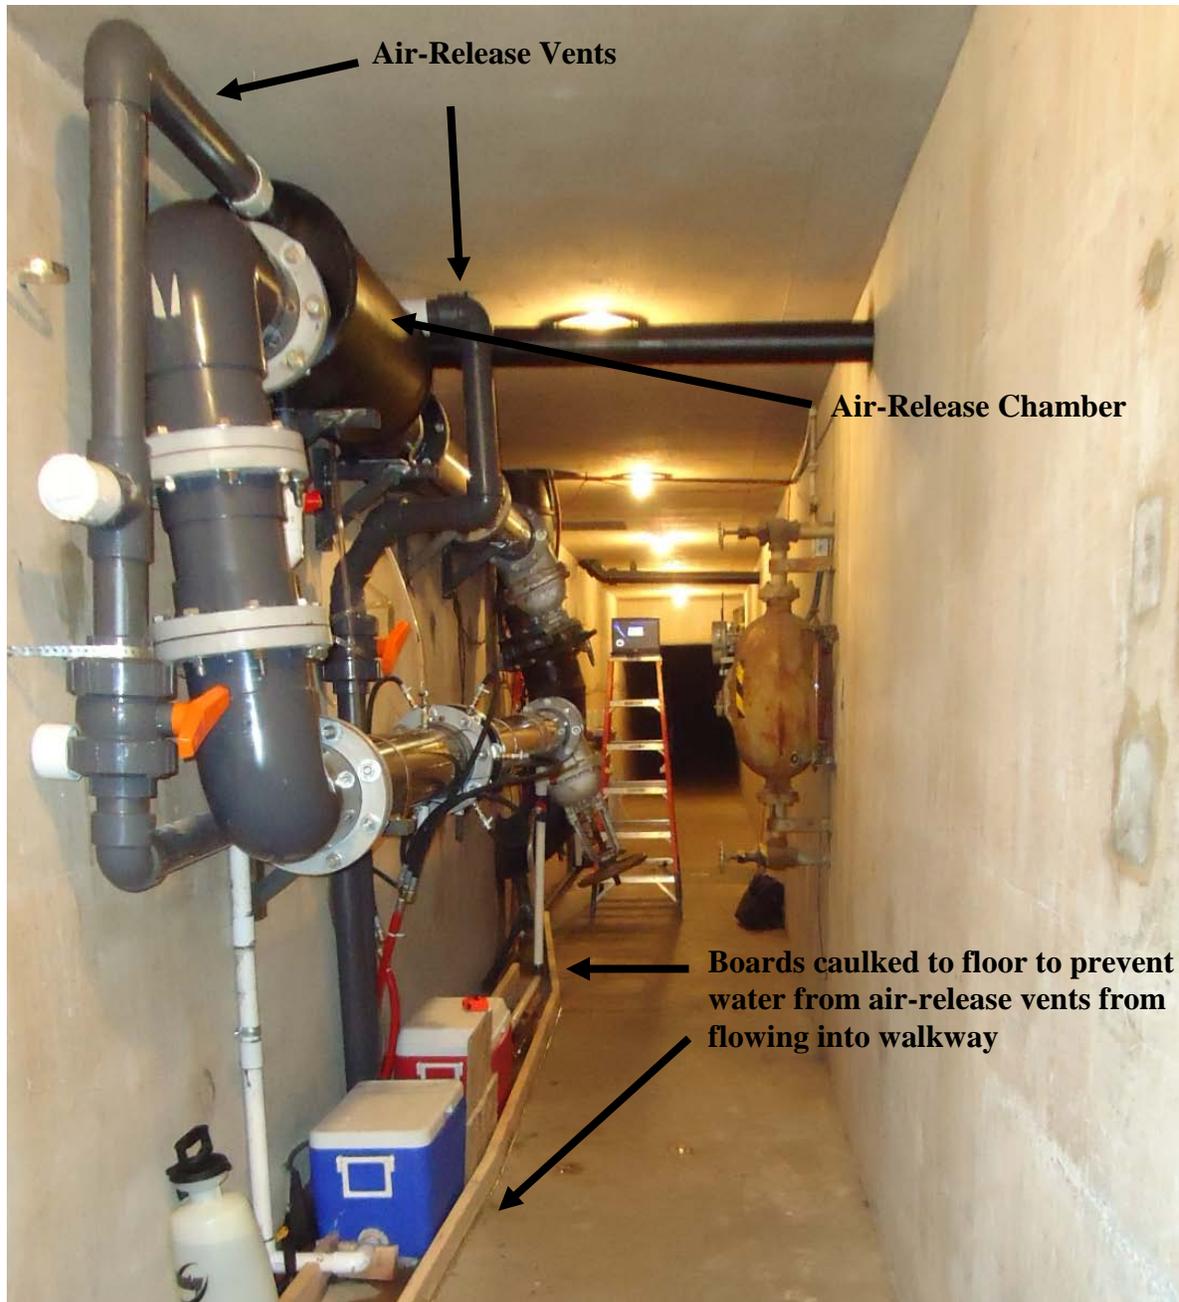
Tuesday afternoon (29<sup>th</sup>) through Thursday (31<sup>st</sup>) were spent installing an air-release and venting system to remove the air entrained in the test system (Fig. 2). The installation of this air-release system was a significant improvement over previous attempts to remove air from the test pipe. However, about 1-1/2 inches of air remained at the crown of the test pipe when the water surface elevation was high in the tale race (multiple units on) and about 4 inches when the tale race low (only a few units on). This will alter the hydrodynamics of the flow through the turbulence generator, possibly biasing test results. It was decided to continue with testing until preliminary results become available before planning any other modifications to the test system. The turbulence test system (includes pipe flow from cooling system and pressure pumps for flow to turbulence jet nozzles) was then left running for an extended period of time to verify long term operation before leaving the site.

**Figure 2. Turbulence test system with air capture chamber & vents, shown here after 20 hrs of continuous operation.**

The main concerns for long term operation of the turbulence test system are sufficient water supply to the pressure pumps and splashing water from the air-release vents onto the floor of the main walkway. These concerns were addressed by moving the pump water supply to a hose spigot connected to the cooling water inlet on the 2<sup>nd</sup> floor where there is more water pressure (clogging of filters is still of concern). Also, boards were installed near the vents to keep splashing water in the trench against the wall that leads to the floor drain (Fig. 2).

**Davis Dam:** An air-release system was installed on the turbulence test system to remove air entrained in the test pipes. A thin layer of air still existed at the pipe crown which may affect the results of the study. However, the study will still continue with Sherri Pucherelli collecting veliger samples weekly and Davis Dam personnel conducting a daily walk-thru of the test system in the draft tube discharge gallery. They will notify Josh of any problems or necessary shut-downs of the test system.

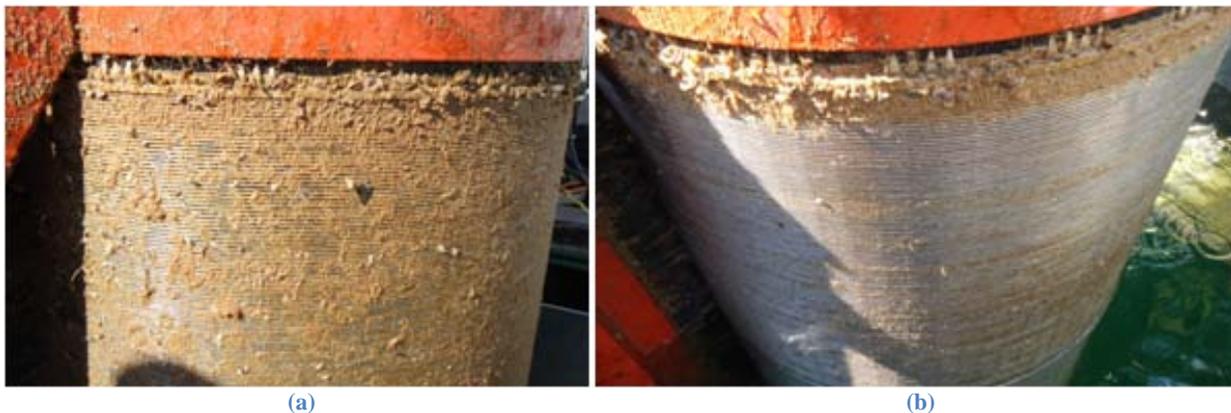
Josh and Jimmy arrived at the boat marina about 7:30 am on Friday (1<sup>st</sup>) to repair the fish drum screen ISI controller as well as document mussel growth on all of the fish screens under testing. The controller was repaired by replacing the DC power supply and installing an inline conditioner to regulate power going to the controller. The drum screen, which had not been cleaned for several weeks due to electrical problems, was raised above the water surface for photo documentation before cleaning (Fig.3, a) and after 3 cleaning cycles (Fig.3, b). All other screens were photographed and documented and a temperature logger was deployed at a depth of 10 ft. Correct operation of all components (Hydrolox screen, pump, and ISI screen) was confirmed before leaving the boat at about 10:30 am. At that time Jimmy dropped Josh off at the airport for a return flight and drove the government vehicle back to Denver.

**Figure 3. Photograph of ISI drum screen before cleaning (a) and after 3 consecutive cleaning cycles (b).**

**Lake Mead Boat Marina:** The ISI drum screen controller was successfully repaired and regular cleaning operation (3 cycles per day) was resumed on Friday June, 1<sup>st</sup>. No other problems were encountered for continuous operation of the Hydrolox screens or propeller pump. Josh will provide photo and video documentation to Cathy Karp who is the team lead for this project.
