TR-2015-03

Travel to Trenton Dam, Nebraska

Trenton Dam – Canal outlet works instrumentation installation and vibration testing

TRAVEL REPORT

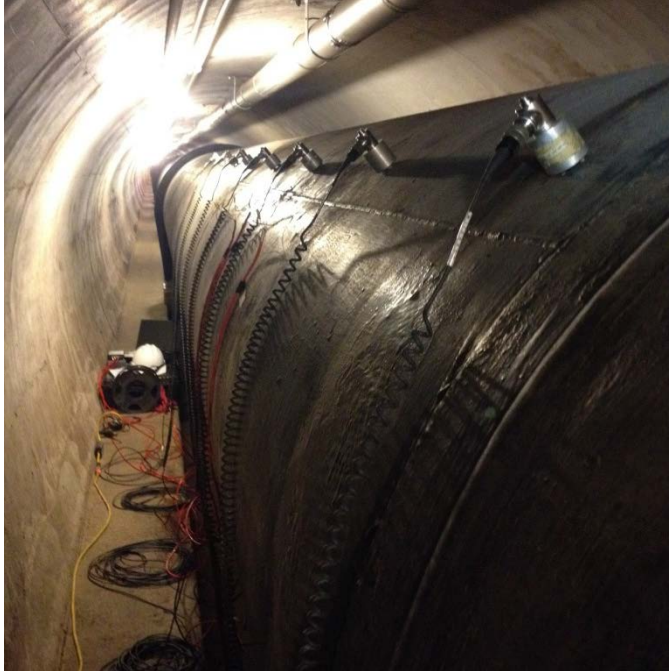
Eight (8) uniaxial accelerometers were mounted on the weld repaired section of piping, 3-1/2 in. off the axial seam weld, using magnetic bases (Figure 1). Accelerometer No. 1 was positioned 1-3/4 in. upstream of the downstream-most ring support in the outlet works tunnel (Figure 2), with the remaining 7 accelerometers located equidistant upstream on 2 ft 6-3/16 in. centers covering 1/2 of the pipe length between ring supports. Four (4) additional low frequency tri-axial accelerometers were mounted at various locations along the canal outlet works piping well upstream of the test location.

Figure 1. - Accelerometers mounted using magnetic bases (view looking upstream).

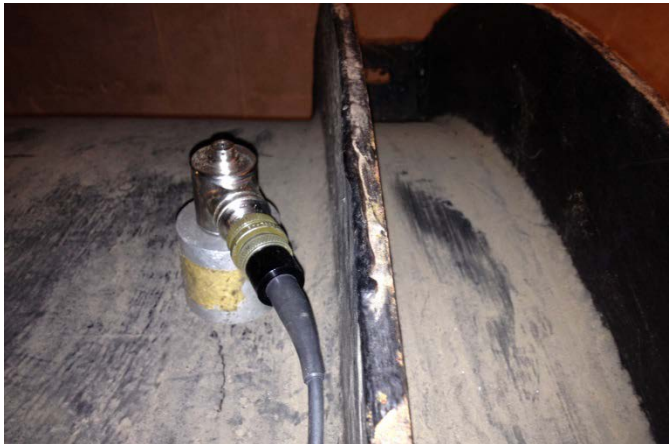
Figure 2. Accelerometer #1 located just upstream of downstream-most ring support.

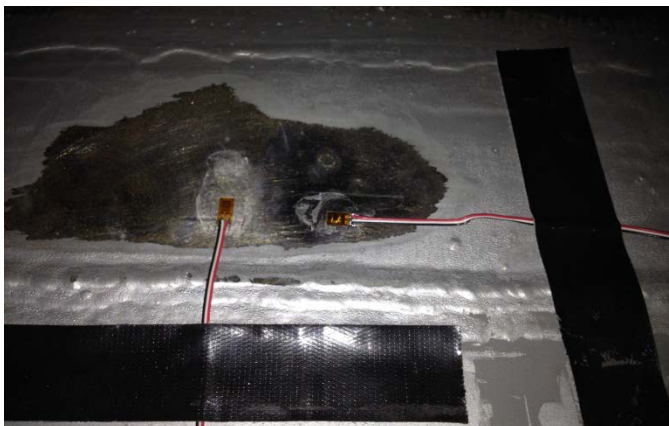
Four (4) uniaxial strain gauges were installed near the weld seam at the location of the 2013 weld repair. Three (3) of the strain gauges were oriented in the circumferential (hoop) direction and the remaining strain gauge was oriented in the axial direction (Figure 3).

Figure 3. Strain gages located near seam-weld repair for longitudinal and hoop stress measurements.

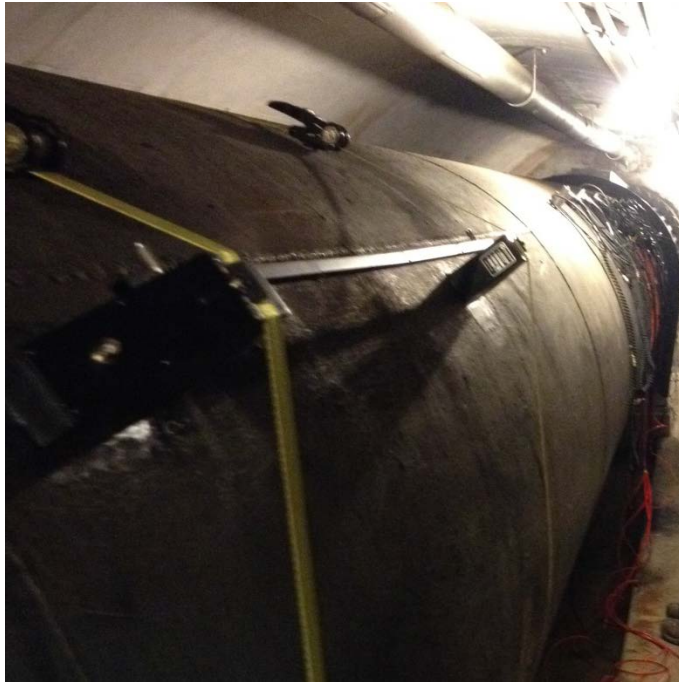
An external mount ultrasonic flowmeter was installed using ratchet straps on the same pipe section at a location upstream of accelerometer #8 (Figure 4). The installation was completed around 5:30pm (CDT) after which the team traveled to McCook, NE east of Trenton Dam to stay overnight.

Figure 4. Ultrasonic flowmeter located upstream of accelerometers (view looking downstream).

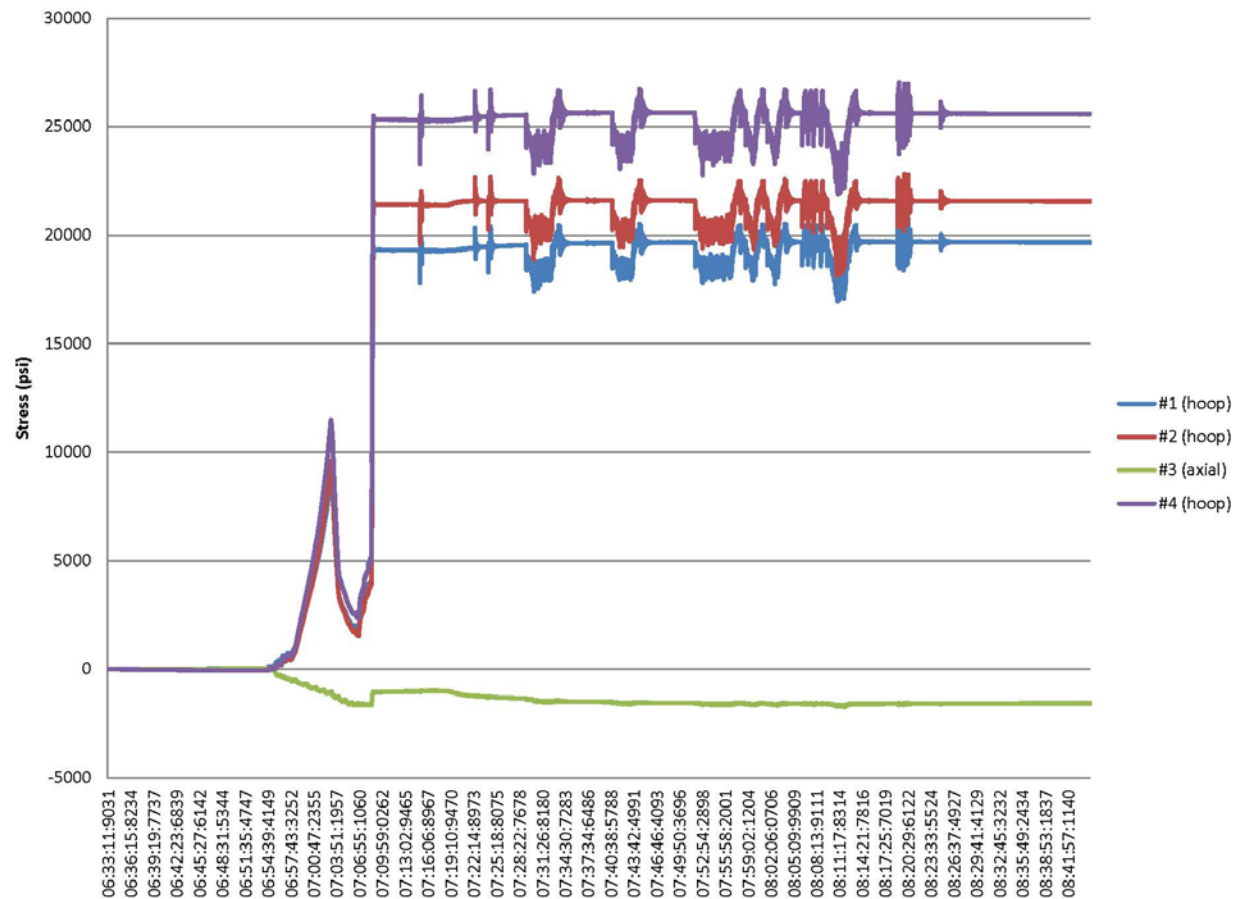
Strain gage data acquired during testing are plotted as hoop and axial stresses (using $E = 30 \times 10^6$ psi) in Figure 5. All gages were zeroed prior to water up. The initial peak in stresses during pressurization was due to adjustments in the vent valve during filling. Other changes in the time series data reflect operational changes that reduced static pressure via changes in regulating gate settings which produce changes in outlet works discharge. The results show large changes in hoop stresses in the vicinity of the weld repair. Theoretical calculations for a perfectly round cylinder indicate hoop stresses should be on the order of 3,000 psi given the reservoir head during testing.

It should be noted that uncertainty is introduced by unknown residual stresses in the vicinity of the welds. It is conceivable (though not likely) that residual stresses could be in compression for the unpressurized state. If that were the case, the stresses in tension would be less than these results indicate. However, given the past weld repair, a conservative approach is warranted and additional testing is needed to confirm the large stresses measured during this testing. Confirmation could be accomplished installing strain gages away from the weld for the weld repair section of pipe and comparing measurements from that section with strain gage measurements at similar locations on another section of pipe that is in “good” condition.

Although measured changes in stress are considered large, observations during this testing did not indicate excessive vibrations. However, close monitoring of the outlet works is recommended (especially during shutdowns) and if the previously observed resonant vibration occurs in the future, action (including closure of the emergency gate as necessary) should be taken to immediately eliminate it. A description of how the outlet works was operated at the

Figure 5. Hoop and axial stresses measured near weld repair.

6. Action correspondence initiated or required: Further testing to confirm large stresses near the longitudinal weld repair. This would involve installing additional strain gages at locations away from the weld repair and on another section pipe for comparison.
