TR-2015-05

## Travel to McPhee and Nighthorse Reservoirs

Travel to perform sonar inspections and bathymetry surveys at McPhee and Nighthorse Reservoirs

TRAVEL REPORT

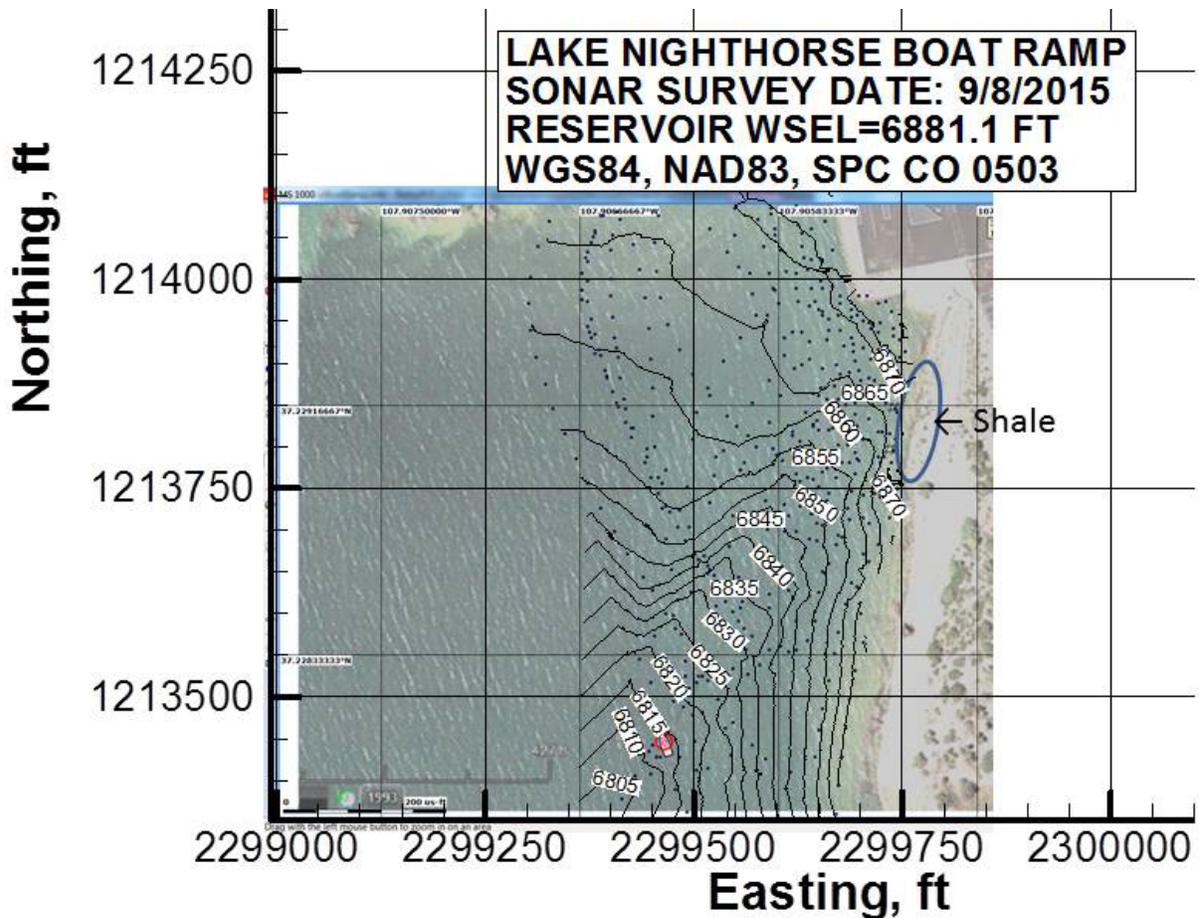
Figure 1. A 5-ft contour map of the shore line near the Lake Nighthorse boat ramp. The black dots represent the boat's path during the survey. The fractured shale area is denoted with the blue oval.

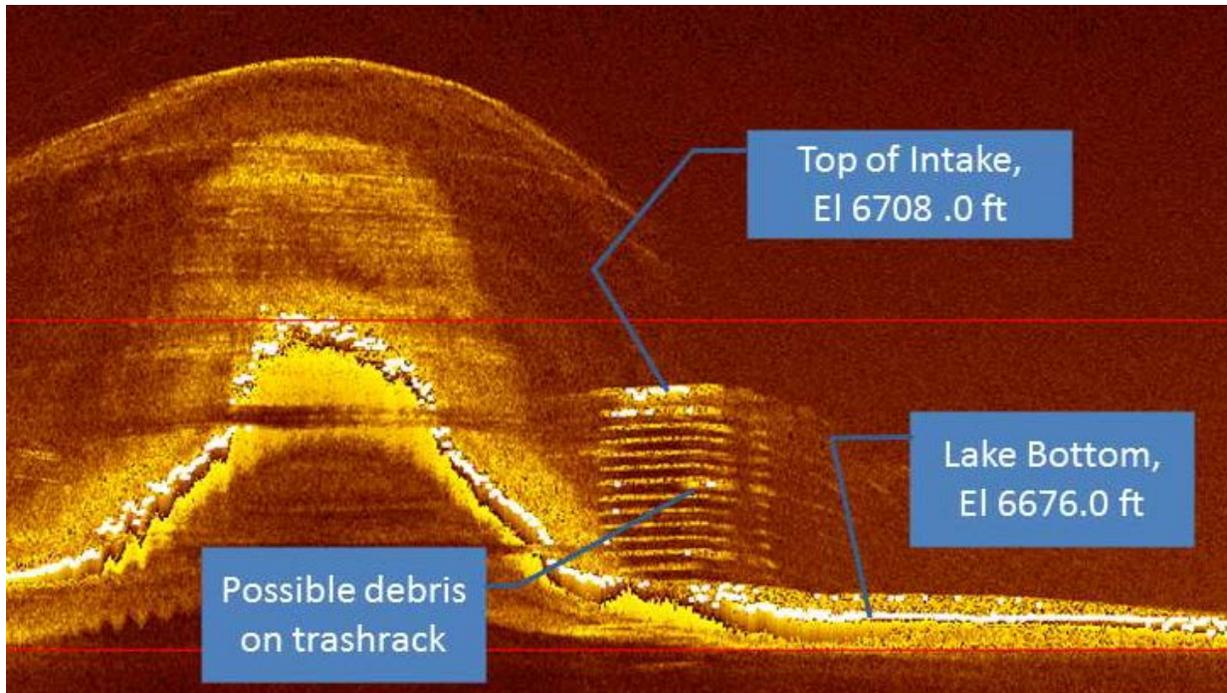
Figure 2 is a typical sonar image of the submerged intake and the surrounding topography. Based on observations of several sonar images there appears to be some debris accumulated on the trashracks and appropriate precautions should be taken when performing the upcoming ROV inspection.

**Figure 2. Typical sonar image (side view) of the river outlet works intake tower. The horizontal lines represent the trashrack support beams. The white dots represent the strongest acoustic reflection. The lake bottom appears to have 4 to 5 ft of sediment accumulation from the as-built intake channel elevation, El. 6671.0 ft obtained from drawing 71-D-116.**

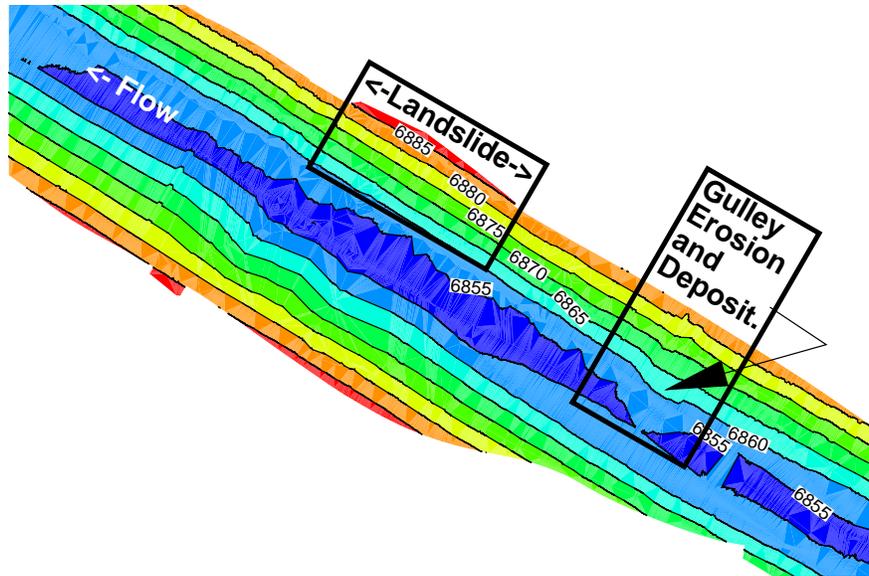
Next we went to the Great Cut Dike on McPhee Reservoir to survey an area where Casey Hall observed a small landslide on the intake channel's right bank near GPS coordinates 37.5101°N, 108.5847°W. We made several survey transects along the bank line to map the bathymetry. Figure 3 shows the contour lines produced from the bathymetry data. Note: these contours were produced using differential GPS position data and are not considered survey-grade. The landslide area did not contain any major deformations, but there is some gulley erosion and deposition near GPS coordinates 37.50969°N, 108.58389°W as shown on figure 4. Further down the right bank there is deposition of material near the toe of the slope.

Figure 3. Contour map of bathymetry data collected on September 9, 2015 near the Great Cut Dike. Data collected near the landslide location did not indicate any significant changes in the bank. However, there is some gulley erosion and deposition near GPS coordinates 37.50969°N, 108.58389°W.

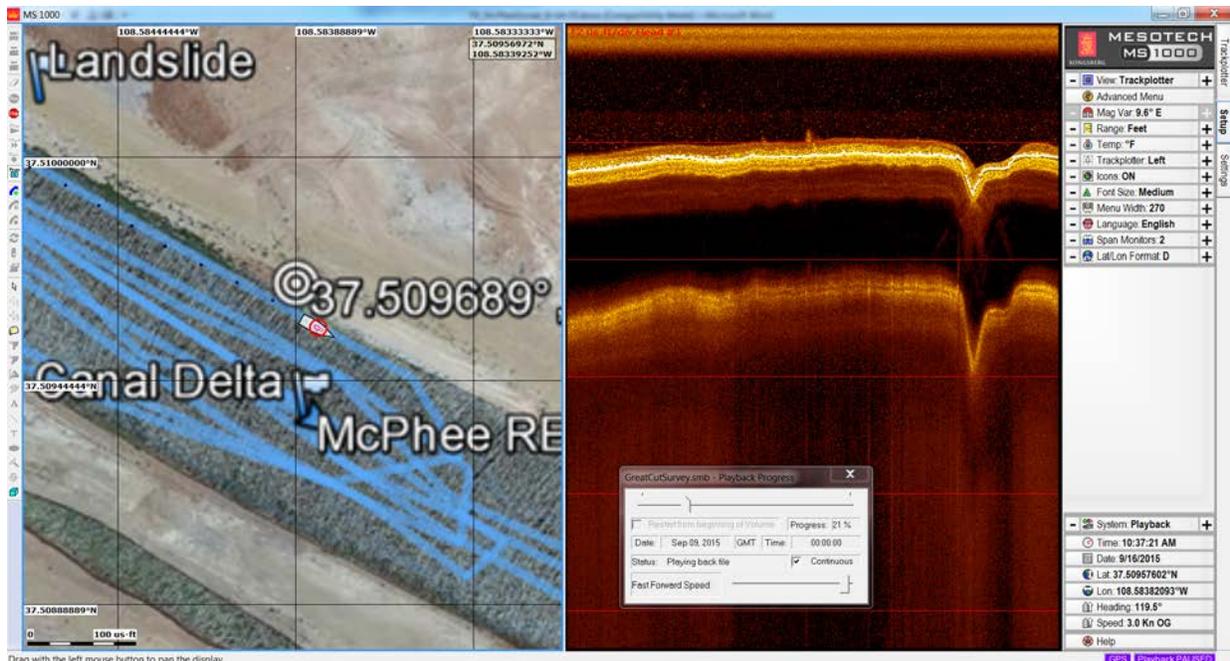
Figure 4. Screen capture from sonar software package showing the location of the sonar (left panel) and the gulley erosion that was measured to extend about 4 ft deep from a depth sounding taken along the right bank (right panel).
