RECLAMATION

TR-2016-01

Travel to Upper Molina Powerplant

To perform cavitation detection testing for research project 2944.

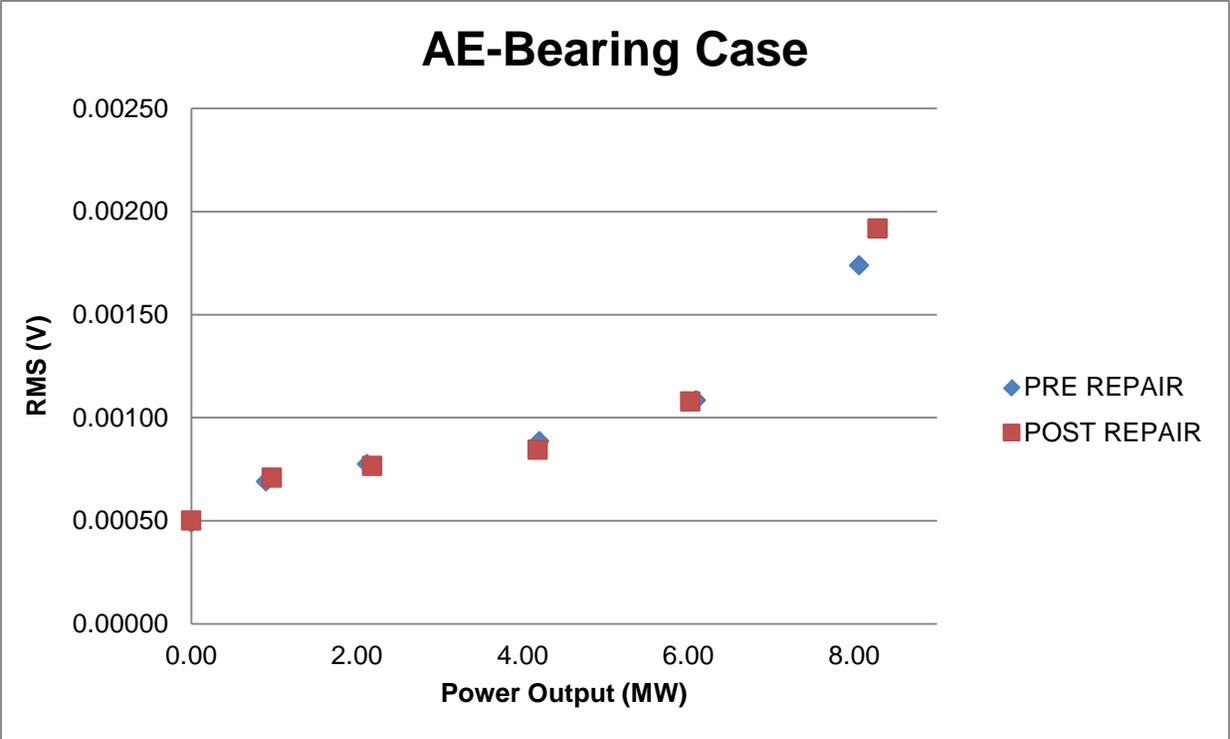
5. Conclusions: While an initial data analysis is shown in this report, a more thorough analysis will be included in a final R&D report at the end of FY2016. The shaft bearing case and lower bonnet test locations seemed to be the most sensitive to changes in unit power output (see Figures 4-9). The root-mean-square (RMS) of each signal was quantified to show any change in overall signal amplitude. Figure 4 shows that the RMS of the AE signal on the bearing case is almost identical before and after the repair. In contrast, lower bonnet accelerometer data show the post-repair signal is significantly less than the pre-repair signal (Figure 5).

Figure 4. Comparison of cumulative RMS signals from the AE sensor on the shaft bearing case.

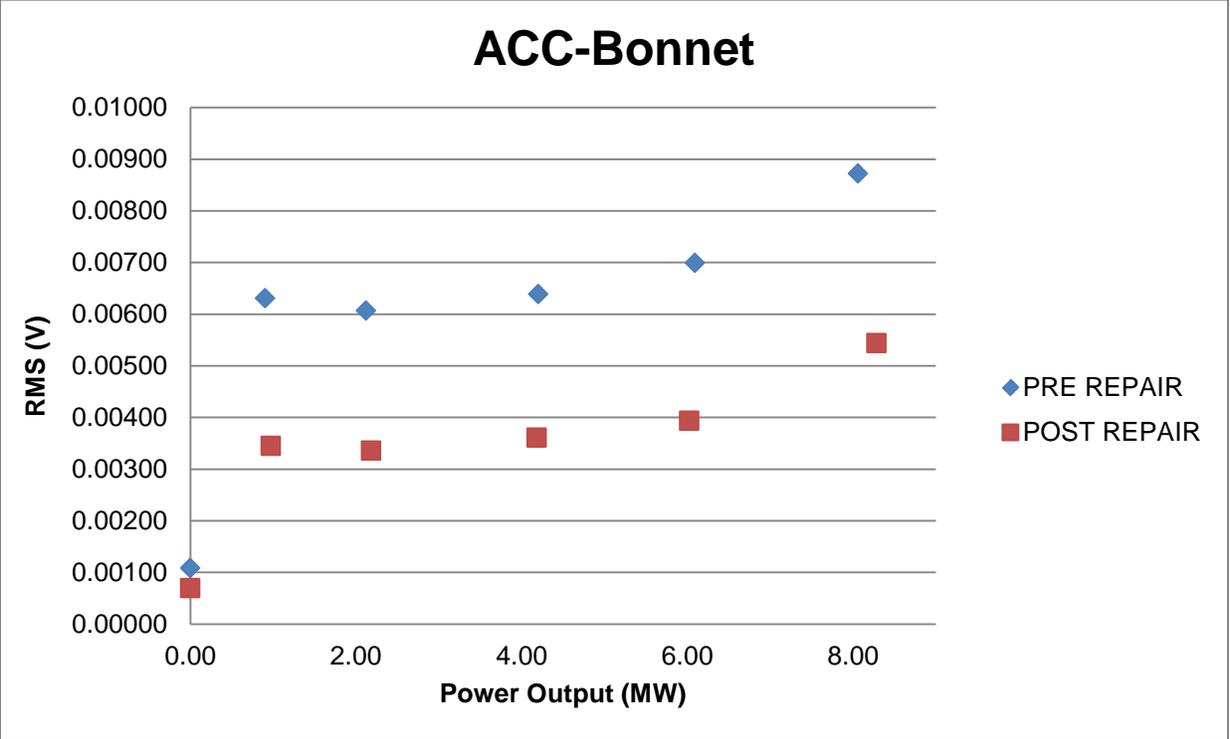
Figure 5. Comparison of cumulative RMS signals from the accelerometer on the lower bonnet.

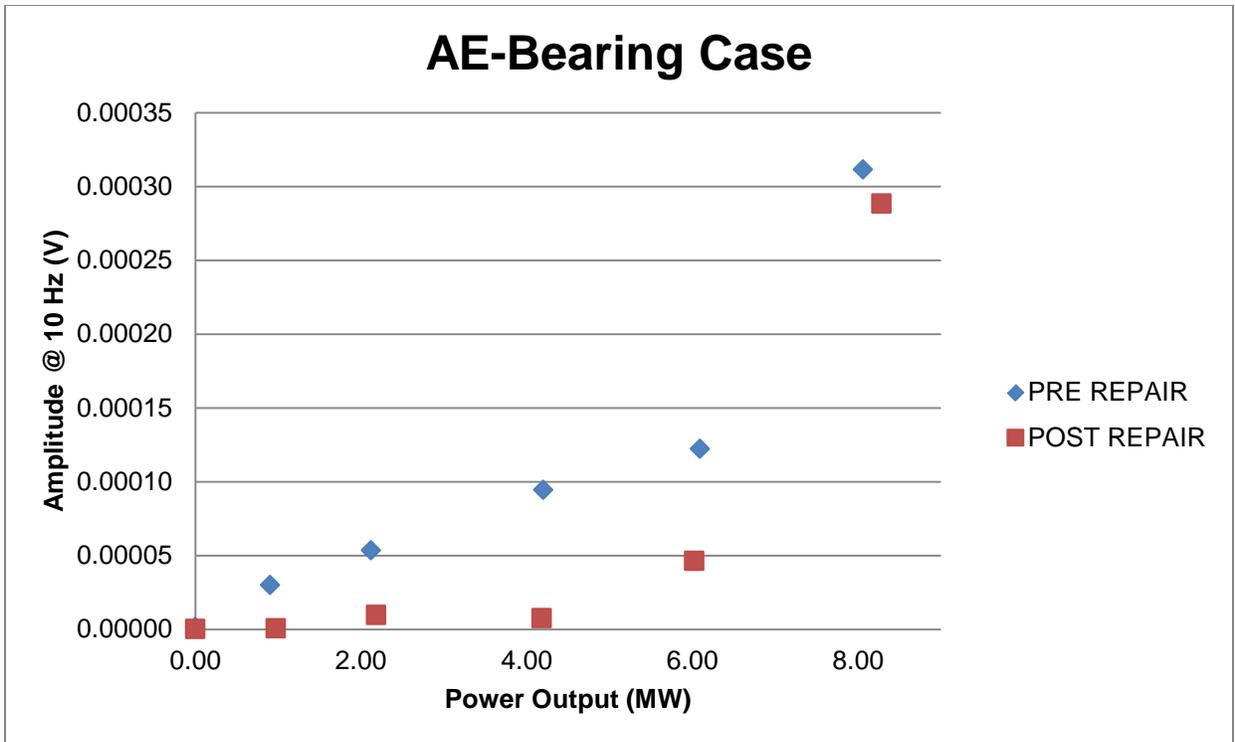
Figures 6 and 7 show results from a frequency analysis using demodulation to identify the magnitude of high frequency activity (such as cavitation erosion) at a low frequency occurrence (single bucket passing frequency – 600 rpm or 10 Hz). These initial results (shown in raw voltages that are not scaled to engineering units) show that the amplitudes of the post repair signal are slightly lower in general compared to those measured before the repair. However, the trends of both signals which increase with power output are very similar. Also, time series (Figure 8) and frequency domain (Figure 9) comparisons of the pre-repair and post-repair shaft bearing AE signals show very little difference.

Figure 6. Comparison of amplitudes for the demodulated AE signals at 10Hz on the shaft bearing case.

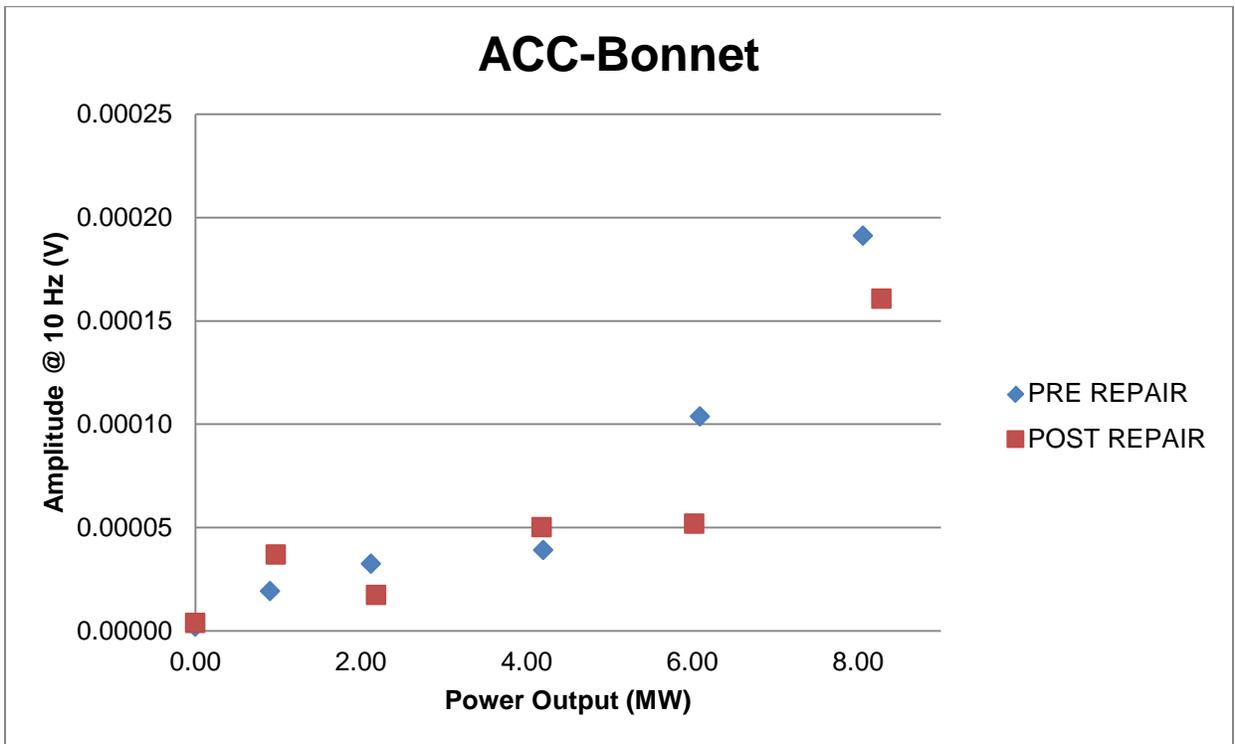
Figure 7. Comparison of amplitudes for the demodulated accelerometer signals at 10Hz on the lower bonnet.

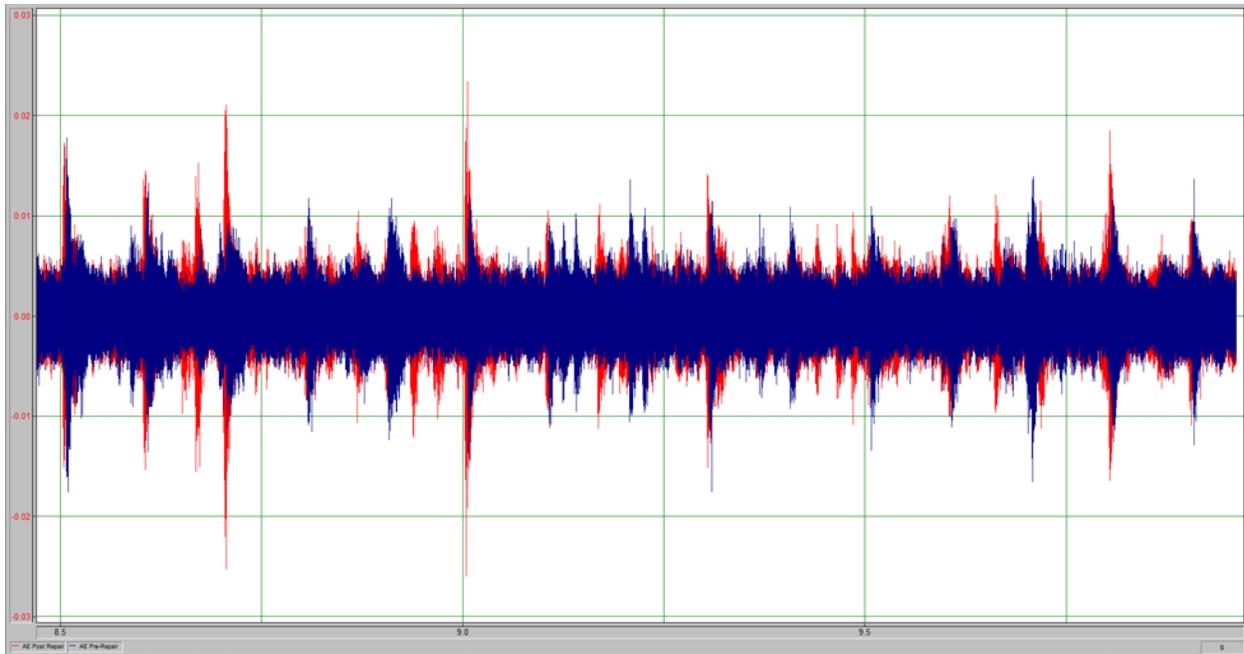
Figure 8. Time series signal of the AE sensor at the bearing case before the bucket repair (blue) and after the repair (red) at 8 MW. Green grid lines are spaces at 0.25 sec on x-axis.

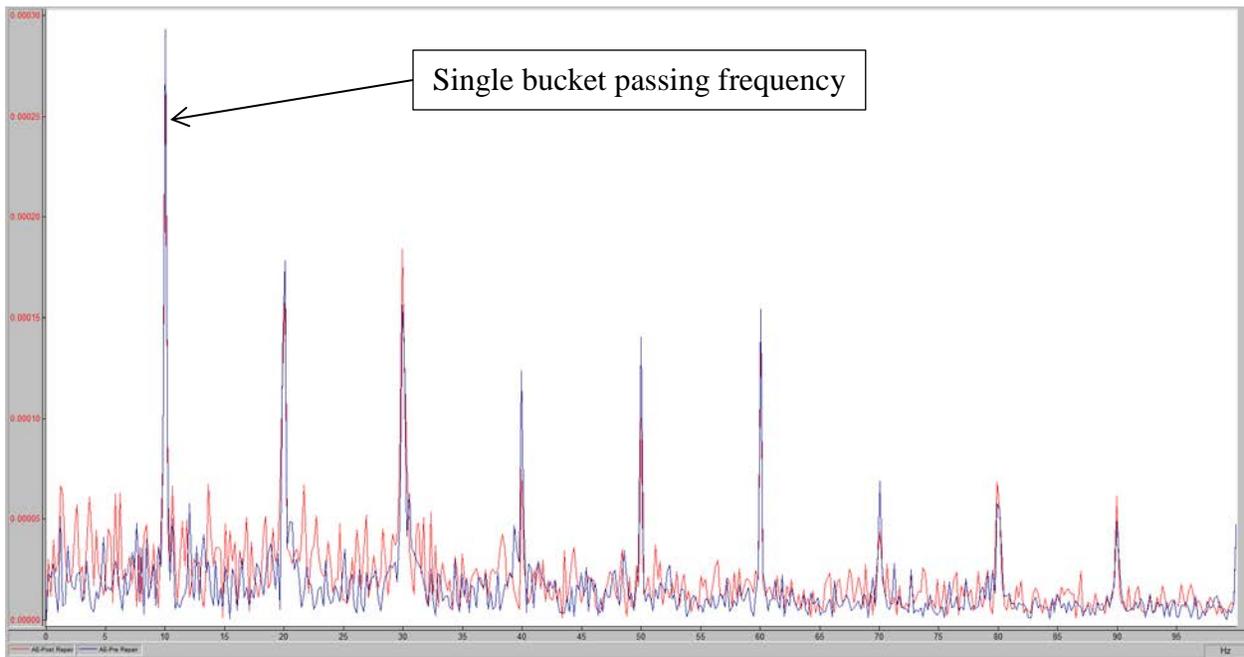
Figure 9. Demodulated signals in the frequency domain of the AE sensor at the bearing case before the bucket repair (blue) and after the repair (red) at 8 MW.
