TR-2017-01

Travel to Senator Wash Pump-Generation Plant to observe penstock vibrations

TRAVEL REPORT

Date: May 3, 2017

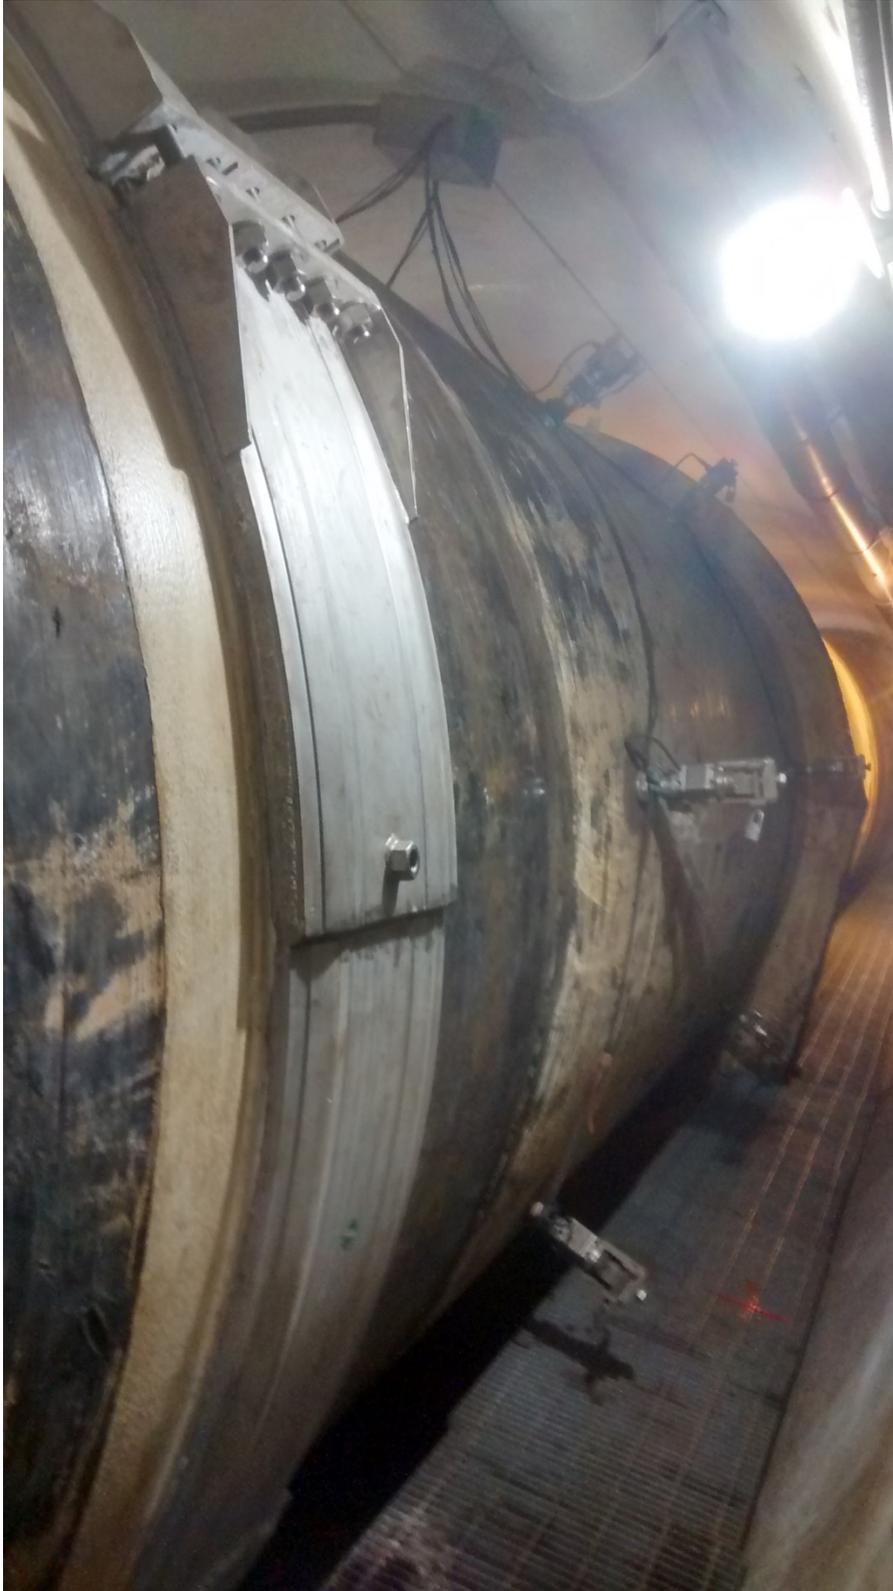
A new expansion joint was installed on the penstock in January 2017 and is thought to be a potential cause of increased vibration. Engineers from TSC's Hydraulic Investigations & Laboratory Services group (86-68560) were asked to travel to the plant and observe penstock vibrations during operation.

It is unknown why the penstock vibrates only in generation mode. It could not be determined that the new expansion joint is the cause of vibration. This is unlikely as the estimated resonant frequency of the expansion joint is much higher than dominant frequencies identified with the accelerometer. While blade passing frequency remains the same for both pump and generating mode, potential operational differences include direction of the flow, pressure gradient, and discharge (which were not measured during observation tests) which could be a cause of exciting different modes when generating. Also, it was confirmed that the plant was designed to a standard for pumping efficiency but not a generating efficiency [2] which may result in generating operations that are rougher, less efficient, and more susceptible to vibrations.

Figure 1 Photo of the penstock and newly installed expansion joint, looking toward the reservoir.

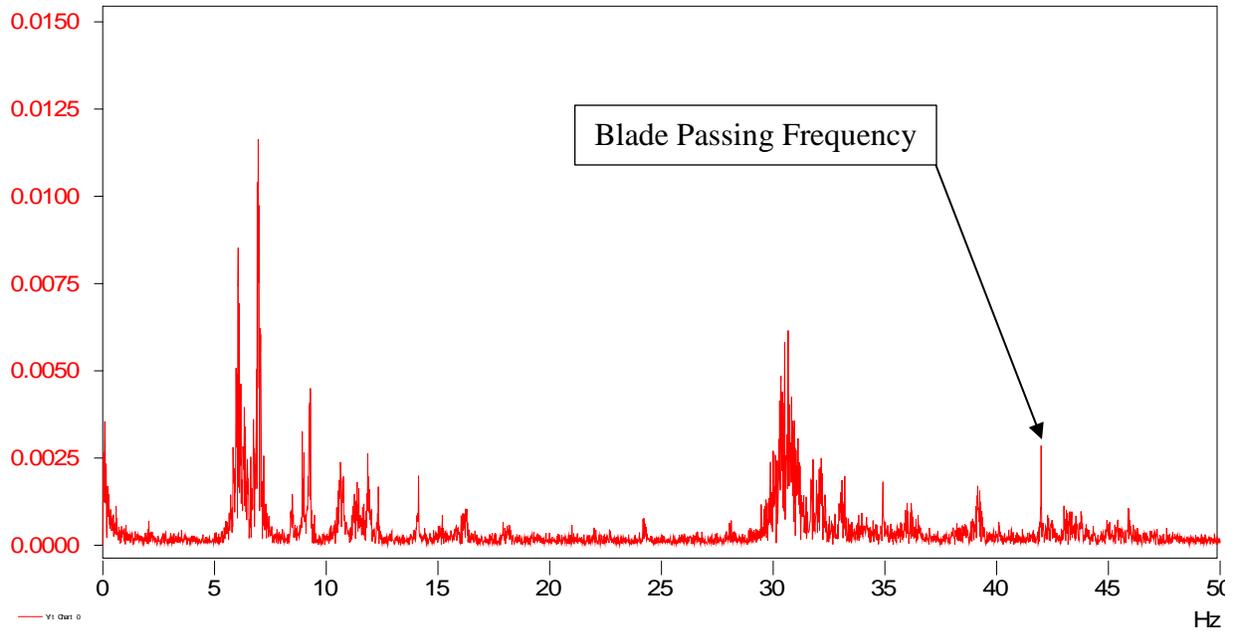
Results from test runs in generator mode showed a maximum penstock displacement on the order of 1/16-inch, which did not vary significantly with the number of units generating. Dominant frequencies were in the range of 6-9 Hz, and 31 Hz. The blade passing frequency of 42 Hz (7 vanes, 360 rpm) was detected but not significant compared to the lower frequency vibrations (Figure 3). For one test with a single generating unit the accelerometer was moved up to approximately 45° from the top where displacement magnitudes were slightly higher but at similar frequencies compared to the side location at 90°. No unusual noises or sounds were observed. Jesse Alvarado, who observed the vibration last February, indicated that vibrations we observed on March 21st appeared the same as before. Similar vibrations were observed in other sections of the penstock up and downstream of the expansion joint.

Figure 3 Plot of the acceleration signal in the frequency domain in generating mode. Dominant frequencies occurred in the range of 6-9 Hz and near 31 Hz. Blade passing frequency was detected but not significant.

6. Action correspondence initiated or required: A field test is recommended to further assess penstock vibrations. Physical data are needed to verify that fluctuating stresses in the penstock are within an acceptable range (i.e., below the endurance limit), which would be the main objective of the test. This could be done by installing strain gauges at strategic locations on the penstock to measure stresses during operation. A secondary objective of the test would include further investigation of the cause of vibration. This could be done by identifying longitudinal and circumferential modes with accelerometers and measuring penstock pressures and discharges during both pumping and generating operations. Testing could be performed by TSC's Hydraulics Investigations and Laboratory services group.

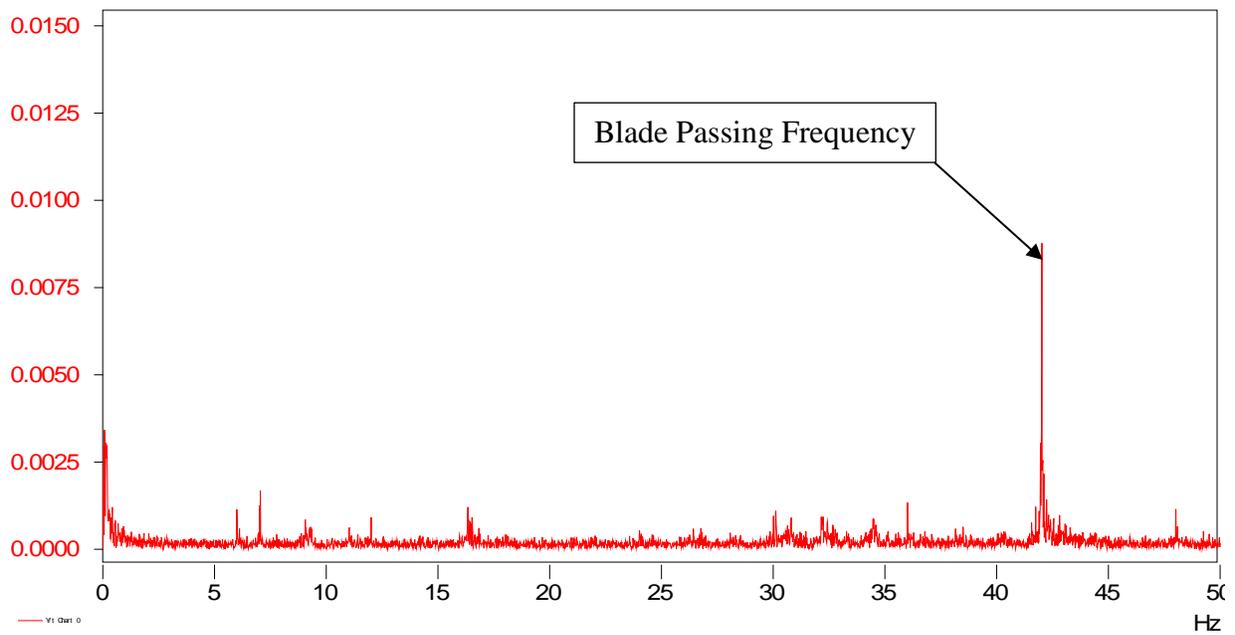
For pump mode, no significant vibrations were observed. Displacement was not measurable and a single dominant frequency was recorded at 42 Hz (blade passing frequency, Figure 4). A slight sound was heard that seemed to be on the same order as the blade passing frequency but did not seem unusual or concerning.

Figure 4 Plot of the acceleration signal in the frequency domain in pumping mode. Blade pass frequency (42 Hz) was dominant with no other significant vibrations.
