TR-2019-06

Platoro Outlet Pipe Inspection

TRAVEL REPORT

Subject: Platoro Outlet Pipe Inspection

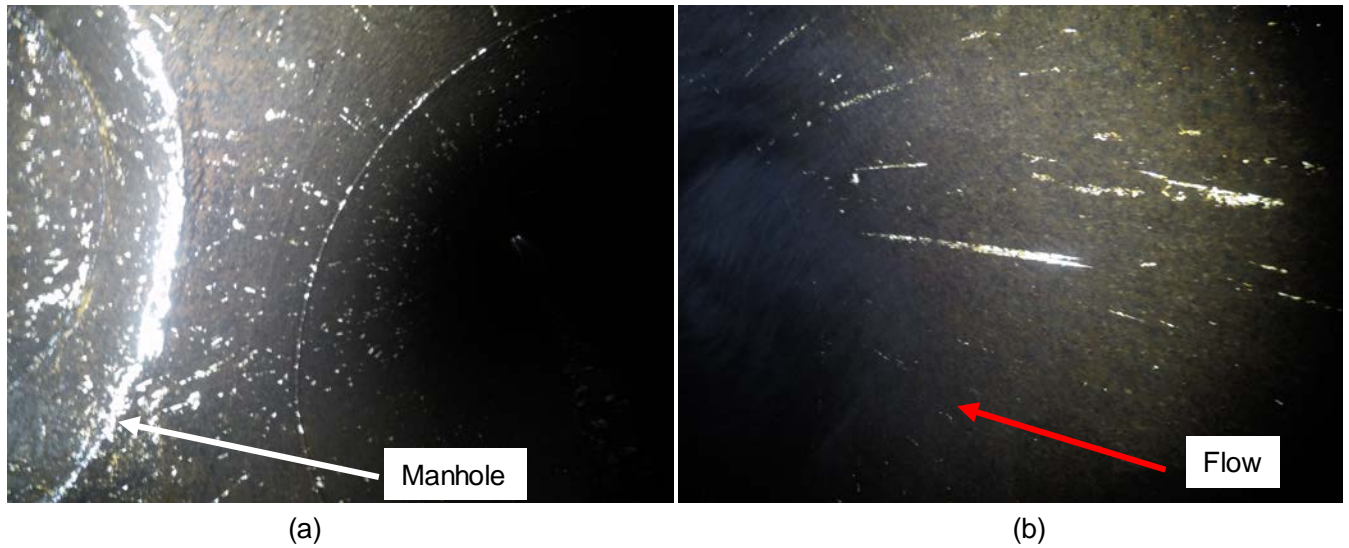
Overall the condition of the interior of the outlet pipe and coating (Polyurethane applied in 2010) appeared to be good. There were no signs of cavitation damage around the manholes (Figures 1 and 2) and the expansion joint. Throughout the length of the main 56-inch conduit and upstream end of the bifurcation there were sections where the slimy film on the pipe wall had been removed and the white surface of the coating was exposed (Figures 1 and 2). Light abrasion or scuffing was apparent on the coating surface of some sections (Figure 3). According to Nathan, exposed sections of coating were new since the previous inspection about 2 years ago. They appear to have been caused by flow laden with sediment or debris.

Figure 1 Photos of the upstream manhole (a) and upstream portion of the conduit (b), looking downstream. White markings are where the slimy film has been removed by flow or sediment and the coating is exposed.

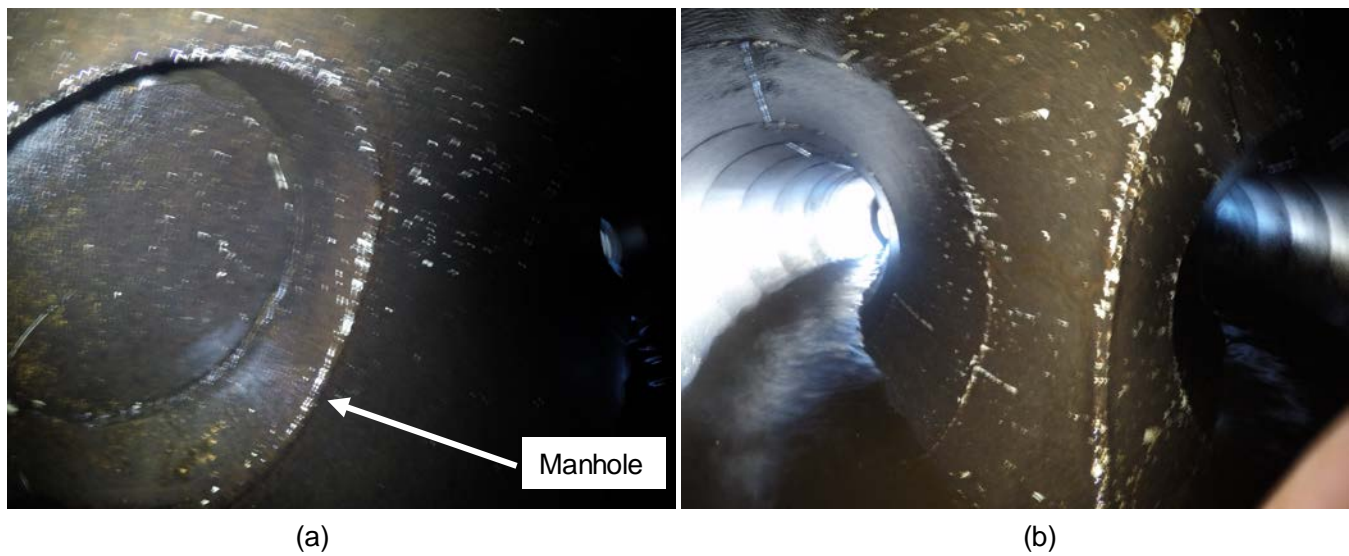
Figure 2 Photos of the downstream manhole (a) and the bifurcation (b), looking downstream.

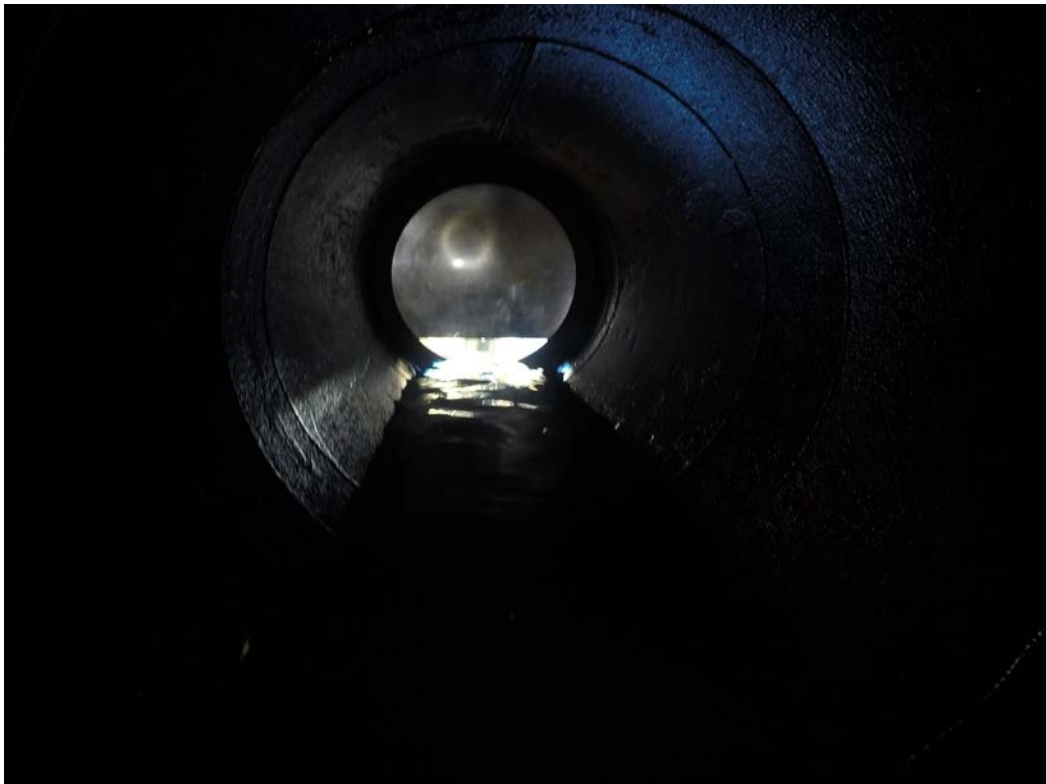
The right leg of the bifurcation was in good condition with little exposed coating surface and no apparent damage or removal of the coating.

Figure 4 Photo of the right bifurcation looking downstream to the jet flow gate. No coating damage was seen in the right leg of the bifurcation.

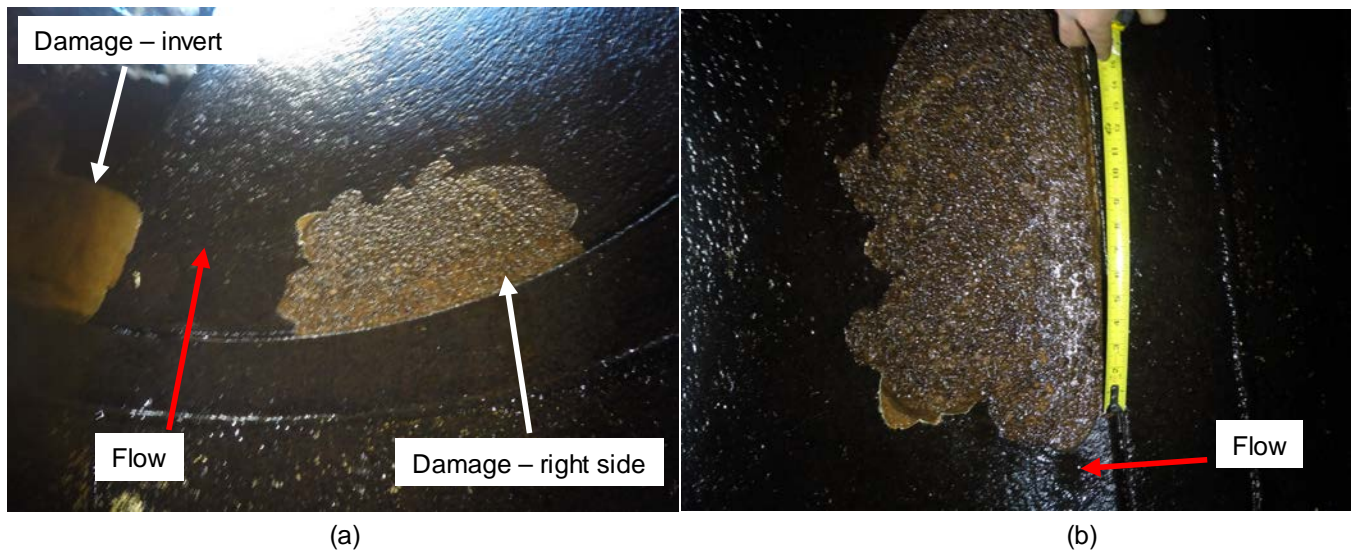
The left leg of the bifurcation was also in good condition except for two areas where the coating had been removed and bare pipe was exposed (Figure 5). The coating removal of both areas was initiated at a pipe joint recessed away from the flow 64 inches upstream from the leaf of the jet flow gate. There was not a recessed pipe joint in the right leg of the bifurcation. The first area was at the invert of the pipe and was approximately 10-inch wide by 12-inch long. The second was near the invert on the right side and was approximately 18-inch wide by 12-inch long and

appeared to have been there longer than the first due to accumulation of rust nodules (Figure 5).

While the root cause is unknown, coating damage may have initiated in the small gap of the pipe joint where proper surface preparation is difficult to achieve and where corrosion between the coating and metal is most likely to exist. Any initial weakness due to corrosion or cracking in the coating may have been exasperated by flow conditions triggered at the recessed pipe joint (i.e. cavitation or extreme turbulence). Once initial damage has begun, high velocity flows can penetrate the underside of the coating and produce uplift pressures causing it to peel or pop off the pipe. Photos in Figure 6 indicate that this is what likely happened. Care should be taken to identify and repair any initial cracking along other areas of the pipe joint besides the two main damage areas when future repairs are made.

Figure 5 Photos of damage areas near the invert and right side of the left leg of the bifurcation looking downstream (a) and of the right side looking perpendicular (b). Both damage areas initiated at a pipe joint located 64 inches upstream from the jet flow gate leaf.

Two areas were found in the left leg of the bifurcation where the coating had been peeled off. These areas should be repaired before the peak discharge season to prevent further damage from high velocity flows. TSC's Materials and Corrosion Lab can assist in specifying appropriate repair materials and procedures.

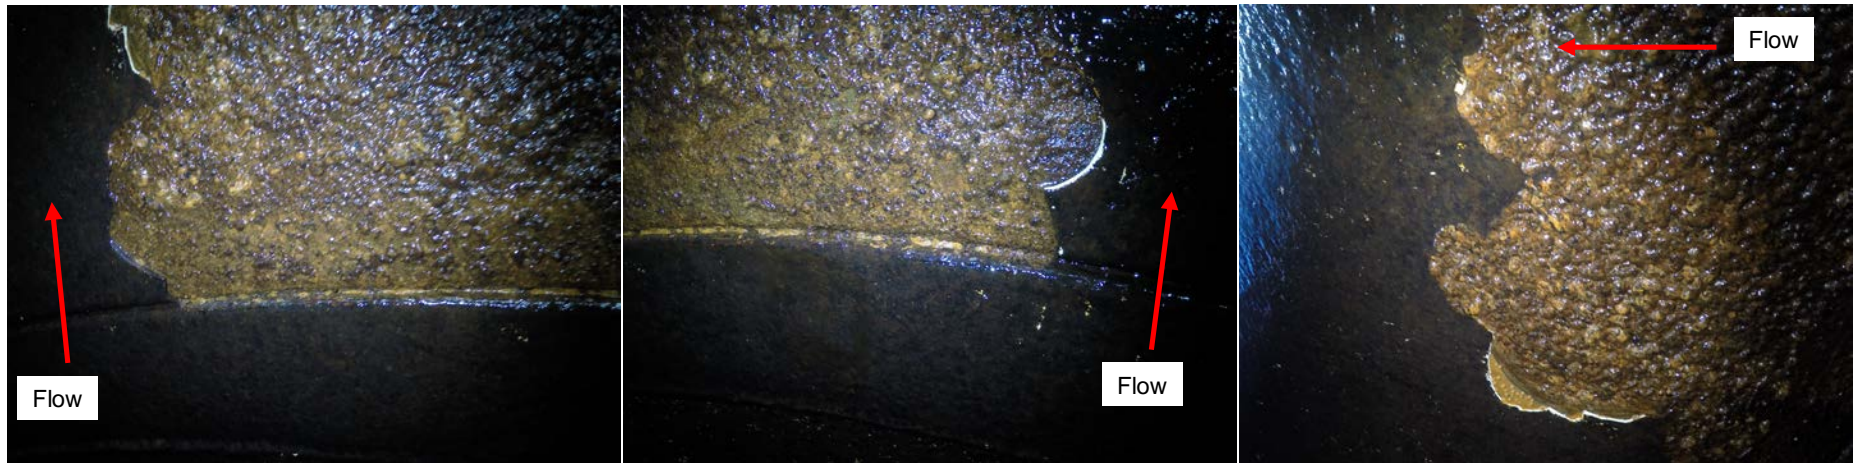
Figure 6 Photos of the damage section near the right side of the invert in the left leg of the bifurcation. The coating, which appeared to be approximately 1/8-inch thick, had been peeled off. The coating will likely continue to be stripped off by high velocity flow until repaired.

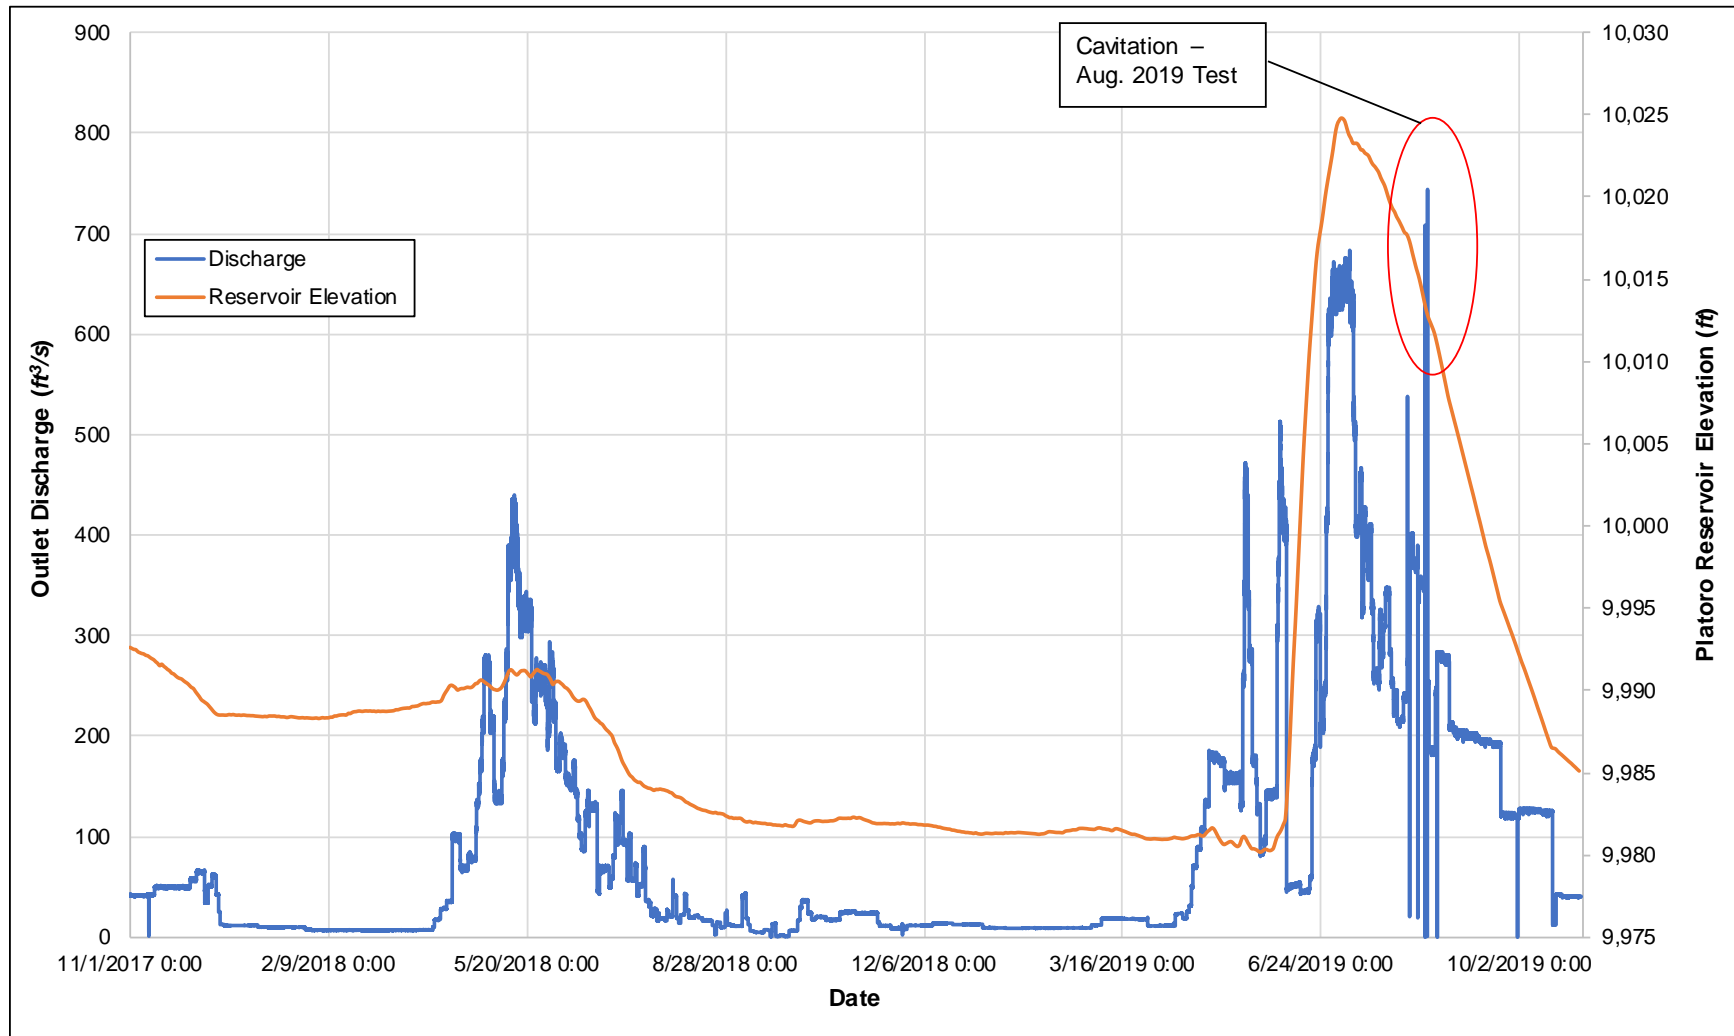
Figure 7 Discharge and Reservoir Elevation data since November 2017. Discharges over $630 \text{ ft}^3/\text{s}$ were corrected according to flow differences identified in the river gaging station and pipe flow meter during the Aug. 2019 test [1].

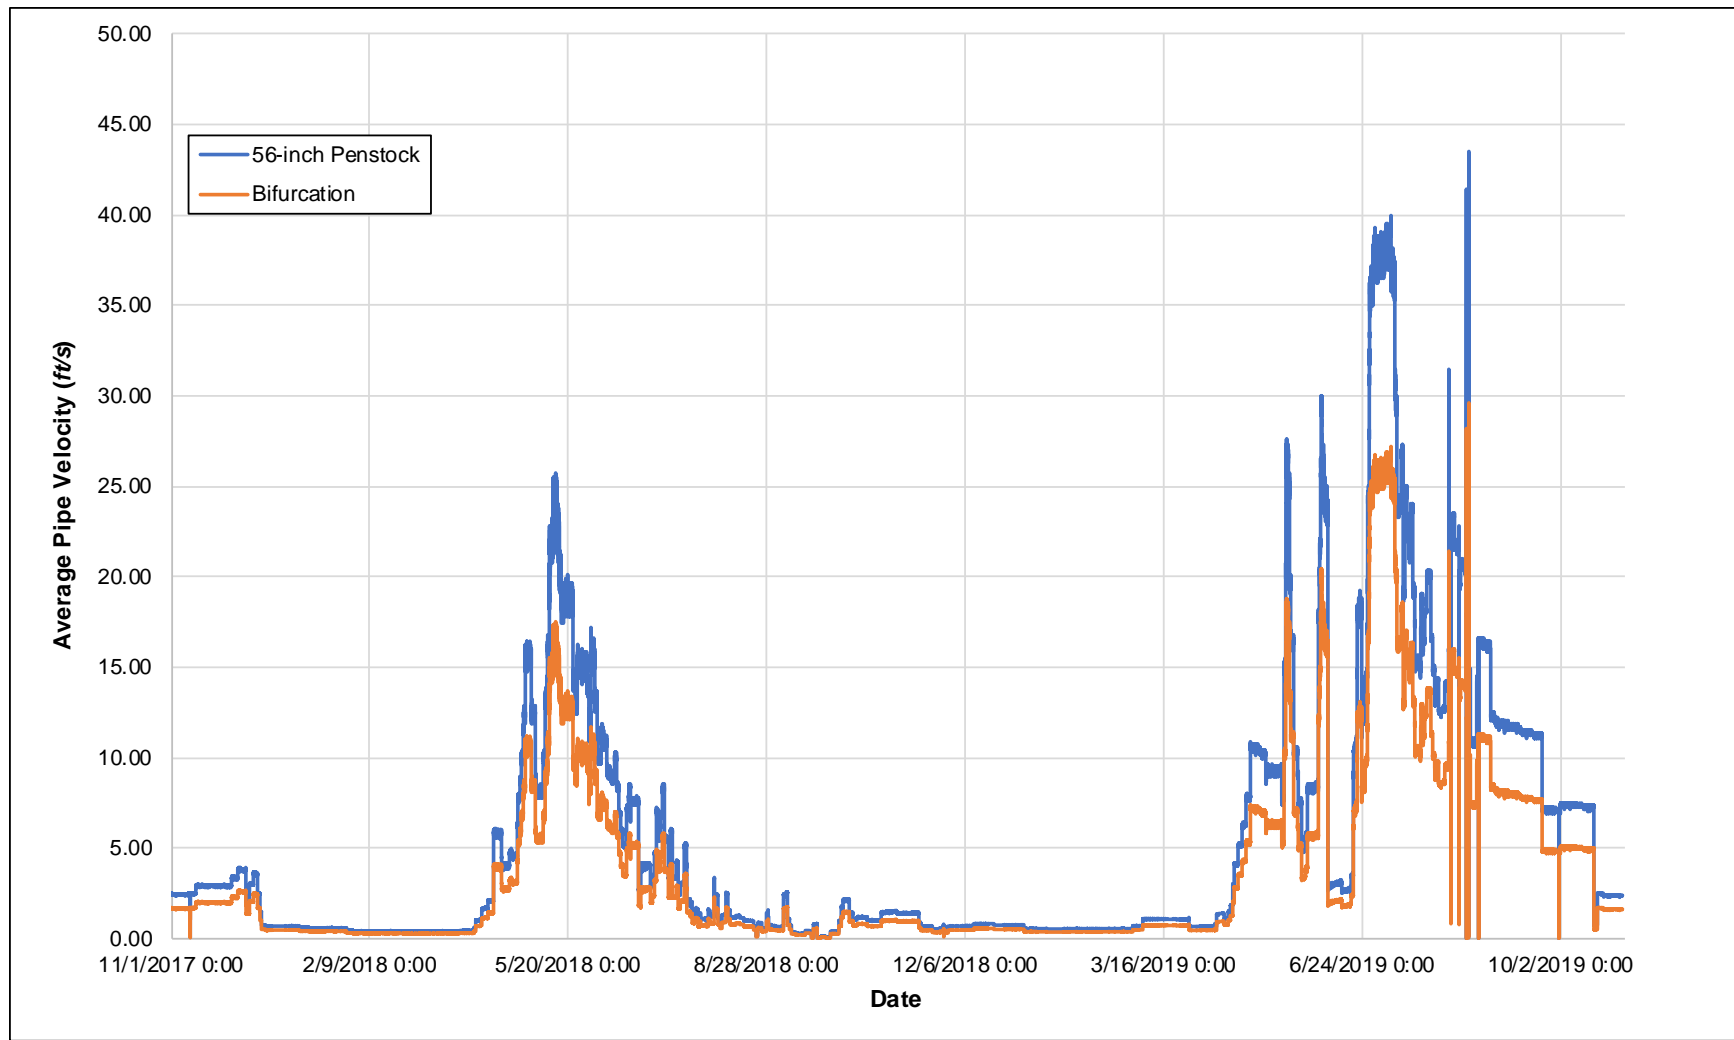
Figure 8 Average velocities in the 56-inch outlet pipe and the 48-inch bifurcations since the previous internal outlet pipe inspection.
