Dams and Public Safety

A Water Resources
Technical Publication

U.S. DEPARTMENT OF THE INTERIOR
Bureau of Reclamation

**By
Robert B. Jansen**

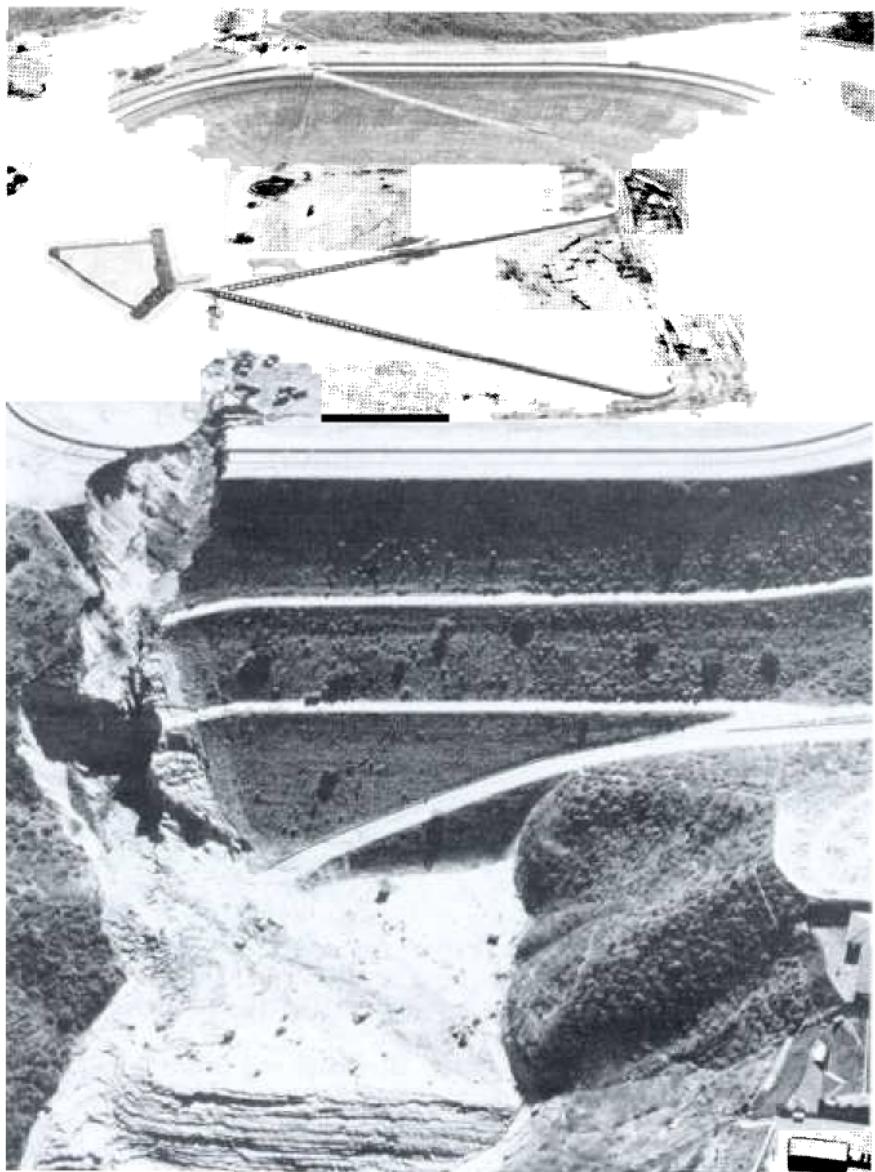
At 3:38 p.m., a huge gush of water blew mud and debris through the lower face of the dam, and poured down the steep ravine leading to a residential street 275 meters (900 feet) away. A witness described the collapse: "(The) sloping earth wall was leaking muddy water from a top to bottom crack. It gushed in a 10-foot-wide brown stream from a fissure at the bottom ***. Next, there was a roar like a great cannon, then a rumbling and shuddering of the ground as the face of the slope erupted. A mighty jet of water and mud and fragments of earth shot out ***. The explosion point

Figure 4-1.—Baldwin Hills Reservoir after failure (Courtesy, Calif. Dept. of Water Resources). P-801-D-79346.

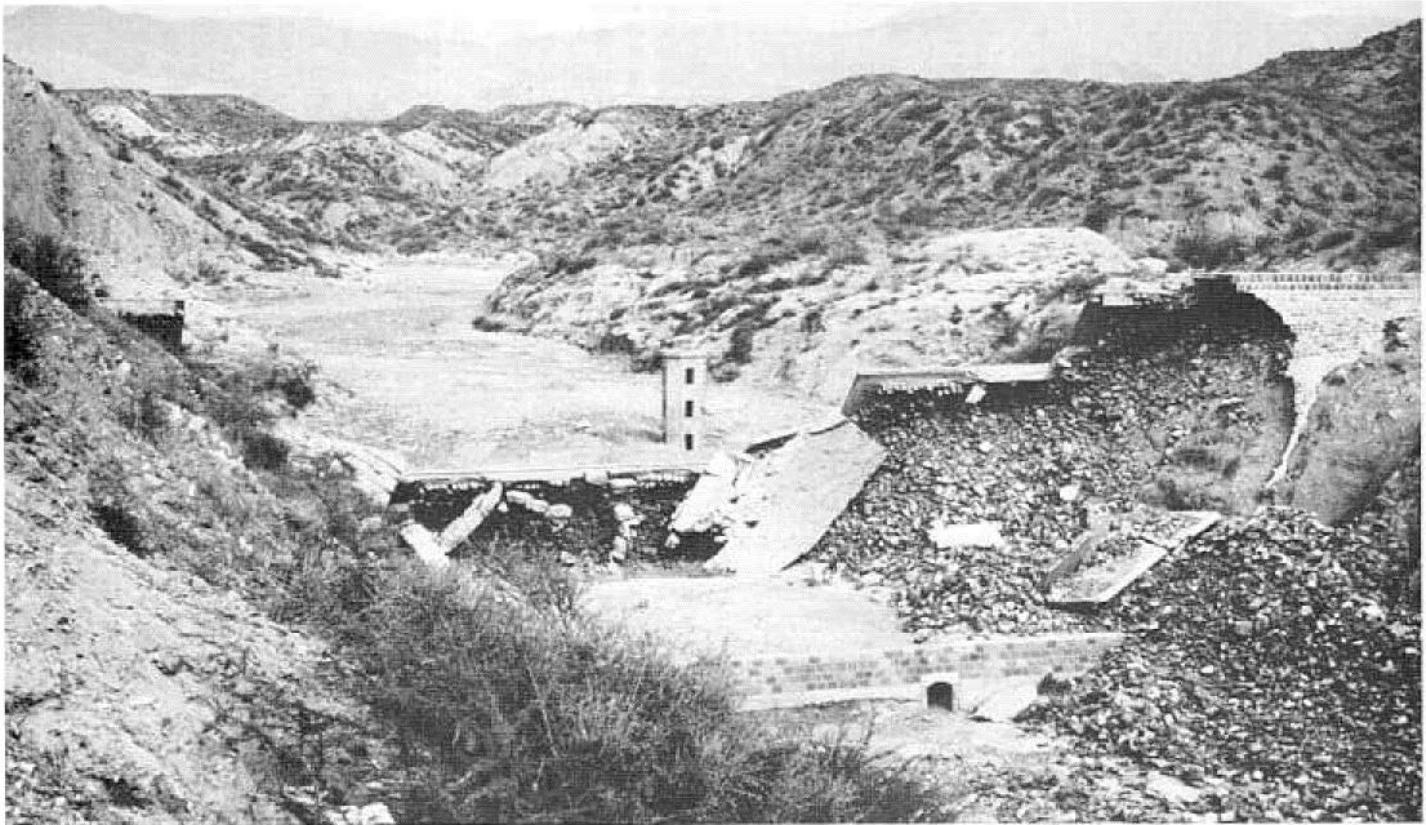
The reservoir on the Río Seco Frías had a storage capacity of only 200 000 cubic meters (161 acre-feet), whereas the flood volume was many

Figure 4-5.—Frías Dam after failure, downstream view (Courtesy of C. J. Cortright). P-801-D-79350.

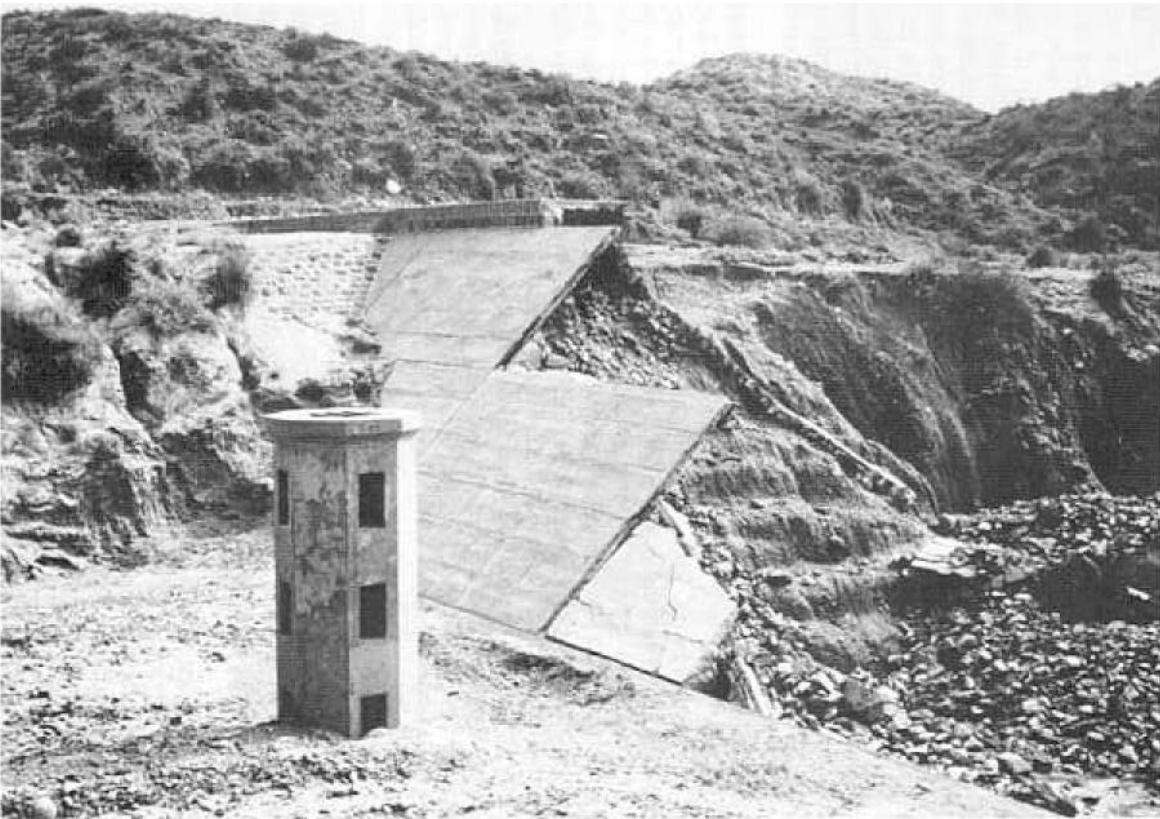
Figure 4-6.—Frías Dam after failure, upstream view (Courtesy of C. J. Cortright). P-801-D-79351.

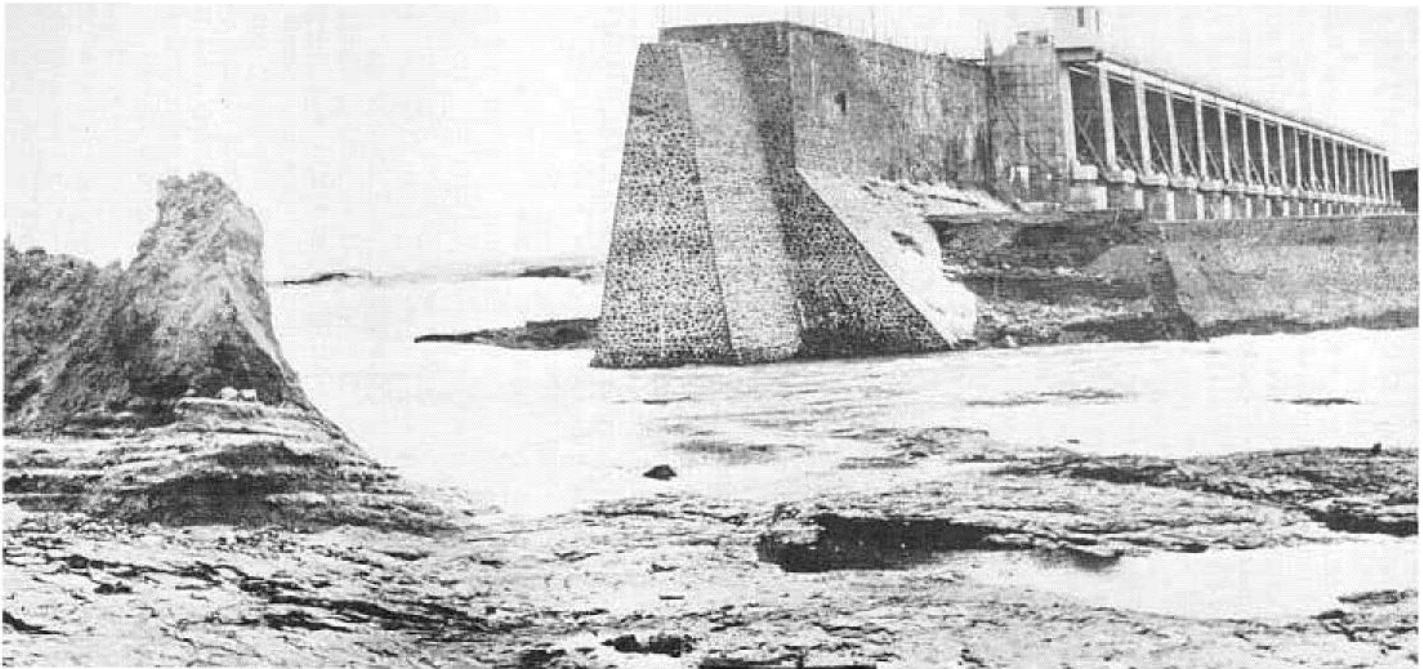
Figure 4-7.—Machhu II Dam after failure (Courtesy, Irrigation Department, Government of Gujarat India). P-801-D-79352.

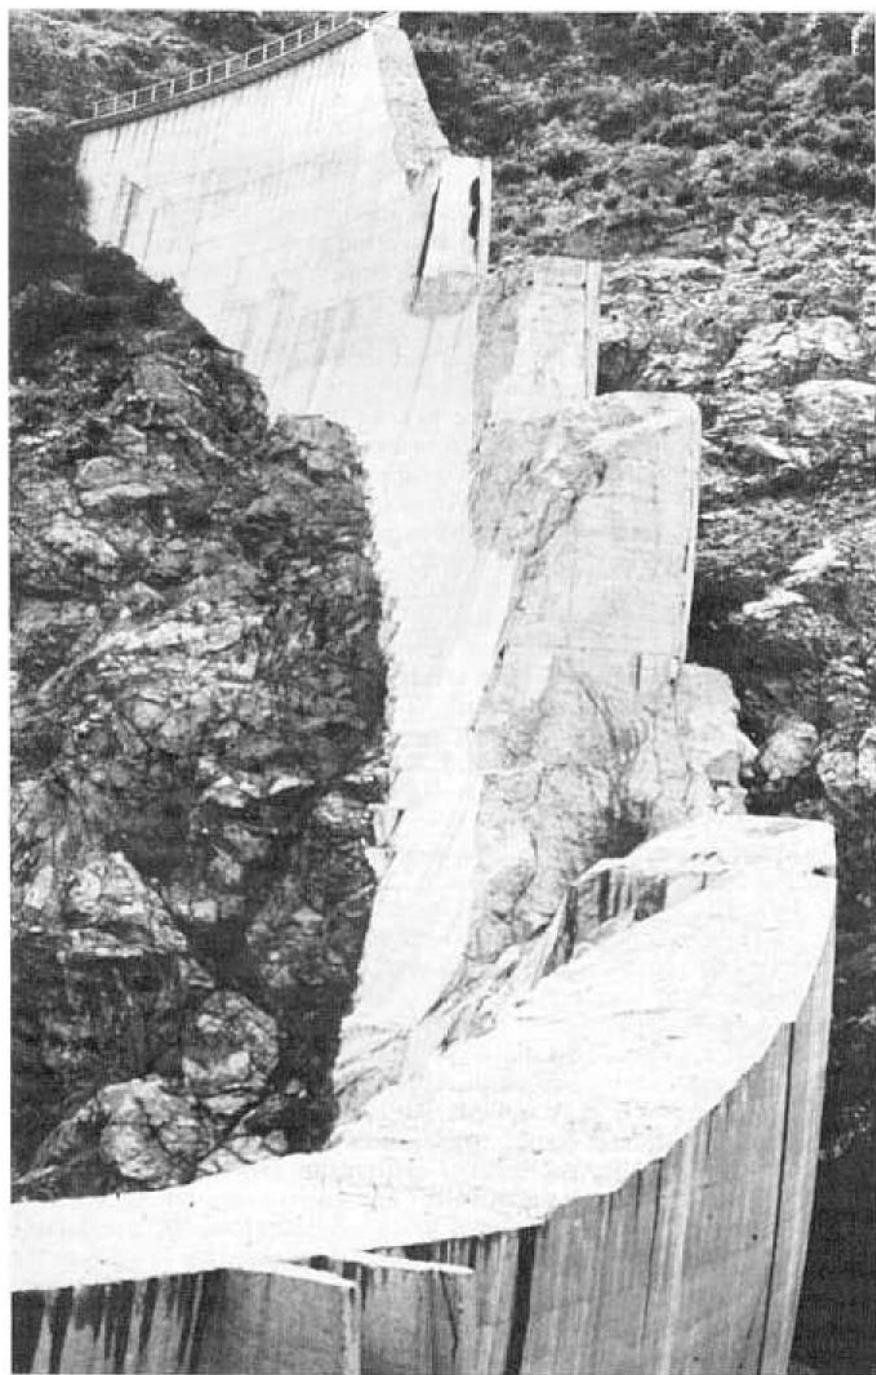
Figure 4-8.—Malpasset Dam, right abutment, showing remnant (Courtesy of L. B. James).
P-801-D-79353.

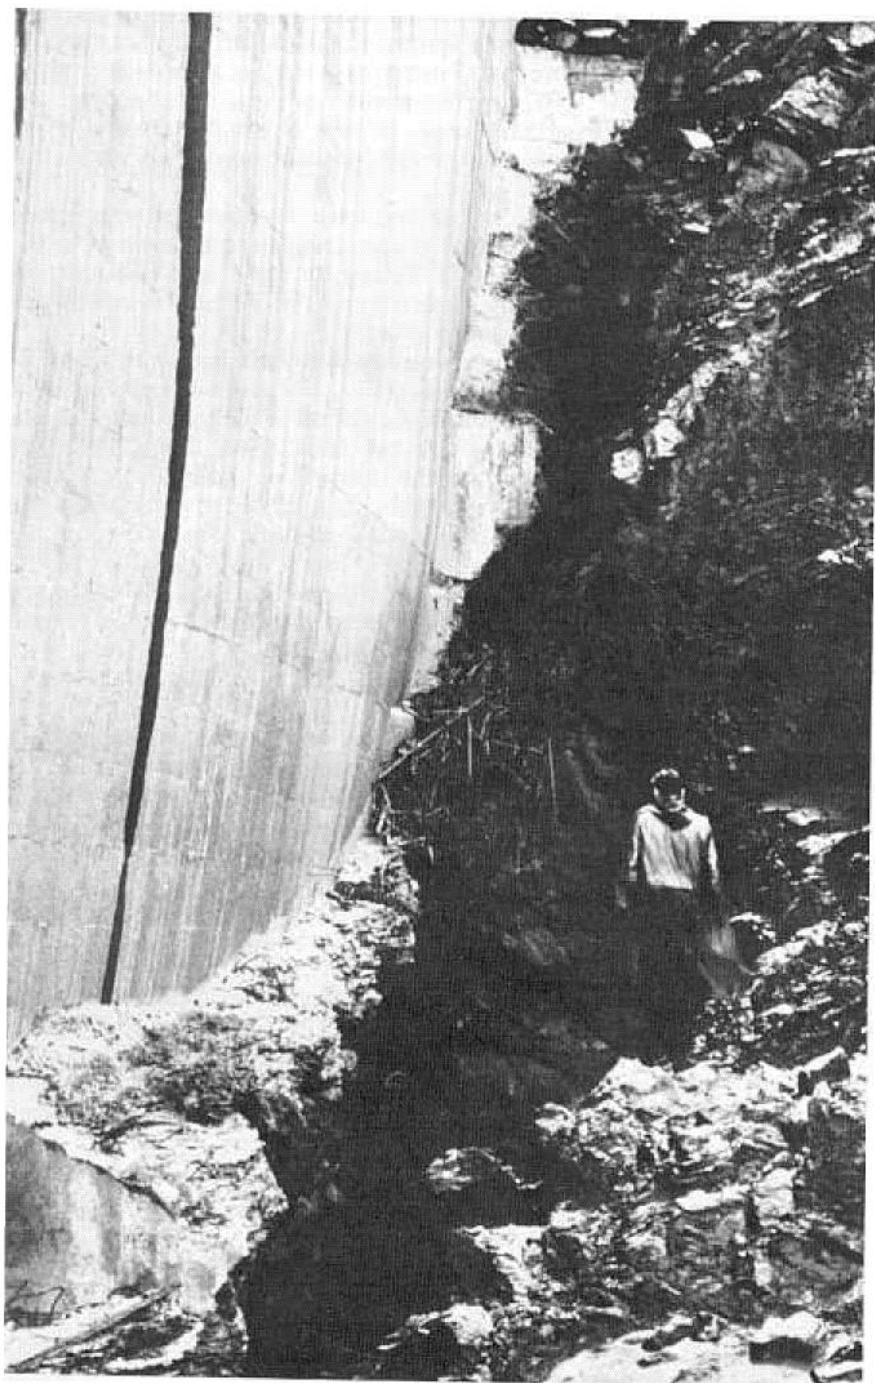
Figure 4. —Malpasset Dam, right abutment, showing gap caused by pivoting (Courtesy of L. B. James). P-801-D-79354.

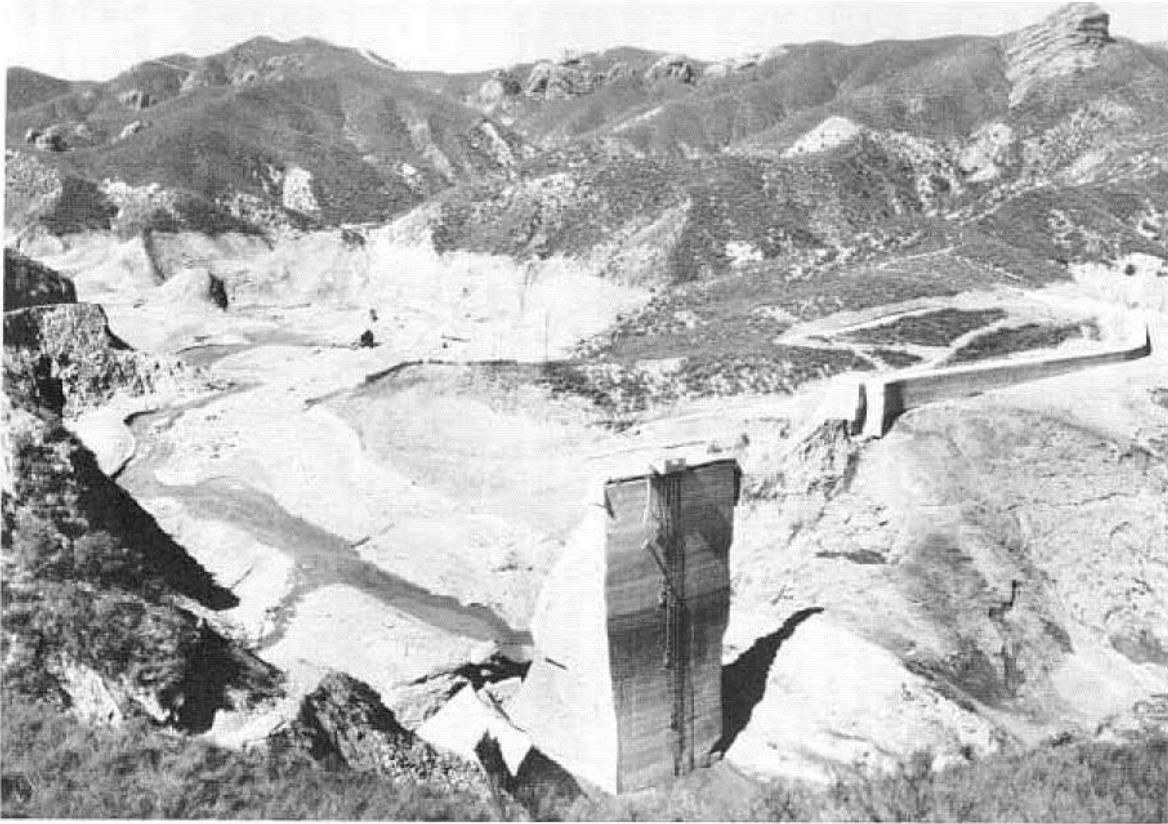
Figure 4-11.—St. Francis Dam after failure (Courtesy, Calif. Dept. of Water Resources). P-801-D-79356.

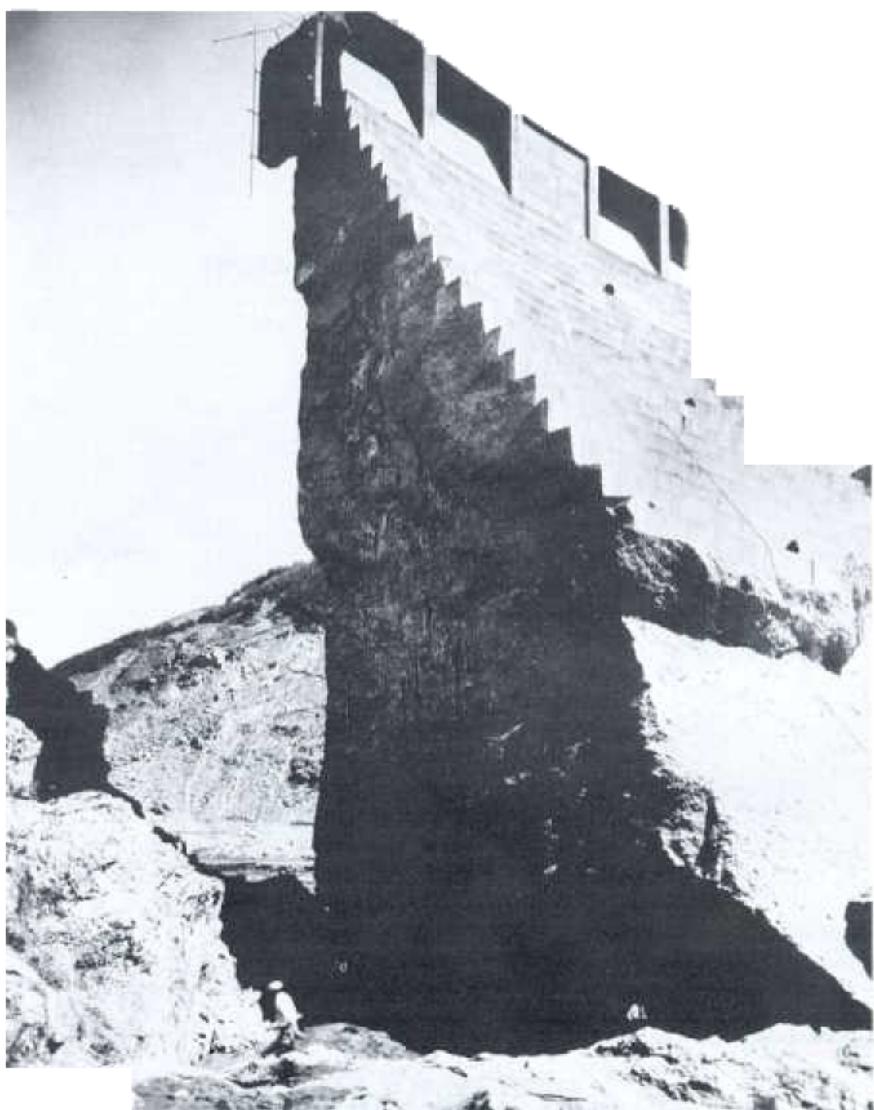
Figure 4-13.—Surviving monolith of St. Francis Dam (Courtesy, Calif. Dept. of Water Resources). P-801-D-79358.

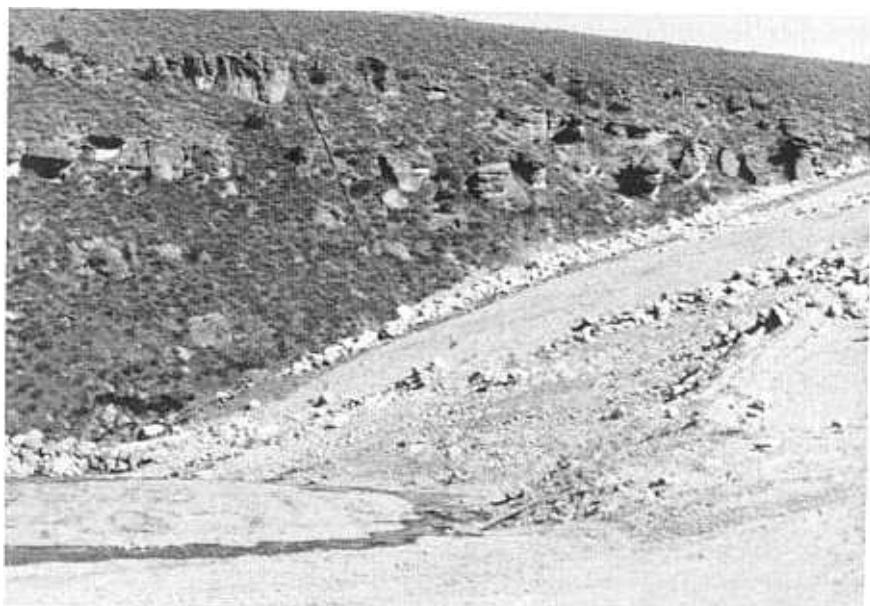
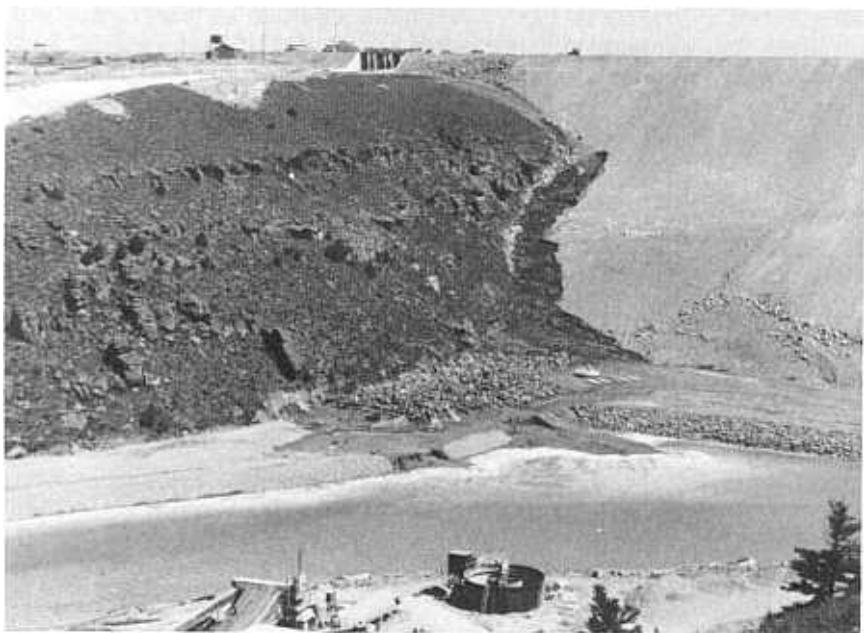
Figure 4-16.—Teton Dam failure sequence, June 5, 1976.

Muddy flow at about El. 5045, 20-30 c.f.s., 8:30 a.m. P-801-D-79362 (top).

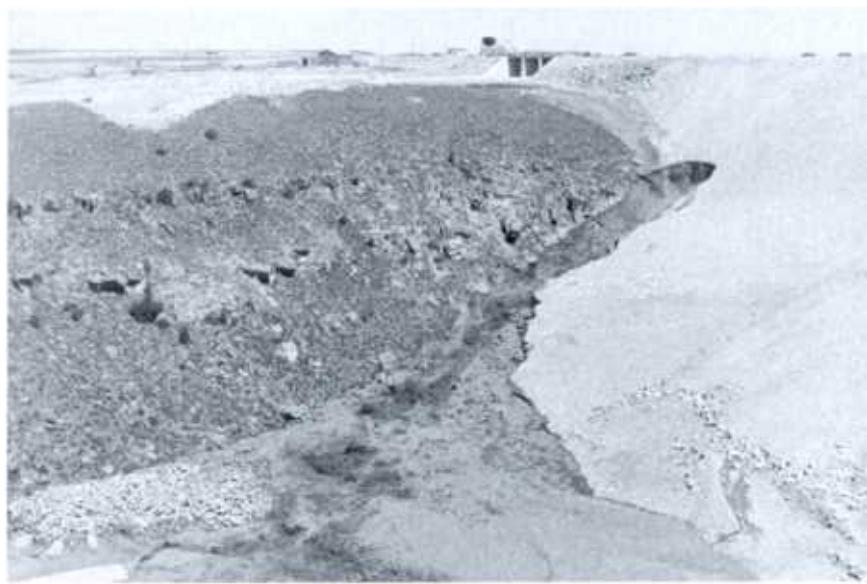
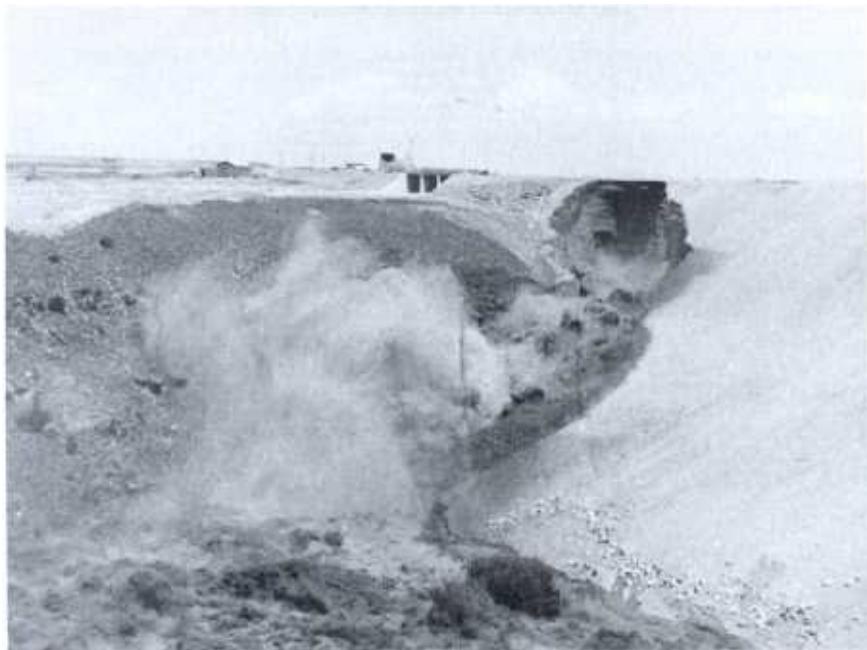
Figure 4-16.—Teton Dam failure sequence, June 5, 1976—Continued.

Dozers lost in hole, about 11:20 a.m. P-801-D-79364 (top).

Dam crest breaching, 11:55 a.m. P-801-D-79365 (bottom).

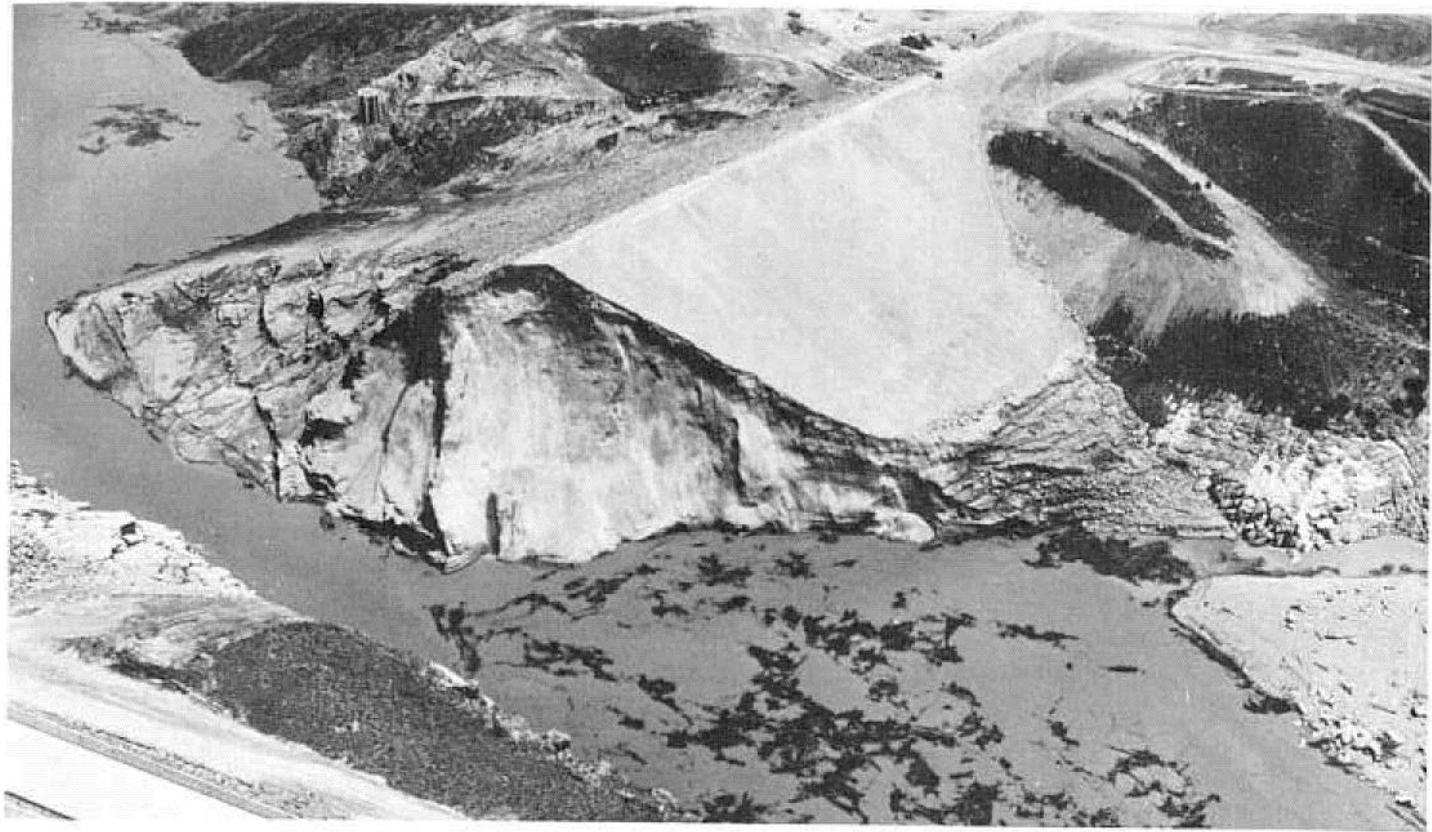
Figure 4-17.—Teton Dam, downstream view after failure (P549-100-215A). P-801-D-79368.

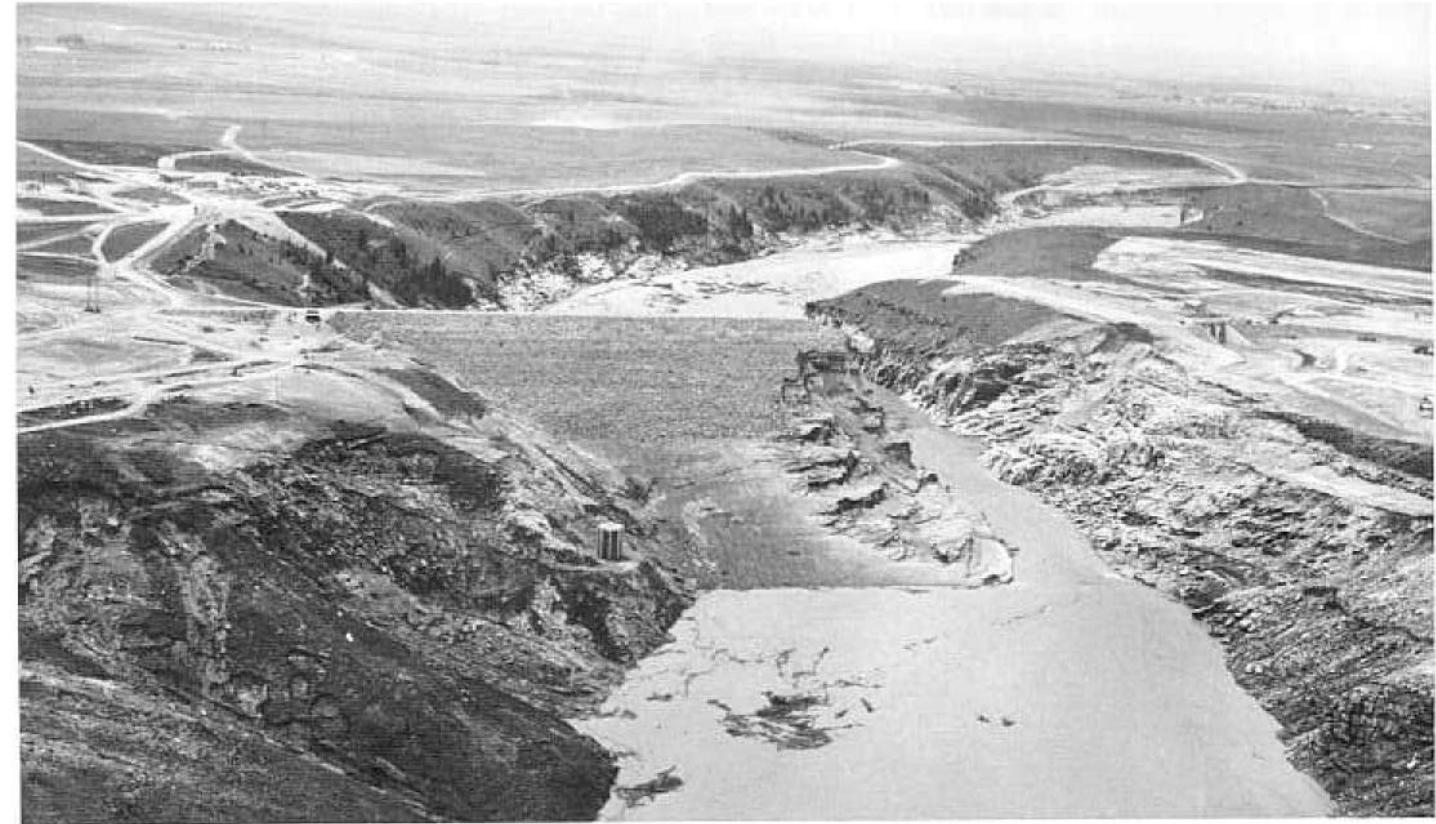
Figure 4-18.—Teton Dam, upstream view after failure (P549-100-218A). P-801-D-79369.

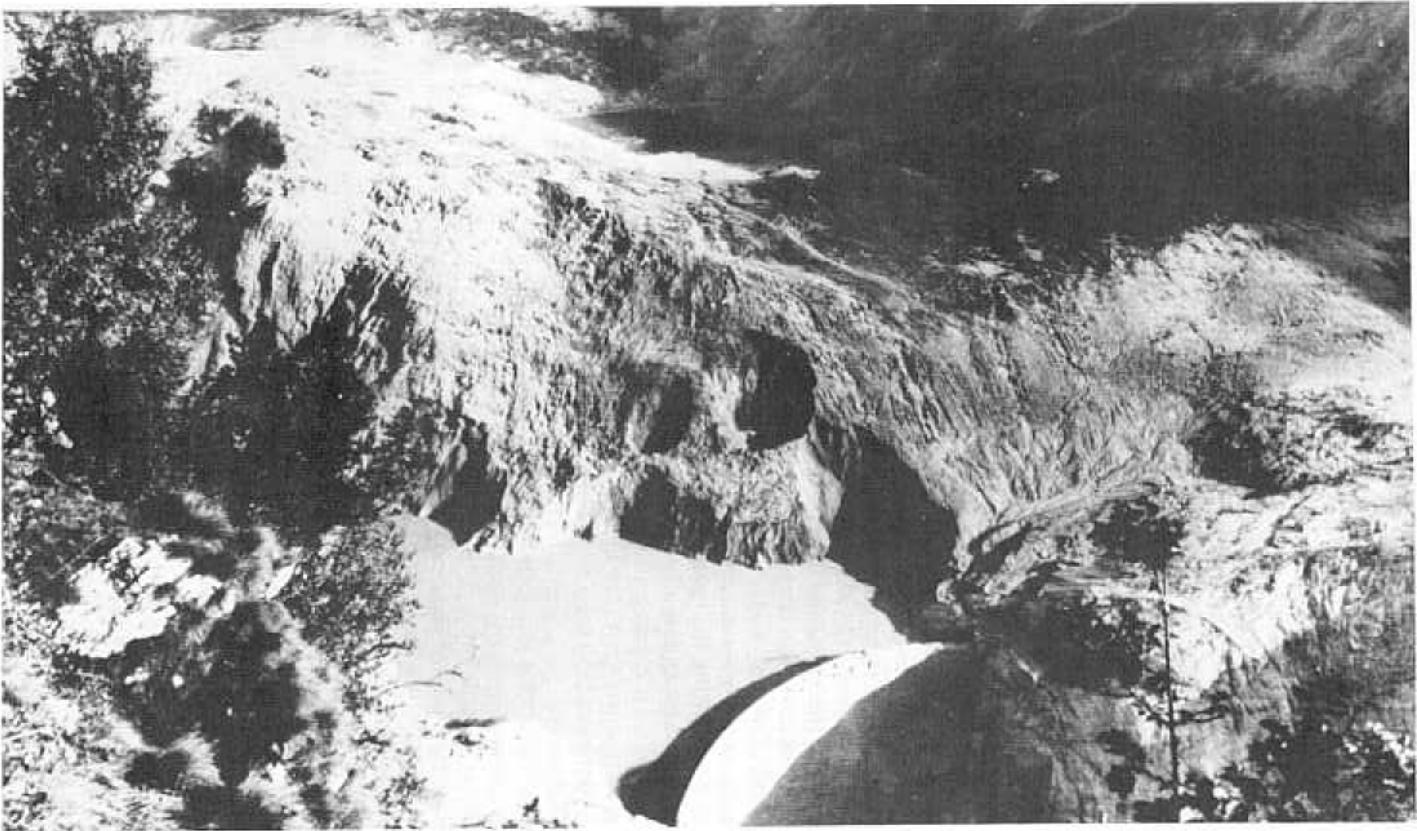
Figure 4-23. -Vajont Dam after failure, showing massive slide upstream of dam. P-801-D-79375.

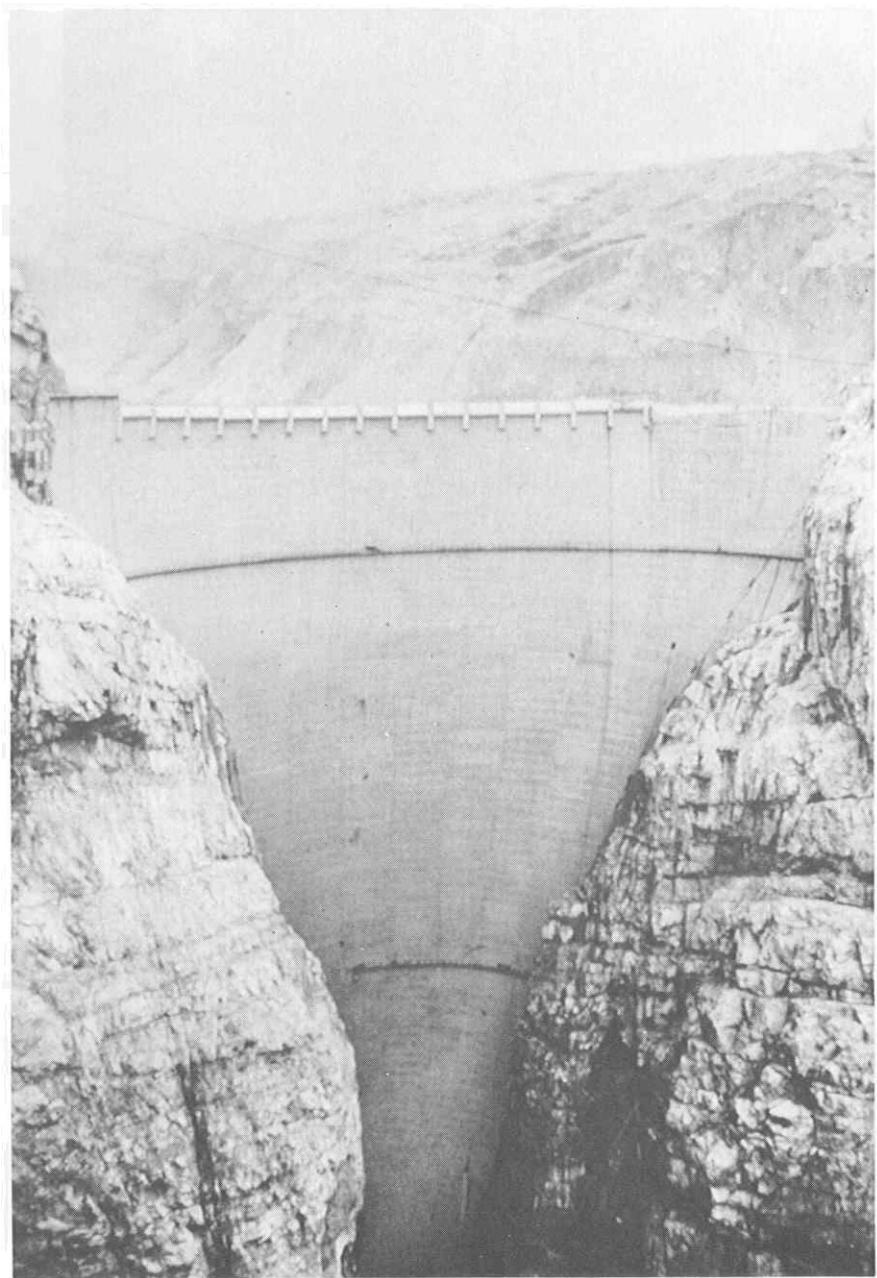
Figure 4-24.—Vajont Dam after failure, looking upstream at slide mass. P-801-D-79376.

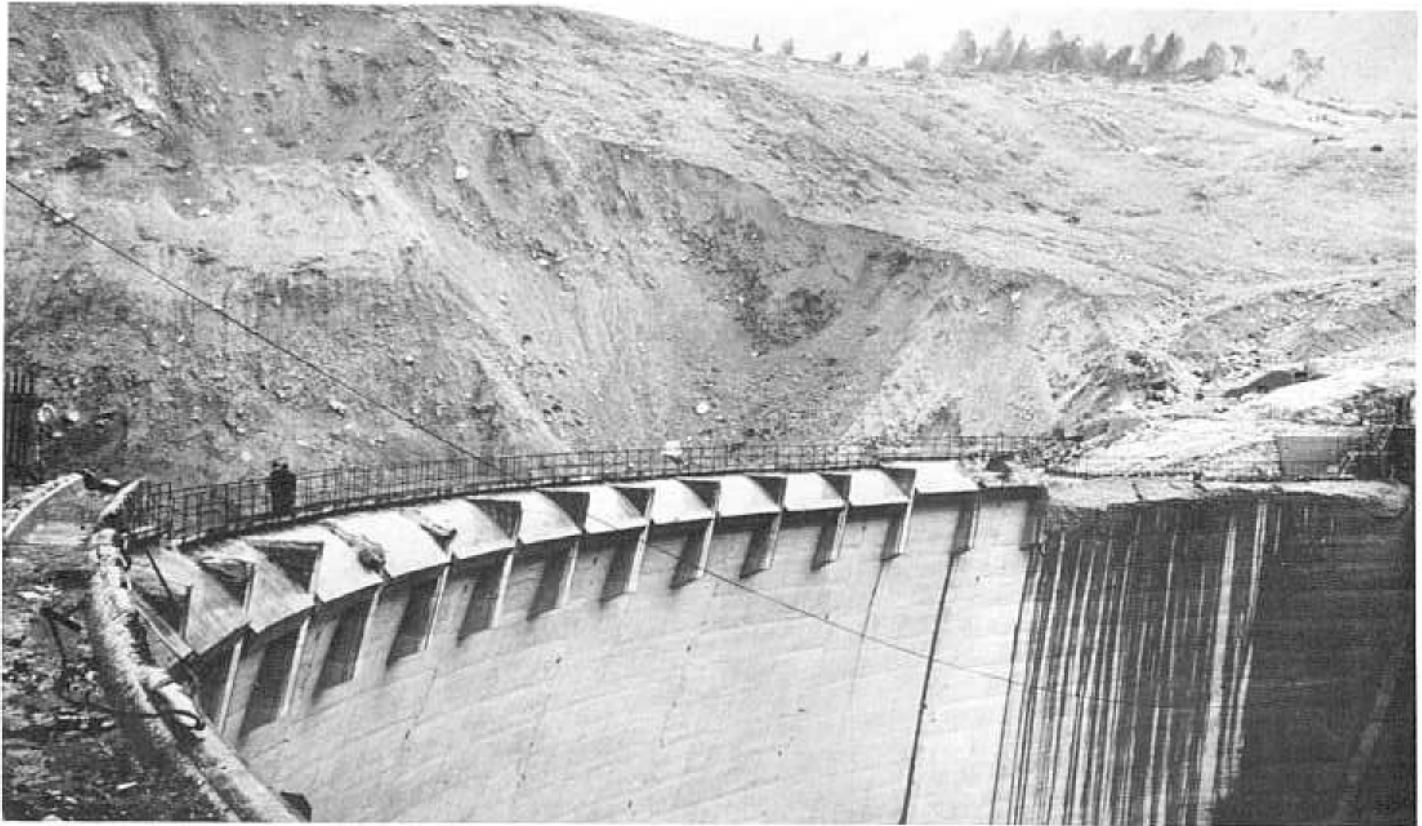
Figure 4-25.—Vajont Dam showing damage to top of dam and spillway. P-801-D-79377.

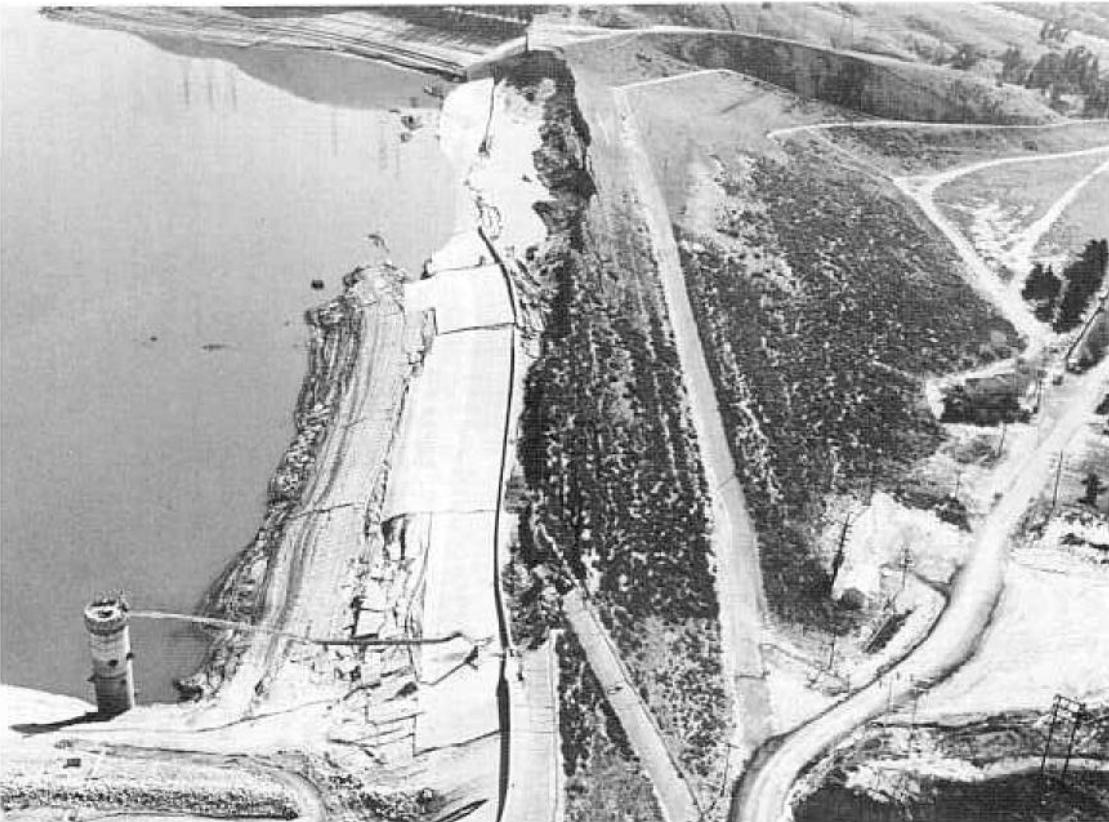
Figure 4-26.—Lower Van Norman (San Fernando) Dam after earthquake of February 9, 1971 (Courtesy, Calif. Dept. of Water Resources). P-801-D-79378.

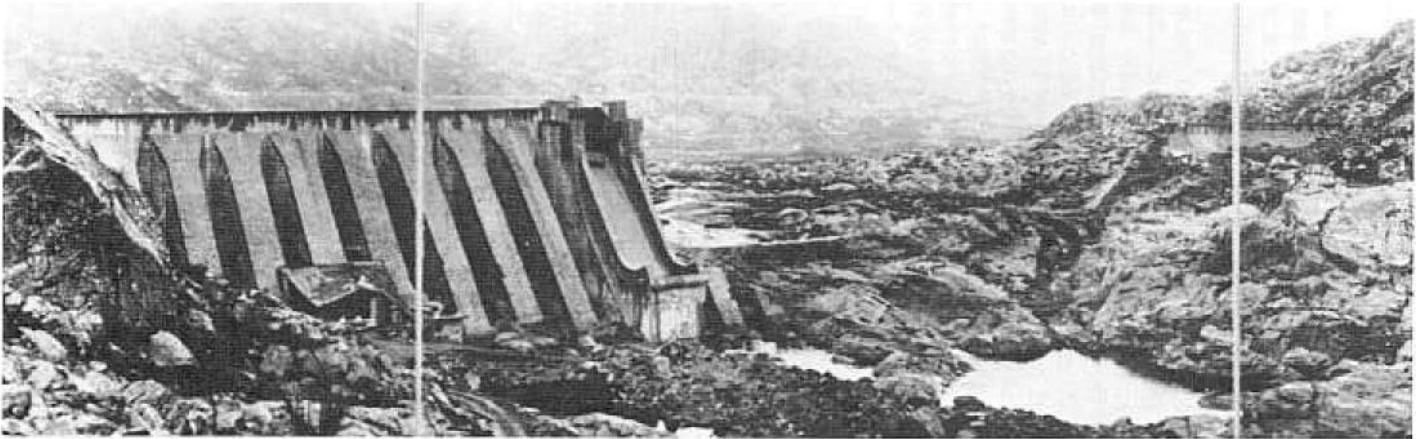
Figure 4-28.—Vega de Tera Dam after failure (Courtesy, Comité Nacional Español, ICOLD). P-801-D-79380.

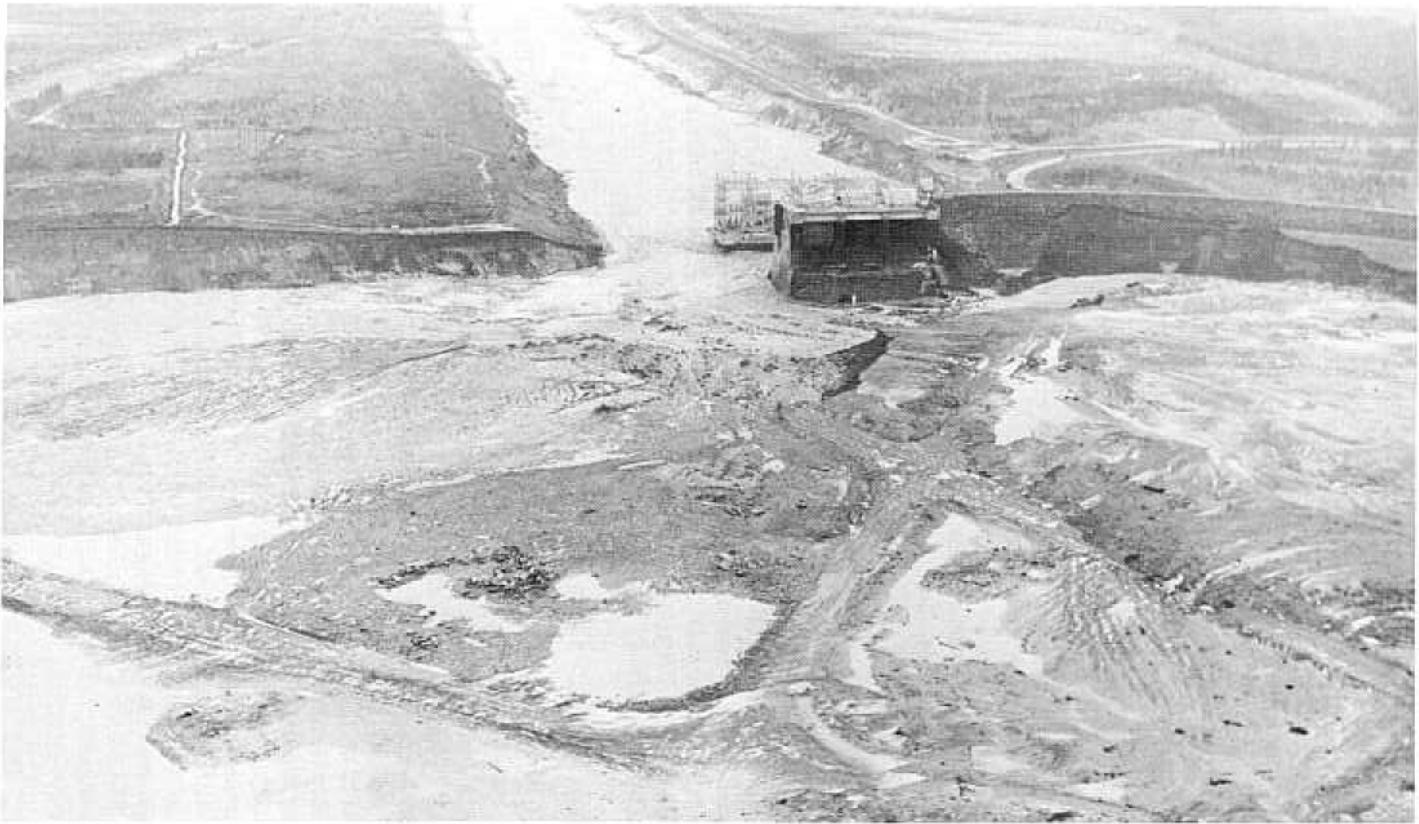
Figure 4-29.—Walter Bouldin Dam after failure (Courtesy, The Alabama Power Company). P-801-D-79381.

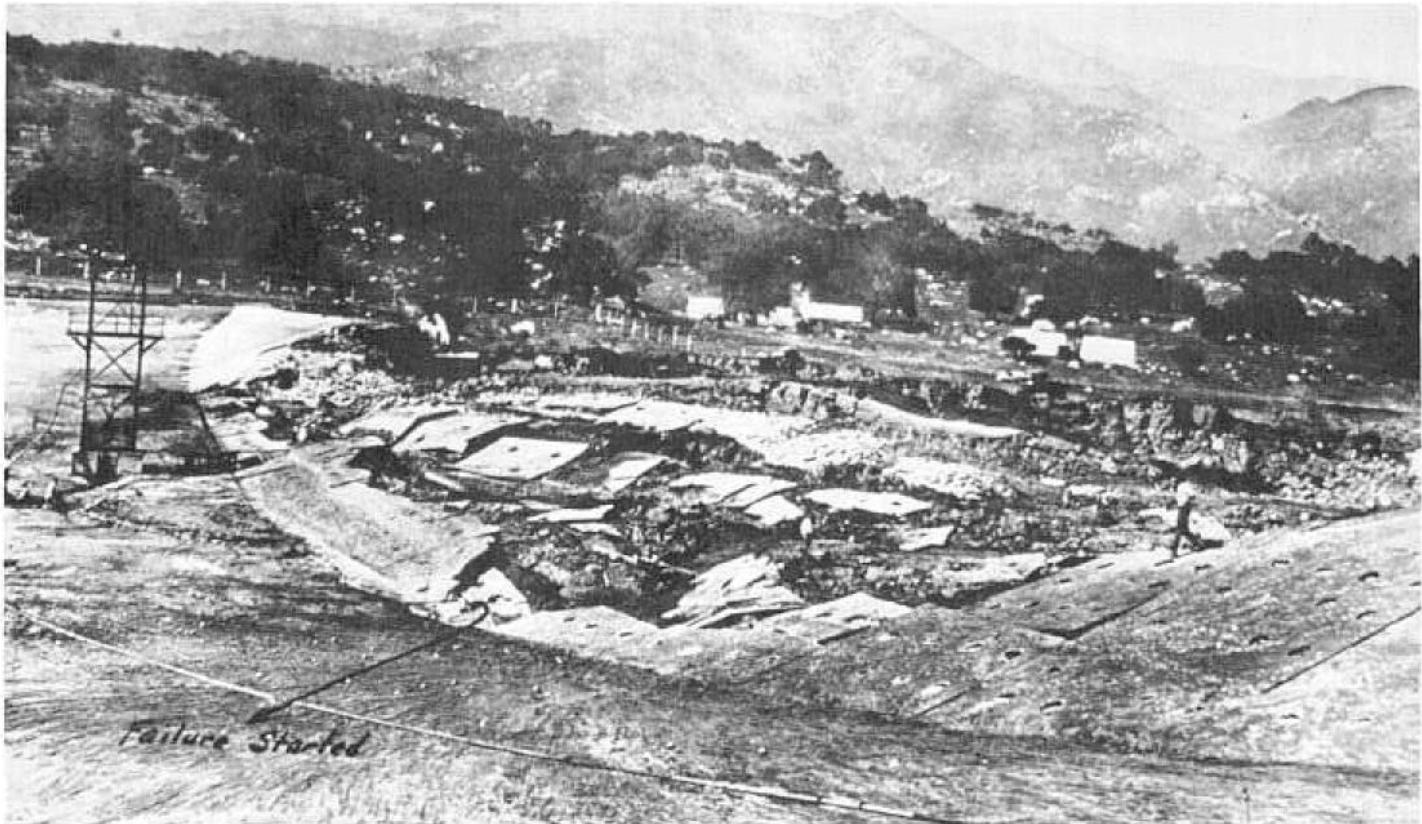
Figure 5-1.—Sheffield Dam following failure (Courtesy, Calif. Dept. of Water Resources. P-801-D-79382).

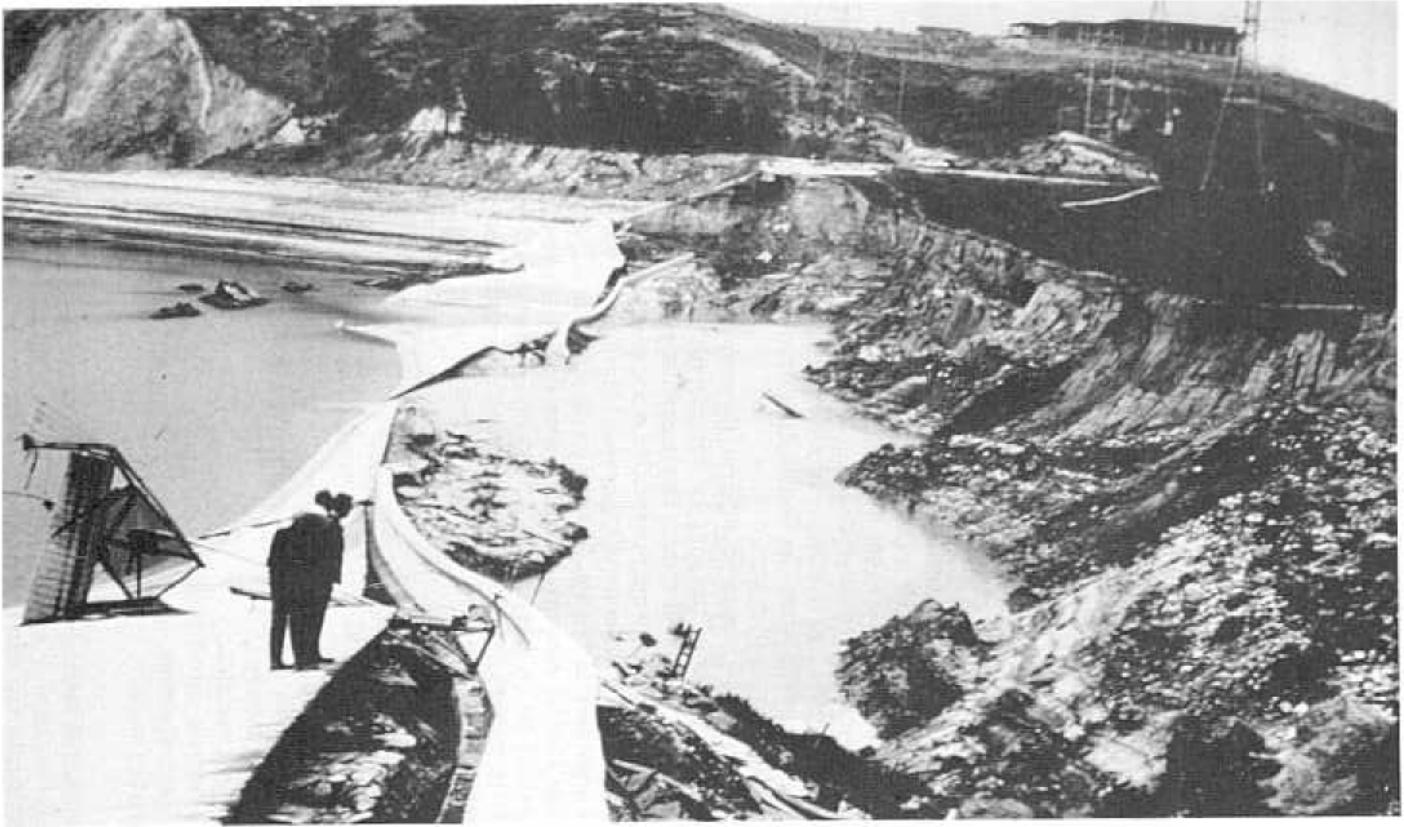
Figure 5-2. Upstream face of Lower Van Norman (San Fernando) Dam after failure (Courtesy, Calif. Dept. of Water Resources). P-801-D-79383.

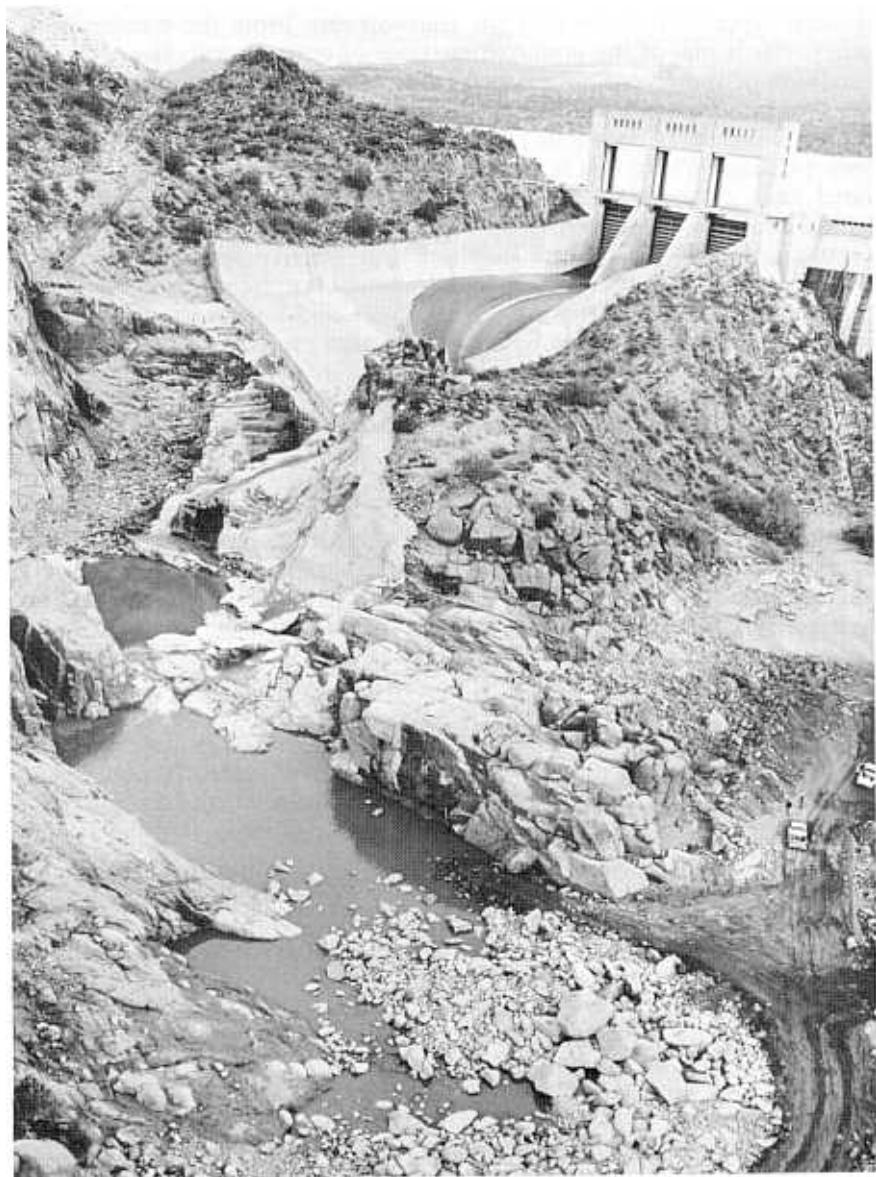
Figure —Spillway damage
