Dams and Public Safety

A Water Resources
Technical Publication

U.S. DEPARTMENT OF THE INTERIOR
Bureau of Reclamation

**By
Robert B. Jansen**

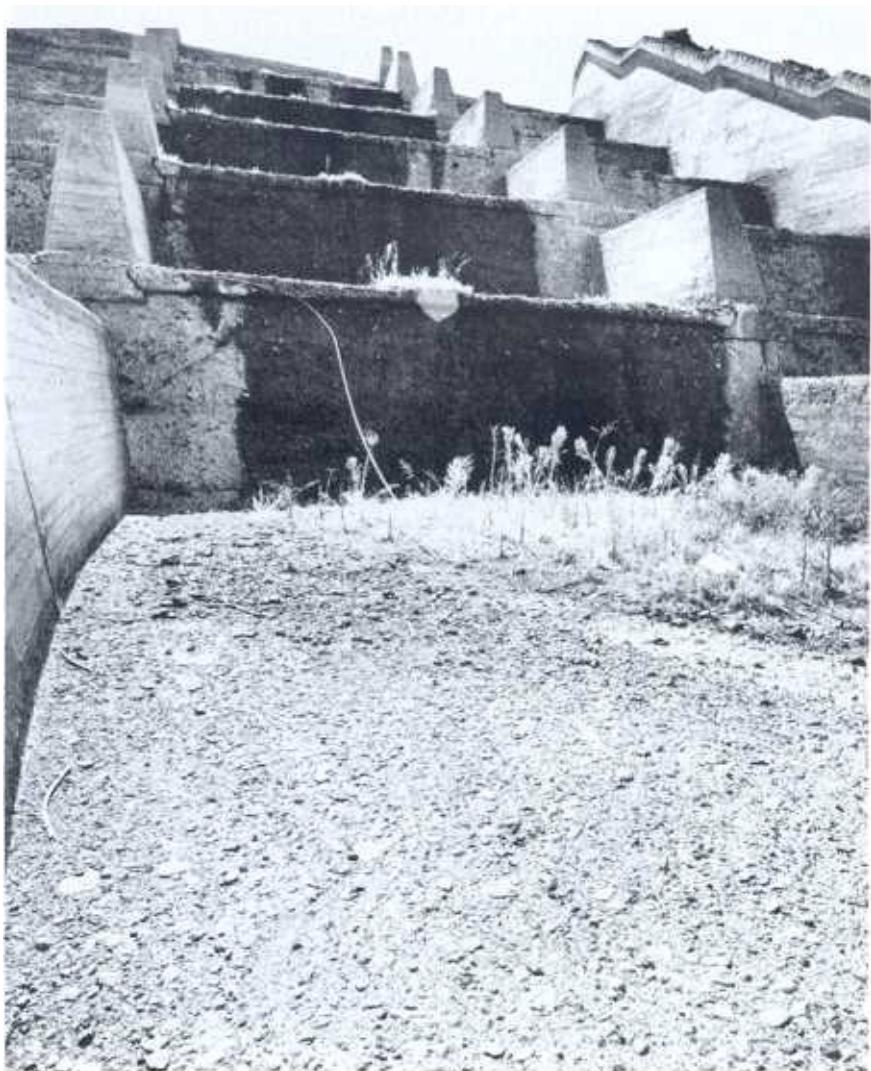
Figure 5-5.—Lahontan Dam, spillway damage. P-801-D-79386.

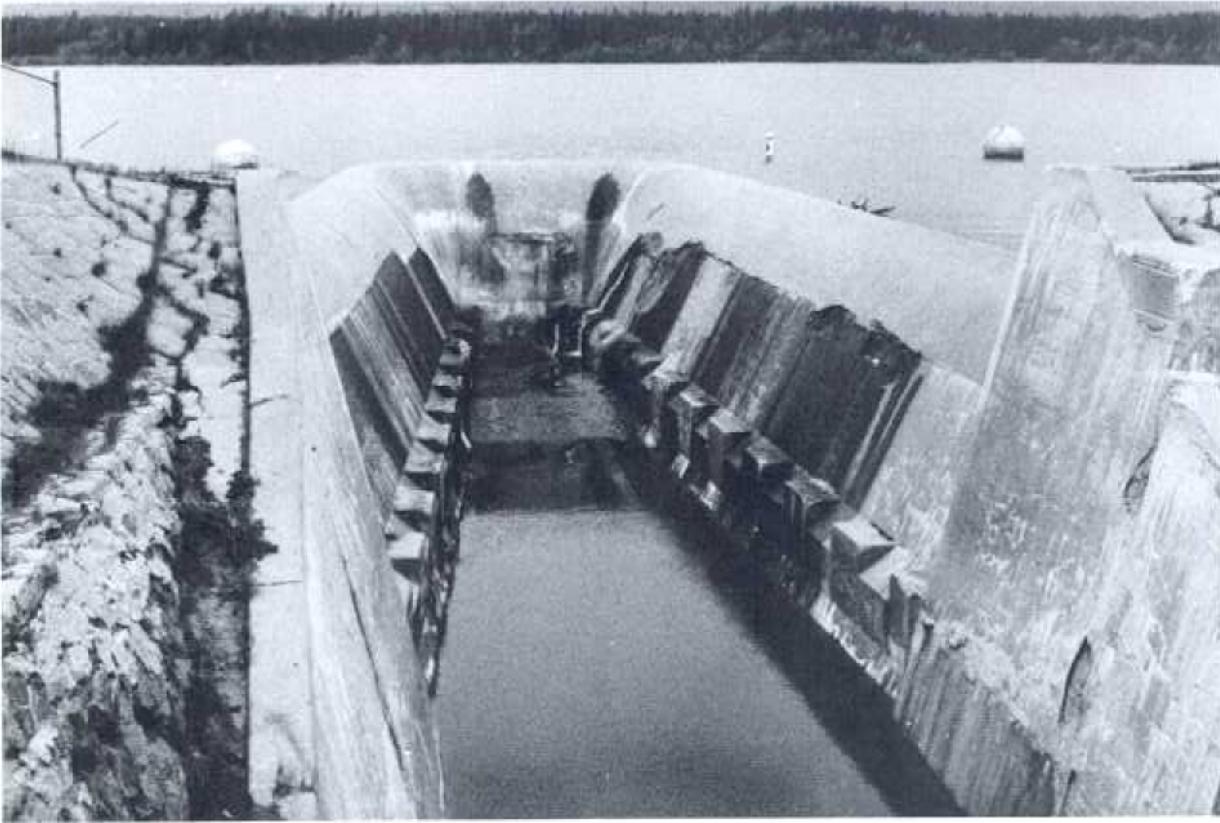
Figure 5-6.—Island Park Dam, spillway damage. P-801-D-79387.

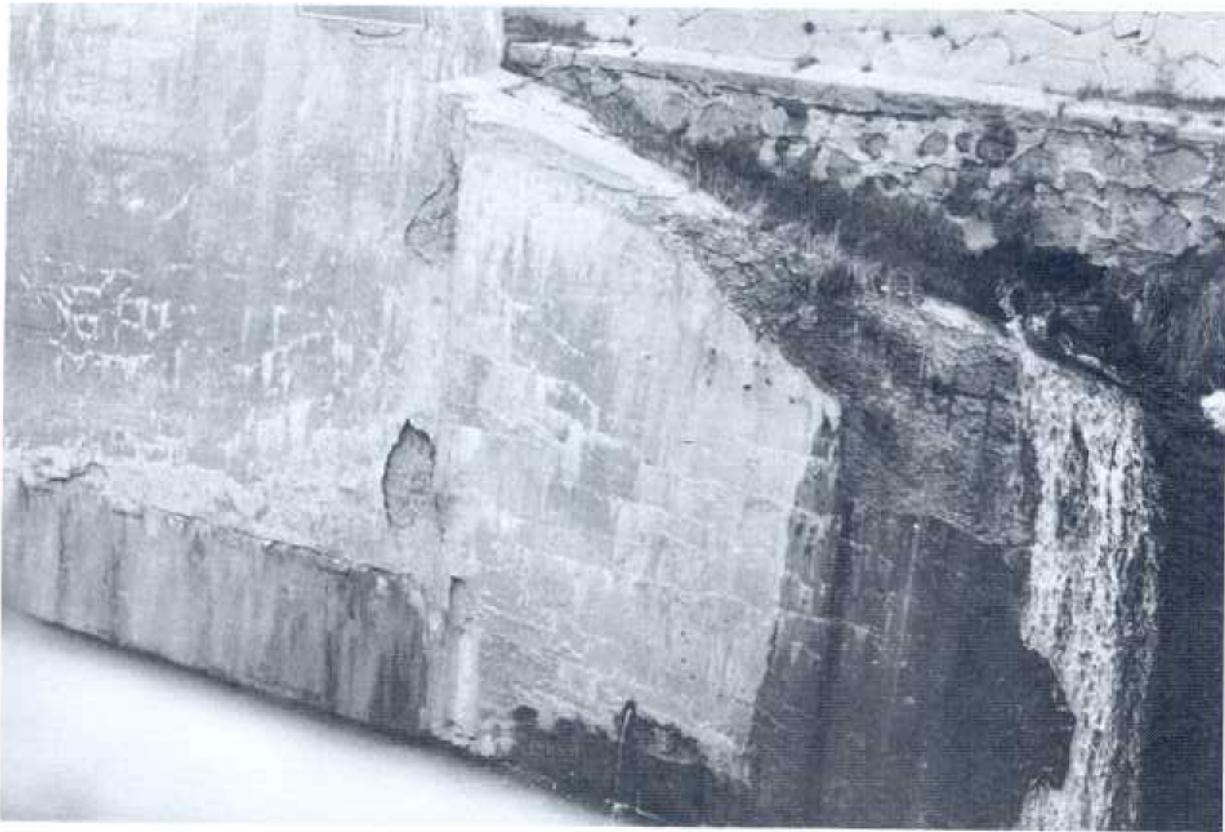
Figure 5-7.—Island Park Dam, closeup of spillway damage. P-801-D-79388.

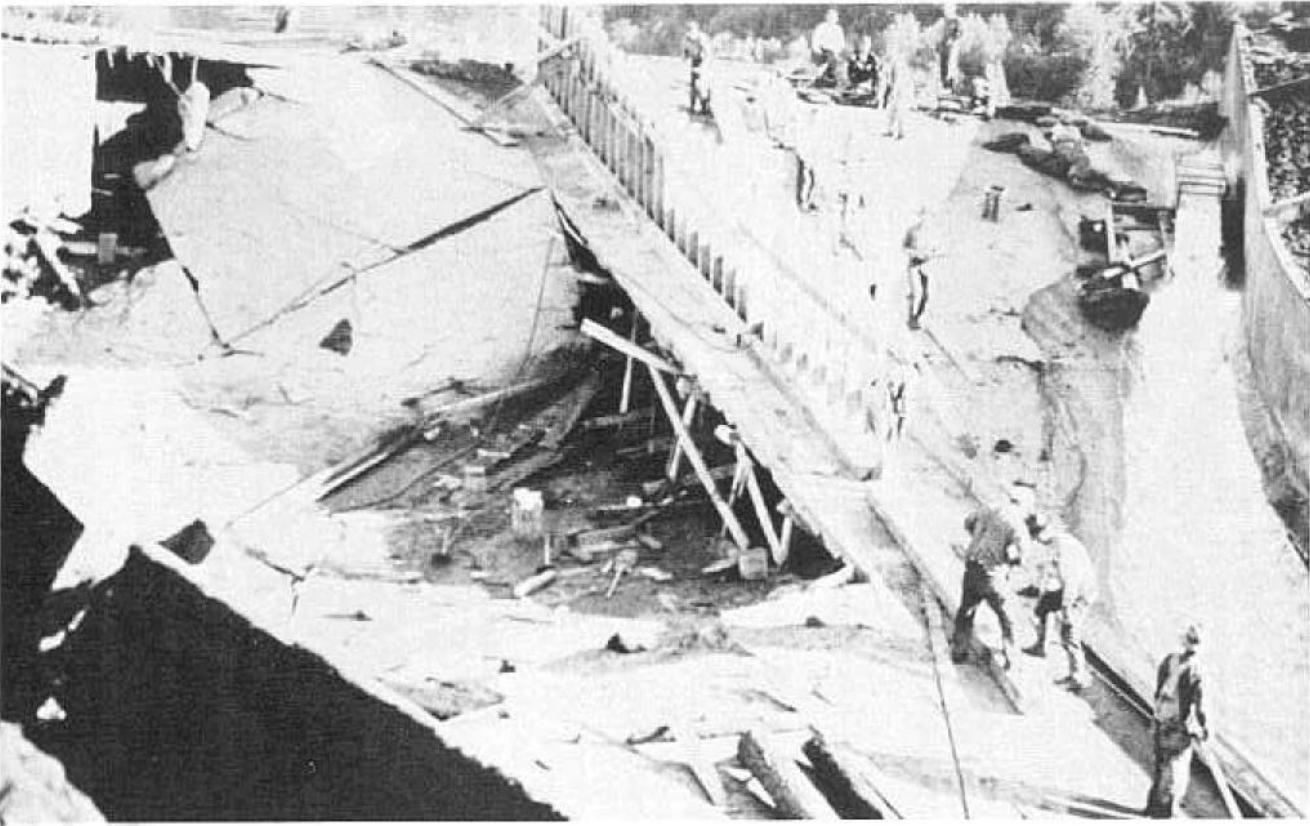
Figure 5-8.—Damaged spillway on embankment—Middle Fork Dam (Courtesy, Calif. Dept. of Water Resources). P-801-D-79389.
