D-8312  
PRJ-13.00

Subject: Interim Guidelines for Embankment Drain Inspections, Evaluation and Follow-Up Activities

## Guidelines for Embankment Drain Inspections, Evaluation, and Follow-Up Activities

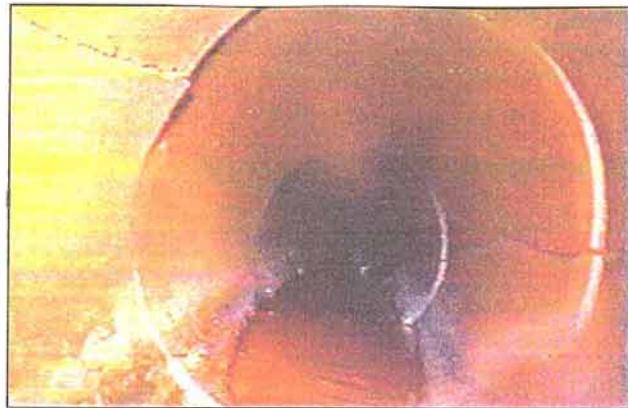
**Figure D-2.**—Extensive longitudinal cracking within a clay tile pipe.

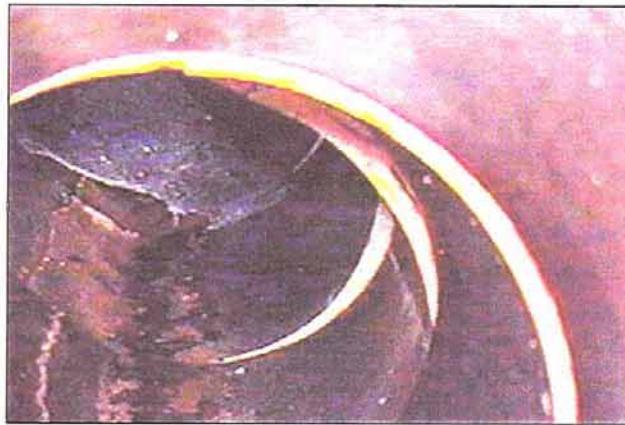
**Figure D-3.**—Extensive joint offsetting within a clay tile pipe.

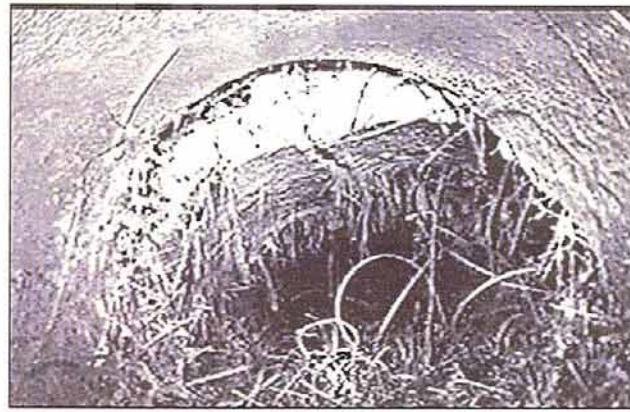
Shape deformation and failure were observed in 24 percent of all clay tile pipes. Shape deformation ranged from minor to extensive. Figure D-4 shows a clay tile pipe experiencing a failure of the crown.

**Figure D-4.**—Clay tile pipe experiencing inward collapse of the crown.

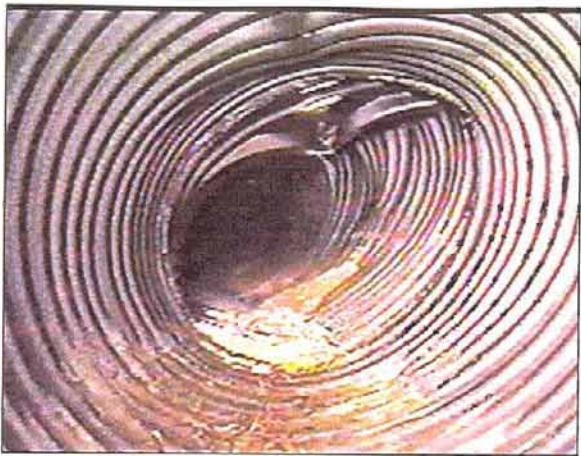
- *HDPE.*—Shape deformation and failure was observed in 56 percent of all HDPE pipes. Shape deformation ranged from minor to extensive. Figure D-5 shows an HDPE pipe experiencing extensive shape

**Figure D-5.**—HDPE pipe experiencing extensive shape deformation.

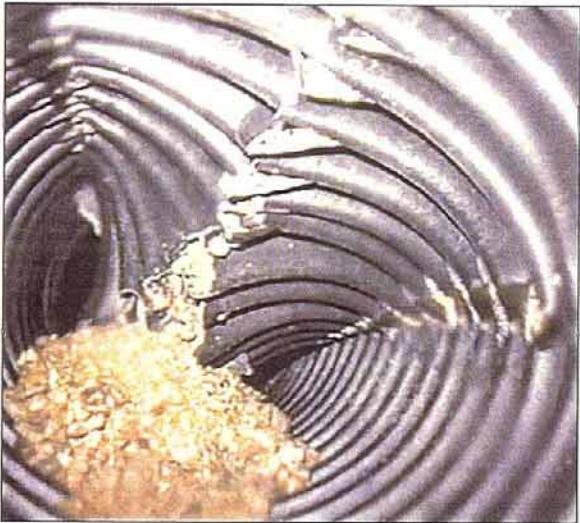
**Figure D-6.**—HDPE pipe experiencing failure at the crown. Materials surrounding the pipe have entered through the failure.

deformation. Figure D-6 shows an HDPE pipe that has experienced failure.

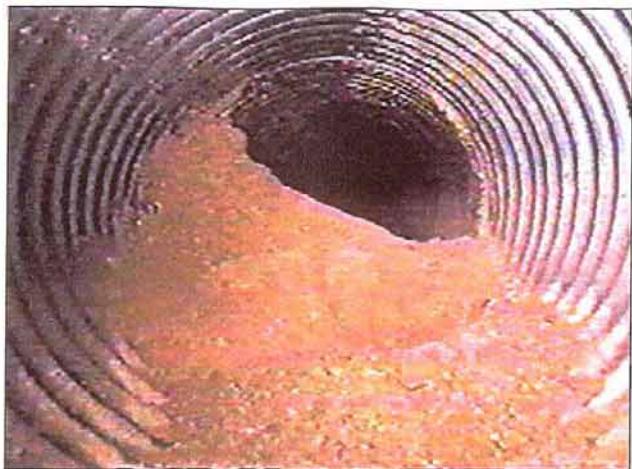
Joint offsets and separations were observed in 11 percent of all HDPE pipes. Joint offsets and separations ranged from minor to extensive. Figure D-7 shows an HDPE pipe joint that has experienced an extensive separation and has allowed materials surrounding the pipe to enter through the separated joint.

**Figure D-7.**—An HDPE pipe joint has experienced extensive separation. Materials surrounding the pipe have entered through the separated joint.

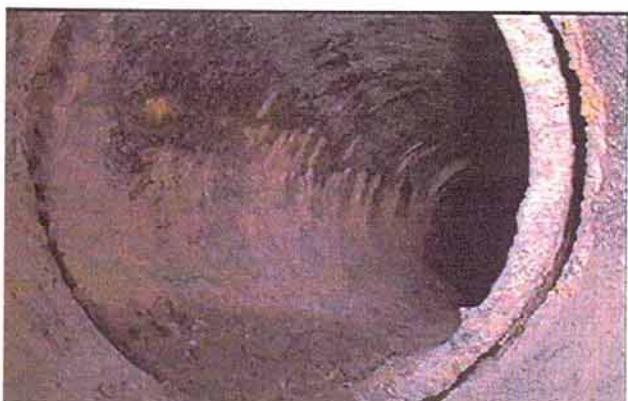
**Figure D-10.**—Concrete pipe experiencing extensive joint offset and separation at a bend in the pipe.

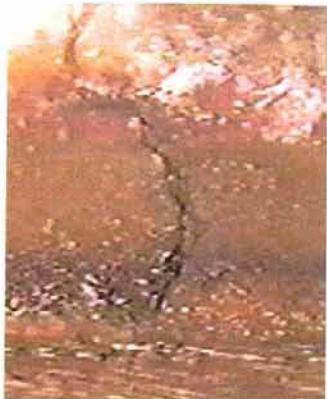
Cracks were observed in 42 percent of all concrete pipes. Cracks ranged from hairline to extensive. Figure D-11 shows a concrete pipe that has experienced extensive transverse cracking.

**Figure D-11.**—Extensive transverse cracking within a concrete pipe.

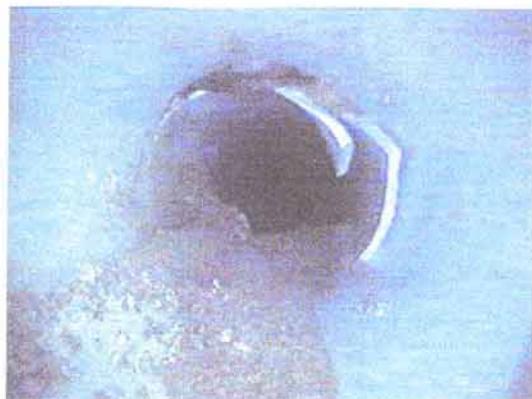
- *Asbestos cement, PVC, and iron.*—A few cracks and joint offset/separation observations were noted within asbestos cement, PVC, and iron pipe. Figure D-12 shows a PVC pipe that has experienced extensive transverse cracking.
- *Plugging mechanisms.*—Plugging mechanisms can affect the performance of pipe perforations and slots and also the conveyance of collected seepage water. The most common plugging mechanisms encountered were (the percentages shown are based on the number of embankment drain systems

**Figure D-12.**—PVC pipe experiencing extensive transverse cracking.

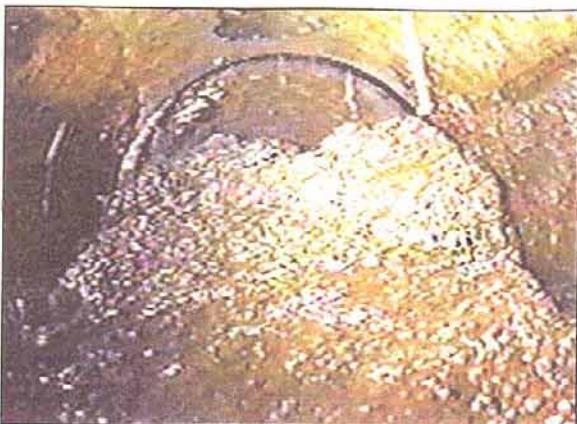
**Figure D-13.**—Accumulation of sediments has resulted in plugging of the pipe.

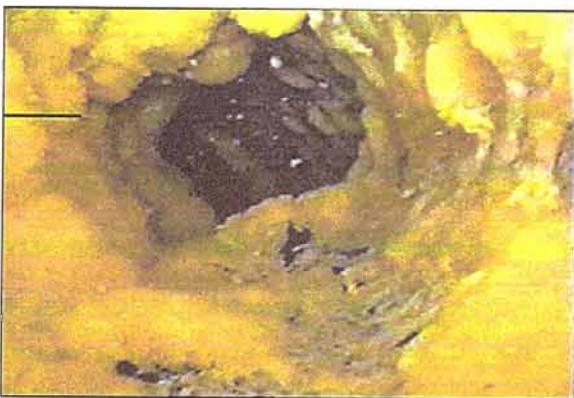
**Figure D-14.**—Biofouling has resulted in plugging of the pipe.

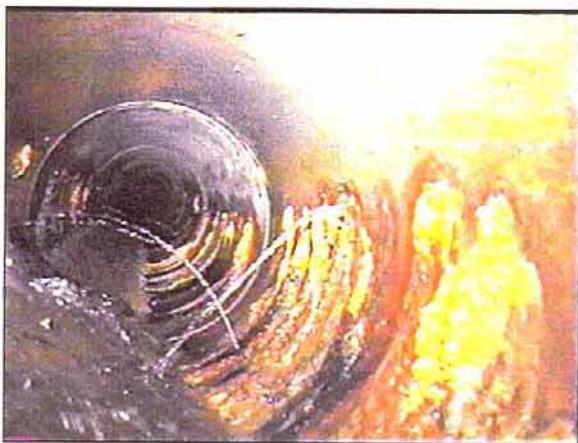
**Figure D-15.**—Mineral incrustation has resulted in plugging of a number of the pipe perforations.

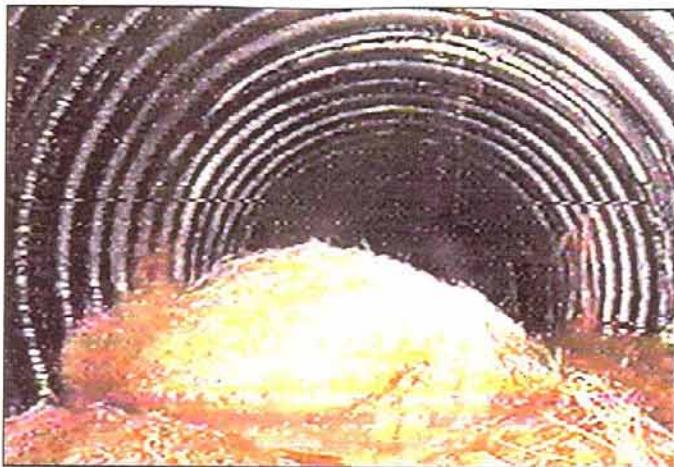
**Figure D-16.**—Root growth has resulted in partially plugging the pipe.
