R-94-08

PRESTRESSED CONCRETE PIPE FAILURE JORDAN AQUEDUCT, REACH 3

July 1994

**U.S. DEPARTMENT OF THE INTERIOR
Bureau of Reclamation
Denver Office
Research and Laboratory Services Division
Materials Engineering Branch**

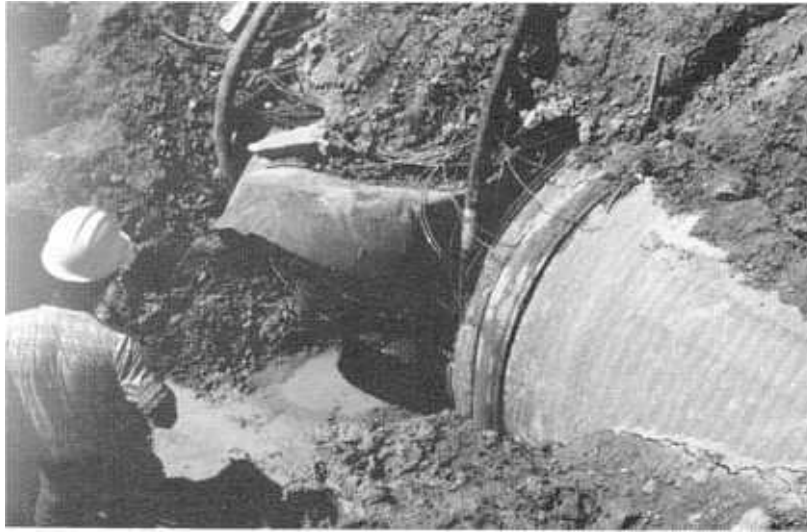
Pipe unit 797, which burst, was designed for 400 feet of head and 10 feet of earth cover. This unit was located 160 feet from a cathodic protection ground bed. Observations of the rupture disclosed that the No. 8-gage (0.162-inch-diameter) prestressing wire (class III) failed near spring line for a length along the pipe of about 7 feet (fig. 3). Wire fractures exhibited cup-and-cone matching surfaces with essentially no macroscopically observable reduction in area (figs. 4 and 5). The 5-1/4-inch-thick core and steel cylinder failed slightly below spring line.

Unit 797 failed while under a static head of 366 feet. Analyses for transients indicated that operating procedures were not likely the cause for the rupture.

Figure 3. Burst pipe unit 797, station 1428+60.

Examination of the wire through several inspection windows along the pipeline revealed defective wire throughout the prestressed section. Therefore, all 2.3 miles were rehabilitated by lining with steel prior to commissioning for service.

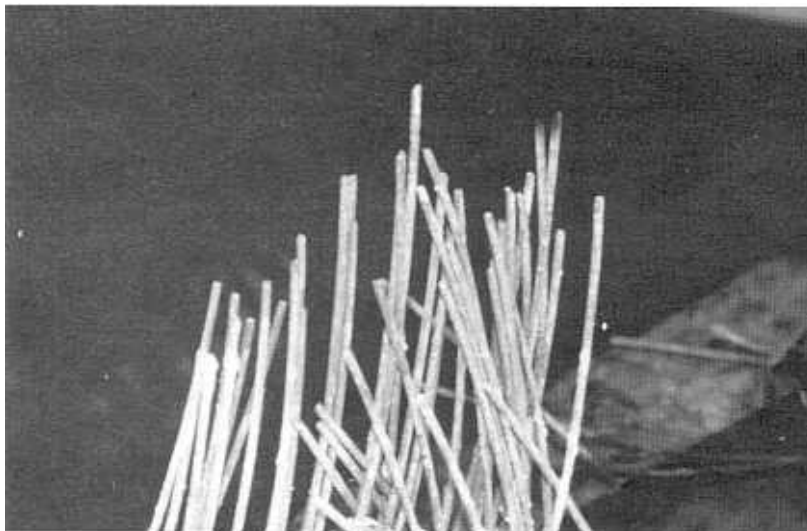
of the wire from the failed pipe section showed a combination of two types of failure, including a cup and cone ductile failure in combination with a sharp tongue formed by an offset between longitudinal cracks in the wire. This finding indicated the failure was initiated by stress concentrations at the termini of the longitudinal cracks.

Figure 4. Fractured ends of prestressing wire at rupture.

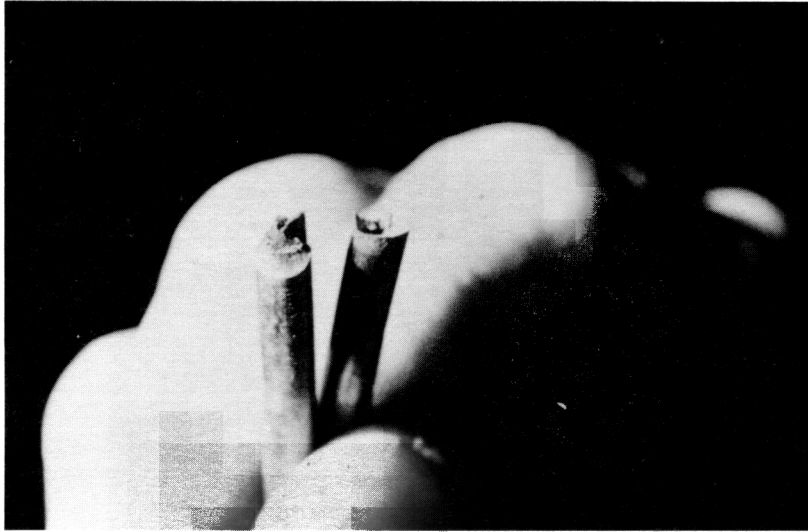
Figure 5. - Characteristic cup and cone fracture.

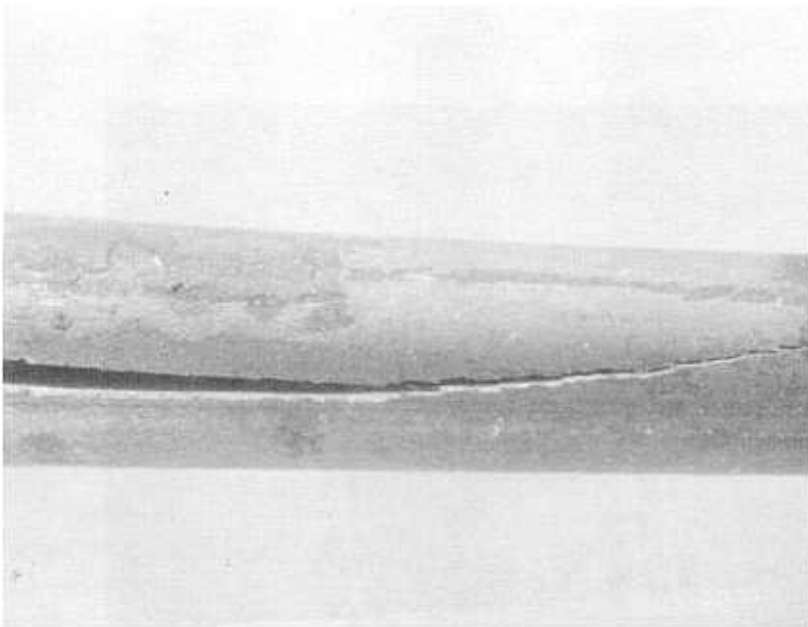
Closer examination after rupture revealed that the wire was cracked along its longitudinal axis (fig. 6). The crack, when forced open, revealed an oxidized layer and dark red deposits on the crack surfaces (figs. 7 and 8).

Figure 6. - Longitudinal crack along surface of prestressing wire, about 9X.

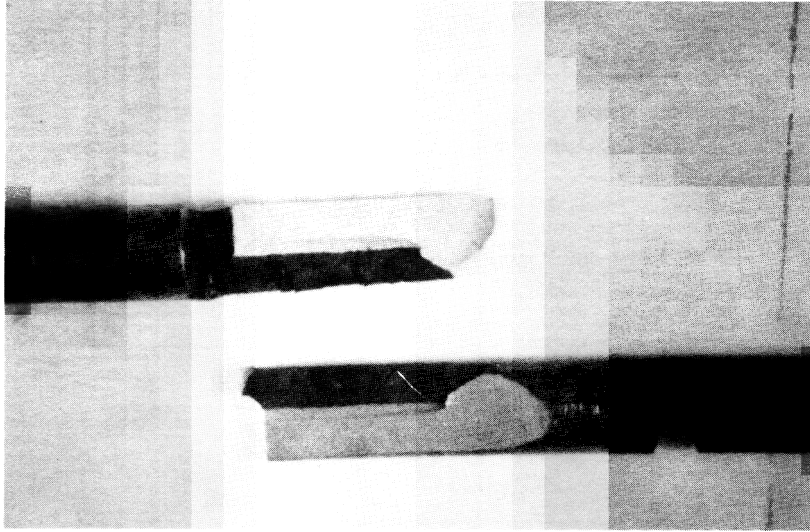
Figure 7. - Wire after forcing to split open. Dark surface is oxidized; light surface is freshly fractured, about 3X.

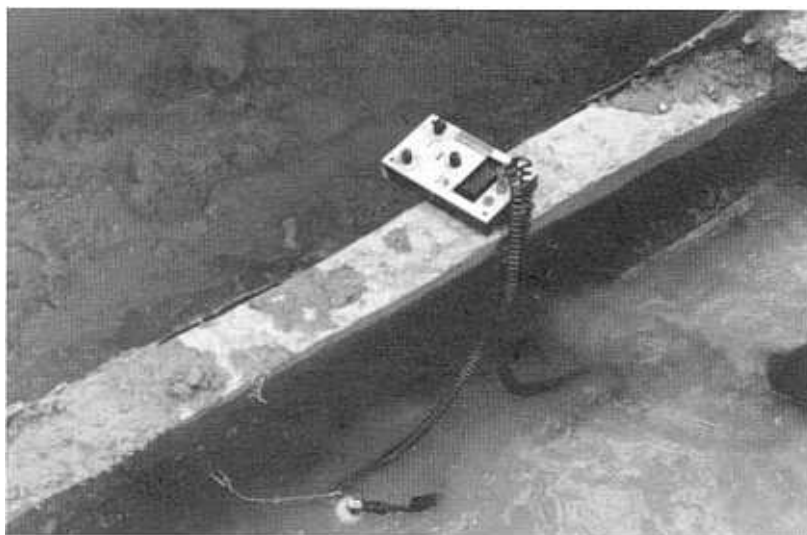
A potential survey conducted soon after failure revealed a polarized potential of -1.16 volts at the ground bed near the ruptured unit. Following failure, the ruptured pipe exhibited a polarized potential of -0.96 volt. Further, a potential survey of each wire coil with a close electrode disclosed a maximum wire polarized potential of -1.07 volts (fig. 10).

Figure 10. Testing for polarized potential of individual wire coils with reference to the coil under test.

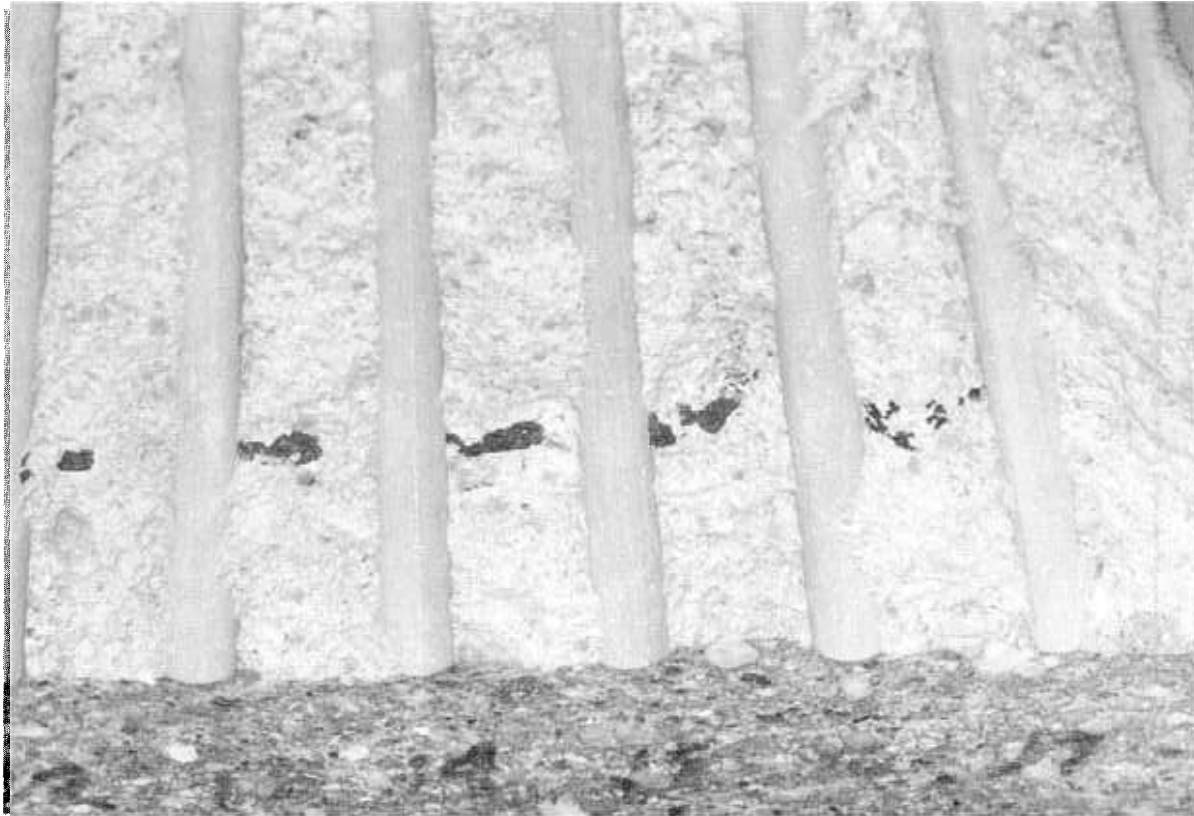
Because petrographic examinations of the mortar coating had disclosed ridges in the concavity formed by the wire, the coating opposite wider, longitudinal cracks in the wire was closely inspected. In many cases, the surfaces of the concavity exhibited a ridge or imprint of the corresponding longitudinal crack (figs. 12 to 14). X-ray spectral analyses showed the ridge, the smooth surfaces of the concavity, and the fractured mortar surfaces between concavities to be of the same elemental composition. The major constituent was calcium, and moderate amounts of silicon and aluminum were found. No cracking of the mortar was observed beneath the ridges (fig. 15).

Figure 12. - Mortar coating opposite the prestressing wire. Note line in center of the middle concavity, about 2.5X.

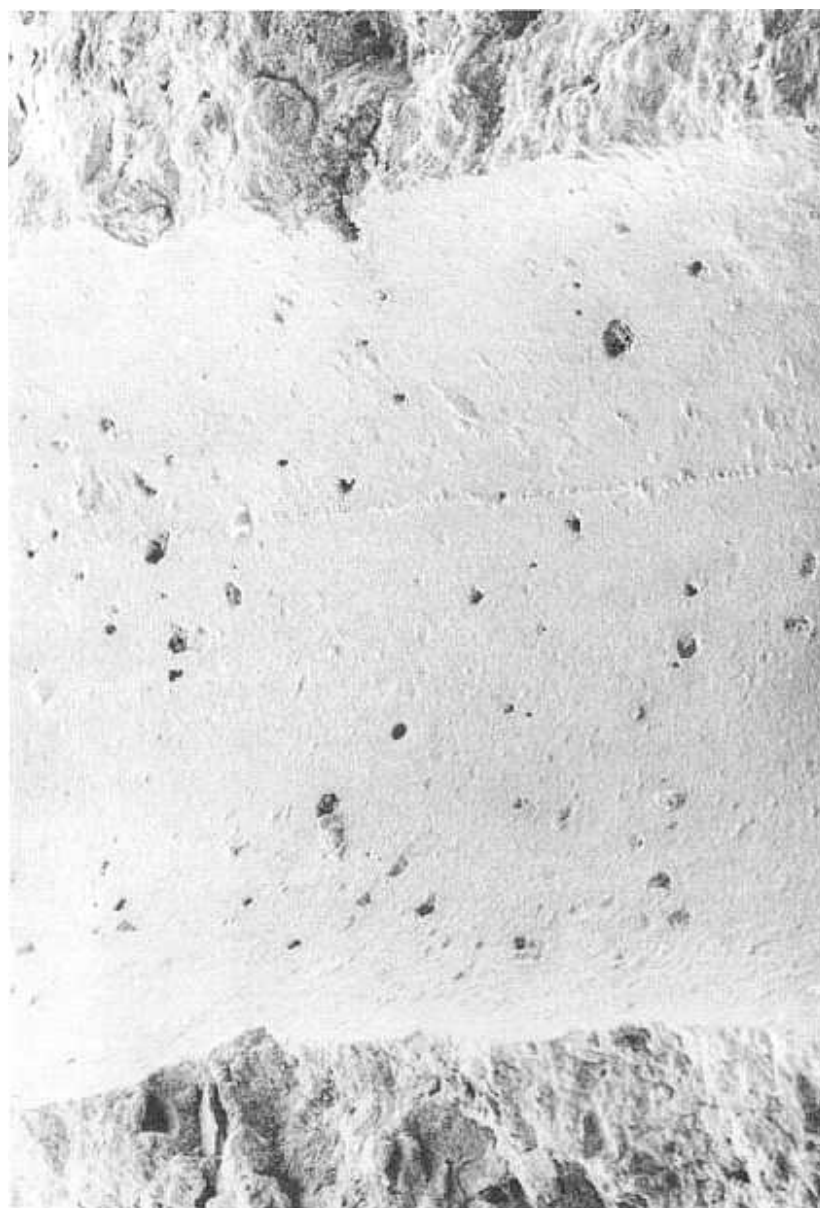
Figure 13. - Magnified view of ridge in concavity, about 30X.

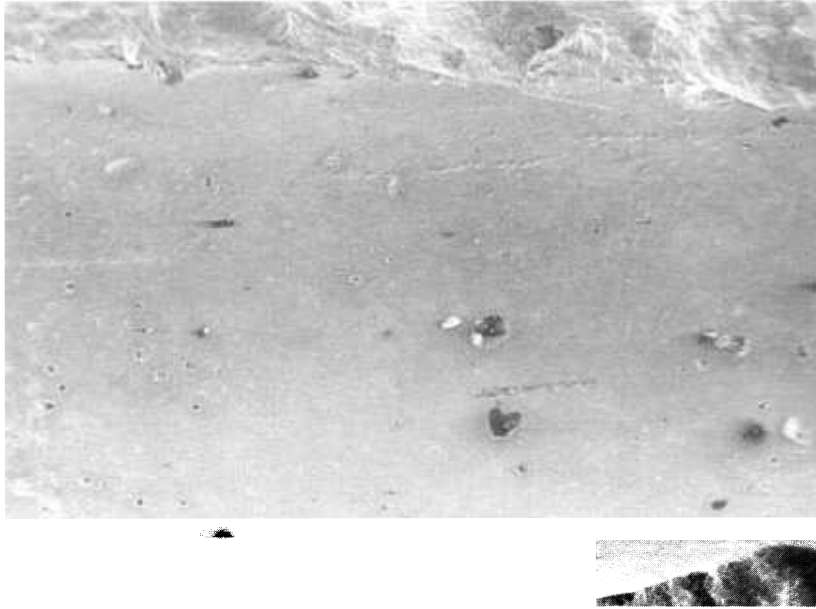
Figure 14. - Offsetting ridges in mortar concavity.

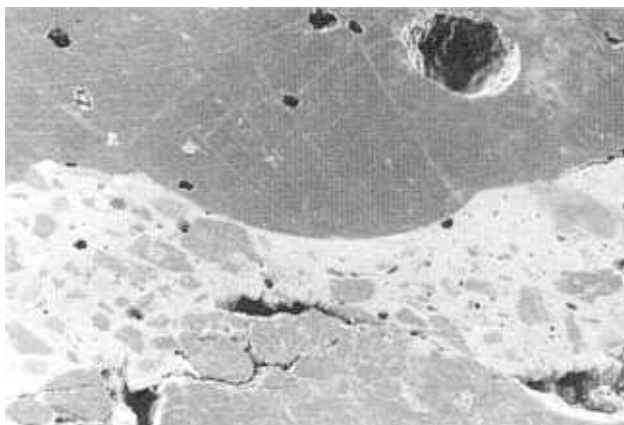
Figure 15. - Cross section of mortar coating concavity after encapsulating in plastic. No voids in mortar and no cracking of the mortar beneath ridge, about 14X.

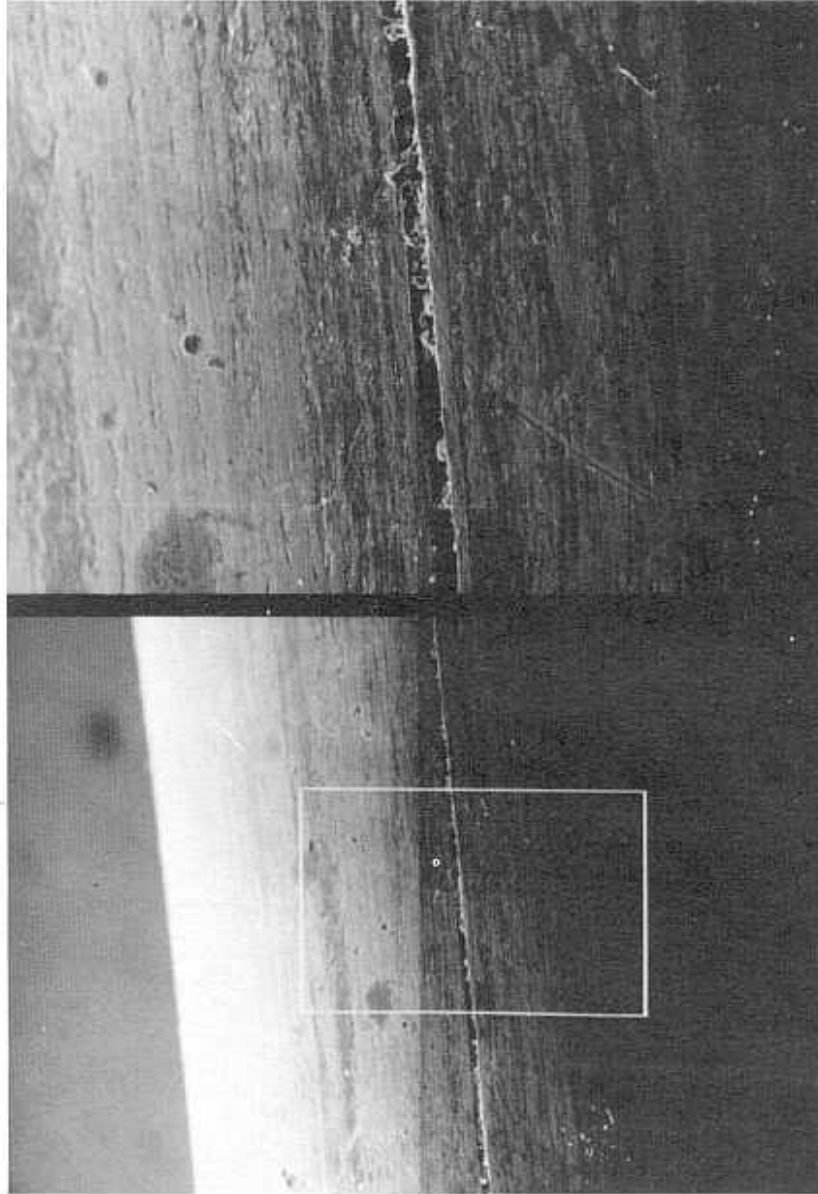
In some cases, particles of solid material were seen lodged within longitudinal cracks (figs. 16 to 20). Energy dispersive, elemental x-ray spectral analyses showed the major constituent of the particles to be silicon. The appearance of the particles was that of quartz grains.

Figure 16. - Particles lodged within longitudinal cracks. Right photo is enlargement of area on left photo bordered in white. Crack is about 25 micrometers wide.

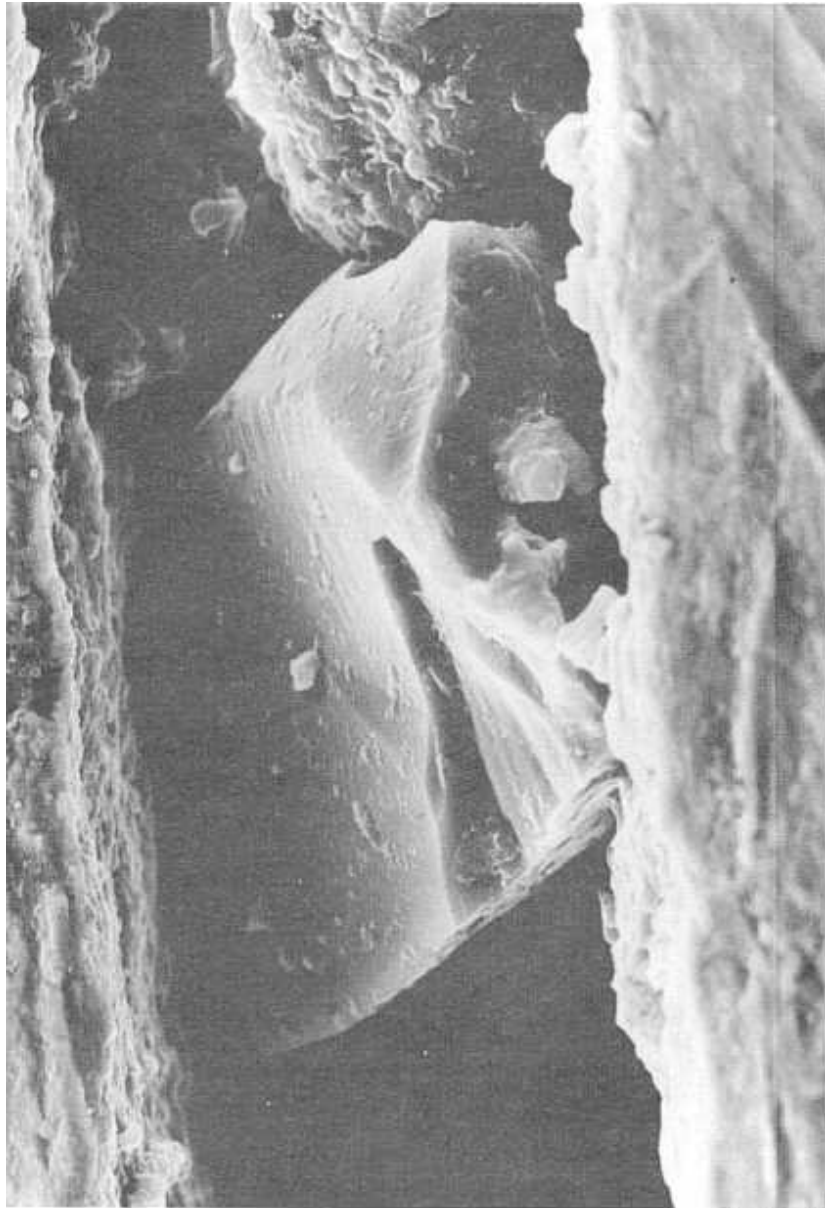
Figure 17. - Further enlargement of particles within the 25-micrometer-wide crack.

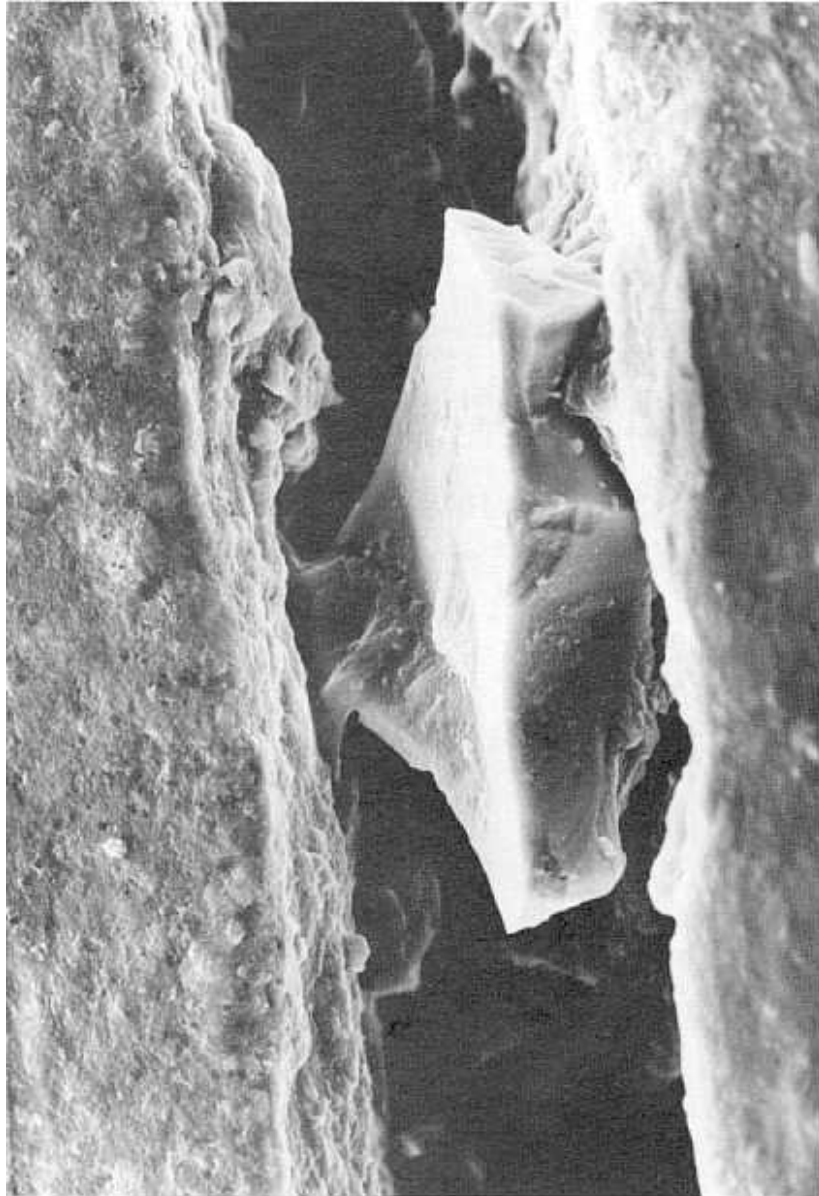
Figure 18. - Magnified view of particle in 22-micrometer-wide crack.

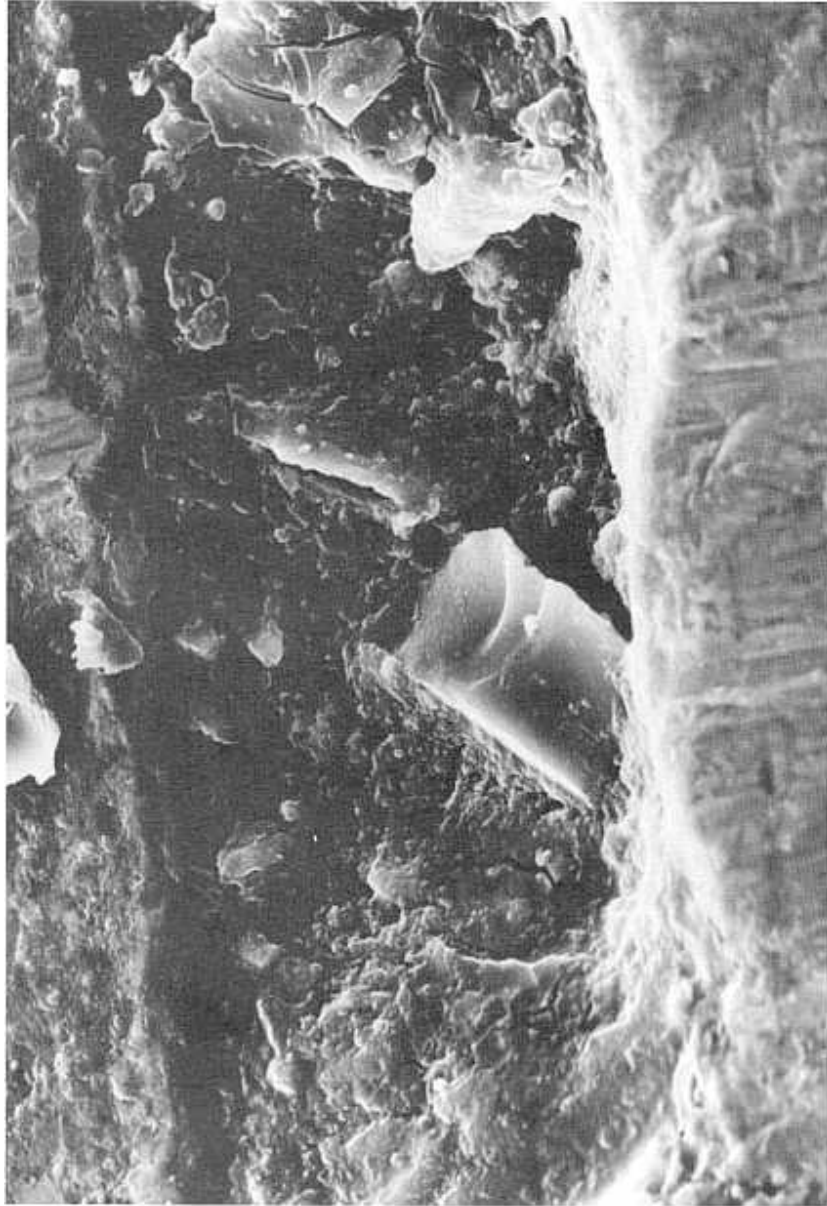
Figure 19. - Particles embedded in 27-micrometer-wide crack.

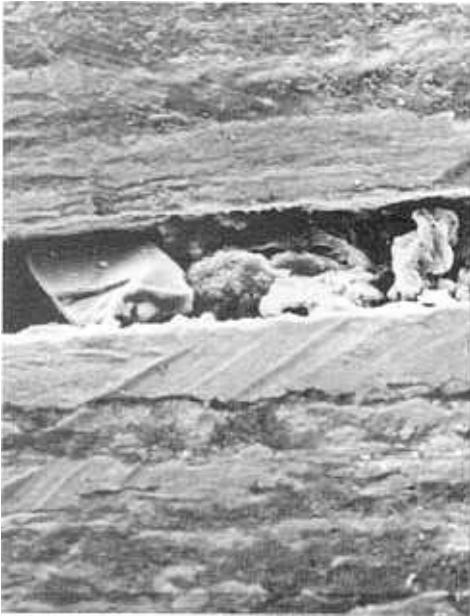
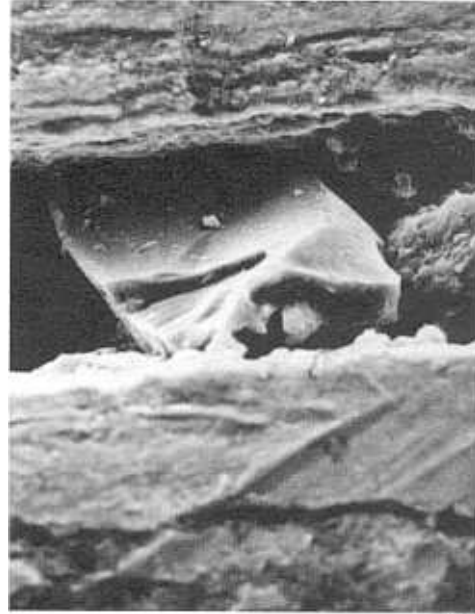
Figure 20. - Particles that have been lodged or impacted within longitudinal cracks.

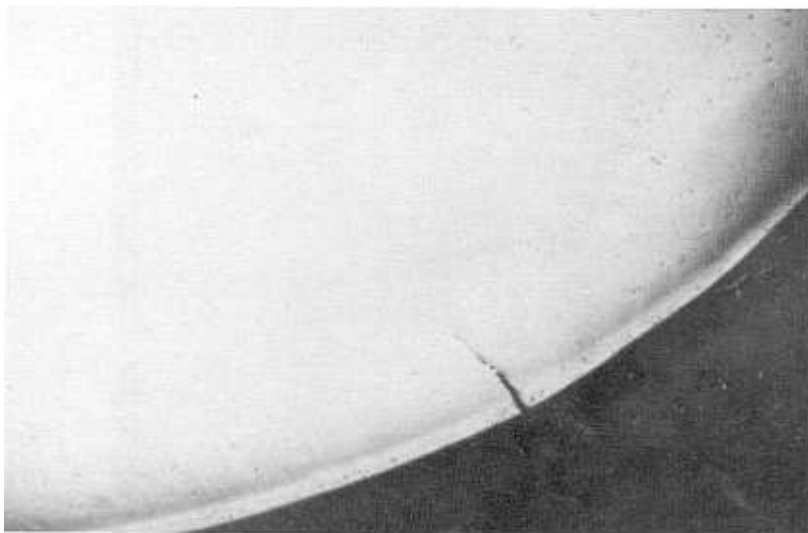
Metallographic examinations of the wire's cross section also showed that the longitudinal cracks were radially oriented and varied substantially from a few hundredths of an inch (fig. 21) to a radius or more in depth (fig. 22). On some cross sections, two parallel cracks on the wire surface could be seen to join or nearly join (fig. 23). Longitudinal sectioning exhibited many instances where longitudinal cracks overlapped or joined such that a filament of steel was observed between the cracks (figs. 24 and 25).

Figure 21. - Photomicrograph of wire cross section. Crack is 0.01 inches deep, about 80X.

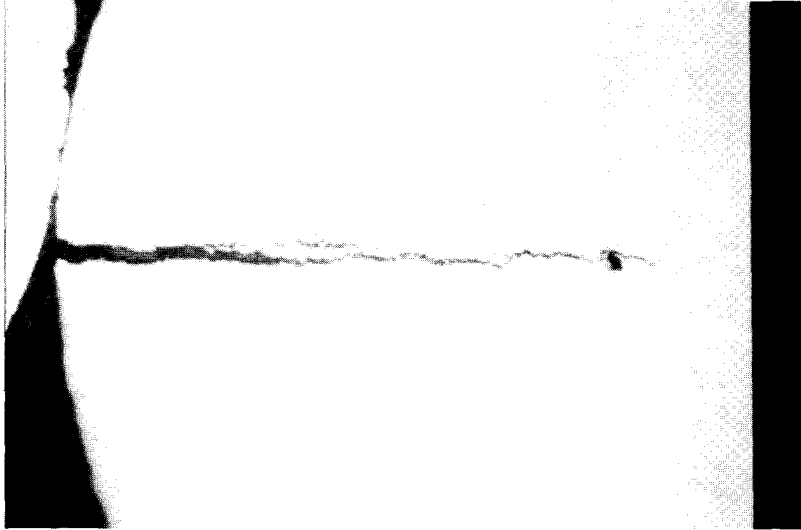
Figure 22. - Photomicrograph of wire cross section. Crack is 0.09 inches deep, about 35X.

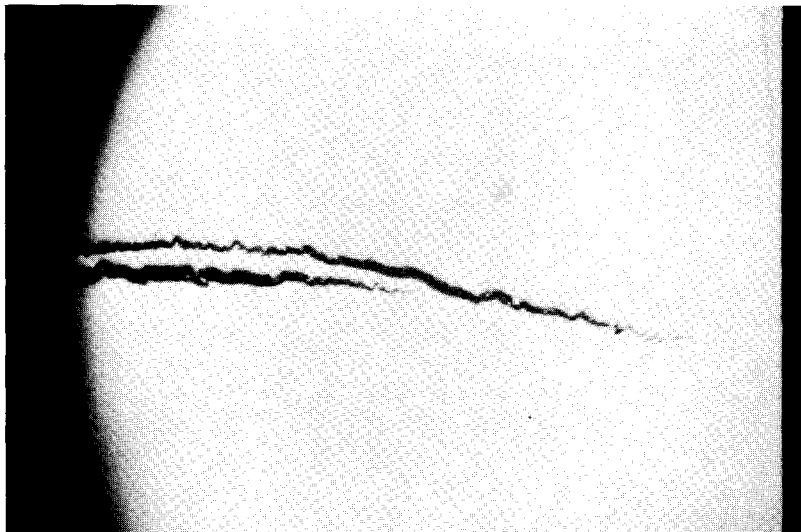
Figure 23. - Two longitudinal cracks have not quite joined in this cross section, about 35X.

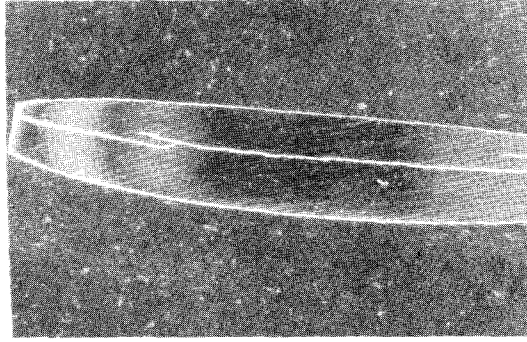
Figure 24. - Photomacrograph of a short length of wire after mounting in plastic and grinding to slight depth. Note overlapping and offsetting longitudinal cracks, about 3X.

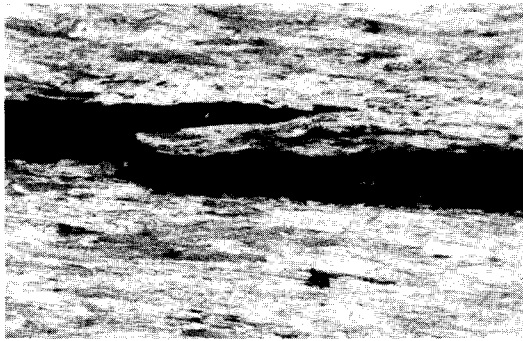
Figure 25. - Photomicrograph of longitudinal section. Notice the filament of steel between the cracks, about 200X.

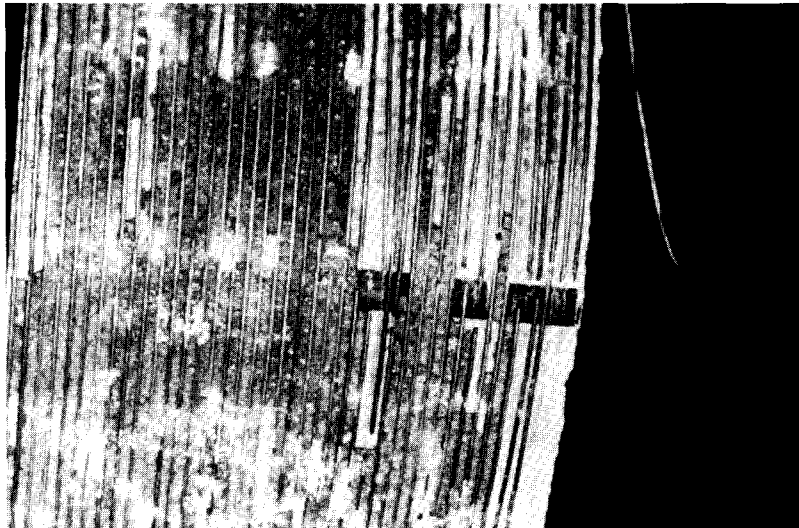
Transverse wire fractures. - The intact bell end of unit 797 exhibited many fractured coils (fig. 26) which were largely located over or near one of the bonding straps. This unit was oriented in service such that the bonding straps were at the 3 and 9 o'clock positions. Wire fractures were also noted on unit 798 (fig. 27) when the mortar coating was removed after pressure testing. However, they were fewer in number and randomly located about the pipe circumference. The bonding straps were at the 5 and 11 o'clock positions on this unit in service. No other wire fractures were observed at other locations along the line where windows were opened for wire inspection.

Figure 26. - Numerous wire fractures were observed opposite the bonding strap on unit 797. The unit was oriented in service such that the bonding straps were at spring line.

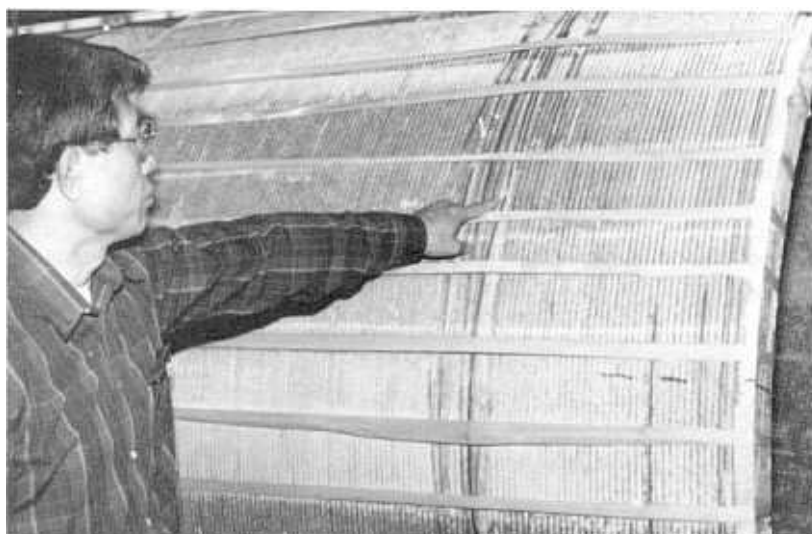
Figure 27. - Fewer and randomly located fractures were found on unit 798. The bonding straps were at the 5 and 11 o'clock positions on this unit in service.

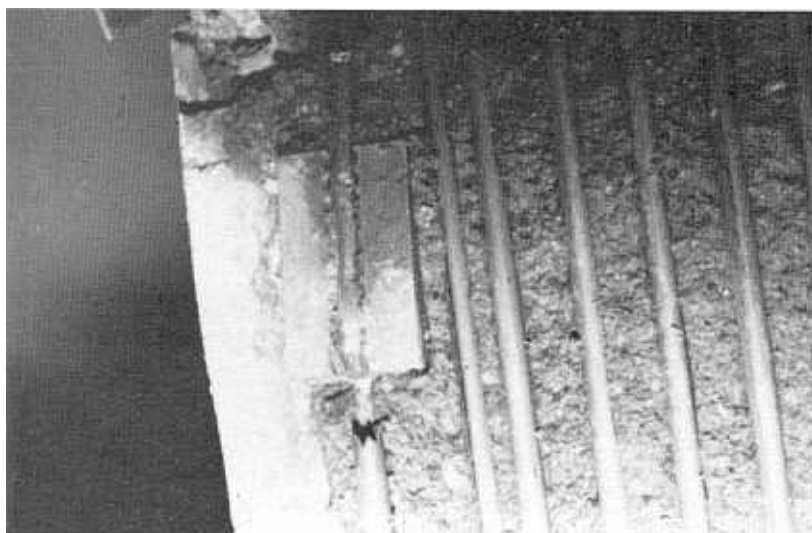
Wire was found to be fractured on the stressed side of the unit 798 bell anchor (fig. 28). The fracture originated at a notch in the wire formed by the swedge-type anchor (fig. 29). The fracture was imprinted in the concavity of the mortar coating opposite the anchor (figs. 30 and 31). Spectral analyses indicated that the imprinted crack, the smooth surfaces formed by the wire and anchor, and the fractured surface of the mortar consisted of calcium and progressively lower amounts of silicon and aluminum.

Figure 28. - Wire fracture adjacent to bell anchor of unit 798.

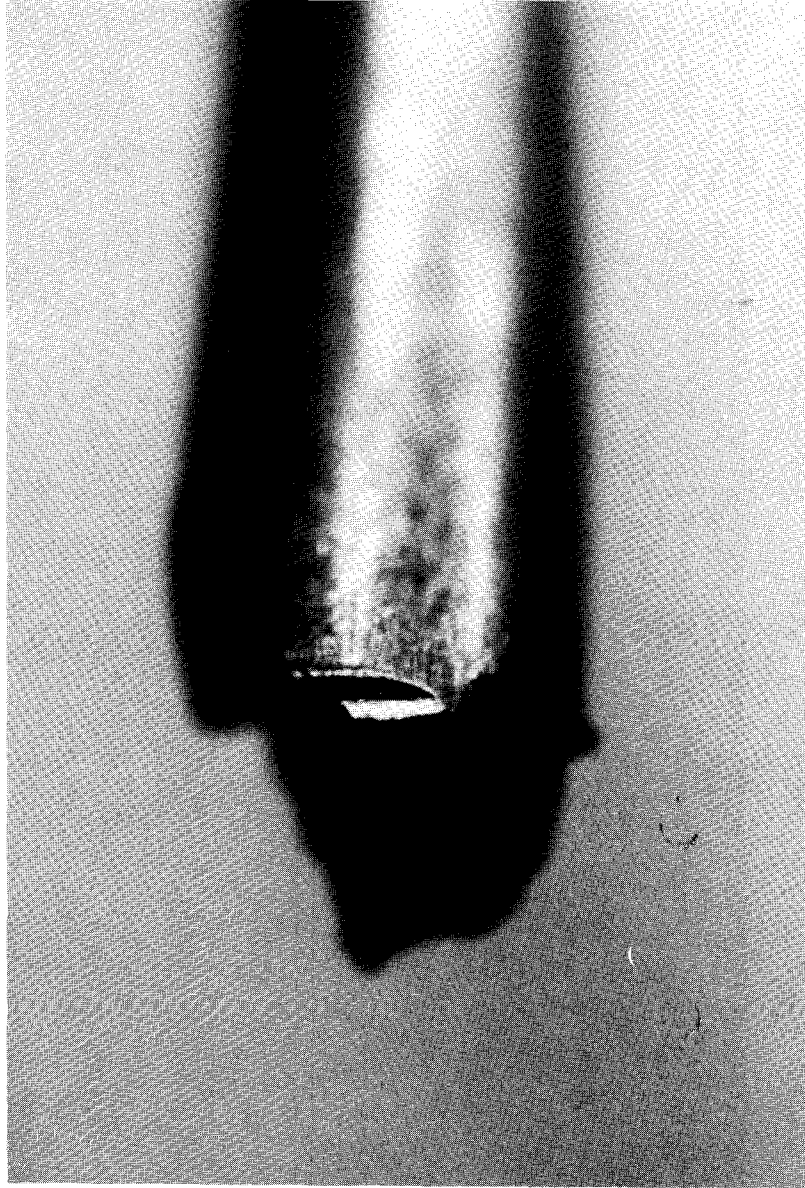
Figure 29. - Close-up of fractured wire at bell anchor of unit 798. Note notch at tip, about 14X.

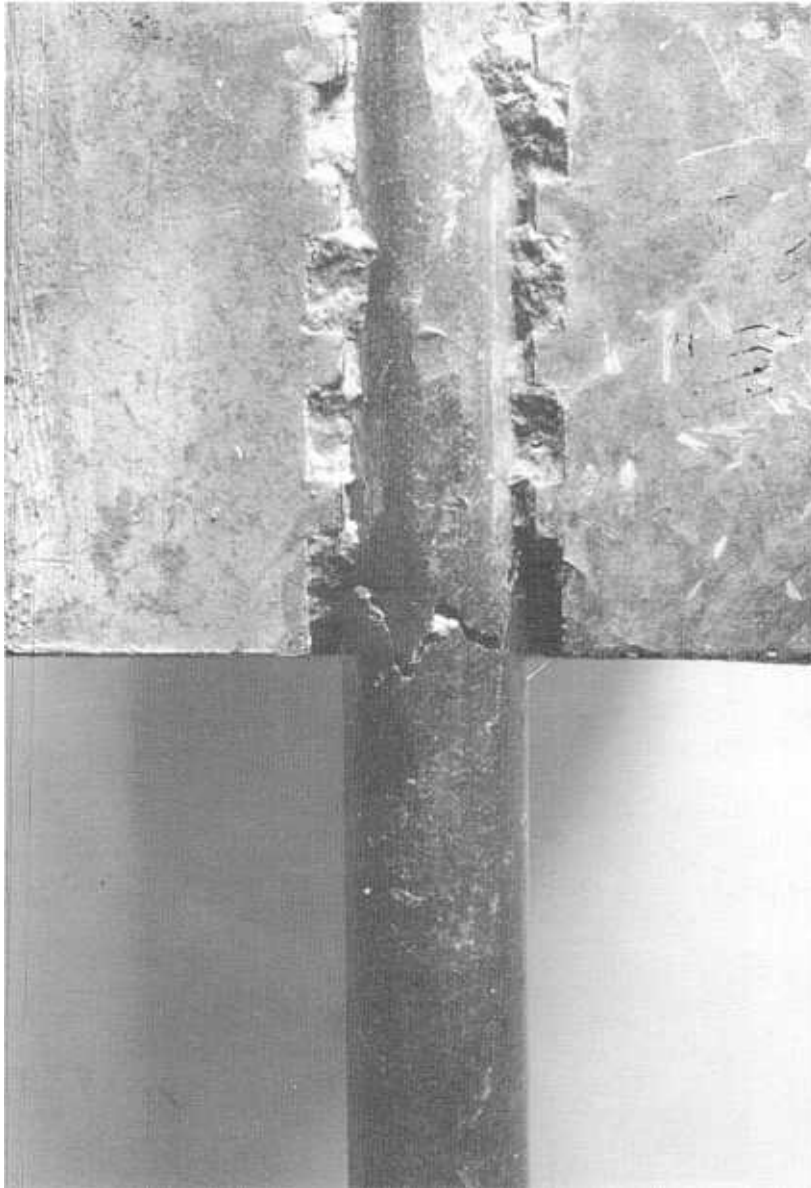
Figure 30. - Anchor and fractured wire, bell anchor, unit 798, about 5.5X.

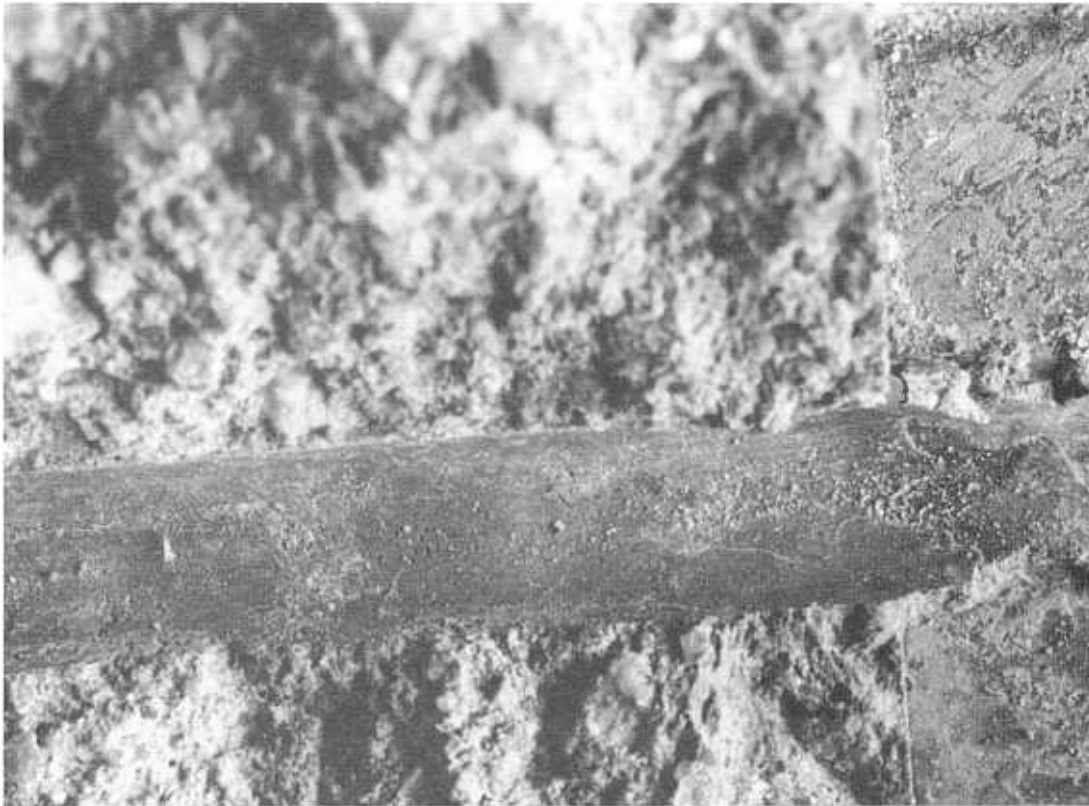
Figure 31. - Mortar coating opposite bell anchor, unit 798. Mirror image of wire fracture is imprinted, about 5.5X.

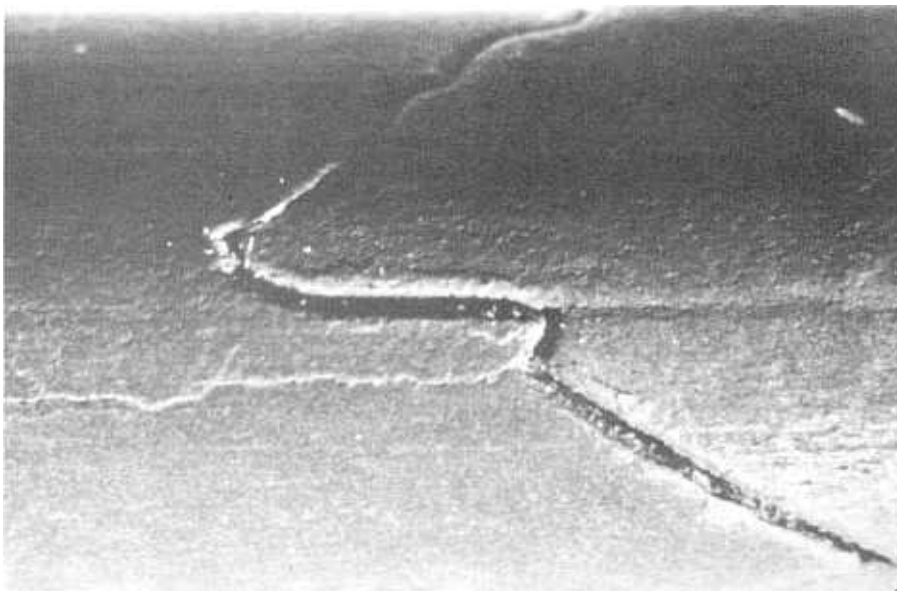
Field fracture morphology. - All 245 field-fractured coils of wire were sampled from unit 797 both above and below the rupture. Matching resulted in pairing 109 fractures such that the wire on both sides of the fractures could be inspected. Paired fractures from unit 798 were also examined. The examination revealed that all matched fractures occurred at cross sections where a crack terminated and another originated (fig. 32). In addition, fracture morphologies consistent with overload failure were apparent. These fractures were of the ductile cup and cone type in combination with a sharp metal tongue formed by offsetting, overlapping longitudinal cracks (figs. 33 to 35). No areas of typical brittle fracture were observed. Extensive examination of wire surfaces failed to reveal a single secondary transverse crack extending only partially into the wire cross section. Either the wire was totally fractured or only longitudinal cracks were found (Mote, 1985a).

Figure 32. - Matched field fractured wires showing fractures occurred at a cross section where two longitudinal cracks meet, about 12X.

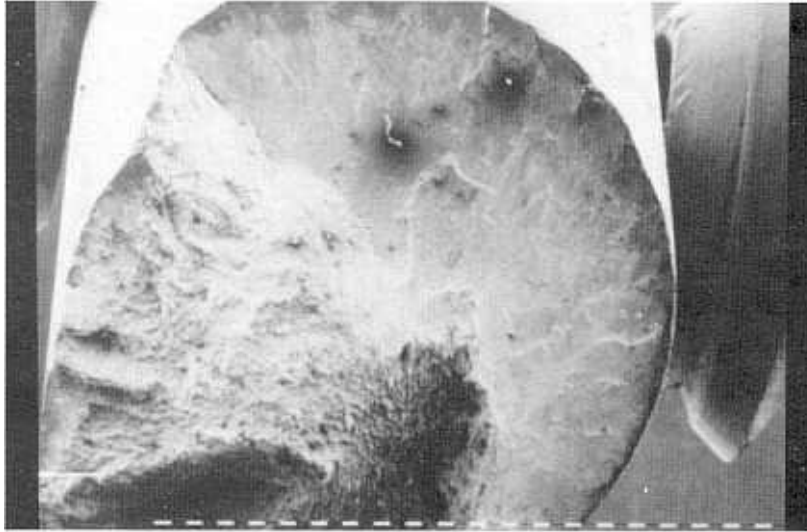
Figure 33. - Field fractured surface of wire, about 20X.

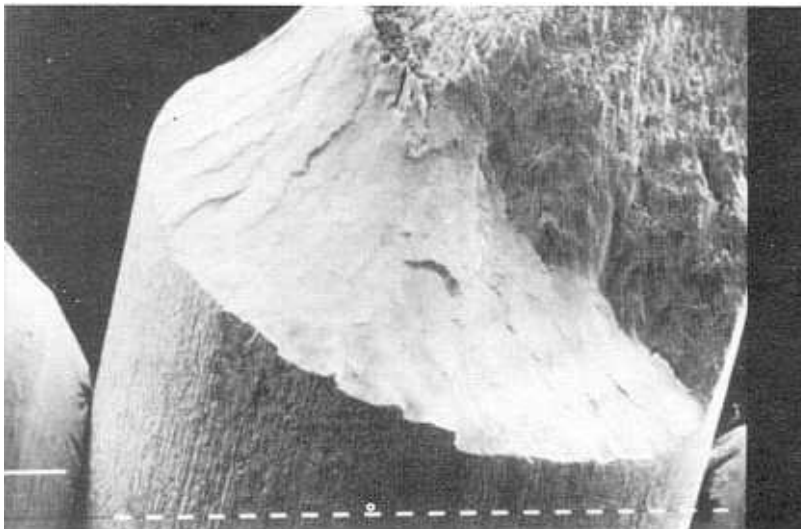
Figure 34 - Field fractured surface of wire, about 20X.

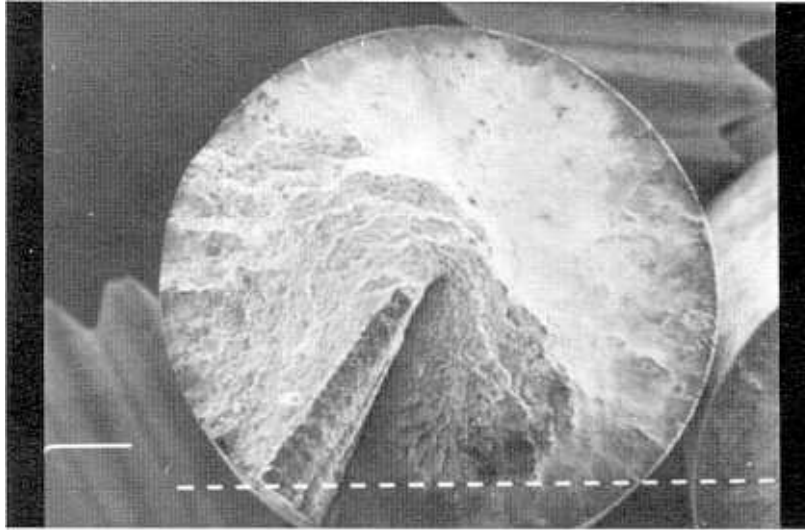
Figure 35. - Field fractured wire, about 20X.

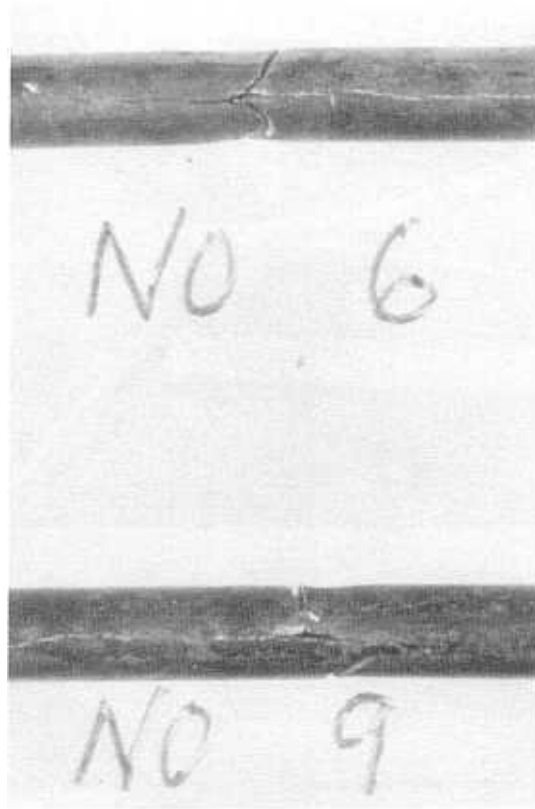
Destructive testing. - Laboratory testing was also conducted on wire from the failure site to verify compliance with the destructive test criteria of ASTM A 648-73 (fig. 47), which was in effect when the pipe was fabricated. During tensioning, the wire was loaded at rates specified in ASTM A 370. After fracture, the ends of the broken specimen were fitted together and the dimensions of the smallest cross section were measured to the nearest 0.001 inch. The area reduction was calculated as the difference between the area after fracture and the initial area, expressed as a percentage of the initial area. Although ASTM A 648-73 did not contain an area reduction criterion and placed no upper limit on the tensile strength, its successor, ASTM A 648-84, required that class III wire achieve a tensile strength ranging from 262,000 to 297,000 lb/in² for 8-gage wire and a minimum area reduction of 30 percent. As the data indicate, wire from the failure site (pipe 797) met the tensile strength requirements of both ASTM A 648-73 and ASTM A 648-84, but failed to meet the ASTM A 648-84 area reduction criterion. The mean tensile strength of ten samples was 283 kips/in² with a standard deviation of 3.9 kips/in² and a coefficient of variation of 1.4 percent. The mean area reduction of the same samples was 13.8 percent with a standard deviation and coefficient of variation of 6.7 and 48.5 percent, respectively (table 4). Wire from pipe 798 also achieved the required tensile strength and exhibited a mean of 288 kips/in² with a standard deviation of 2.4 kips/in² and a coefficient of variation of 0.8 percent for the ten samples tested. The average reduction in area of three of the ten samples was 10.5 percent with a corresponding standard deviation and coefficient of variation of 1.2 and 11.4 percent, respectively. Many specimens failed at the jaw-wire interface, indicating wire susceptibility to notch effects. The area reduction measurements were not tabulated in these cases (table 4).

Figure 47. - Two wire samples fractured by laboratory tensile testing. Note similarity to field fracture, fig. 32, about 3X.

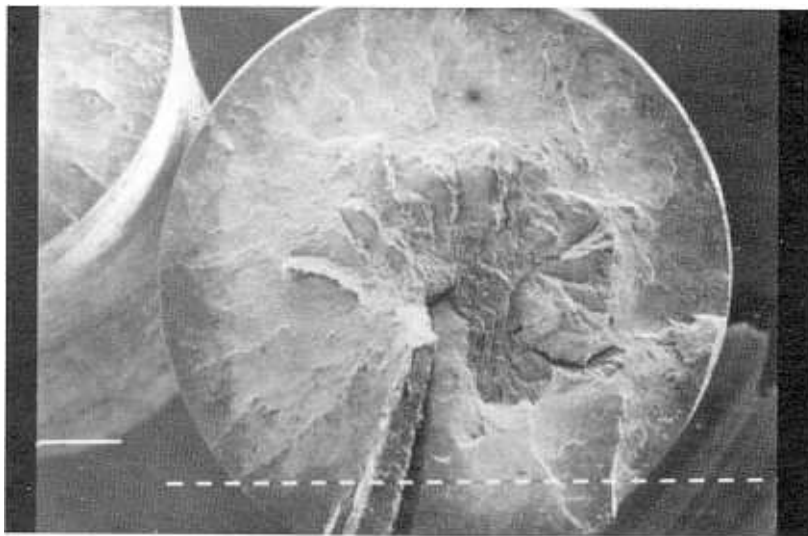
In-service wire fractures with further reduced, or no, neck down were reproduced in the Reclamation laboratory by rapidly loading Jordan wire to failure in tension. To perform these tests, specimens were preloaded to about 60 percent of the minimum ultimate tensile strength of the prestressing wire at a rate of 50 kips/in²/min and rapidly loaded to failure at 1100 kips/in²/min. One of the fractures (17 percent) occurred in the free length between the jaws and exhibited virtually no neck-down when tested in this manner (fig. 48).

Figure 48. - Laboratory fractured wire. Note similarity to fig. 35, about 20X.

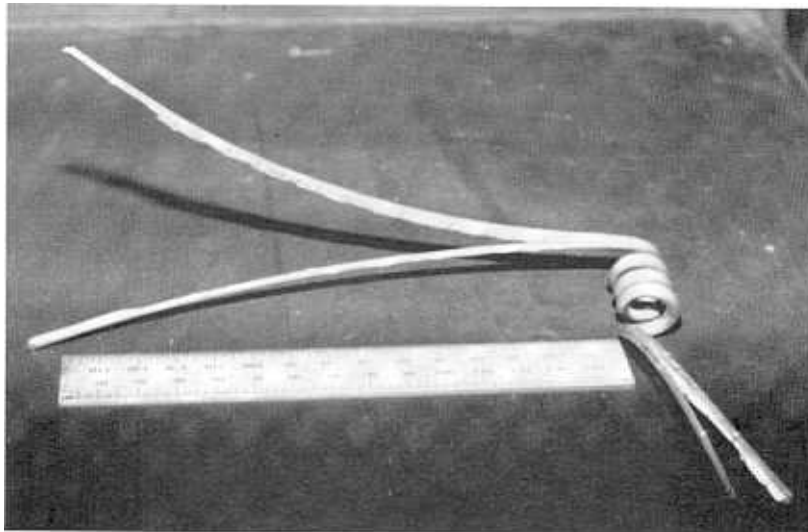
Wrap tests were performed by closely wrapping prestressing wire about a mandrel twice the nominal wire diameter. A specimen is considered to have failed if any cracks appear in the wire after the first complete turn. All specimens from unit 797 and unit 798 failed the wrap test (table 4). Wire from unit 797, however, commonly failed the wrap test by breaking whereas wire from unit 798 usually could be wrapped around the test mandrel without breaking. Wire from stations 1499+56 and 1478+44 passed the wrap test (table 5). In many cases, wrap test specimens showed no visible signs of cracking in the wrapping coils, but longitudinal cracks were easily split open on the ends with bolt cutters (fig. 49).

Figure 49. - In many cases, wrap test specimens showed no visible signs of cracking in the wrapping coils, but longitudinal cracks were easily split open on the ends with bolt cutters.
