R-94-13

HAIGHTS CREEK RPM PIPE FAILURES

September 1994

U.S. DEPARTMENT OF THE INTERIOR
Bureau of Reclamation
Technical Service Center
Research and Laboratory Services Division
Materials Engineering Branch

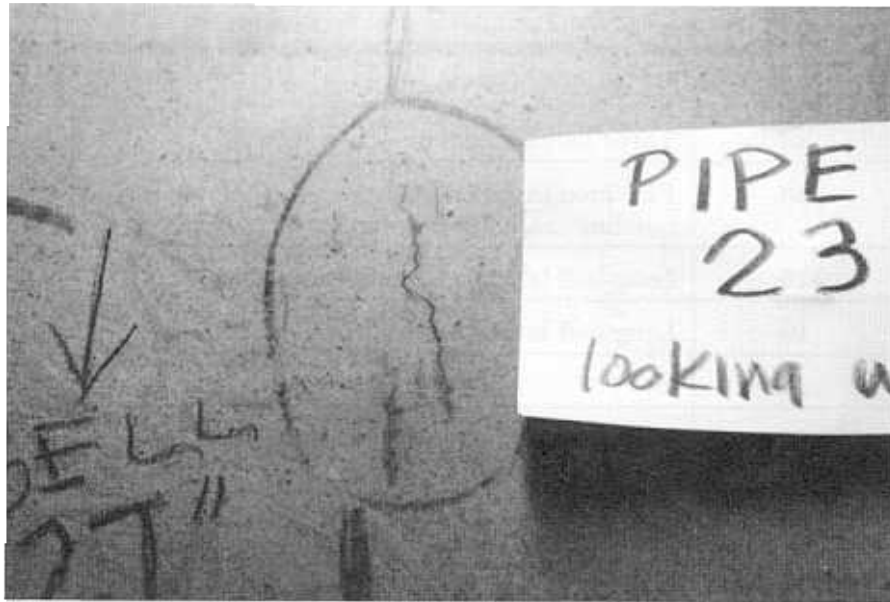
Figure 2. - Longitudinal invert crack in pipe No. 23.

Pipe No. 23 had two major longitudinal cracks in the invert as shown on figure 2. These cracks were about 2 feet from the bell end of the pipe and oozed water when pressed.

For pipe No. 23, a soil mound was apparently placed under the bell end of the pipe during construction. This area of the mound is at the same location as the major interior longitudinal invert cracks.

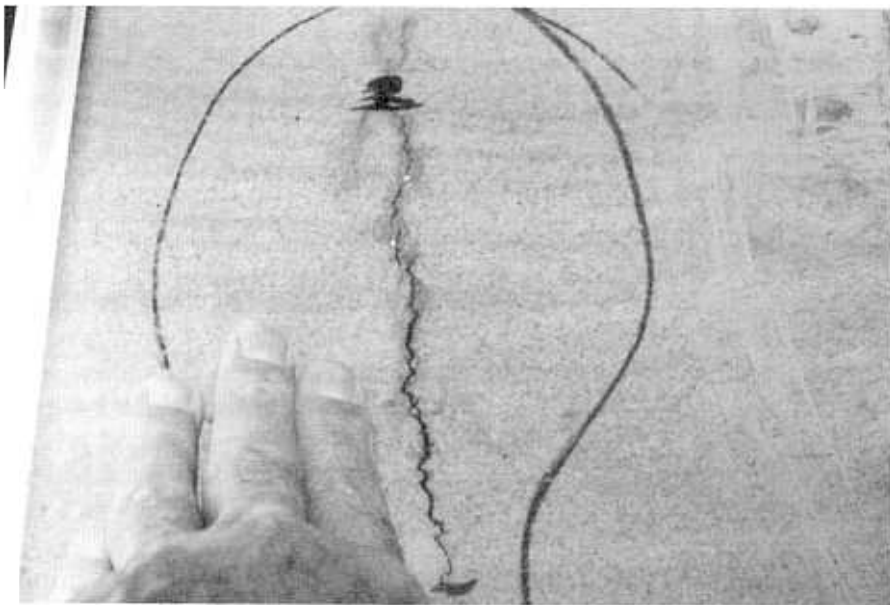
Figure 3. - Major longitudinal crack in pipe No. 25.

Pipe No. 25 had two major longitudinal cracks, one 6-1/2 inches long, in the invert as shown on figure 3. Water would come out of the crack when pushed in place. This crack was located about 2 feet from the bell end. The crack was raised as shown by the shadows in the close-up view on figure 4. The area around the cracks sounded hollow when tapped.

A major interior longitudinal invert crack was found near the bell end of pipe No. 25. This crack is shown on figures 3 and 4. The crack is at the area where an apparent soil mound was used to raise the pipe off of the bottom of the trench to bring the pipe to grade. The evidence for a soil mound is:

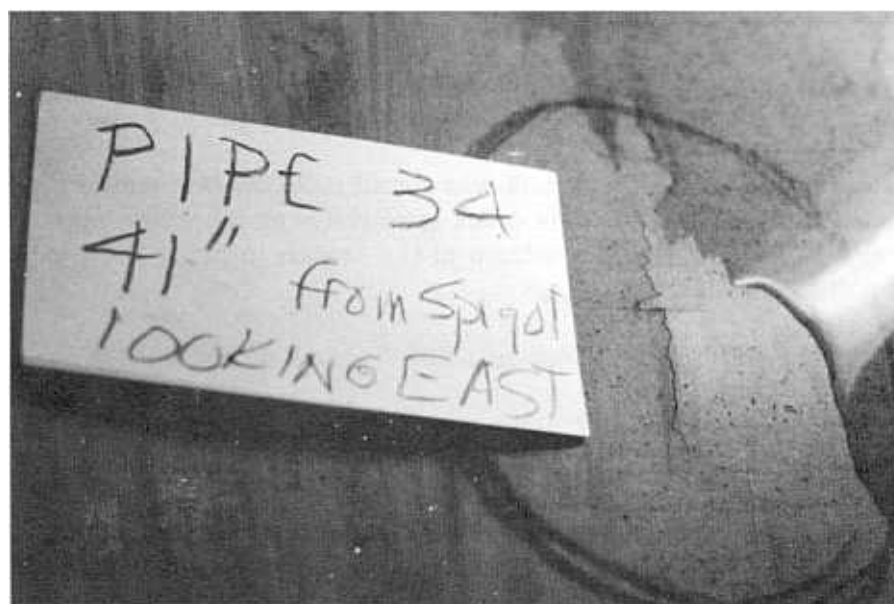
Flattened with longitudinal invert of pipe No.

Pipe No. 34 had a major longitudinal invert crack about 3-1/2 feet from the spigot end of the pipe as shown on figure 5.

In pipe No. 34, a flat spot in the invert containing a severe crack had been detected during the crawl-through. Figure 5 shows the flat spot and crack as it appeared in place. The reason for the flat spot was readily apparent as shown on figure 6. During construction, a 4- by 4-inch timber had been placed under the pipe. The area around this pipe was all recent fill and the timber was obviously used to bring the pipe to grade while soil was placed under the pipe, and then the timber was left in place, probably erroneously. The piece of timber created a hard spot and a point loading on the bottom of the pipe, and as the pipe settled and deflected, the hard spot created a flattened area in the invert, causing excessive tensile strains on the inner surface of the pipe and resulting in longitudinal cracking of the pipe.

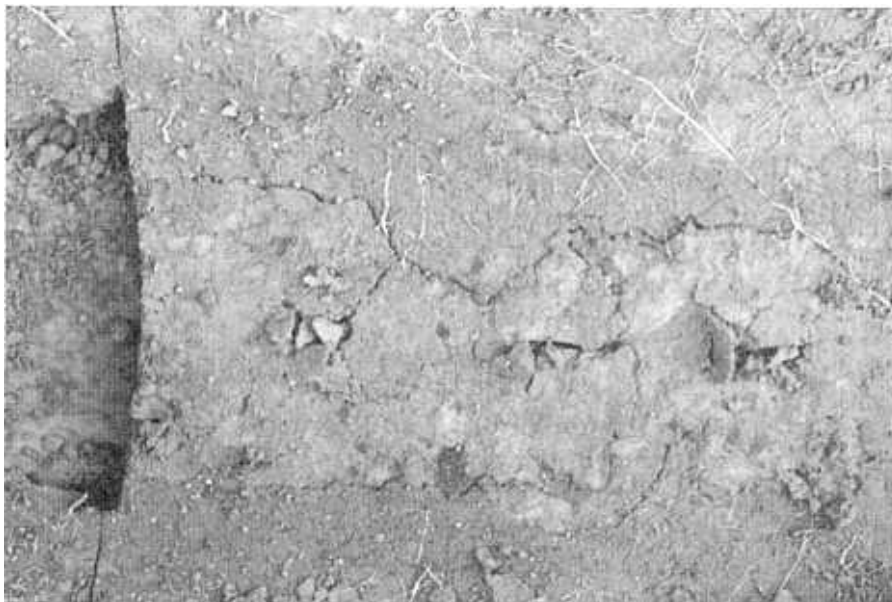
Figure 7. Soil foundation of pipe No. 25 showing mound.

1. Area is a different soil color, as illustrated on figure 7 as the lighter shade.
2. As the soil dried, the "soil mound" soil separated from the surrounding soil, revealing an outline of a different soil as shown on figure 7.
3. The blade of a putty knife penetrated less at the site of the crack than anywhere else along the pipe, indicating a hard spot in the foundation at that point.
4. A cross section of the soil beneath the pipe shows this area of lighter color to be about 1 inch deep over the trench bottom, as shown on figure 8. The in situ material was easy to detect because it was a stratified material.

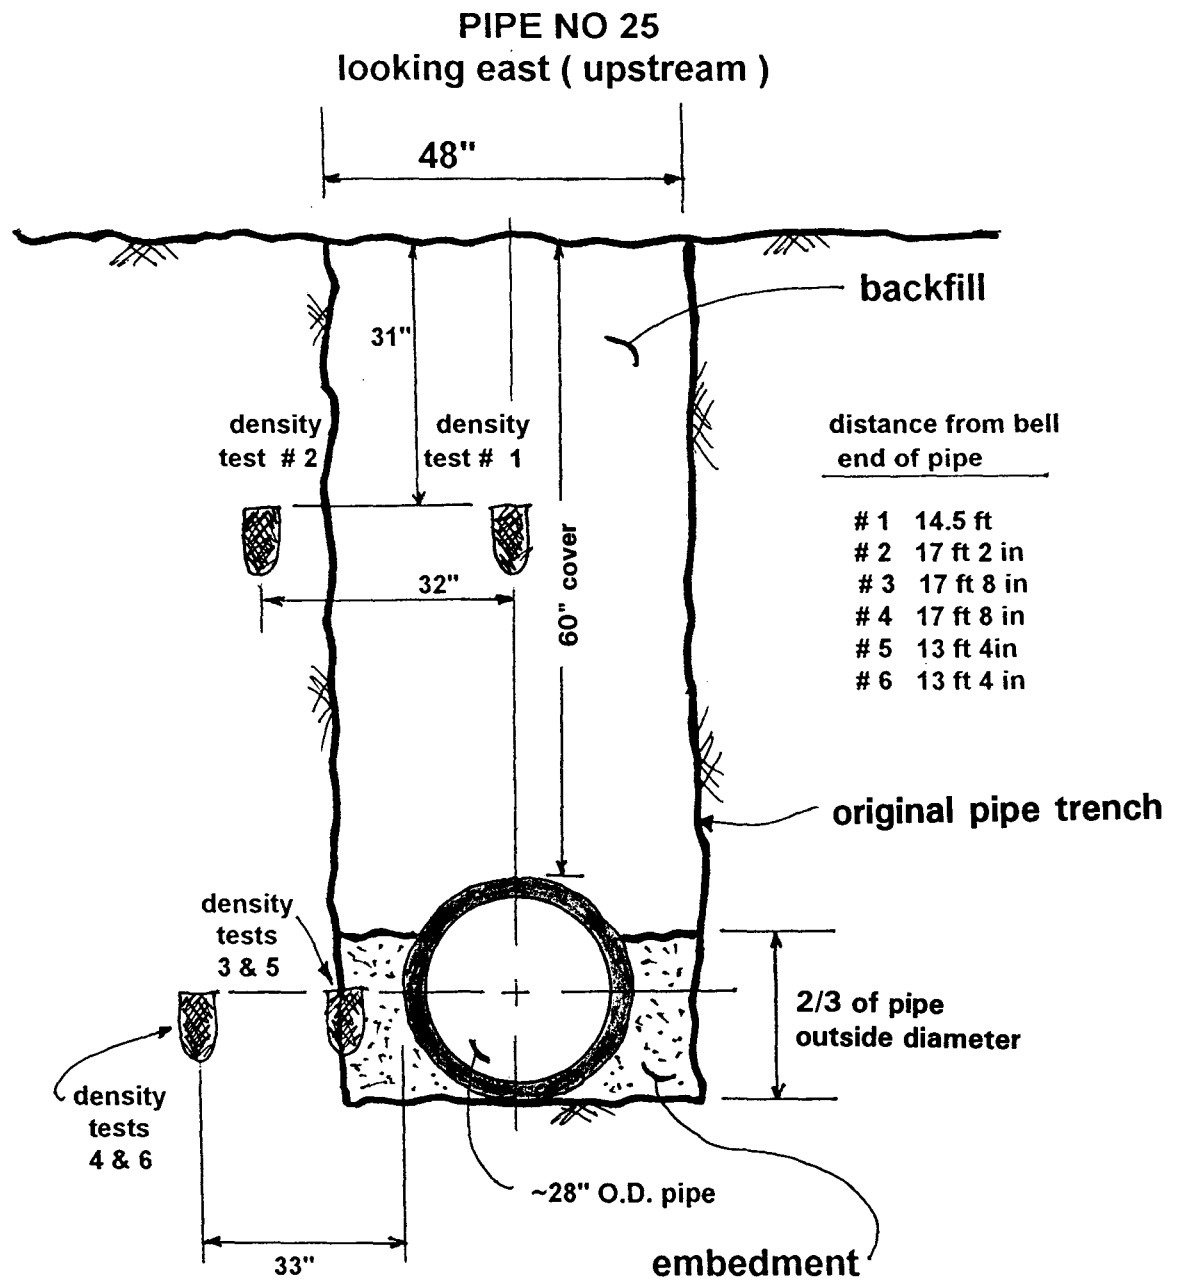
Figure 9. - Locations of six field density tests about pipe No. 25.

In-place soil density tests were performed in the vicinity of pipe No. 25 in the embedment next to the pipe, in the backfill placed over the pipe, and in the in situ soil in what would have been the trench walls during construction. The tests were performed by Reclamation personnel from the Bonneville Projects Office in Provo, Utah, in accordance with designation E-23 in the *Earth Manual* (Reclamation, 1974). In addition, gradation analysis and Atterberg limits tests were performed on the soil removed from the density test in order to classify the soil. The results of the tests showing the in-place densities are given in table 2. In table 3, the results of gradation tests, Atterberg limits tests, and the resulting soil classification are shown.

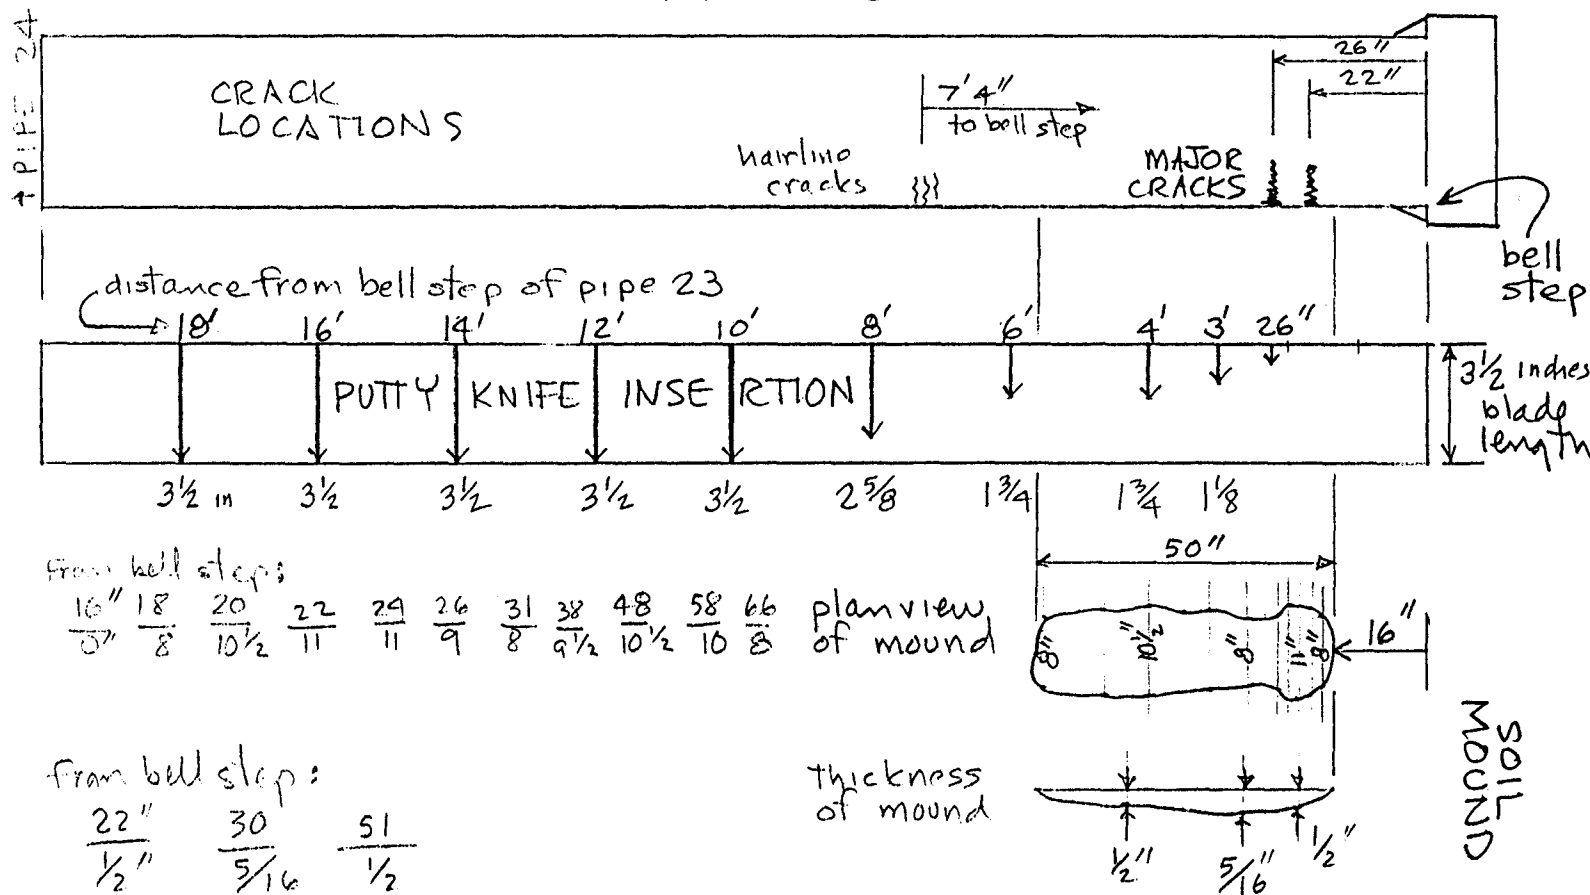
PIPE 23

crack at 22" from bell step is 2" long, longitudinal in invert
oozes water when pushed, sounds soft

crack at 26" from bell step is 2 1/2" long, longitudinal in invert
oozes water when pushed, sounds soft

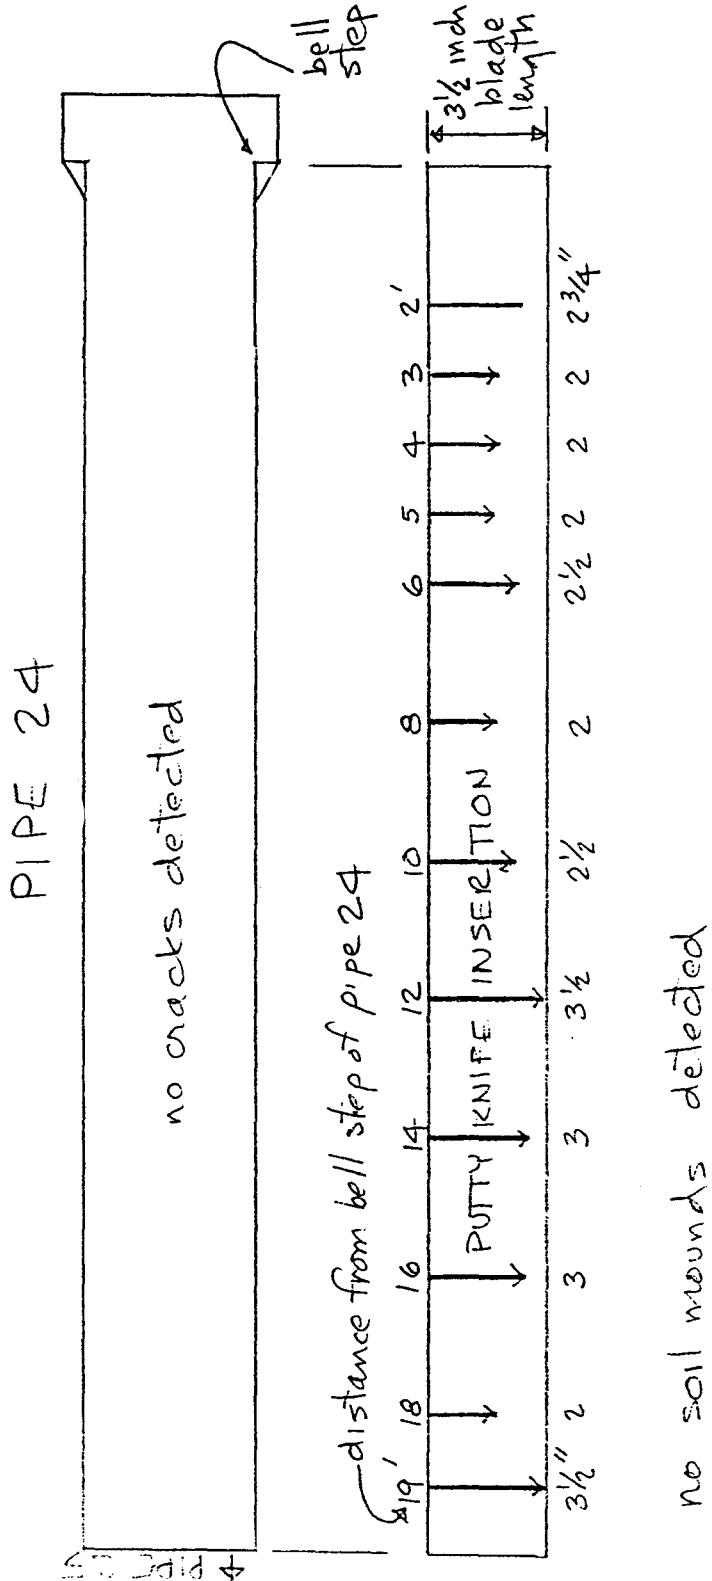
BY	DATE	PROJECT HAIGHTS CREEK	SHEET ____ OF ____
CHKD BY	DATE	FEATURE RPM PIPE INSPECTION	
DETAILS PIPE 24

For pipe No. 24, no cracks were detected in the pipe, and the foundation was uniform under the pipe with no signs of mounding.

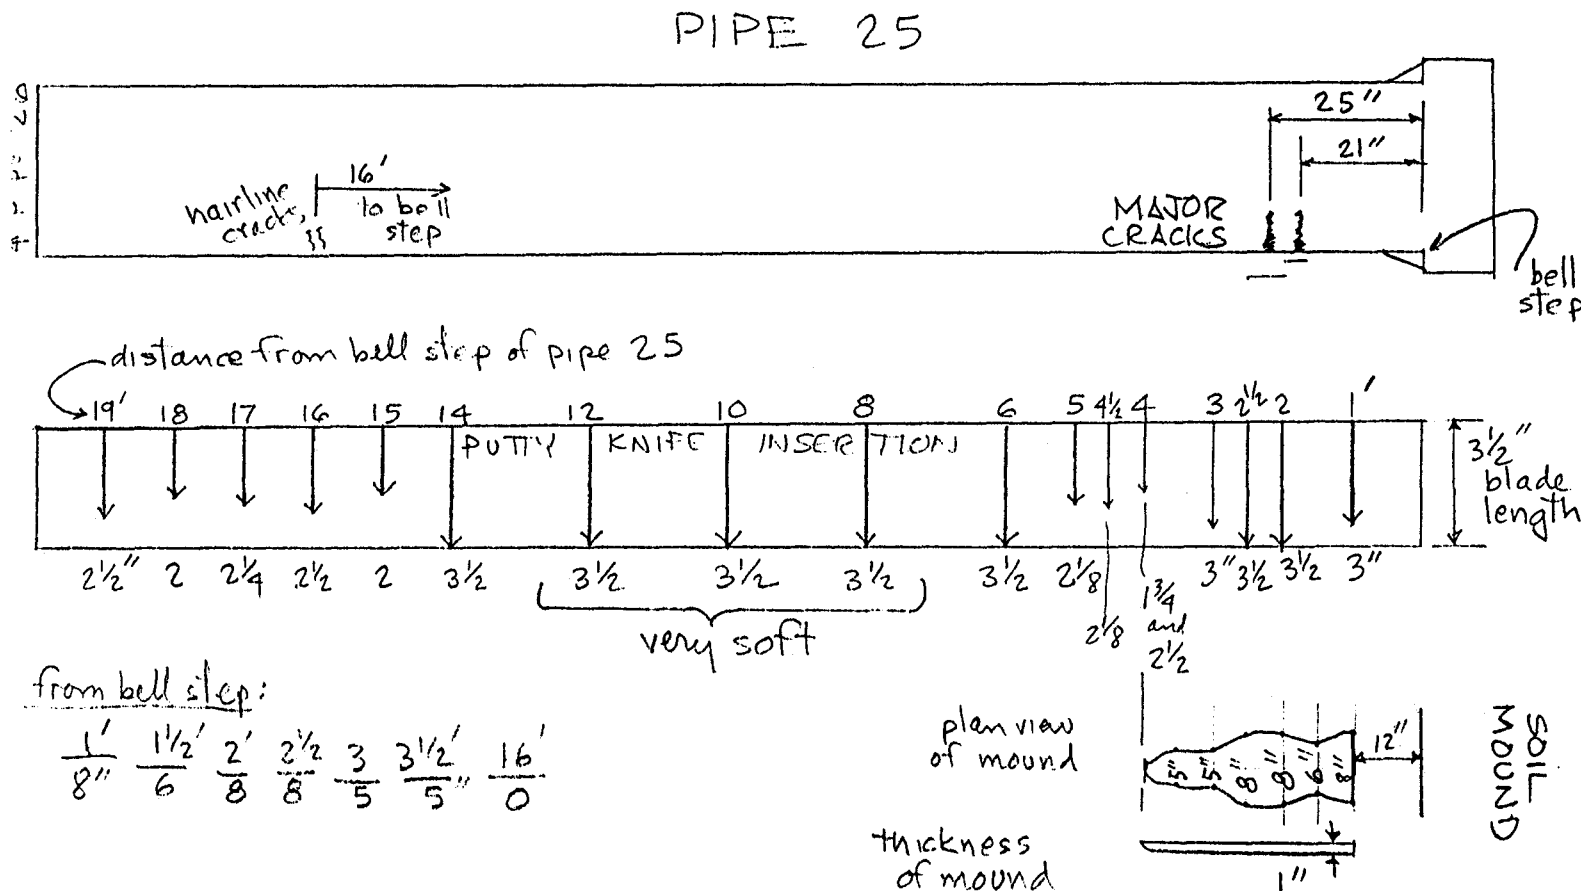
BY	DATE	PROJECT	SHEET
CHKD BY	DATE	FEATURE	OF
DETAILS		PIPE 25

longitudinal invert crack is 3" long, from 20" to 23" from bell step
 longitudinal invert crack is 6 1/2" long, from 22 1/2" to 29" from bell step
 oozes water when pushed

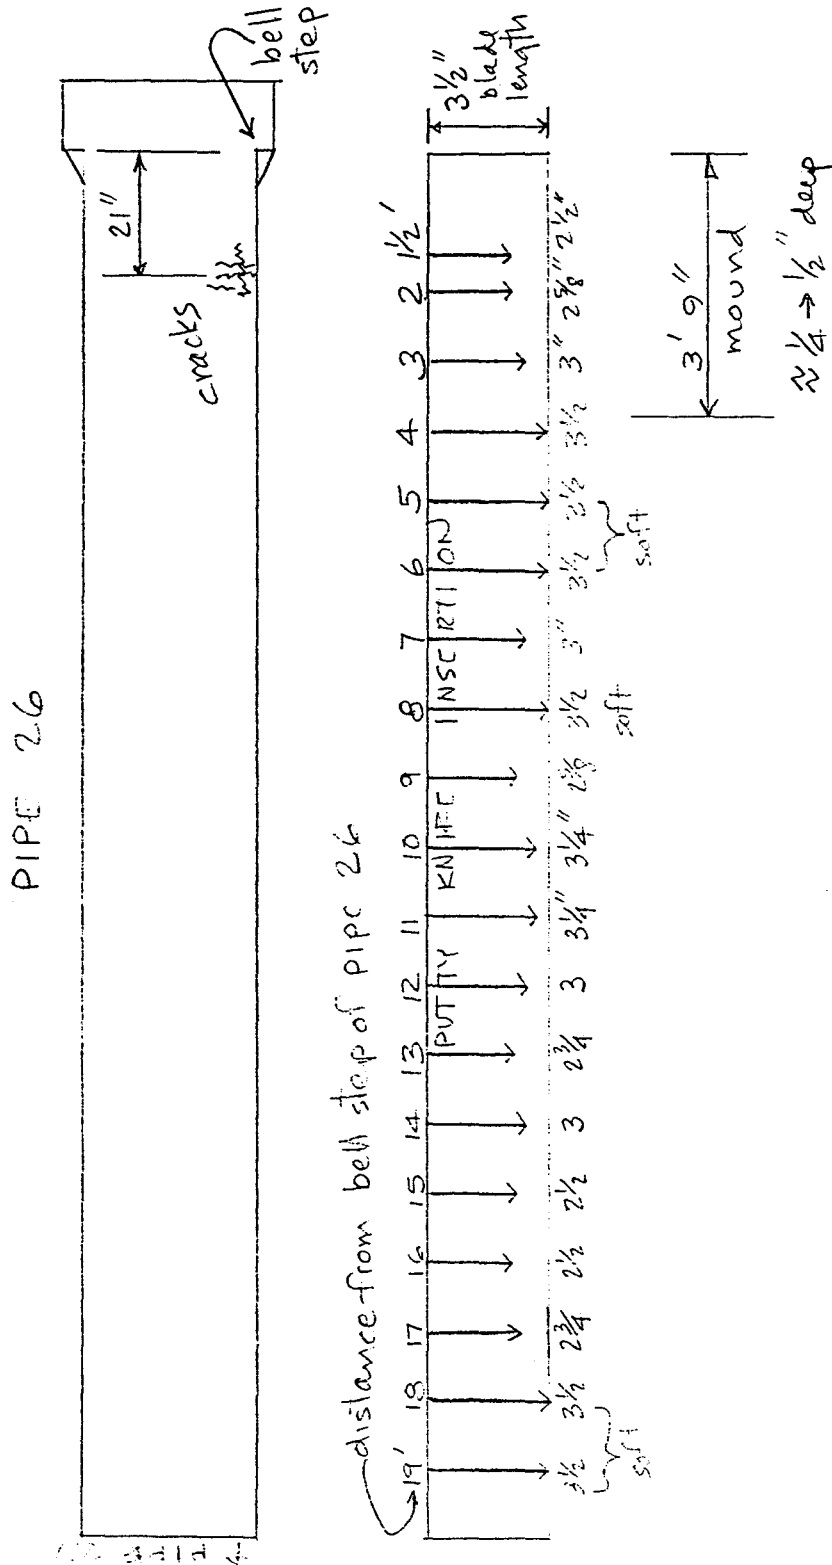
BY	DATE	PROJECT HAIGHTS CREEK	SHEET ____ OF ____
CHKD BY	DATE	FEATURE RPM PIPE INSPECTION	
DETAILS PIPE 26

Pipe No. 26 had numerous small circumferential cracks with one small longitudinal invert crack. The foundation appeared to be uniform under this pipe.
