# **DESCHUTES—CANAL-LINING DEMONSTRATION PROJECT DURABILITY REPORT—YEAR 2**

September 1994

**U.S. DEPARTMENT OF THE INTERIOR**  
Bureau of Reclamation

Technical Service Center  
Research and Laboratory Services Division  
Materials Engineering Branch

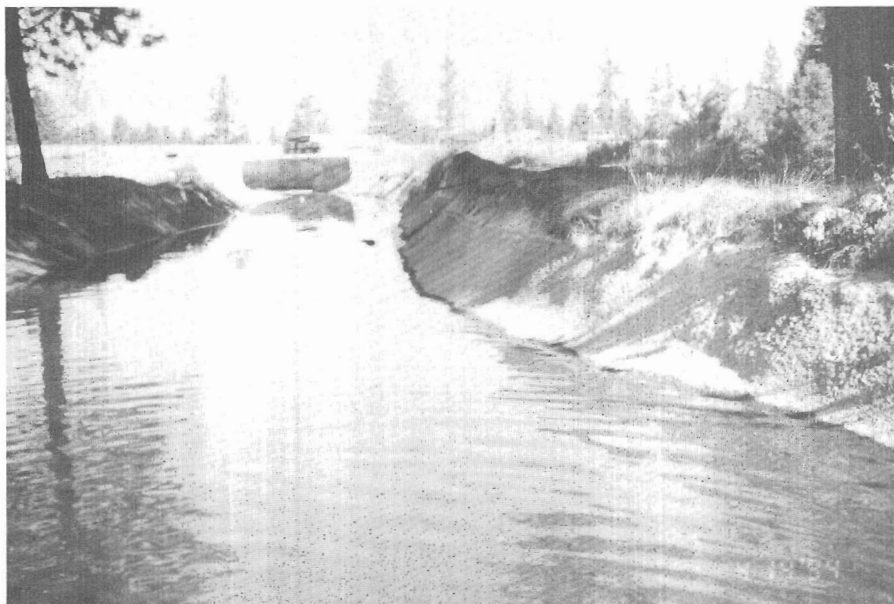
**Condition:** Excellent - the shotcrete lining is in excellent condition, completely protecting the underlying Petromat geosynthetic liner from weathering and mechanical damage. After two winters, no freeze-thaw damage has been observed. Several (perhaps a dozen) transverse contraction cracks have developed, ranging in width from hairline up to about 1/8 inch. The cracks are mostly in the sidewalls and do not usually extend into the invert. Also, one longitudinal crack on the side slope was discovered. The first 500-foot section contains 1½ lb/yd<sup>3</sup> polyfiber reinforcement and has a similar cracking pattern to the second 500-foot section without fiber reinforcement. These transverse and longitudinal shotcrete cracks are not considered detrimental because the Petromat geomembrane underliner provides the seepage control, and the shotcrete cover protects the geomembrane from weathering, ultraviolet light, mechanical damage, vandalism, and animal damage. The shotcrete has developed some minor random cracking over the anchor trench where the shotcrete tapers off. Sediment in the majority of the invert is less than 1/8 inch deep. However, on one curve the sediment is about 3 inches deep.

Photograph 1. - Canal overview—excellent condition.

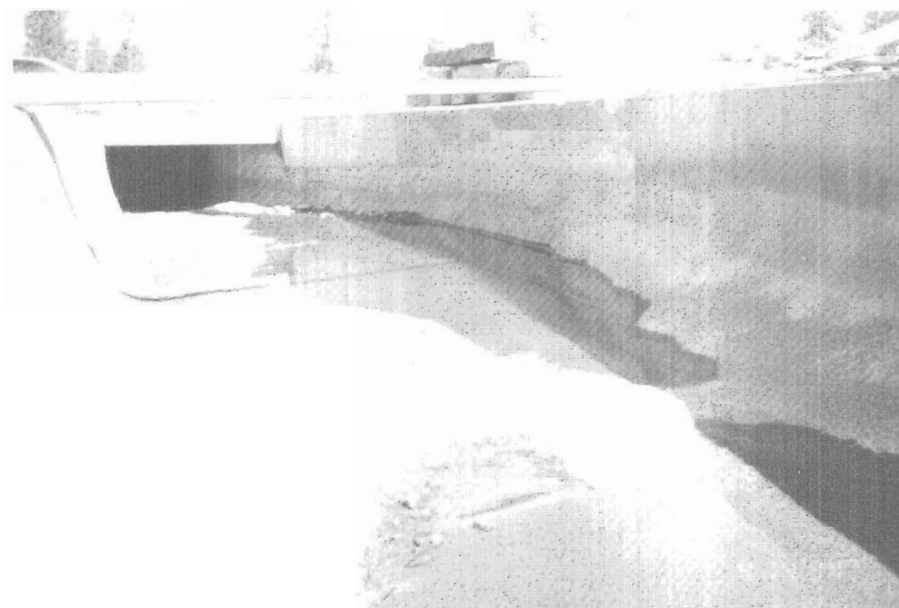
In March 1994, about 100 linear feet of this test section was torn-out and replaced when the Highway 97 bridge at station 7+00 (estimated) was widened from two lanes to four. The new replacement lining uses the same construction materials and techniques as the old lining (Petromat with 3-inch shotcrete cover). Costs for this lining replacement will not be included in either the initial construction costs or in the maintenance costs.

Photograph 2. - About 100 linear feet of shotcrete and Petromat lining were replaced in March 1994 when the highway bridge was widened.

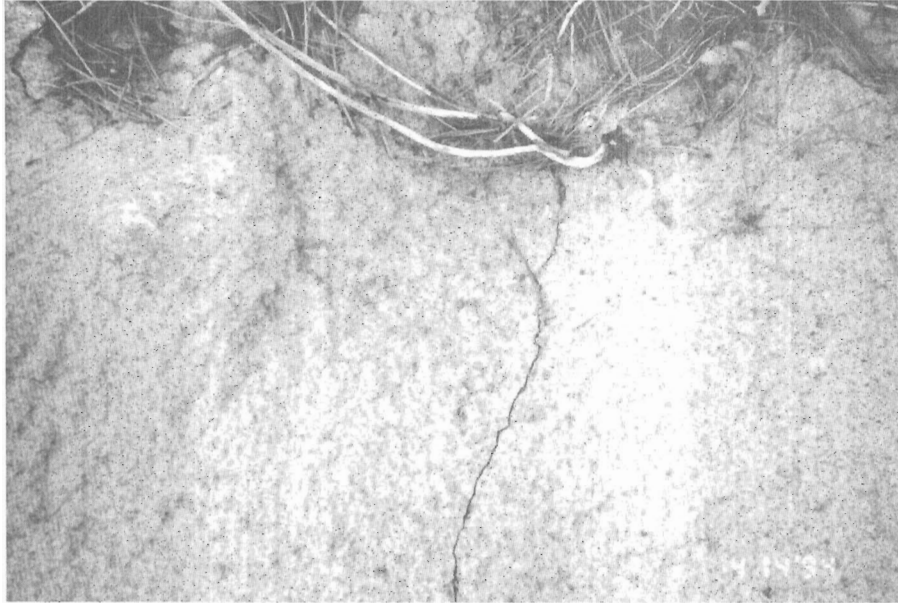
Photograph 3. - Transverse contraction crack in shotcrete lining.

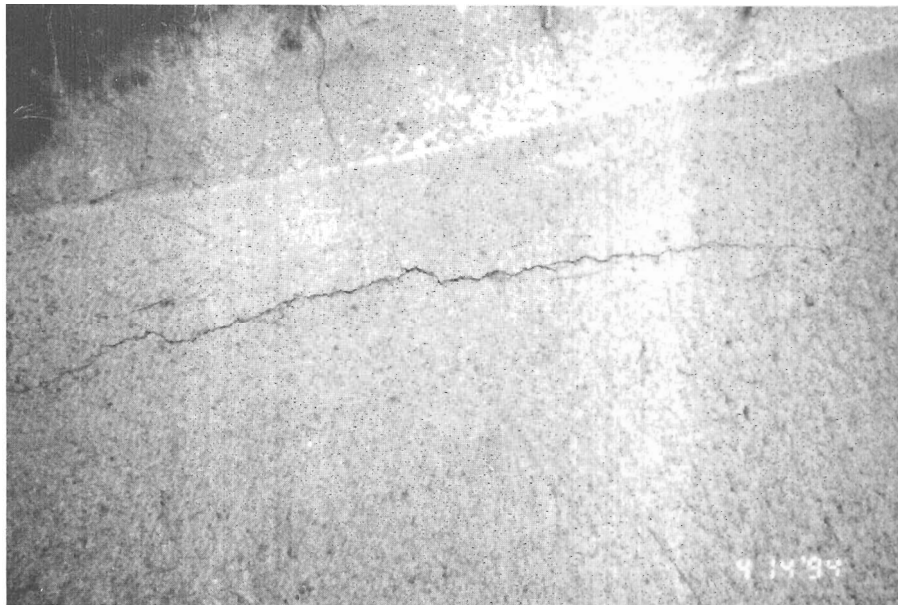
Photograph 4. - Longitudinal contraction crack in shotcrete lining.

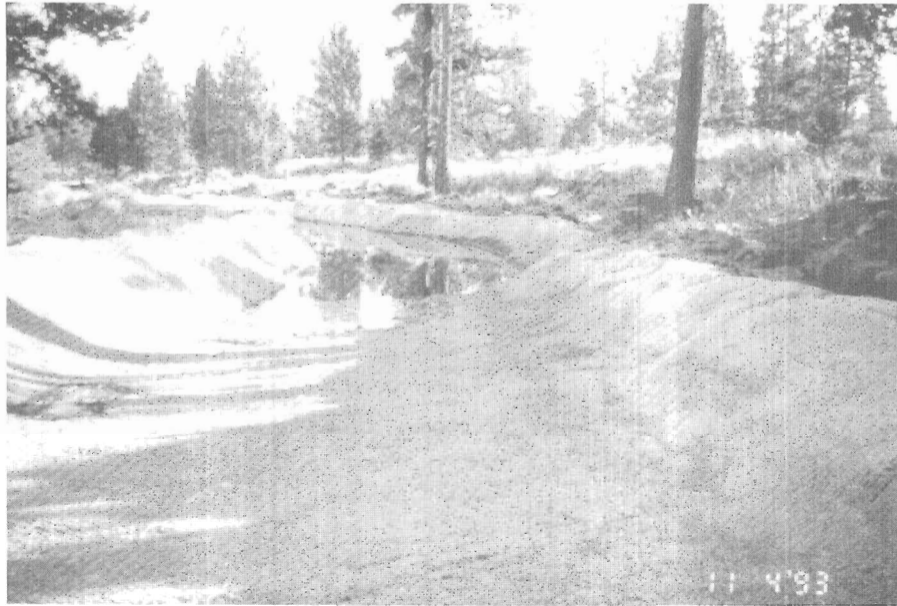
Condition: Excellent - the shotcrete lining is in excellent condition, completely protecting the underlying VLDPE geosynthetic liner. After two winters, no freeze-thaw damage has been observed. A few transverse contraction cracks and one longitudinal crack have developed on the sidewalls. The transverse crack at station 13+00 (estimated) extends completely across the canal prism and measures about 3/16 inch wide. Cracking in the thin, tapered shotcrete over the anchor trench is slightly more severe than on test section 1, but is not a problem at this time. Little to no sediment has collected in the canal invert.

Photograph 5. - Canal overview—excellent condition.

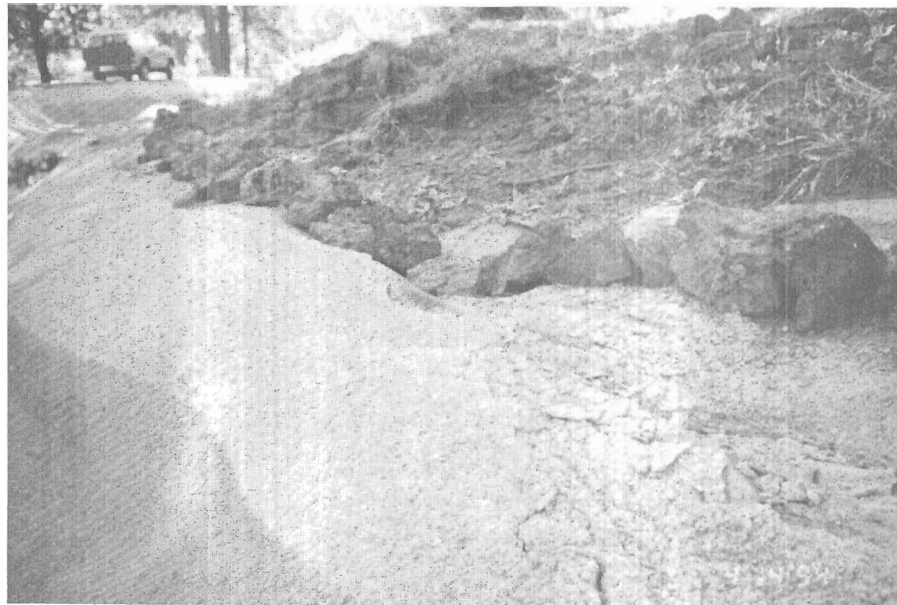
Photograph 6. - Tapered shotcrete over anchor trench has been damaged (cracked) by foot traffic.

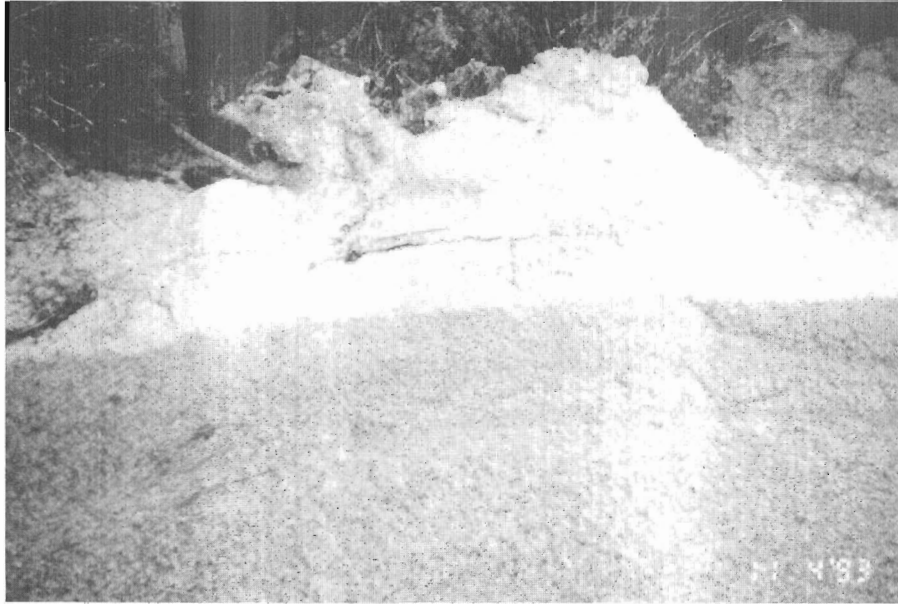
Photograph 7. - Longitudinal contraction crack just above the waterline.

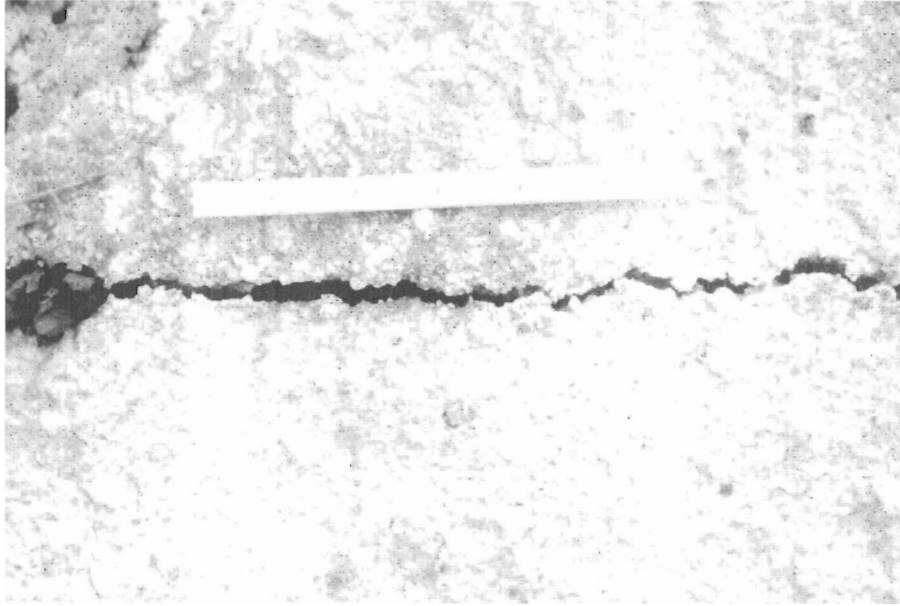
Photograph 9. - Close-up of longitudinal contraction crack.

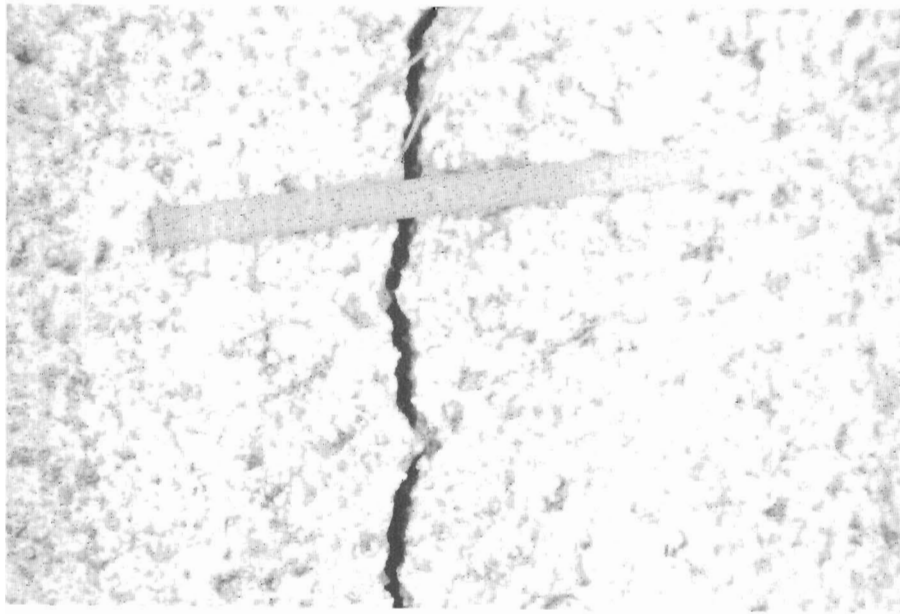
Photograph 10. - Close-up of transverse contraction crack.

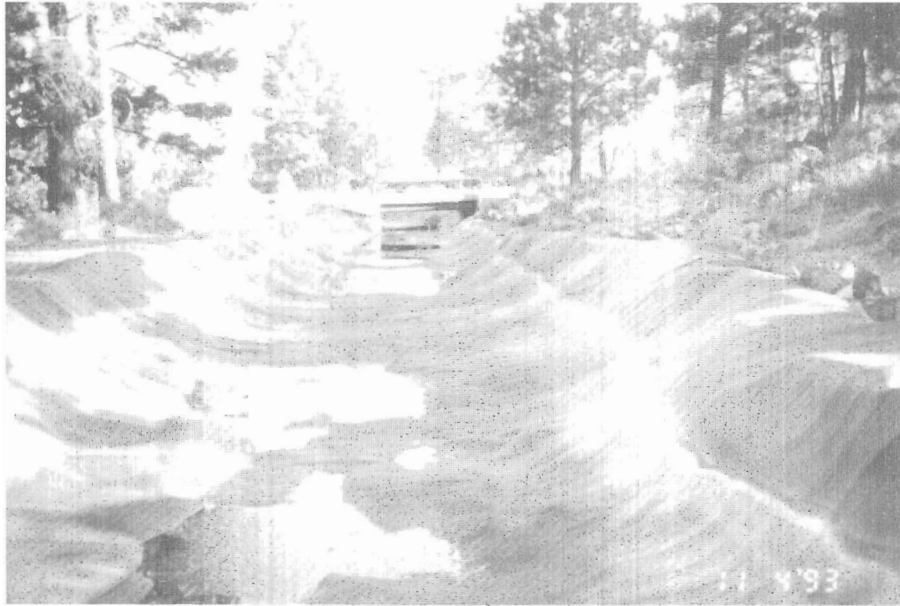
Condition: Very Good to Excellent - the exposed HDPE liner is in excellent condition. Longitudinal wrinkles from excess slack are apparent throughout. A semicircular tear (thought to be from an animal hoof) was found on the left bank above the water line about 75 feet downstream from the bridge. Little to no sediment has collected in the canal invert. The rock fill in the anchor trenches is performing well. Very little freeboard is available on the right bank; however, the extra HDPE in the anchor trench is sufficient to increase the freeboard if needed. At station 19+80 (estimated), the HDPE is stretched very tightly over a rock, and this area will be monitored for future potential puncture. A small tear at the upstream end (station 15+00 estimated) is believed to be caused from backhoe operation during dike construction for post-construction ponding tests.

Photograph 11.- Canal overview-excellent condition.

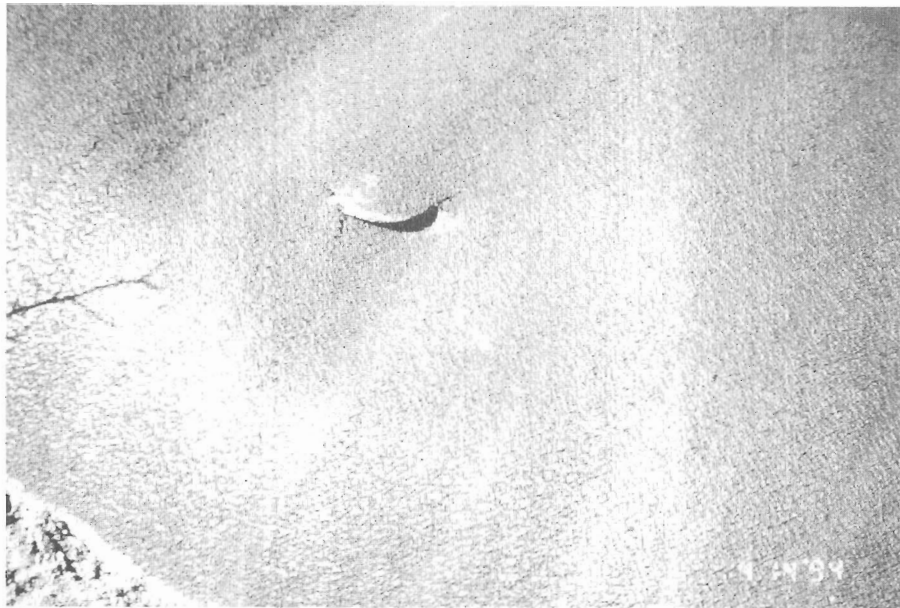
Photograph 12. - Suspected animal hoof damage.

Needed: Patch two or three small tears in the liner.  
To perform repairs, irrigation district needs an extrusion welder, extra membrane, and specialized training.

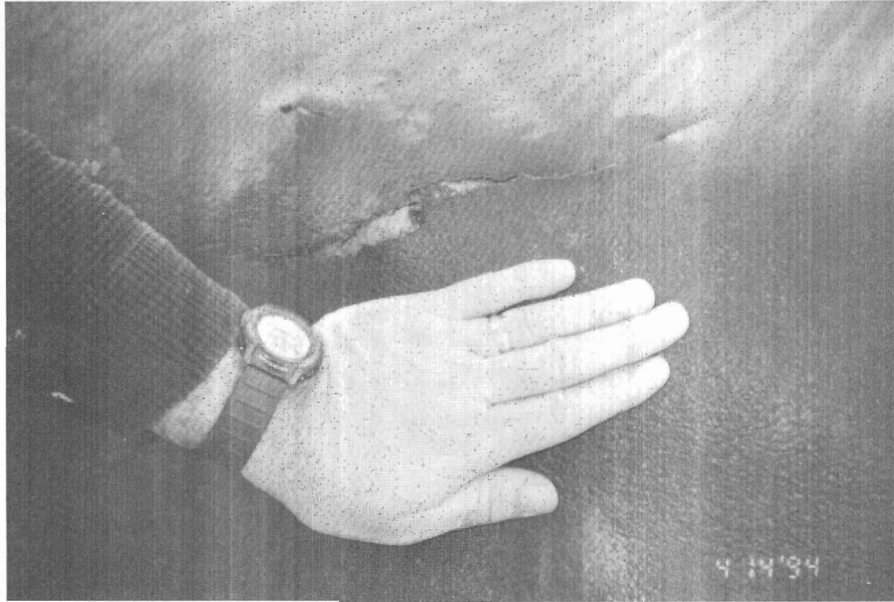
Photograph 13. - Tear from sharp subgrade rocks.

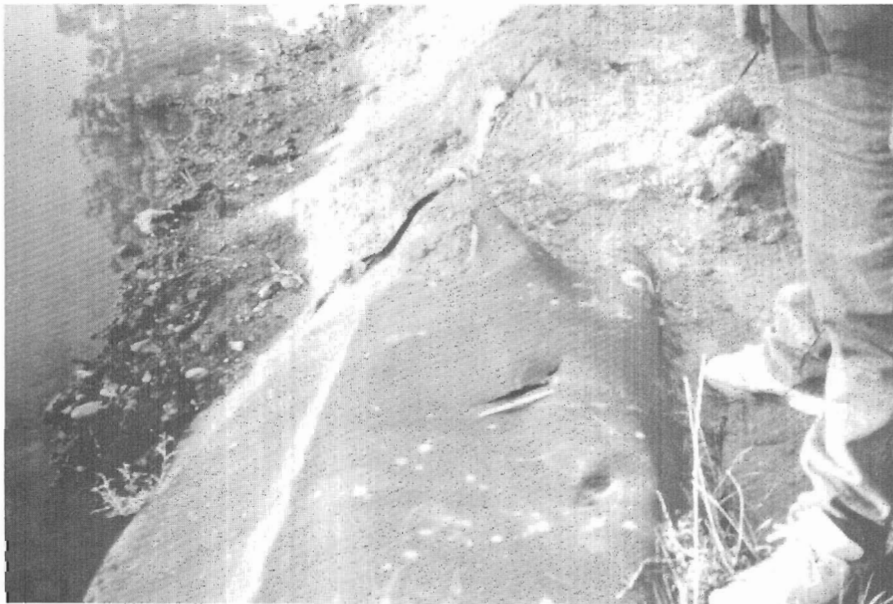
Photograph 14. - Backhoe damage at upstream dike.

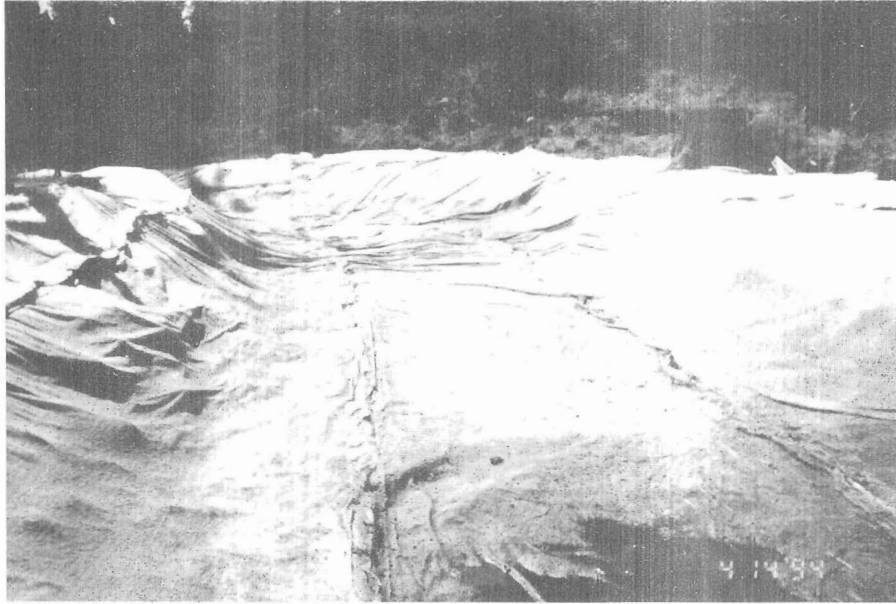
**Condition:** Excellent - actually performing much better than expected. The exposed geotextile is collecting dirt. About 1 inch of sediment has collected in the canal invert, which is actually beneficial because the sediment anchors the exposed geomembrane and provides UV protection. The geotextile is in good condition with little deterioration to date. "Scuffing" of the geotextile along the top of each berm is probably caused by animals or workers entering and exiting the canal. Many of the geotextile seams still need to be sewn. As photo 17 shows, hog-rings have not been effective for seaming the geotextile except where spaced very closely (every 6 inches). Many unsewn seams beneath the waterline are filled with sediment, which is forcing open the unseamed sections further. Where the PVC geomembrane is exposed on the sides of the canal, it has turned white in color. Any exposed PVC beneath the waterline remains a gray color. This color change may be a sign of deterioration. The integrity of the geotextile cover is essential for protection of the PVC geomembrane from UV light.

Photograph 15. - Canal overview—excellent condition.

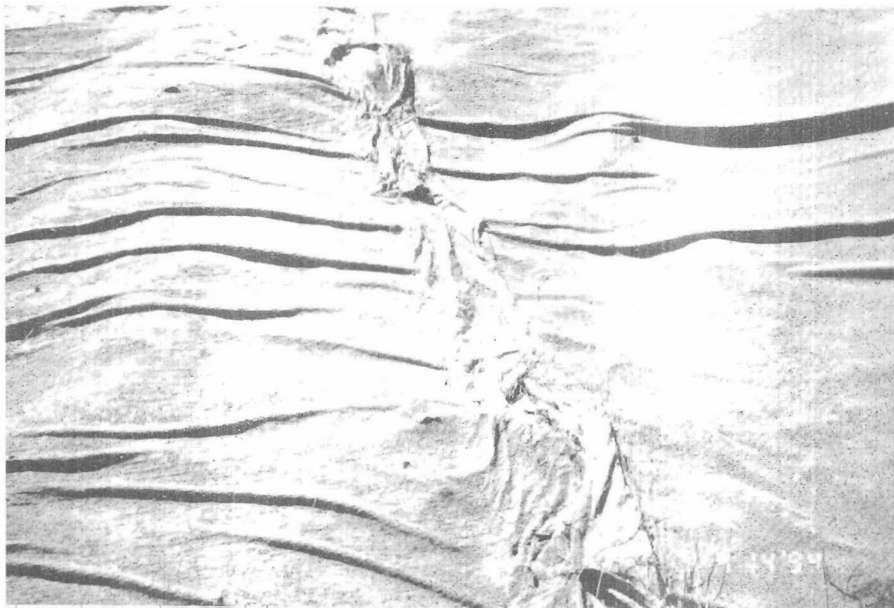
Photograph 16. - Close-up of sewn geotextile seam.

**Needed:** Additional geotextile seams need to be sewn, hog-ringed, or glued to protect PVC geomembrane from degradation caused by UV light exposure. To perform future repairs to the geomembrane, the irrigation district needs PVC solvent cement, extra Geolam, and specialized training.

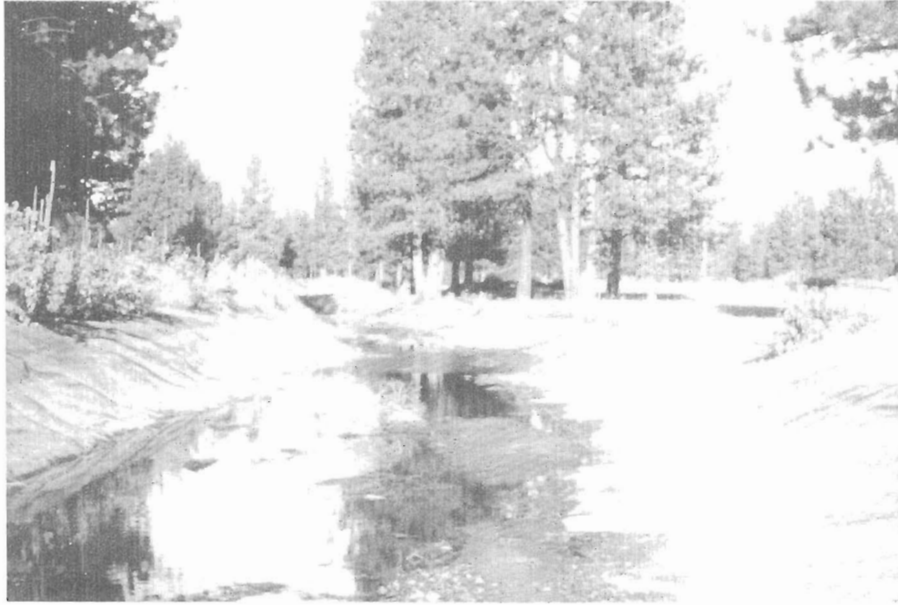
Condition: Excellent - the exposed Hypalon geomembrane is holding up well. No damage or tears have been observed to date. Again, colored algae film is visible below the waterline.

Photograph 21. - Canal overview—excellent condition.

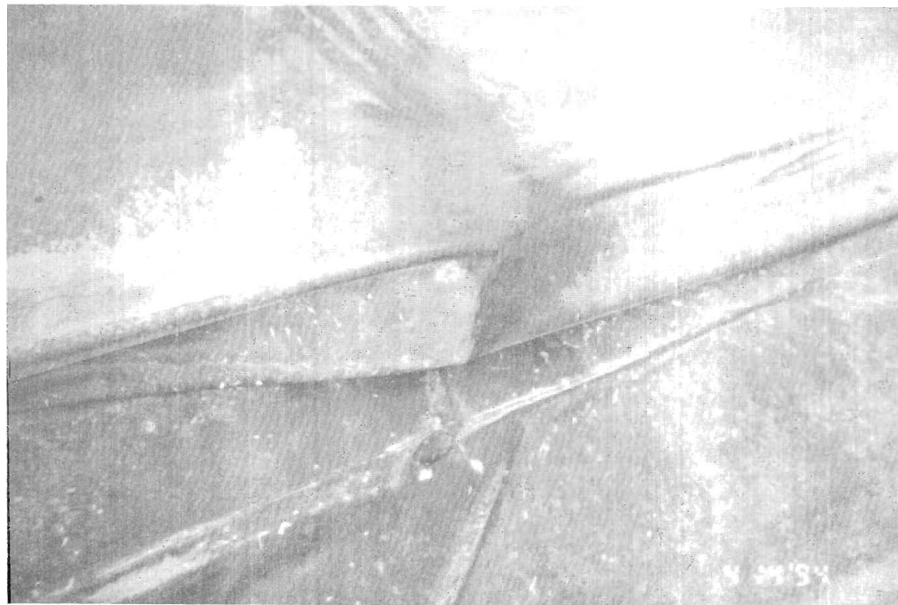
Photograph 22. - Colored algae growing below water line.

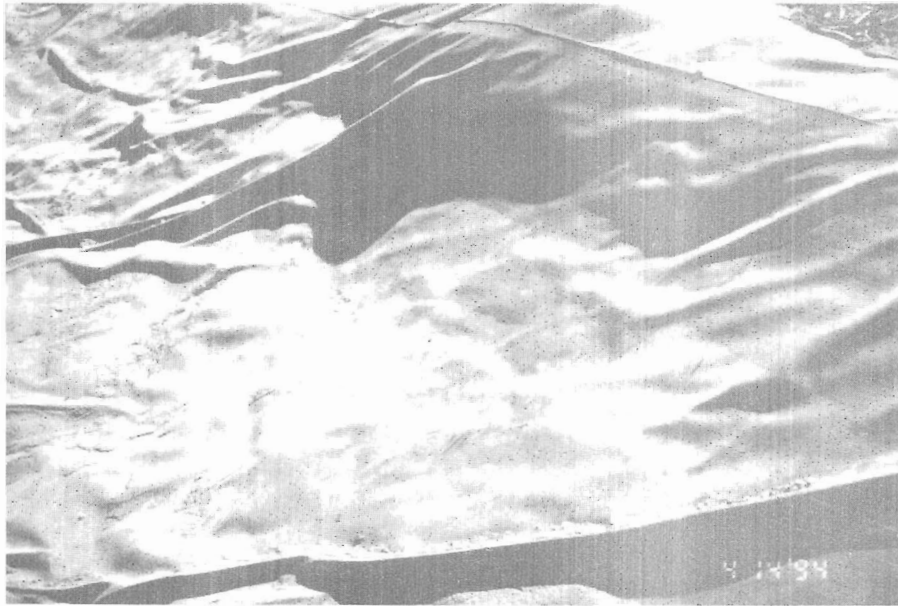
Photograph 23. - Wrinkles in exposed geomembrane provide slack for thermal expansion and contraction.

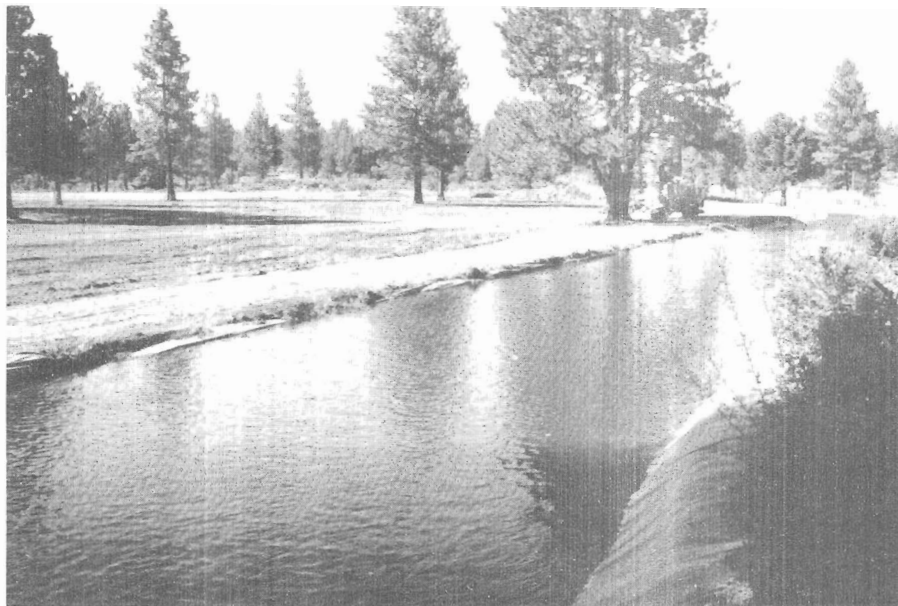
Photograph 24. - Canal in service.

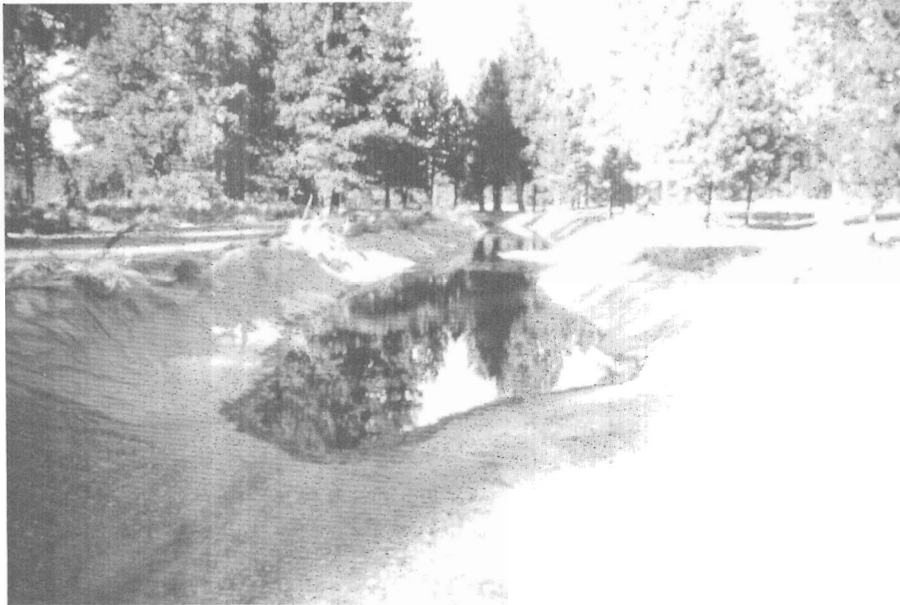
Photograph 25. - Canal overview—excellent condition.

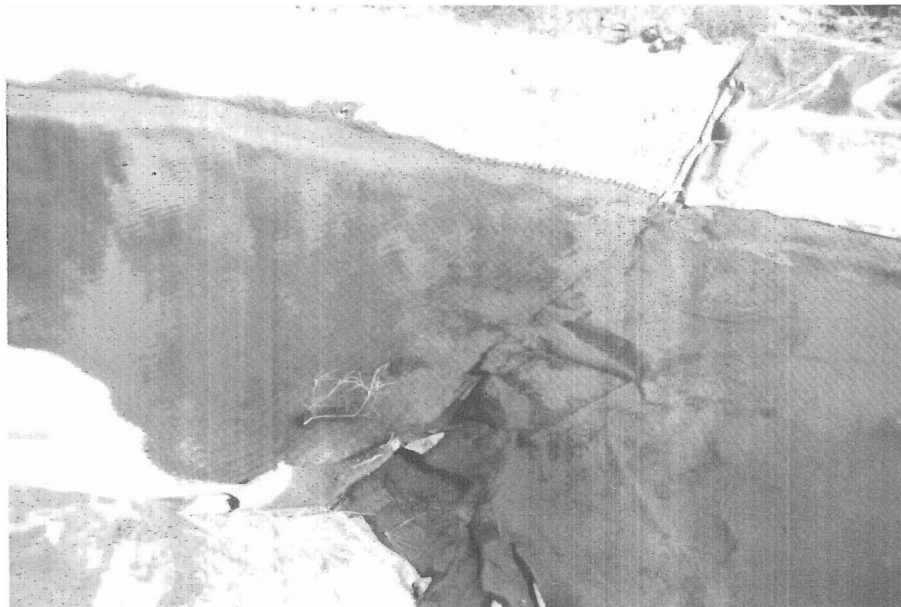
Photograph 26. - Cuts in geomembrane in invert at downstream dike need to be repaired.

Needed: Repair cuts in liner at station 39+90.  
To perform future repairs to the geomembrane, the irrigation district needs Hypalon solvent cement, extra Hypalon, and specialized training.

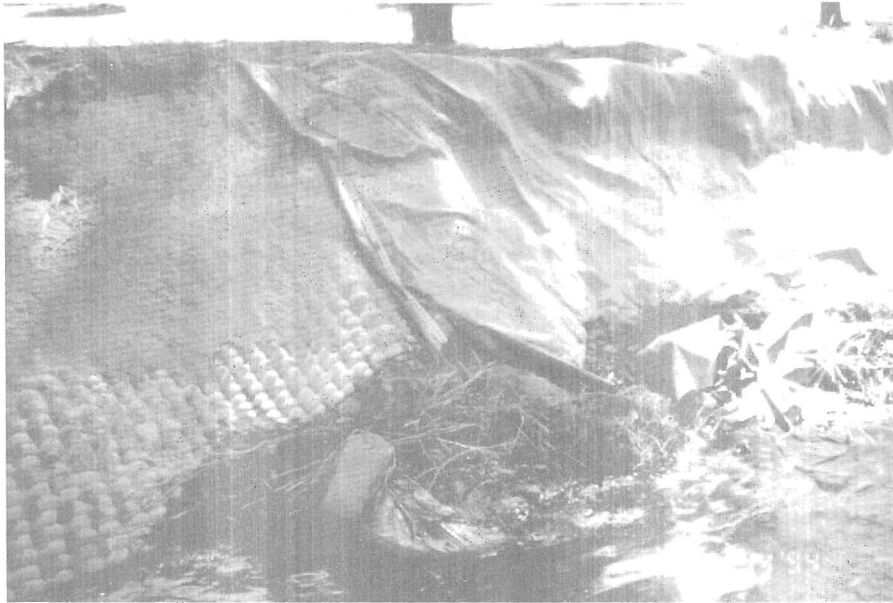
Photograph 27. - Damage at downstream dike.

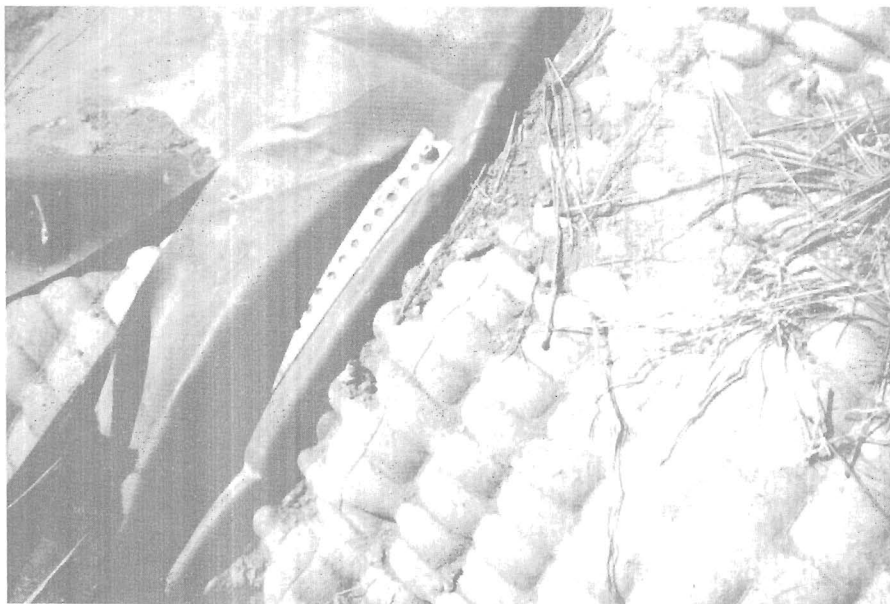
Photograph 28. - Batten strip ties exposed Hypalon into grout mattress in adjoining test section.

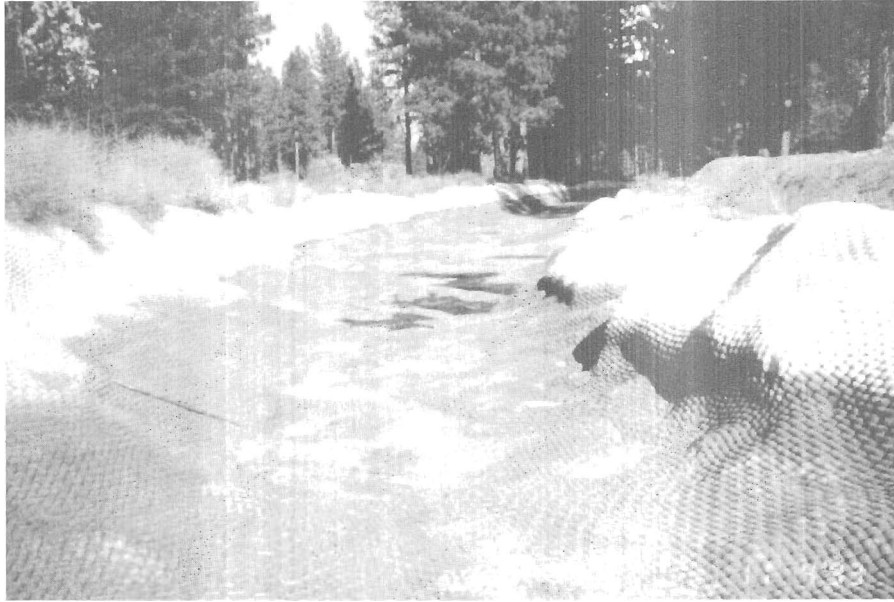
Photograph 29. - Canal overview—excellent condition.

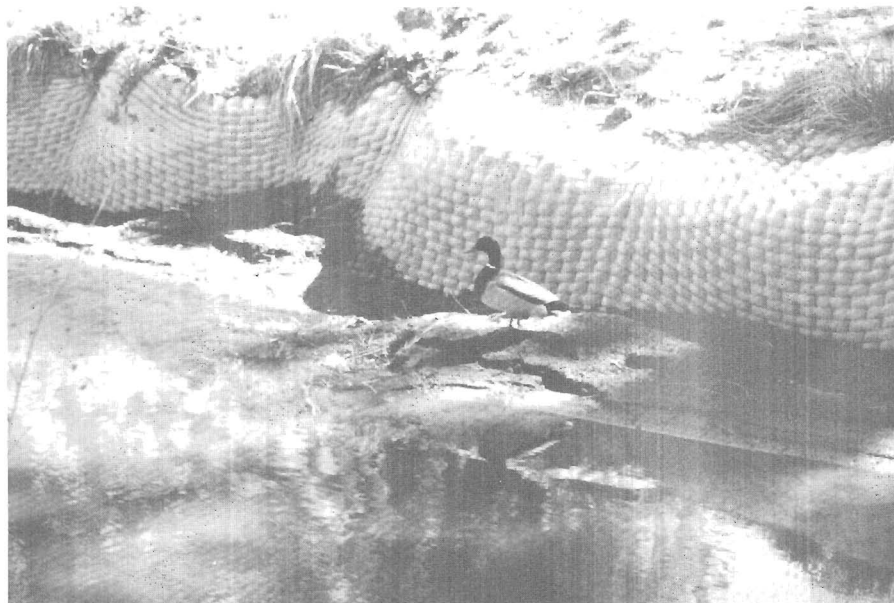
Photograph 30. - Standing water in this test section is used as a watering hole by local wildlife.

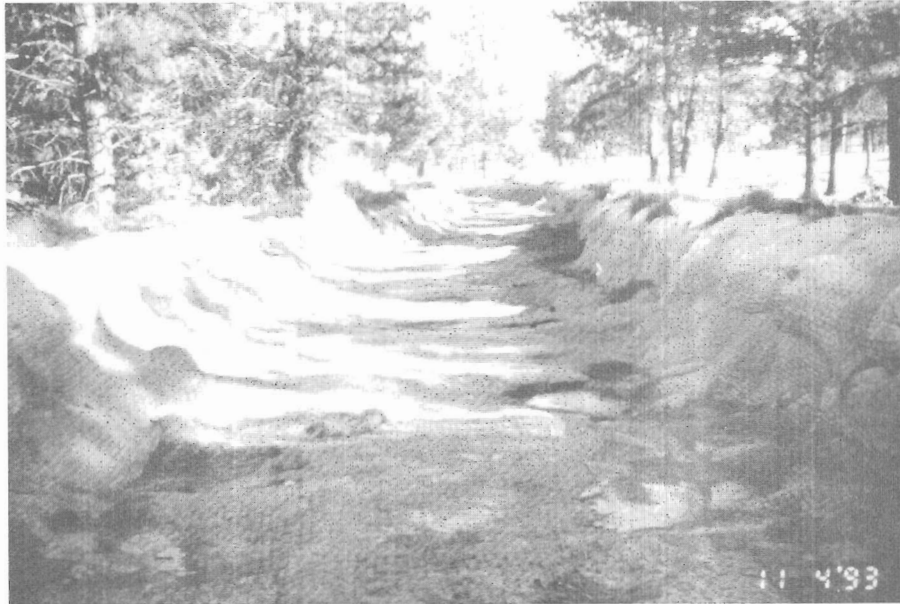
Photograph 31. - Canal overview—excellent condition.

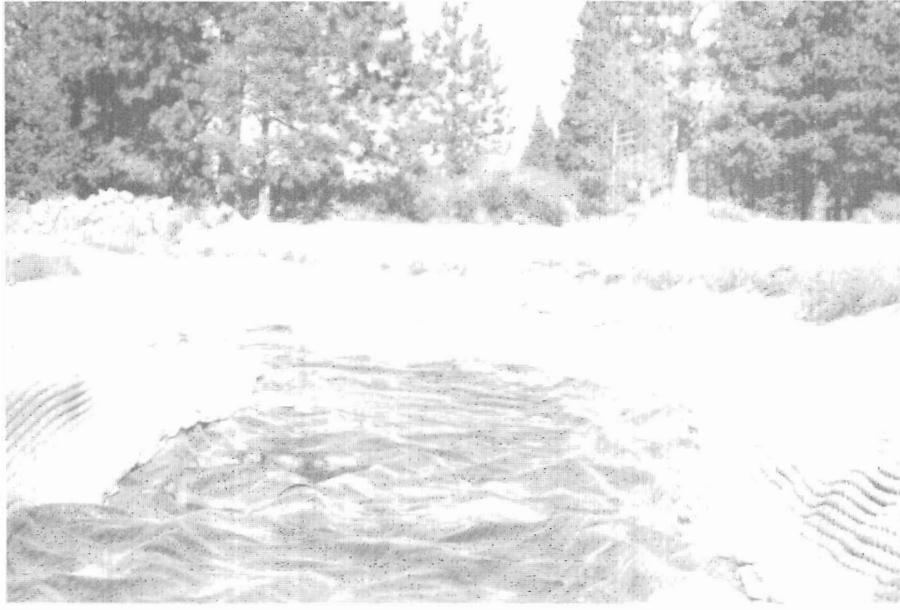
Photograph 33. - Canal overview—marginal condition.

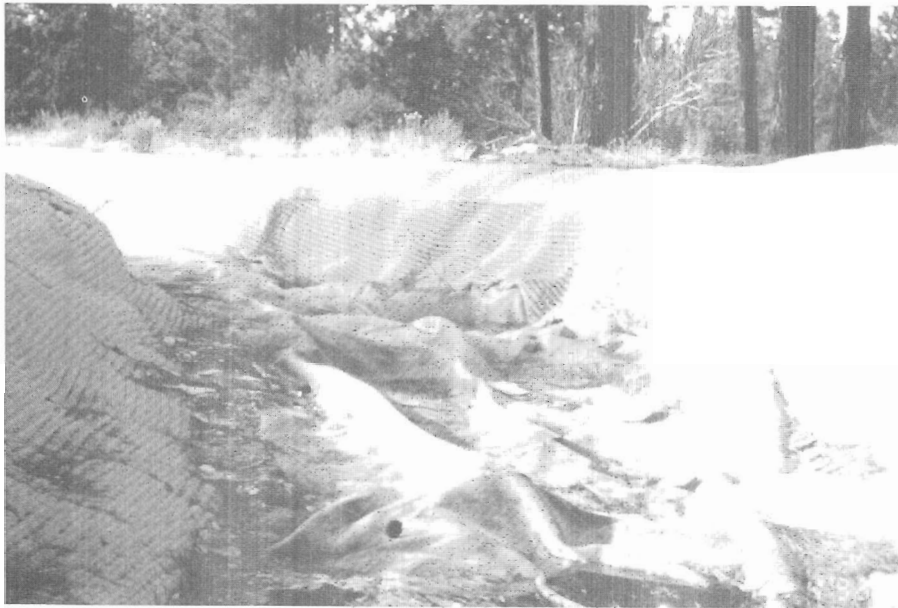
Photograph 34. - Extensive longitudinal wrinkles have developed in the canal invert.

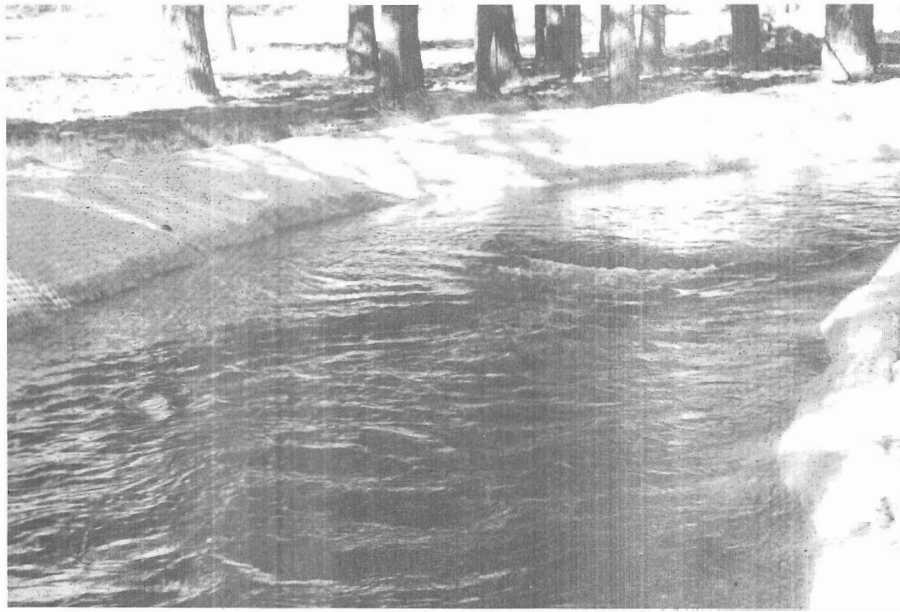
Photograph 35. - Ballooned liner (whale) is just below the water surface, creating the "wave" in this photograph.

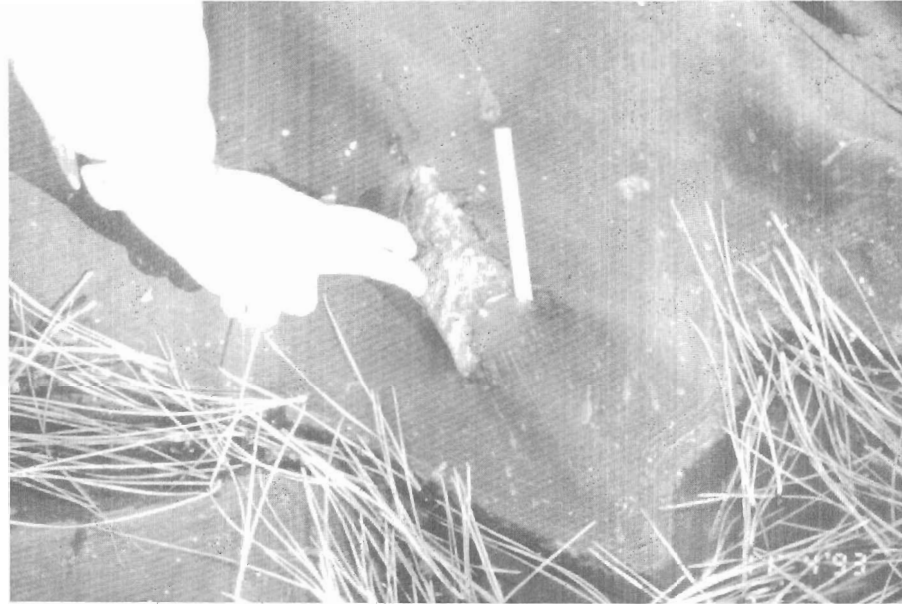
Photograph 37. - Tear over large sharp subgrade rock.

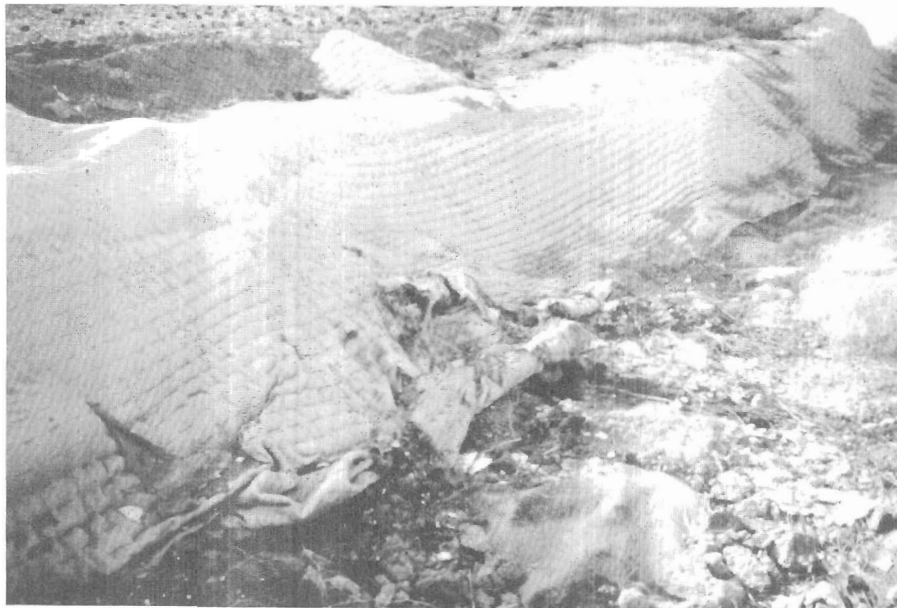
Photograph 38. - Backhoe damage at downstream dike

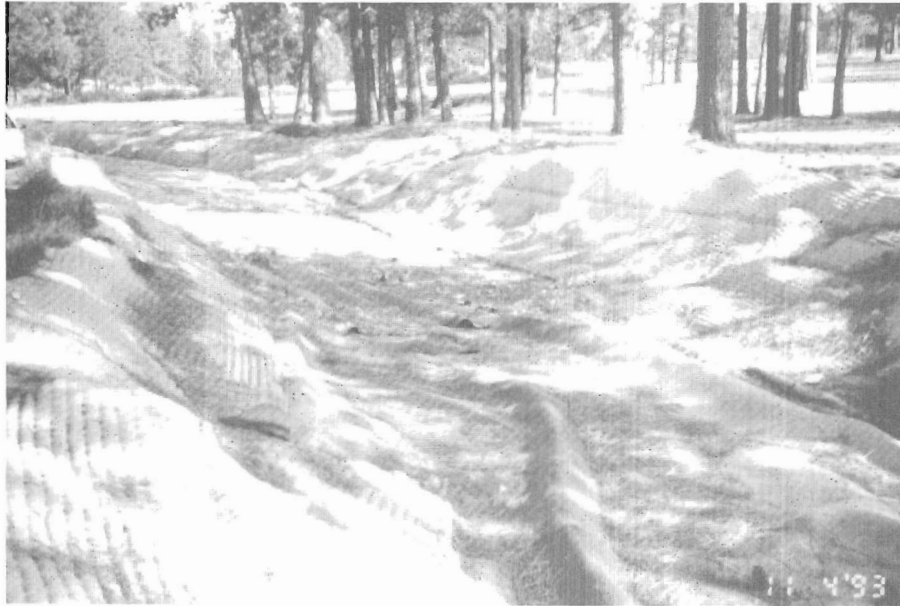
Photograph 39. - Canal overview—marginal condition.

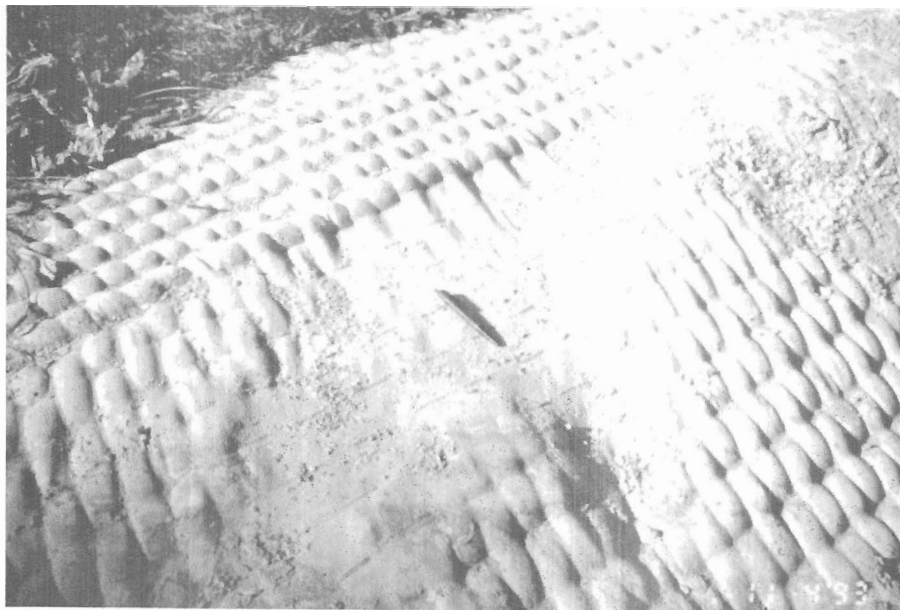
Photograph 40. - Empty pocket in grout mattress.

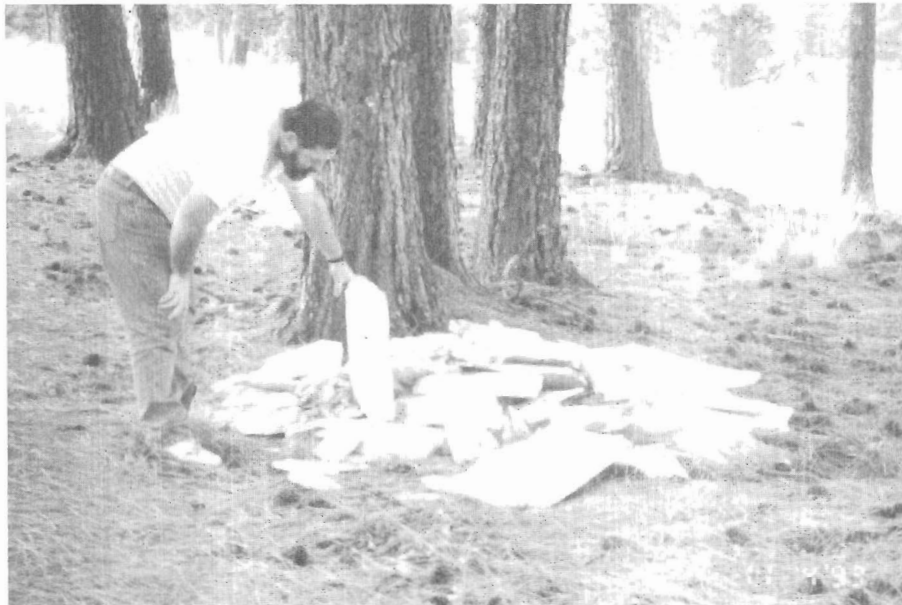
Photograph 42a. - Irrigation district removed some of the portland cement deposits in October 1993.

Maintenance:	Extensive maintenance required to date
Performed:	Removed about half of the portland cement deposits (cost = \$320)
Needed:	Remove remaining portland cement deposits. Repair cuts and tears in exposed HDPE in invert. Anchor geomembrane in invert with concrete blocks or a concrete pad. Patch grout mattress where not full of grout. To perform repairs, irrigation district needs an extrusion welder, extra membrane, and specialized training.
Photographs:	39 through 44

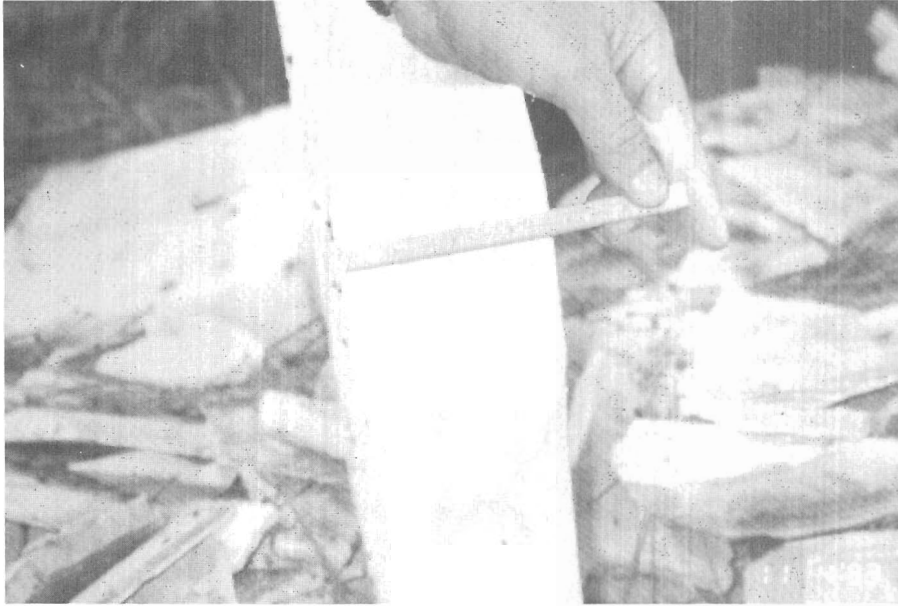
Photograph 42b. - Portland cement deposits are up to 4 inches thick.

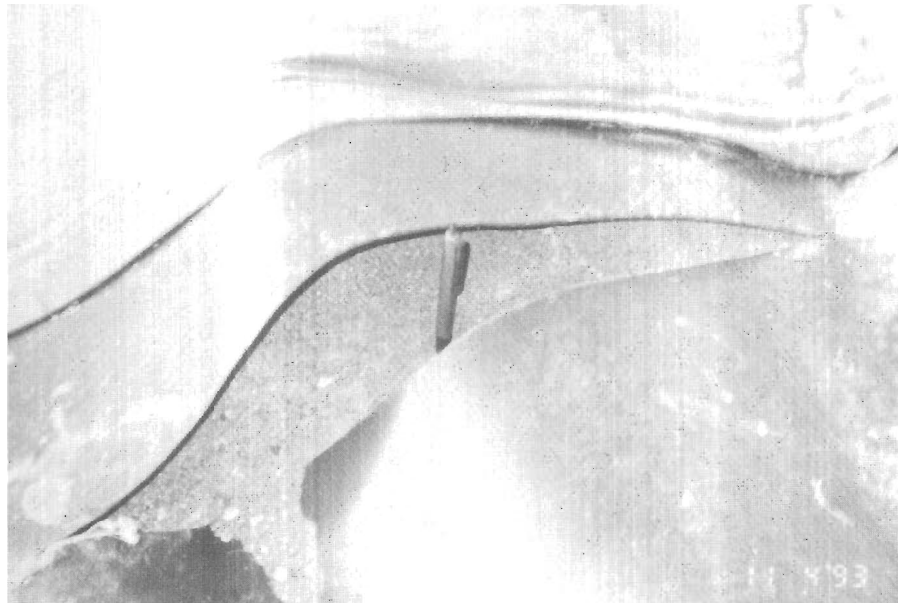
Photograph 44. - Cut in geomembrane to relieve "whale". Sand deposits found beneath liner.

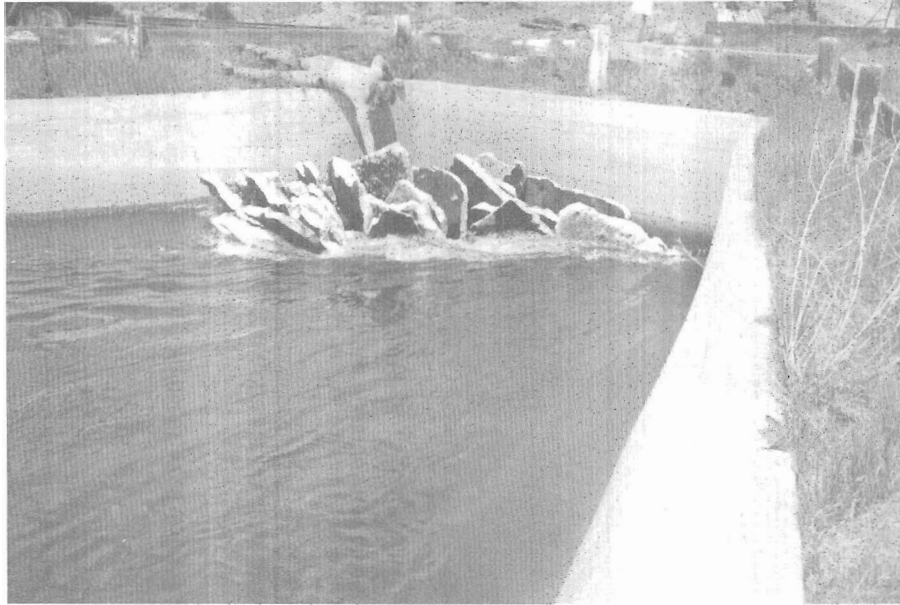
Photograph 47. - Washed-out foam collected downstream at siphon inlet.

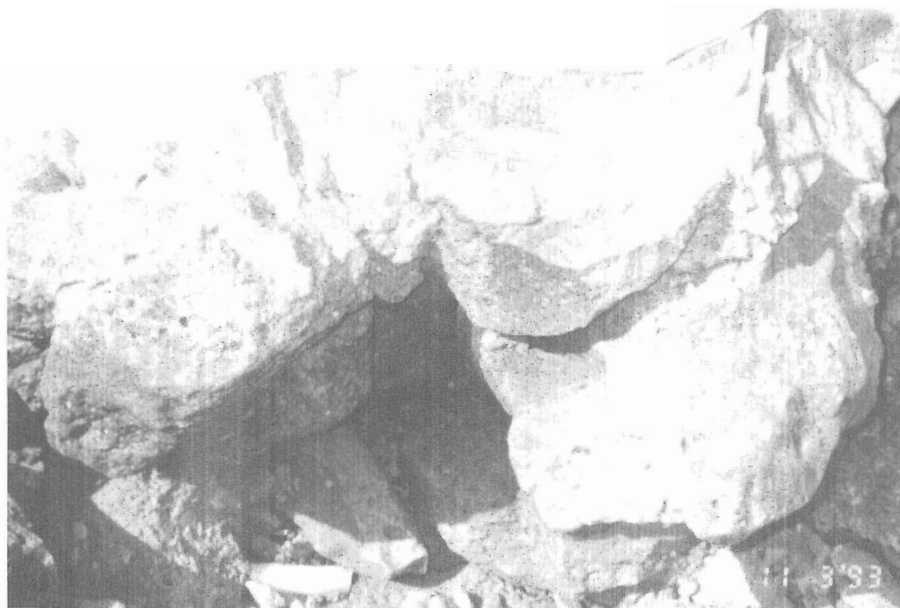
Photograph 48. - Foam is well-bonded to subgrade rocks and provided sufficient buoyancy to "float" even large rocks (6- to 12-inch diameter).
