# **DESCHUTES—CANAL-LINING DEMONSTRATION PROJECT DURABILITY REPORT—YEAR 2**

September 1994

**U.S. DEPARTMENT OF THE INTERIOR**  
Bureau of Reclamation

Technical Service Center  
Research and Laboratory Services Division  
Materials Engineering Branch

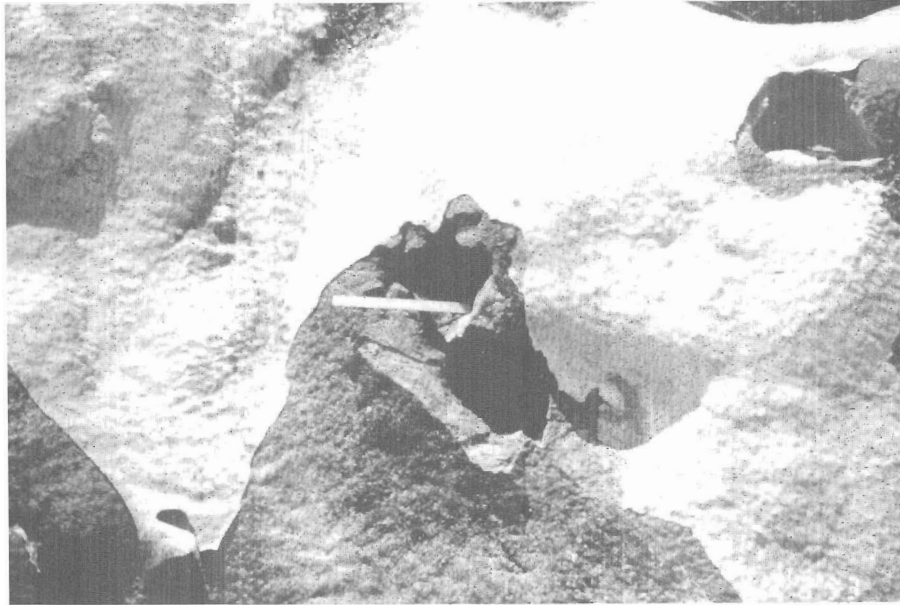
Photograph 49. - Poorly bonded coating stripped from foam.

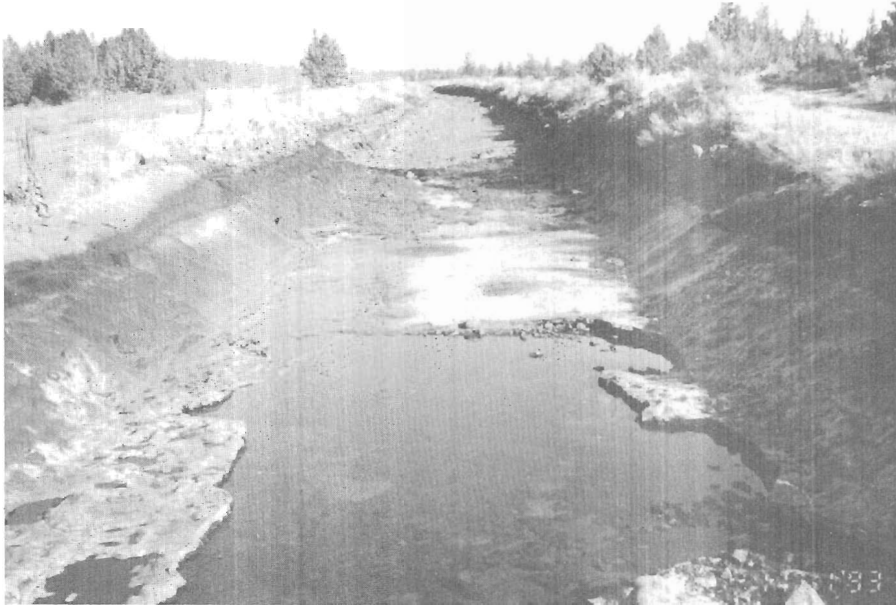
Photograph 51. - Canal overview—partially failed. Foam has washed out under bridge in upstream half of this test section.

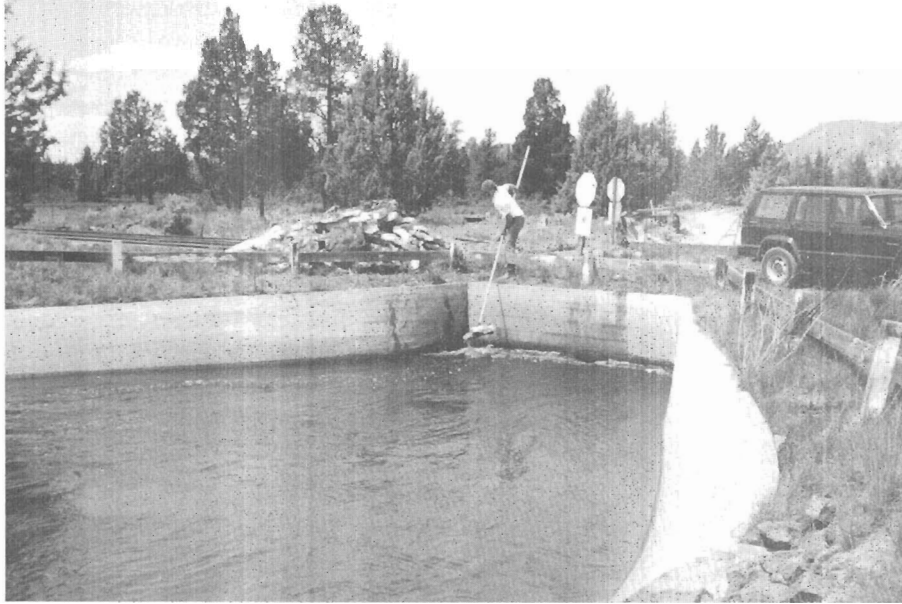
Photograph 53. - Irrigation district removes washed-out foam where it collected at siphon inlet.

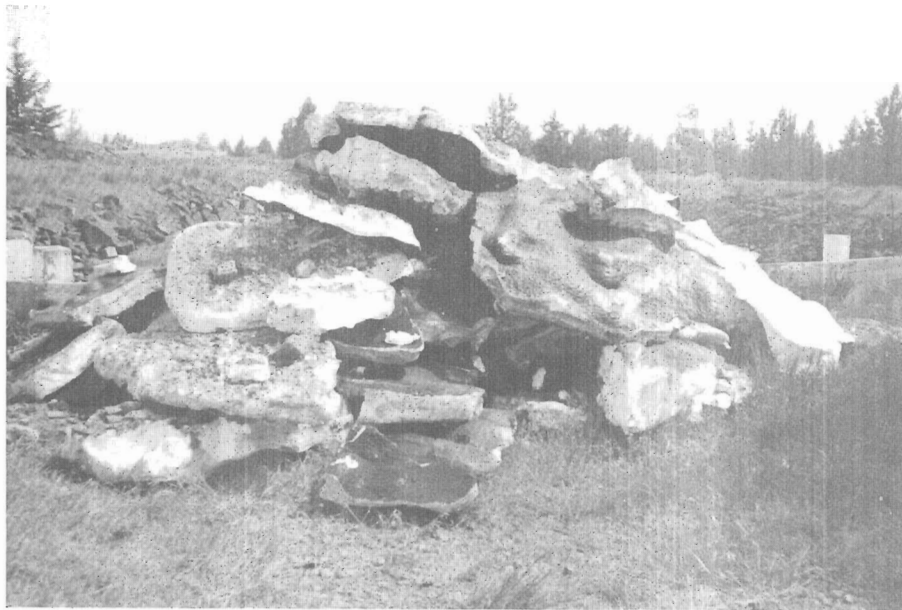
Photograph 54. - Several cubic yards of washed-out foam were collected at the siphon inlet.

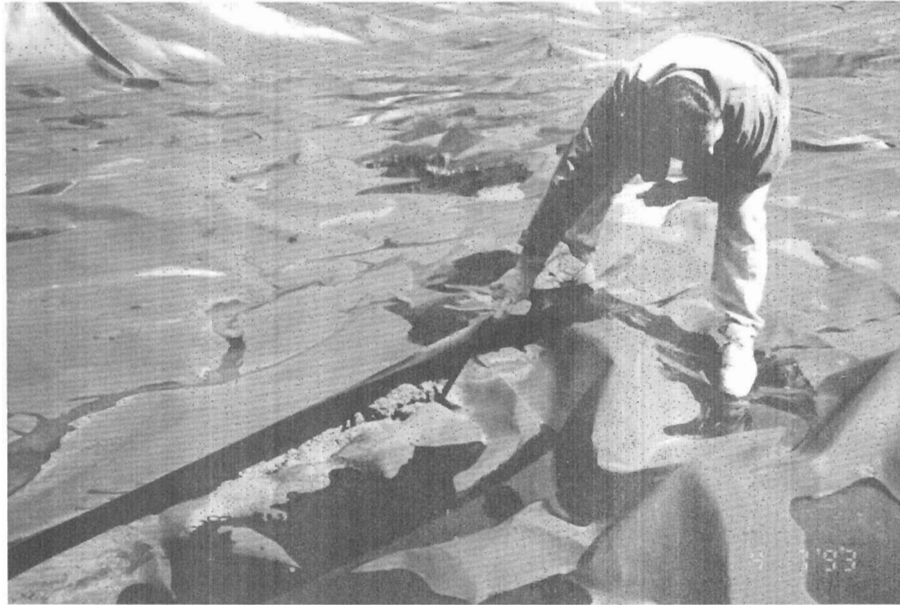
Photograph 55. - 20-foot seam with essentially zero bond.

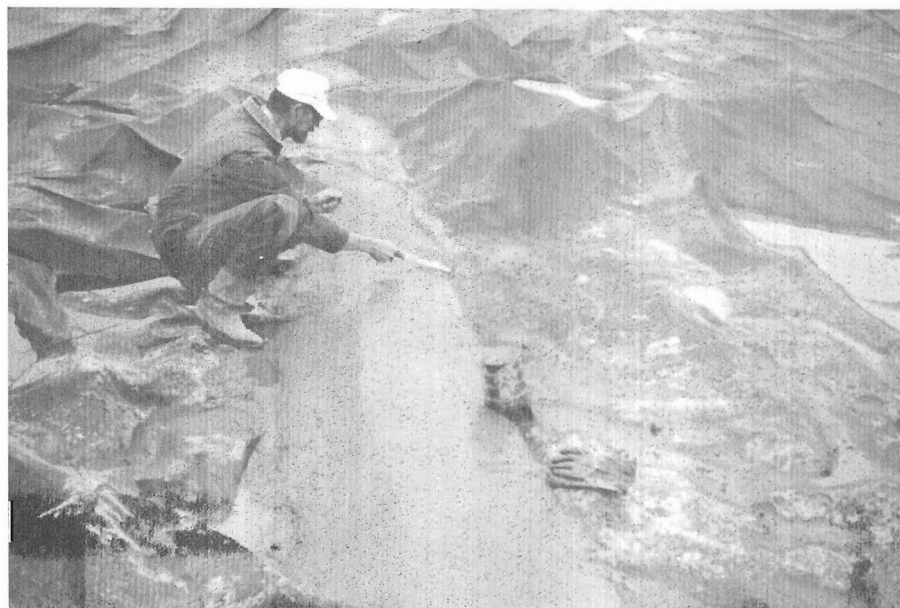
Photograph 56. - Irrigation district repairs seam with a concrete cap.

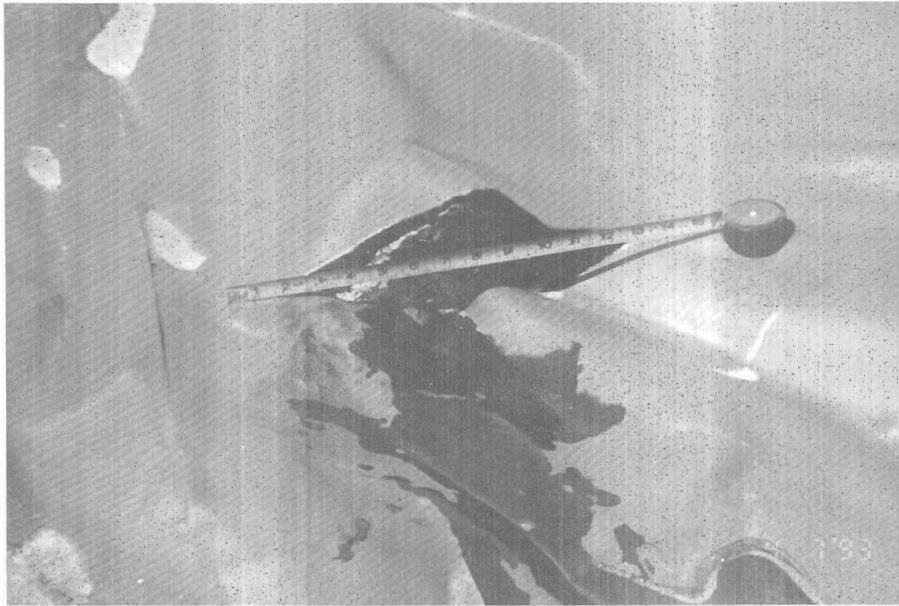
Photograph 57. - Dozens of rips in geotextile around rocks.

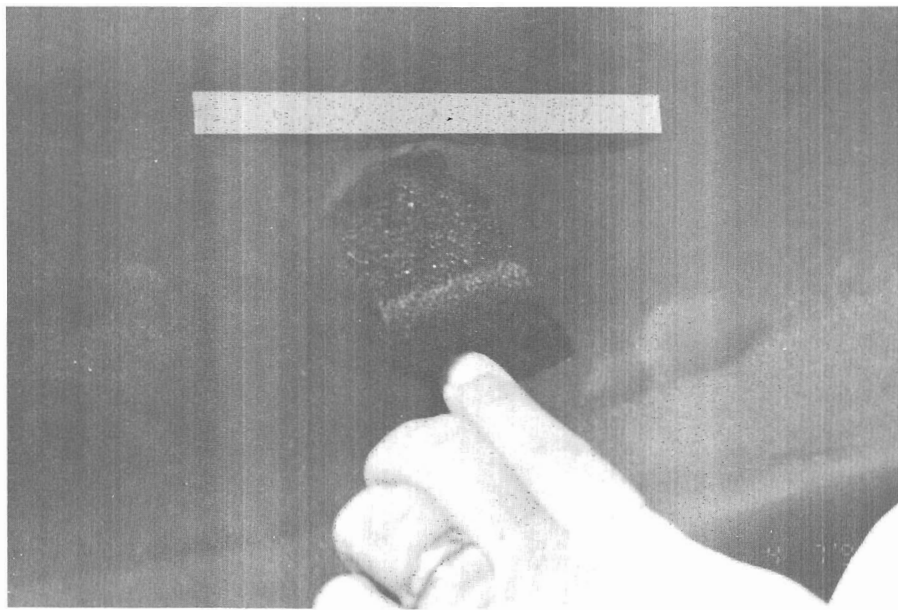
Photograph 58. - Blister in Geothane 5020 coating, applied too thick?

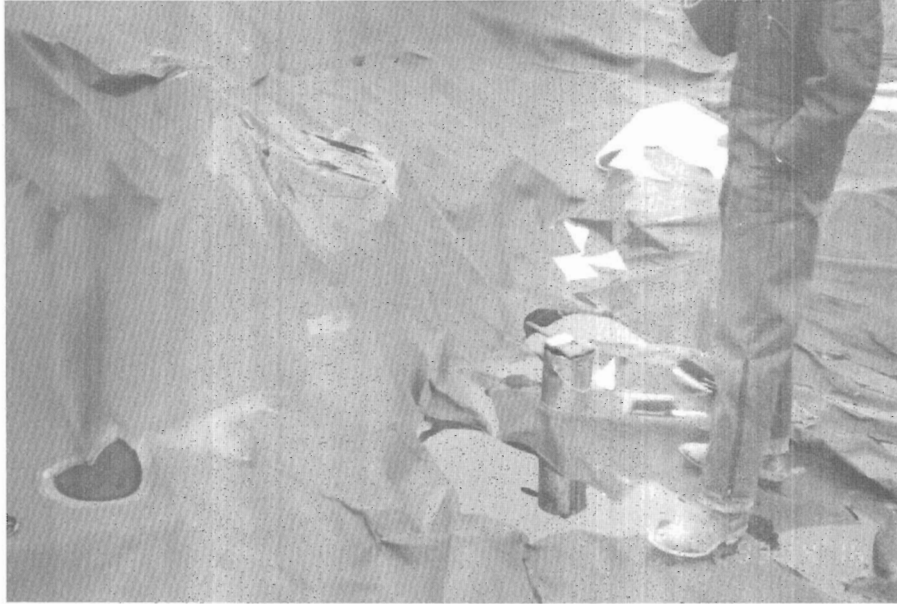
Photograph 59. - Irrigation district used hand-mix version of Geothane 5020 for repairs.

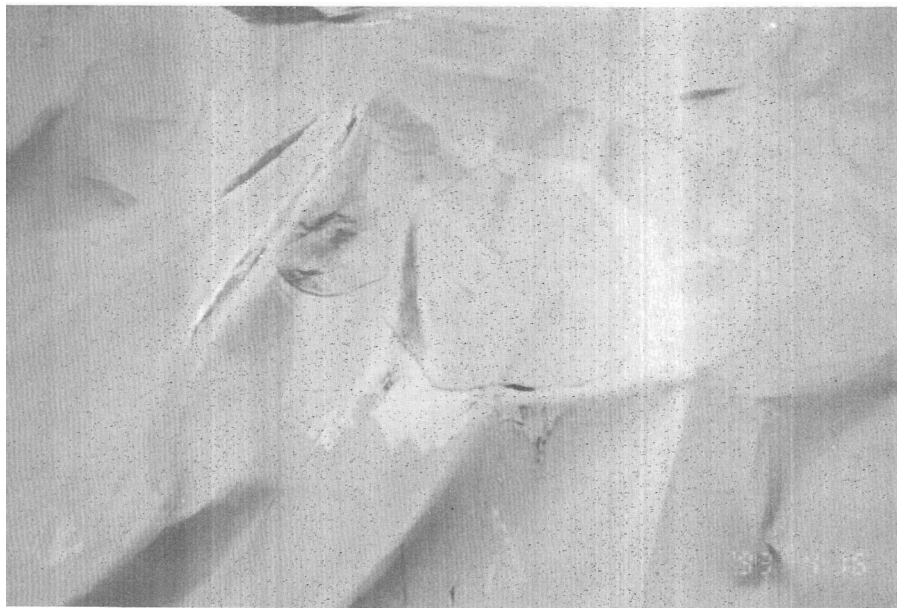
Photograph 60. - Completed geotextile patch.

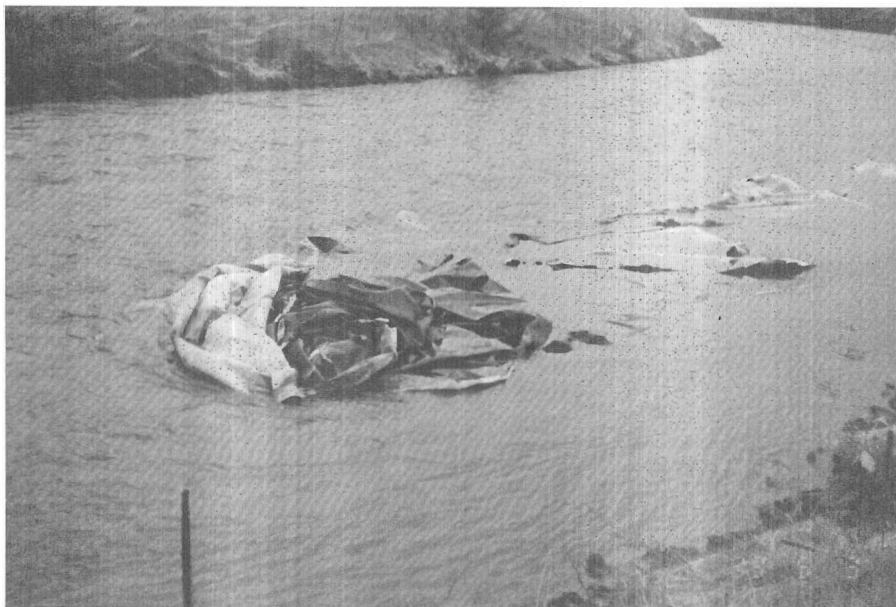
Photograph 61. - Sections of geotextile liner tore loose when the canal was filled with water.

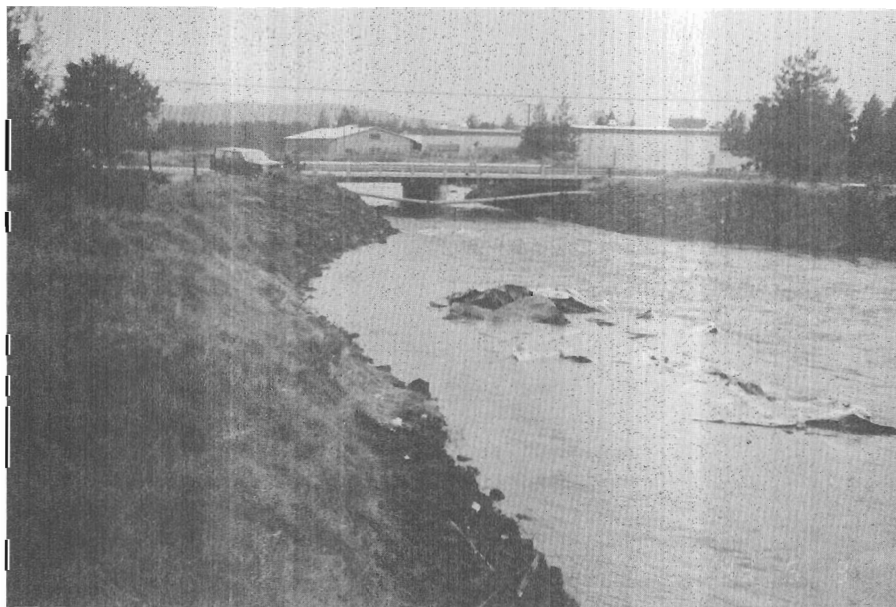
Photograph 62. - Runaway floating geotextile liner damaged the pipe crossing shown near bridge.

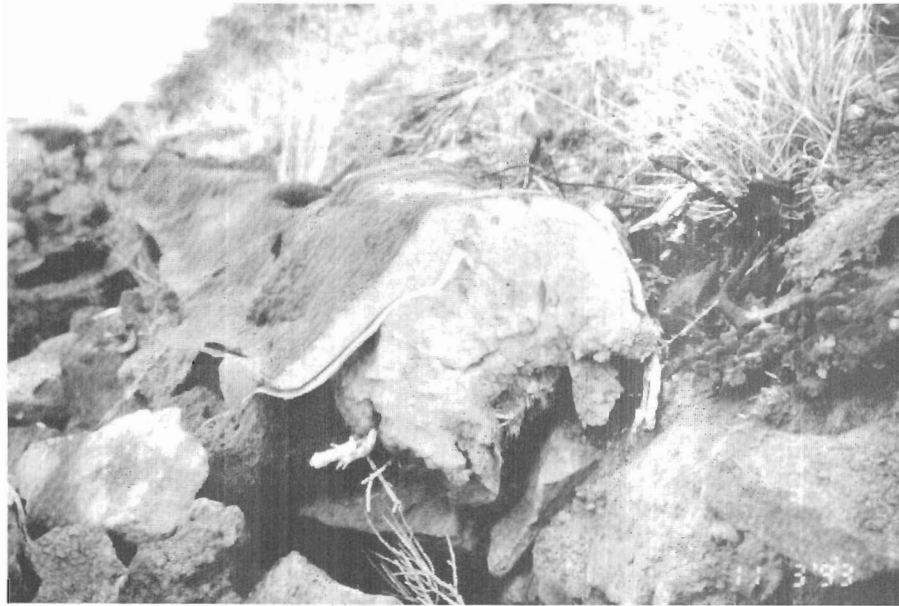
Photograph 63. - Geotextile liner tore parallel to foam anchor trench.

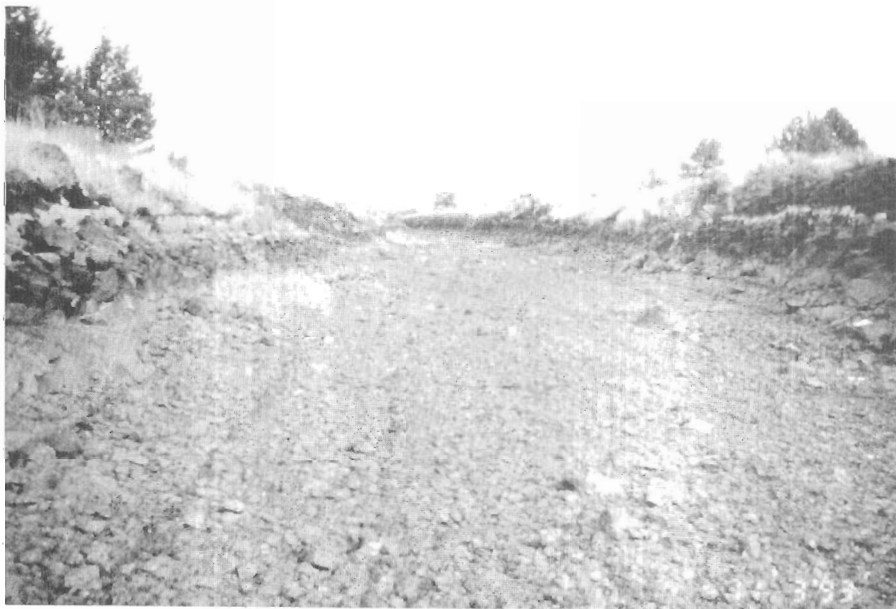
Photograph 64. - Irrigation district removed all remaining geotextile liner from these test sections.

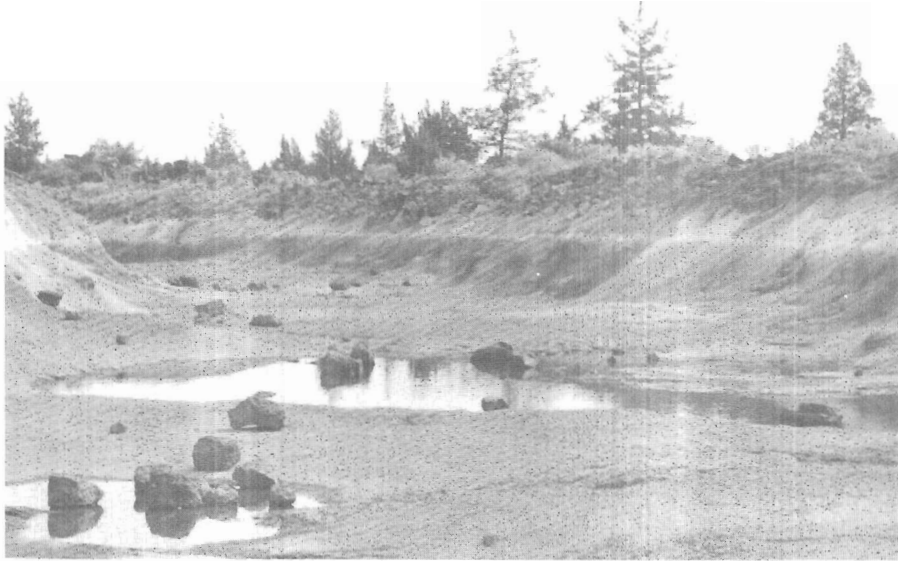
Photograph 65. - Canal overview—excellent condition. Boulders in invert were probably rolled in by local residents.

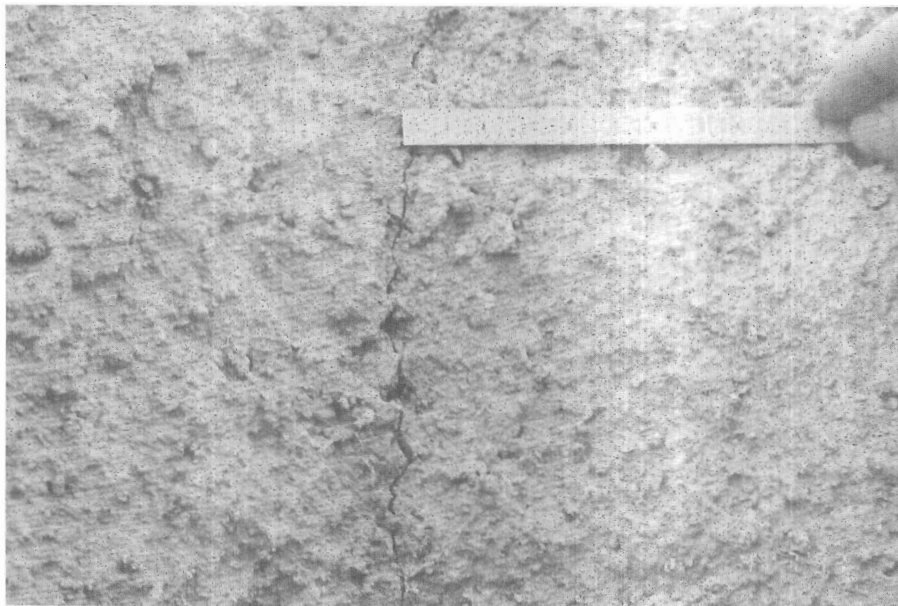
Photograph 66. - Transverse contraction cracks in side slopes every 100 to 200 feet.

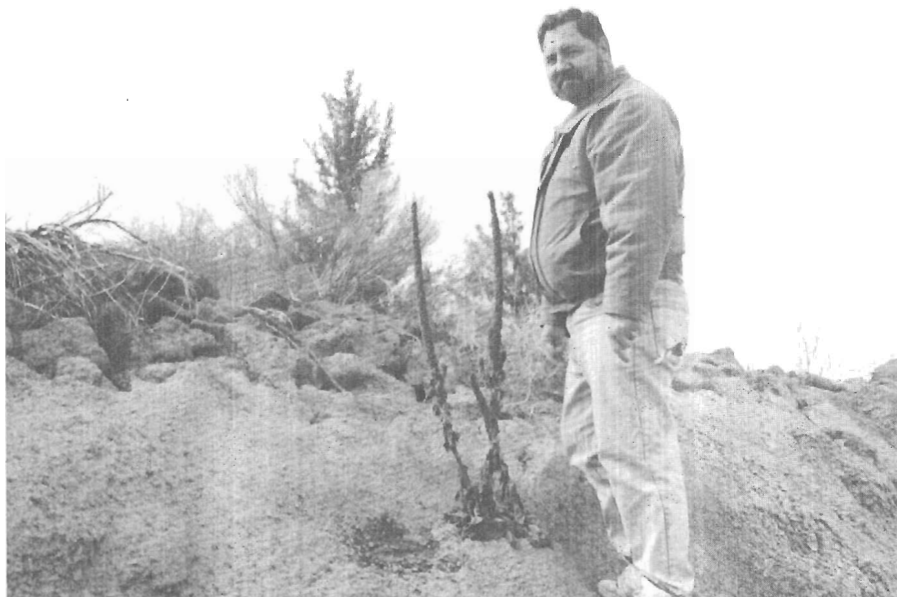
Photograph 67. - Vegetation occasionally growing out of shotcrete on side slopes.

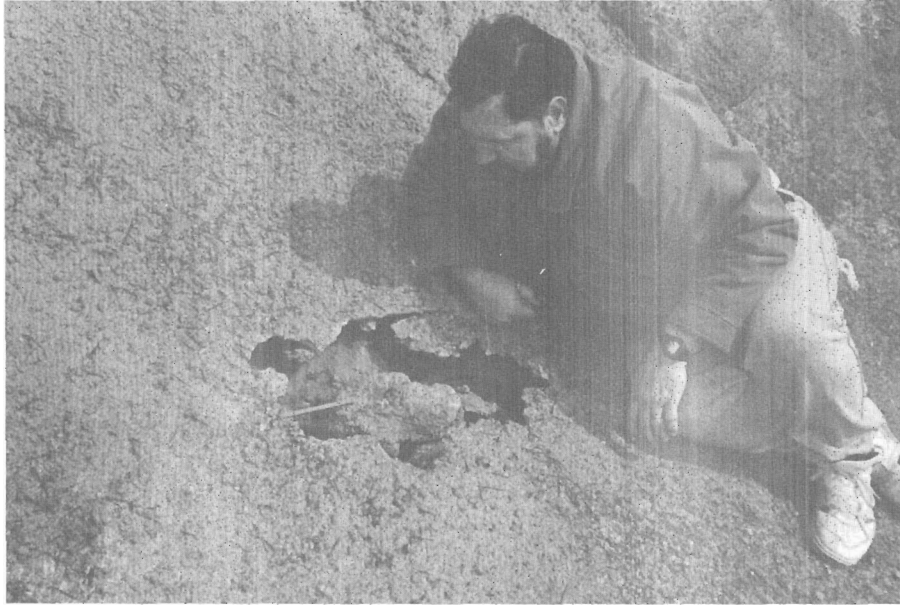
Photograph 69. - Two-foot-diameter hole in shotcrete on left bank.  
Shotcrete is only about 1 inch thick at this location.

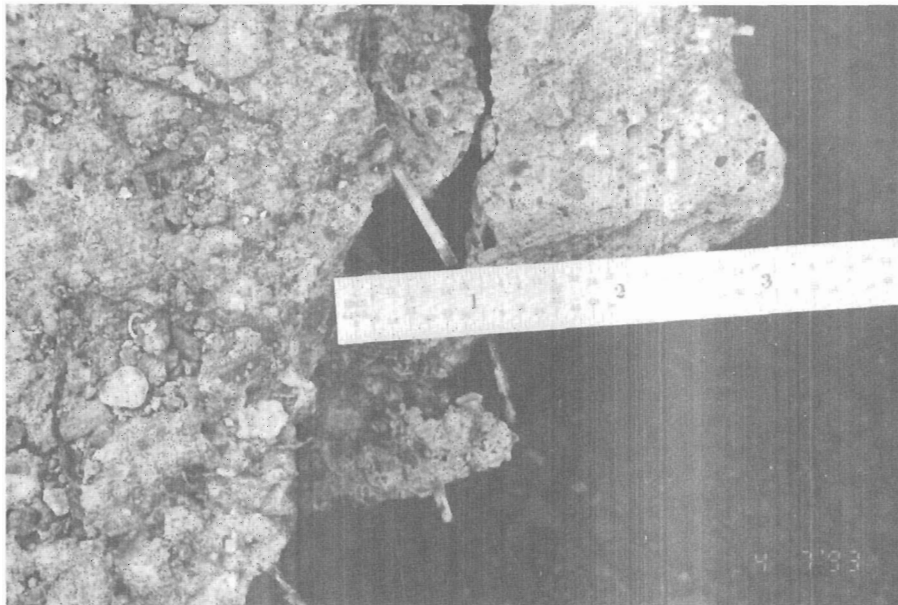
Photograph 70. - Exposed steel fibers have corroded and are quite weak.  
Embedded steel fibers have been protected and are still shiny.

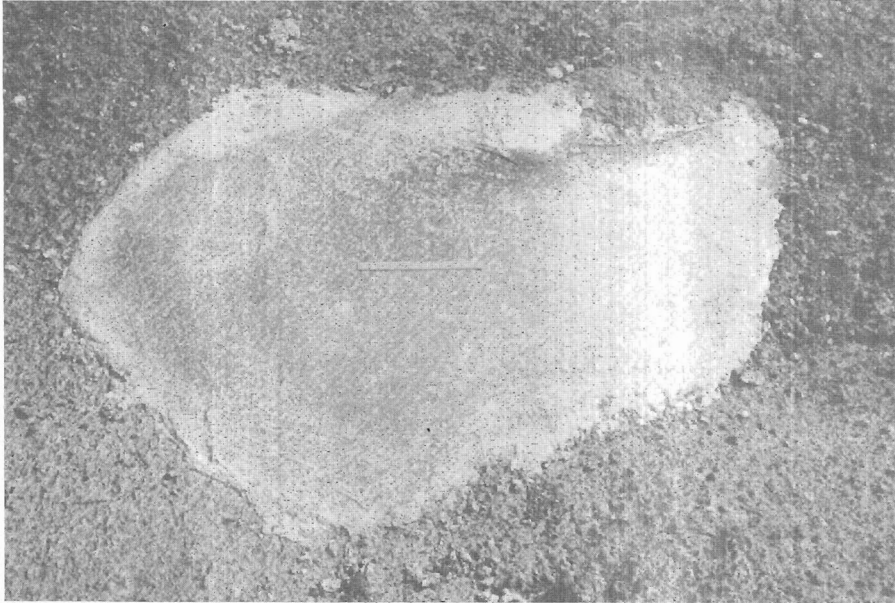
Photograph 71. - Irrigation district patched two 2-foot-diameter holes that developed in the shotcrete.

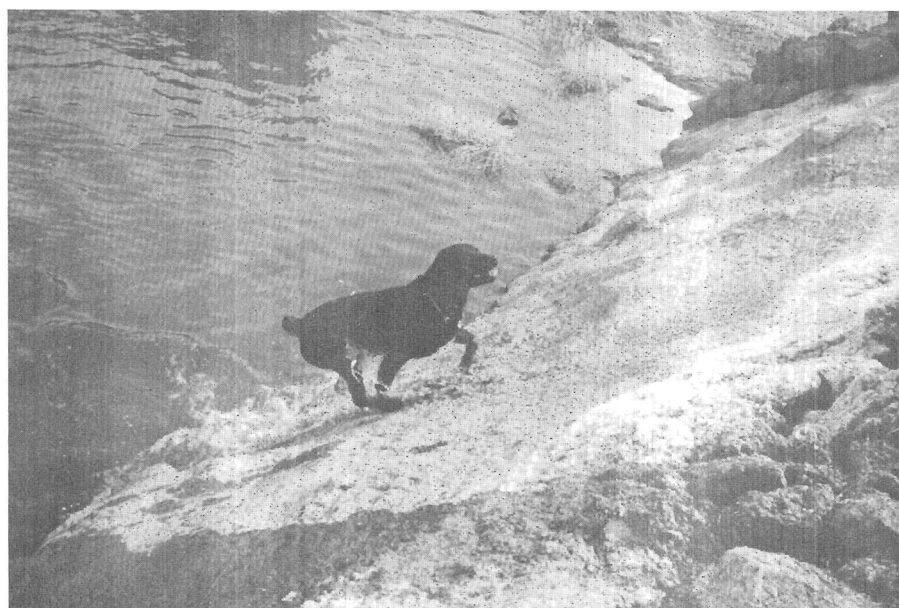
Photograph 75. - Rough shotcrete surface allows for animal escape.
