R-95-08

EVALUATION OF STATOR COILS REMOVED FROM HEADGATE ROCK GENERATING UNIT 3

July 1995

**U.S. DEPARTMENT OF THE INTERIOR
Bureau of Reclamation
Technical Service Center
Infrastructure Services
Hydroelectric Research and Technical Services Group**

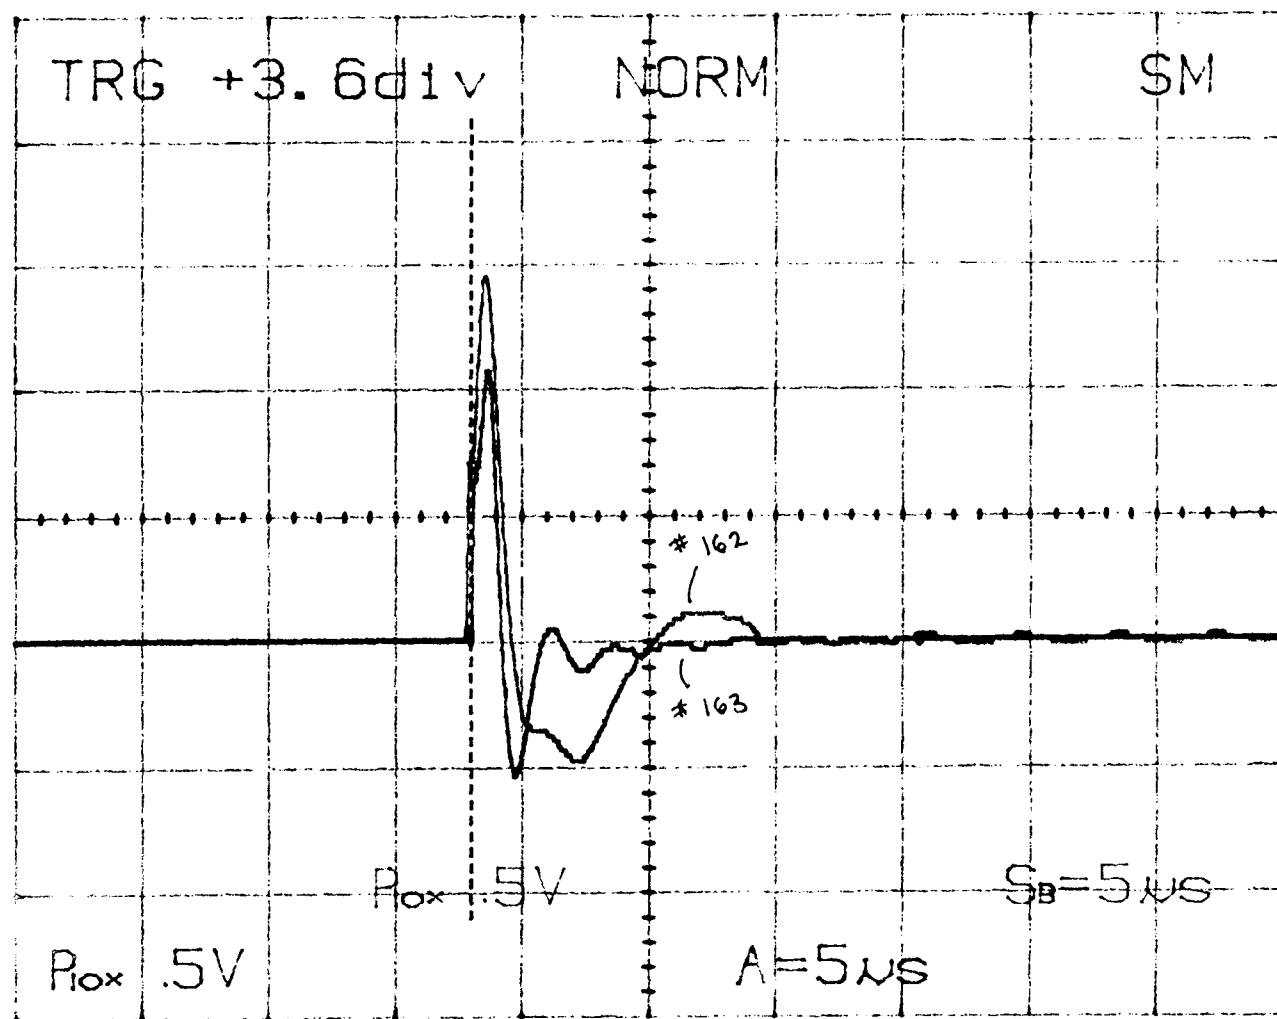
Headgate Rock
Coils #162 & 163

Surge test data exhibit pronounced differences between waveforms of coils with turn failures and the waveform of the good coil. The failed coils display a lower initial voltage peak (for the identical output setting of the surge tester) as well as a higher frequency of oscillation, evidenced by a zero-crossing shift to the left. Such differences in surge test waveforms are

Surge test comparing
coil w/ turn insulation
failure (#163) and
coil w/o turn insulation
failure (#162).

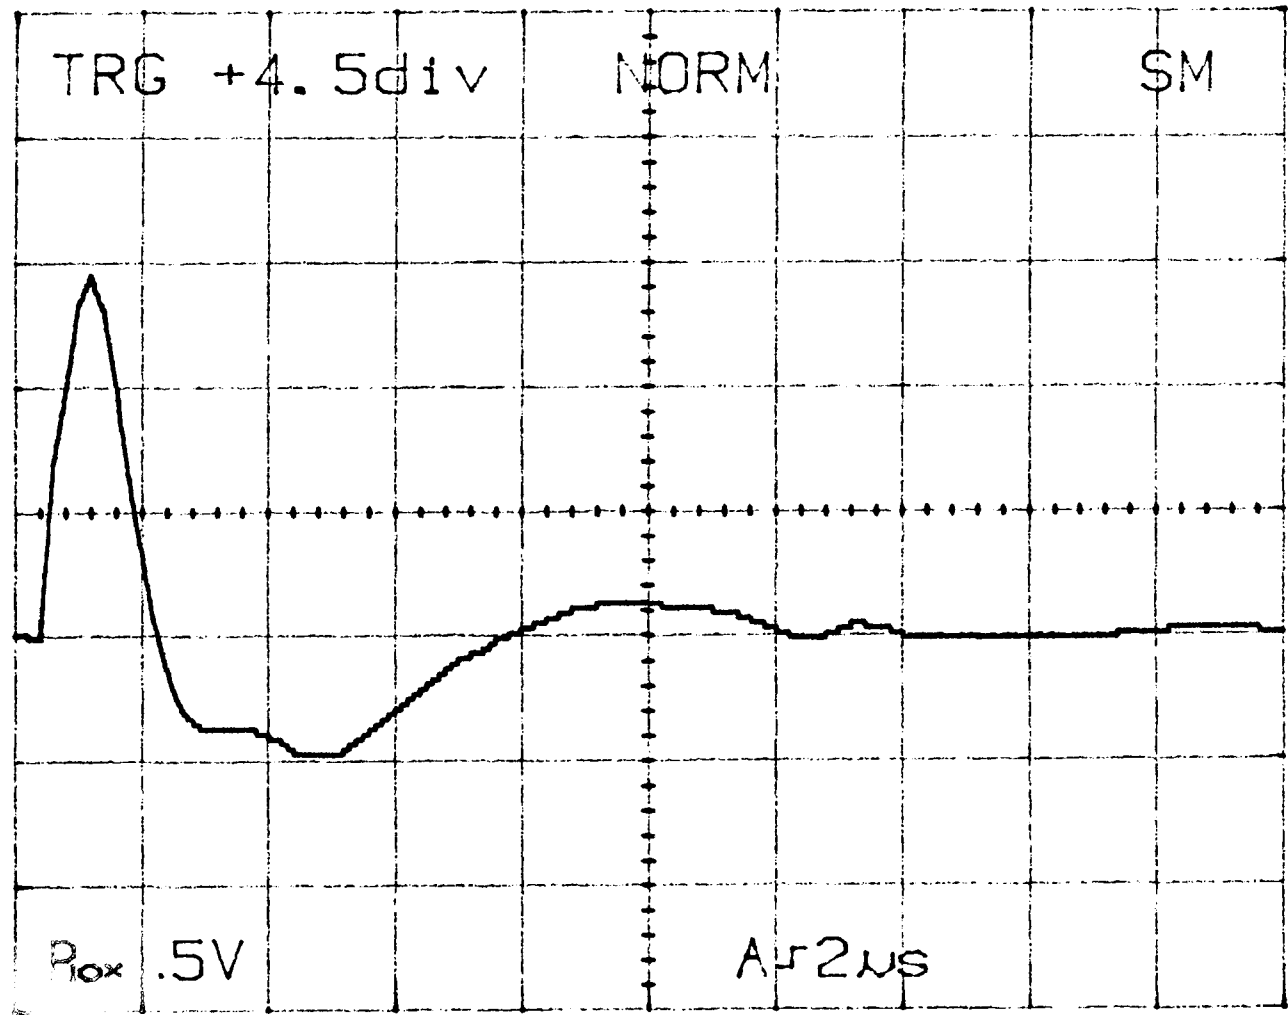
Headgate Rock
Coil #162

Coil No. 498 was surge tested before and after the circulating current test. No difference in the surge test waveform was observed. Coil No. 162 (the good coil) initially passed the surge test at about 1050 V/turn. The test voltage was gradually increased and, after several repetitions, the coil experienced a turn-to-turn failure at about 1200 V/turn. An audible "snap" could be heard as the turn insulation failed. Strand-to-strand resistance measurements were repeated on coil No. 162. A low resistance value of 1.7 kΩ was measured between strands 1 and 3, indicating that a permanent fault remained between the strands.

Before turn
failure.

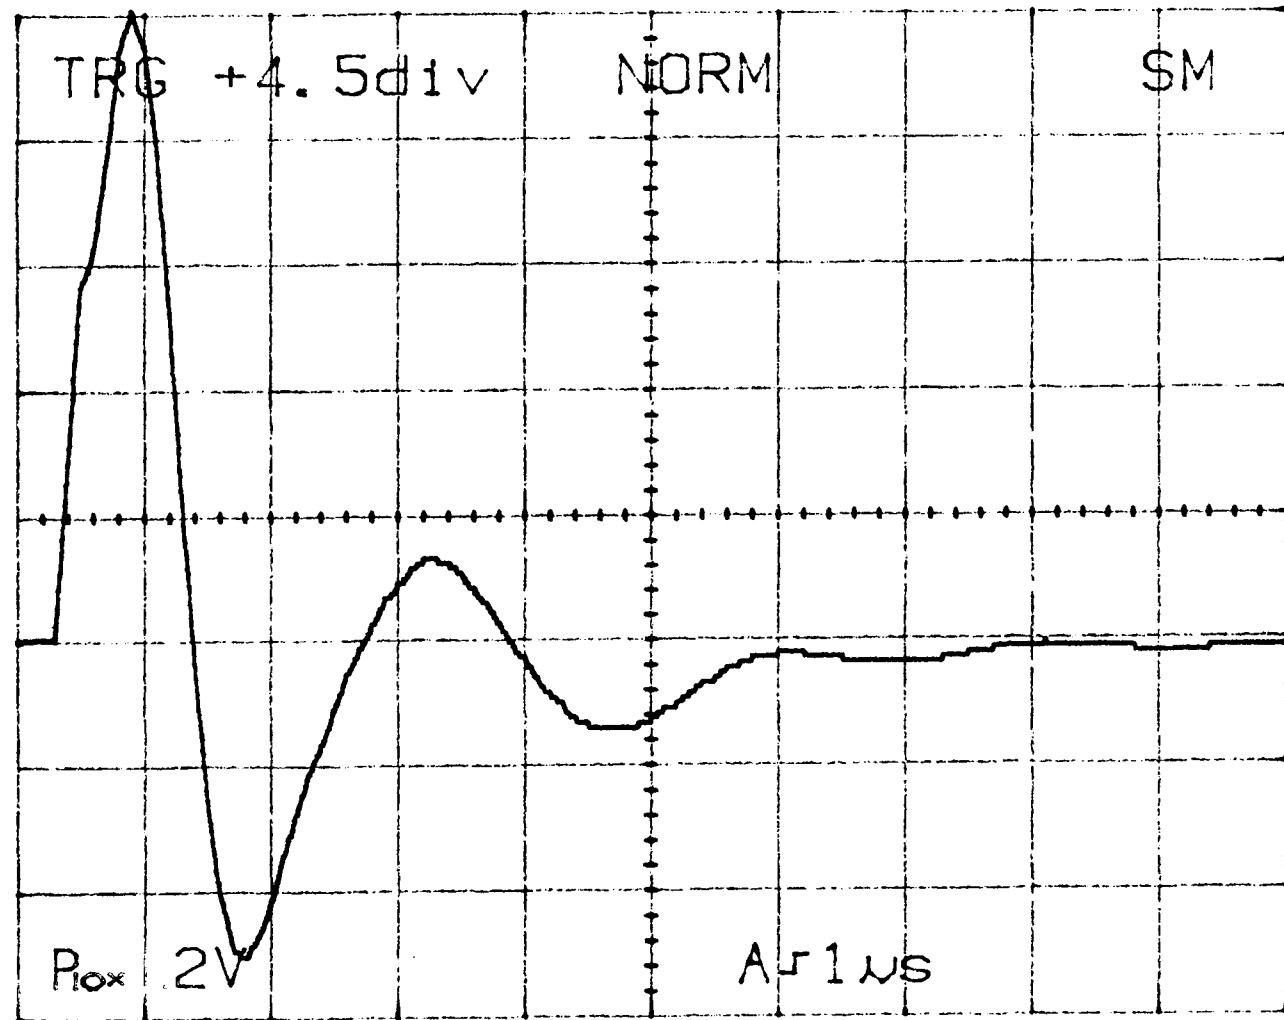
Headgate Rock
Coil #162

After turn
failure.
Note: Different
time scale.

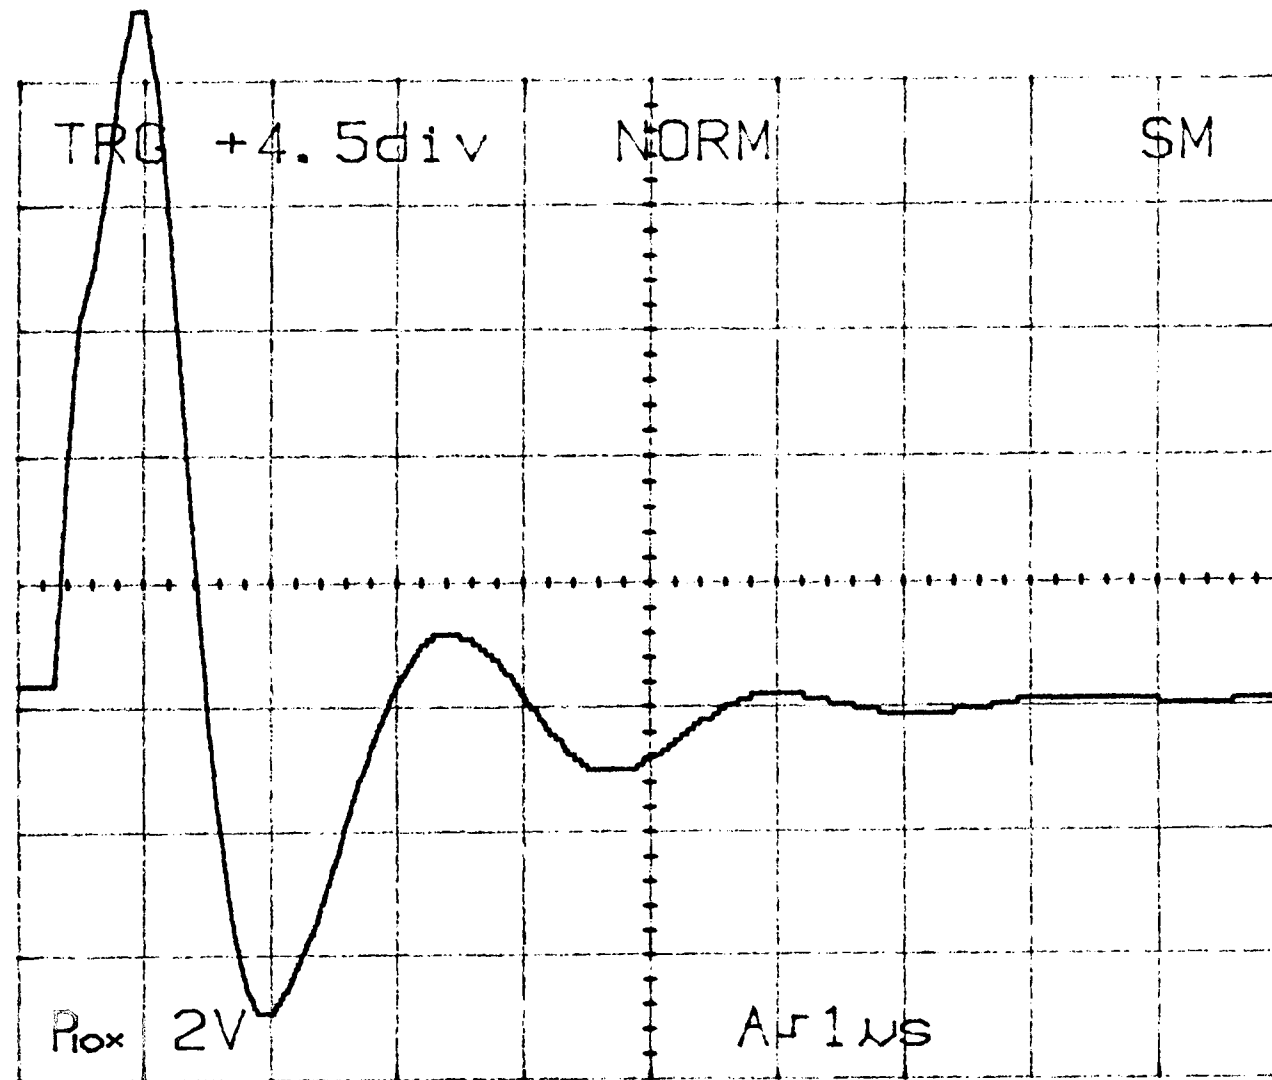
Headgate Rock
Coil # 498

Repeated Surge Test After Circulating
8Amps between Strands 1 and 3.
(No change.)

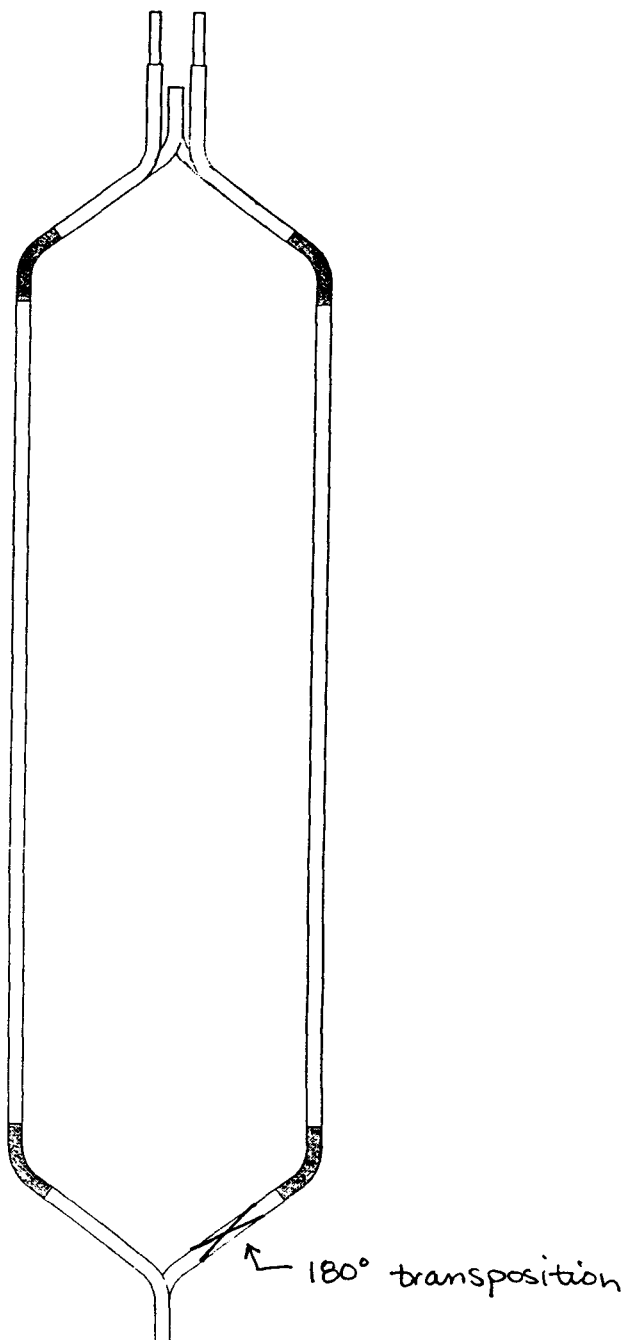
BY L. Rux	DATE 5/93	PROJECT Headgate Rock	SHEET ____ OF ____
CHKD BY	DATE	FEATURE Stator Coil	
DETAILS Location of of turn transposition

the coil knuckle opposite from the coil leads and is completed over a distance of about 6 cm. Refer to appendix B for a diagram illustrating the location of the turn transposition and a photograph of a cross sectional view of the transposition.

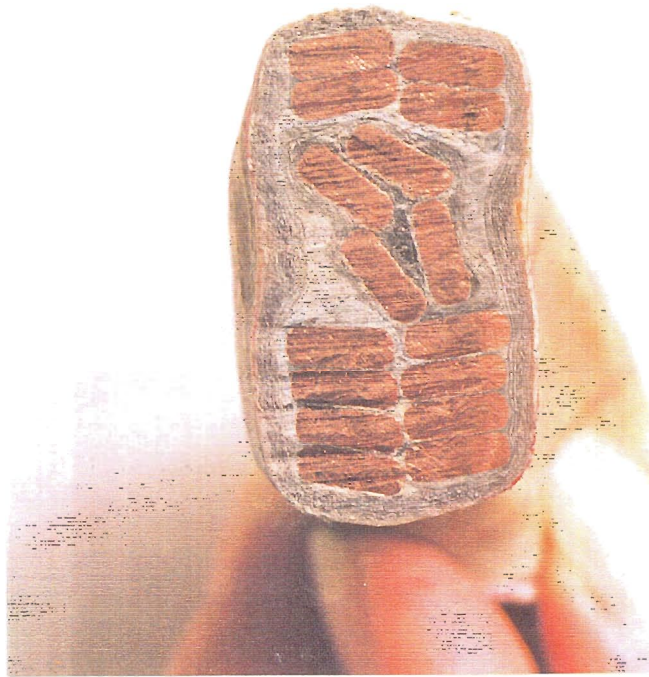
Coil dissection and analysis. — One inverted turn, located in the arm of each coil, provides for compensation of differences in induced voltage between individual strands. (The explicit location of the turn transposition was not given on the coil drawings supplied by the manufacturer.) Laboratory dissection revealed that the transposition starts about 4 cm from

Photograph B.1. - Turn transposition.

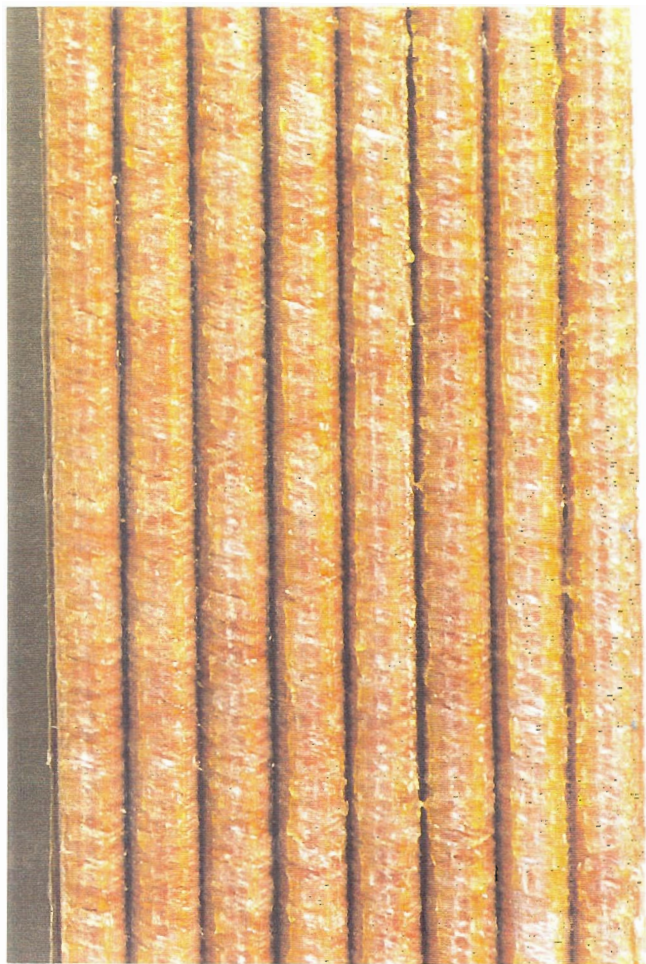
The groundwall insulation of several coils was visually inspected for abnormalities. The insulation in the slot area appeared free of voids and/or delaminations. However, numerous tiny contaminants were imbedded within the insulation. Several distinctly different kinds of impurities were found. None seem to be metallic in nature, nor do they appear to be associated with the turn insulation failures. Photographs C1 and C2, located in appendix C, provide examples of the contaminants. Although presumably not related to the turn-to-turn failures, the number and variety of impurities in the insulation system tend to indicate a lack of manufacturing cleanliness and quality standards.

Photograph C.1. - Green, rubbery impurities in groundwall insulation.

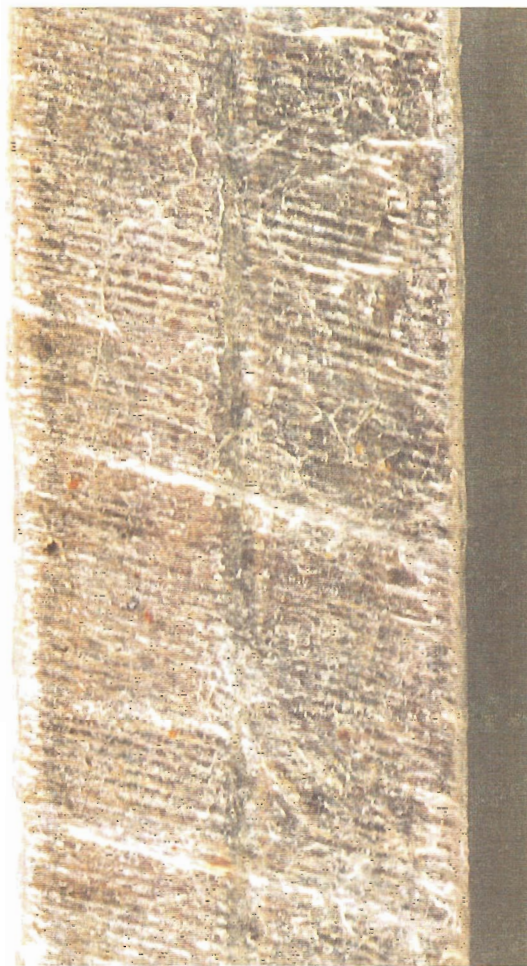
Photograph C.2. - Reddish-brown impurities in groundwall insulation.

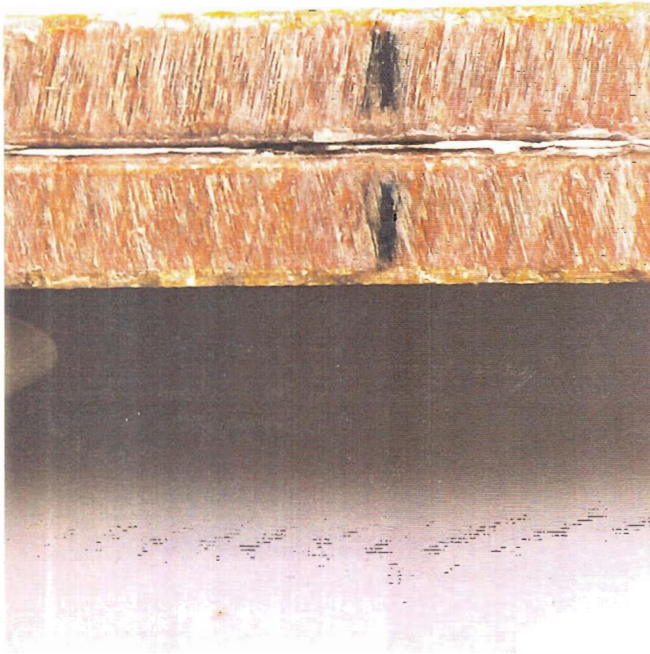
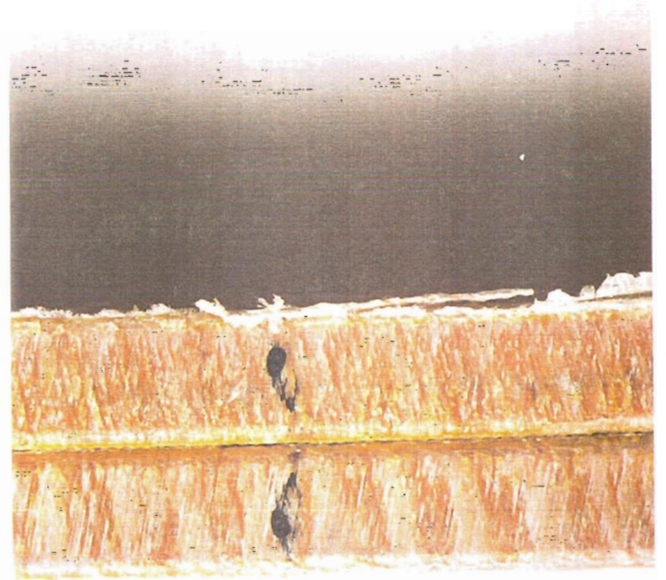
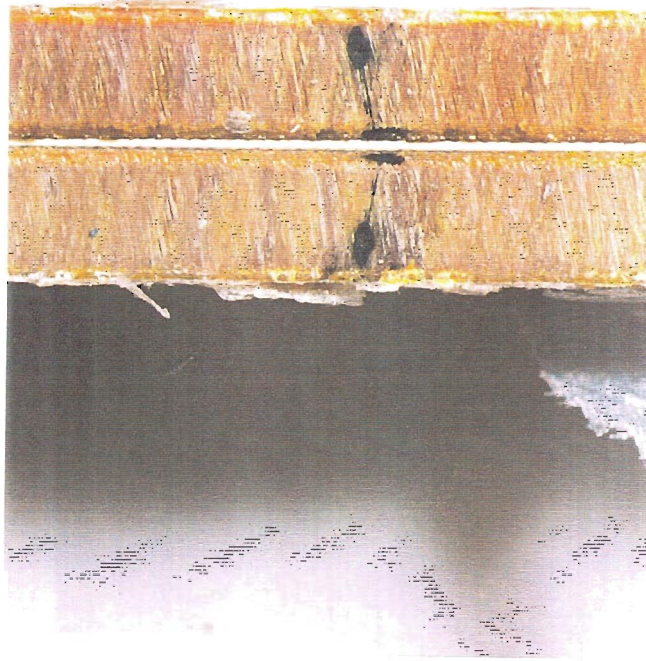
Five stator coils were randomly selected for detailed visual analysis of the turn insulation failures. A 12- to 18-cm length of coil, identified during the circulating current test described above, was sectionalized from the rest of the coil. The groundwall insulation was removed and the strands were examined for evidence of burned insulation between turns. In cases where no signs of the failure were immediately obvious, the coil turns were separated until the site of the failure was found. This simple procedure enabled verification of the turn-to-turn failures on all five of the dissected coils. Photographs D1, D2, and D3 in appendix D illustrate typical turn-to-turn failures.

Photograph D.1. - Turn-to-turn insulation failure.

Photograph D.2. - Turn-to-turn insulation failure.

Photograph D.3. - Turn-to-turn insulation failure.

Rewinding unit 3 using coils with dedicated mica-tape turn insulation, as the manufacturer proposes, will likely eliminate the turn-to-turn insulation failures seen with the old design. The proposed insulation system appears to have sufficient turn insulation to withstand the specified surge tests. Nevertheless, a complete laboratory analysis of the new coils is highly desirable.

Given the history of the unit 3 turn insulation failures and the results of the laboratory evaluation, we strongly recommend, that along with unit 3, the stator windings of units 1 and 2 also be rewound with coils having dedicated turn insulation.

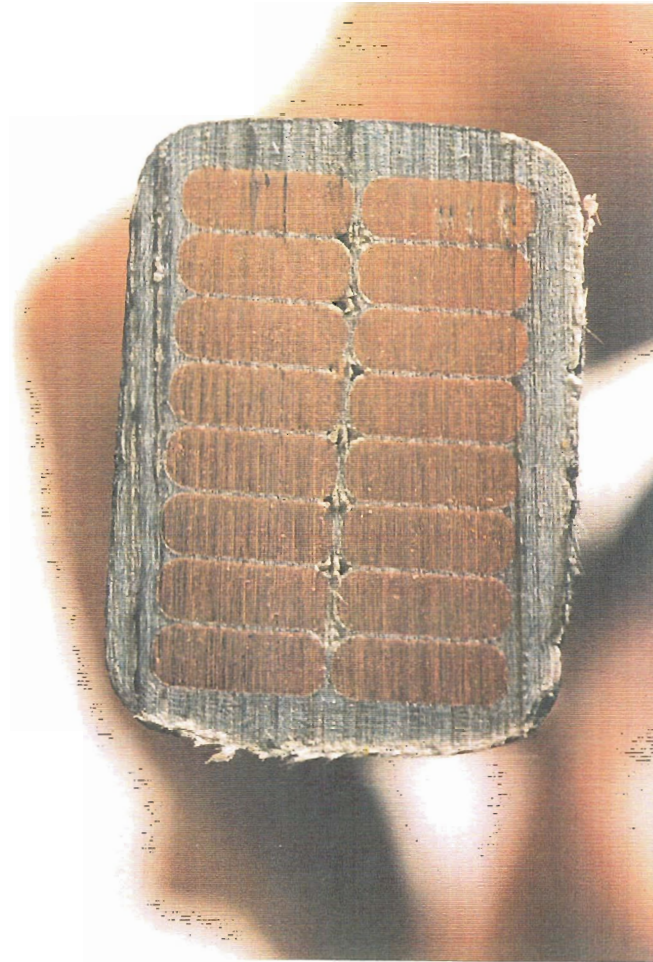
To identify the cause of the turn failures, the insulation and conductors around the faulted area were carefully examined for manufacturing defects, impurities, mechanical damage, etc. No obvious defects in the insulation system were found. However, an abundance of voids in the epoxy resin between strands and between turns was observed. Apparently, the epoxy resin binder from the groundwall tapes was not adequately impregnated and/or retained between strands during manufacture of the coils. Refer to photographs E1 and E2 in appendix E.

The evidence and test data cited above indicate the turn-to-turn insulation failures of the Headgate Rock stator coils are the result of 1) inadequate turn insulation thickness and 2) voids within and/or between the two layers of strand insulation.

Photograph E.1. - Cross section of coil in slot area; shows voids between conductor tiers.

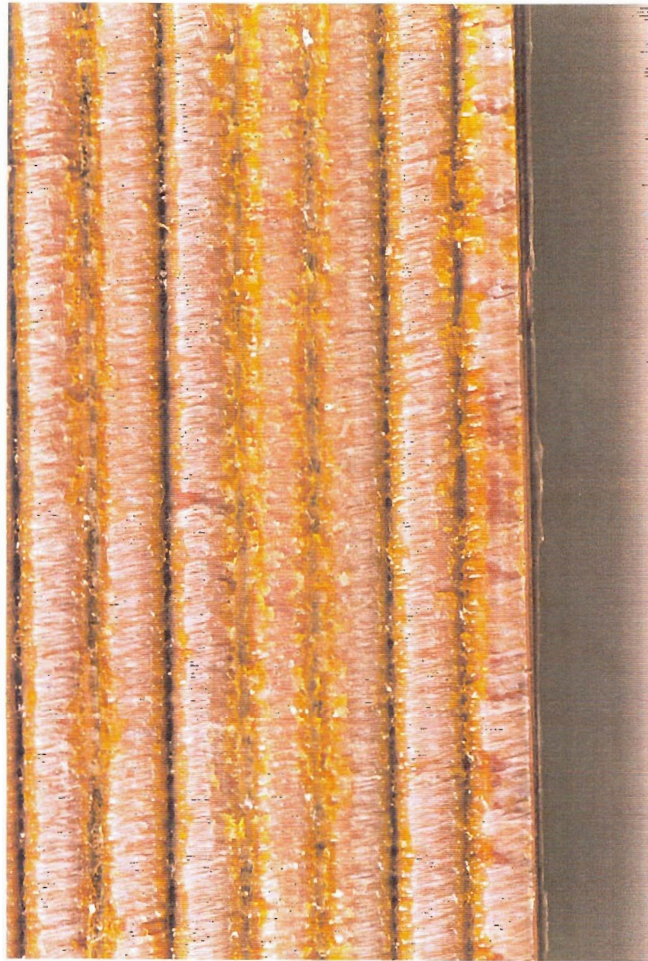
Photograph E.2. - Side view of conductor tier; shows voids in strand insulation and between adjacent turns.
