**DESCHUTES—CANAL-LINING
DEMONSTRATION PROJECT
YEAR 5 DURABILITY REPORT**

Upper Deschutes River Basin Water Conservation Program

January 1997

**U.S. DEPARTMENT OF THE INTERIOR
Bureau of Reclamation**

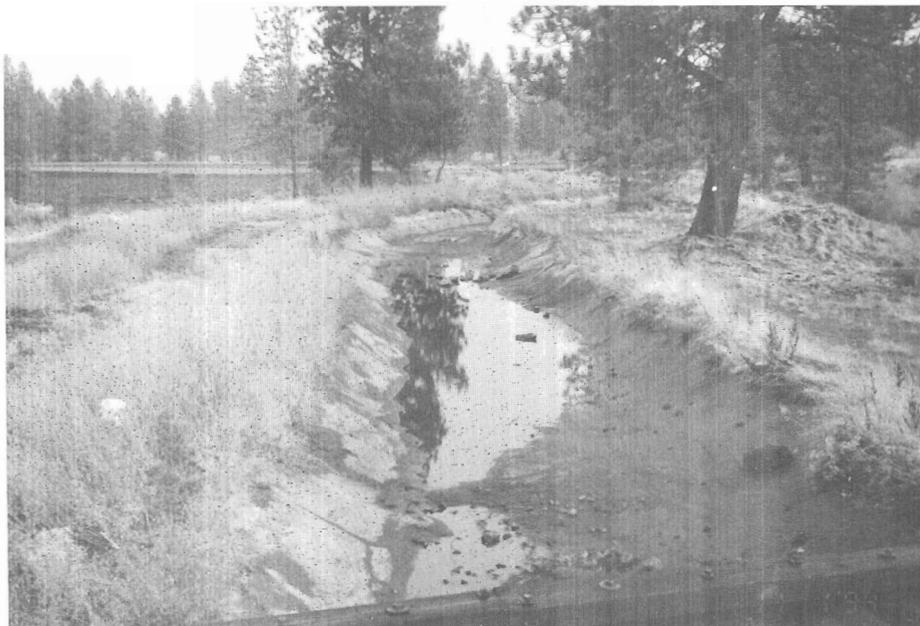
Photograph 28.—Lots of sediment and debris have collected in the canal.

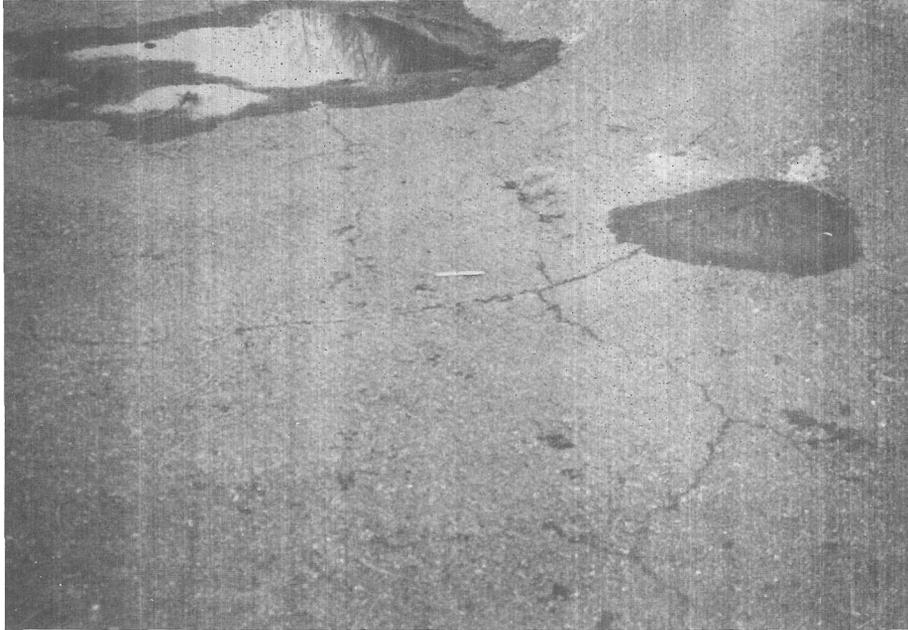
Photograph 29.—In one of the few areas not covered with standing water, random cracks are visible in the invert as well as the side walls.

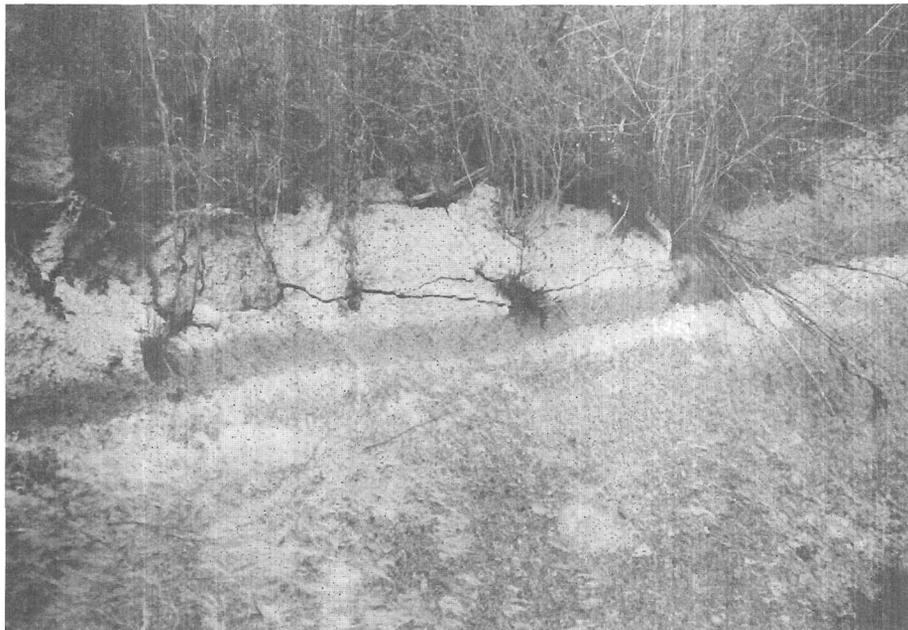
Photograph 30.—Cracking is most pronounced at the top of the side walls where the shotcrete thickness tapers down to 1 inch or less.

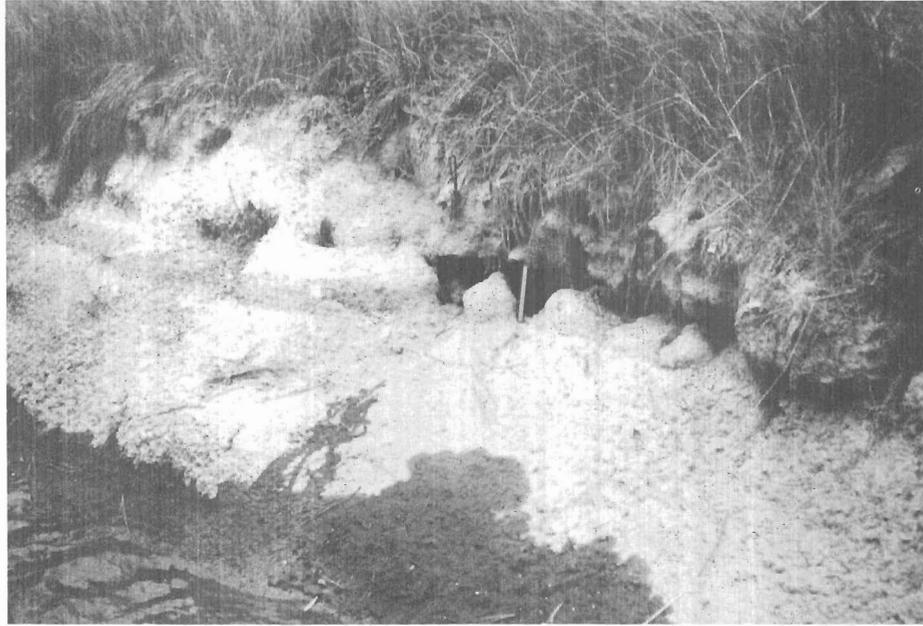
Photograph 31.—Petromat does not extend far enough up the side slope at this location (approximately station 9+00), and a few holes in the shotcrete lining need to be patched to prevent erosion of embankment behind the shotcrete lining.

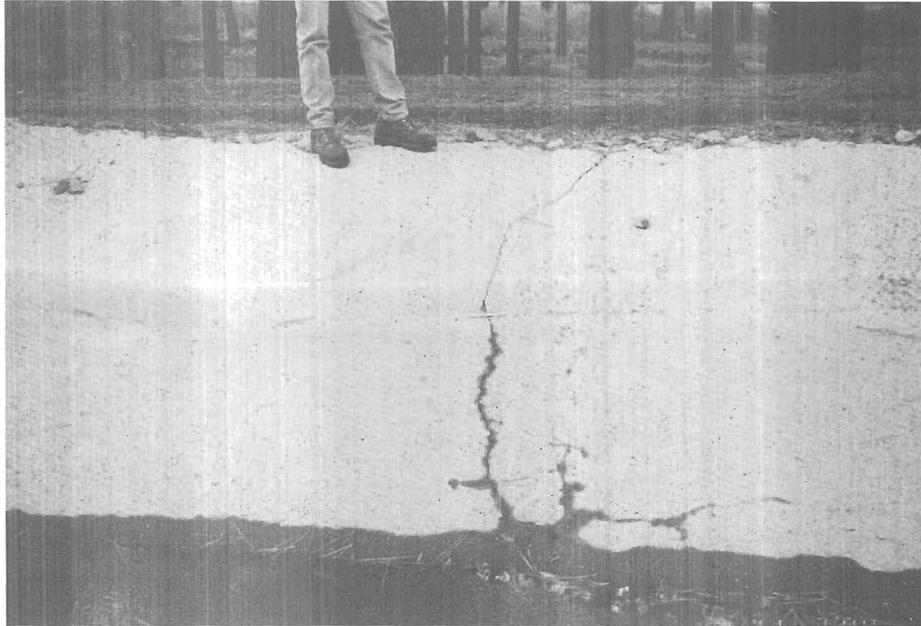
Photograph 37.—Transverse contraction cracks are common in the side walls.

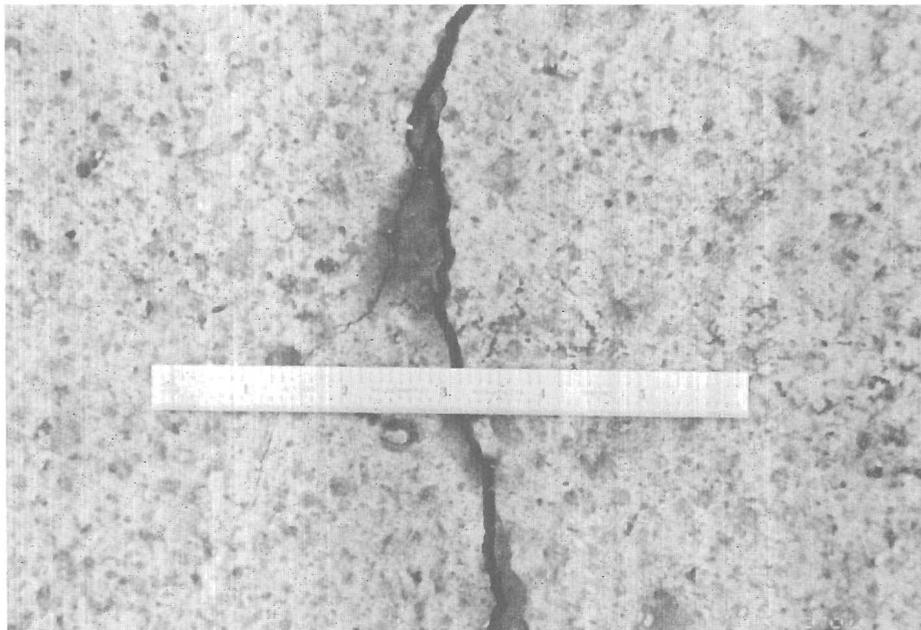
Photograph 38.—Largest cracks measure up to 3/16 inch wide and extend completely across the canal.

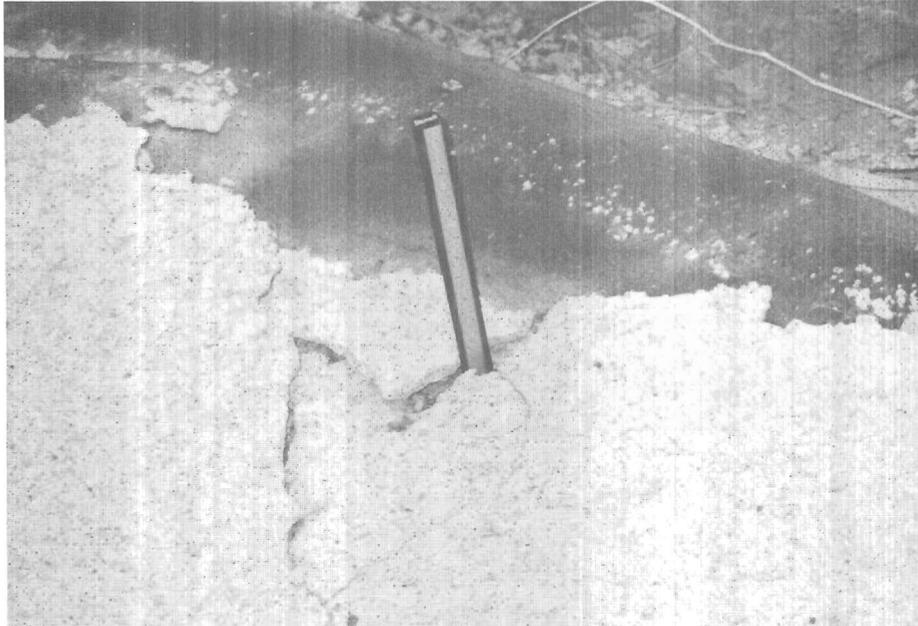
Photograph 39.—Thin shotcrete over anchor trench is breaking up.

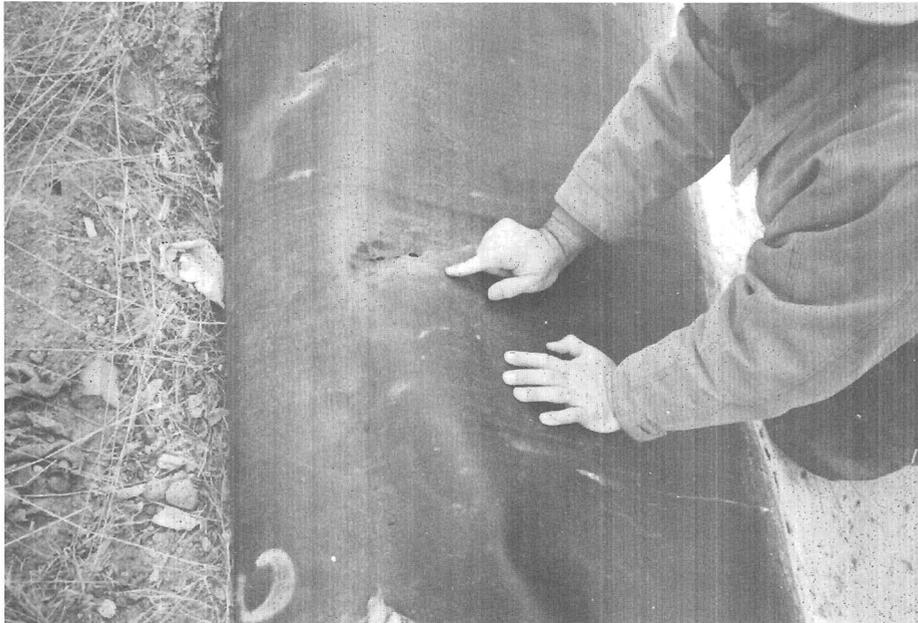
Photograph 42.—Small tears (station 15+00) were probably caused by a backhoe during removal of the earthen dikes used for the post-construction ponding tests.

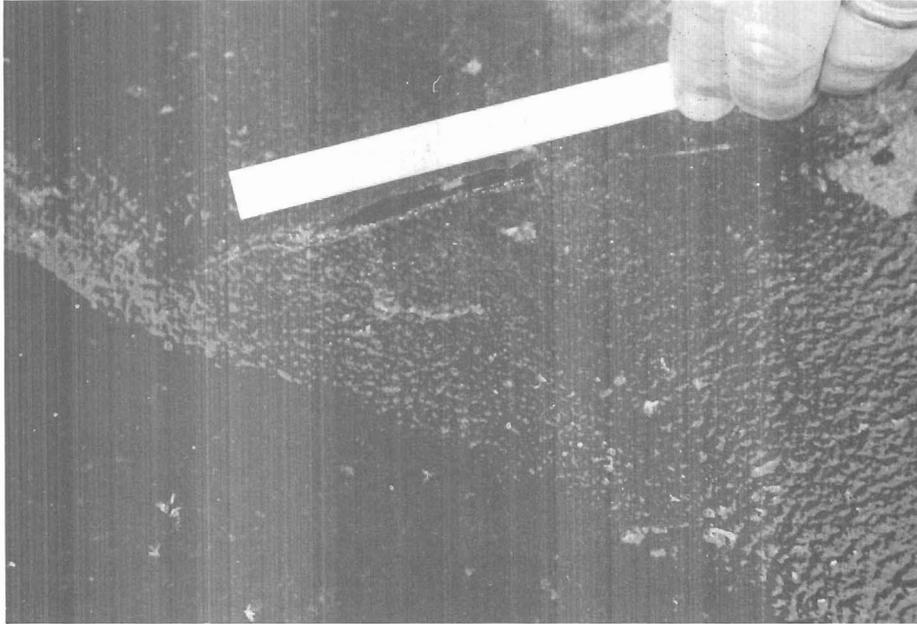
Photograph 43.—Small tear in the liner at station 16+00.

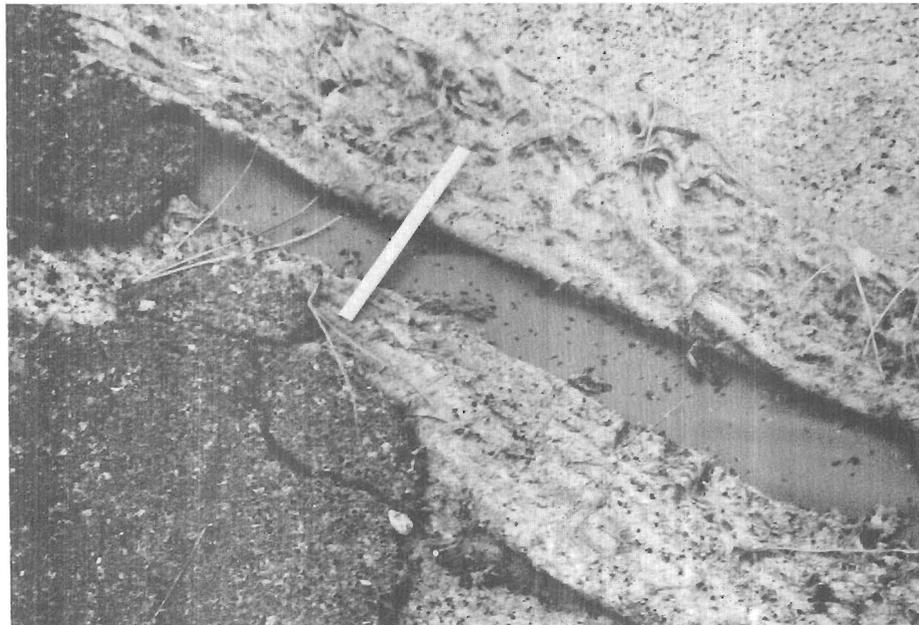
Photograph 48.—Many of the geotextile seams need to be sewn or thermally welded.

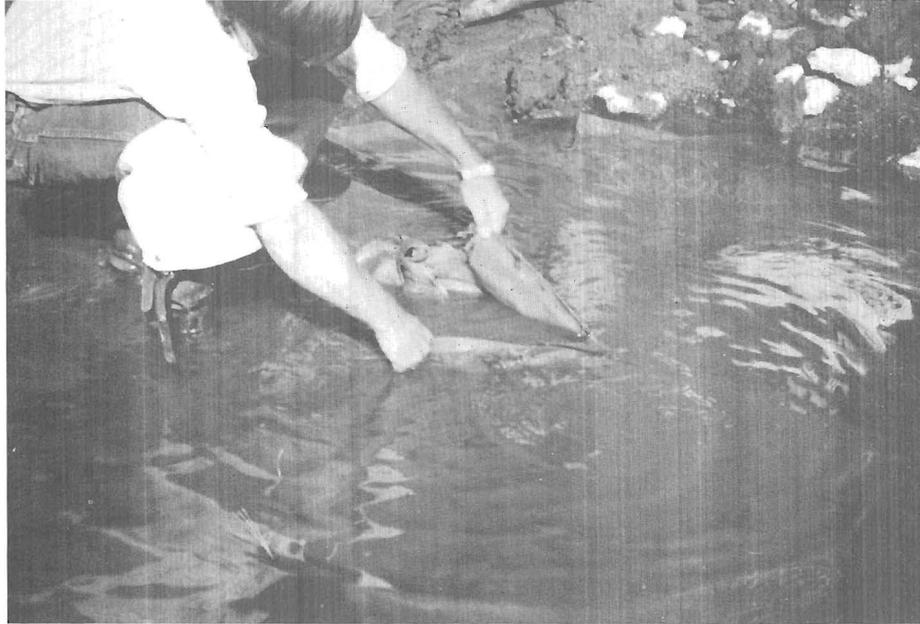
Photograph 49.—Tears in geomembrane liner caused by a backhoe.

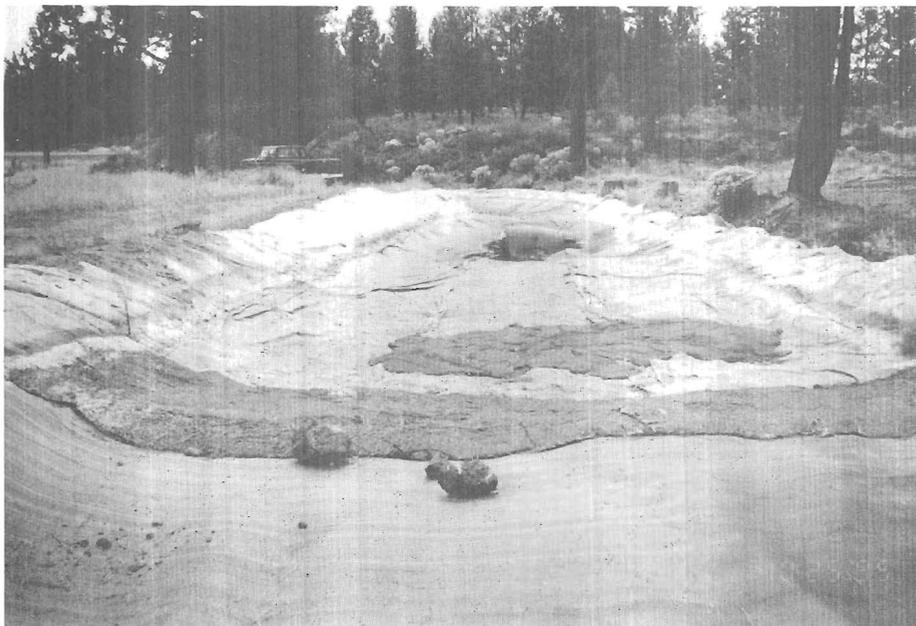
Photograph 50.—Irrigation district used a 10-foot by 10-foot concrete patch to repair tears in the geomembrane liner.

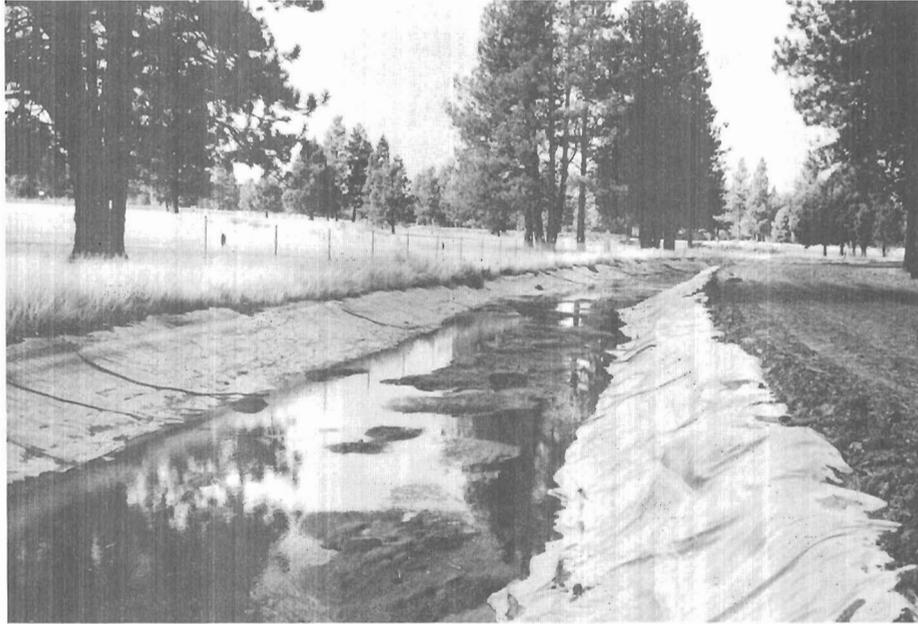
Photograph 51.— A great deal of sediment has collected in the canal around this bend at stations 23+00 to 27+00.

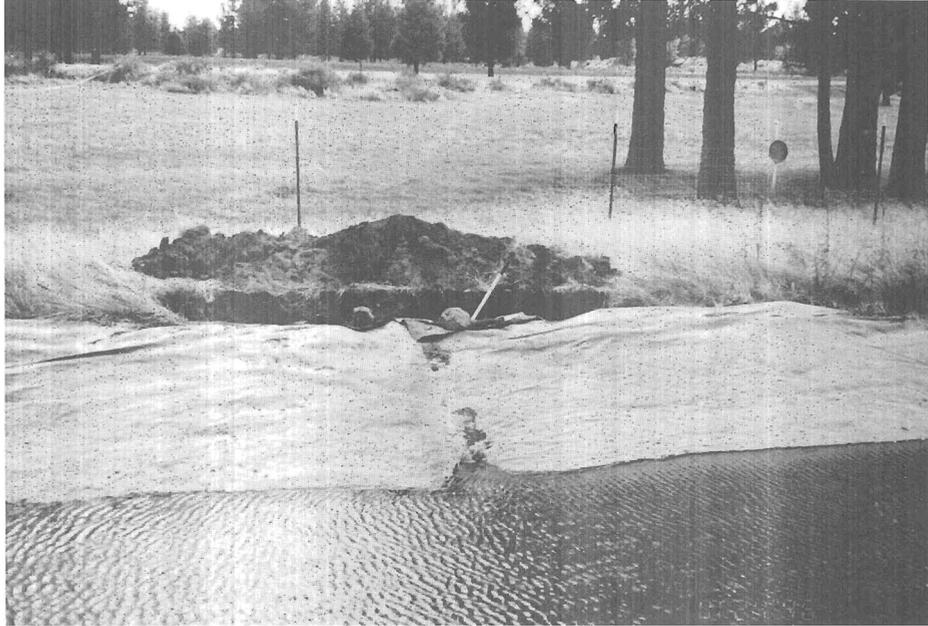
Photograph 63.—Station 37+00 - Irrigation district excavates anchor trench to investigate subsidence - no cause for the subsidence was found.

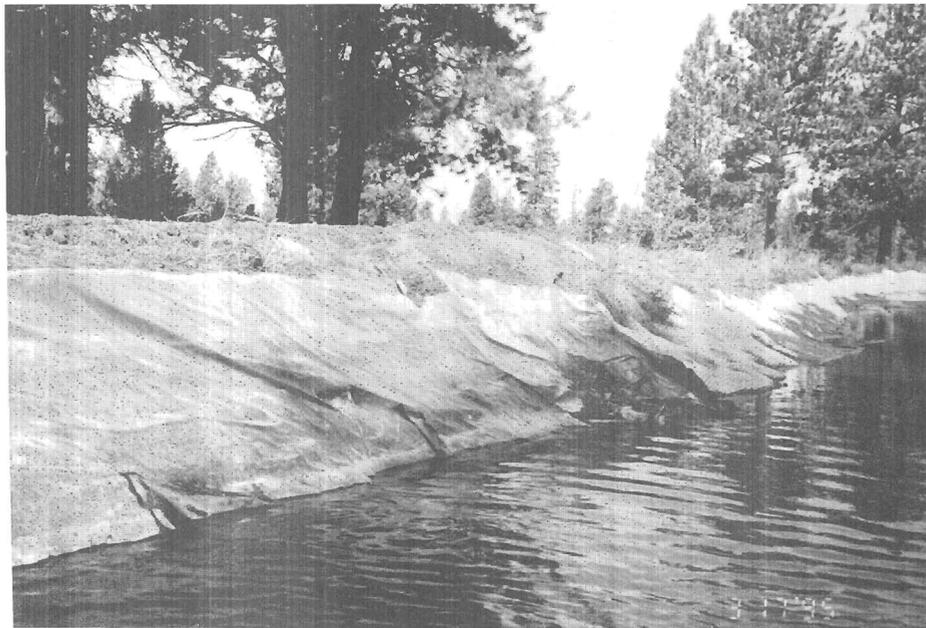
Photograph 64.—Several small tears at the downstream end (station 40+00) are in need of repair.

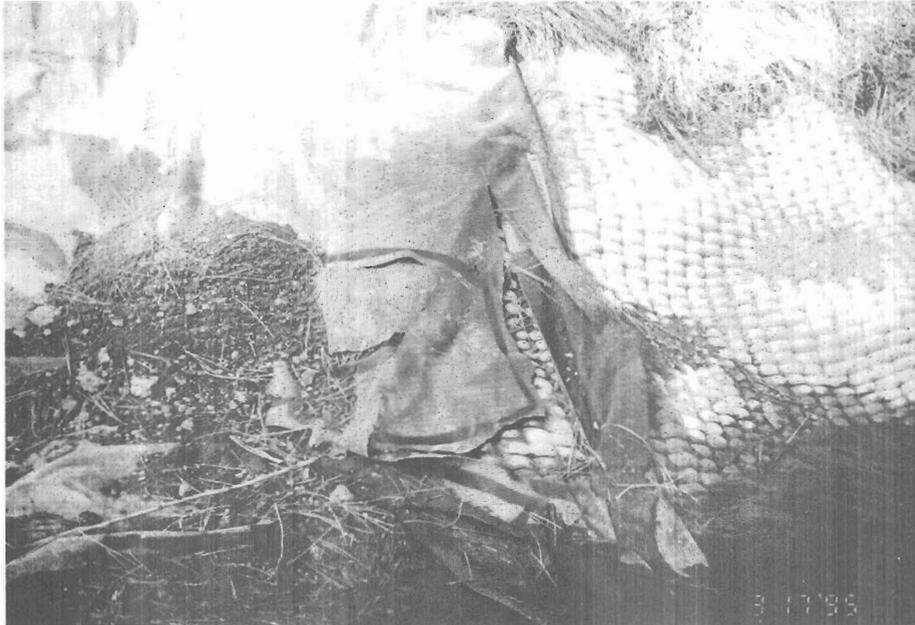
Photograph 65.—Close-up of backhoe damage to the geomembrane (station 40+00).

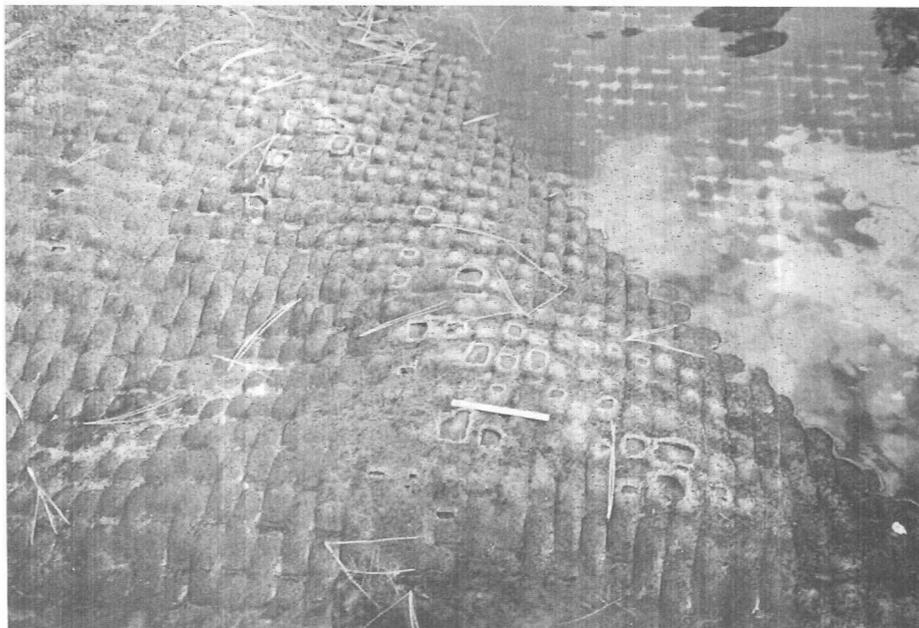
Photograph 69.—The outer fabric of the grout-filled mattress is beginning to deteriorate as was expected.

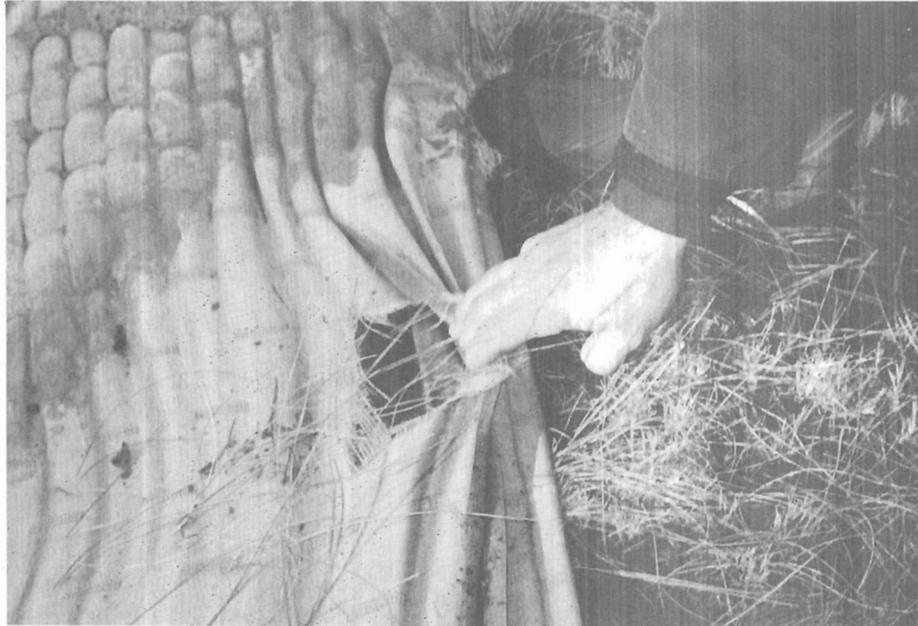
Photograph 70.—Above the waterline, the geotextile covering for the grout-filled mattress is very weak and can be easily torn by hand. Again, this deterioration was expected.

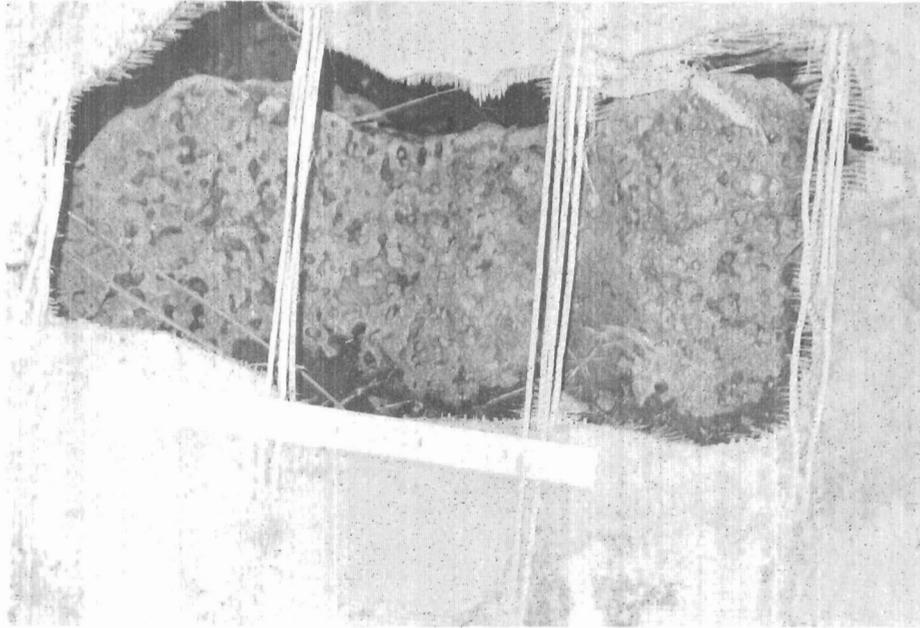
Photograph 77.—Three "bricks" missing above the waterline at station 54+50. A subgrade rock is visible which caused the grout mattress to be very thin at this location.

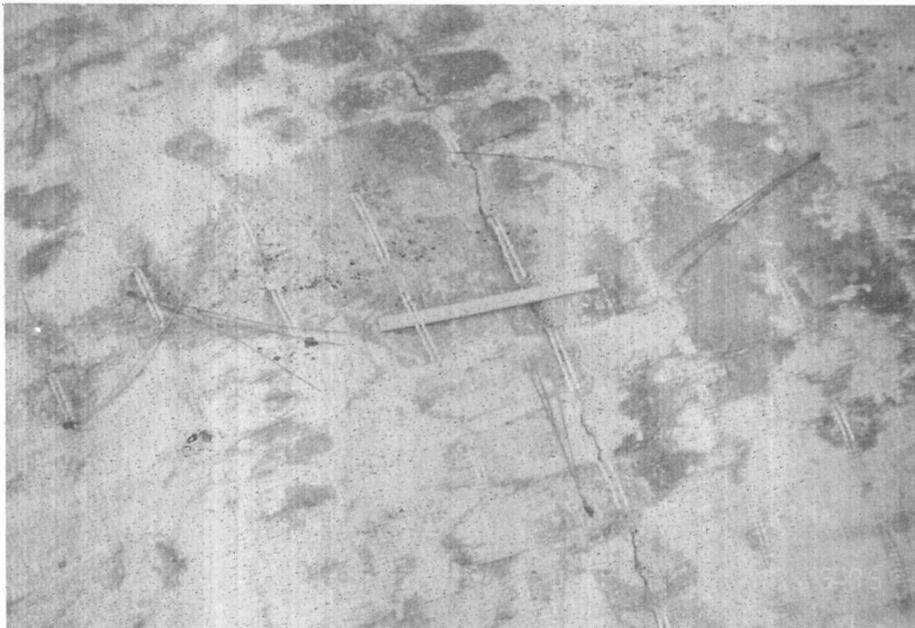
Photograph 78.—Station 54+50 - Outer fabric has worn away.

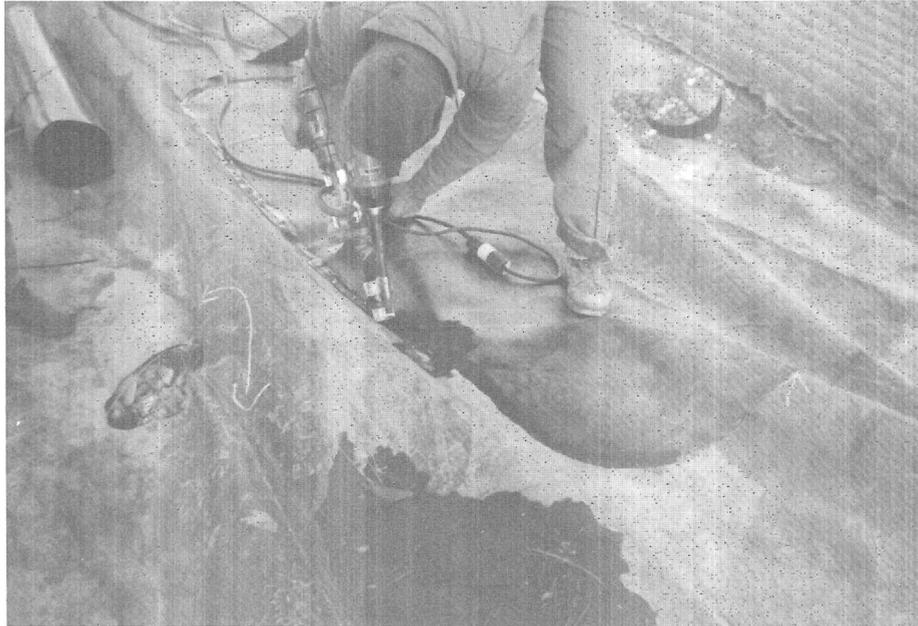
Photograph 83.—December 1994 - Contractor repairs geomembrane by grinding the VLDPE, tack-welding patch into position, and finally, attaching patch with extrusion welder.

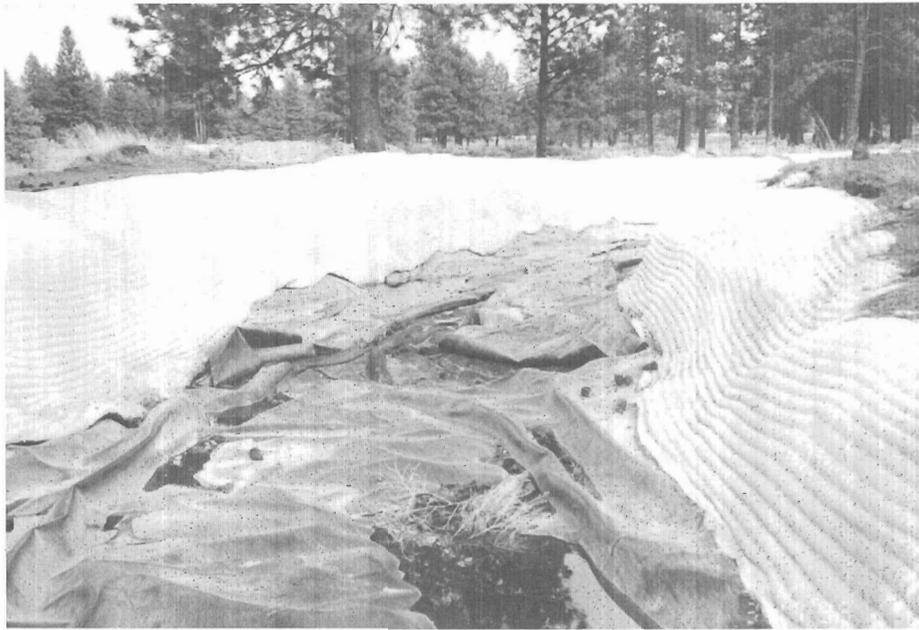
Photograph 87.—After 2 years of service, test section was in poor condition with numerous rips, tears, and cuts in the geomembrane.

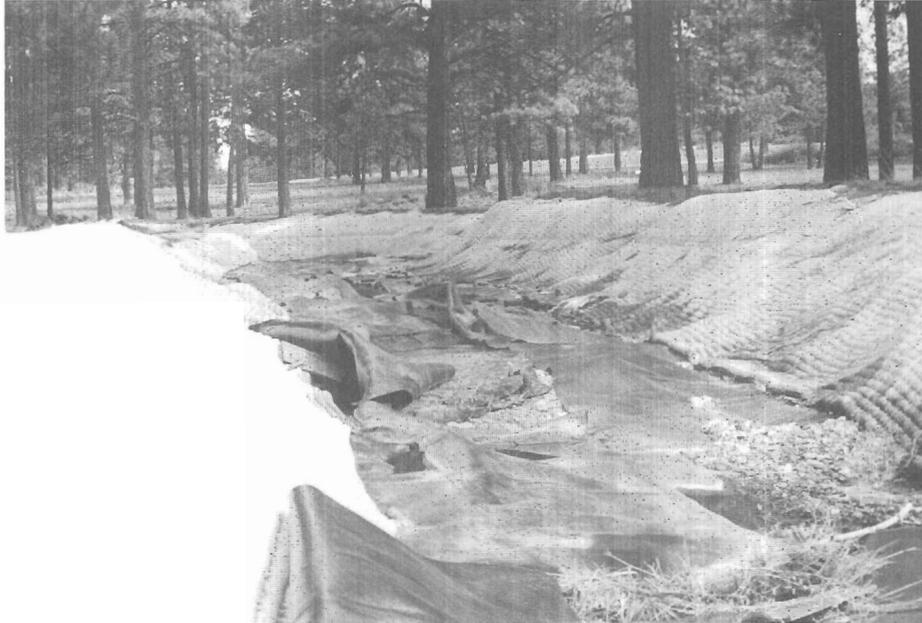
Photograph 89.—After 2 years of service, test section was in poor condition with numerous rips, tears, and cuts in the geomembrane.

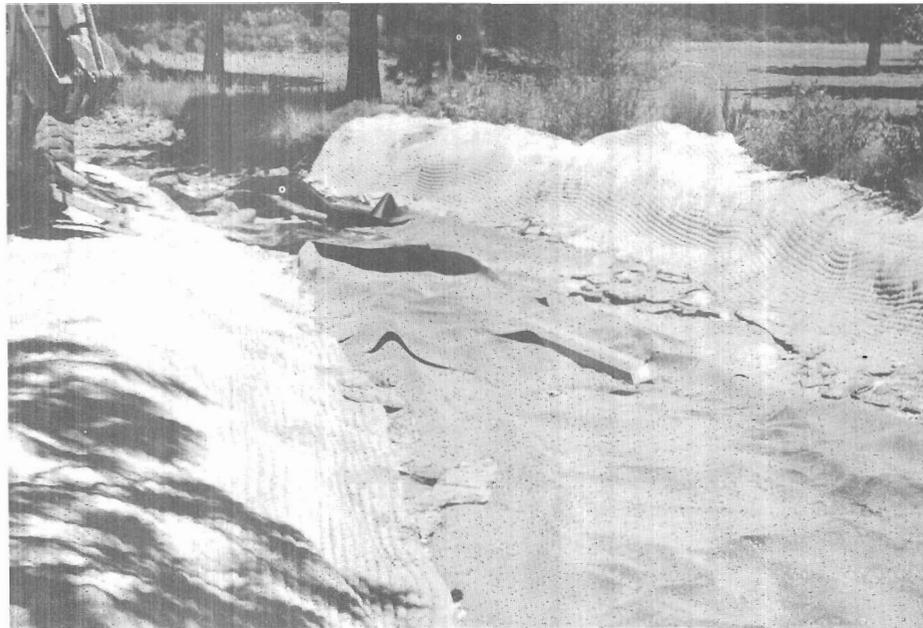
Photograph 90.—Irrigation district used concrete parking blocks to ballast liner "whales," with little success.

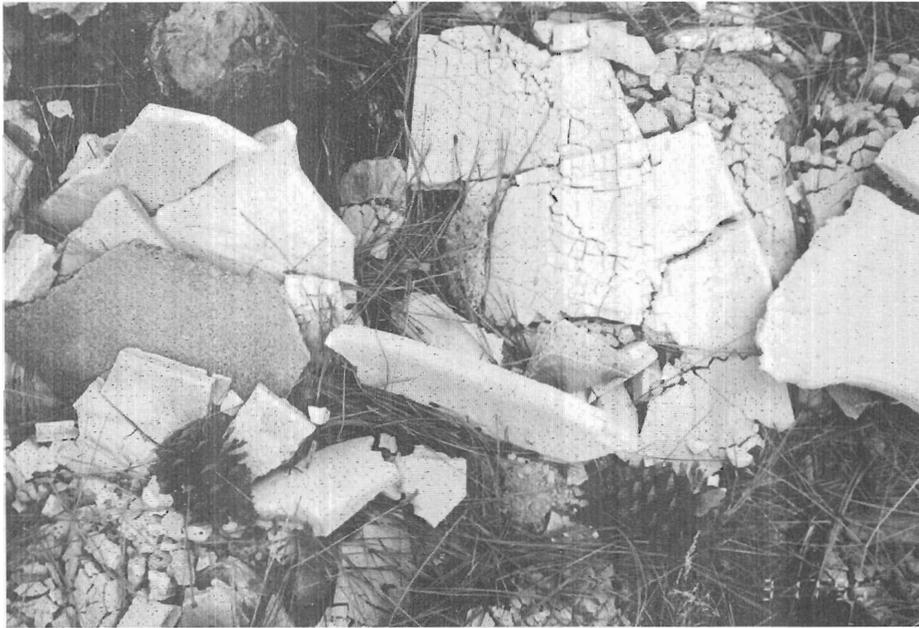
Photograph 93.—Extensive cement paste deposits found in test section A-10.

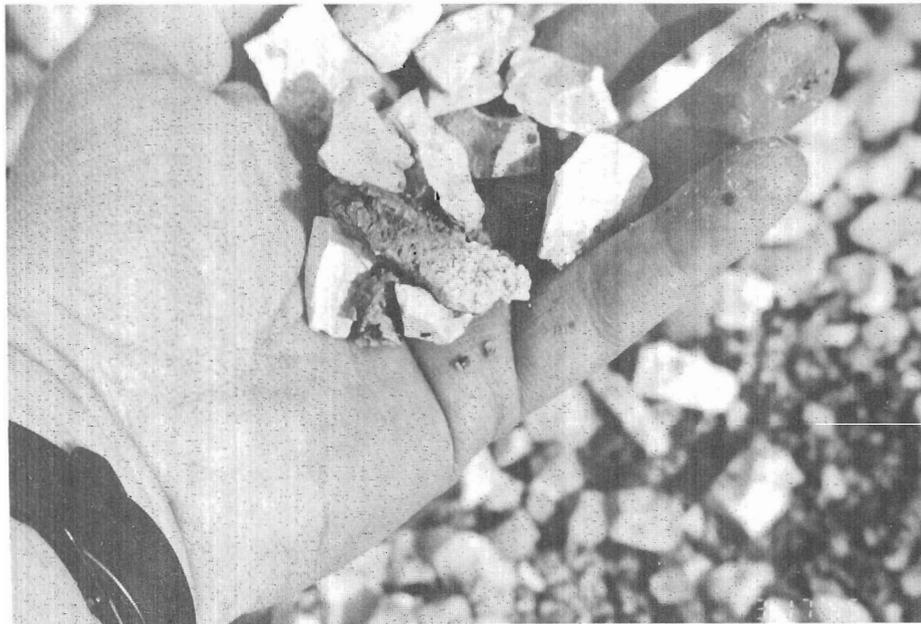
Photograph 94.—Natural weathering is rapidly breaking-down the cement-paste deposits.

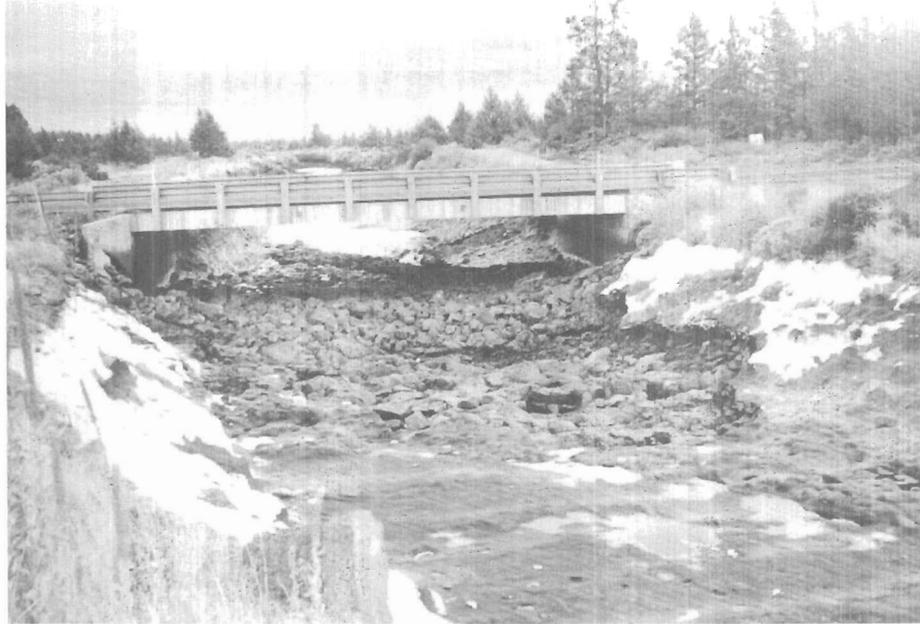
| | Test Section | 2-Year Condition | 4- to 4½-Year Condition | Comments |
|---|--|---|---|---|
| N-1 | SPF with Futura 500/550 Protective Coating | Partially Failed 25%* | Partially Failed 50%* | Partial Foam wash-out |

Photograph 95.—Canal overview - poor condition (partially failed) after 4 years of service. About 90% of the coating is missing and about 20% of the foam has been washed out.

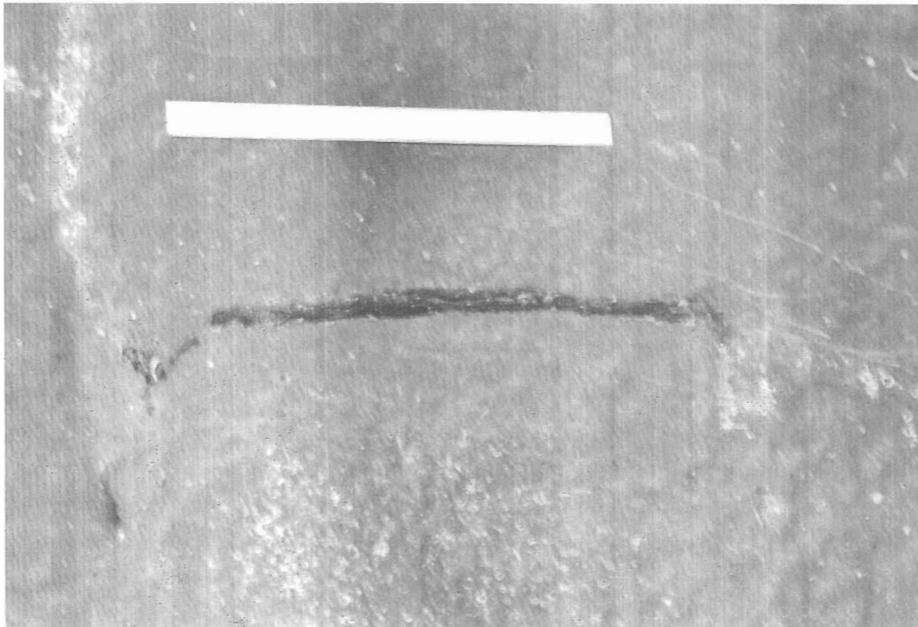
Photograph 100.—Crack is approximately 8 inches long and extends completely through the foam.

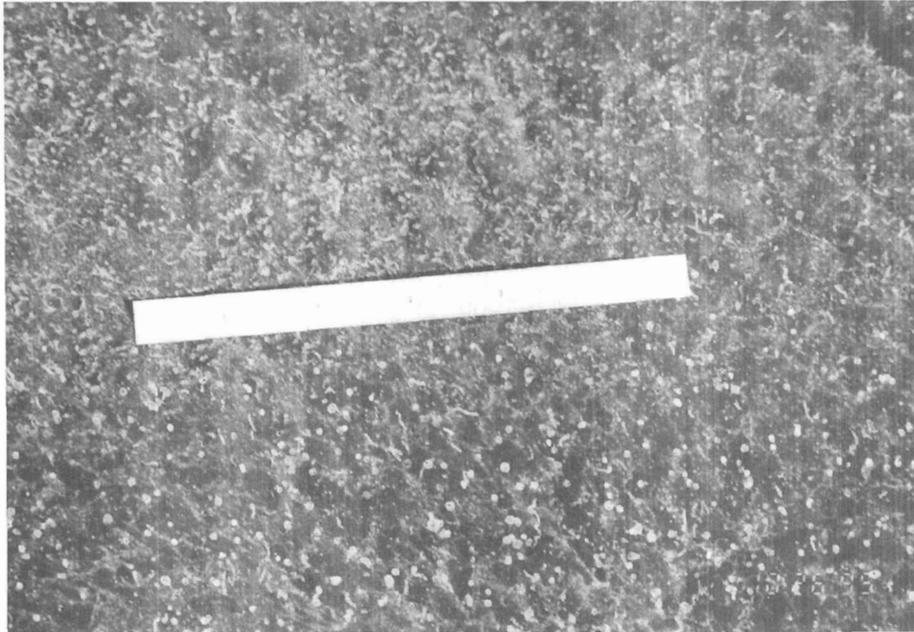
Photograph 101.—Protective coating on the north bank (south-facing) is showing moderate degradation.

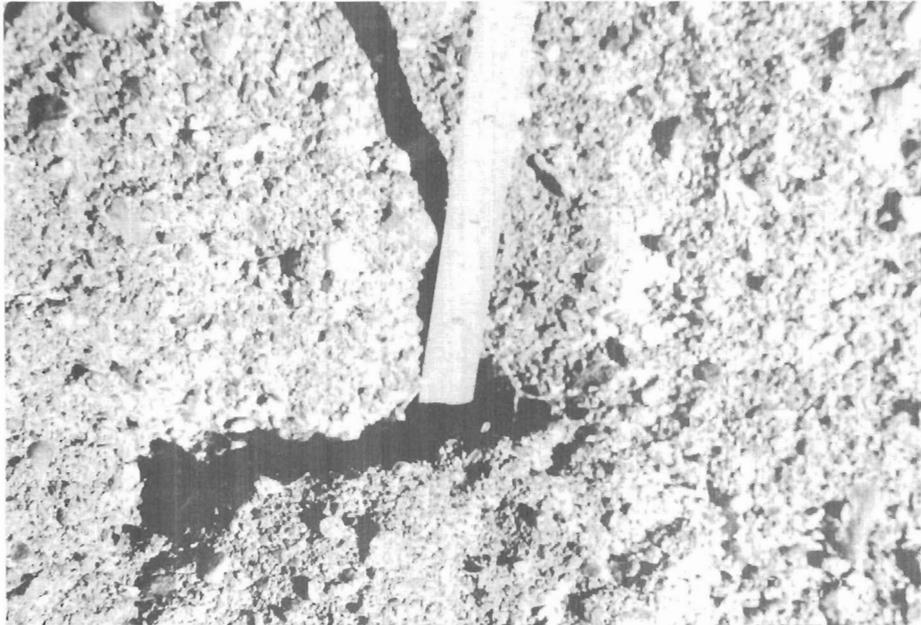
Photograph 110.—Many small voids have developed in the shotcrete.

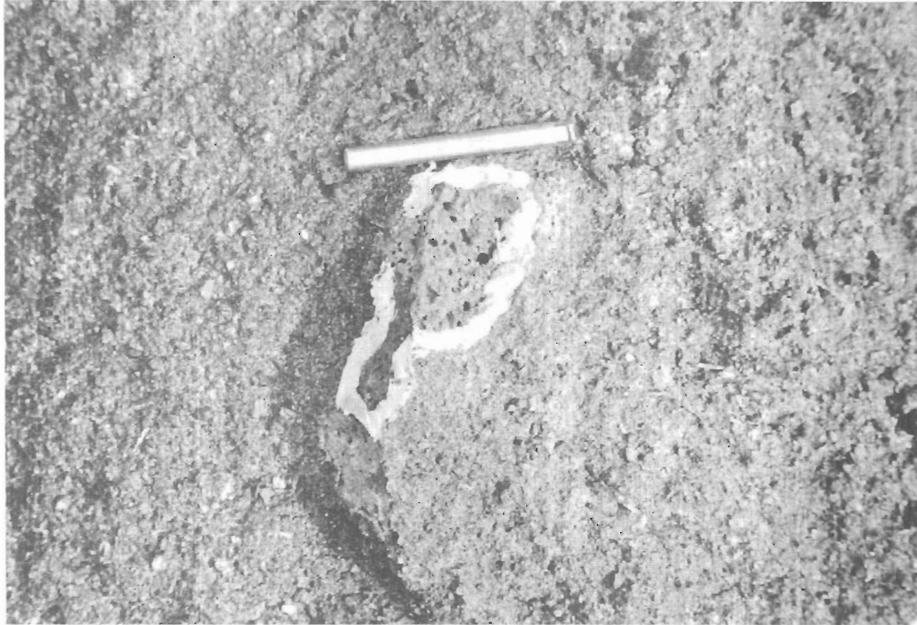
Photograph 120.—Sealant used to seal around exposed subgrade rock where shotcrete was less than 1-inch thick.

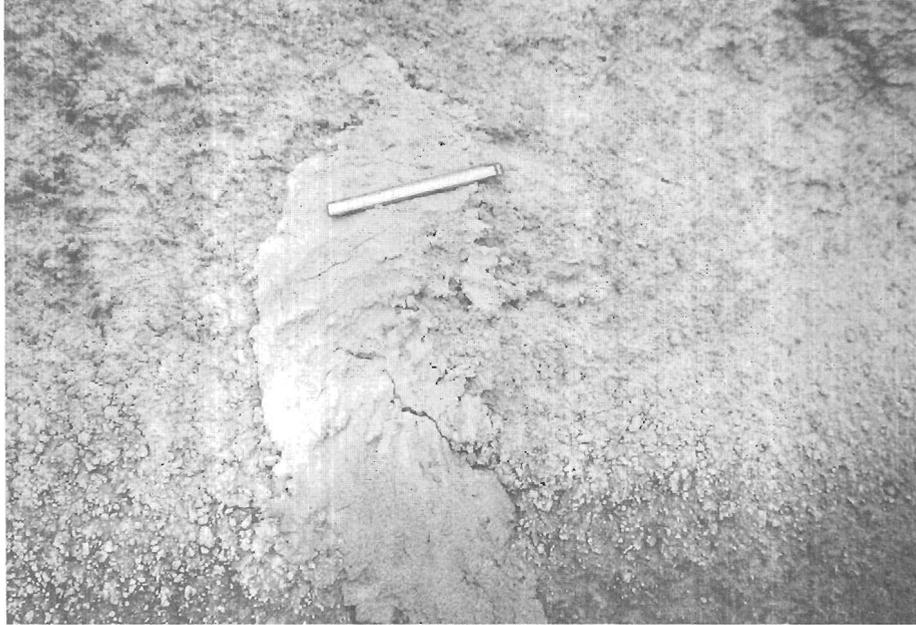
Photograph 132.—Irrigation district has patched several small holes where shotcrete was very thin because of protruding subgrade rock.

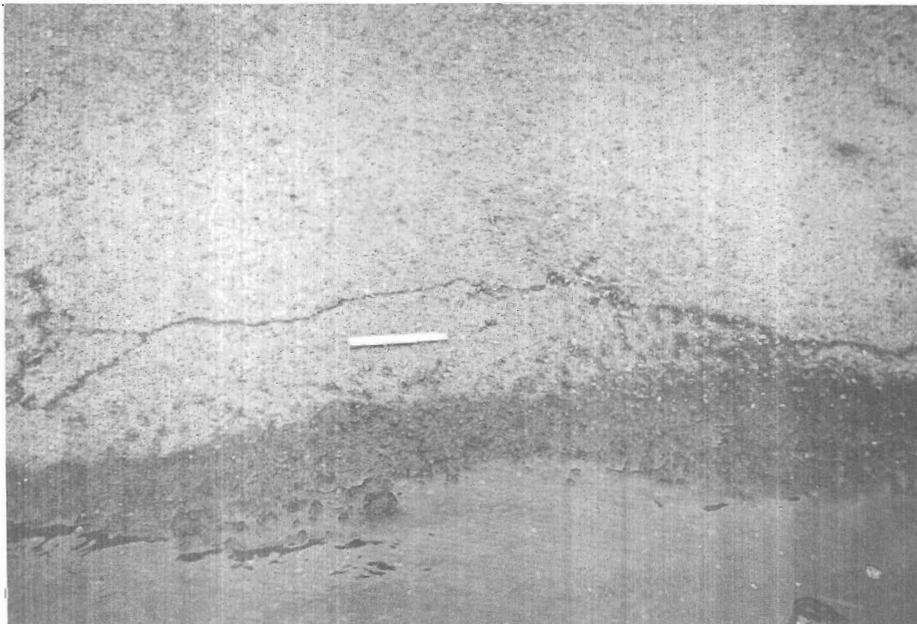
Photograph 135.—This 5-foot-long crack is one of the few longitudinal cracks found in the shotcrete test sections.

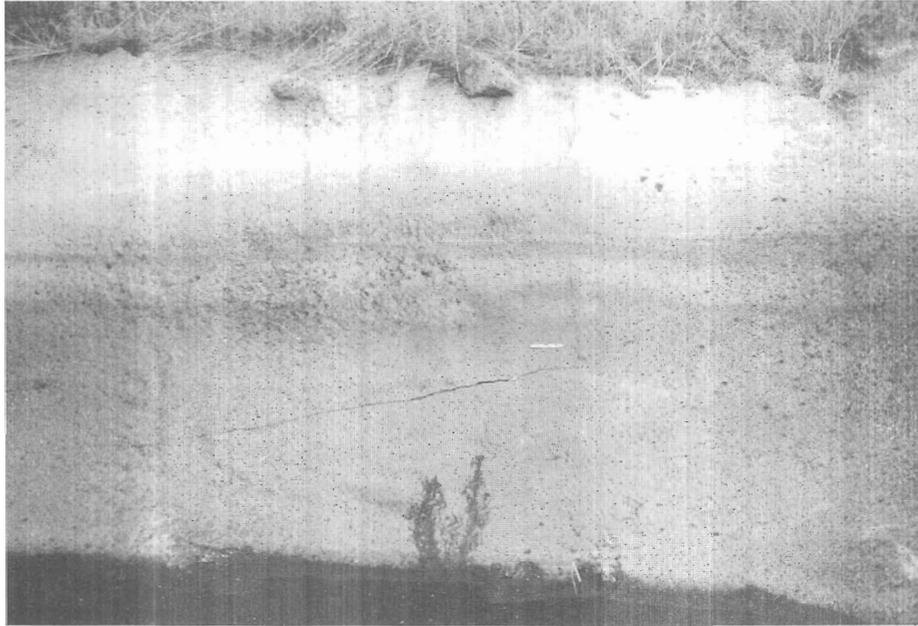
Photograph 136.—The most severe cracking in any of the shotcrete test sections is shown in this photo at station 31+00.

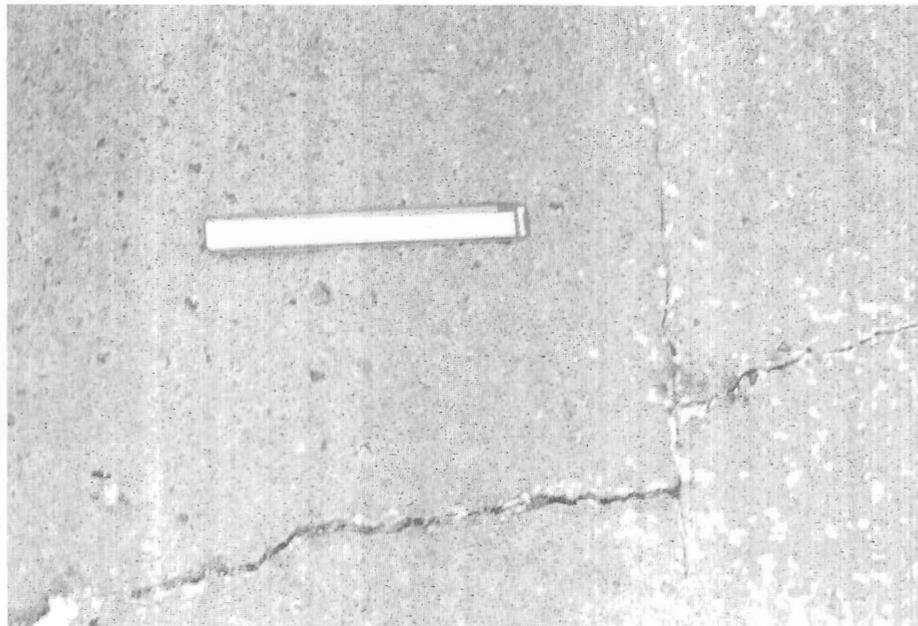
Photograph 137.—Close-up of cracks at station 31+00.

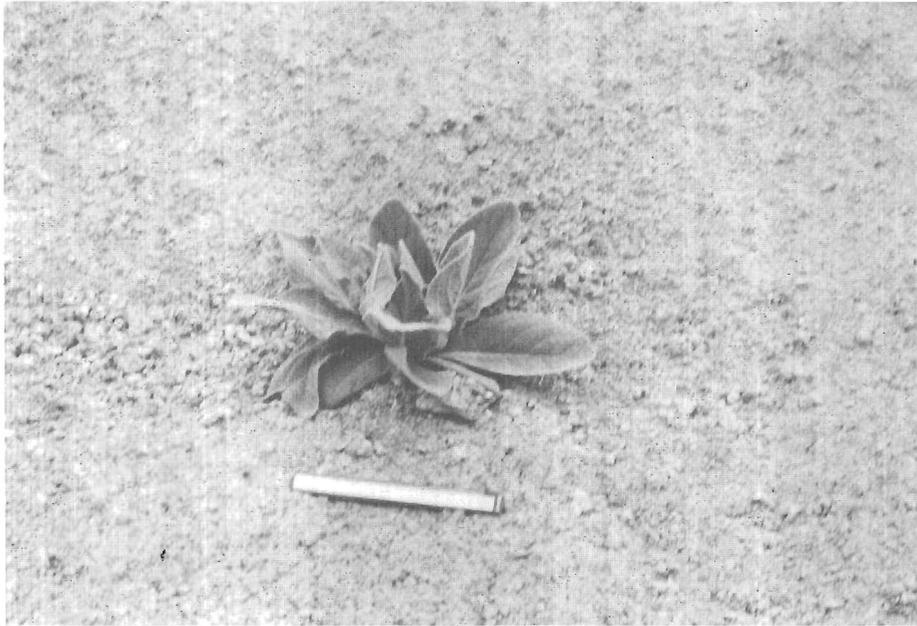
Photograph 138.—Typical vegetation growing out of shotcrete side walls

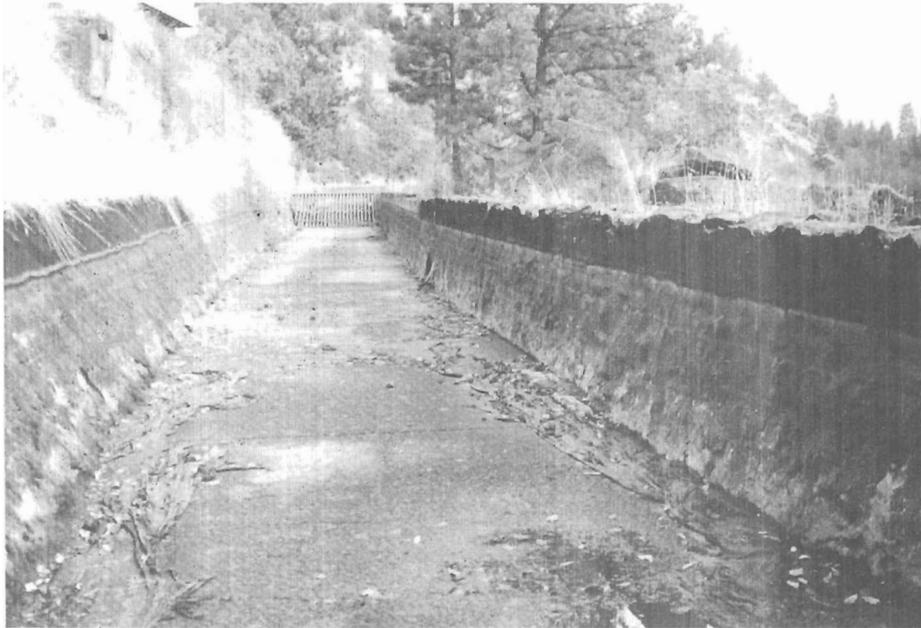
Photograph 140.—Canal overview - poor condition after 2½ years of service.

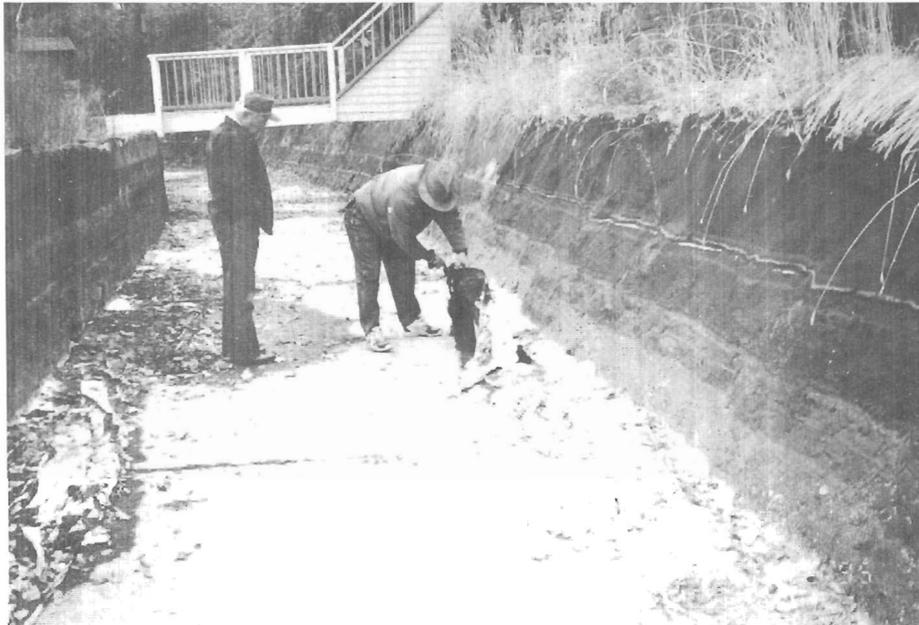
Photograph 141.—Liquid Boot has completely disbonded from the concrete invert and rolled up into the corners against the side walls.
