**DESCHUTES—CANAL-LINING
DEMONSTRATION PROJECT
YEAR 5 DURABILITY REPORT**

Upper Deschutes River Basin Water Conservation Program

January 1997

**U.S. DEPARTMENT OF THE INTERIOR
Bureau of Reclamation**

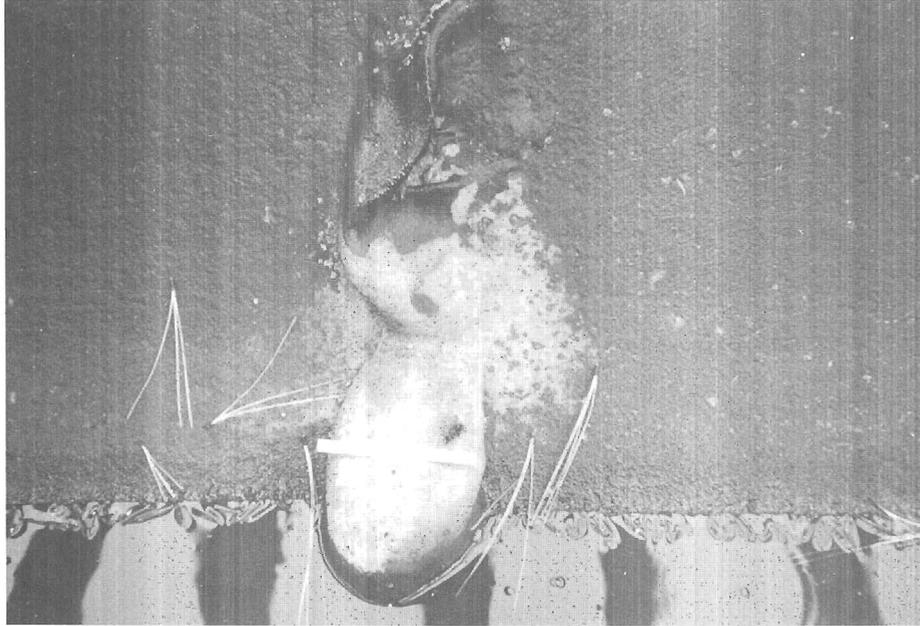
Photograph 146.—Typical blister found in the invert measures 6-inches across and 1- to 2-feet long.

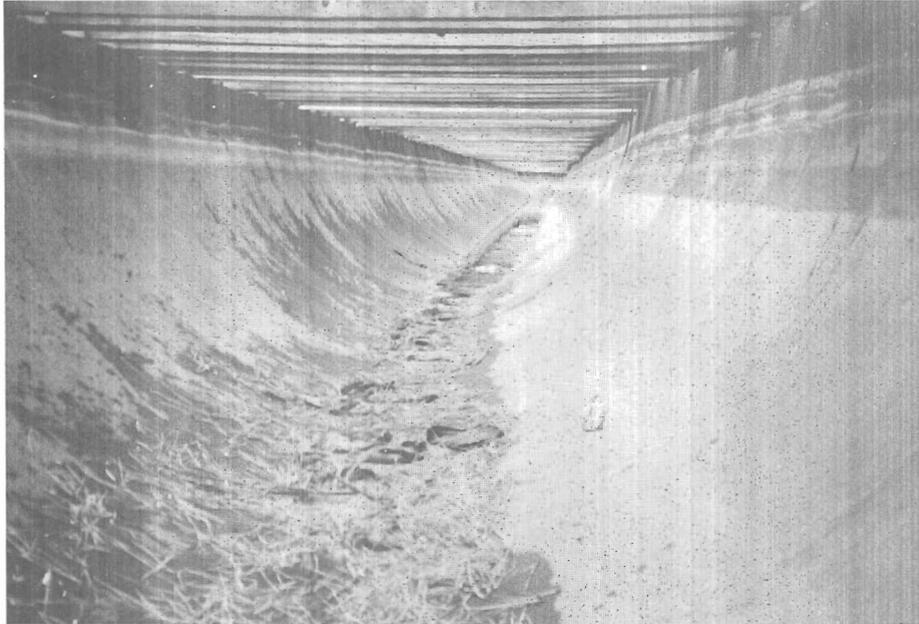
Photograph 152.—Most of the blisters are in the upstream shaded end of the flume.

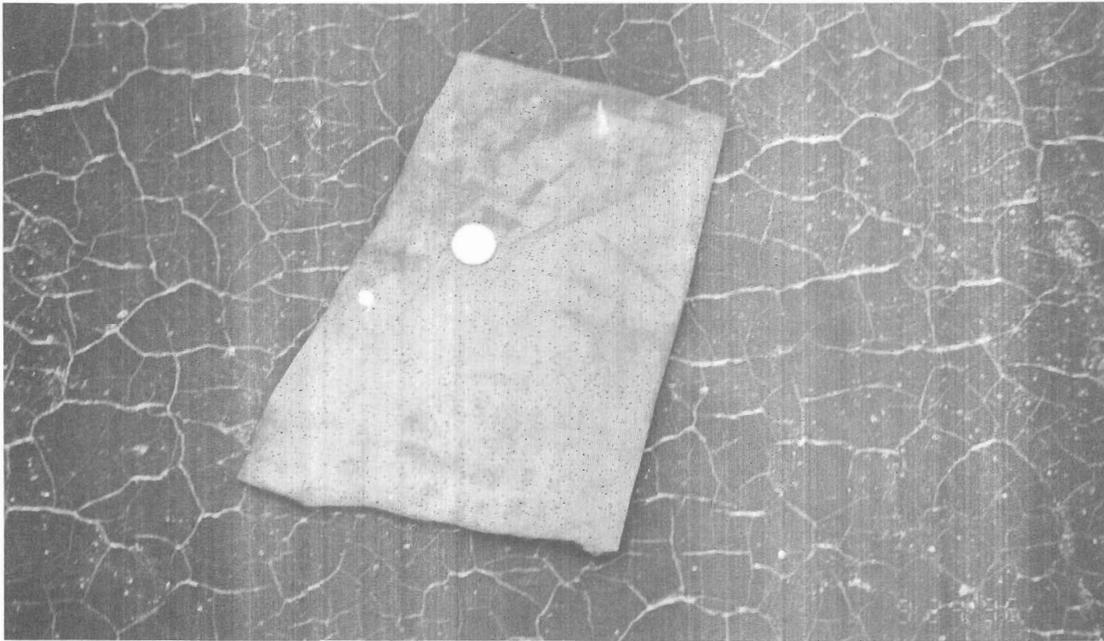
Photograph 155.—An unaged piece of Teranap is placed on the aged Teranap for comparison. The aged Teranap shows surface cracking (alligator cracking) which is normal for this product.

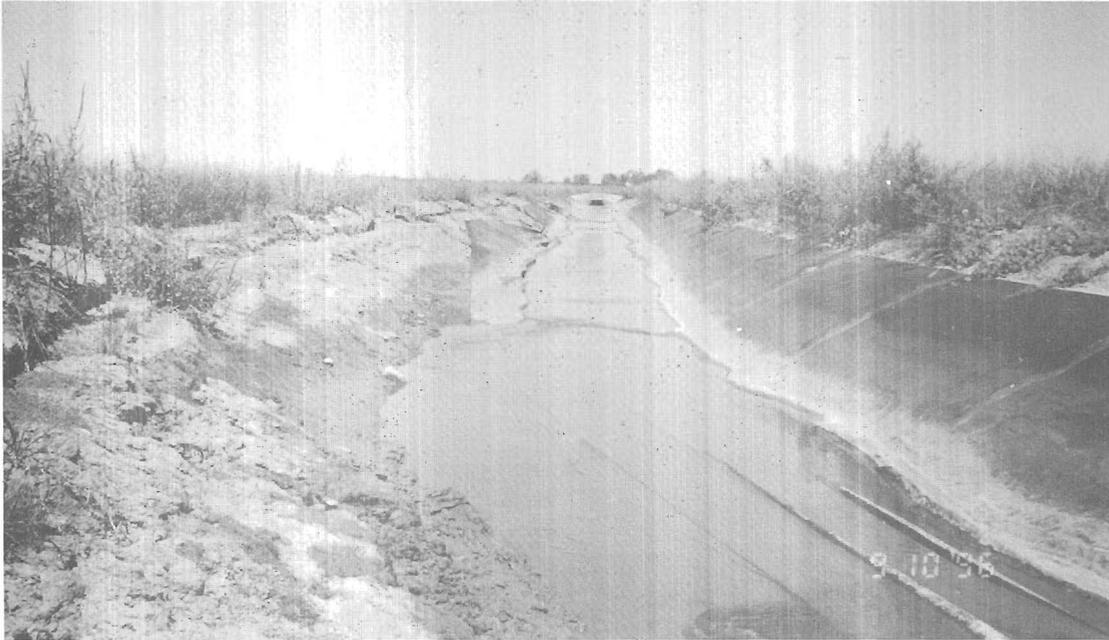
| | Test Section | 2-Year Condition | Comments |
|---|---|---|---|
| L-1 | Exposed Teranap Geomembrane | Very Good | Partial wash-out has been repaired |

Photograph 156.—On the upstream end of the canal, about 300 linear feet of Teranap washed-out on the west bank.

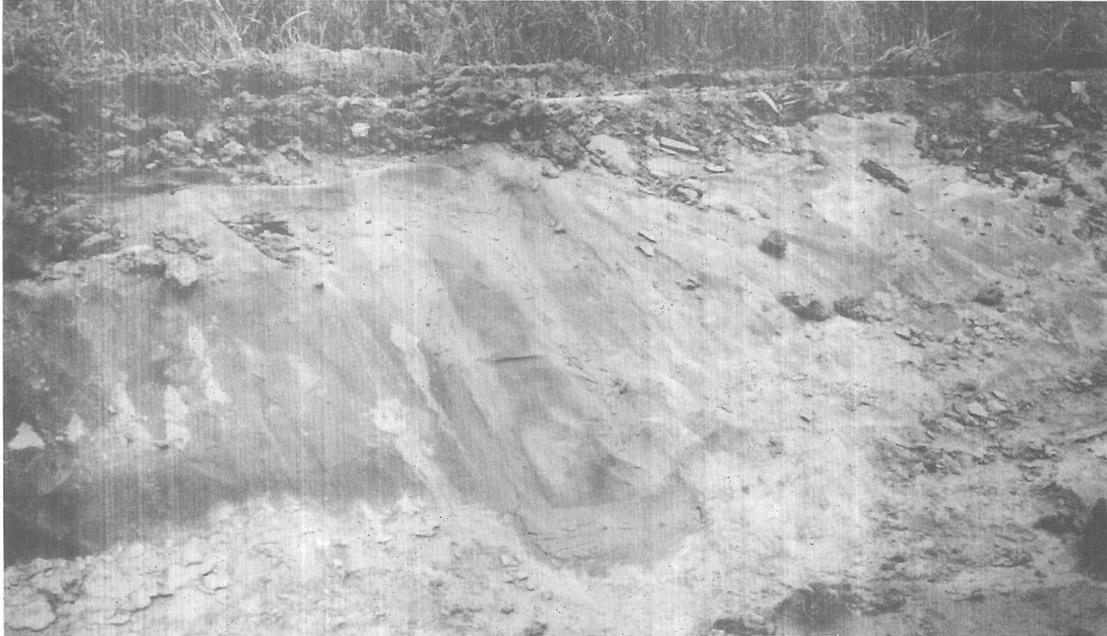
Photograph 160.—Tears in the Teranap were repaired with a patch of new Teranap.

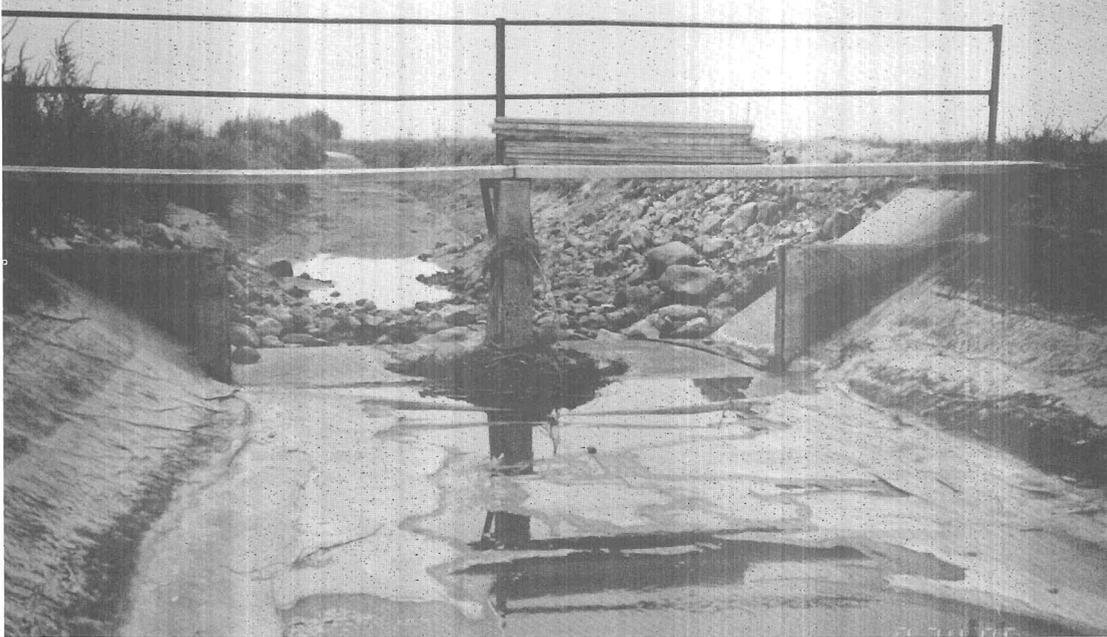
Photograph 162.—Teranap at the downstream check structure is in very good condition, needing only minor repairs.

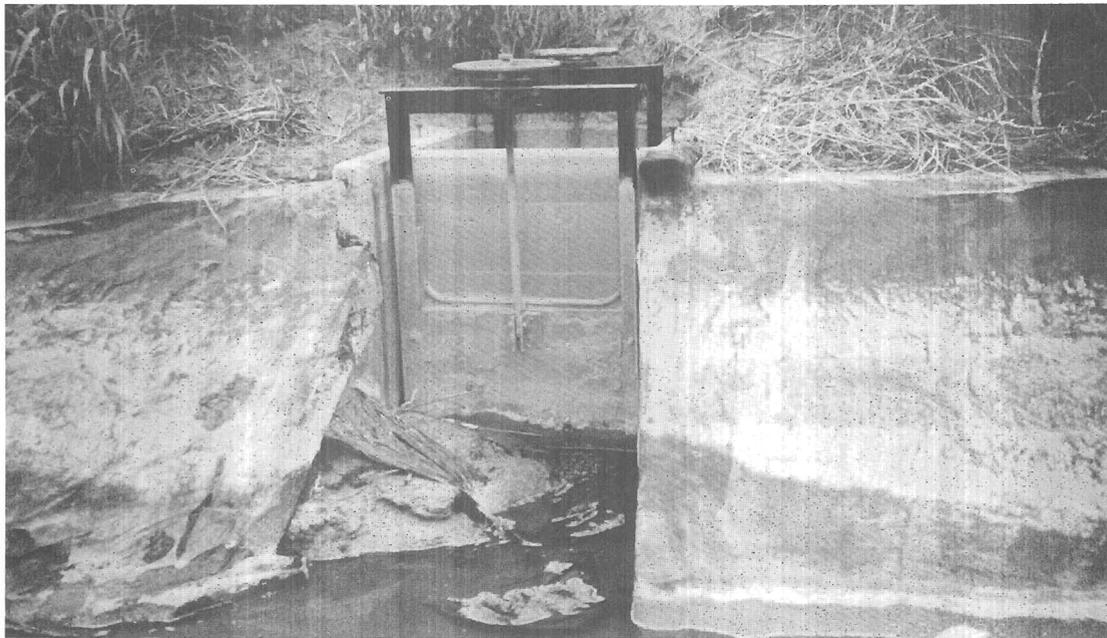
Photograph 163.—Teranap at this outlet structure needs minor repair
