REC-ERC-71-47

HYDRAULIC MODEL STUDIES OF AERATION DEVICES FOR YELLOWTAIL DAM SPILLWAY TUNNEL, PICK-SLOAN MISSOURI BASIN PROGRAM, MONTANA

**D. M. Colgate
Engineering and Research Center
Bureau of Reclamation**

December 1971

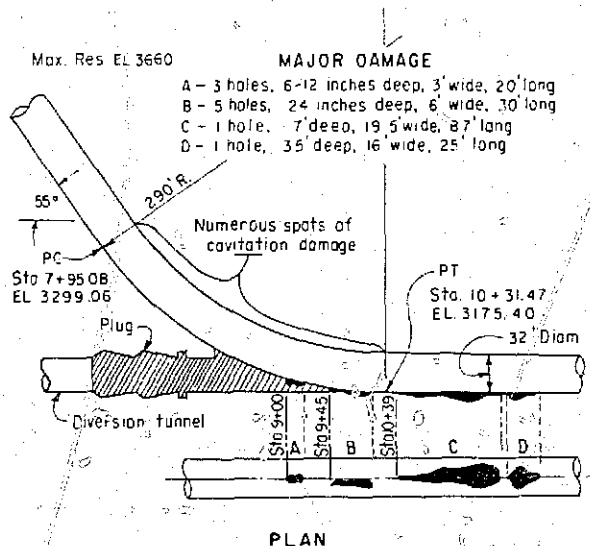
After flood danger had passed, the tunnel was dewatered and the concrete tunnel lining was subjected to a thorough examination (Figure 3). The largest damaged area was centered on the tunnel invert beginning 8 feet downstream from the P.T. of the tunnel bend and extending downstream for 125 feet (Figure 4). A surface discontinuity was responsible for the cavitation that initiated the damage, and a combination of cavitation and jet action continued to erode the concrete and foundation rock downstream. The surface discontinuity resulted from the partial failure of an epoxy patch which had been placed to fill in an eroded area in the tunnel invert before spillway releases were made. The spalled area was 1/4 inch deep, 6 inches wide, and 10 inches long. Remains of epoxy mortar could be seen around the perimeter of the patch. Cavitation damage started immediately downstream from the depression, and damage in the first 25 feet was sufficiently deep to expose reinforcement bars. In the next 100 feet (approximately), the tunnel invert concrete and large quantities of the limestone foundation rock had been

Figure 3. Yellowtail Dam—Section through tunnel spillway bend—Location of major damaged areas, 1967 flood releases.

removed. The crater reached a maximum depth of 7 feet and a width of 19.5 feet. Portions of the concrete lining along the sides of the damaged area had been undercut as much as 6 feet.

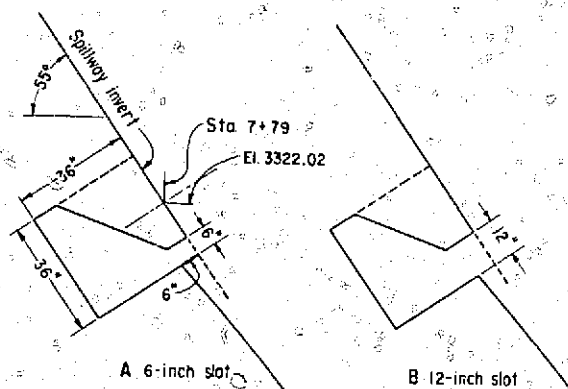
Figure 9. Narrow aeration slots.

In an attempt to prevent water from entering and filling the slot, the slot was narrowed to 6 inches, with a 6-inch away-from-the-flow offset downstream (Figure 9A). Although some air was entrained in the jet at low discharges, water entered the slot near the water surface for all spillway discharges. For discharges less than 20,000 cfs, water drained down the slot and flowed out into the jet at the tunnel invert, reducing the amount of entrained air as the spillway discharge increased. At a spillway discharge of 20,000 cfs, the water surface in the slot was at the same elevation as the spillway water surface, and no air entered the jet. For spillway discharges greater than 20,000 cfs, the water was forced into the slot at a sufficiently high head to cause it to boil up the slot above the spillway water surface and spill out onto the surface of the jet.

The slot width was increased to 12 inches (Figure 9B). The flow with this configuration was similar to that with the 6-inch slot. The discharge, at which the water surface in the slot was equal to that of the spillway water surface, was 30,000 cfs.

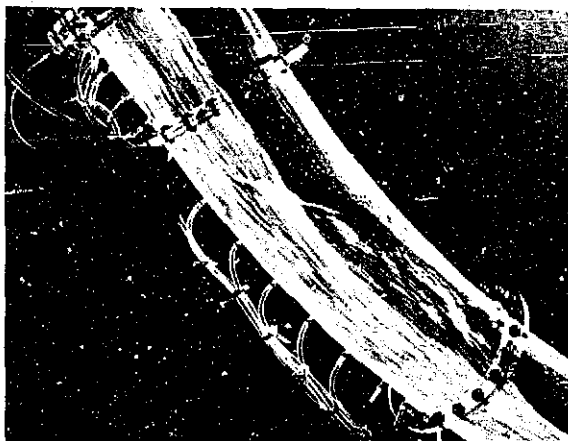
Figure 13. Recommended aeration slot, Station 7+79. Discharge is 30,000 cfs. These maximum side fins, one each side of the jet, do not reach the crown of the tunnel, Photo P459-D-68800

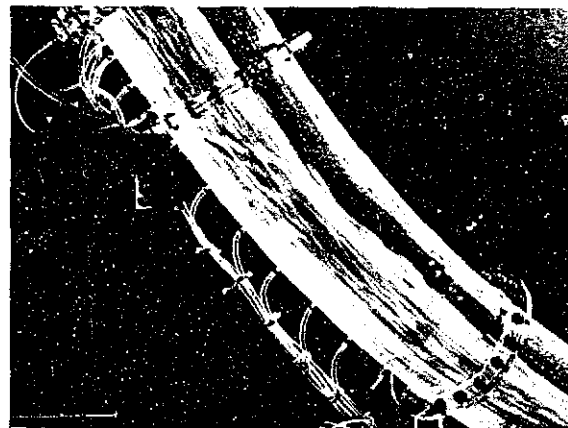
The impingement of the jet on the tunnel invert downstream from the aeration slot caused side fins to form. For discharges less than 50,000 cfs these side fins swept uninterrupted up the walls of the tunnel past the contracted jet. The maximum side fins, which occurred at a discharge of 30,000 cfs, were not objectionable and did not reach the top of the tunnel (Figure 13). Since the lift diminished as it neared the tunnel springline, the upper portion of the jet was subjected to less contraction than the lower portion. Consequently, the upper elements of the jet impinged on the walls of the tunnel farther upstream and at a much smaller angle, as the discharge and flow depth increased. For discharges greater than 30,000 cfs, the upper portion of the jet interfered with and reduced the side fins, and for discharges greater than 50,000 cfs, the side fins were entirely contained by the upper portion of the jet (Figure 14).

Figure 14. Recommended aeration slot, Station 7+79. Discharge is 50,000 cfs. The upper portion of the jet has spread to the tunnel walls and suppressed the side fins. Photo P459-D-68810

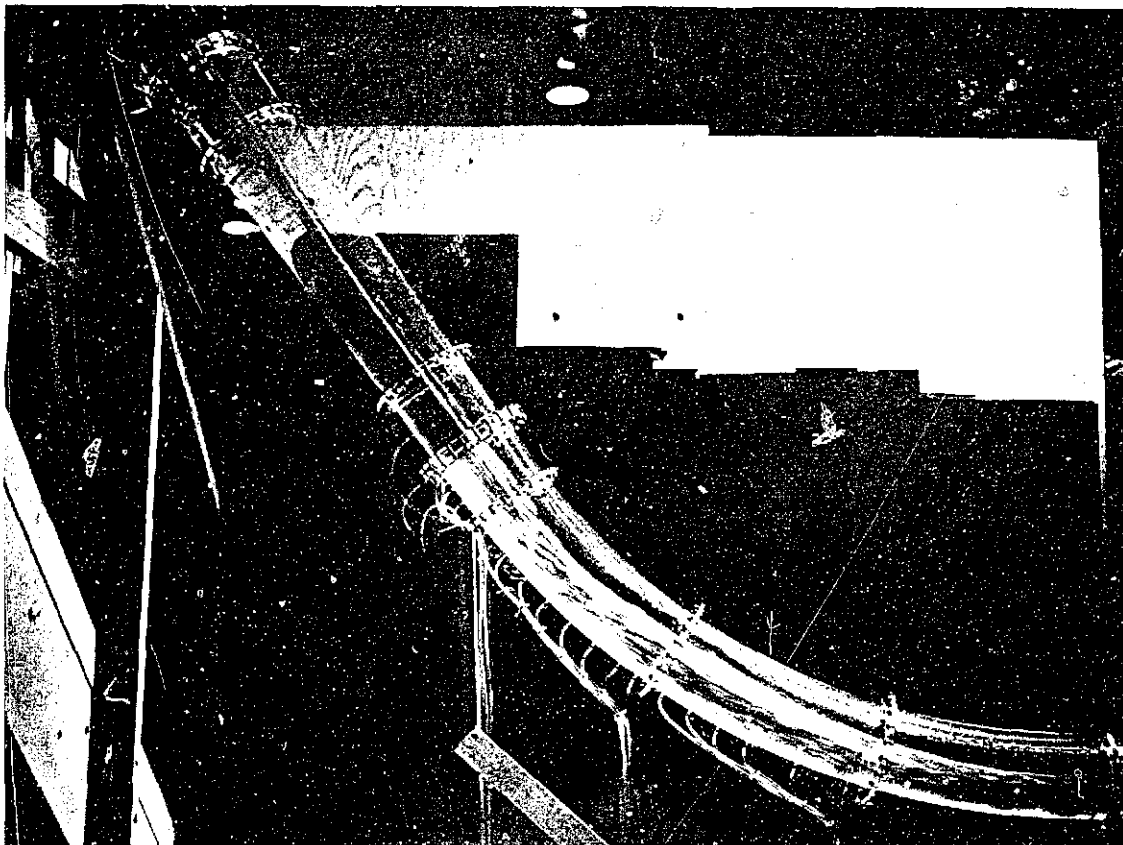
bend (Figure 15). However, it was not known whether the amount of air remaining adjacent to the tunnel flow surfaces in the downstream portion of the bend would be sufficient to prevent cavitation damage. The relationship between model and prototype with respect to entrained air is unknown. As a further precaution against cavitation damage, it appeared that air should be reintroduced into the jet at some station upstream from the P.T. of the bend.

Figure 15. Overall view of the spillway model. Recommended aeration slot at Station 7+79. The slot at Station 6+64, upper left, has been closed. Air entrained at the aeration slot continues throughout the bend. Mixing tends to reduce the air near the flow surfaces in the downstream portion of the bend. Photo P459-O-68808

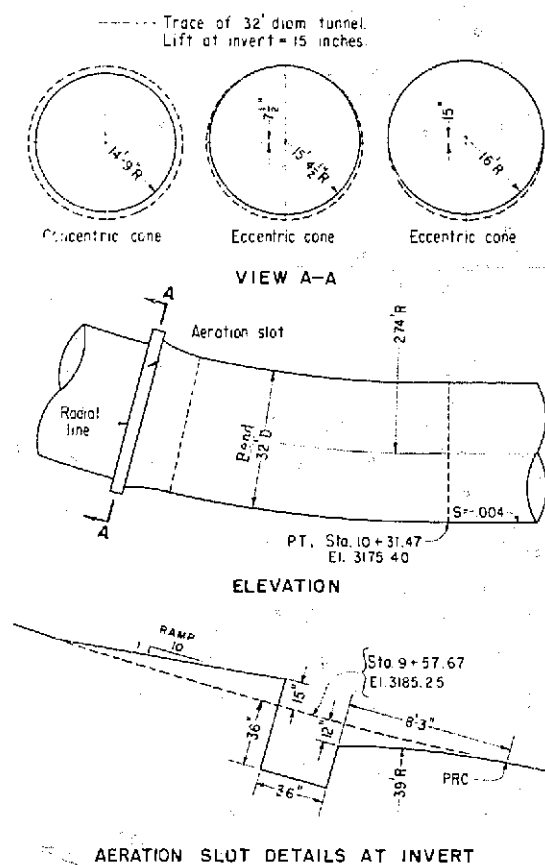
Figure 16. Aeration slot in the bend, Station 9+57.67 (not recommended).

Model studies were continued to evaluate an aeration slot in the downstream portion of the vertical bend at Station 9+57.67 (Figure 16). The centrifugal force of the water in the bend made this location quite different hydraulically from the location in the conical

portion of the tunnel. The initial study was made with no lift upstream from the slot, and a 12-inch away-from-the-flow offset downstream. The slot partially or completely filled with water for all discharges. A small amount of air entered the jet for discharges less than 15,000 cfs, but for discharges

greater than 15,000 cfs water filled the slot and no air was entrained in the jet.

Various ramps and lifts were installed in the tunnel upstream from the slot. Each design tested produced satisfactory air entrainment and hydraulic operation for a limited range of discharges; however, none would operate satisfactorily over the full range of discharges. Figure 17 shows the fin produced by one configuration with a discharge of 60,000 cfs. This fin choked the tunnel downstream.

These limited tests indicated that the necessary modifications for a satisfactory aeration device to be installed in the vertical bend of an existing structure would be too extensive to be practical. However, an aeration device could undoubtedly be developed for installation in a bend during initial construction of a spillway tunnel.

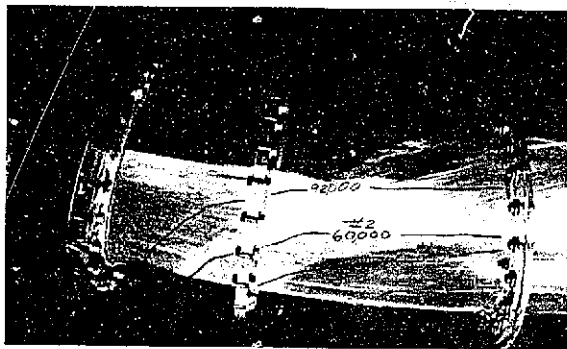
Figure 17. Aeration slot in the bend at Station 9+57.67. Discharge is 60,000 cfs. The side fins choke the tunnel downstream. Photo P459-D-68811

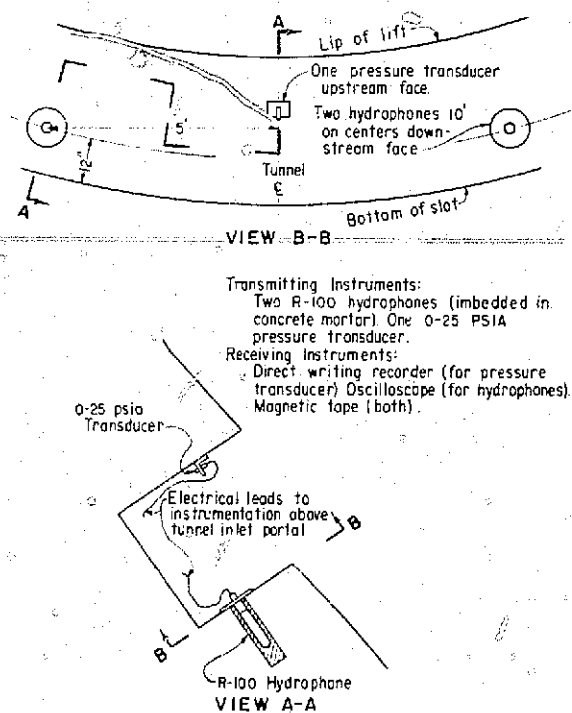
Figure 18. Prototype instrumentation.

tunnel. Electronic surveillance was supplied by two hydrophones and one pressure transducer installed in the aeration slot prior to the start of the first spillway test (Figure 18). The hydrophones were embedded in the concrete in the downstream face of the slot to indicate any change in vibration and the pressure transducer was installed in the slot to monitor the slot pressure during the extended tunnel operation.

The prototype study included three tests: 5 days' spillway operation at 5,000 cfs, 1 day at 15,000 cfs, and 4 days at 14,500 cfs. Examination after each test

revealed small areas of surface repair failure, but no indication of cavitation damage. The higher discharges were made with known surface irregularities in the downstream portion of the bend. These irregularities were similar in size, shape, and location to irregularities which caused extensive cavitation damage during the spillway releases in 1967. The prototype testing confirmed the results of the model study relative to the location and configuration of the aeration slot. The final examination indicated that a sufficient volume of air was being supplied to the flow to protect the flow surfaces from cavitation damage.
