REC-ERC-82-17

FROST ACTION IN SOIL FOUNDATIONS AND CONTROL OF SURFACE STRUCTURE HEAVING

June 1982

**U.S. Department of the Interior
Bureau of Reclamation**

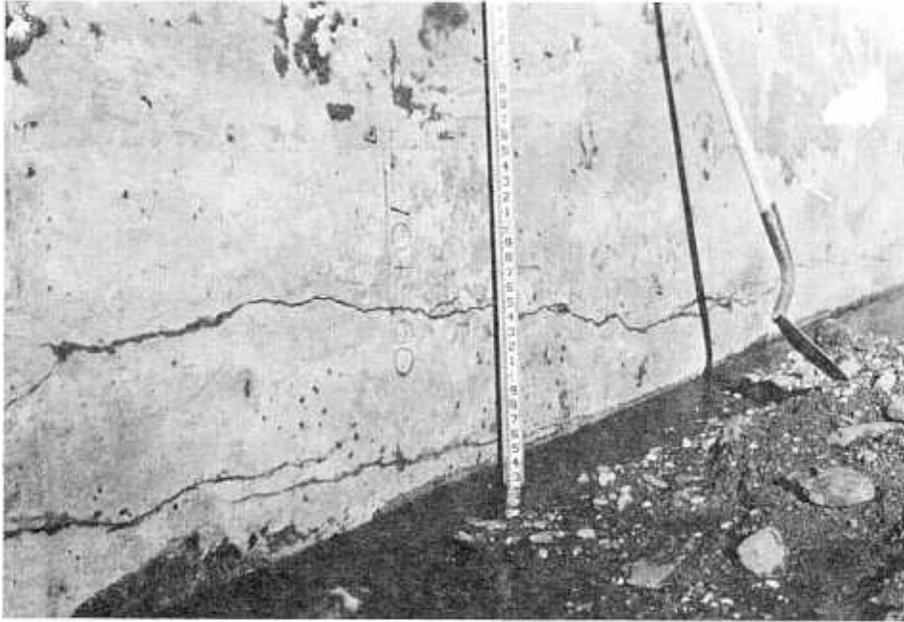
Figure 22.—Cracks caused by frost action in stilling basin wall. Jamestown Dam, 1961
P604-603-128

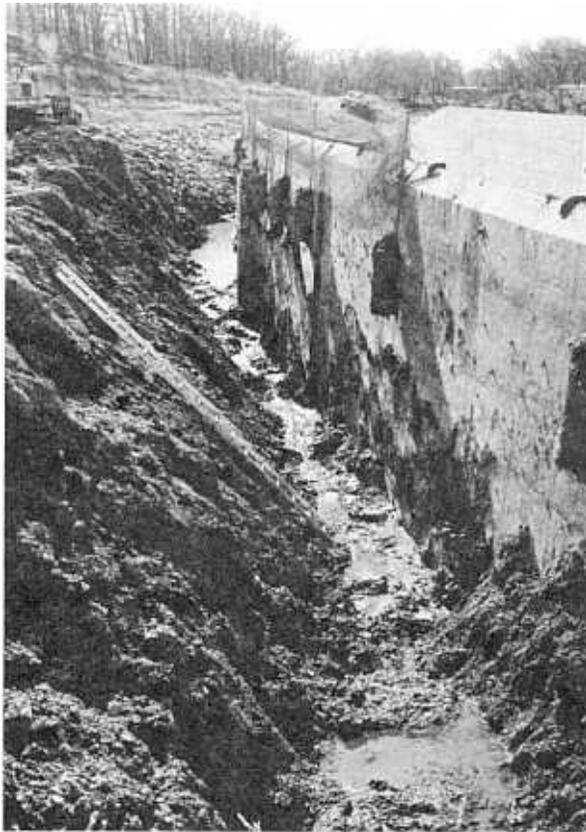
Figure 23.—Excavation behind stilling basin wall. Soil against wall at lower right is gravel. Jamestown Dam, 1961. P604-603-126

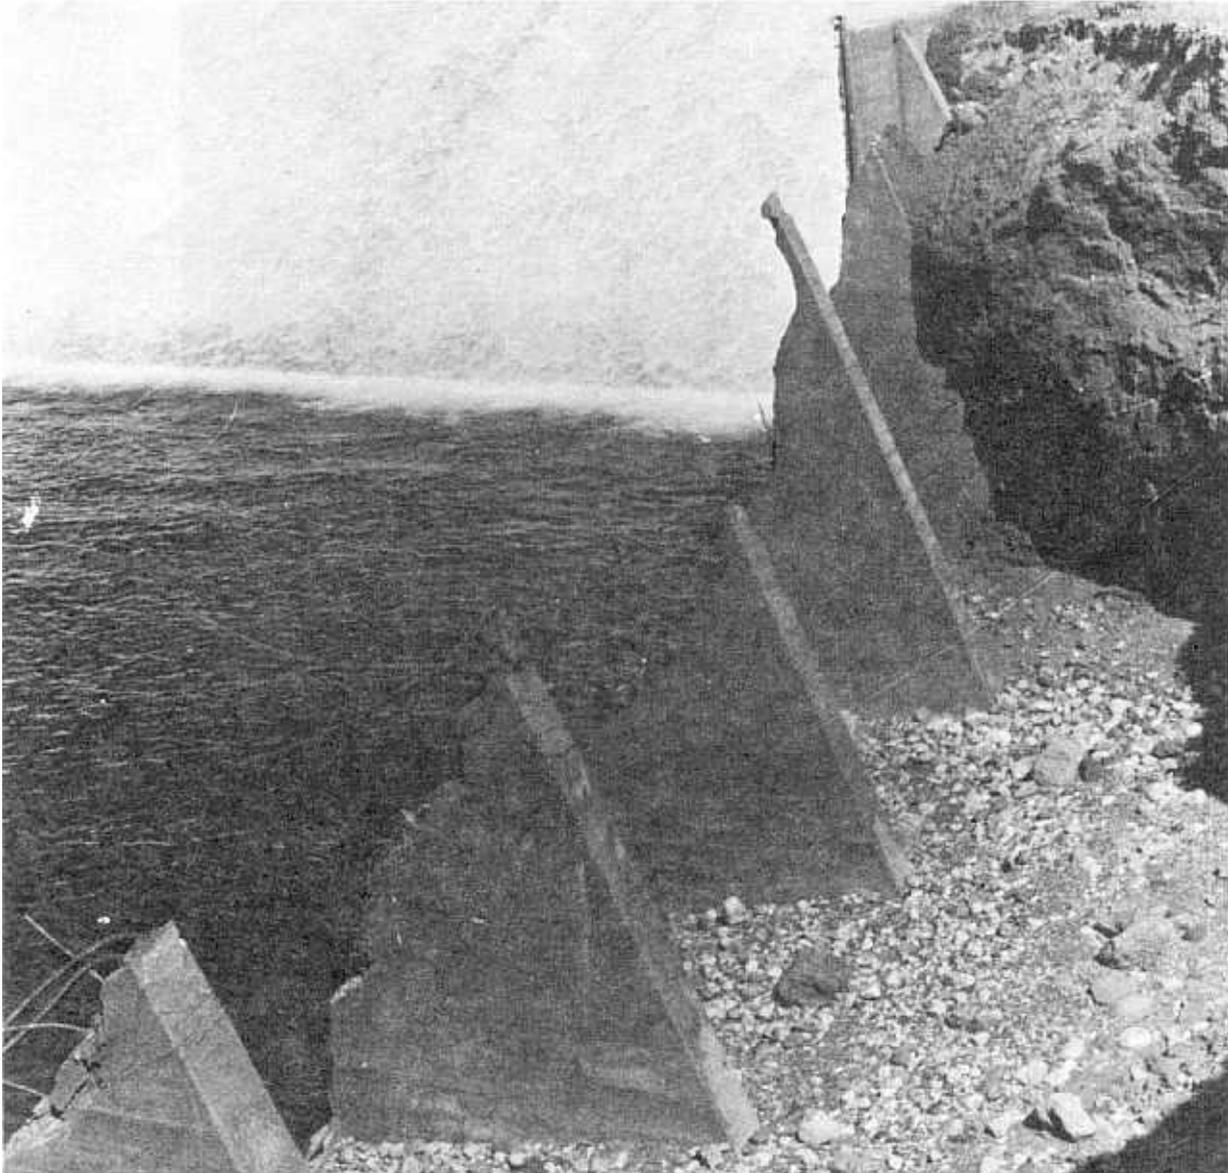
Figure 27.—Failure of left stilling basin wall on Vallecito Dam from frost action in backfill. September 1973. CN191-D-73902

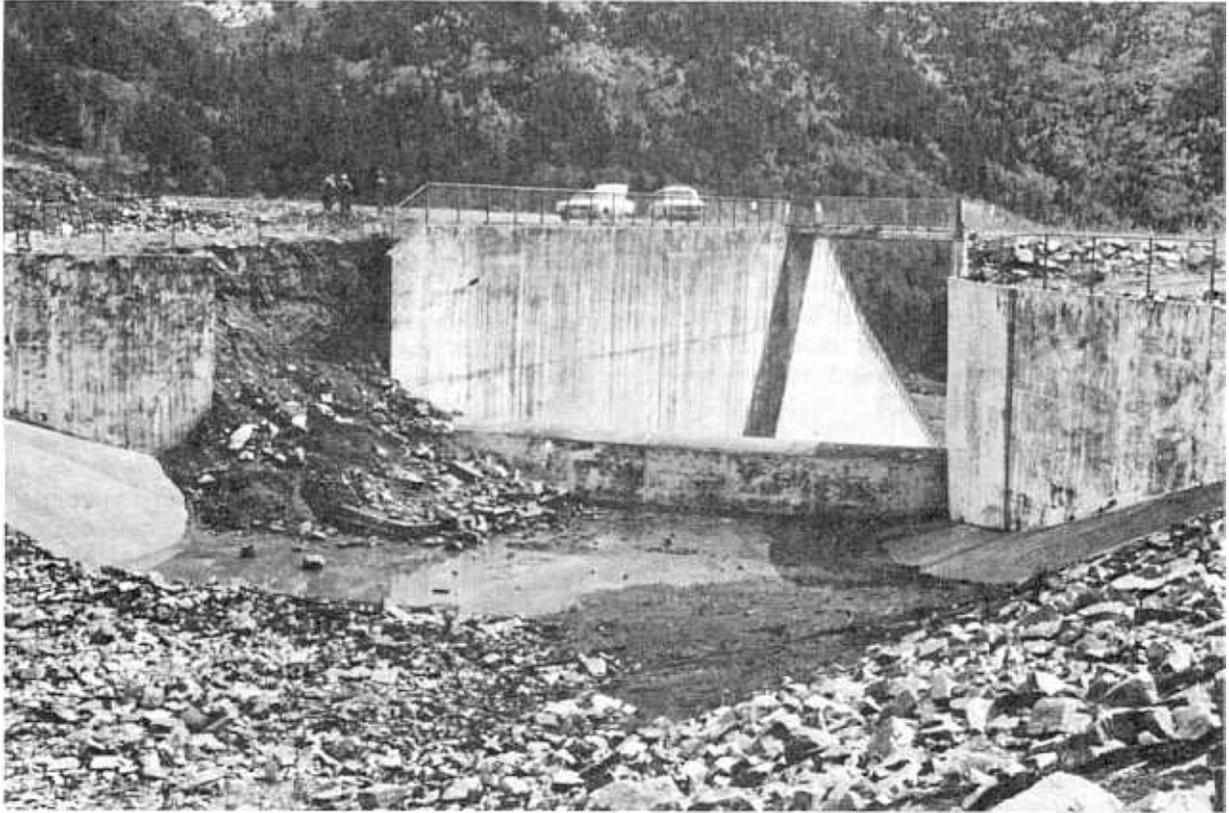
Figure 28.—Failure of spillway wall panel on Lemon Dam from frost action in backfill. September 1973. P519-429-3NA

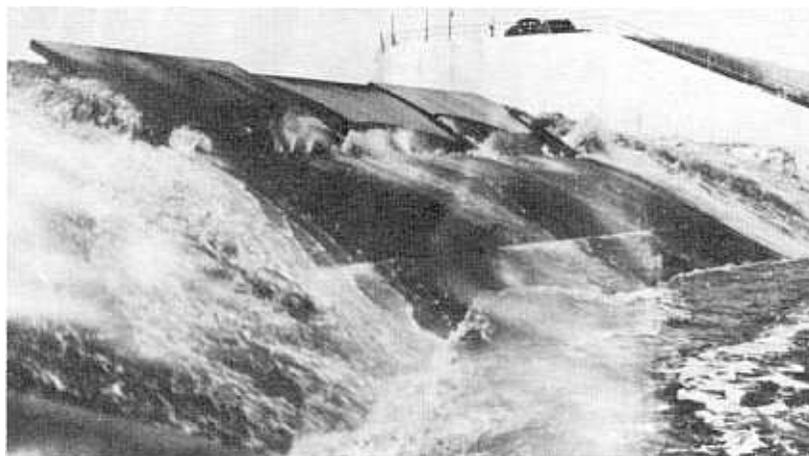
Figure 30.—Failure of Dickinson Dam spillway in April 1954. P203-603-347NA

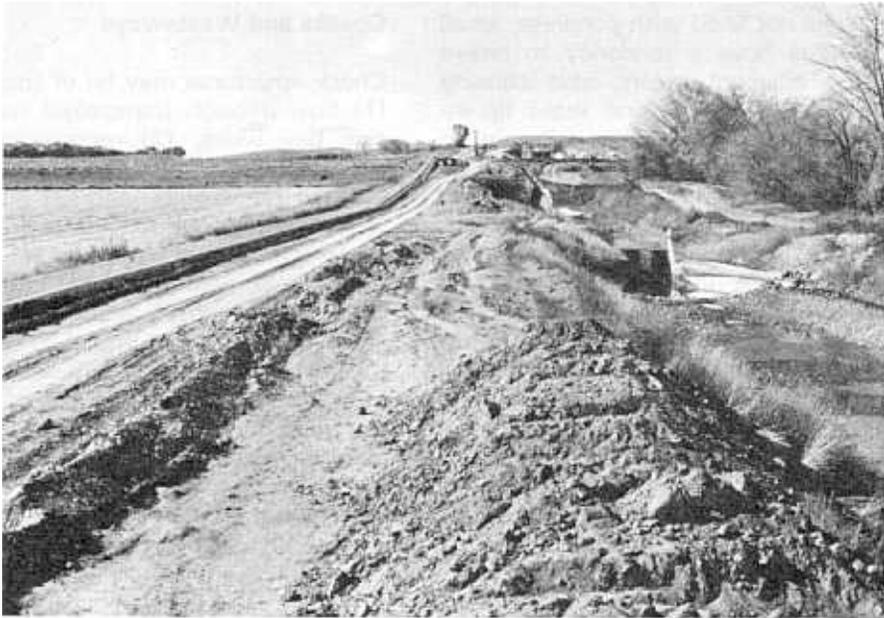
(a) Original canal with frost damaged chute and drop structures on right. 1236-617-1984

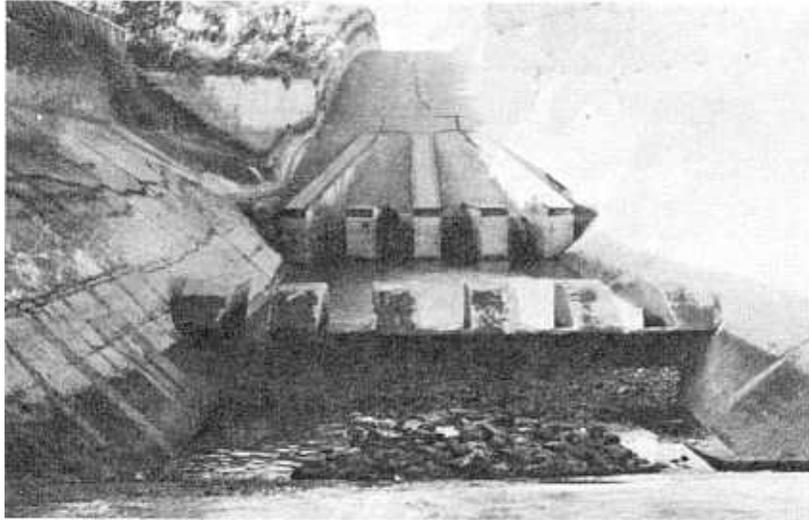
Figure 32.—Drop structure with inadequate weep holes and impervious backfill that resulted in frost damage. Lower Turnbull Drop, Sun River Project. P801-D-79858

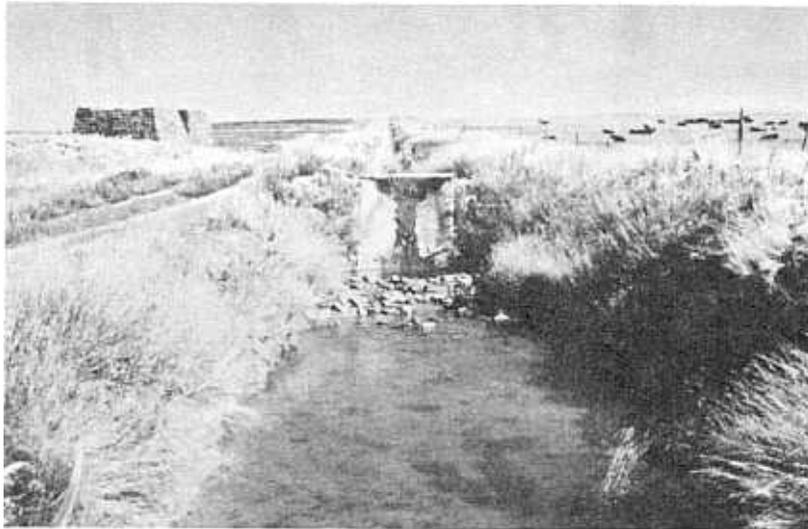
Figure 33.—Drop structure susceptible to frost action to be replaced by pipe. Lateral G.M. 58, Sun River Project. P801-D-79859

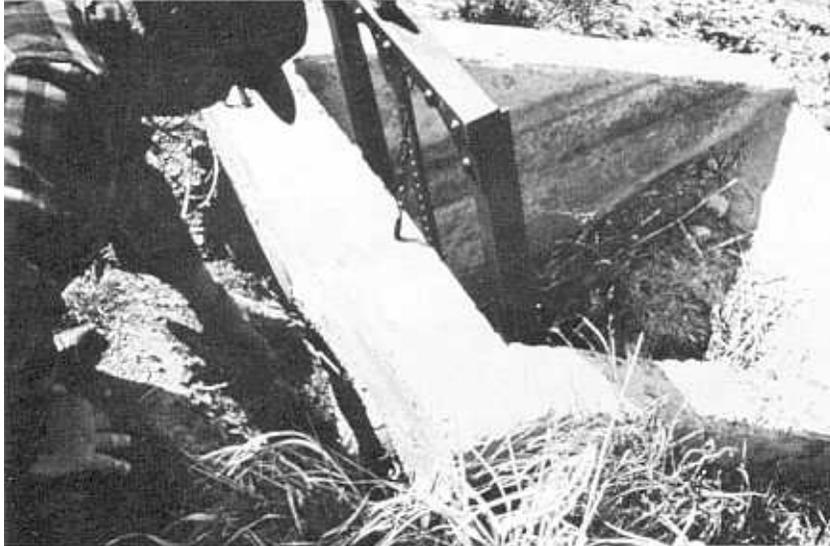
Figure 34.—Break between outlet structure and pipe resulted in a cavity forming behind headwall at pipe turnout. Lateral 23.2, Riverton Unit. P801-D-79860

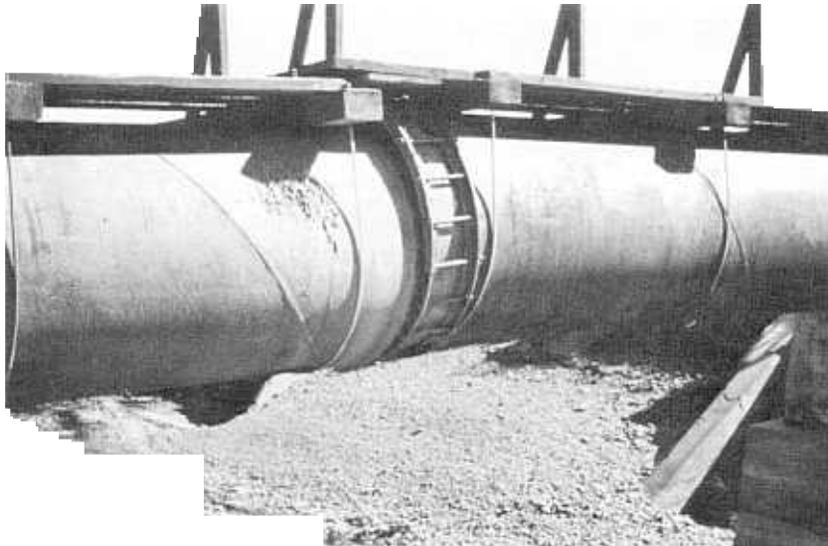
In April 1974, a 600-mm (24-in) steel pipe, near the Thomas Point Pumping Plant crossing the main canal of the Lower Yellowstone Project in Montana, was observed to have been damaged by frost heave. The pipe crosses the canal on two piers located in the canal section. Because of differential heave between the piers, the pipe was dislocated about 76 mm (3 in) at a joint (fig. 35). The maximum dislocation had been about 152 mm (6 in) during the preceding winter. During the preceding 1973-74 winter,

Figure 35.—Displacement at pipe joint due to differential heave between supporting piers. Lower Yellowstone Project in Montana. P801-D-79861

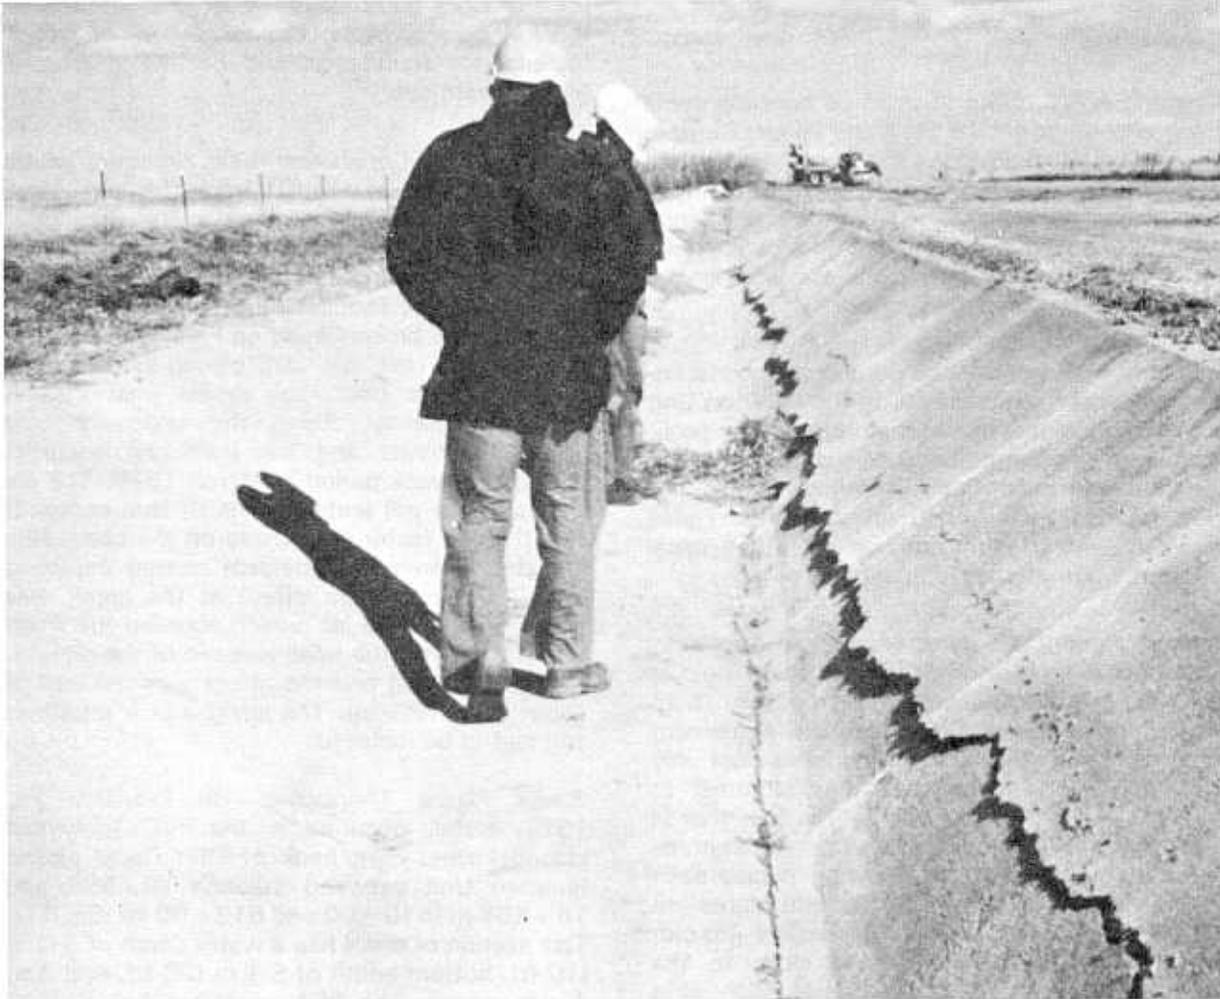
Figure 36.—Breakage of concrete canal lining during spring thawing period. Fivemile Lateral, Riverton Unit. P801-D-79862

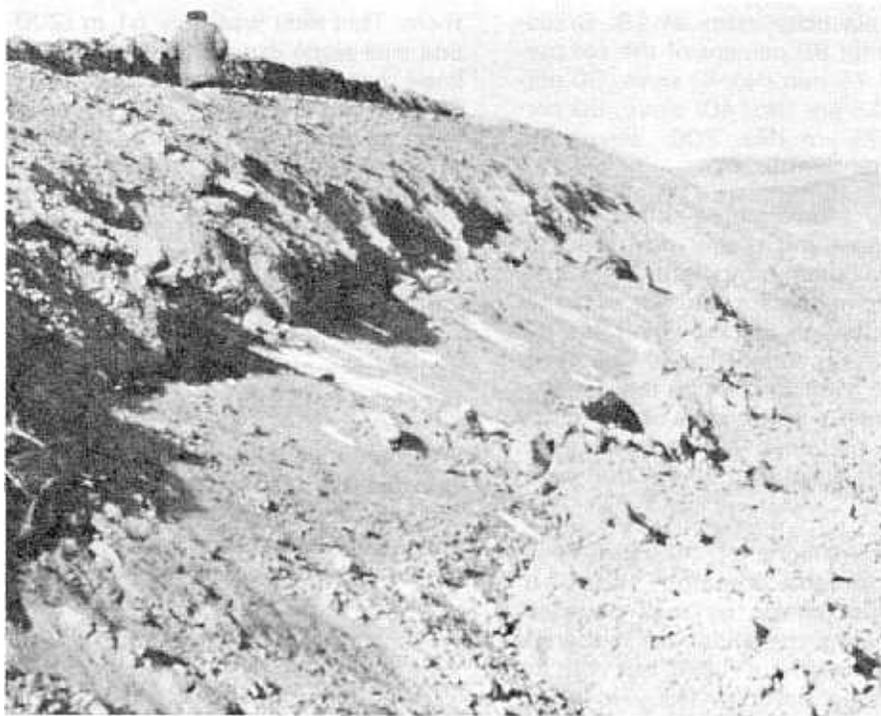
Buried Plastic Membrane.—On February 15, 1977, a slide occurred on the PVC- (polyvinyl chloride) lined right bank of Pilot Canal of the Riverton Unit between stations 18+593 and 18+654 m (610+00 and 612+00 ft) (fig. 37). This section of canal has a water depth of 3.0 m (10 ft), bottom width of 9.1 m (30 ft), and 2 to 1 side slopes. The 254- μm (10-mil) thick PVC lining was placed in November 1976 to replace a deteriorated asphalt membrane lining. The cover over the membrane consisted of 230 mm (9 in) of soil from canal excavation and was superimposed with 230 mm of pit-run gravel. The lining was torn below the anchored top portion and slippage occurred between the membrane and the soil underneath. Observations of an adjacent section revealed ice under the lining (fig. 38). Also, for about a 50-mm (2-in) depth beneath the lining, there was a series of ice lenses from about 1 to 3 mm (1/16- to 1/8-in) thick, alternating with layers of soil, which is typical of frost action in soil. The soil beneath the membrane was a sandy clay with a liquid

Figure 37.—Slippage of PVC membrane lining on Pilot Canal, Riverton Unit. Beyond the torn lining at extreme left, patches of ice can be seen. P801-D-79863

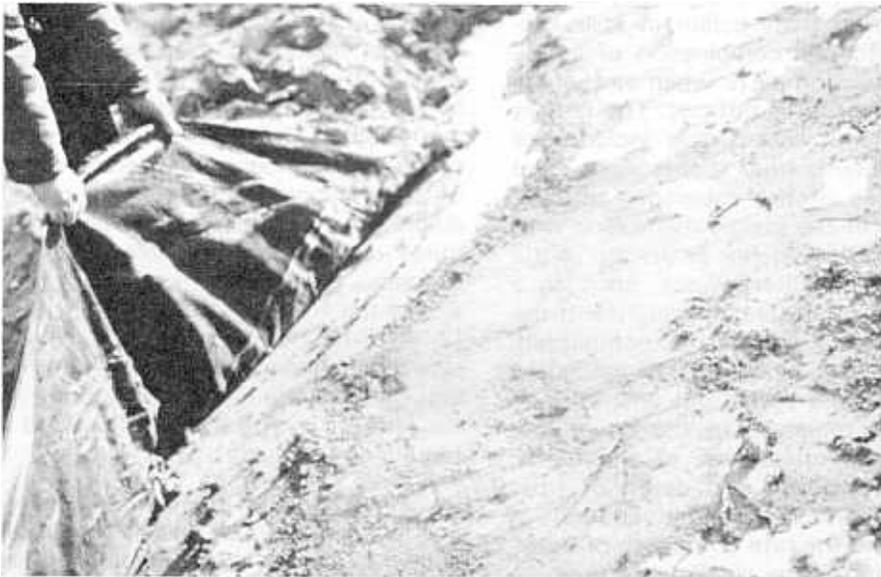
Figure 38.—Ice accumulation beneath PVC membrane lining near slippage area. P801-D-79864

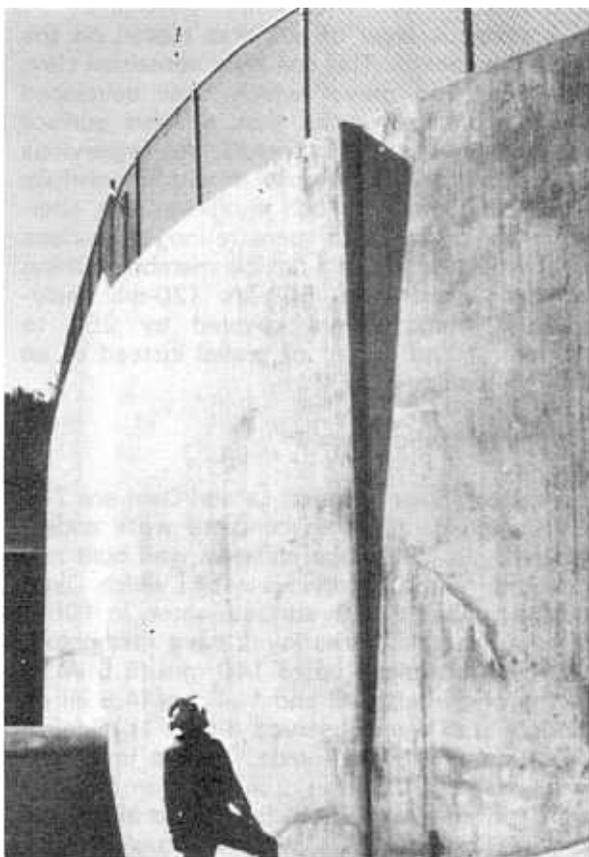
On April 9, 1973, two panels situated on opposite sides of the spillway entrance channel and immediately upstream from the free over-flow crest were observed to be severely deflected. The abutment counterforted walls on the downstream side were in good condition. The base of the walls could not be examined because of snow and ice, but 1971 photographs showed compressive failure spalling at the conjunction of the wall stem with the base on the channel side. The walls were backfilled with impervious embankment which was reportedly saturated by percolating surface water. Corrective drainage features constructed in 1967 had been ineffective because deflections had doubled since their installation. It was believed that water was freezing at the drain outlet, thus blocking any further drainage of the

Figure A-1.—Displacement of right spillway forebay wall panel on Lemon Dam by frost action in backfill. P801-D-79867

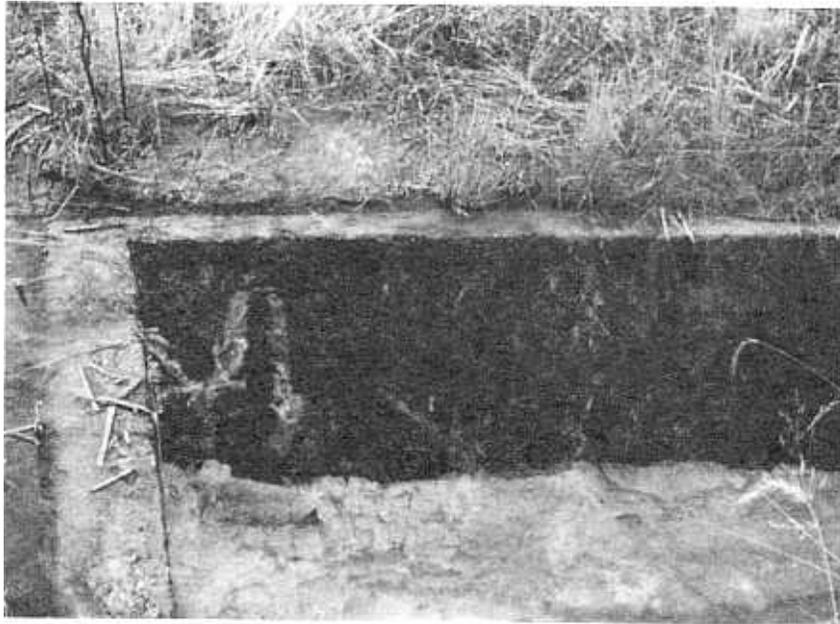
Figure A-3.—Lower end of a small canal structure nearly enveloped with ice. Sand Gulch Lateral 3.0A, Riverton Unit, March 1974. P801-D-79868

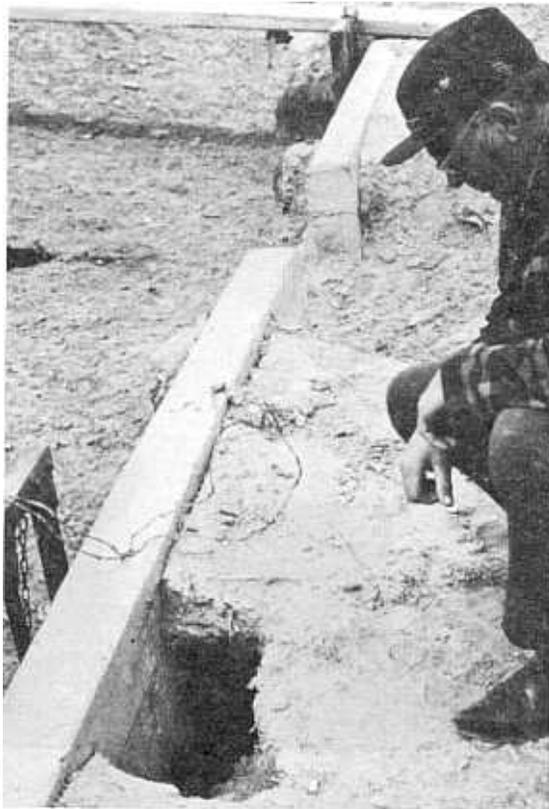
Figure A-4.—Sinkhole caused by waterflow through a break resulting from frost action at joint between headwall and pipe turnout. Pavillion Main Lateral, Riverton Unit. P801-D-79869

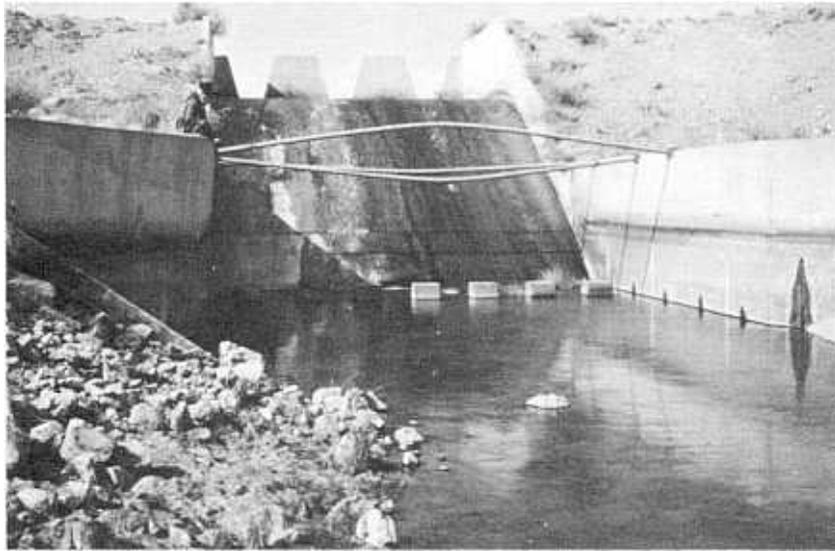
Figure A-5.—Drop structure on east-west oriented Wyoming Canal showing steel wall bracing. Wall on shaded south side has been tipped inward by frost action, and concrete chute floor has cracked from heaving. Riverton Unit. P801-D-79870

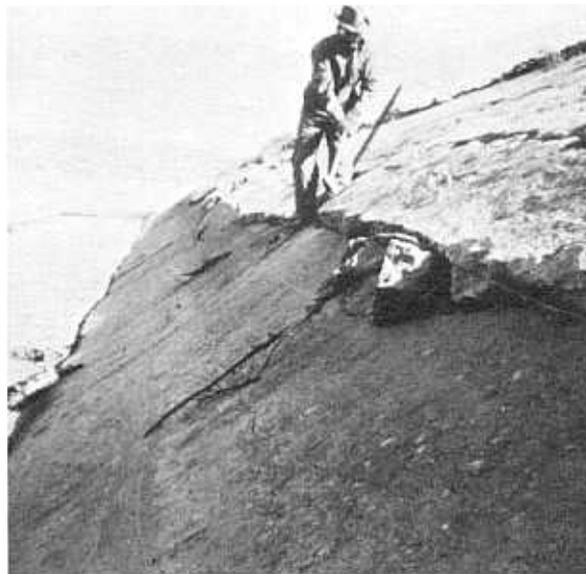
Figure A-8.—Concrete canal lining broken by frost action
Wyoming Canal, Riverton Unit. P801-D-79873

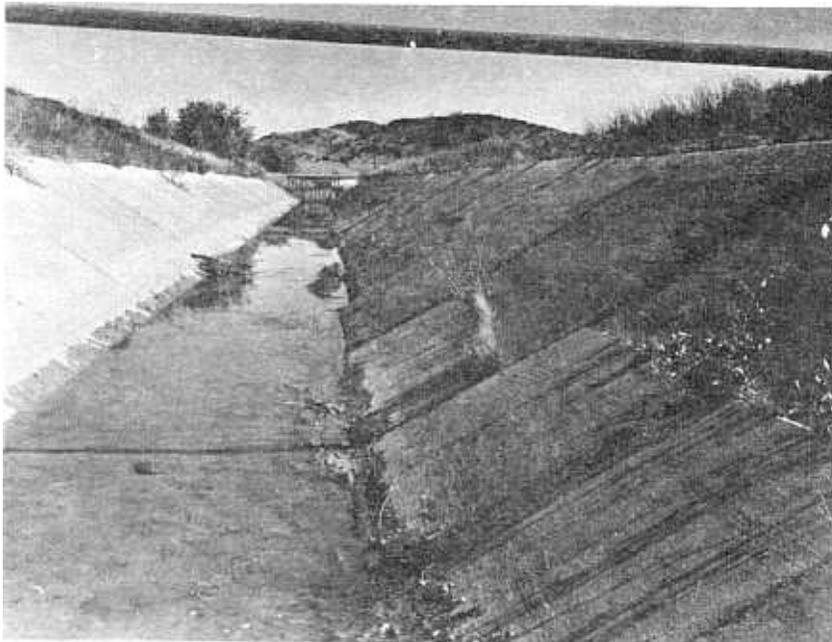
Figure A-10.—Heaved and cracked concrete lining on south (shaded) side of Steinaker Feeder Canal. Central Utah Project. 325-418-1291NA
