**REC-ERC-84-4**

# **SYNOPSIS OF INSULATION PROBLEMS AT YELLOWTAIL POWERPLANT**

**October 1983**

**Engineering and Research Center**

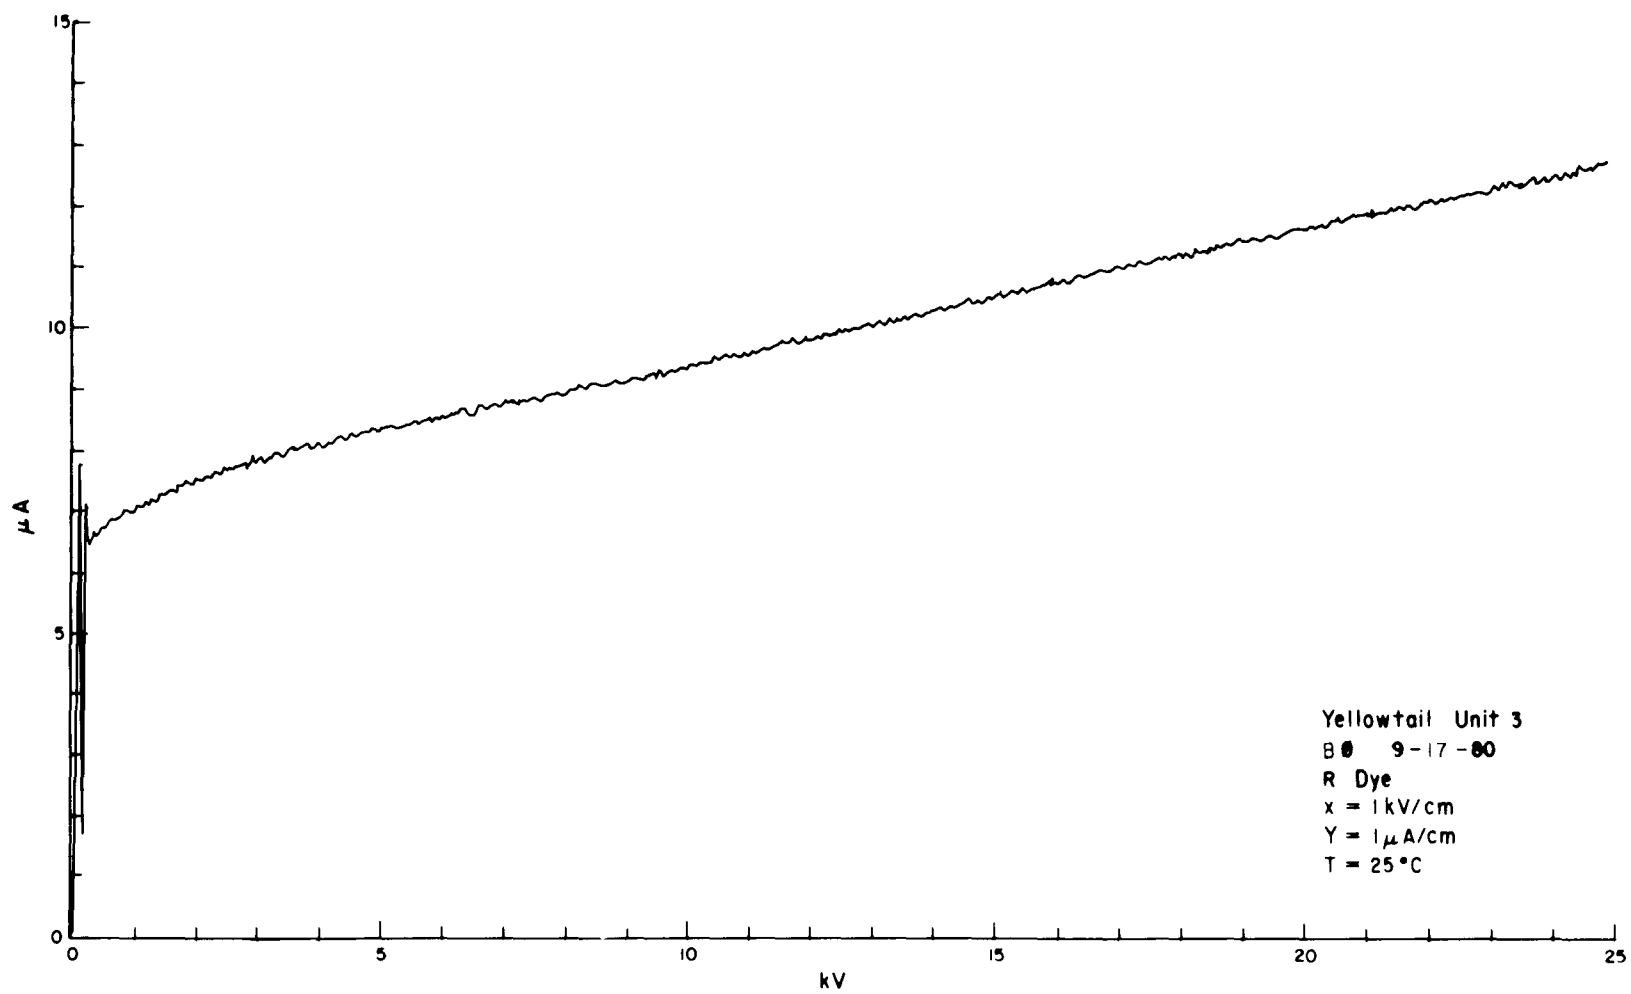
The results of these tests showed that, on phases B and C, the V-I curve did not have any discontinuities or sudden current increases (figs. 6 and 7). This indicated good quality insulation. On phase A, the V-I curve (fig. 8) was linear up to 23 kV, at which point the current suddenly increased and went off scale. The quality of the corona suppression was questioned, more plastic tape added, and the phase retested. This time the current increased and went off scale at 23.7 kV (fig. 9). We now suspect that arc-overs occurred in the isolated phase bus during these tests. The remaining portion of the isolated phase bus was disconnected from the generator leads, the generator leads insulated from the isolated phase bus by use of micarta blocks, and the unit retested on September 22, 1980. The V-I curve for phase A showed a moderate tip-up<sup>2</sup> starting at 21.5 kV (fig. 10). Another test was made with the same results, except the tip-up started at 22 kV (fig. 11). For this test, it appeared that the insulation was serviceable and that the moderate knee observed on phase A was apparently due to insufficient corona shielding on the winding terminals. Therefore, it was assumed that the V-I curves indicated acceptable quality insulation and the unit was returned to service.

Figure 1.—Ramped d-c absorption test V-I curve, B phase.

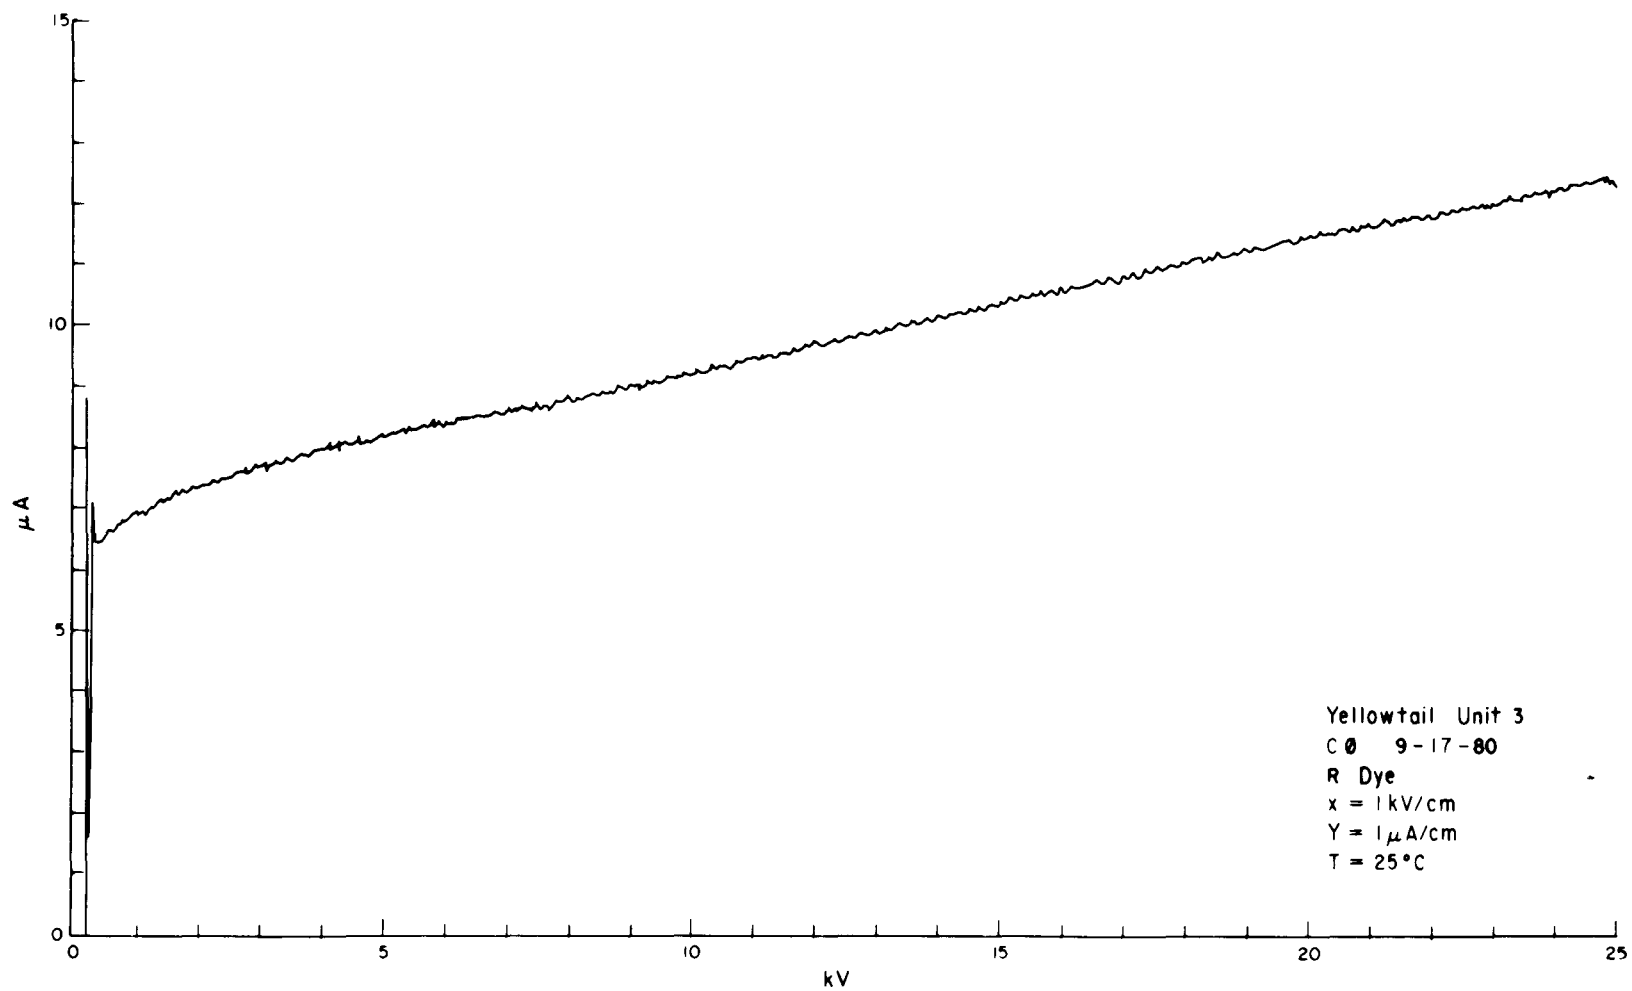
Figure 2.—Ramped d-c absorption test V-I curve, C phase.

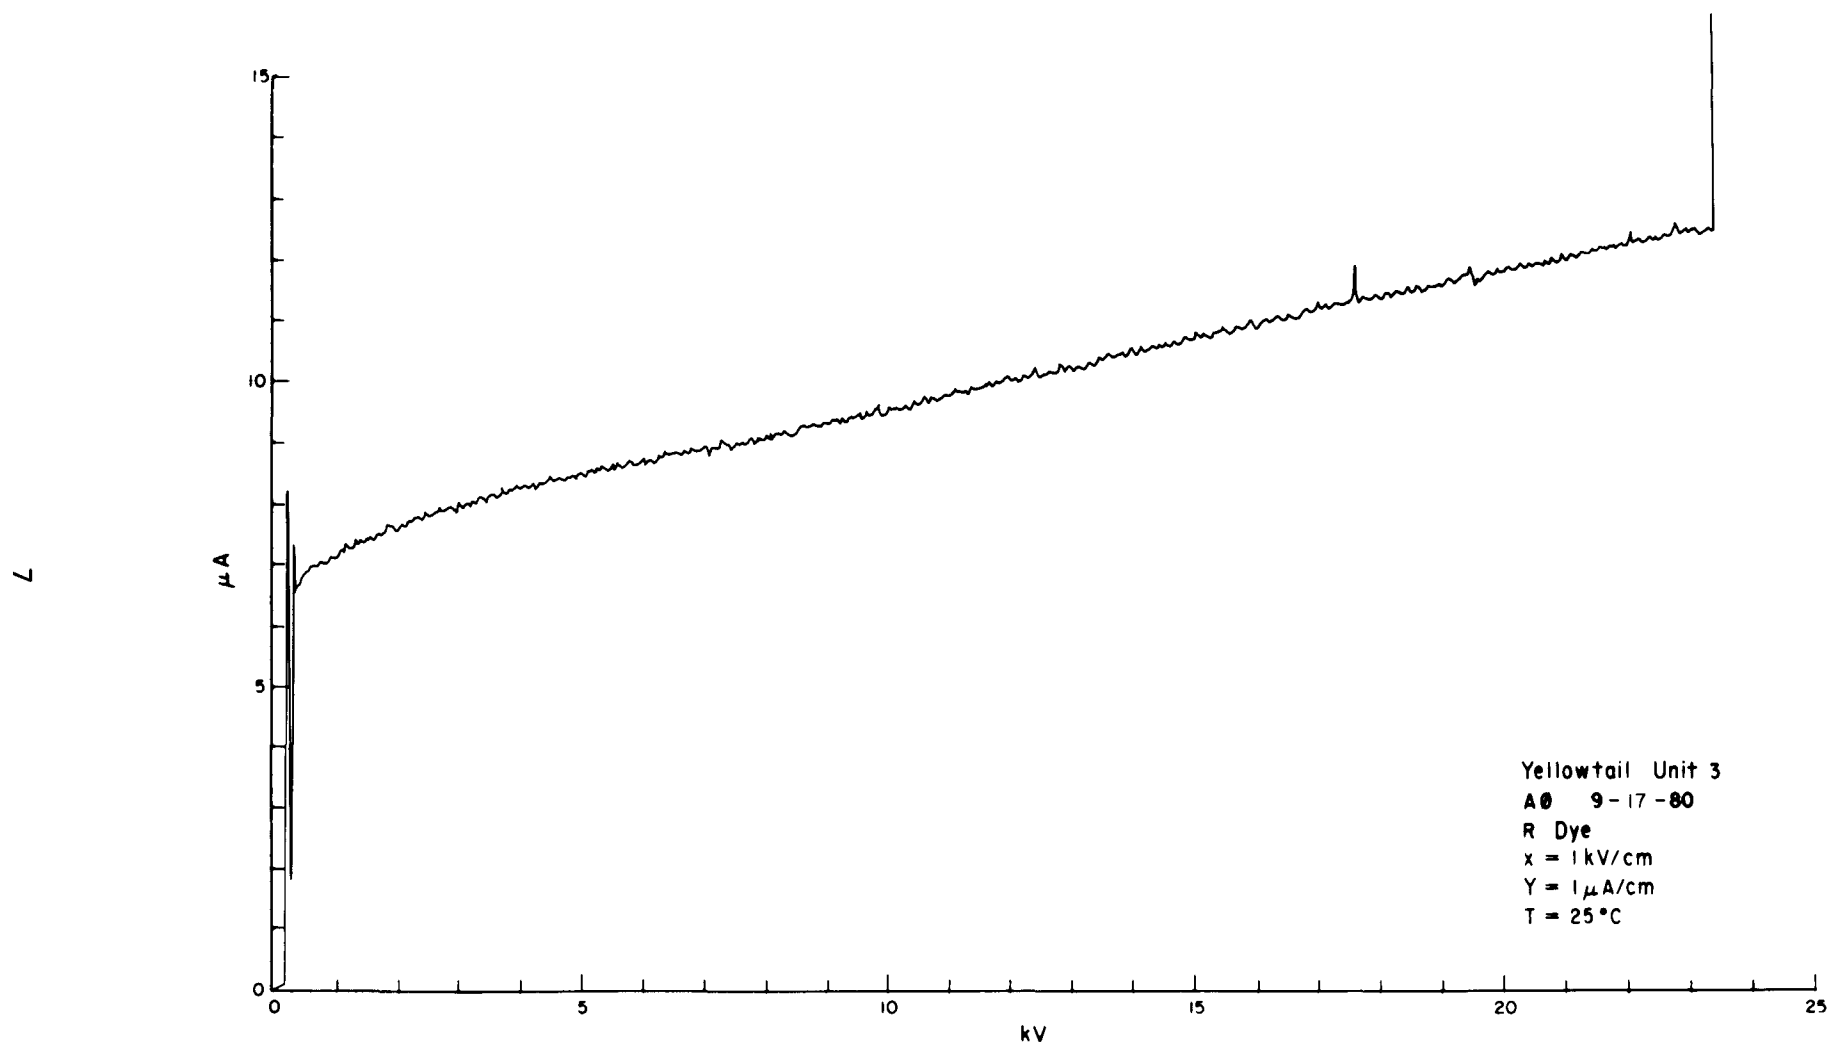
Figure 3.—Ramped d-c absorption test V-I curve, A phase, (flashover).

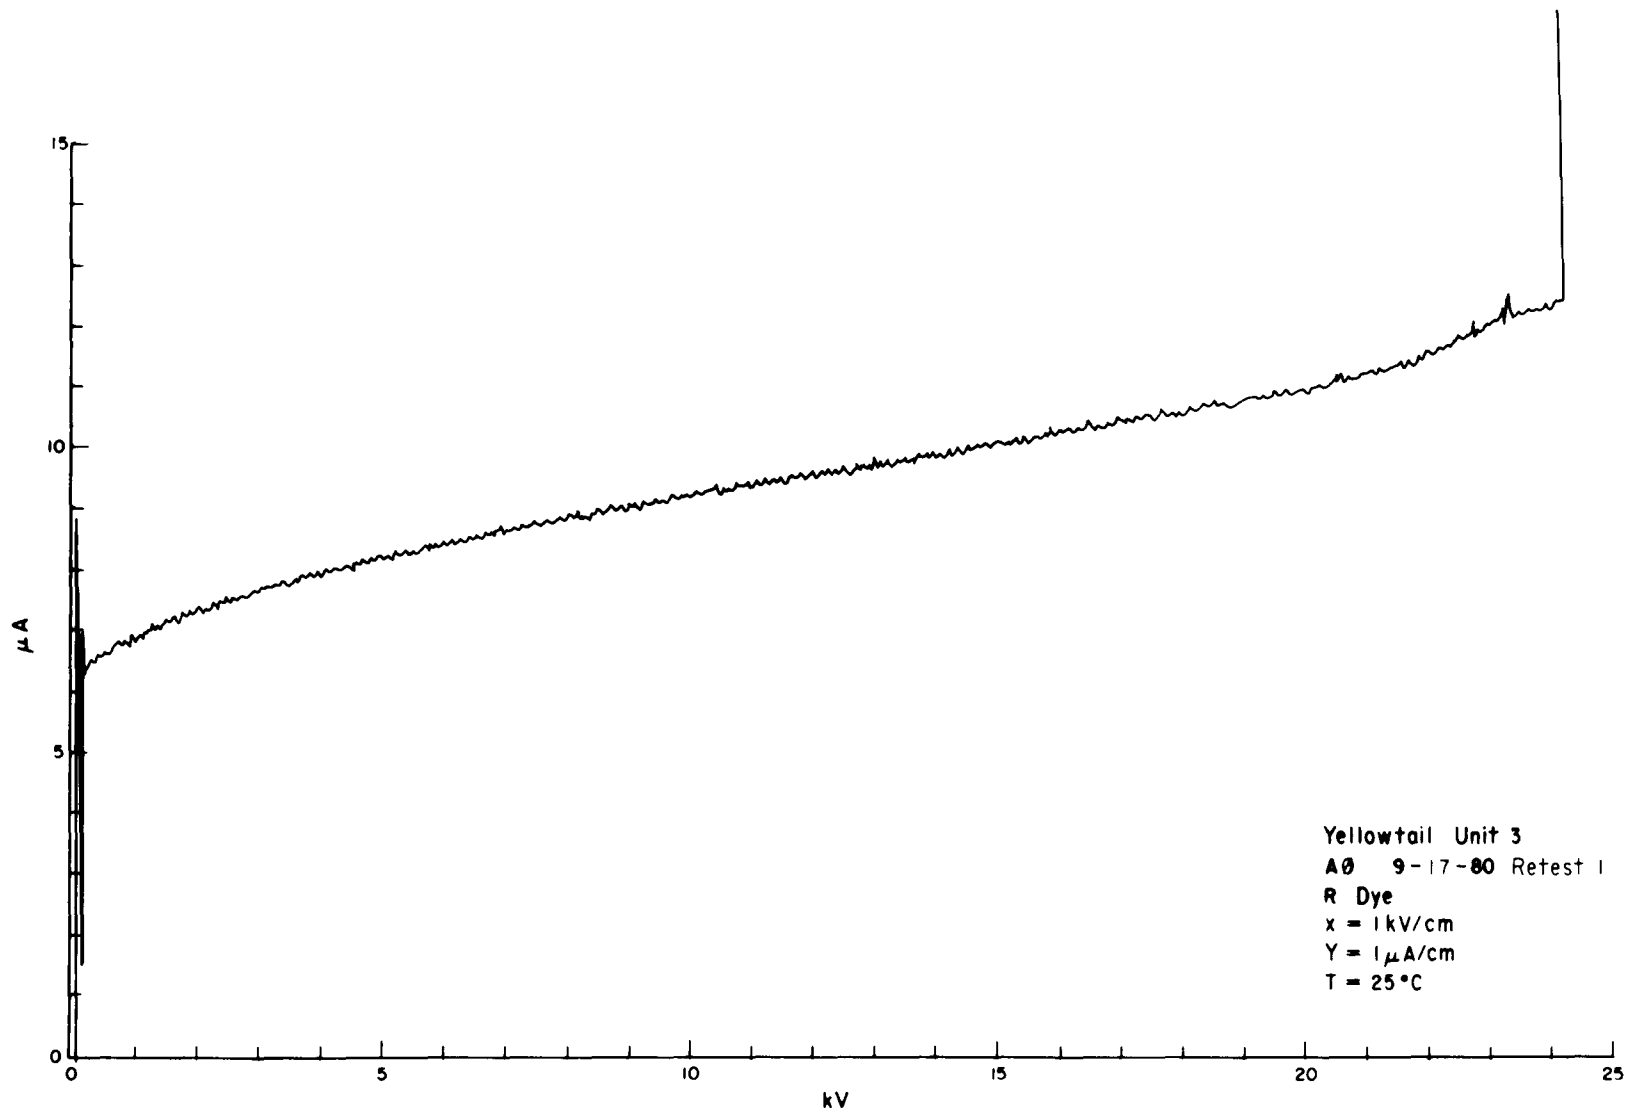
Figure 4.—Ramped d-c absorption test V-I curve, A phase, retest (flashover).

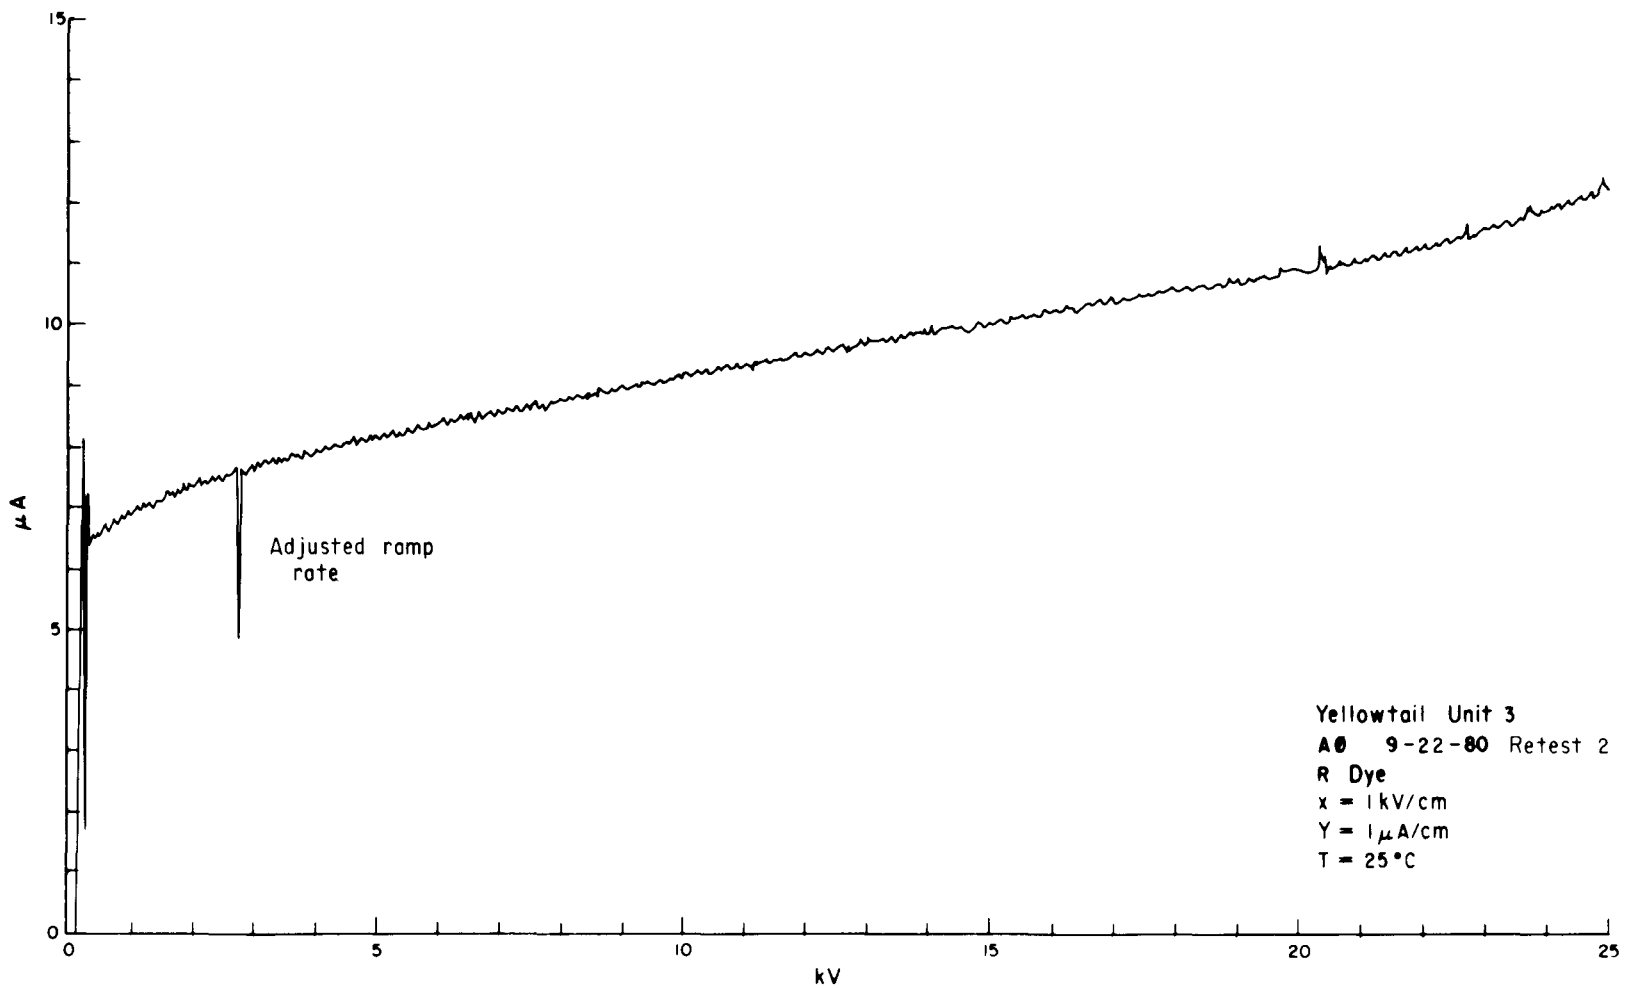
Figure 5.—Ramped d-c absorption test V-I curve, A phase (retest 2).

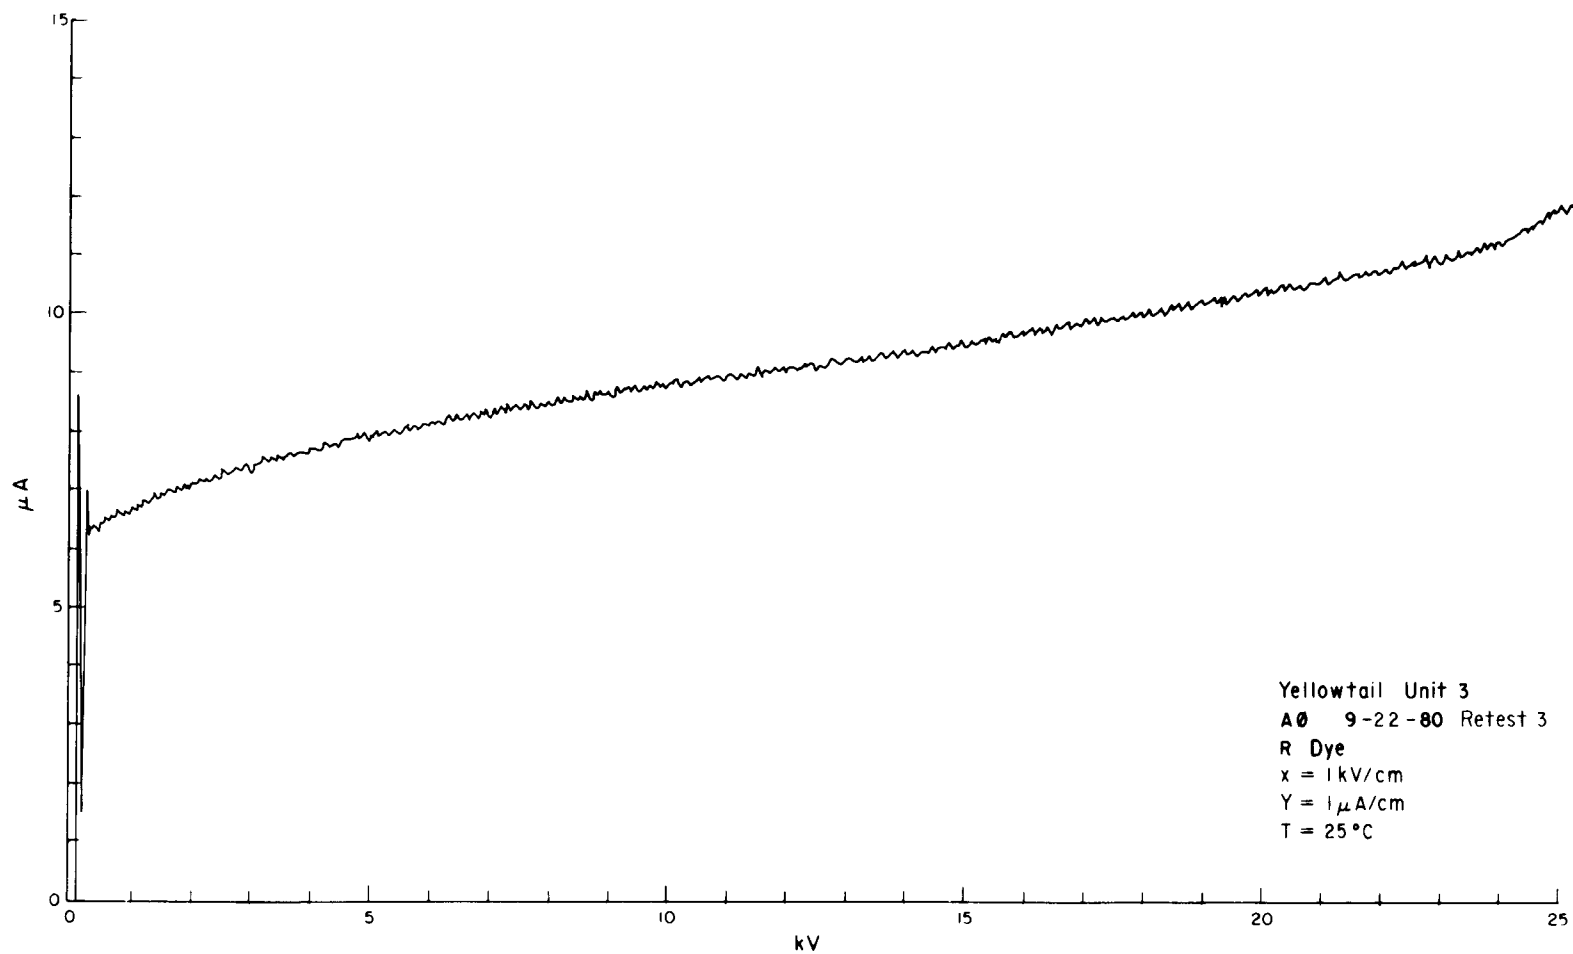
We now conclude that the arc-overs that occurred during testing on September 17, 1980, may have overstressed the already weakened groundwall insulation on the coil that eventually failed. This is further reinforced by the fact that the ramp test run after the faulted half-coil was replaced (fig. 12) did not have the tip-up that was present on the last ramp test run on September 22, 1980 (fig. 11).

Figure 6.—Ramped d-c absorption test V-I curve, A phase (retest 3).

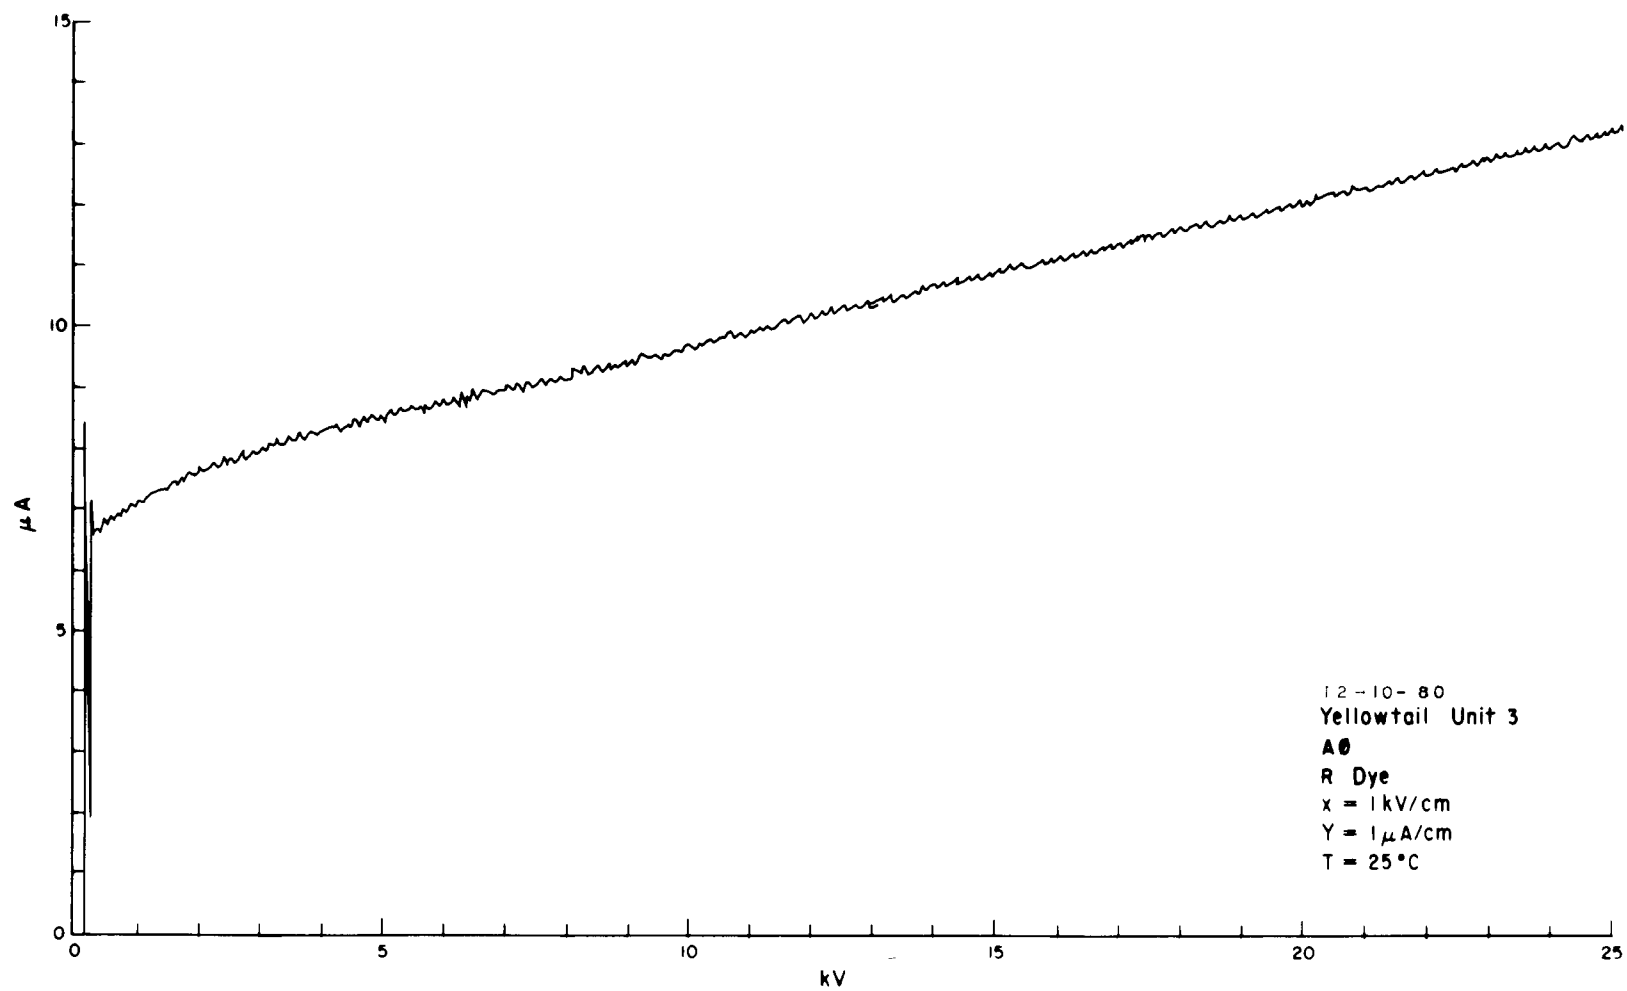
Figure 7.—Ramped d-c absorption test V-I curve, A phase after repairs.

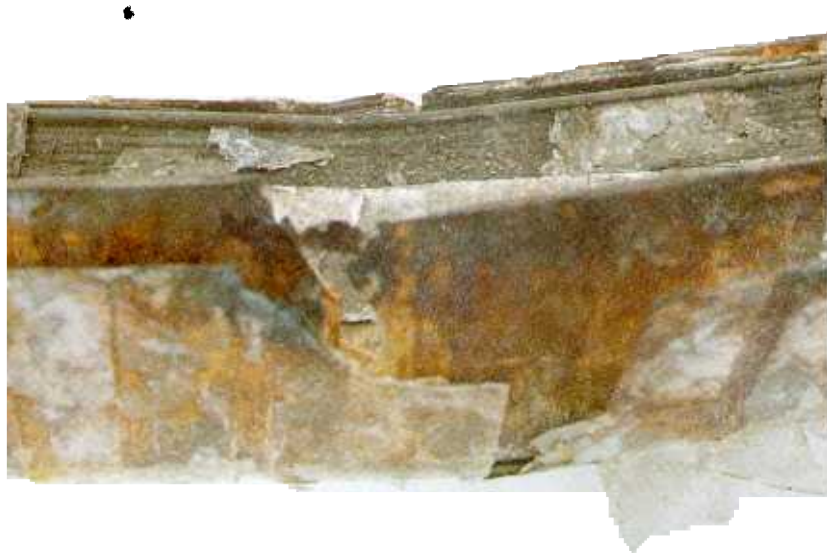
The following conditions were found during removal of the groundwall and turn insulation (figs. 1 and 2):

Figure 9.—Closeup view of dissected coil prior to removal of all groundwall and turn insulation P801-D-79796.

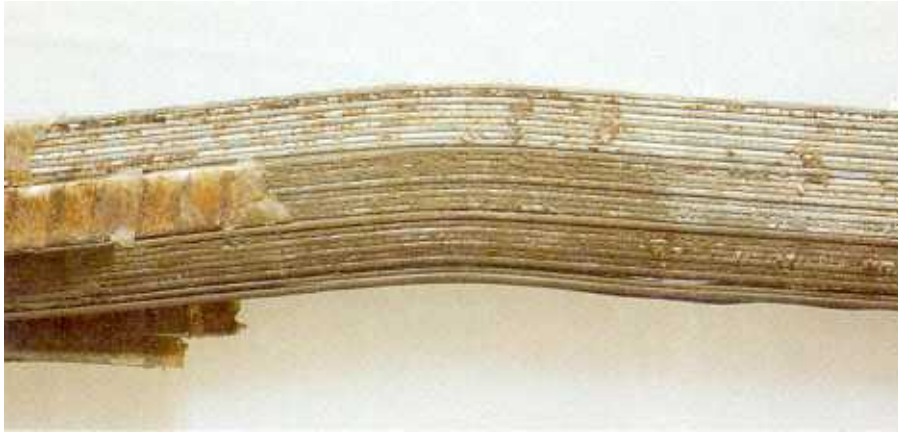
2. The final two strands of the boreside turn were distorted and misplaced about 3 mm (1/8 in). The distorted strands had formed an angle at their interface which had created a sharp knife-like edge. The outer edge had worn through the turn insulation and four to five layers of the groundwall insulation. In the area of the fault, there was evidence of extensive corona activity under the groundwall and throughout the badly deteriorated turn insulation. None of the binder was intact, and only brown dust was found. Through the first two turns, the strand insulation had completely decomposed into dust (fig. 5). In the third turn, the strand insulation was intact but no binder could be found.

Figure 11.—Groundwall and turn insulation removed from coil. P801-D-79798.

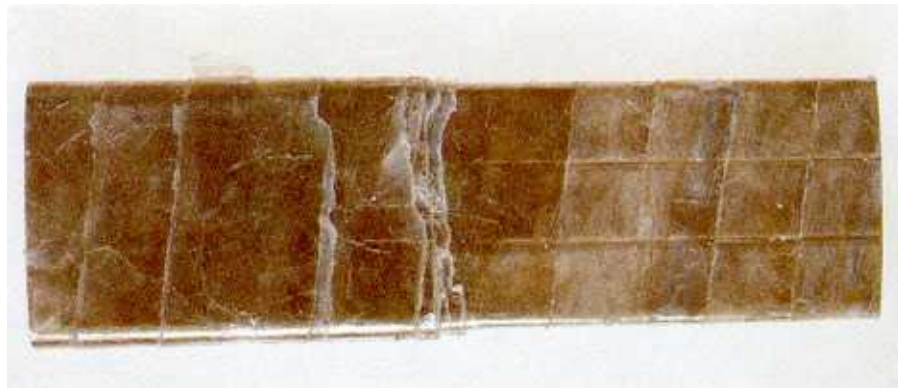
1. The binder used to hold the mica together was dry and dark yellow to brown in color (fig. 3). It had apparently deteriorated, because the layers of mica were peeled apart very easily, as compared to the force required to peel the

comparative sections of a portion of the spare coil (fig. 4).

Figure 12.—Portion of unused spare coil showing normal color of binder. P801-D-79799.
