# **ALKALI-SILICA REACTIVITY IN FIVE DAMS IN SOUTHWESTERN UNITED STATES**

**July 1985**

**S. Department of the Interior  
Bureau of Reclamation**

1. REPORT NO. <b>REC-ERC-85-10</b>		3. RECIPIENT'S CATALOG NO.	
4. TITLE AND SUBTITLE <b>Alkali-Silica Reactivity in Five Dams in Southwestern United States</b>		5. REPORT DATE <b>July 1985</b>

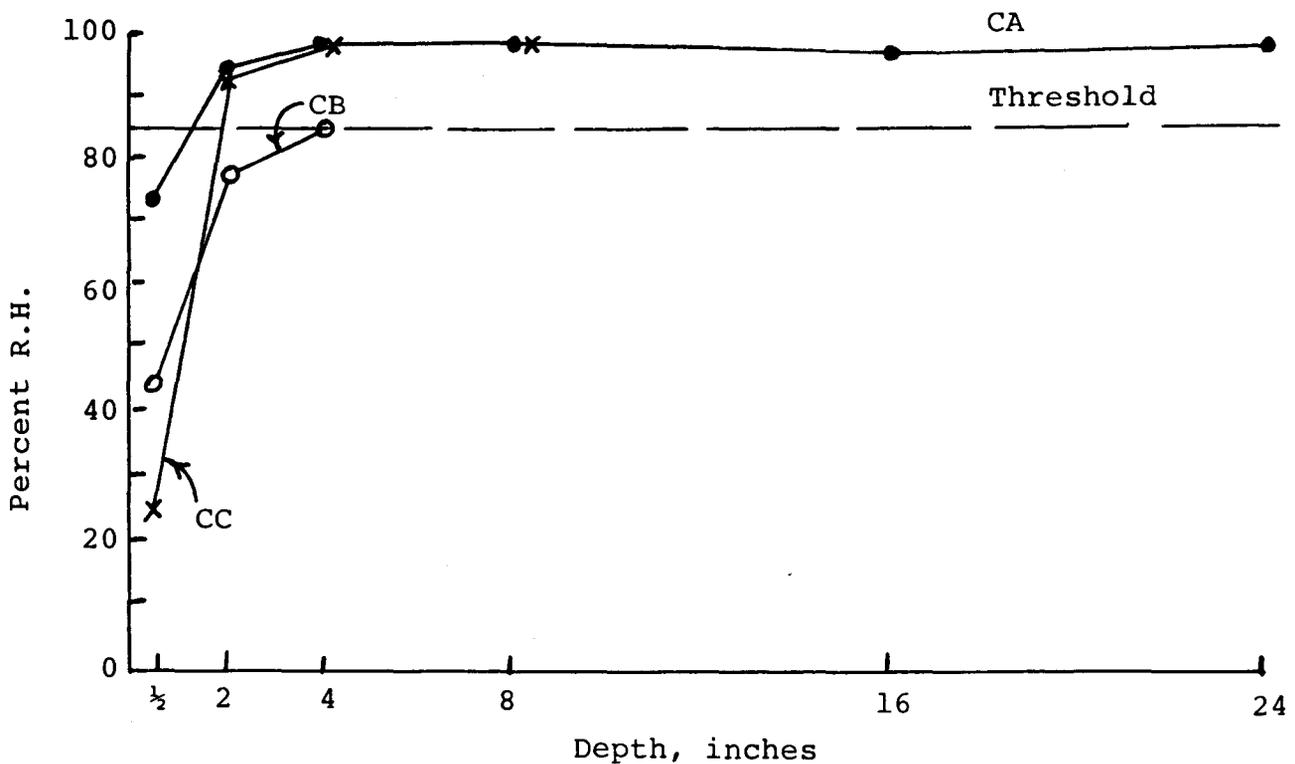
FIG. A1 - RELATIVE HUMIDITY DATA FOR COOLIDGE DAM

**Relative Humidity.** – Measurements shown on figures A1 and A2 indicate that atmospheric drying has reduced RH values to below the threshold level for expansive reactivity only within several inches of exposed concrete surfaces. At the five locations sampled, RH values ranged from 25 to 75 percent at the ½ to 1-inch-depth; this is below the 85 percent threshold value. At three of the five sample locations (CA, CC, and CD), RH values exceeded the threshold level at the 2- to 2½-inch-depth, and remained at 98 to 99 percent at greater depth. At location CE, the threshold level was reached at about the 16- to 16½-

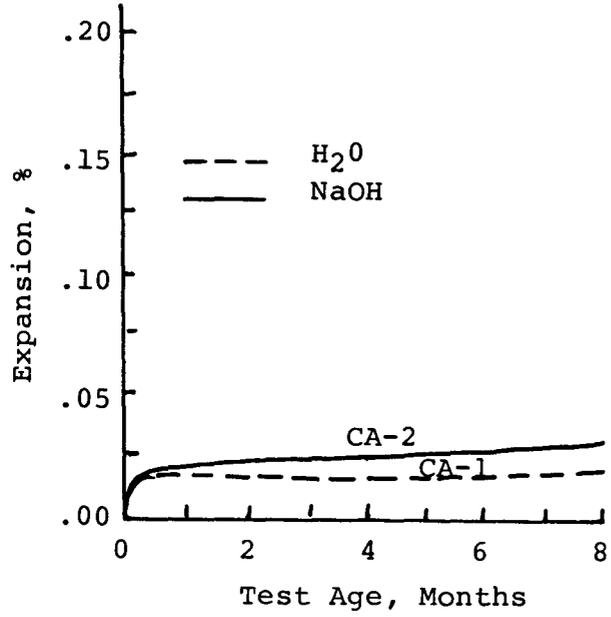
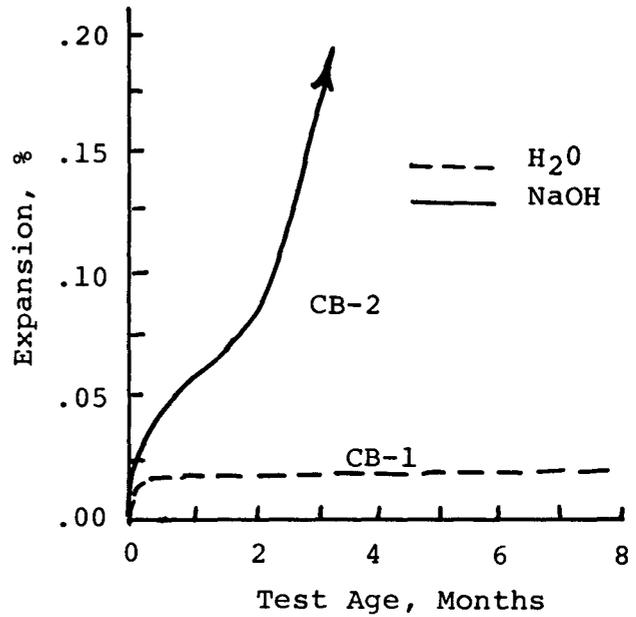
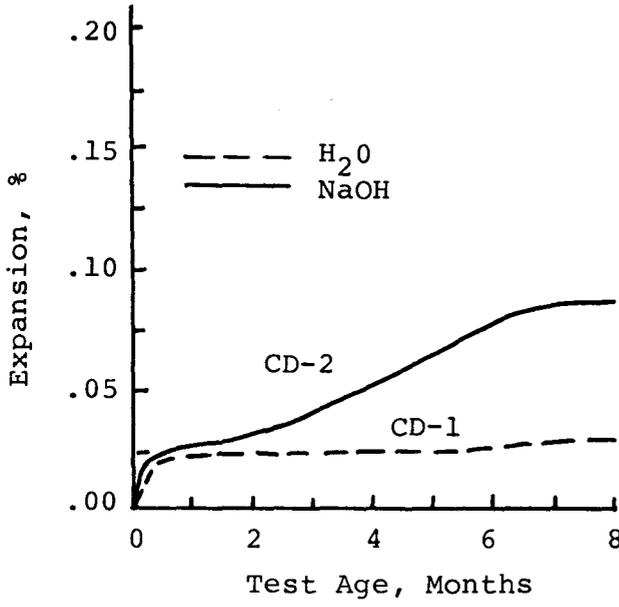
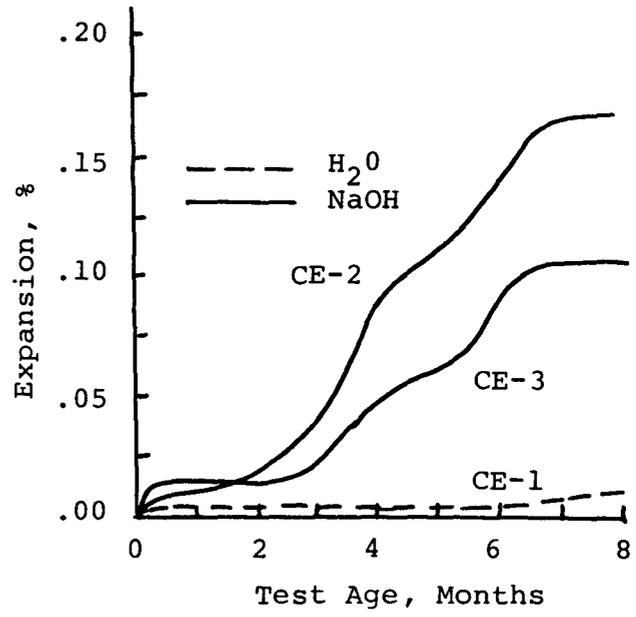
FIG. A5 - LENGTH CHANGES OF COOLIDGE DAM CORES IMMERSSED IN WATER OR 1N NaOH SOLUTION AT 100°F

At location CB, where high-alkali cement was also reportedly used, there was no potential for further expansion without additional alkali. This is reflected in the contrast between the 0.380 percent expansion reached by the core immersed in 1N NaOH solution, and the 0.022 percent expansion reached by the core immersed in water. These results imply that unreacted but potentially reactive aggregate exists in the concrete, but that reactivity causing excessive expansion and cracking has been arrested by reduction of the available alkali in the concrete.

Results for concrete from locations CD and CE, presumably where low-alkali cement was used, revealed significant potential for excessive expansion from alkali-silica reactivity. This is indicated by the relatively large expansions of cores immersed in alkali compared with the expansions of cores immersed in water. Because the petrographic examination failed to disclose evidence of significant reactivity, it was

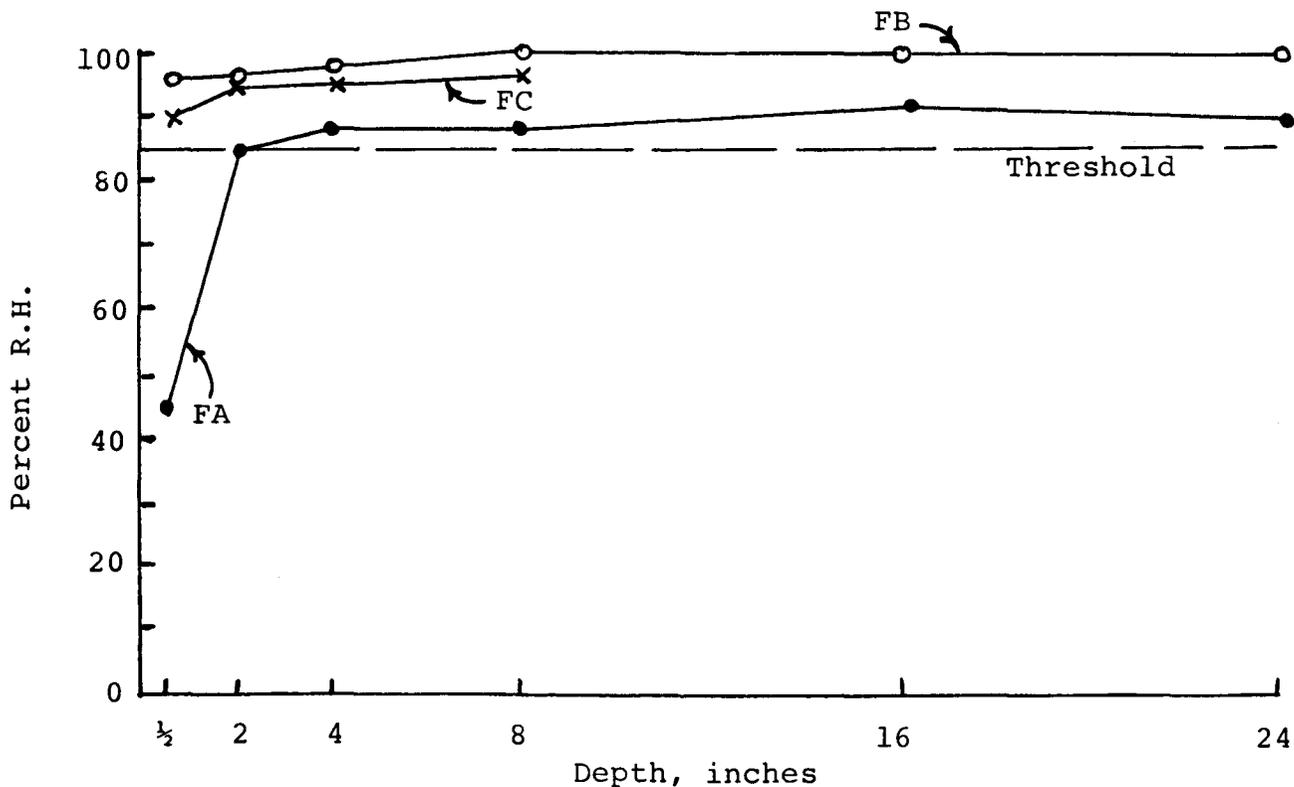
FIG. B1 - RELATIVE HUMIDITY DATA FOR FRIANT DAM

**Relative Humidity.** – The results of RH measurements shown on figures B1 and B2 indicate that atmospheric drying has had only superficial effect in reducing the RH of concrete at the sample locations. At the ½- to 1-inch depth, RH values ranged from 45 to 96 percent, but at the 2- to 2½-inch depth at each location, values reached or exceeded the 85 percent threshold level, and remained well above that level at depths up to at least 24 inches. At four of the five locations sampled, RH values were consistently close to 100 percent. From this it was concluded that similarly high RH levels persist at greater depths from exposed surfaces. It should be noted that measurable rain had fallen two days before sampling, which may have partially accounted for high RH values at the ½- to 1-inch depth at some locations. However, the rainfall is not believed to have influenced measured RH values at depths greater than 4 to 4½ inches.

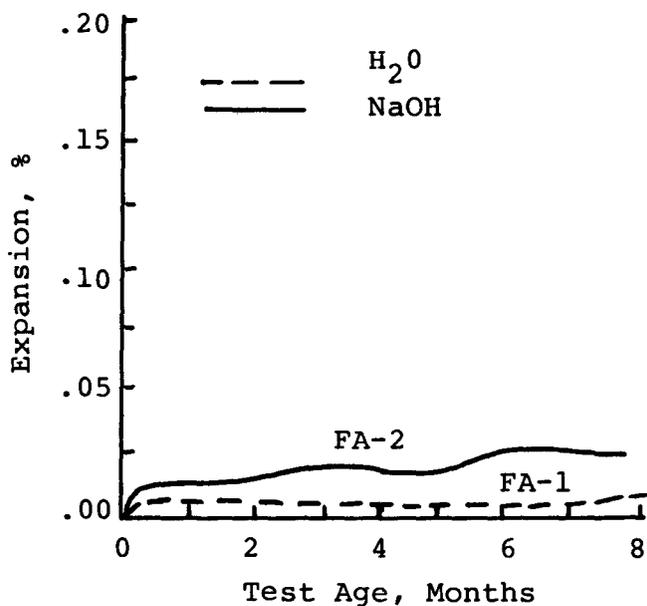
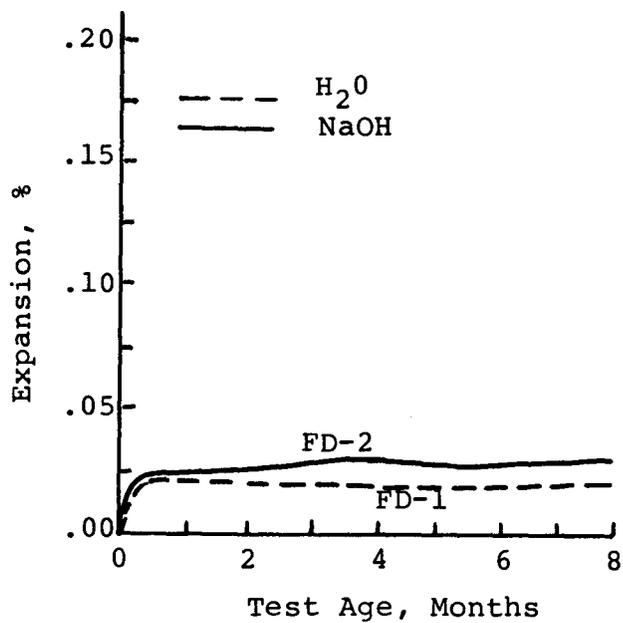
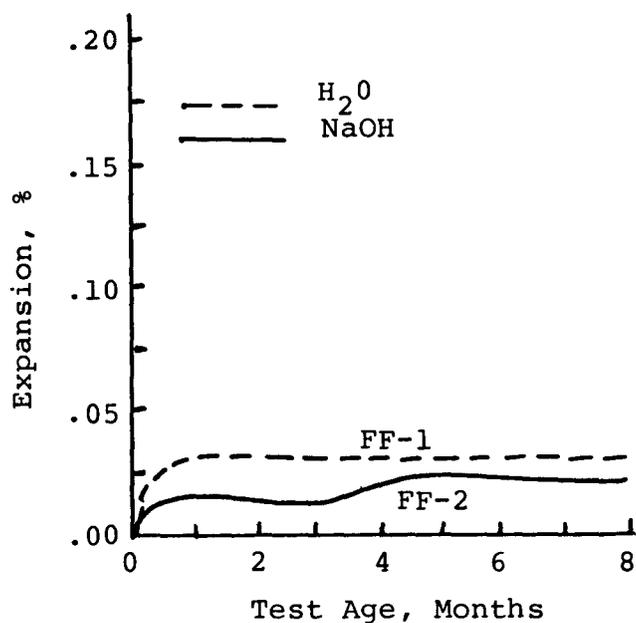
FIG. B5 - LENGTH CHANGES OF FRIANT DAM CORES IMMERSSED IN WATER OR IN NaOH SOLUTION AT 100°F

Cores taken at location FF in the roadway at the top of the dam showed somewhat different results. Core FF-1, immersed in water, expanded 0.043 percent; whereas, core FF-2, immersed in 1N NaOH solution, expanded 0.021 percent. This suggests rehydration of existing gel in core FF-1, and no potential for further expansive reactivity in core FF-2. Map-cracking was observed at this location in the roadway, and minor evidence of reactivity was noted in the petrographic examination of a core from this location. Results suggest that, although previous reactivity had developed, there is little or no potential for expansive alkali-silica reactivity.

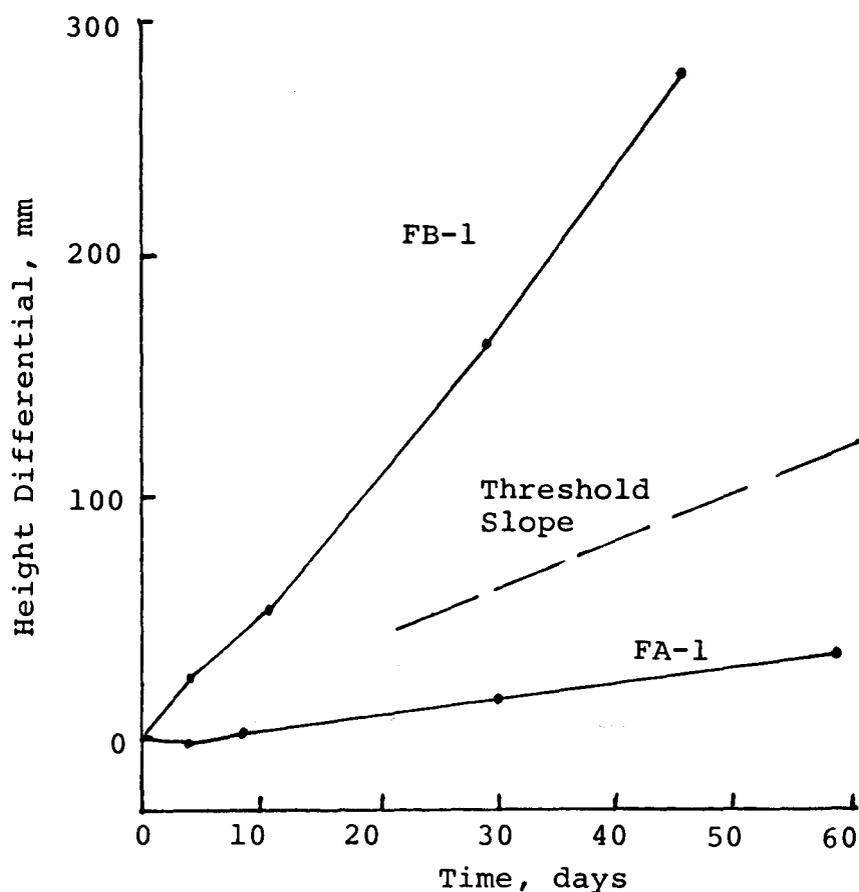
FIG. B6 - RESULTS OF OSMOTIC CELL TESTS FOR AGGREGATE FROM FRIANT DAM

**Osmotic Cell Tests.** – Two andesite coarse aggregate particles were tested in the osmotic cell. The results are given on figure B6. Andesite particle FA-1, taken from concrete in the face of the dam, was found to be nonreactive. This particle showed no evidence of previous reactivity in the concrete, and the petrographic examination did not reveal evidence of previous reactivity in the concrete core. But, andesite particle FB-1, taken from concrete in the stairway that displayed severe map-cracking, was found to be potentially reactive. It displayed evidence of previous reactivity in the concrete core.

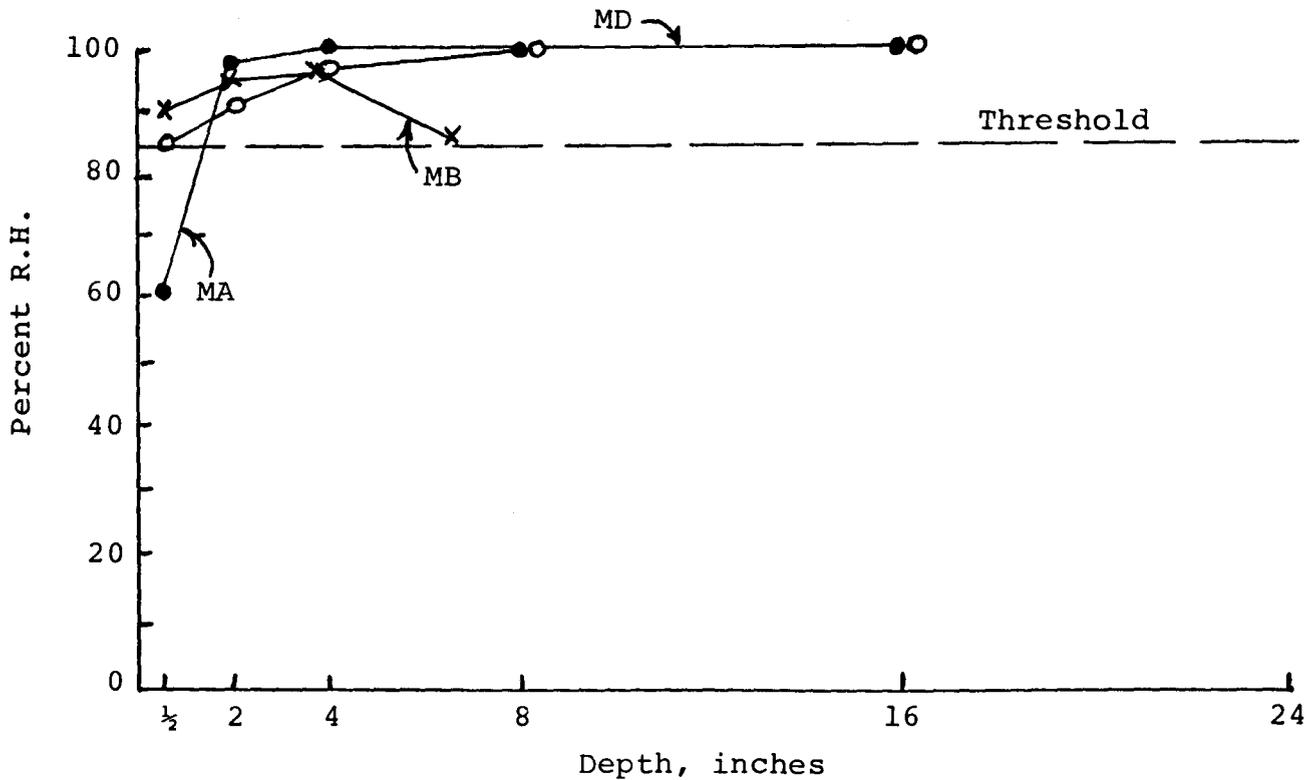
FIG. C1 - RELATIVE HUMIDITY DATA FOR MATILIJA DAM

**Relative Humidity.** – Results of RH measurements shown on figures C1 and C2 suggest that most concrete in the dam contains enough moisture to permit expansion from alkali-silica reactivity. The data show that atmospheric drying has had little or no effect on reducing relative humidities, even at depths as little as ½ to 1 inch from exposed surfaces. At four of the five locations sampled, RH values exceeded the 85 percent threshold level at this shallow depth. Only at location MA, which was in a massive retaining wall, was the RH less than 85 percent at the ½- to 1-inch depth.

The minimal effects of long-term atmospheric drying at the Matilija Dam site are readily seen in RH measurements at location MB, which was in an 8-inch-thick concrete railing. The concrete, which was exposed to the atmosphere on both vertical surfaces, displayed evidence of reactivity. At the ½- to 1-inch depth from each exposed surface, RH values were 86 percent and 90 percent. At the 2- to 2½-inch and the 4- to 4½-inch depths, RH values were 95 percent. Thus, it is understandable that the higher RH values were found near the surface in the more massive units of the dam structure.

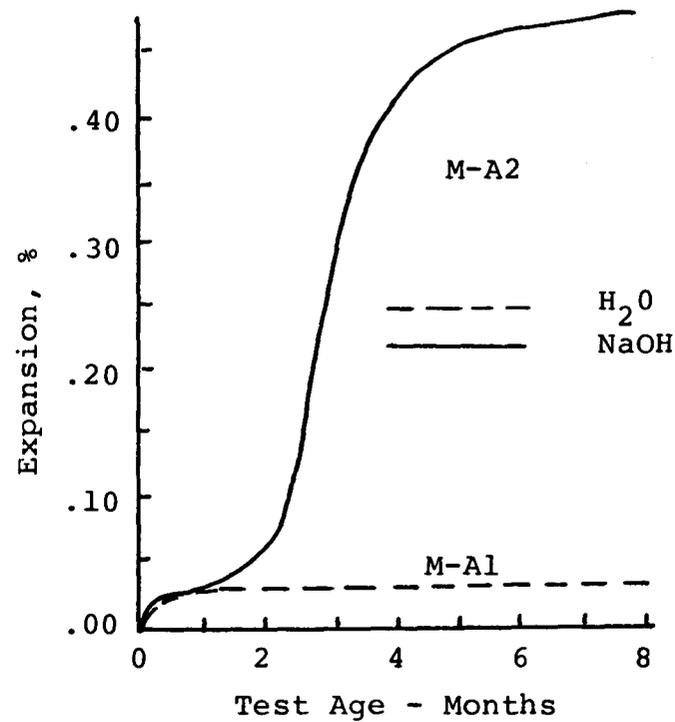
FIG. C4 - LENGTH CHANGE OF MATILIJA DAM CORES IMMERSSED IN WATER OR IN NaOH SOLUTION AT 100°F

Results shown on figure C4 indicate that potential exists for further reactivity and expansion only when additional alkali is present. This is shown by the 0.479 percent expansion for core M-A2. Core M-A1, which was immersed in water, showed only 0.030 percent expansion. This is in the range expected for dried concrete that has simply been rewet. These results suggest that a deficiency in available alkali, which had the effect of arresting expansive alkali-silica reactivity, developed in this concrete.

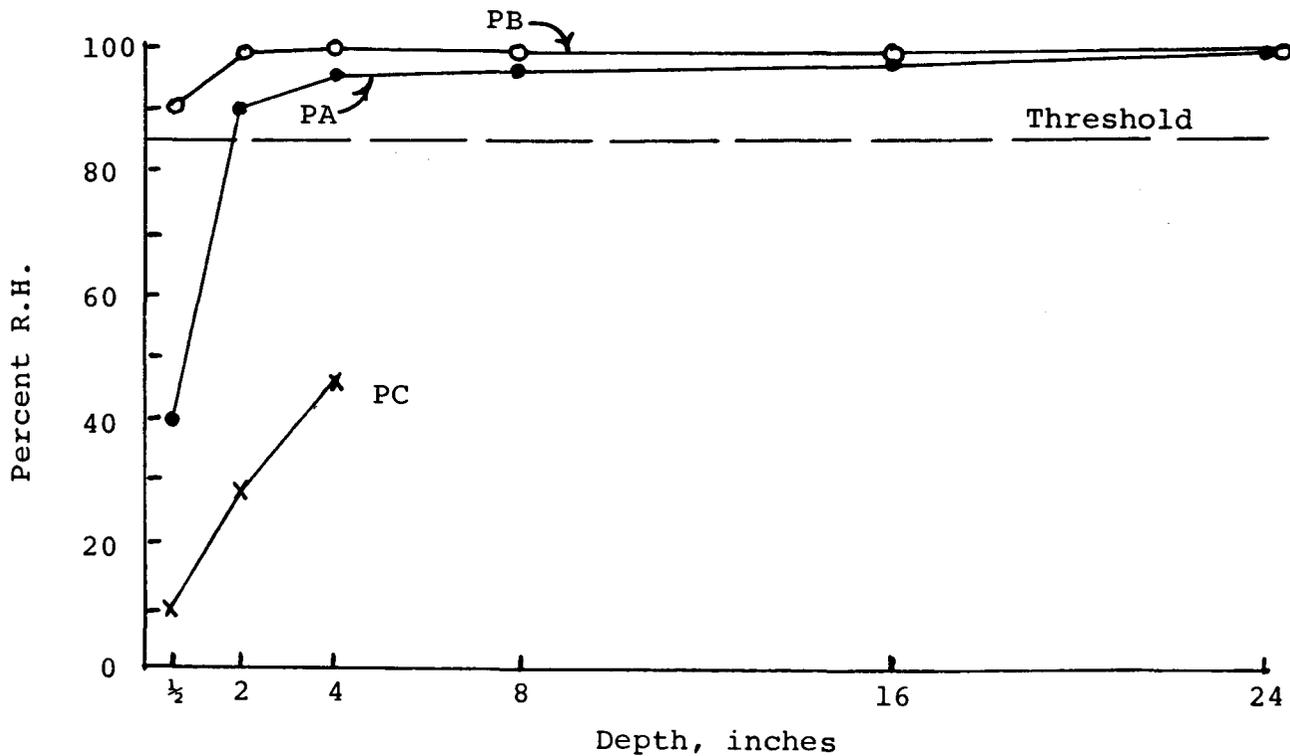
FIG. D1 - RELATIVE HUMIDITY DATA FOR PARKER DAM

**Relative Humidity.** – Results of measurements shown on figures D1 and D2, suggest that RH values are above the 85 percent threshold level for expansive reactivity in most concrete in the dam structure. Only at near-surface depths (generally less than about 2 inches) was concrete sufficiently dry to preclude expansion from reactivity. Similarly high RH levels were found in the 5-foot by 5-foot concrete block at the east end of the wall along the walkway on the dam. Thus, even in certain relatively small concrete members exposed to the atmosphere, RH values were sufficiently high to permit expansion to develop from alkali-silica reactivity.

Two of the five sample locations showed relatively low RH values at depths greater than 4 to 4½ inches. One was above the walkway on the dam in the east column of the west spillway. Here RH values ranged from 10 percent at the ½- to 1-inch depth to 47 percent at the 4- to 4½-inch depth. Reinforcing steel was encountered at the 6-inch depth; thus, no greater depths could be sampled. In this concrete, expansion from reactivity would not develop. However, cracking could develop if the concrete at greater depths contains enough moisture and expansive alkali-silica reactivity occurs.

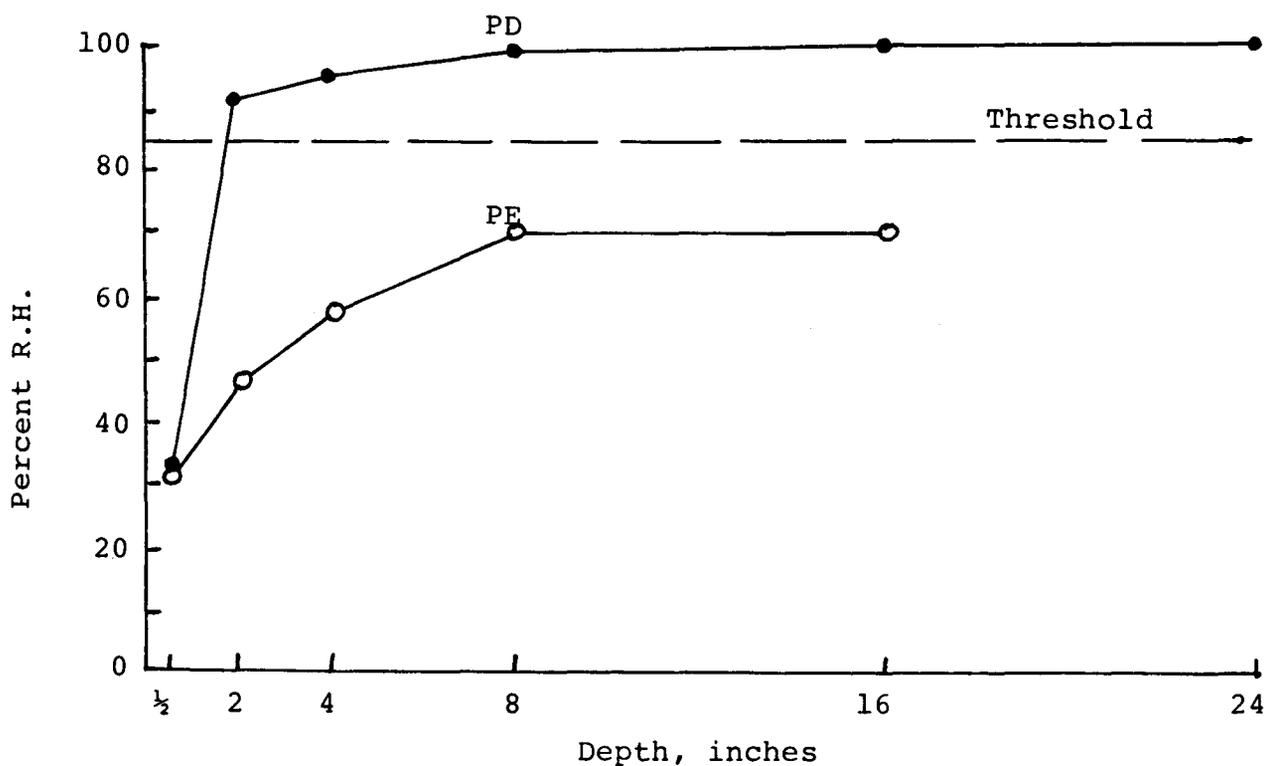
FIG. D2 - RELATIVE HUMIDITY DATA FOR PARKER DAM

The other location where comparatively low RH values were found was in the 24-inch-thick north wall of the powerhouse. This wall displayed faint map-cracking, which might represent only shrinkage. However, the border of each crack segment was discolored to dark gray by a colorless transparent deposit in the concrete, which was believed to be alkali-silica gel. The RH value at the ½- to 1-inch depth from the exterior surface was 32 percent, but it increased progressively with depth to 70 percent. This 70 percent RH value was found across the middle third of the wall. It may represent the highest RH level at this location because the room on the interior side of the wall is air-conditioned under intermediate to low (50 percent) relative humidity. Thus, it is believed that alkali-silica reactivity had developed earlier in the wall concrete, causing the observed map-cracking. Gradually, the RH decreased to below the 85 percent threshold level, arresting further expansive reactivity. Accordingly, expansion from reactivity in this wall is not expected to develop in the future.
