**GR-88-3**

# **BUREAU CASE HISTORY OF LOESS CUT SLOPES IN NEBRASKA**

**September 1988**

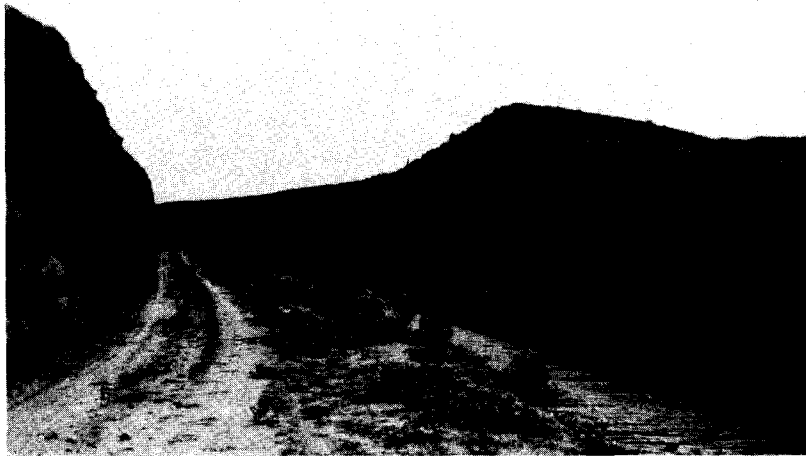
Figure 4 is a current photograph of the Driftwood Canal, located in southwestern Nebraska, as it exists approximately 30 years after construction. Figure 5 is a photograph of Sherman Feeder Canal, located in south-central Nebraska, approximately 25 years after construction. The 1/2:1 cut slope promotes increased vegetation growth, less erosion, and a stable condition.

Figure 4. – Driftwood Canal about 30 years after construction. Note that the 1/4:1 slope is relatively stable with only minor sloughing and erosion. Also note the insignificant amount of vegetation growth on slope. P801-D-81420.

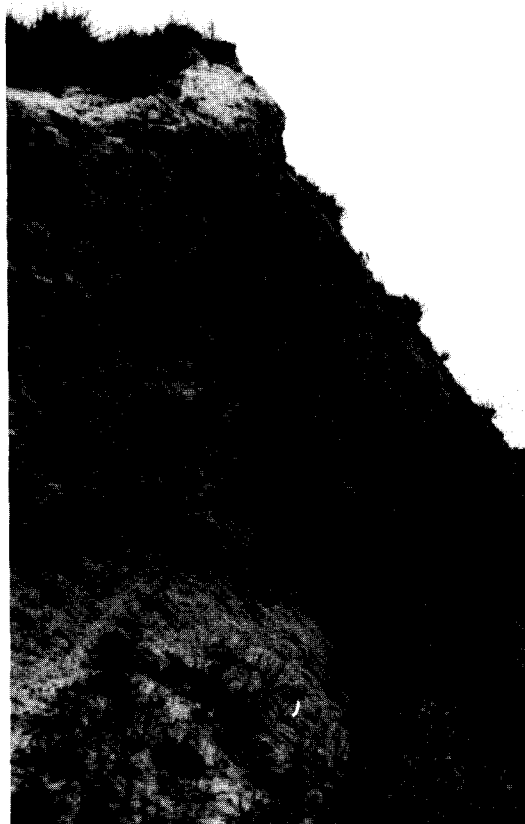
Figure 7. – Natural toe formed by fallen material from a cut slope. P801-D-81423.

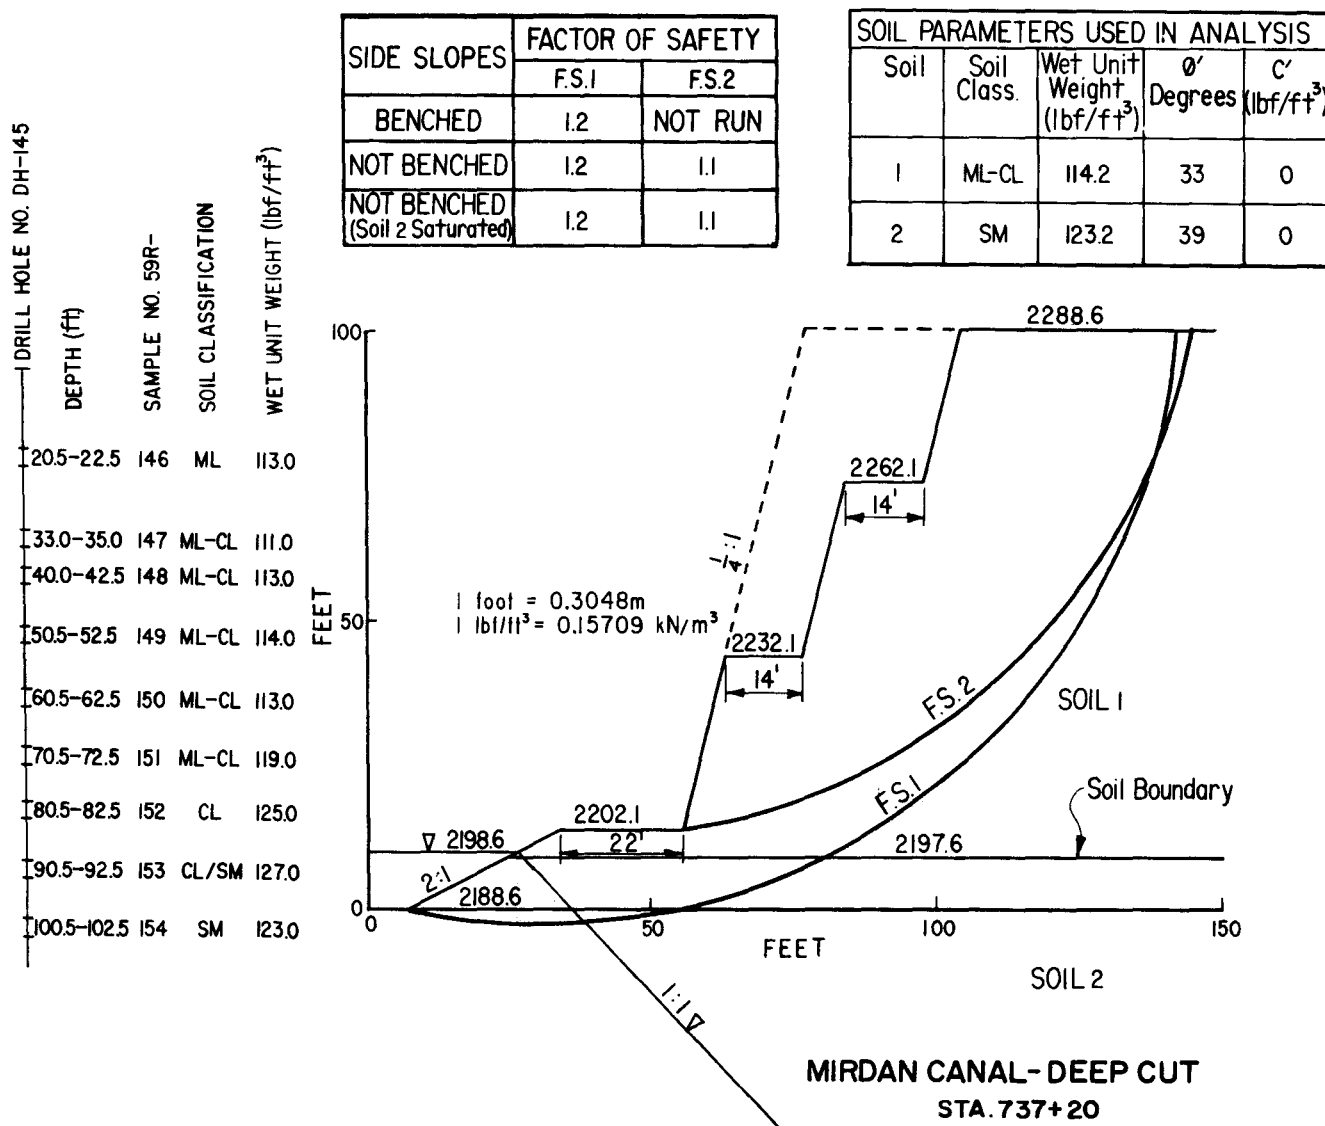
Results of the slope stability analyses for Sta. 737+20 indicated that removing the benches had no effect on the factor of safety against overall failure of the slope. Additional analyses showed that, if the lower sand layer became saturated, the factor of safety against massive overall failure of the slope would not be affected. Figure 10 shows results of the slope stability analyses for this station.

Figure 10. – Slope stability analysis for a 1/4:1 cut slope with a silty sand layer at toe of slope. From [5].

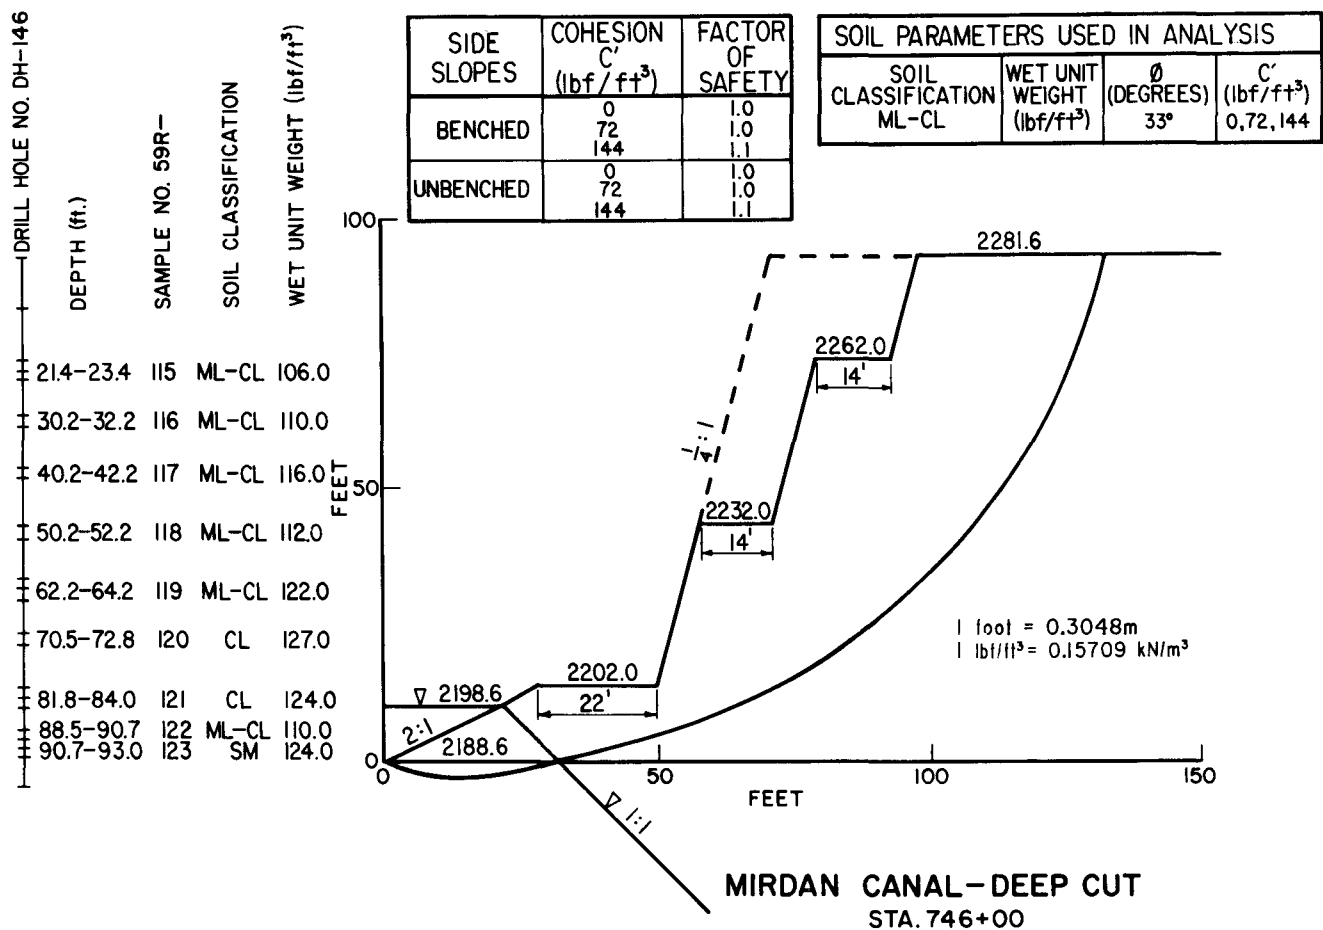
Results of the slope stability analyses for Sta. 746+00 also showed that removing the benches had no effect on the computed factor of safety. In addition, the cohesion varied from 0 to 144 lbf/ft<sup>2</sup> (0 to 6900 N/m<sup>2</sup>), which resulted in an increase of 0.1 in the factor of safety. Results of the slope stability analyses for this station are shown on figure 11.

Figure 11. - Slope stability analysis for a 1/4:1 cut slope constructed primarily in clayey silt. From [5].

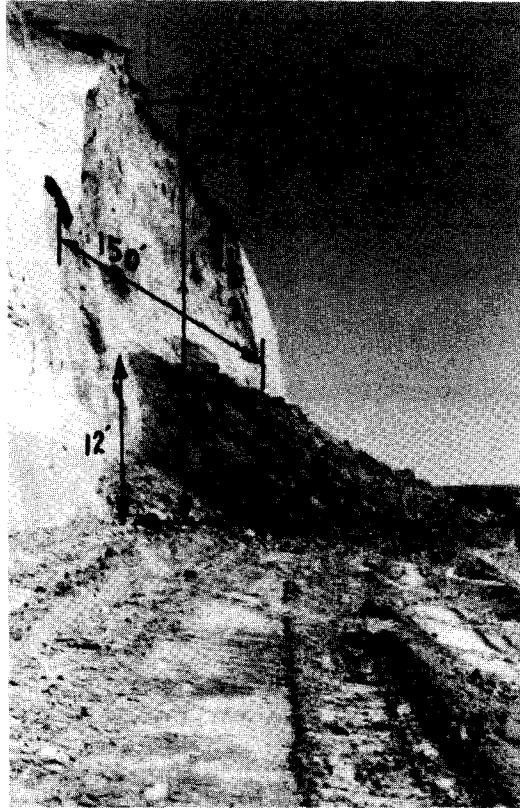
Canal excavation began during the 1982 construction season. During excavation of the first major cut at Sta. 746+00, a failure occurred at a depth of about 60 feet (18 m). This failure had a length of 100 feet (30.5 m), which increased to 150 feet (45.7 m) over a period of several days, see figure 12. The exposed failure plane (head scarp) was near vertical and somewhat irregular. Along failed areas of the slope, spalling occurred at depths of 30 to 35 feet (9.1 to

The head scarp exposed numerous vertical joints or cracks that were randomly oriented. The failure is considered to have been a form of slump and toppling [6]. There were existing or incipient vertical joints in the loess that formed vertical discontinuities having little or no strength. It is not known if the vertical joint at the failure surface existed prior to failure. When the vertical load of the wedge formed by the 1/4:1 excavated slope and the vertical joints exceeded the lateral strength of the wedge, failure or movement in a lateral or horizontal direction occurred. The block moved out laterally and then dropped down the steep face.

Figure 12. – First major cut failure on Mirdan Canal.  
Sta. 746+00. P801-D-81425.

The remedy was to modify the 1/4:1 slope using 20-foot (6-m) wide benches spaced at about 30-foot (9-m) vertical intervals for cut depths exceeding 35 feet (11 m). These guidelines were

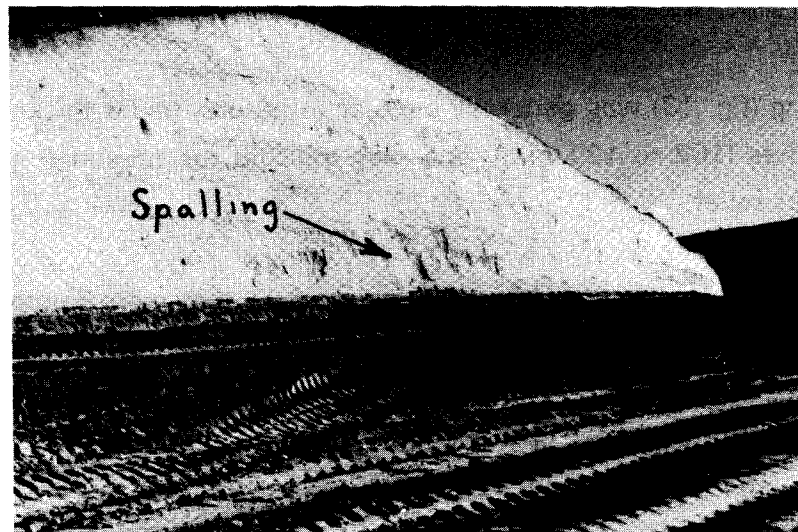
10.7 m). The spalling (fig. 13) was generally circular in nature, had a thickness normal to the slope of 4 to 5 inches (102 to 127 mm), and may indicate the presence of lateral forces or stresses due to stress relief.

Figure 13. – Spalling on cut slope of Mirdan Canal. P801-D-81426.

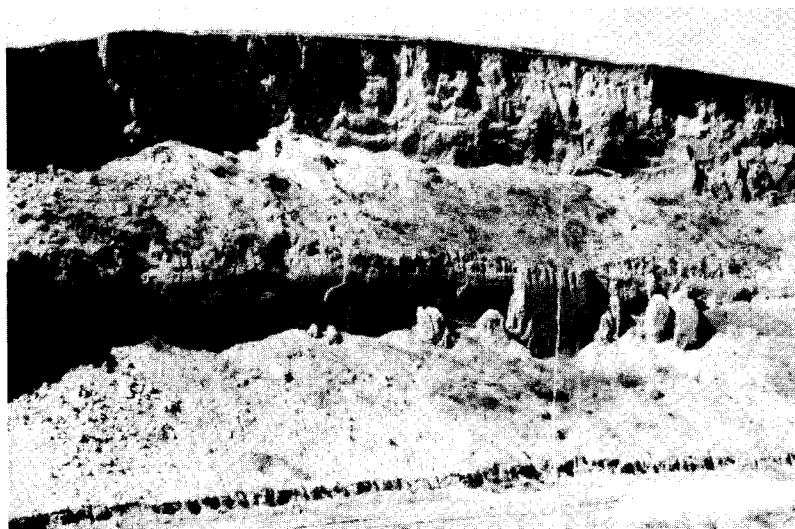
used for the remainder of the construction season. Freezing, thawing, and desiccation resulted in additional slabbing, as shown on figure 14. A decision was then made to further modify the slope configuration. All slopes were to be excavated at 1/2:1; however, benches at 30-foot (9-m) vertical spacing were retained. These revised slopes have performed noticeably better; minor failures that have occurred were generally associated with lithologic contacts or material changes.

Figure 14. – Mirdan Canal slope failure on benched 1/4:1 cut slopes.  
P801-D-81427.

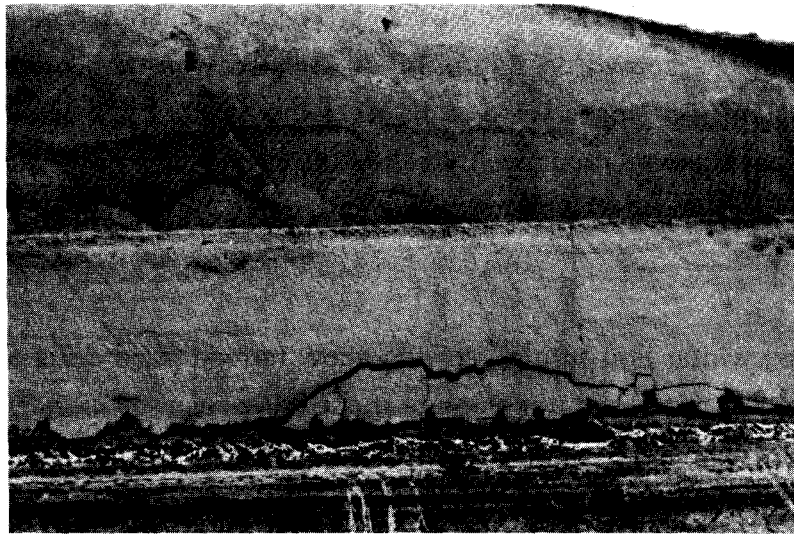
During the following winter and spring, blowing snow formed large drifts at the base of many of the 1/4:1 cut slopes. Subsequent melting of these drifts resulted in moisture contents close to saturation. This wet material in the 1/4:1 slopes failed in thin sheets in the lower 2 to 3 feet (0.6 to 0.9 m) of the slopes, resulting in an undercut condition. A photograph of this condition is shown on figure 15. These slope failures had thicknesses of 5 to 6 inches (127 to 152 mm) normal to the slope and initiated upward progressive failure to the top of the slope. Debris accumulated at the toe of the slope and adversely affected longitudinal drainage along the toe. Ponded drainage further saturated the slope and finally caused transverse drainage to break out over the bench or over the O&M road surface.

Figure 15. – Failure due to saturation along lower portion of 1/4:1 cut slope.  
P801-D-81428.

In later specifications, the Bureau has added a 5-foot (1.5-m) high, 1:1 slope at the toe of both 1/4:1 and 1/2:1 slopes. Loess is stable in a wet condition on a 1:1 slope, which eliminates undercutting and upward progressive failure of material. The 1:1 slope performed as expected and has now been included in the design of slopes above O&M roads. These 1:1 slopes provide additional benefits in that they help catch debris and assist in establishing vegetation and

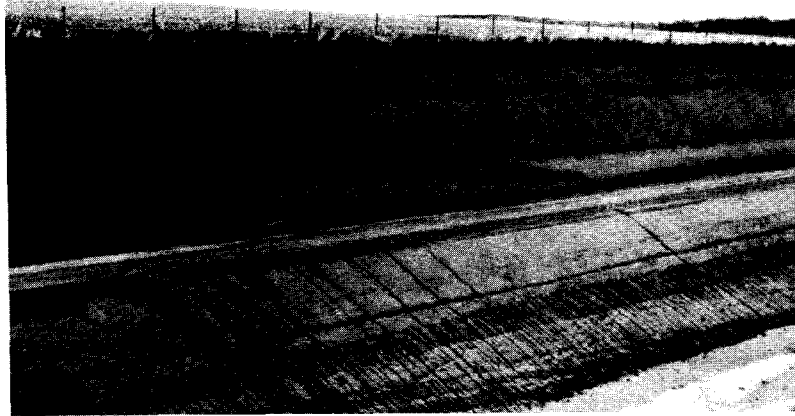
increasing stability. Figure 16 shows the stable condition of a 1/2:1 cut slope with a 5-foot high, 1:1 toe.

Figure 16. – Stable condition of a 1/2:1 cut slope with a 5-foot-high, 1:1 toe. P801-D-81429.
