# CONCRETE REPAIR MATERIALS— A PROGRESS REPORT

December 1985  
Engineering and Research Center

1. REPORT NO.  
GR-84-2

Fred E. Causey

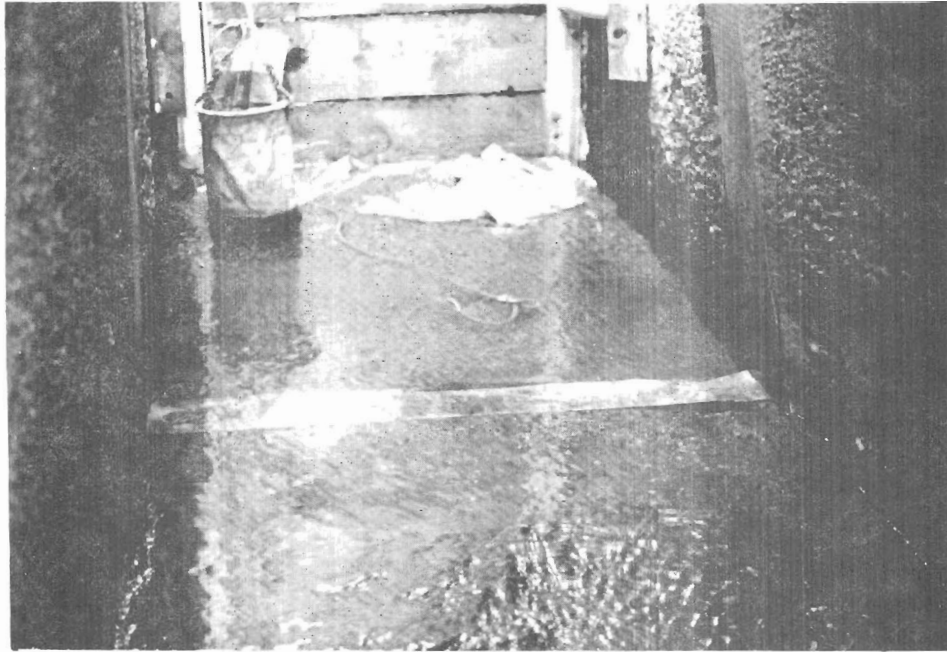
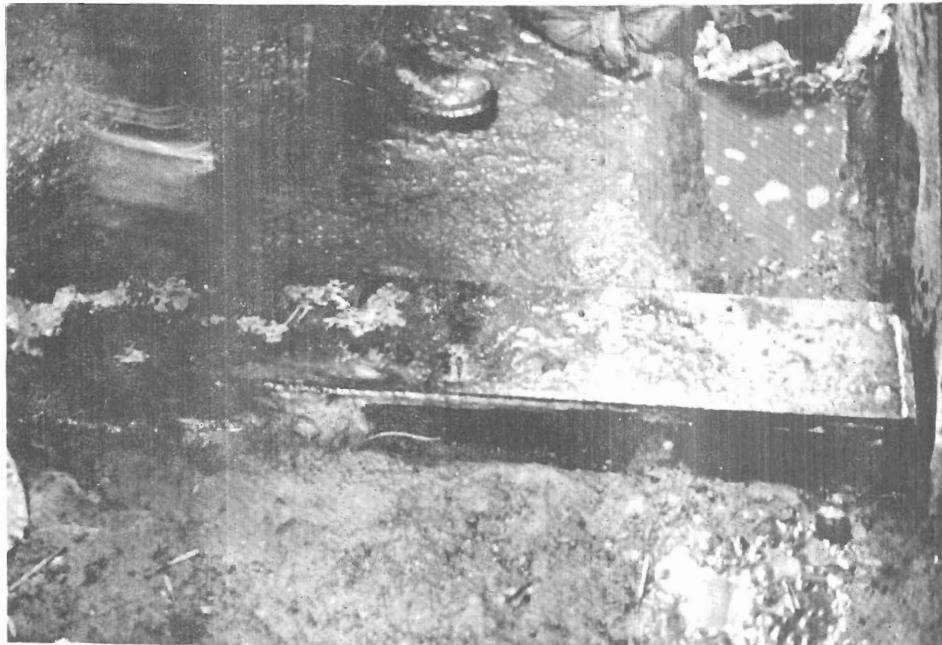
Loveland office O&M personnel and D. O. Arney, Co-principal Investigator for Concrete Repair research DR-380, inspected a deteriorated area of the Dille Diversion Dam, Colorado-Big Thompson Project, on November 14, 1980. Flood conditions had caused abrasion of the concrete under and along the radial gate sill and wall plates.

Condition of structure prior to repair.

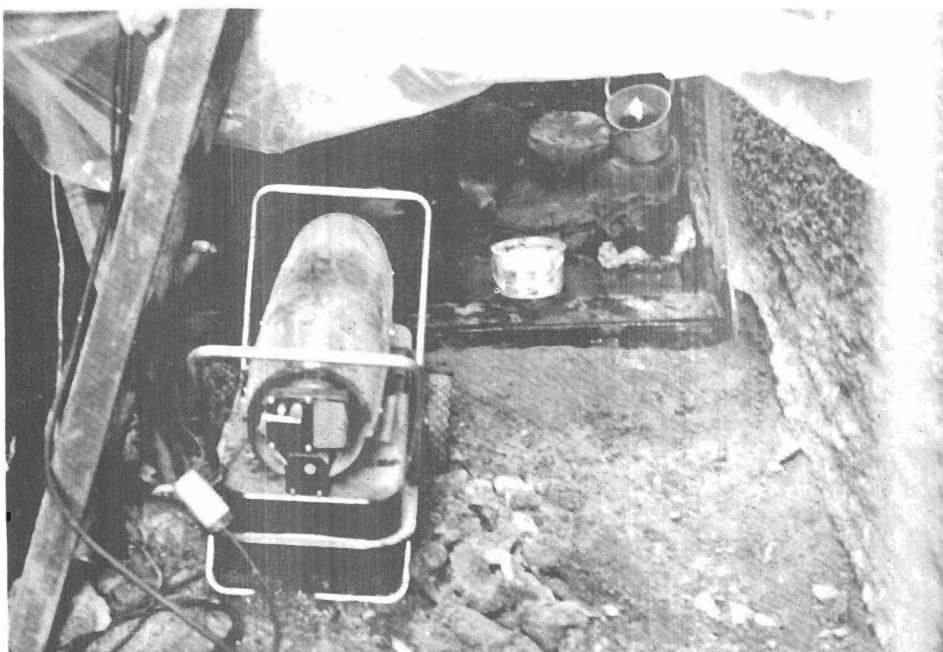
Forced air heater used for drying.

In preparation for repair, unsound concrete was chipped away with a pneumatic hammer, and the surface was dried with hot forced air. The recommended concrete primer, Concresive 2042, was then scrubbed into the substrate and underneath the sill plate where necessary. Conditions for placing this repair were not ideal. Ice had to be chipped from the floor before the repair could begin, and the pump removing water from the leaking, temporary bulkhead continuously failed to operate.

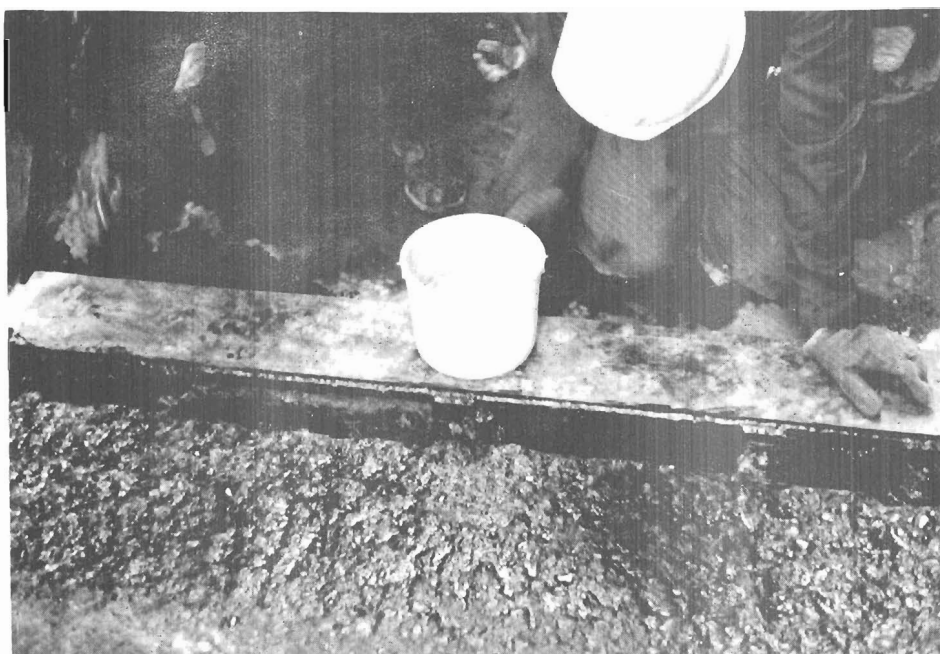
Bond coat being applied.

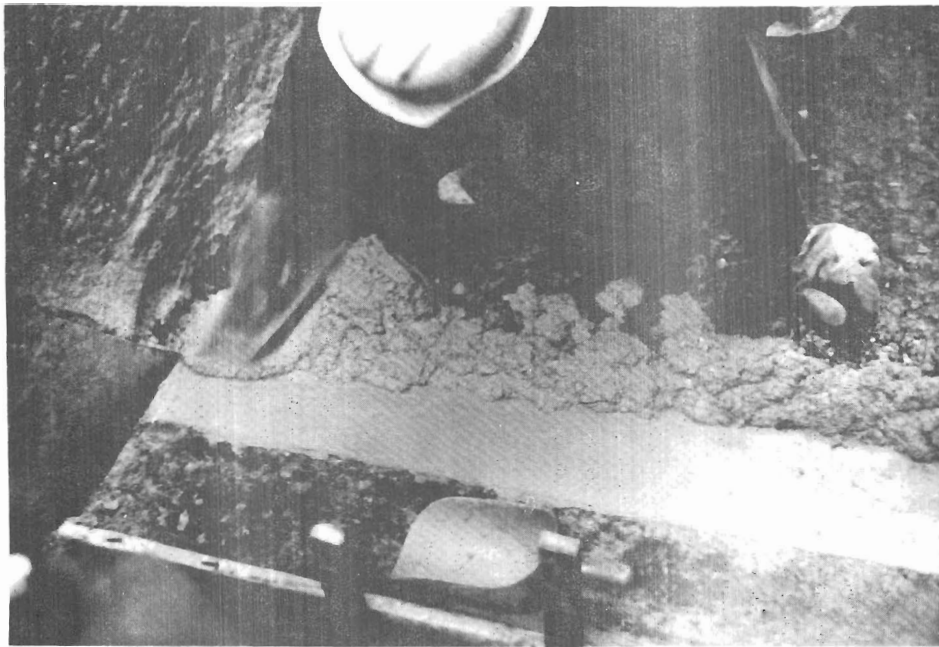
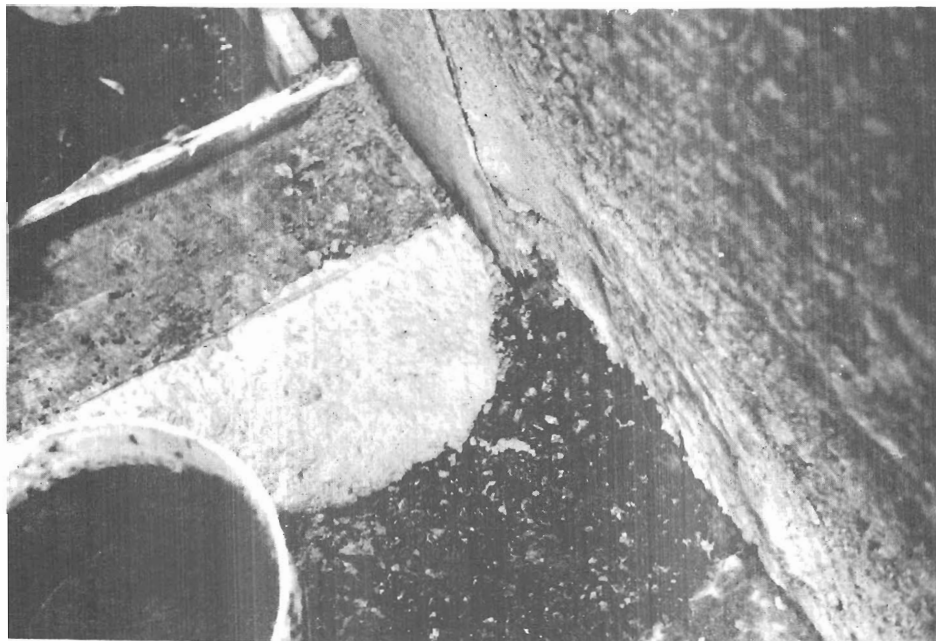
Polymer concrete mortar being applied  
downstream from sill plate.

1. The more shallow areas of repair, upstream and behind the base of the wall plates, were repaired with a Concsive mix extended with No. 8 sand.
2. The sill plate and deeper downstream repairs (4 to 6 inches), were made with a mix extended with graded aggregate as follows:

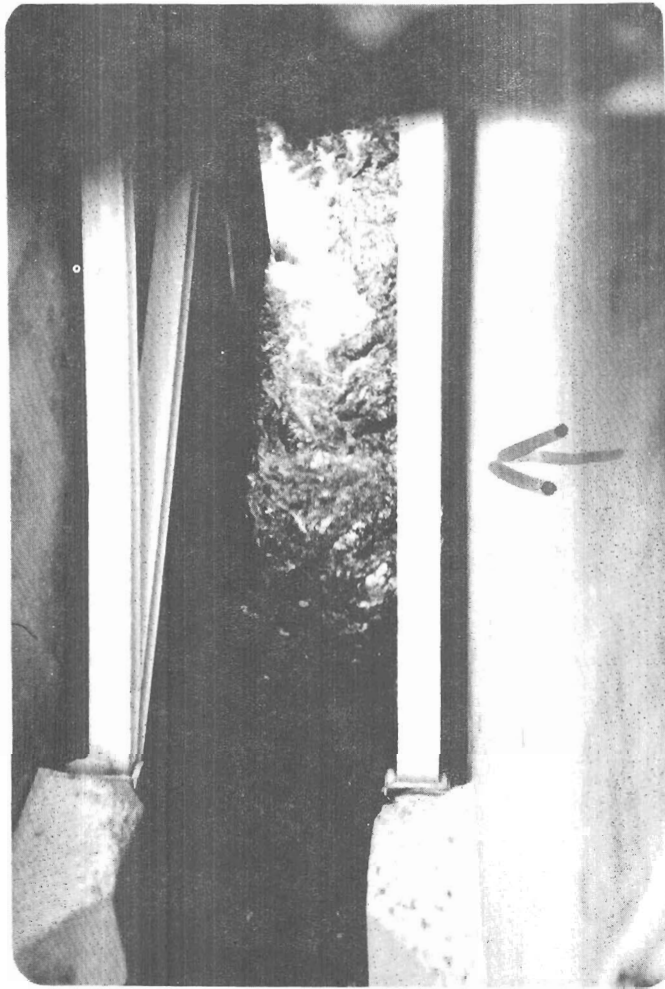
After the repair was finished, water seeped into a small area at one corner of the sill plate. The O&M foreman decided the following day to remove the small area that had gotten wet and to use conventional dry-pack concrete on that surface. The rest of the polymer concrete repair looked sound.

Area of repair after structure  
placed back in service January 2, 1981.
