CORONA RELATED INSULATION TESTING AND EVALUATION OF PALISADES GENERATOR NO. 2

February 1985
Engineering and Research Center

U. S. Department of the Interior
Bureau of Reclamation
Division of Research and
Laboratory Services
Power and Instrumentation Branch

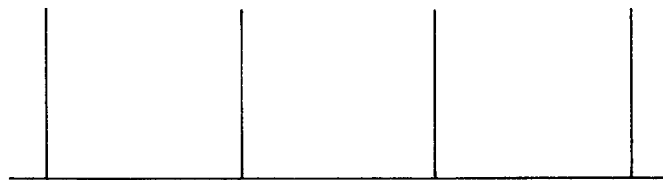
Slot #80

P-850

A-640

E-0

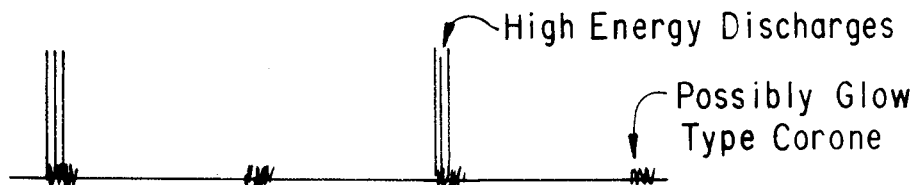
Slot #107

P-650

A-500

E-20

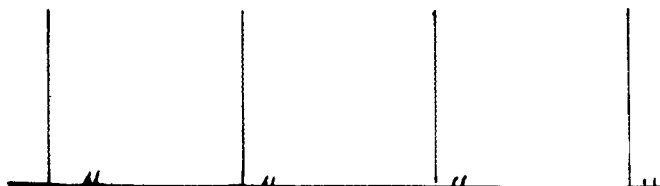
Slot #286

The new corona probe meter also has output terminals that can be monitored with an oscilloscope for observing the actual wave shape and amplitude of the signals detected by the probe. Figure 1 shows a series of wave shapes observed on the oscilloscope monitor along with the associated slot number and meter readings in the left-hand margin.

P-900

A-650

E-5

Figure 1. - Oscilloscope waveshapes, Palisades Powerplant corona test, 10-18-83.
