GR-86-2

ANALYSIS OF UTILIZATION OF GROUT AND GROUT CURTAINS — HOOVER DAM

*February 1986
Engineering and Research Center*

*U.S. Department of the Interior
Bureau of Reclamation
Division of Research and
Laboratory Services
Concrete and Structural Branch*

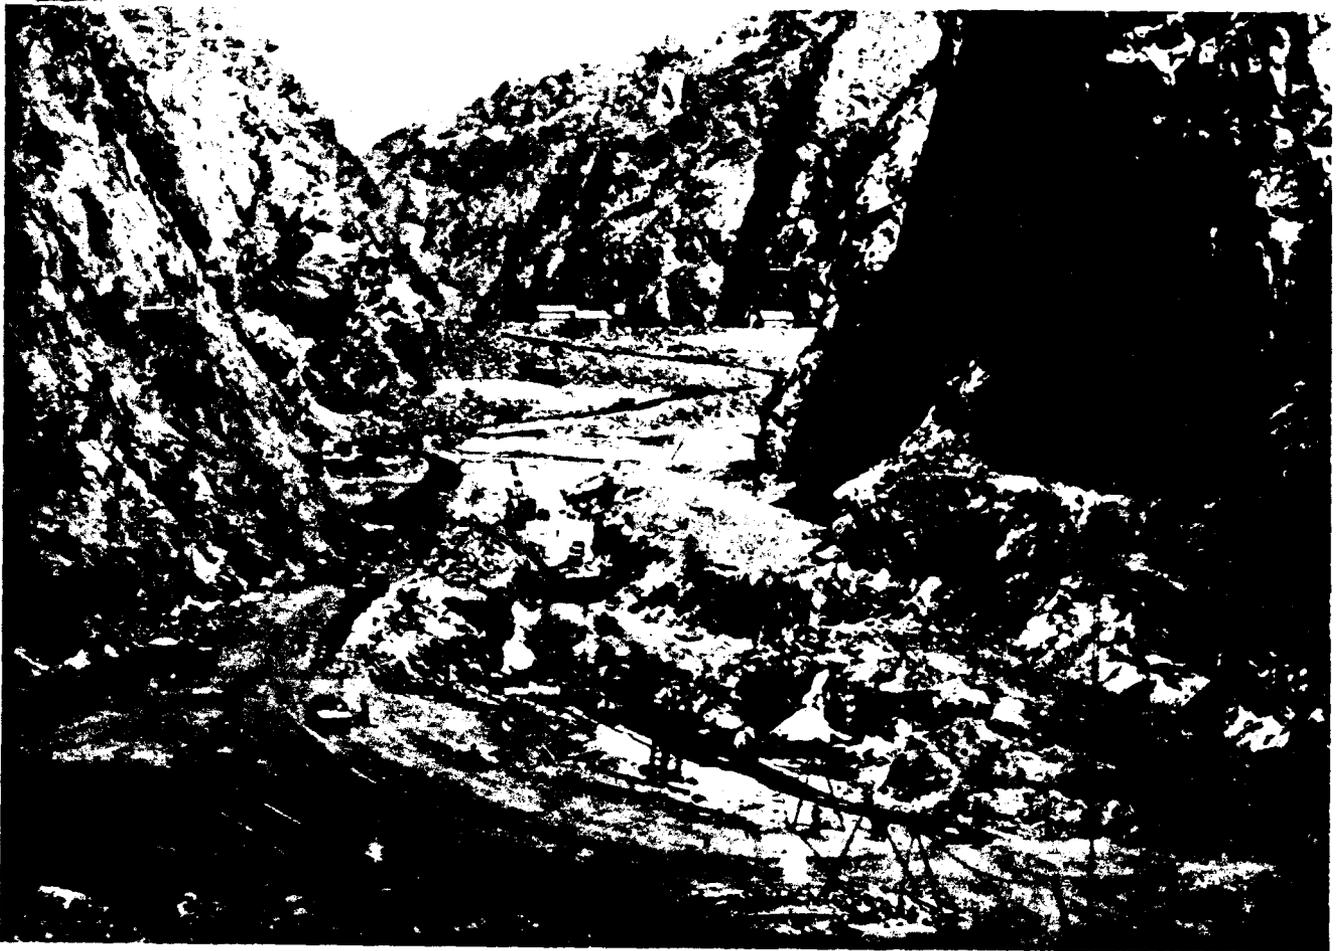
General view looking upstream at foundation excavation. Deeper middle channel is shown prior to any disturbance by blasting. The rock benches are at elevation 600. April 11, 1943.

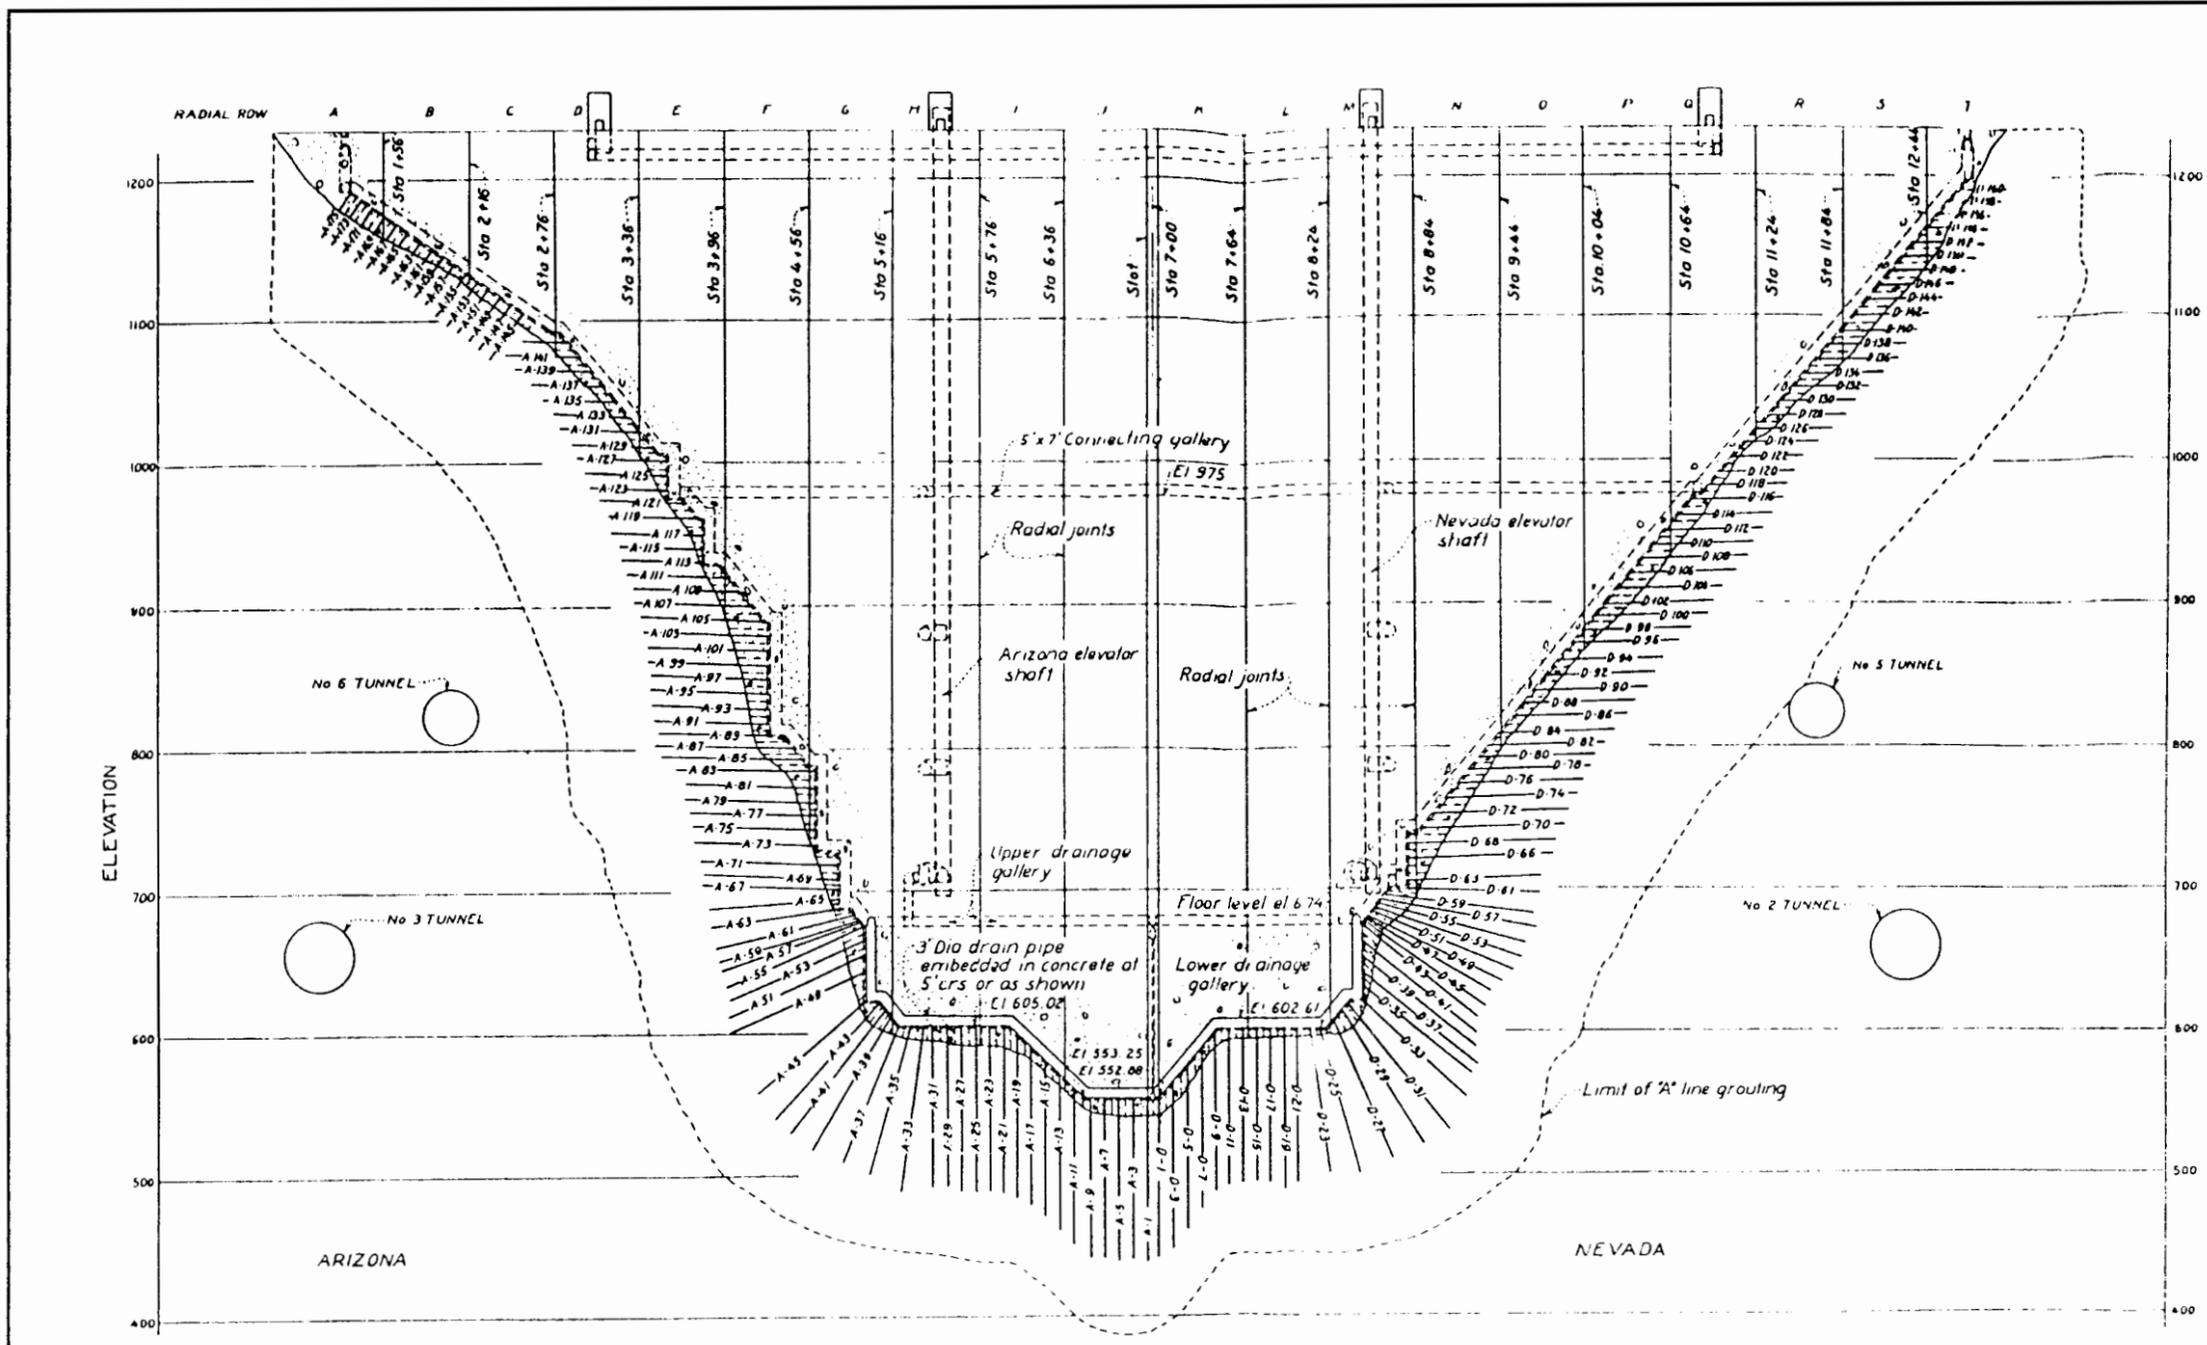
19. Foundation drains. Most of the information available on the drilling of the original drainage curtain is shown on figure 13 which was reproduced from figure 9 of Simonds and Boggess' (6) report. These data indicate that the holes were drilled in the radial plane of the dam. The holes were 2 inches in diameter and ranged in depth from about 100 feet in the bottom of the canyon to about 20 feet near the top of the dam. The drains were discharging about 200 gpm in September, 1938.

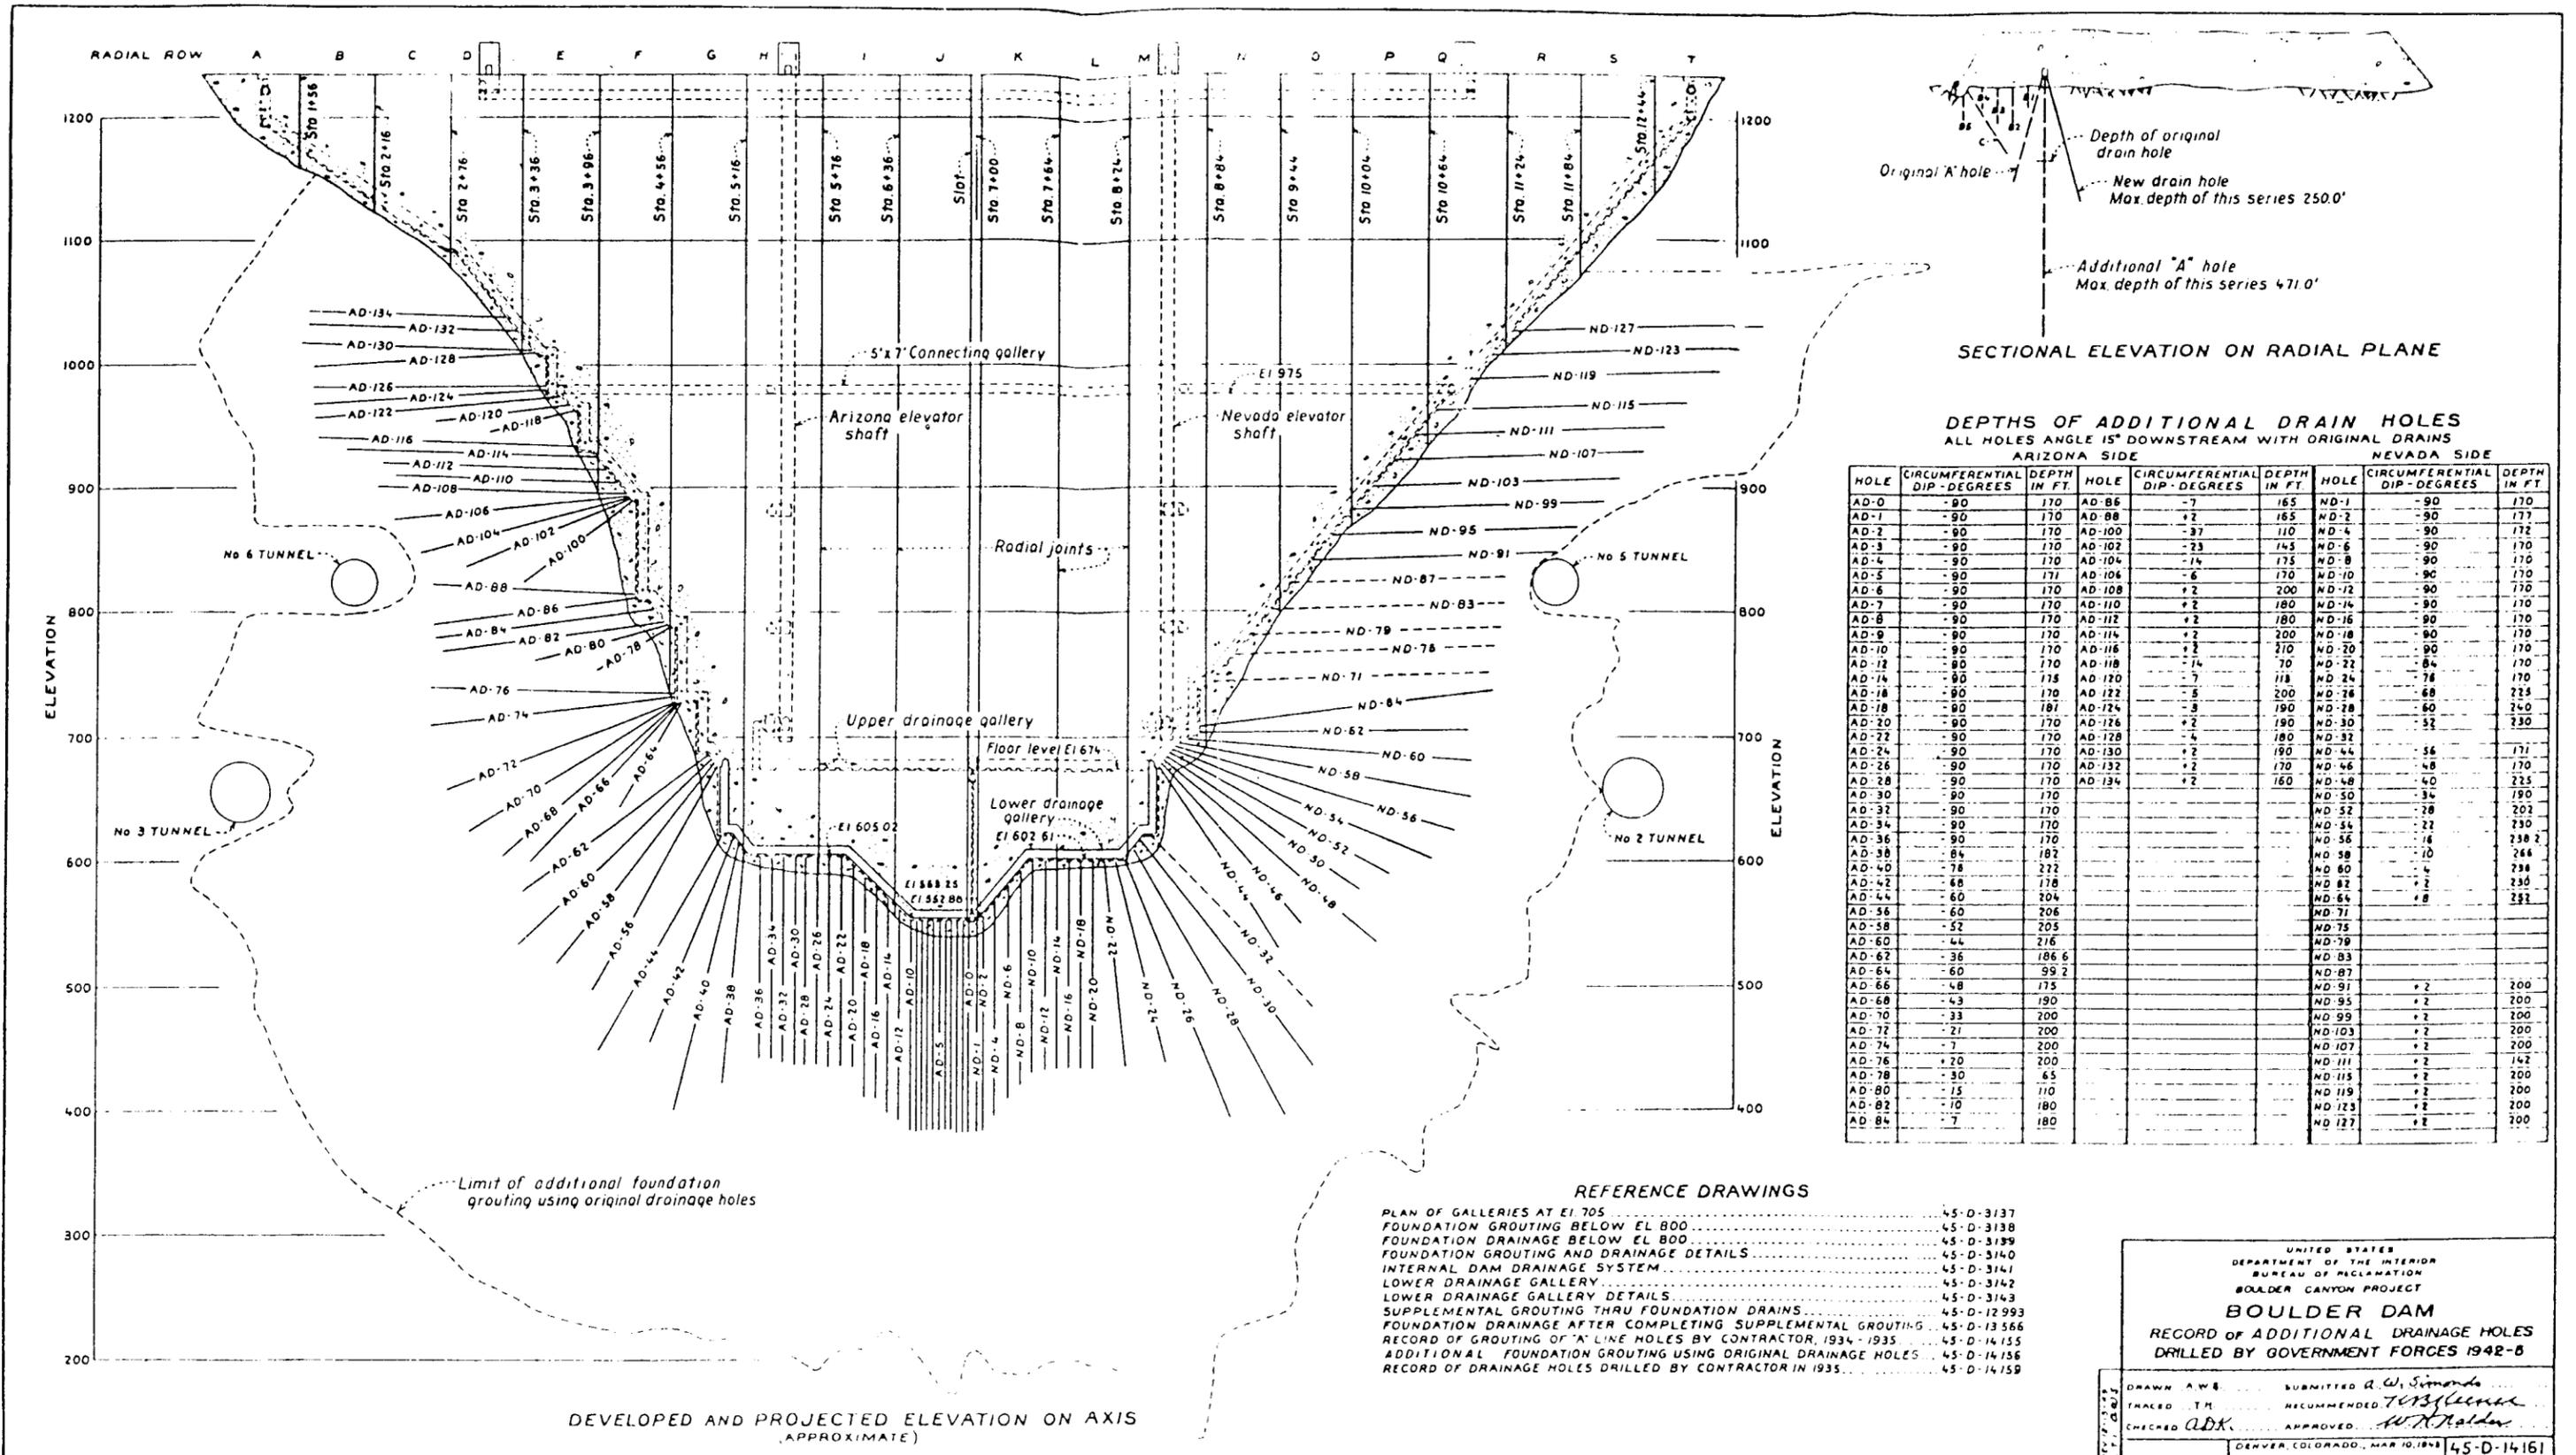
29. Drain holes. New drains were drilled from the grout and drainage gallery. See figure 18. The holes were drilled at an angle 15° downstream from the original line. They were drilled to a maximum depth of 250 feet and were of EX size (1-1/2 inch). In general the holes were drilled to a depth that their effect was noticeable in the uplift pipes. The flow from the drains was appreciable and amounted to 2,030 gpm in September and October,

1939, which was 10 times that produced by the shallower original drains. As the grouting progressed, the flows diminished even though more drain holes were drilled. The original drain holes that were not used as grout holes were retained as drain holes.

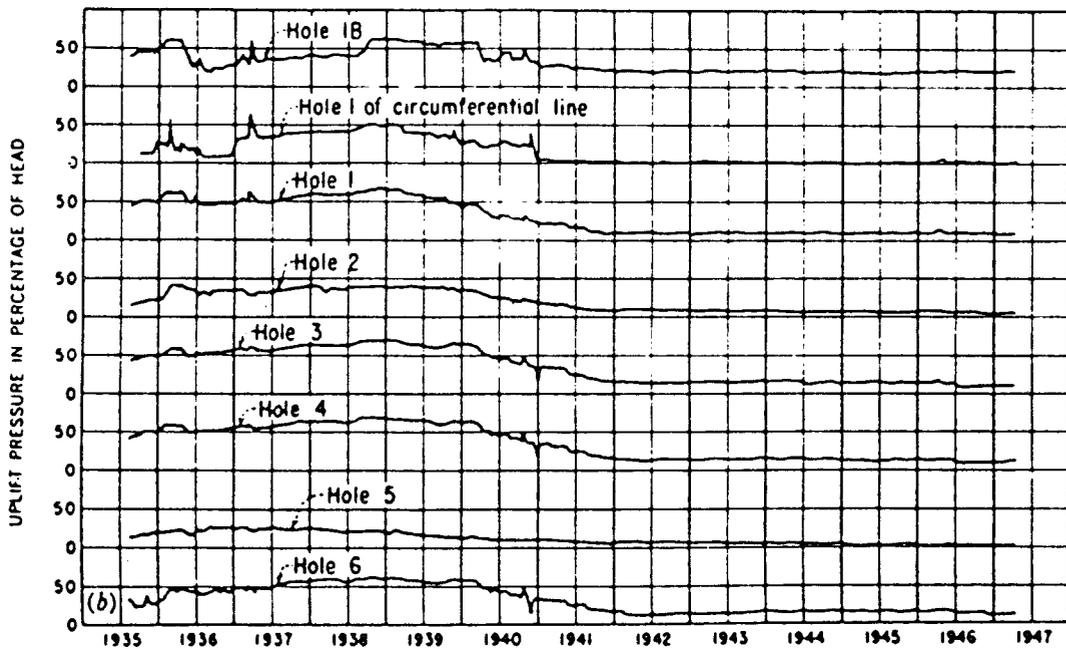
UPLIFT PRESSURES AT BASE, LINE B

Figures 22 and 23 were reproduced with ASCE's permission from figures 12 and 13 of Keener's⁽¹¹⁾ paper on uplift pressures. These plots are extremely valuable because they indicated even during the early stages of filling that all holes along line B had relatively high readings in percentage of head. Of particular concern were readings for holes 3 and 4 which were located 161 feet and 230 feet, respectively, downstream from the dam axis; and of even more concern was the readings from hole 6 which was
