GR-86-3

ANALYSIS OF UTILIZATION OF GROUT AND GROUT CURTAINS — KORTES DAM

*February 1986
Engineering and Research Center*

***U.S. Department of the Interior
Bureau of Reclamation
Division of Research
and Laboratory Services
Concrete and Structural Branch***

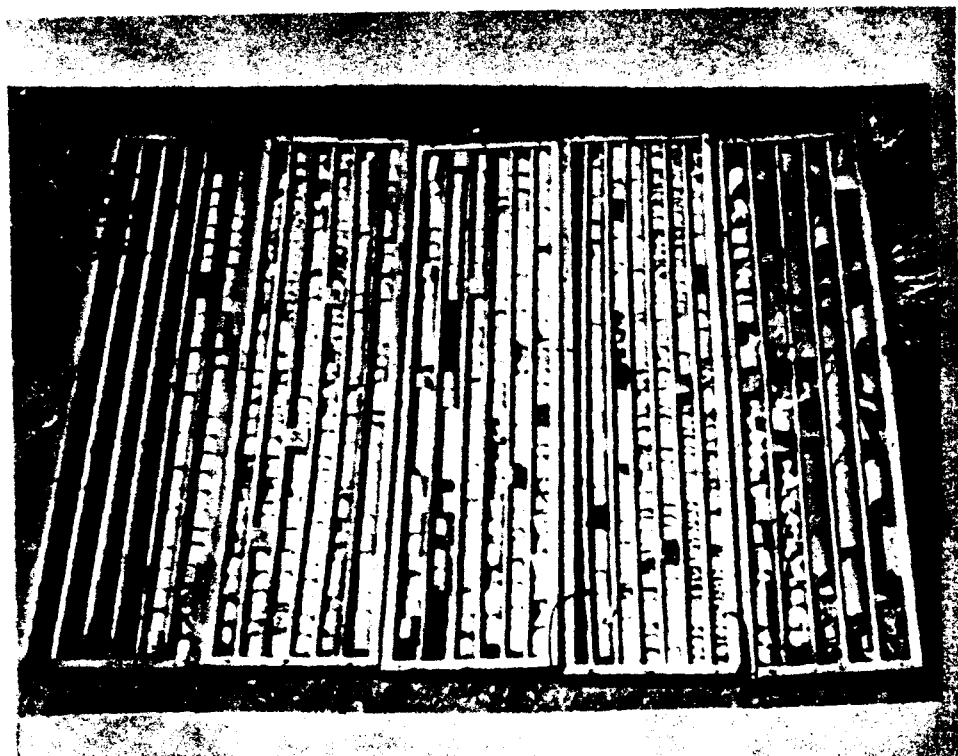
This photograph was taken of the core recovered from diamond-drill hole No. 10. The upper right-hand corner of the right hand core box is the top of the hole; the depth increases progressively towards the left. The dark gray core at the top of the hole represents the diabase dike shown on the geologic map. The lighter-colored core is granite.

The majority of the breaks in the core represent pre-existing joints and are, as the photograph illustrates, more or less evenly spaced throughout the core. This is the basis for the conclusion that the entire rock mass of the abutments and foundation of the Kortes Dam site will be almost as severely fractured at moderate depth as it is on the exposed rock surface. The "button like" pieces shown at "A" (as compared to the pieces 2 to 4 inches in length "B") represent a zone of abnormally close-spaced parallel joint planes. Such zone is referred to in the text as a "sheeted" structure or "sheeted zone".

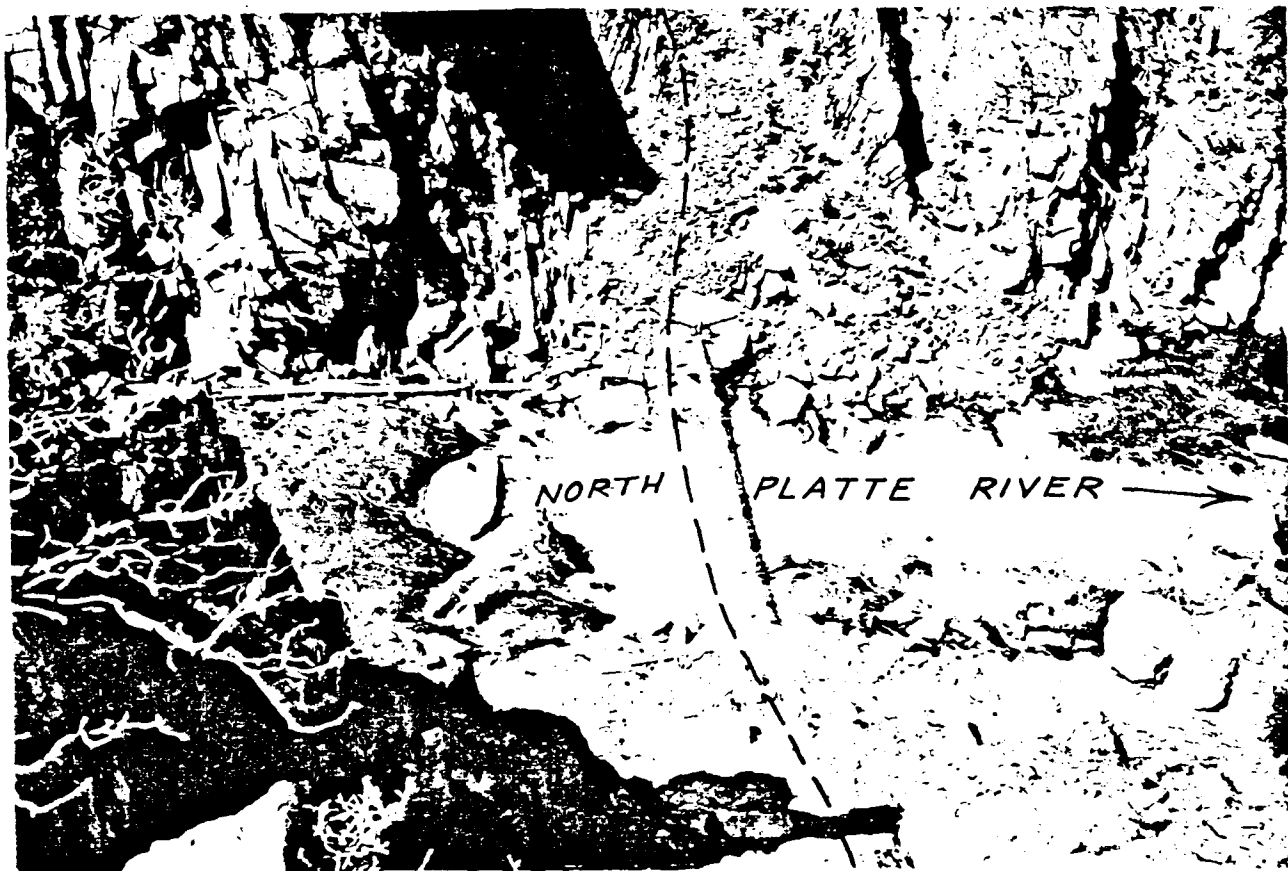
Figure 8 This photograph was taken to illustrate the general relations between bedrock exposures and talus or slide rock in the area of the powerhouse foundation. The approximate position of the prominent sheeted zone which crosses the river through the foundation area of the powerhouse is shown by a "dashed" line.

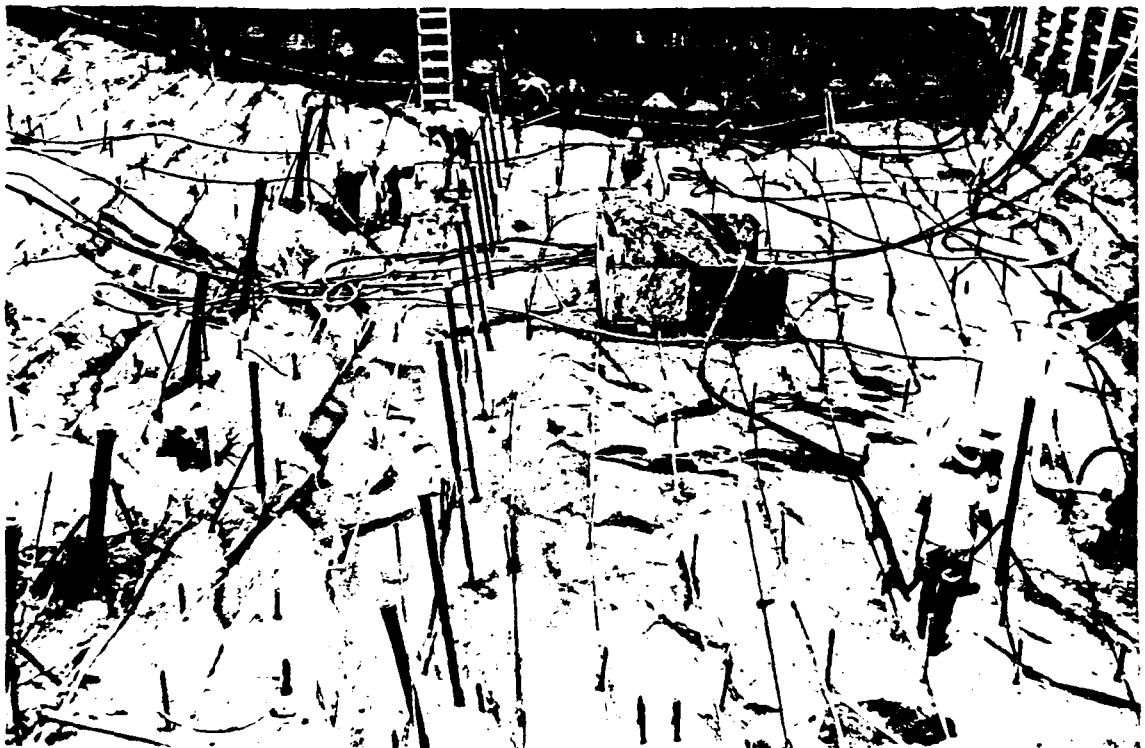
405-354 Foundation rock at the base of dam near the axis. Foundation grout pipe, drain pipe and uplift pipe installed. Cooling coils on rock at 2½ foot centers.

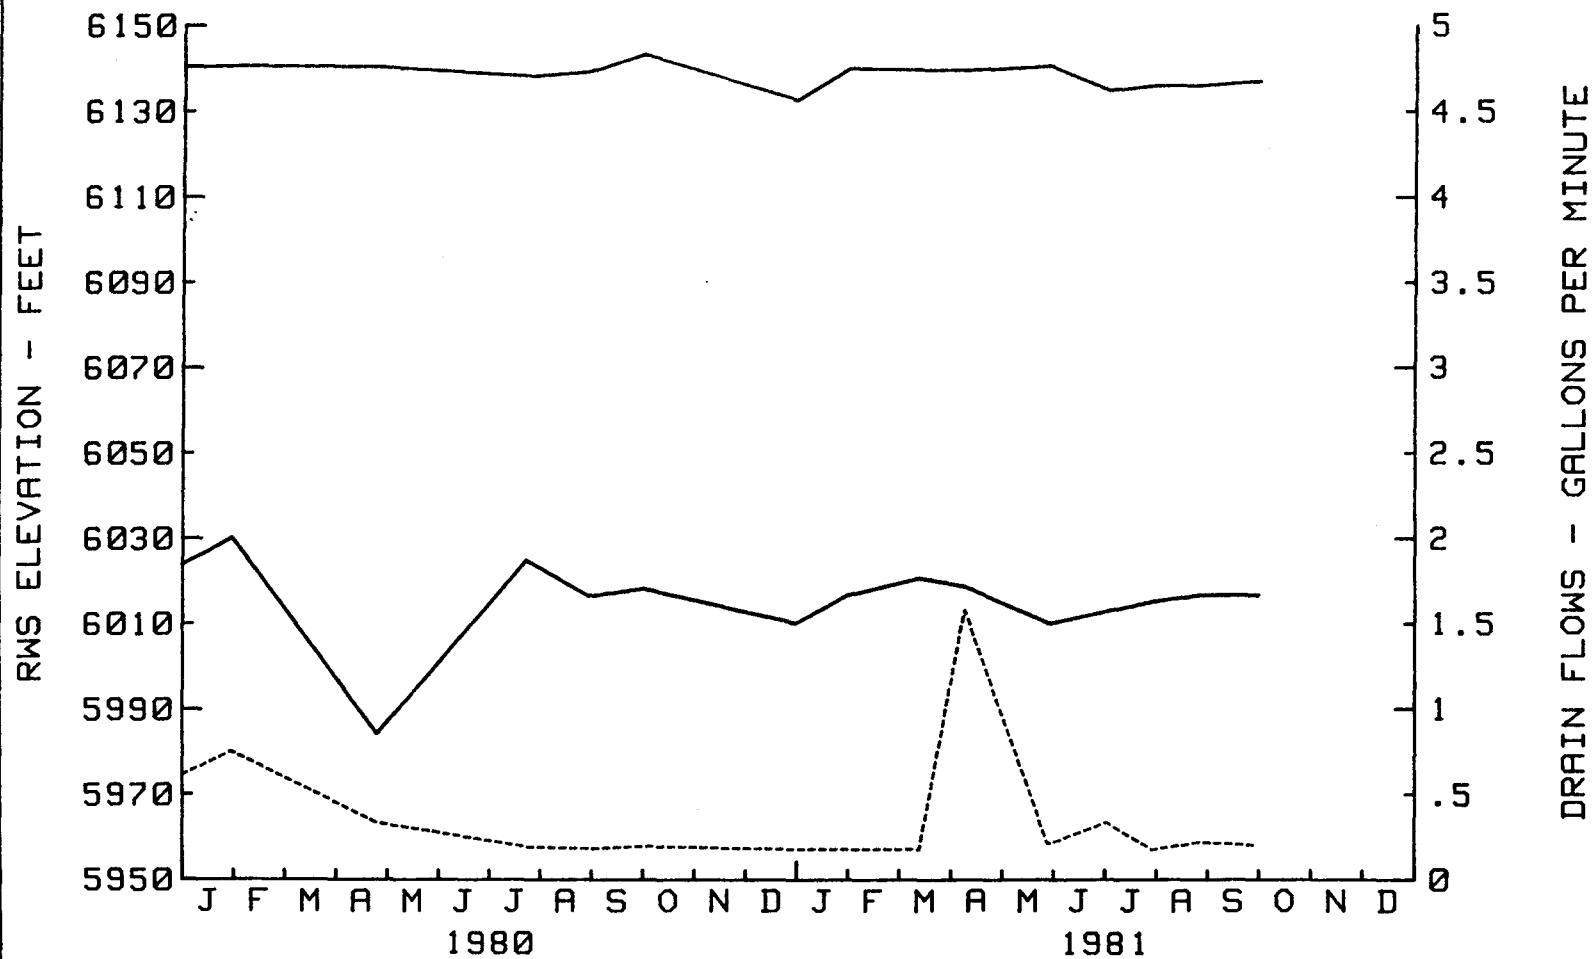
FIGURE 16

KORTES DAM - DRAIN FLOWS WEIR ELEVATIONS 5977.5 & 5960.0
