# ANALYSIS OF UTILIZATION OF GROUT AND GROUT CURTAINS — HUNGRY HORSE DAM

*February 1986*  
*Engineering and Research Center*

*U.S. Department of the Interior*  
*Bureau of Reclamation*  
*Division of Research and*  
*Laboratory Services*  
*Concrete and Structural Branch*

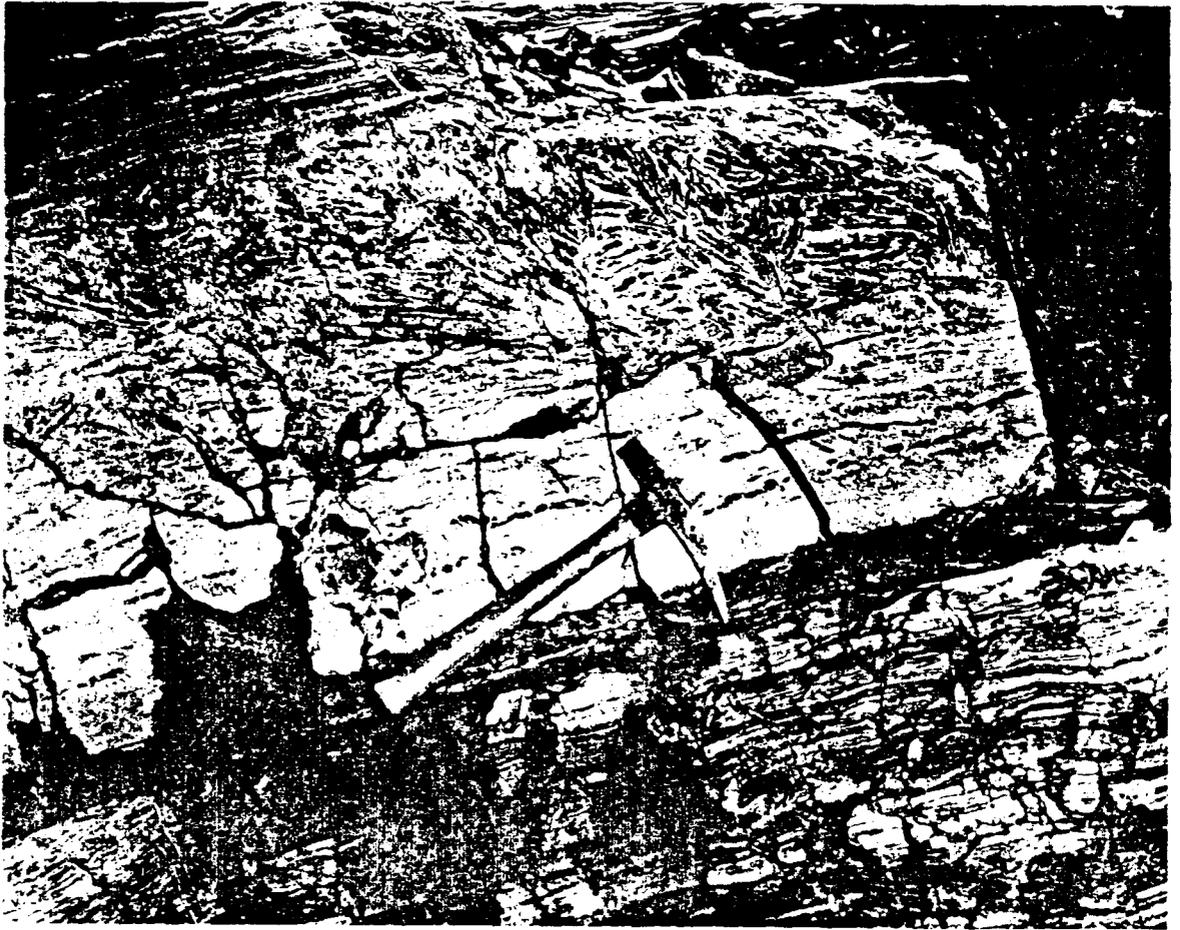
Figure 5 Detailed view in left abutment excavation showing bedding lines and partings and some of the variability of thickness of individual rock layers. Blocky nature of fractured rock is shown, but irregular fractures have been caused by disturbances in excavation. The strikingly marked internal appearance of the central massive bed is a very unusual occurrence and is believed to represent influence of some contemporaneous organic growth. P447-105-1225, May 25, 1949.

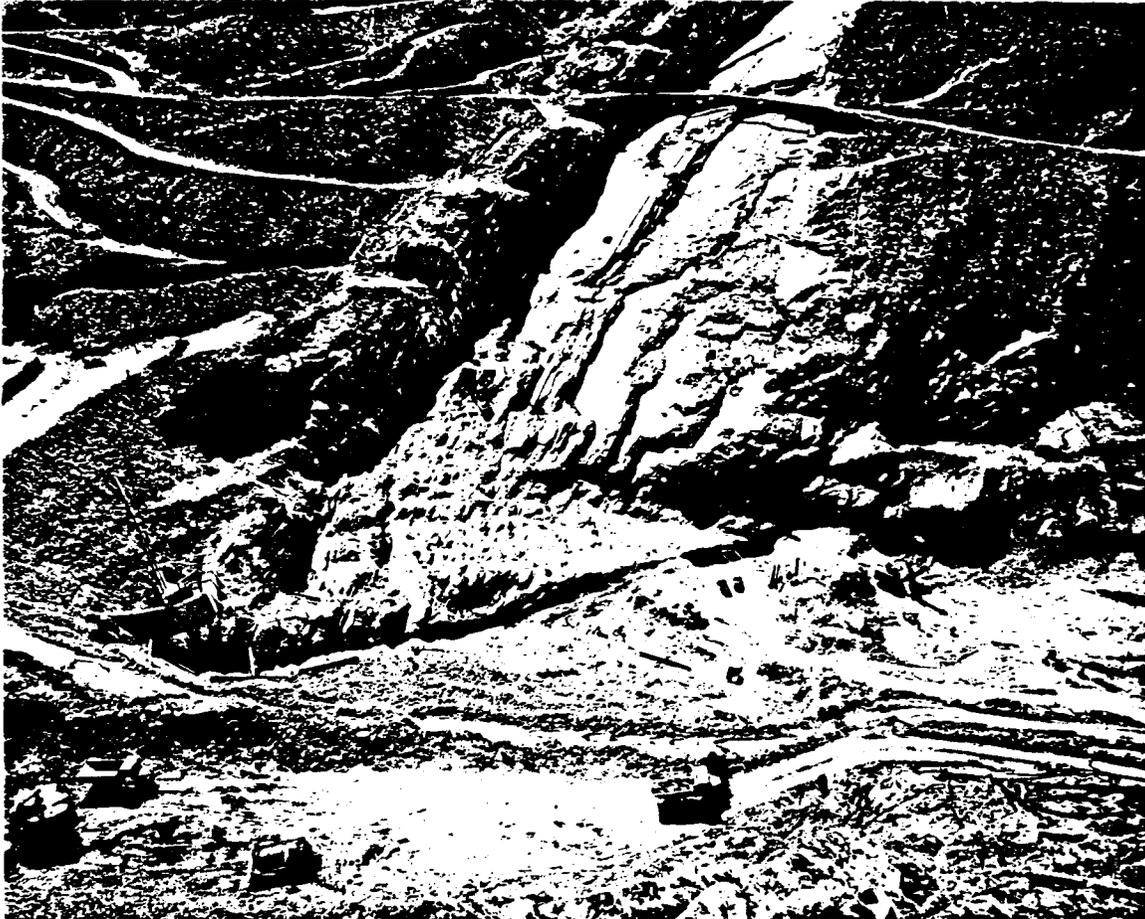
Figure 6 View showing completed left abutment foundation excavation, early stages of Fault Zone 6 excavation marked by diagonal trench in river channel, and rock work on the right abutment and for the powerhouse foundation. P447-105-1631, August 26, 1949.

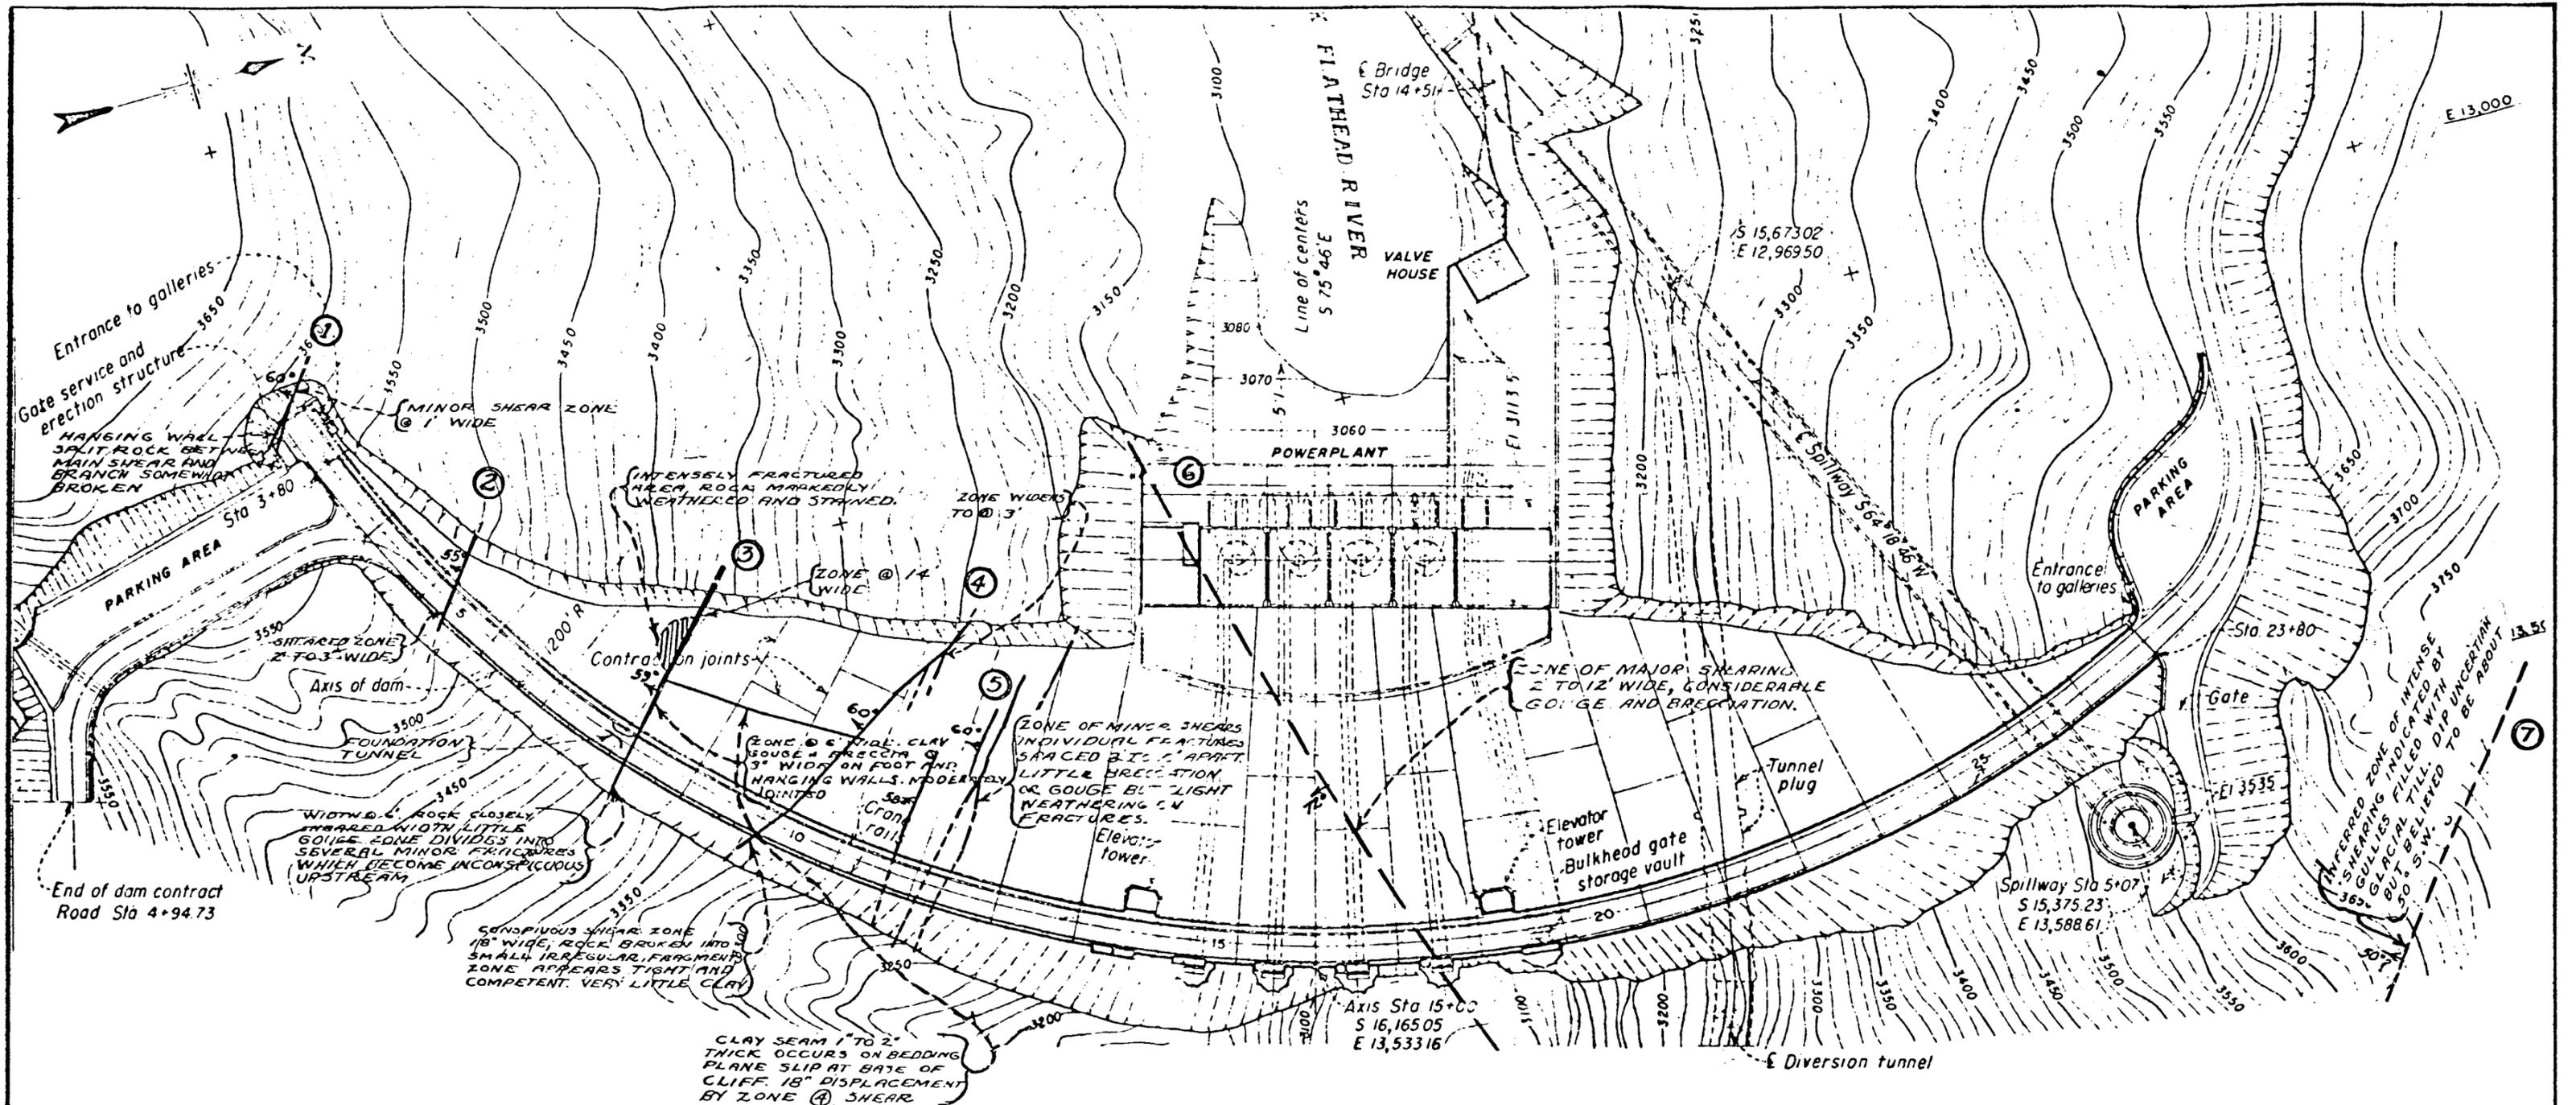
**HUNGRY HORSE DAM  
FOUNDATION FAULTS**

5. Treatment of fault zones. Three minor faults, Nos. 1, 2 and 5, and three major faults, Nos. 3, 4, and 6, were encountered in the foundation area at the locations shown on figures 11 and 12. Treatment of the minor faults consisted of trenching the crushed material to a depth equal to 1-1/2 to 2 times the width of the zone for the full width of the dam and backfilling with concrete. The fault zones were also cross-stitched with grout holes for the full width of the dam.

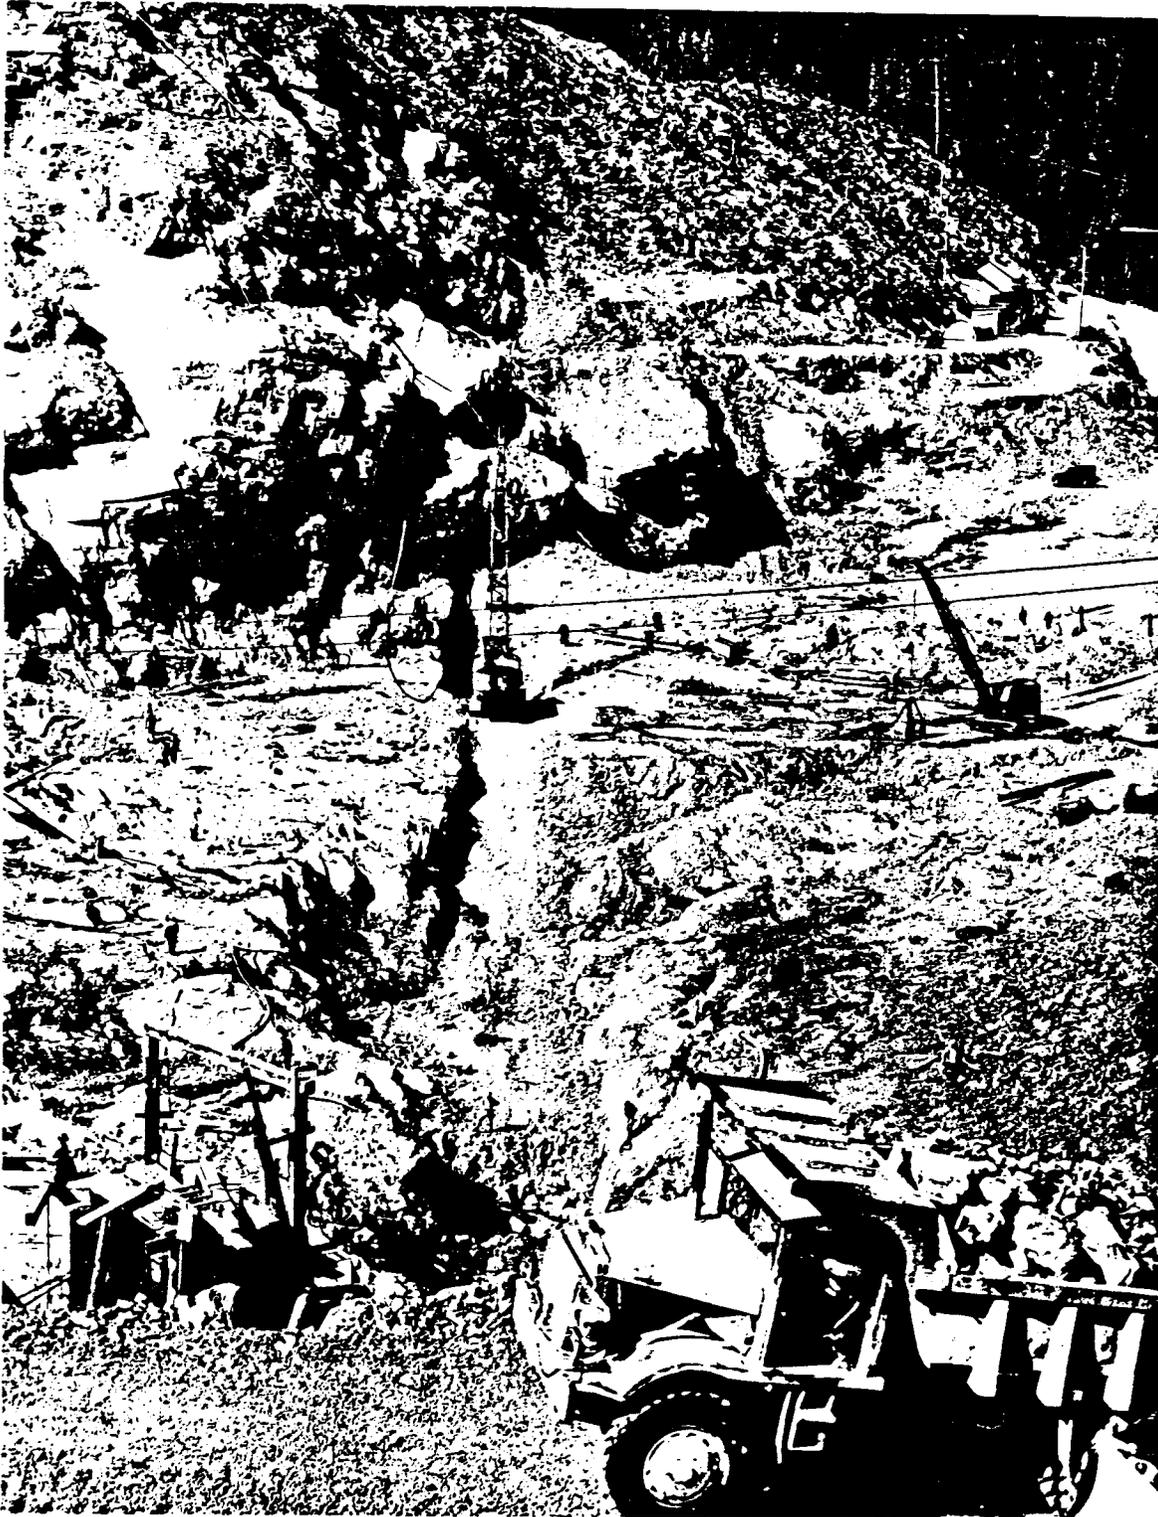
Figure 13 Dam foundation excavation. The trench marks the early stages of excavation of Fault Zone 6 in the former river channel. P447-105-1614, August 18, 1949.

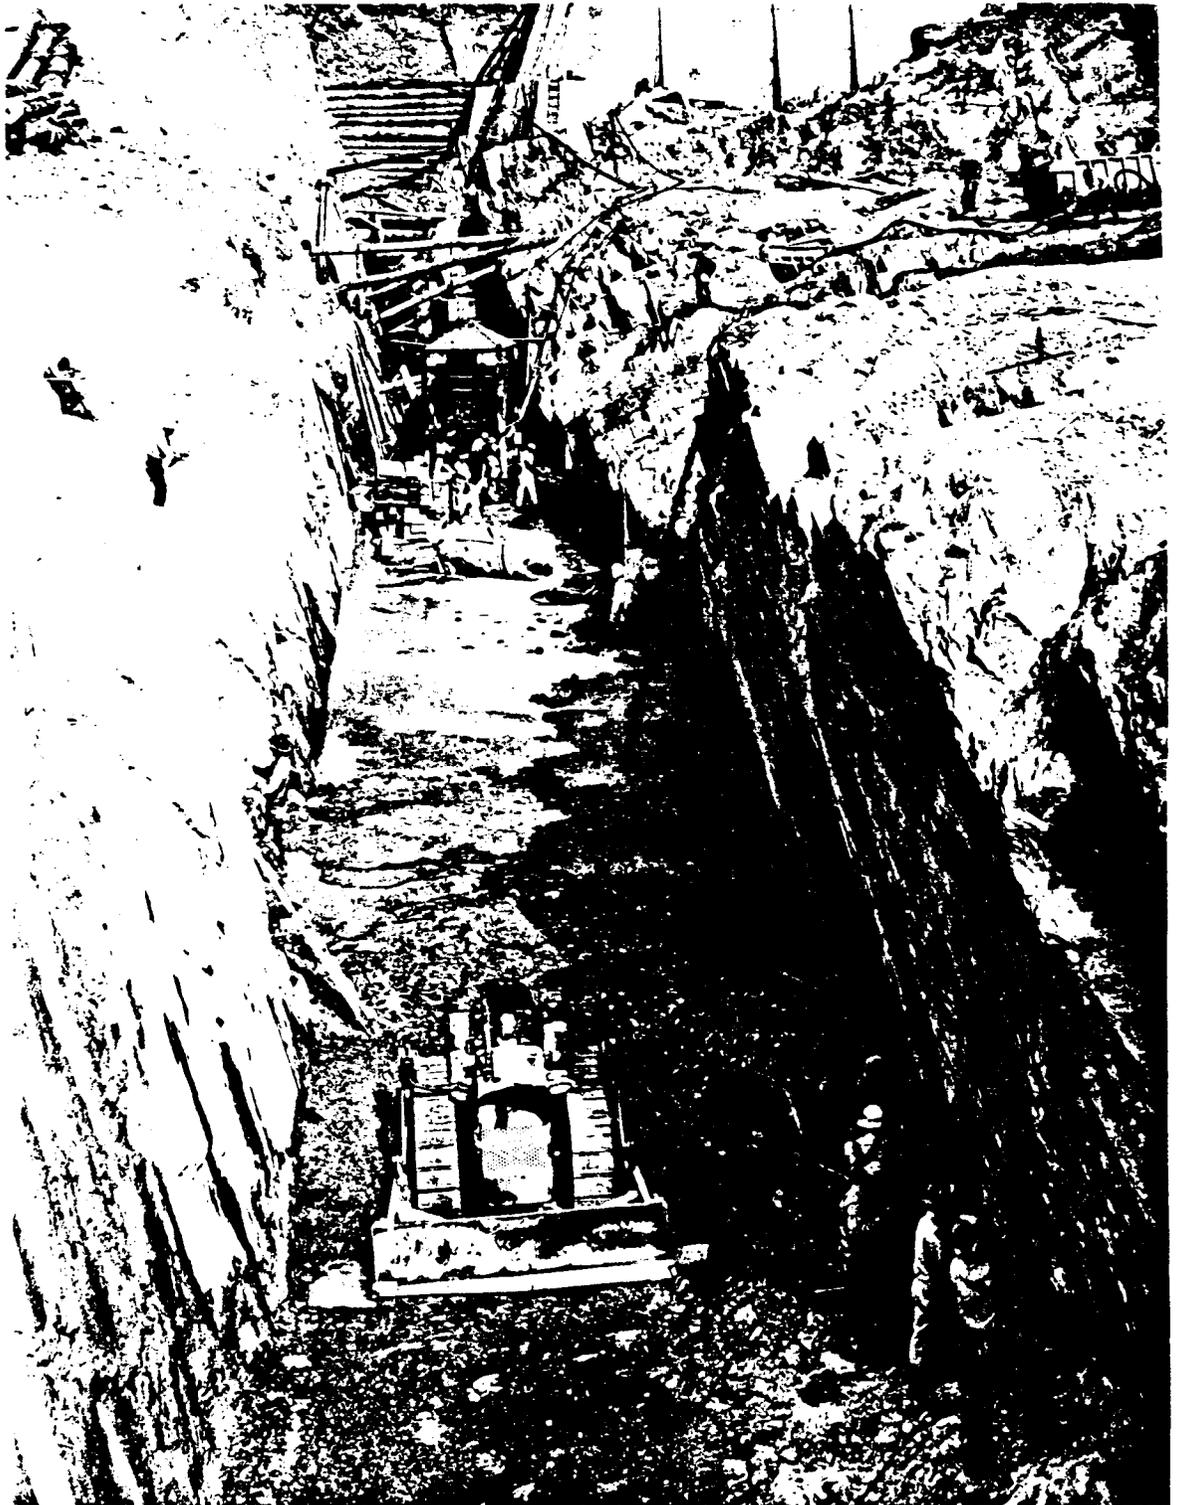
Figure 14 Dam foundation excavation. Fault Zone 6, looking upstream.  
The concrete structure at top of photo forms a pump sump.  
P447-105-1664, September 2, 1949.

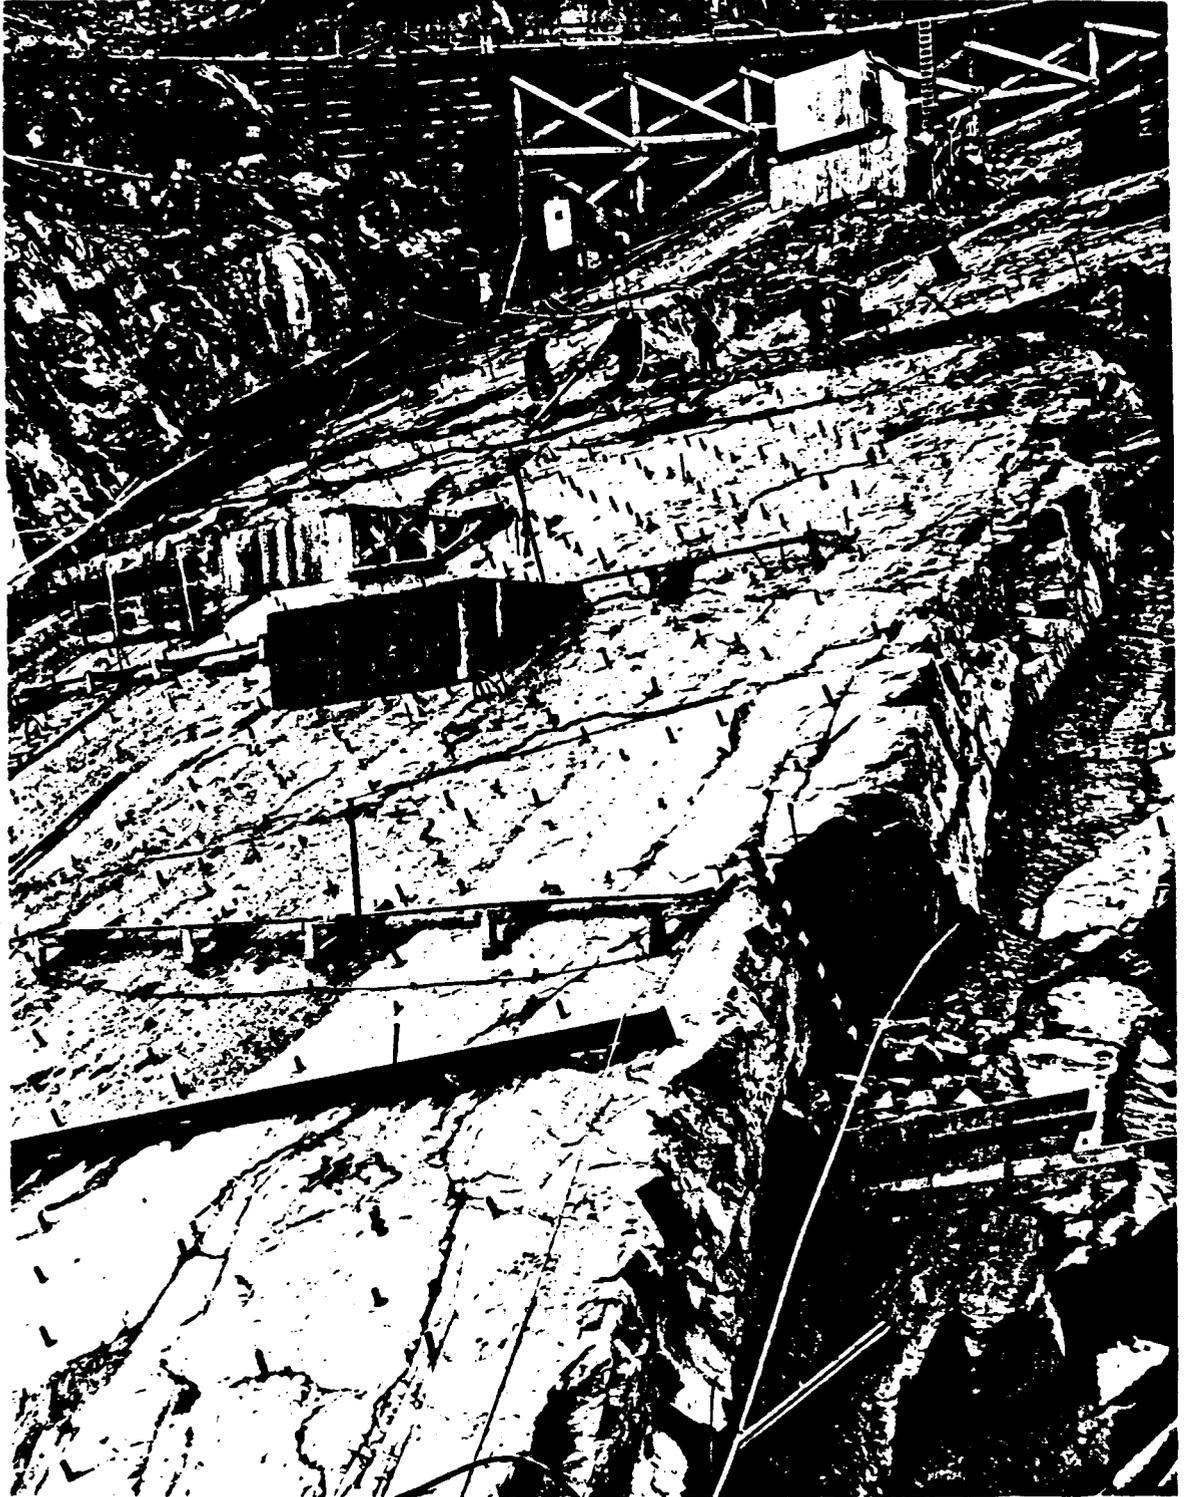
Figure 16 Clay seam treatment. Nipples mark holes in the rock which were drilled for washing and grouting of clay seams. Fault Zone 4 may be seen just below where men are standing. P447-105-3083, October 24, 1950.

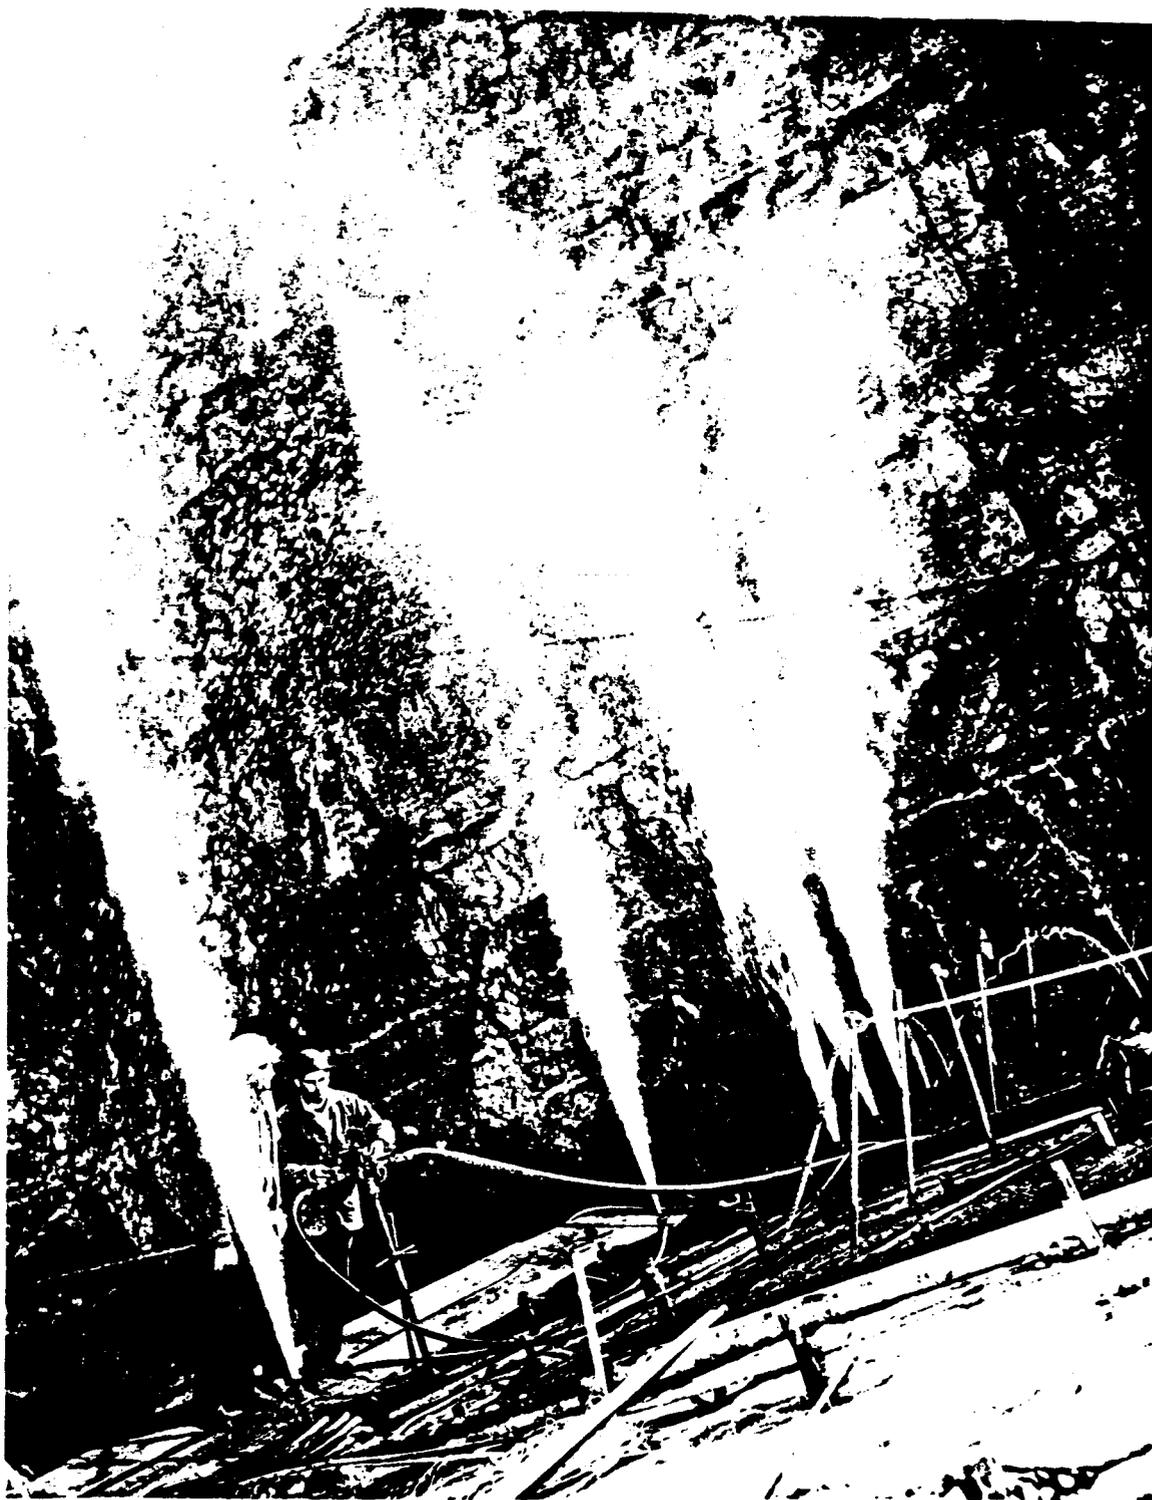
Figure 17 Clay seam treatment. Workmen flushing clay from seams in rock. P447-105-2956, September 16, 1950.

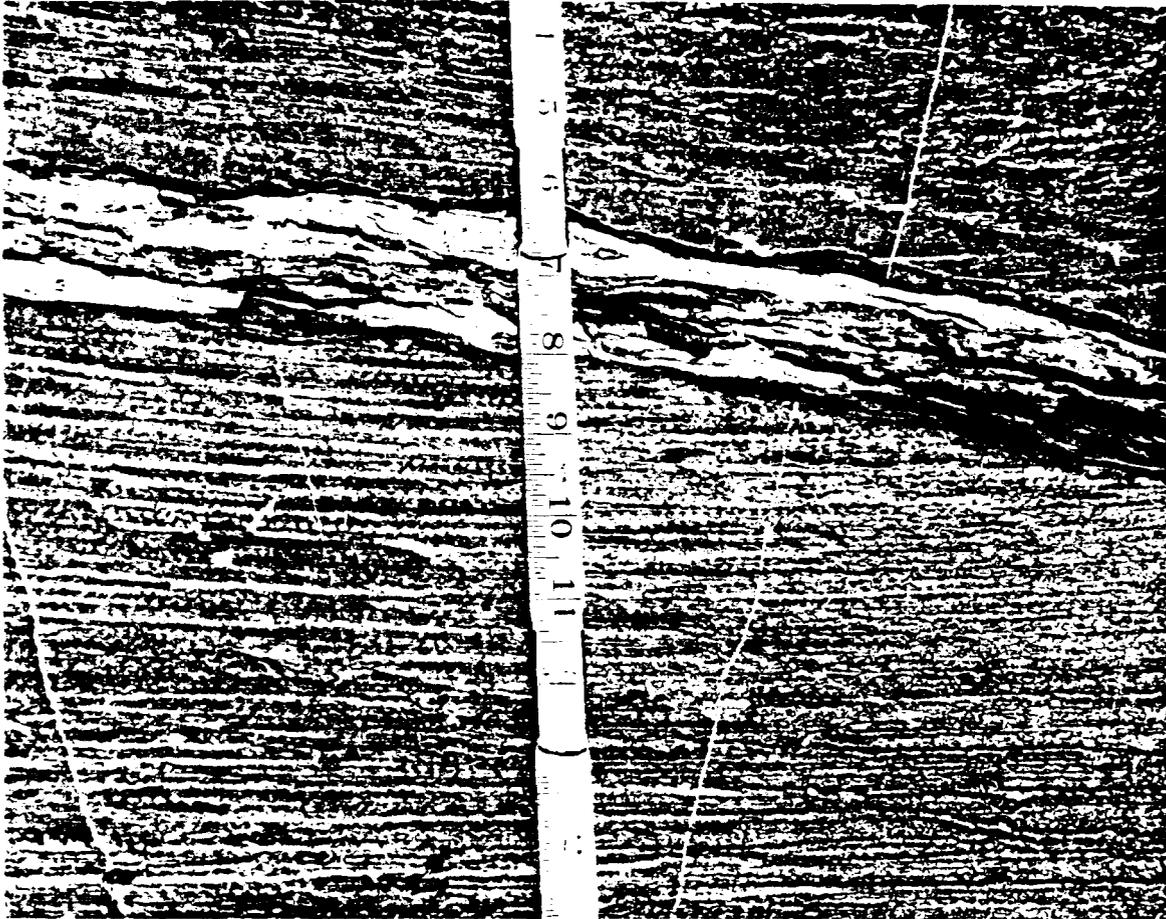
Figure 19 Clay seam treatment. Grouted seam exposed by 36-inch diameter calyx hole. Clay, interbedded with grout, was washed away by drill water. (See photo 2495). P447-105-2494, June 8, 1950.

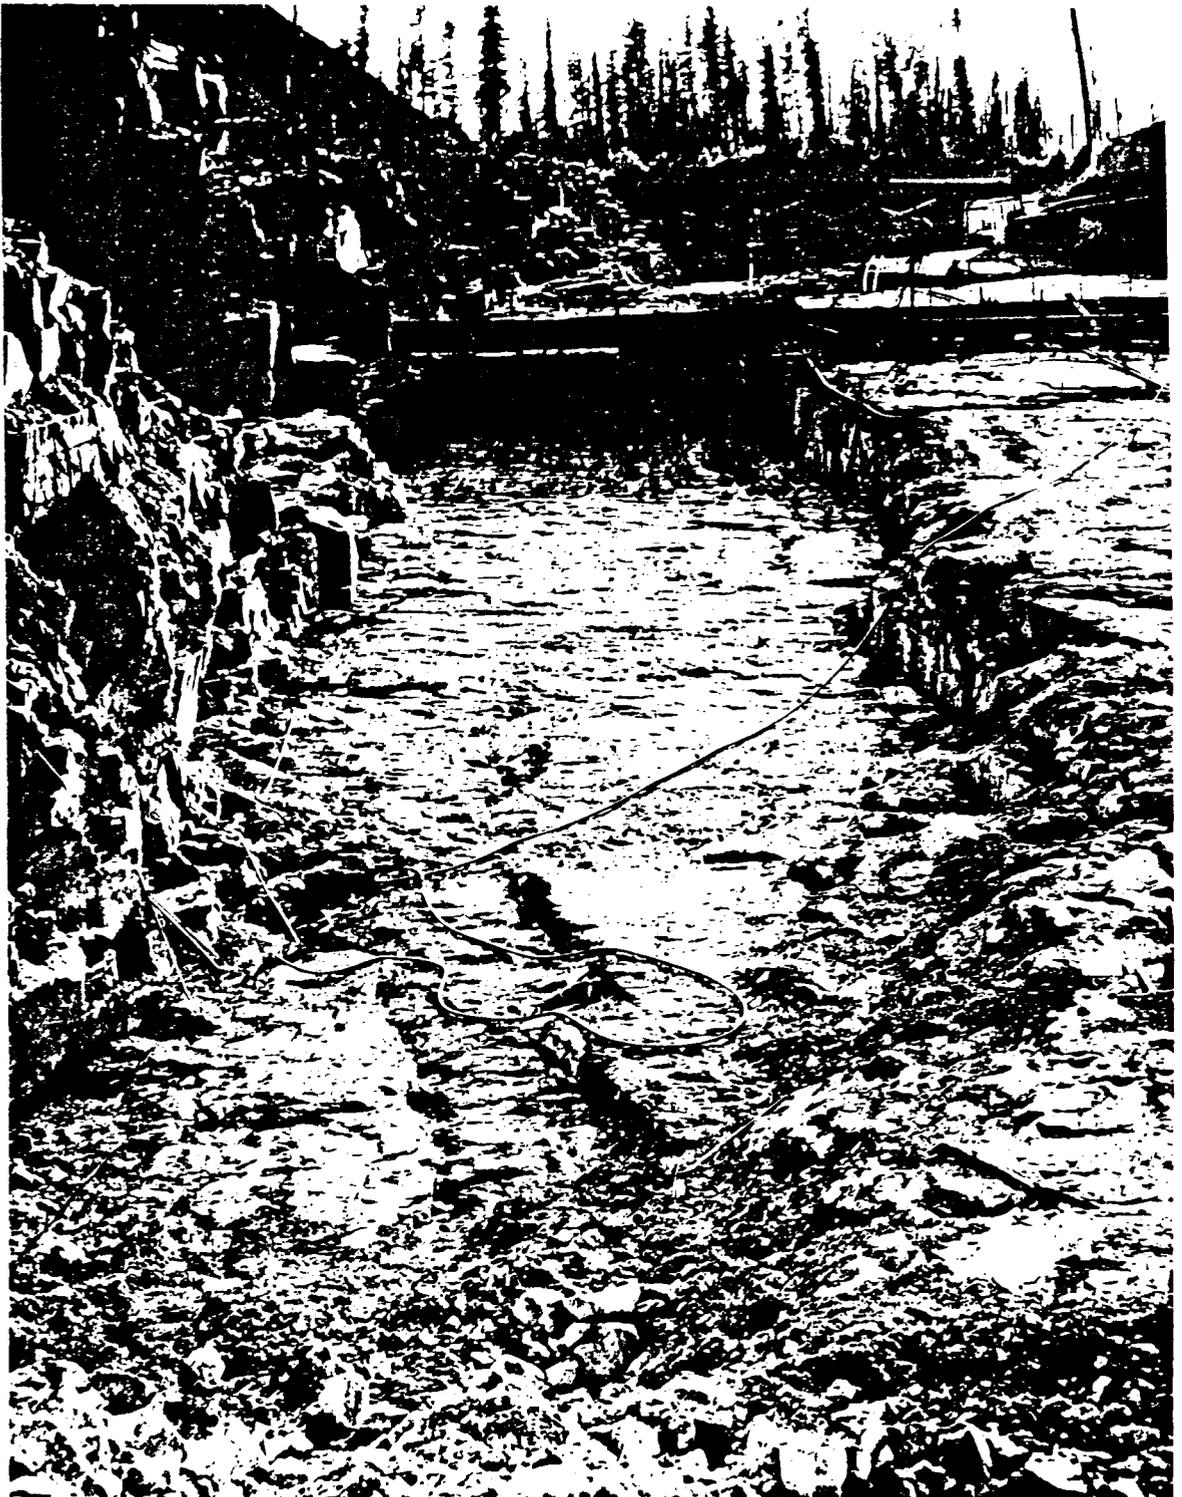
Figure 20 Excavation of rock above clay seam along the axis of dam  
in Blocks 6 and 7. P447-105-3705, July 19, 1951.

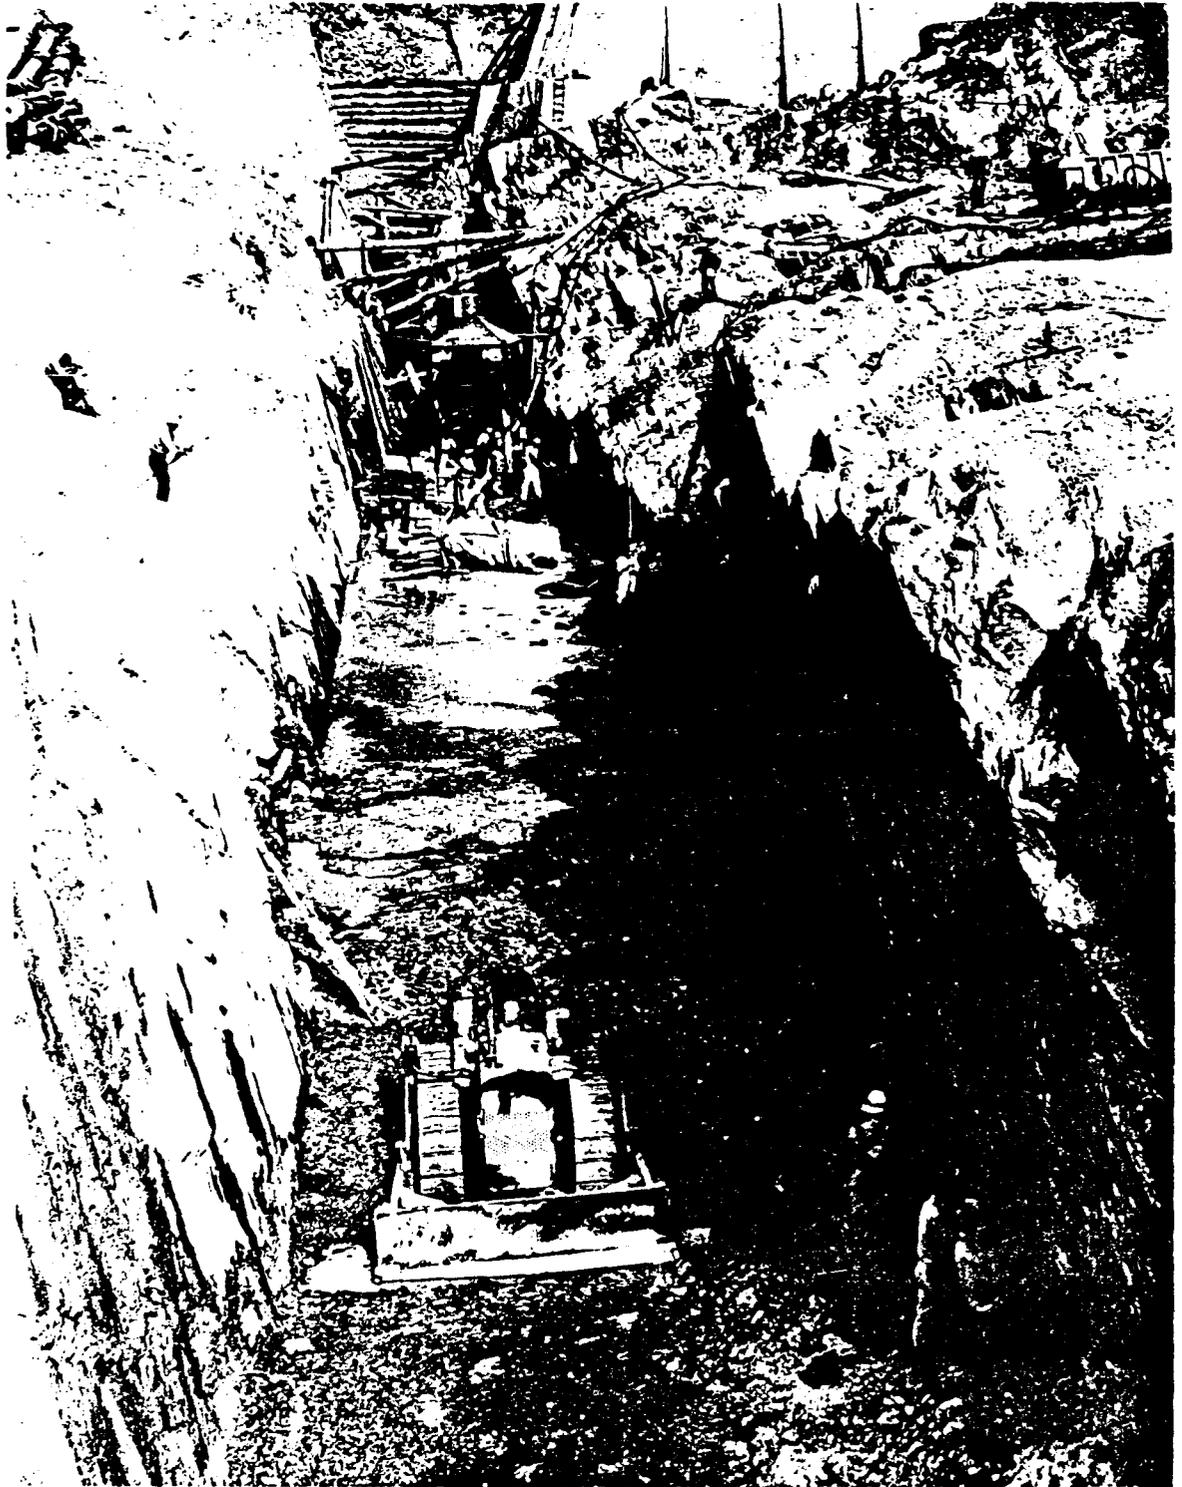
Figure 12. --Excavated channel section in fault zone No. 6, viewed from formwork for downstream shaft. The concrete structure at top of photograph forms a pump sump. P447-105-1664, September 2, 1949.

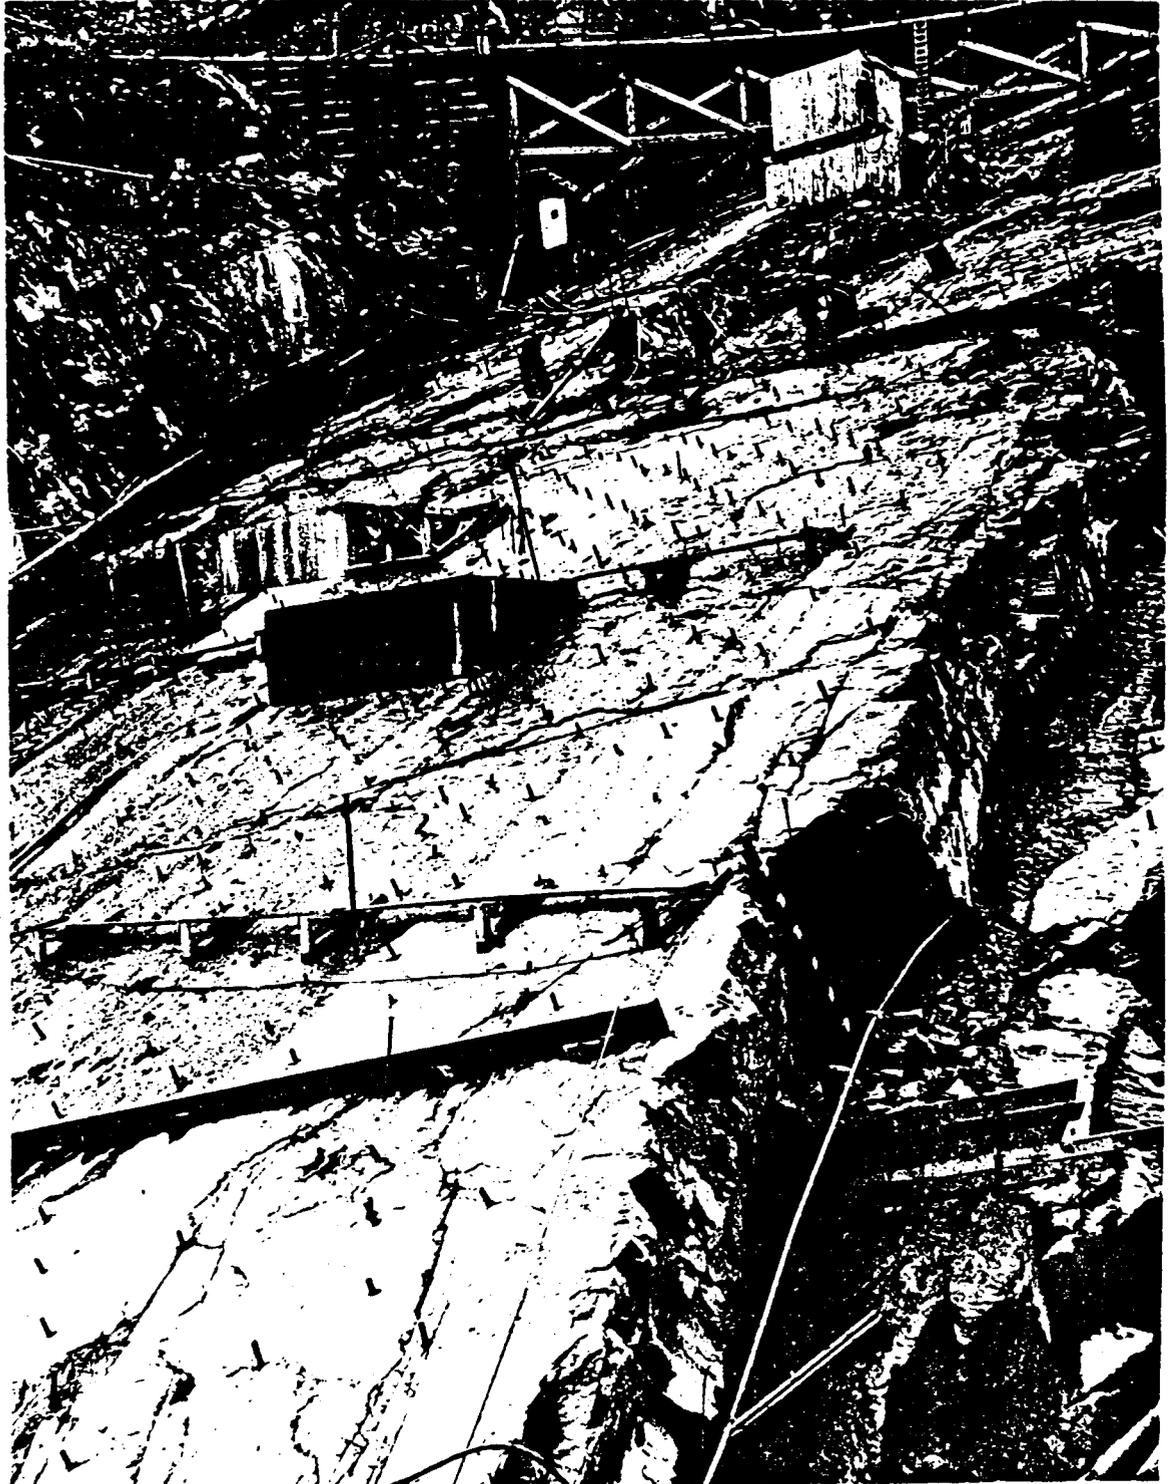
Figure 13.--Clay seam treatment of rock in blocks 11 (foreground) and 10 (background). Nipples are set in holes which have been drilled for washing and grouting of clay seams. P447-105-3083, October 24, 1950.

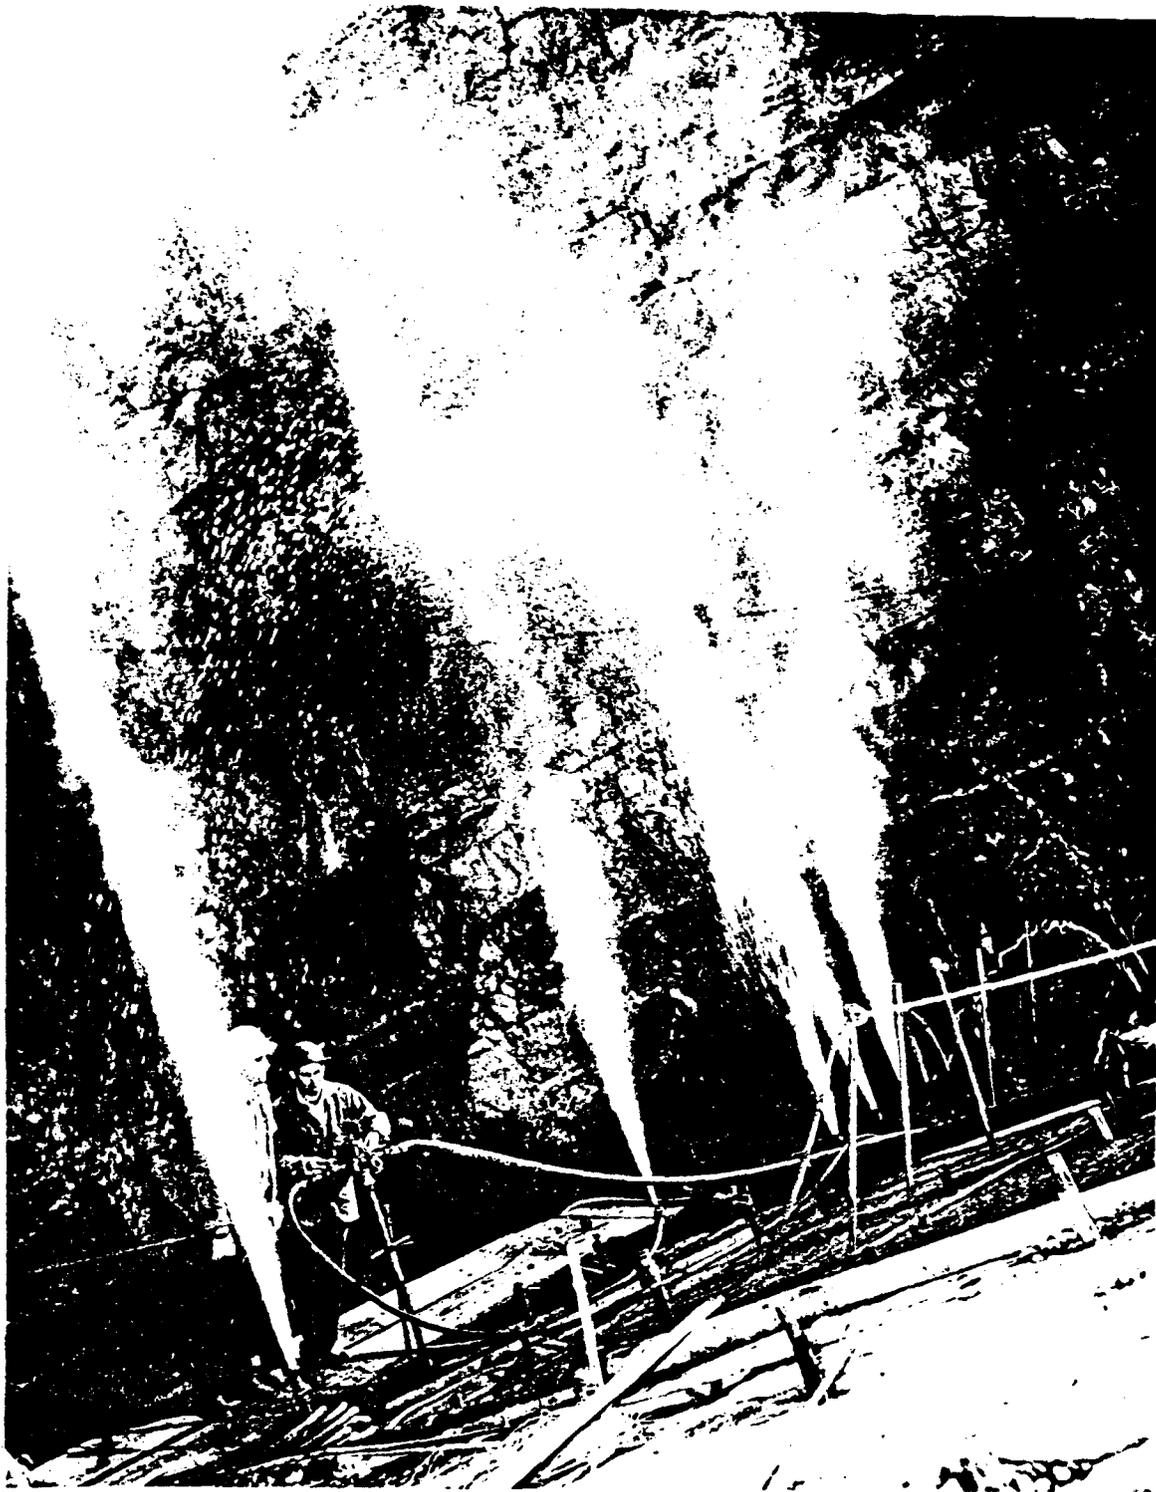
Figure 14. --Clay seam treatment in left abutment. Water which has been forced into the rock under high pressure spurts from drill holes like miniature geysers. P447-105-2956, September 16, 1950.
