GR-86-6

ANALYSIS OF UTILIZATION OF GROUT AND GROUT CURTAINS — MORROW POINT DAM

**February 1986
Engineering and Research Center**

**ANALYSIS OF UTILIZATION
OF GROUT AND GROUT CURTAINS-
MORROW POINT DAM**

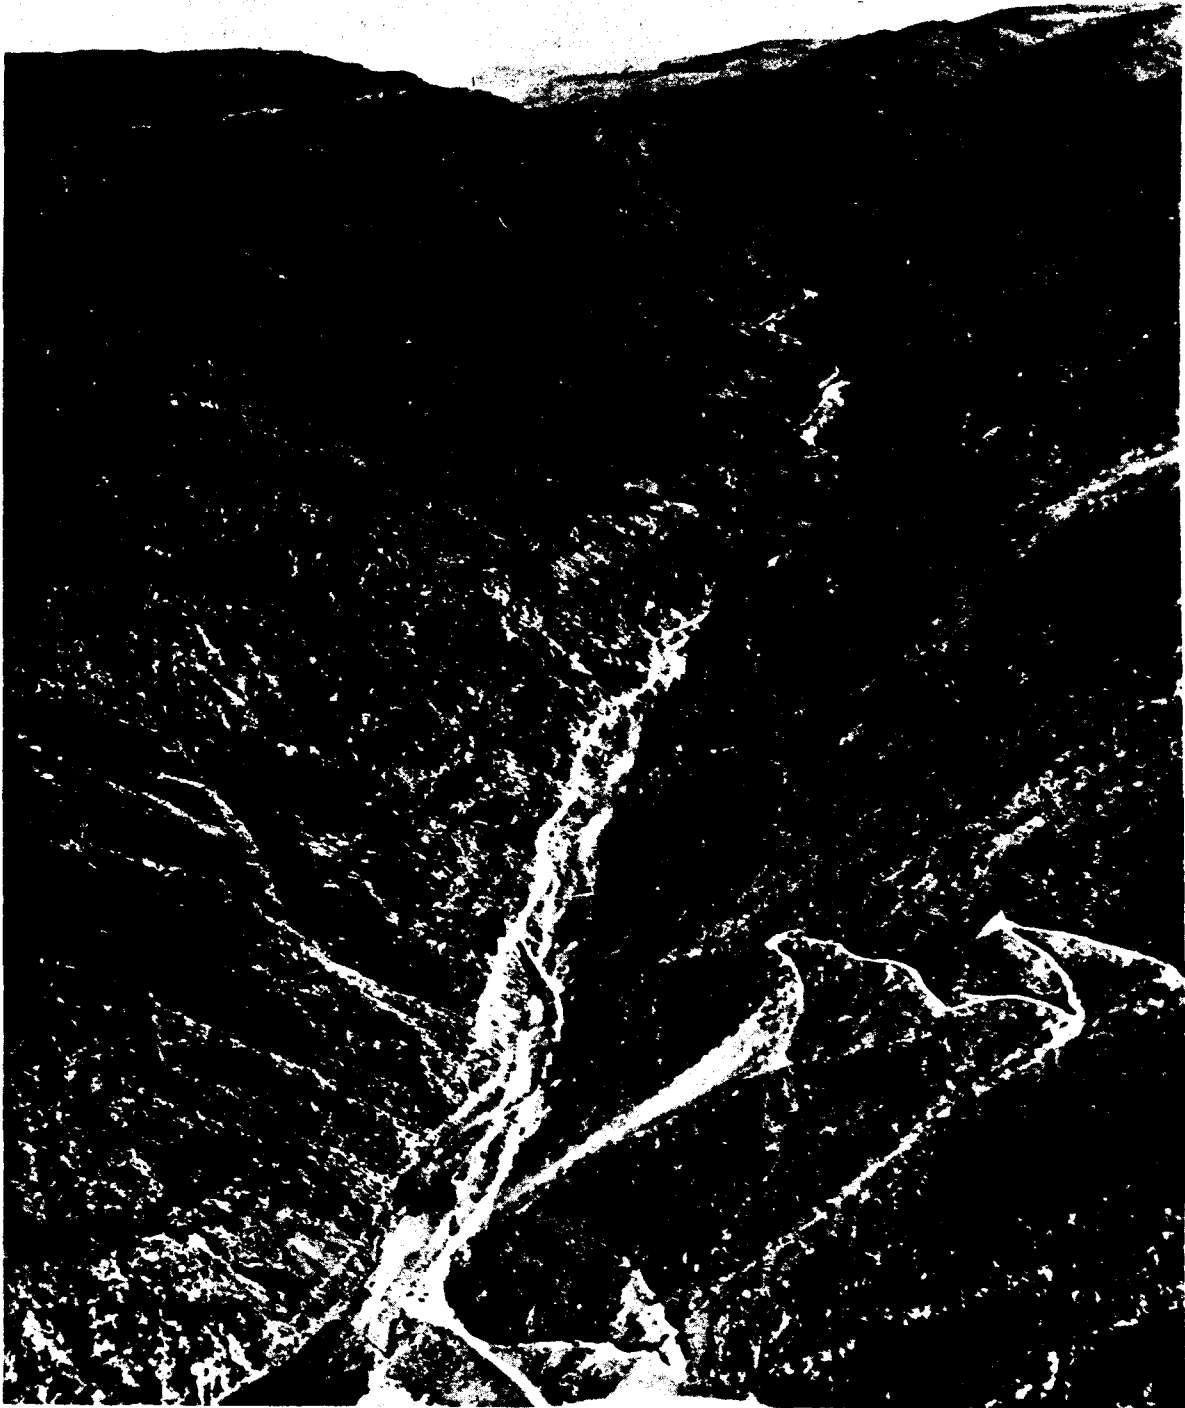
Aerial view looking upstream at Morrow Point damsite. Dam abutments are approximately opposite the old narrow gage railroad bridge shown crossing the Gunnison River. P622B-427-2292, June 25, 1963.

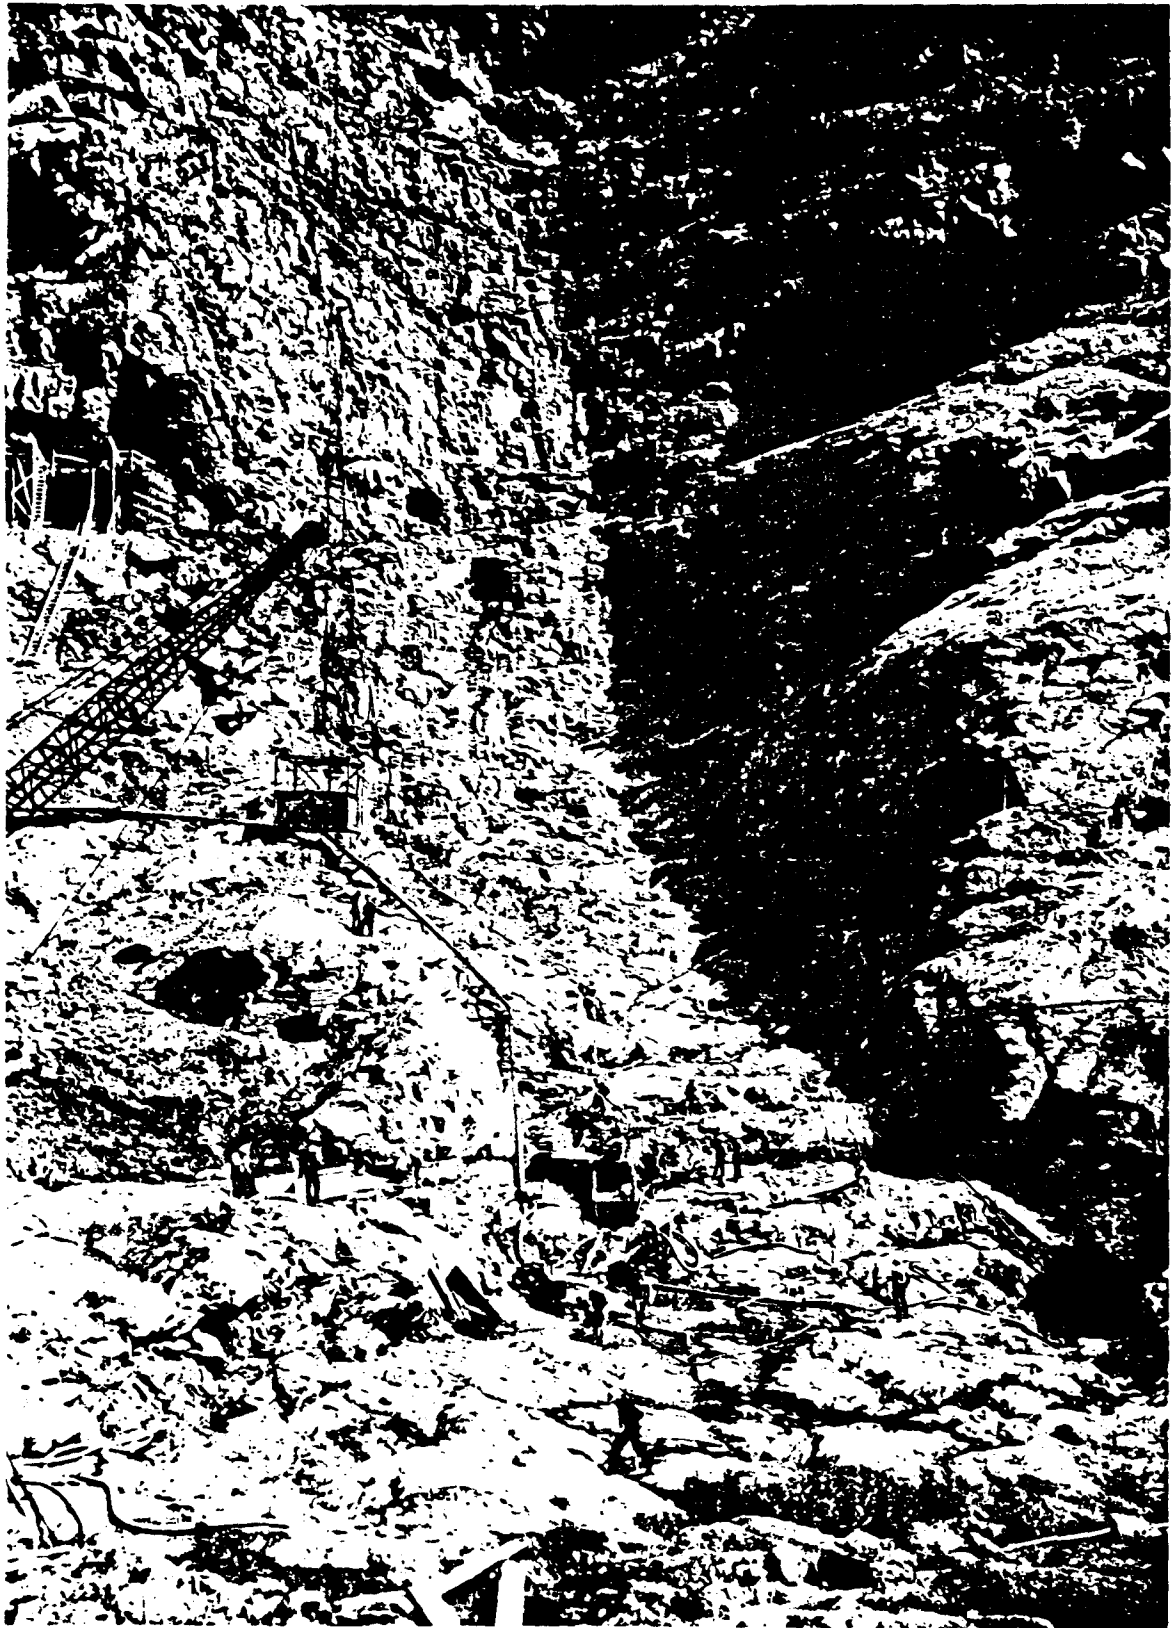
P622B-427-3081 NA---Curecanti Unit---Morrow Point Dam---Colorado
View of the right keyway after excavation has been completed. Grouting is
in progress. 8-4-65

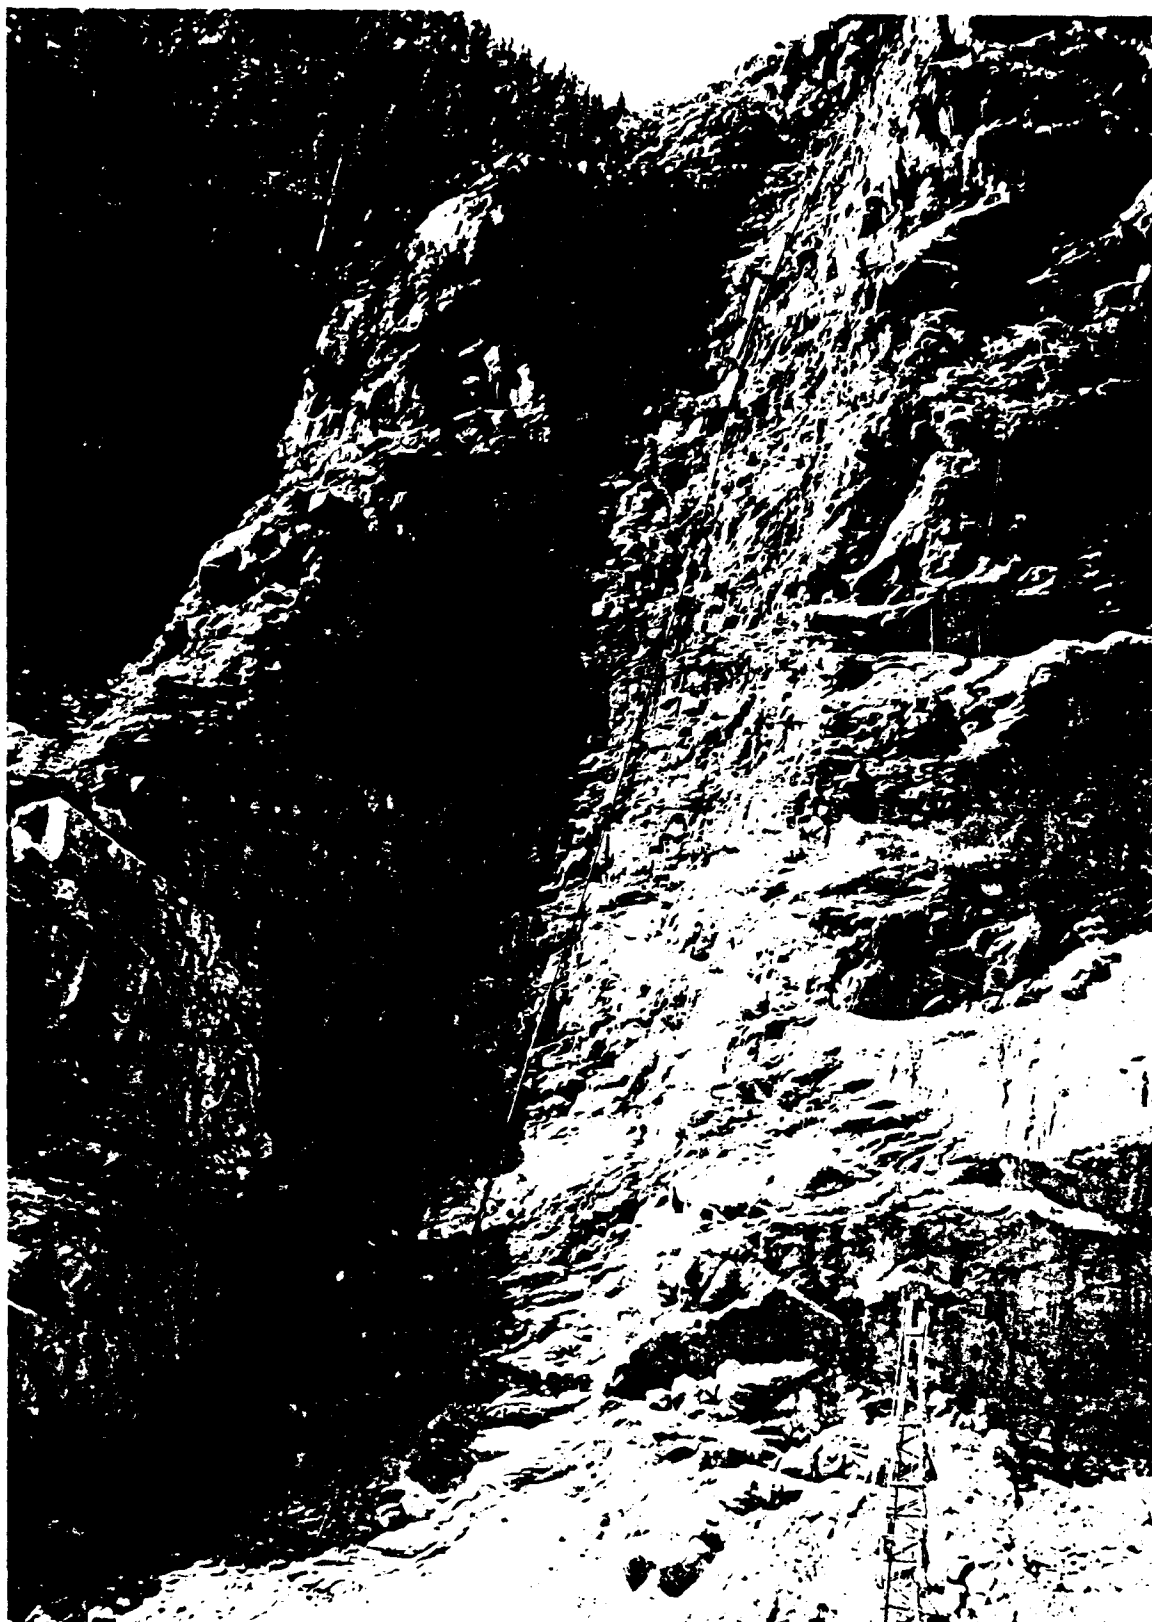
P622B-427-3080 A---Curecanti Unit---Morrow Point Dam---Colorado
View looking at the left keyway after excavation has been completed. 8-4-65

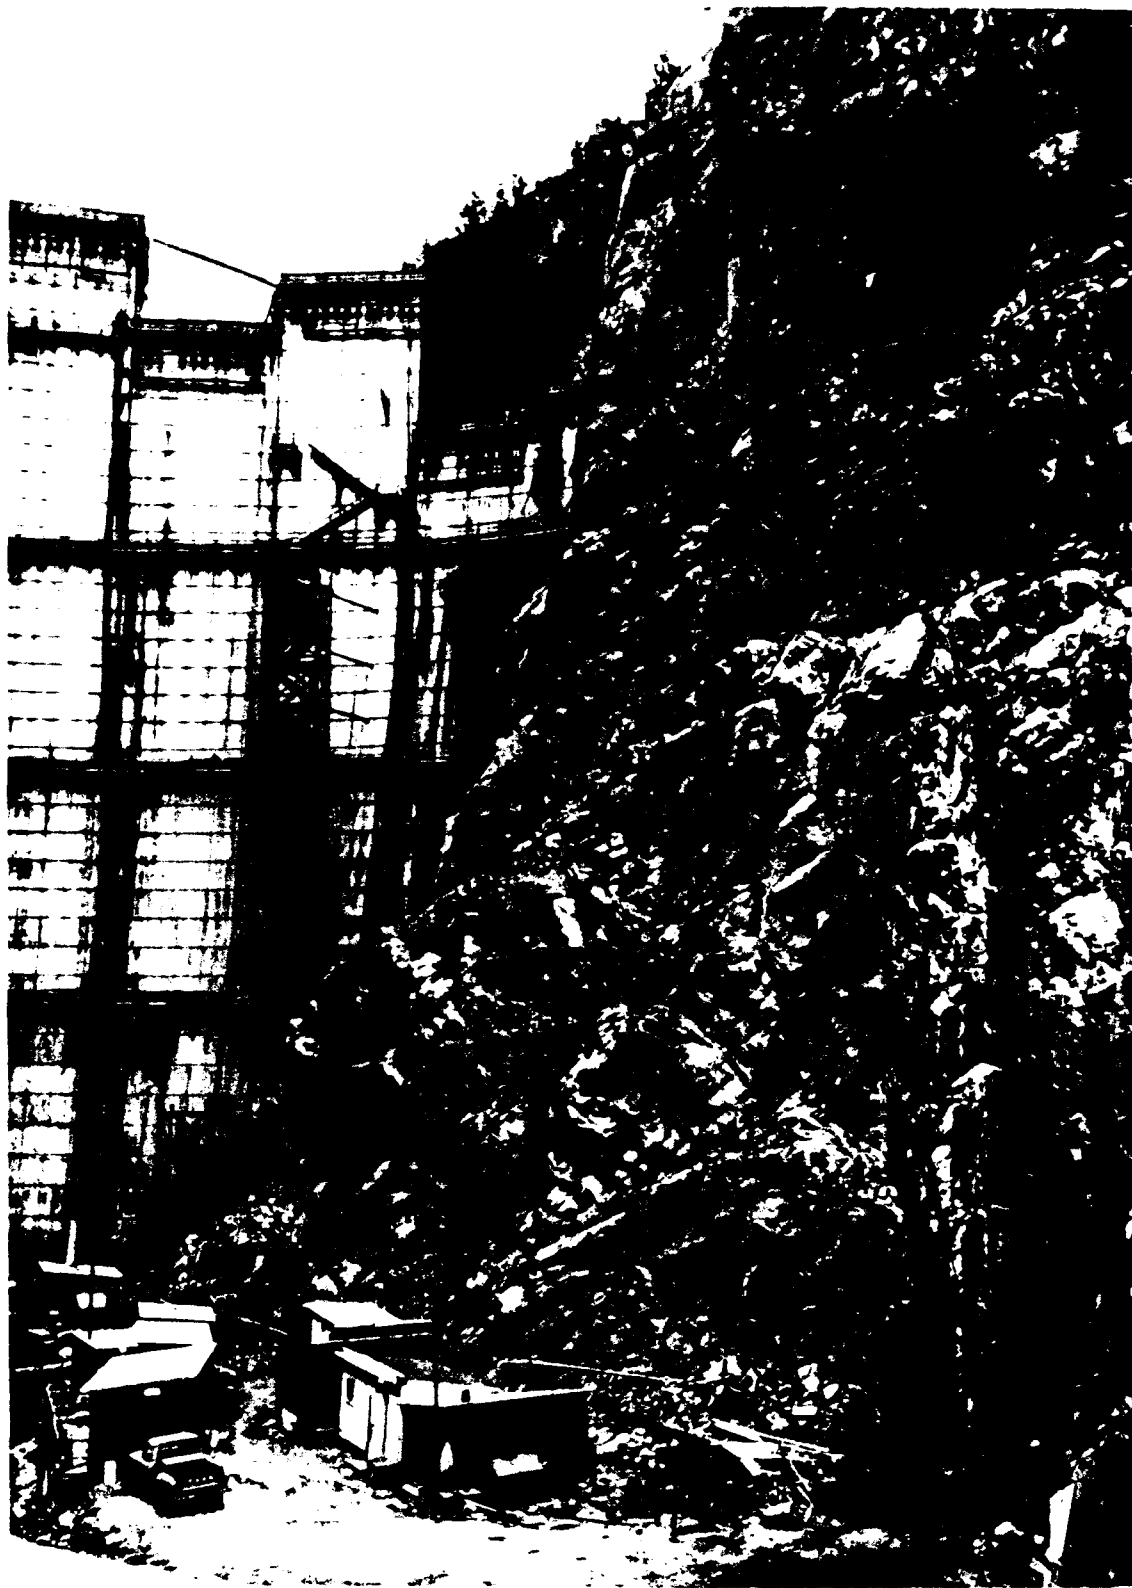
P622B-427-3698 NA--Curecanti Unit - Morrow Point Dam - Colorado--
View of the powerplant open cut area above the downstream portal of
draft tube No. 1. Grout which leaked out above draft tube No. 1 during
the foudation grouting of Block 4 at Elev. 6956+ can be seen in the
right center of the picture. Johnson-MK, Spec. DC-5915. 8-31-66
