# **ANALYSIS OF UTILIZATION OF GROUT AND GROUT CURTAINS — HERON DAM**

*February 1986  
Engineering and Research Center*

*U.S. Department of the Interior  
Bureau of Reclamation  
Division of Research and  
Laboratory Services  
Concrete and Structural Branch*

1. REPORT NO. GR-86-7		2. GOVERNMENT ACCESSION NO.		3. RECIPIENT'S CATALOG NO.	
4. TITLE AND SUBTITLE 3 Analysis of Utilization of Grout and Grout Curtains-Heron Dam 3			5. REPORT DATE 4 February 1986 4

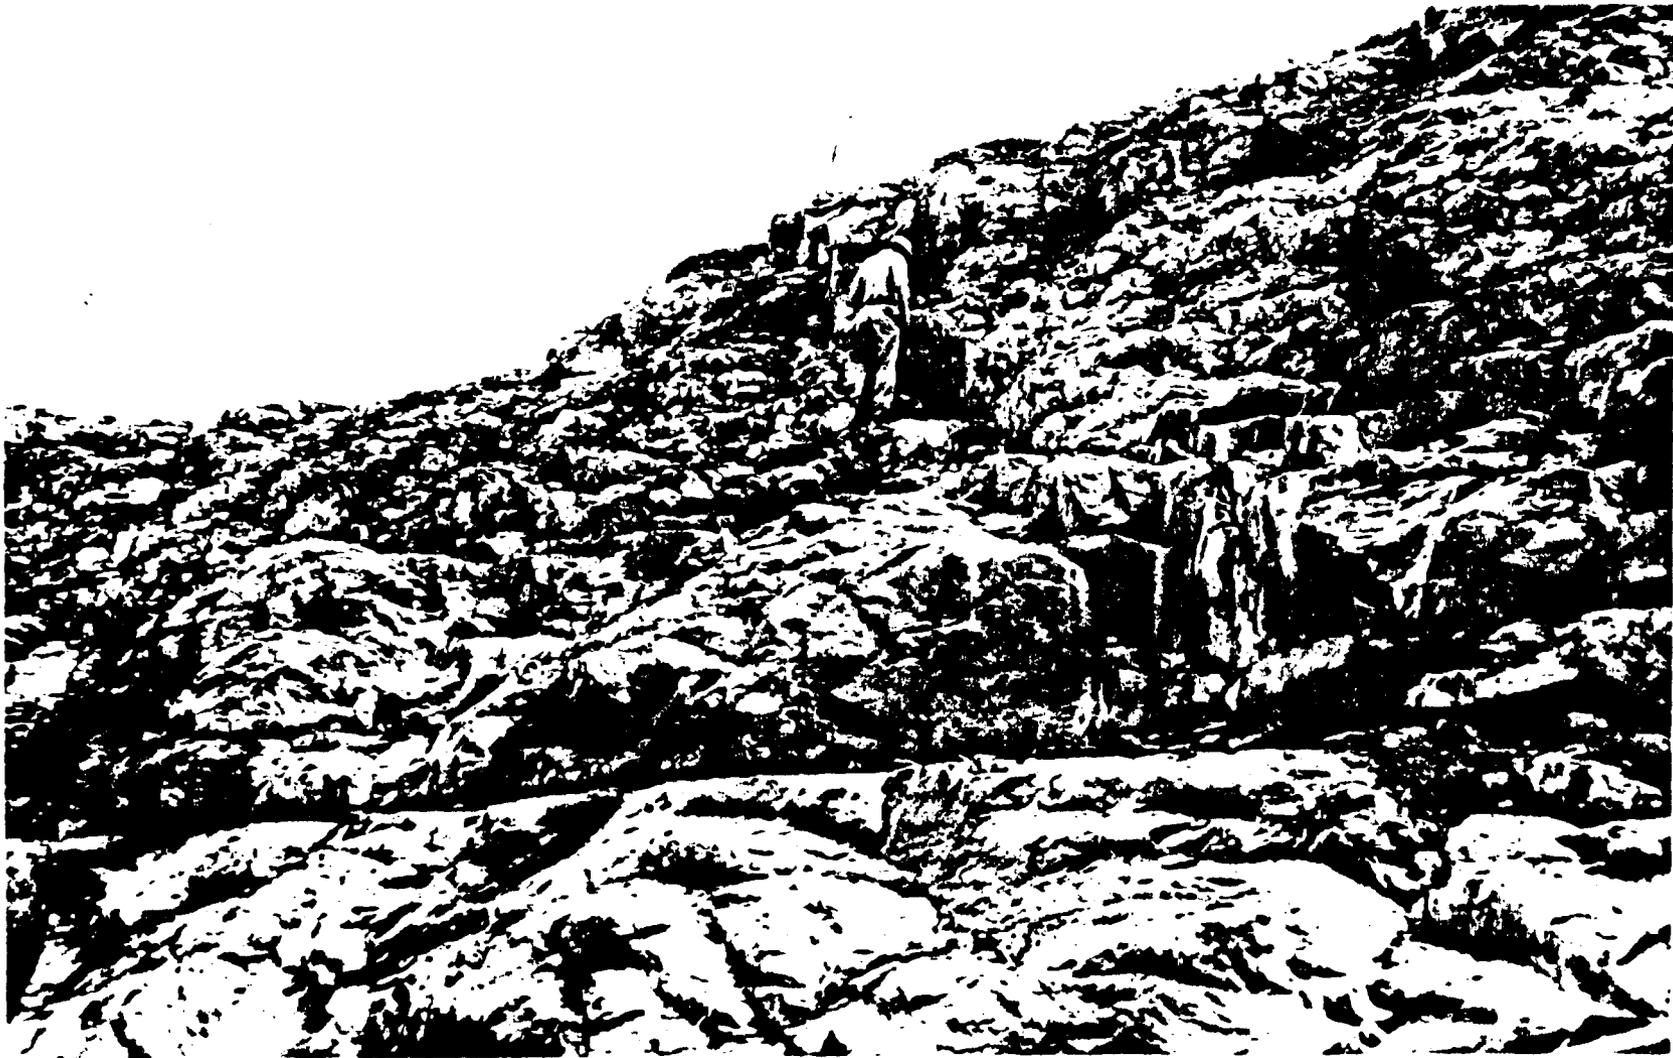
P465-528-2611NA Heron Dam--San Juan-Chama Project--Colorado-New Mexico View of jointing in sandstone near the top of the Dakota formation exposed in the cut-off trench upstream from grout cap station 18+75. Most joints are tight, unhealed, steeply dipping to vertical and strike N 20° - 30° E. The joint on the man's right is open 1 to 2-inches in some places, in others it is filled with 1 to 2-inches of silt and clay.  
Specifications No. DC-6558 Universal Constructors Inc.  
7-21-70 Bureau of Reclamation Photo by D. Manning

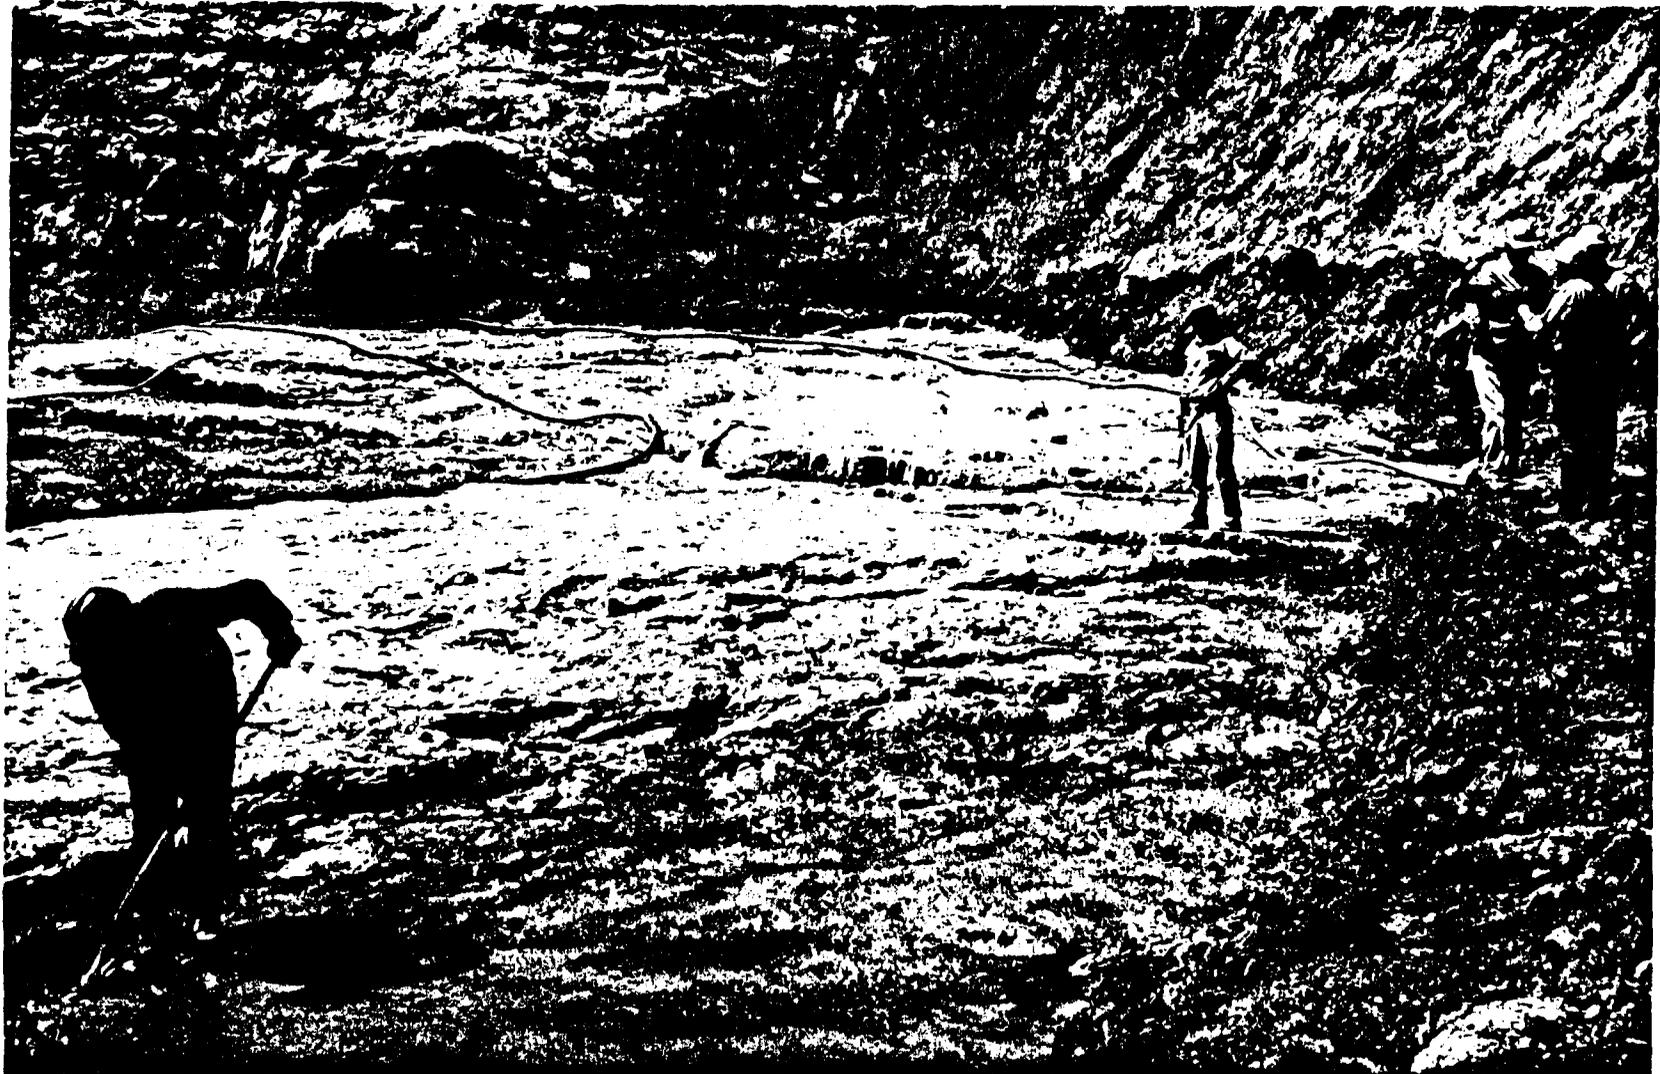
Figure 22

P465-528-2338NA Heron Dam--San Juan-Chama Project--Colorado-New Mexico View of foundation of Heron Dam upstream from the grout cap near the toe of the right abutment. Sandstone of the Morrison formation is present in this area. Water in the lower left of the photo is seeping from a bedding plane.

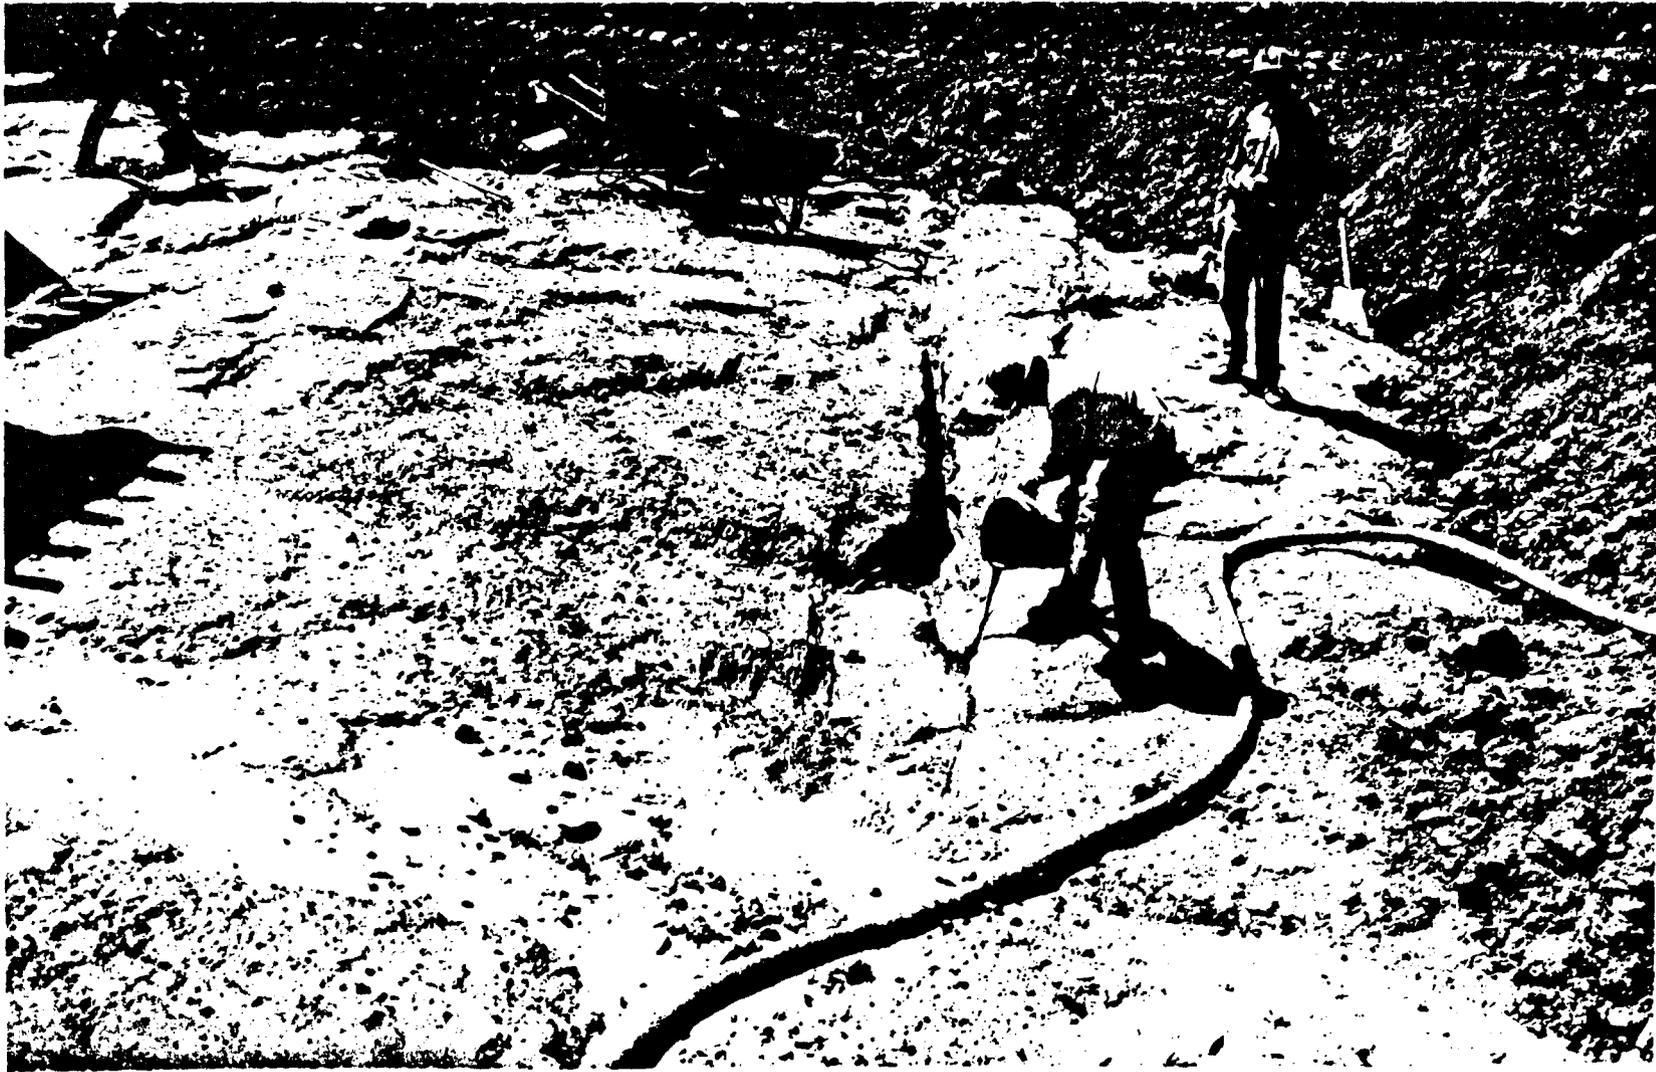
P465-528-2348NA Heron Dam--San Juan-Chama Project--Colorado-New Mexico View of partially open vertical joints in sandstone of the Morrison formation exposed in the foundation downstream from the grout cap. The joints strike N 25° E. Thick cement grout is being poured in these joints.
