Sedimentation Survey
of
SHERIDAN COUNTY STATE LAKE
KANSAS

JANUARY 1950

UNITED STATES DEPARTMENT OF THE INTERIOR

BUREAU OF
RECLAMATION,
REGION 7

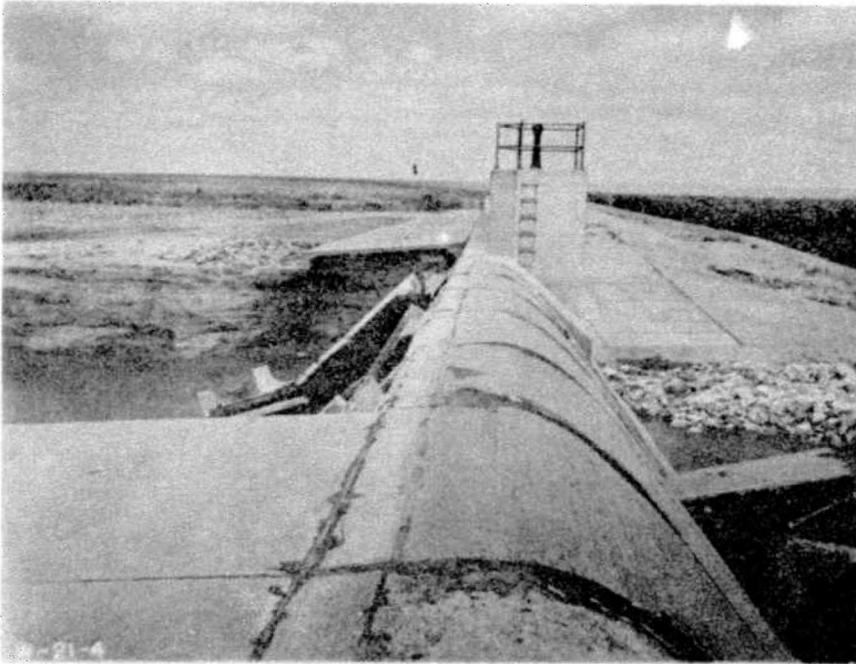
FIGURE 1

At some stage in the life of the dam, the 12-inch weep holes were plugged with concrete. The hydrostatic pressure that built up on the inside of the dam blew off a large section of the downstream face and on June 28, 1948, washed out the hand-placed dry masonry fill from the interior. (See Figure 1.)

View showing break (1948) in Quinter Dam - upstream face of dam on left side.

Repair work on the dam was initiated in October 1948. Repairs included the placement of a cut-off to shale at the upstream toe of the original concrete dam, repair of flood damage to the concrete, and placing the gate in operative condition. The reservoir was filling by April 1949.

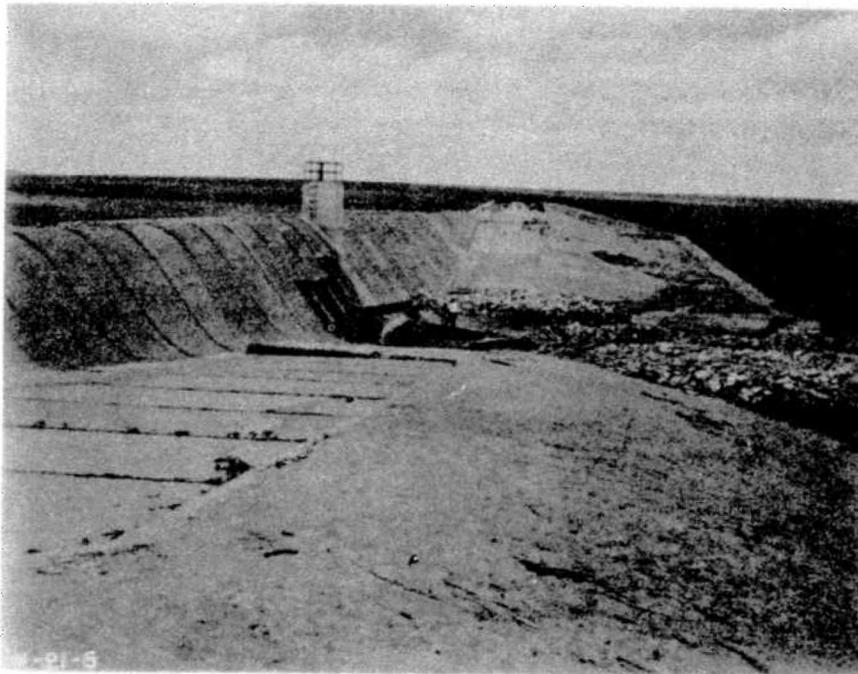
View of downstream face showing break of 1948 due to hydrostatic pressure.

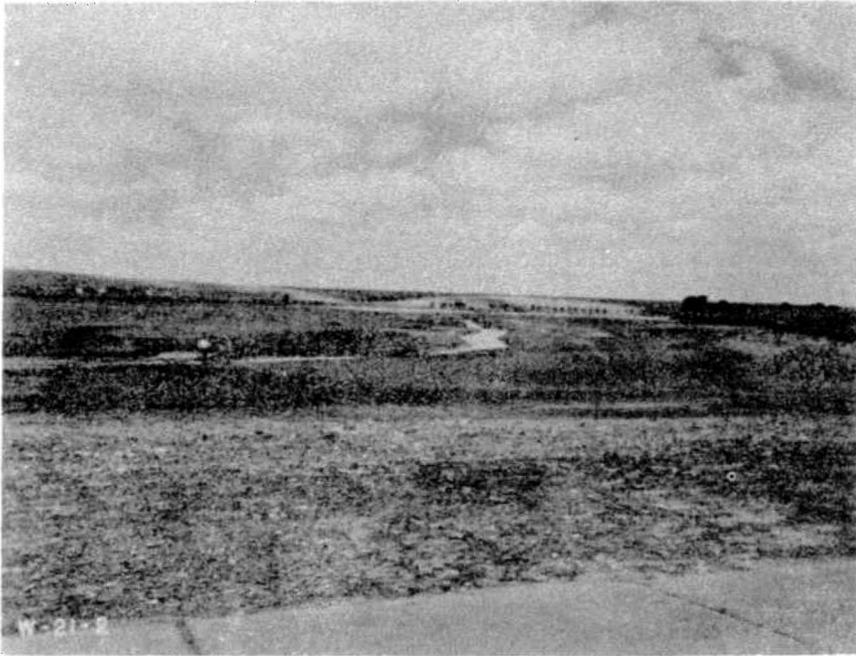
FIGURE 2

Looking upstream - showing sediment deposits in reservoir area above dam.

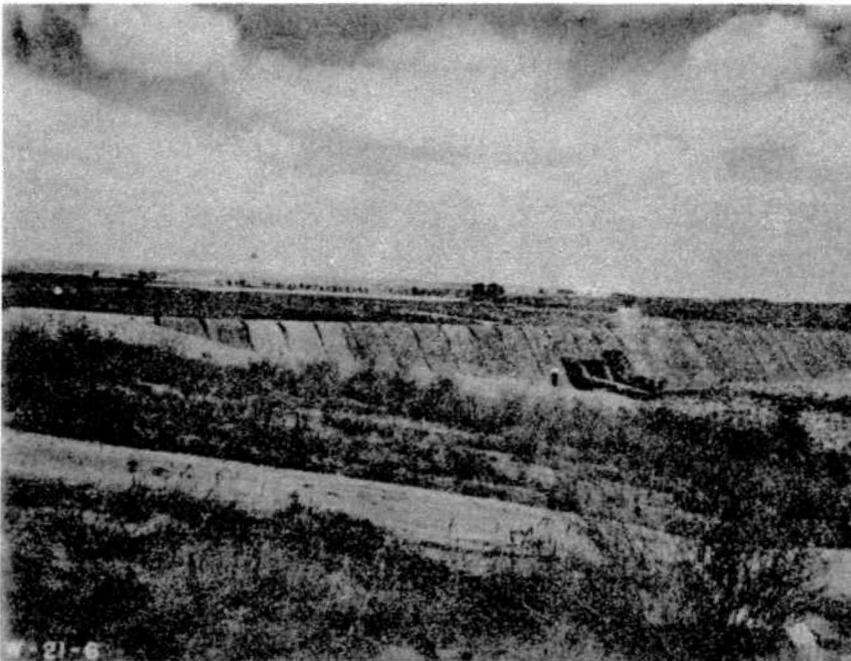
View showing break in Quinter Dam and sediment in reservoir area above dam.

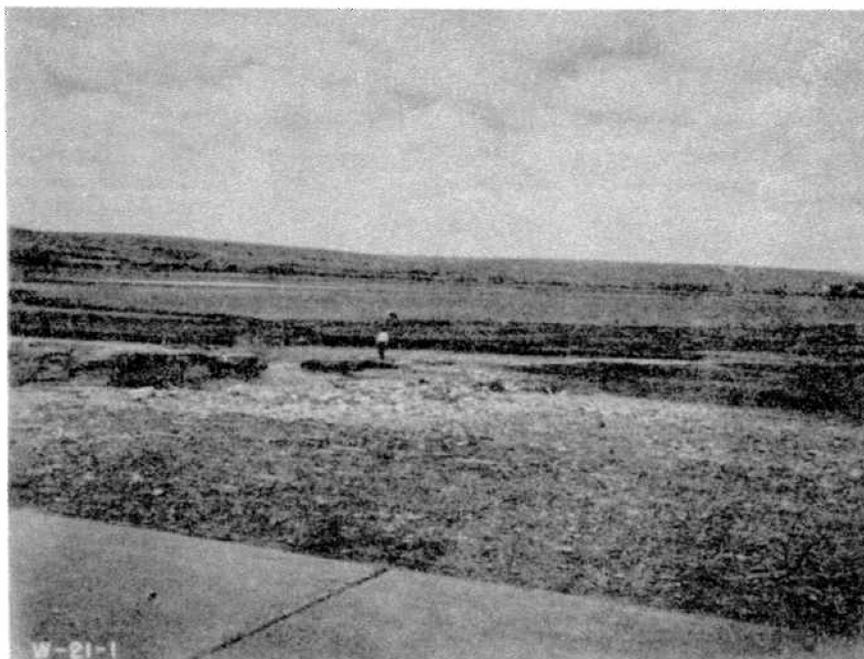
FIGURE 3

View of sediment deposits in reservoir - looking upstream from dam towards right bank.

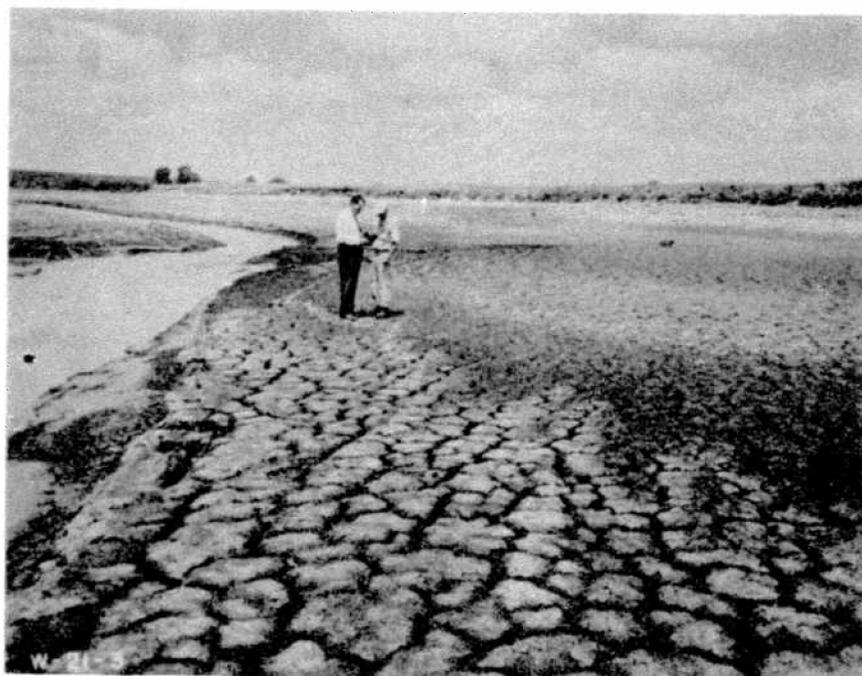
Looking upstream, note sediment deposits in reservoir.
